An Archaeological Watching Brief
at the
The Masons' Yard,
Wells Cathedral

WCM 05 and 06

**Carried out for Purcell Miller Tritton and
The Dean and Chapter of Wells Cathedral**

Report Number 399

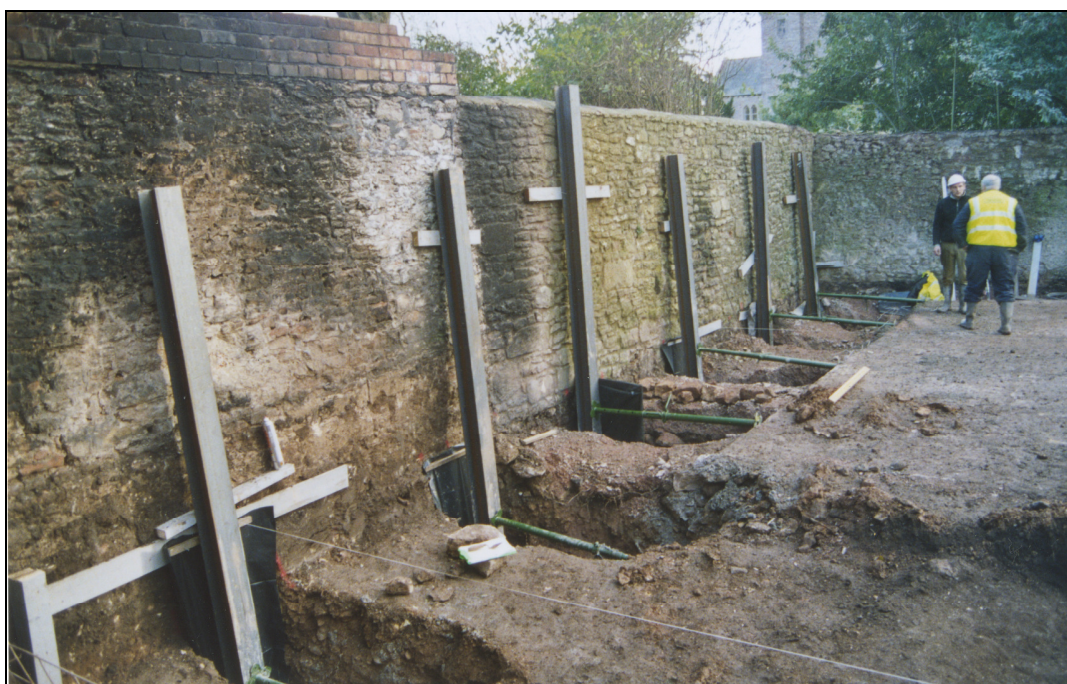
Photograph 1. Reinforcing struts for the Camery wall, set into their pits.

These pits were excavated in order to provide bracing structures to support the East Camery Wall. The wall was protected from the bracing structures and the concrete backfilling of the trenches with a double thickness of heavy plastic. The wall was recorded photographically while it was exposed; apart from the features recorded from the pits, no architectural features were observed. A detailed report on the wall will be included in the forthcoming report on the East Cloister wall.

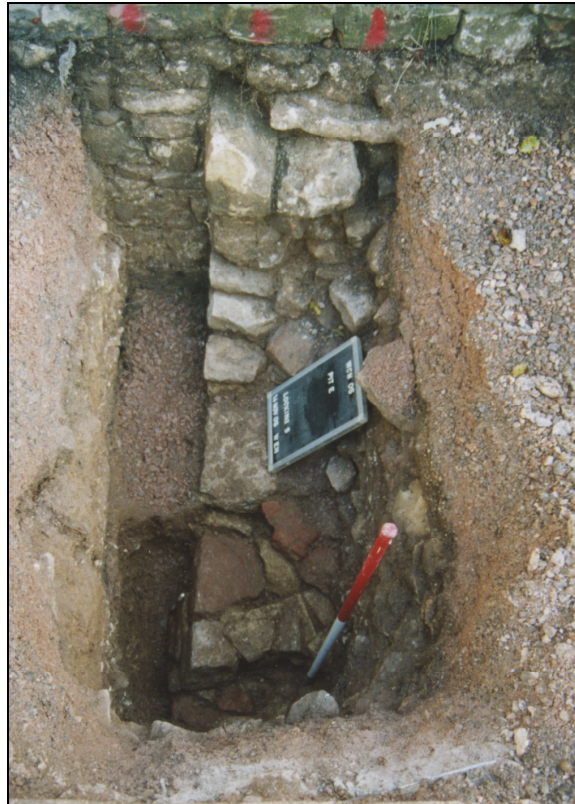
Similar to Pit A, with medieval tile found in light red-brown clay with mortar & charcoal. Southern half of this pit was occupied by the north side of a well-made east-west wall. It was necessary to place a concrete base to a depth of 1.6m on this wall, which was effected by removing one large Doultling block plus a few stones from the next course, revealing 3 lower courses of masonry to a depth of 28cm. Total depth = 1.45m from top of concrete.

Photograph 2. Wall in Pit E.

3.6.3 The wall revealed in Pit E does not appear to extend much further to the west since it was not seen in any of the foundation trenches. If it is confined to the area to the east of the hypothetical relic waterway, it may be earlier than the diversion and channelling of the stream. This wall probably relates to the area surrounding the well-house in the Bishop's Garden, where further information about its dating and nature should be sought.

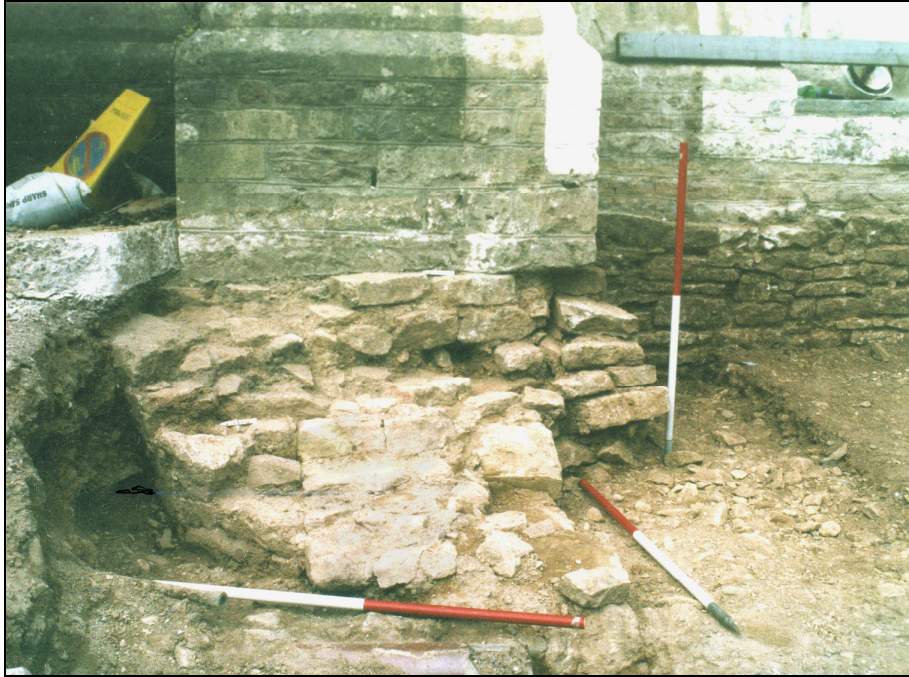
Photograph 3. Eastern elevation of Buttress 1.

The western end of the Camery Wall (**1301**) and the rounded masonry pad (**1306**) had previously been demolished to the lowest few courses before the first wall/buttress (**1346/1343/1346**) was constructed on top of it on a different alignment. Although it has been suggested that **1306** might have been constructed to prevent stone carts from catching on the sharp corners (W. Rodwell, pers. com.), that would only apply if the Camery Wall came to a corner just beyond the point where it became obscured by later masonry. It has not been possible to determine why this end of the Camery Wall was demolished.

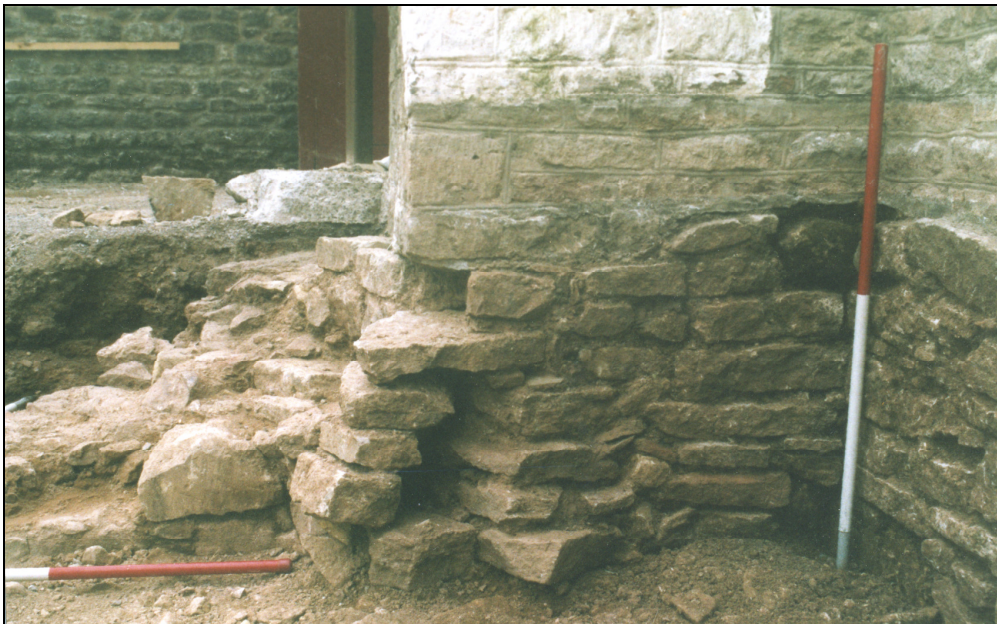
Photograph 4. Buttress 1, north face.

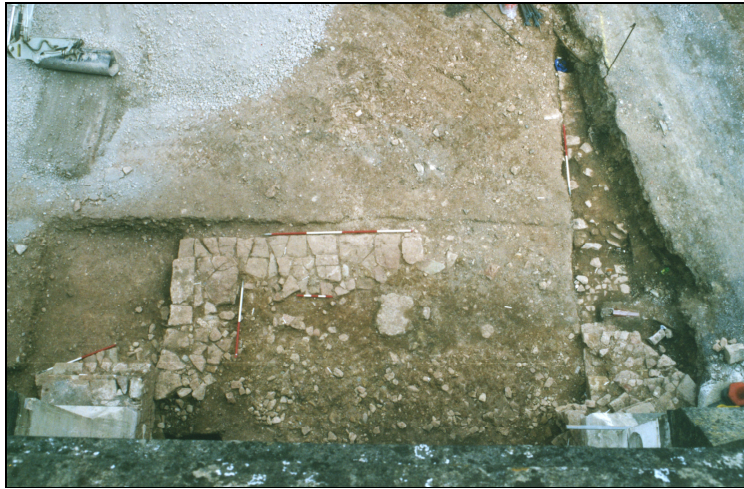
Photograph 5. Porch foundations seen from the Cloister roof. North to the left. To the right lie the remains of the demolished Camery wall (1301).

Removal by machine of the nineteenth century layer in Bay 1 revealed the foundations of a hitherto unknown structure best interpreted as a porch (Figure 7, Photograph 5). Cleaning of the exposed surface produced many sherds of pottery dating to the 12th to 16th centuries (Finds List). The porch gave access to the cloisters via a doorway that had been blocked (Photograph 6).

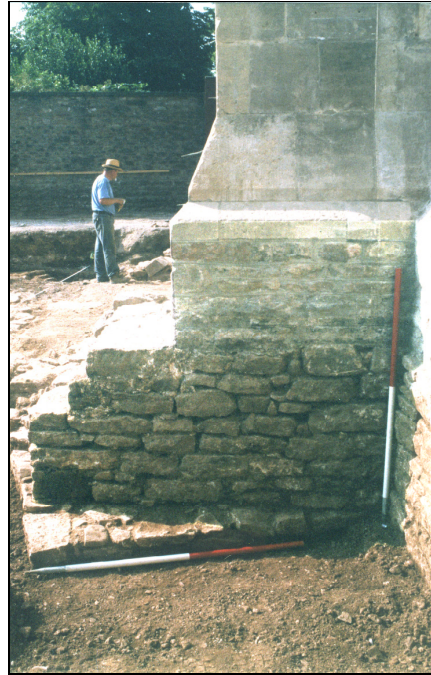
Photograph 8. The foundations of Buttress 1/2, north face.

This buttress has much simpler foundations than those of Buttress 1 and is set squarely below the buttress. The foundations, incorporating three offsets, extend up to 0.6 metres

beyond the buttress itself. The foundations of the cloister porch butt up against these foundations and are clearly of a later date.

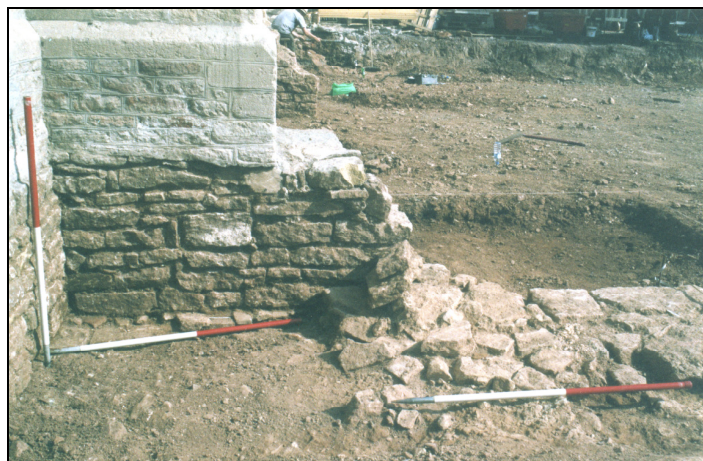
Photograph 9. The foundations of Buttress 1/2, south face.

The relationship between the porch and **Buttress 1/2** indicates that the porch is a secondary feature , as demonstrated in Photograph 9 .

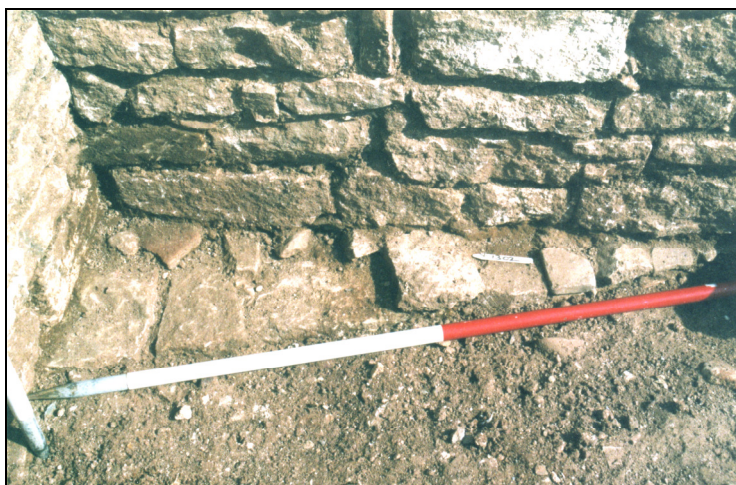
Photograph 10. Wall **1302** below Buttress 1/ 2.

The buttress foundations rest entirely upon a foundation pad (**1302**) lying at an angle to the Cloister walls.

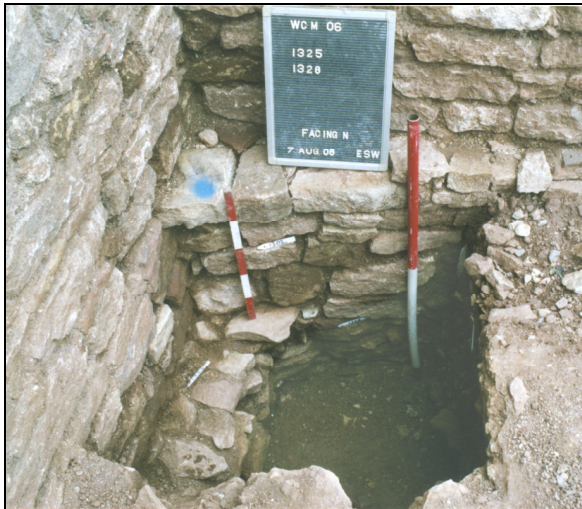
Photograph 11. Sondage F. Cloister wall it to the left.

The sondage revealed that the medieval make-up (**1313**, **1326**, **1340**) and construction (**1325**, **1339**) layers lie immediately below the nineteenth-century trample layer to which had been removed by machine. The foundations for the Cloister wall has an offset (**1328**) which embraced the offset for the earlier buttress **1302**.

The lowest layer in Sondage F (**1341**) produced no datable finds. The sondage revealed that buttress foundation **1302** consists of at least seven courses of masonry and extends to a depth of c80cm. No foundation trench was recognized in Sondage E and the medieval layers in the sondage appeared to butt up against the foundation.

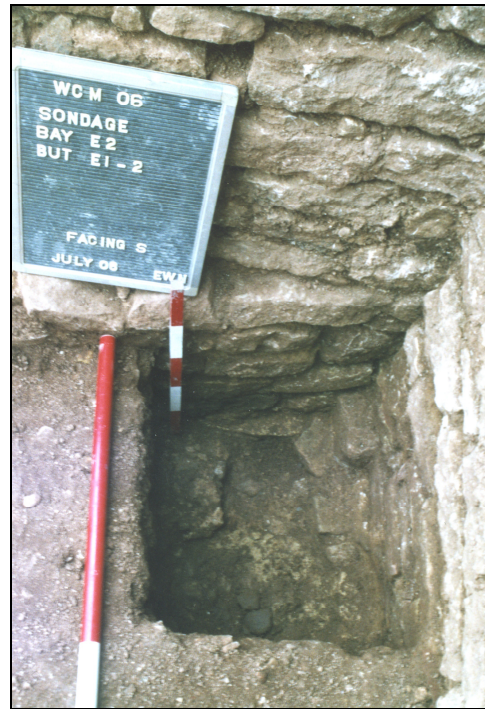
Photograph 12. Sondage E. Cloister wall is to the right.

The construction trench for buttress foundation **1302** was recorded in this sondage.

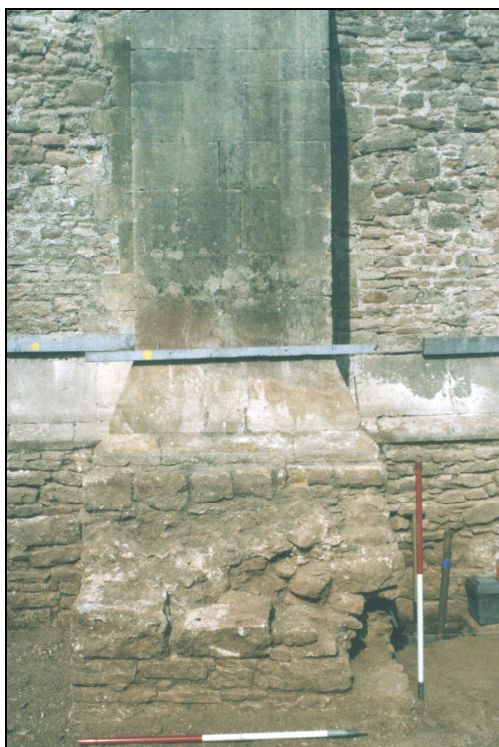
Photograph 13. Buttress 2/ 3, east face.

The construction of Buttress 2/ 3 is similar to that of Buttress 1/ 2, with its eastern stepped offset, in this case disturbed in the recent past, probably in connection with the construction of the sheds for the Masons' Yard. The void in the lower right eastern face is not an original feature (Photograph 13). The south face of the buttress appears to show the eastern offset of the foundation as a secondary feature (Photograph 14), which may have been a response to the difficult ground in which the Cloister was constructed. Whatever the truth of the matter, the similar offset in Buttress 1/ 2 is integral to the foundations.

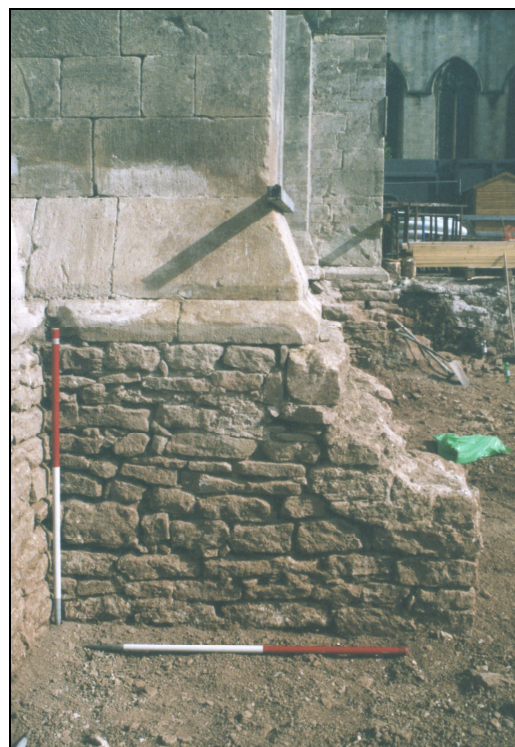
Photograph 14. Buttress 2/ 3, south face.

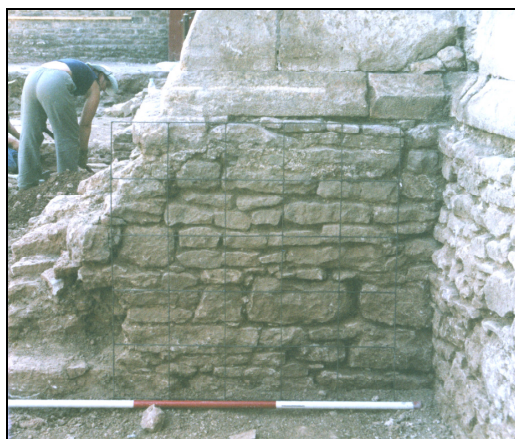
Photograph 15. Buttrass 2/ 3 north face.

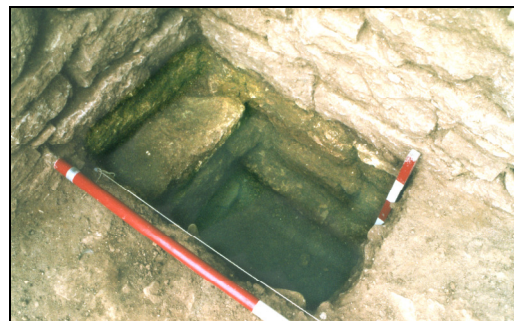
Photograph 16. Sondage A, Buttrass 2/ 3 to left.

Sondage A was located on the northern face of the Buttrass, in Bay 3. It revealed that Buttrass 2/ 3 has an offset which butts up against, and is later than, the offset for the Cloister wall foundation (**1328**).

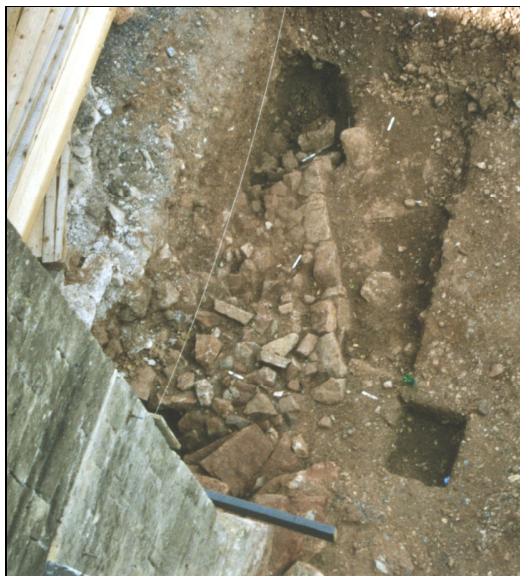
Photograph 17. Latrine tower and wall **1320** from roof.

The edge of the 1979-81 excavations in the Camery (Rodwell, 2001) happened to be close to the edge of the excavations for the new buildings, with a slight overlap of the two excavations; this allowed for the positive identification of wall 1320 as being the same as **F640**, a Saxon wall excavated by Rodwell.

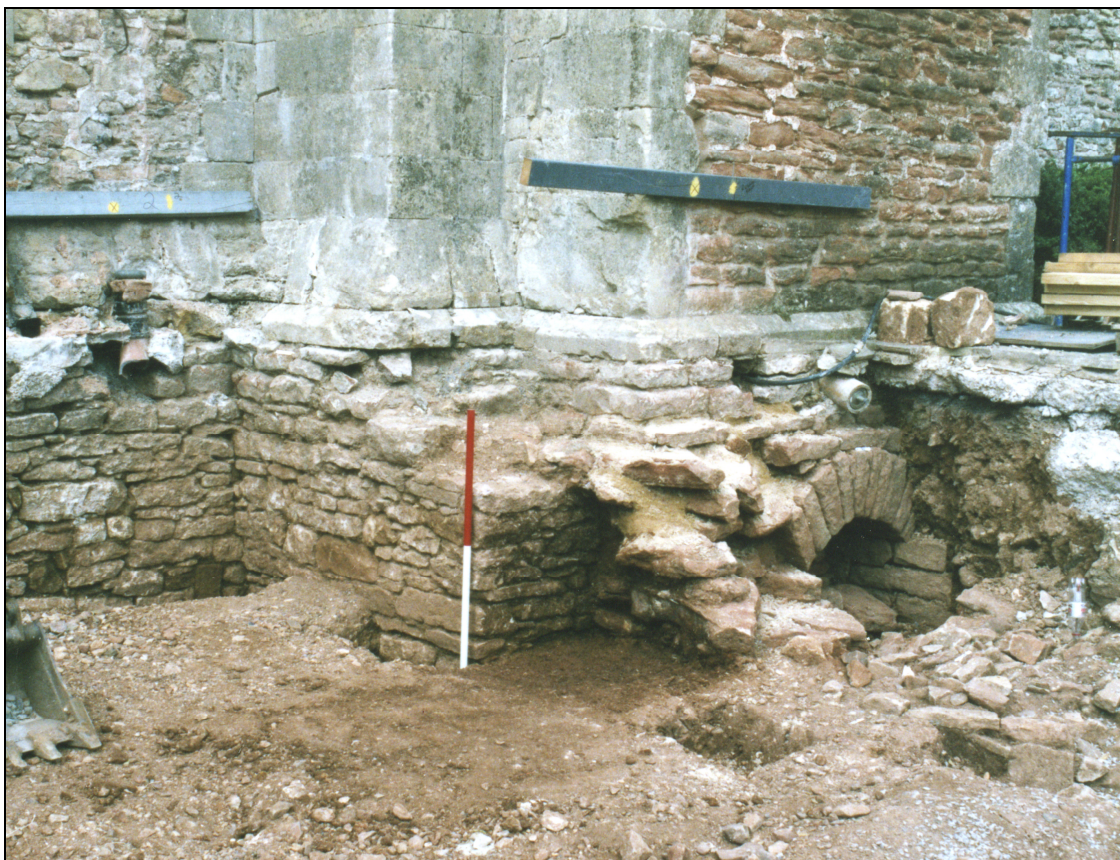
Photograph 18. General view of the Latrine Tower from the south-east. Machining caused slight damage to the left side of the access opening, subsequently repaired.

Buttress 3/ 4 was used as a support for a sixteenth century latrine tower. Matching the other buttresses described above, it carries a stepped foundation pad similar to that of Buttress 2/ 3. Sondage C revealed that the offset of the buttress butts up against the offset for wall **1300**, the Cloister wall foundations.

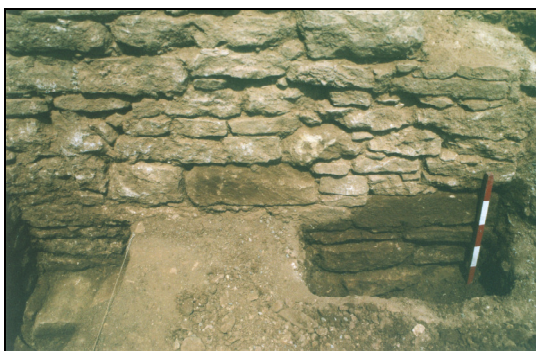
Photograph 19. Buttress 3/4 foundations, south face with sondages.

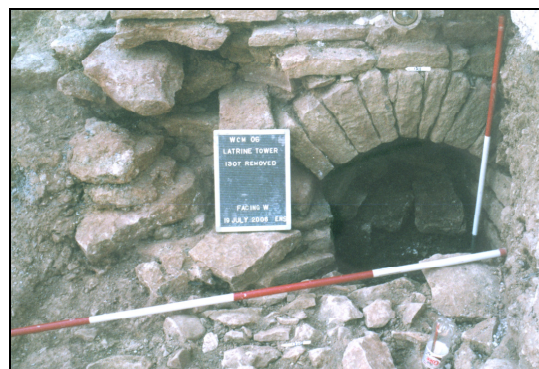
Photograph 20. Latrine opening.

In the area before the latrine opening, the foundations of wall **1320/F640** had been reinforced with pitched stones to form a hard standing (**1308**) in order to aid clearance of the cess from the latrine (Photograph 20). The tower has been pressed into modern
