**Archaeological Excavations at
The building known as
THE TRIBUNAL, GLASTONBURY**
Replacement of Paving in Rear Courtyard

Scheduled Monument no. 22075

Carried out for English Heritage
grid reference for the site is: ST 4993 3896

Report number 505b

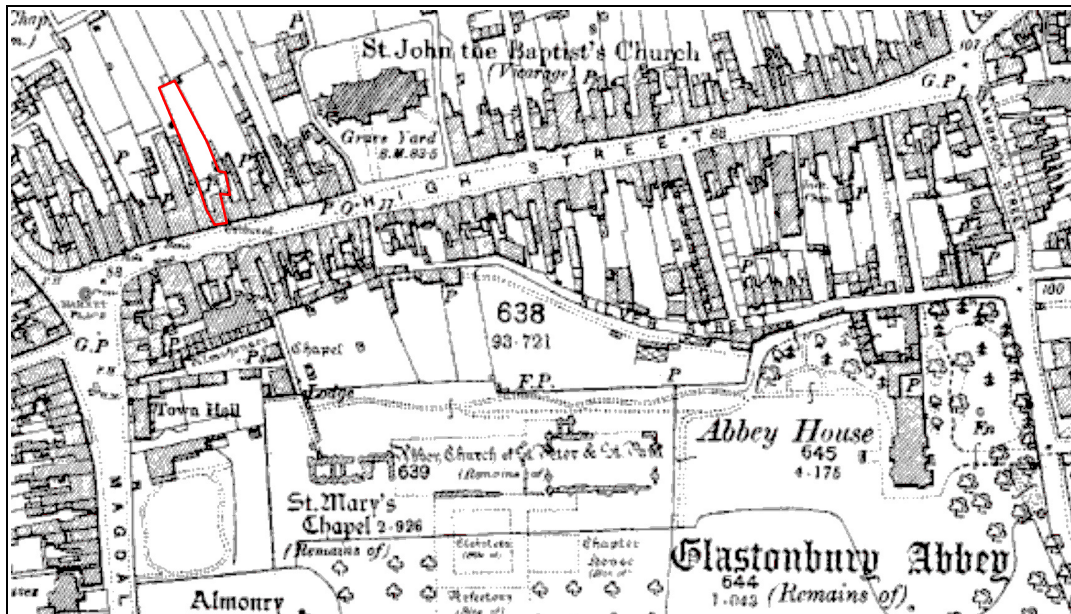
Figure 1. The location of the building called the Tribunal outlined in red on the 1904 Ordnance Survey map.

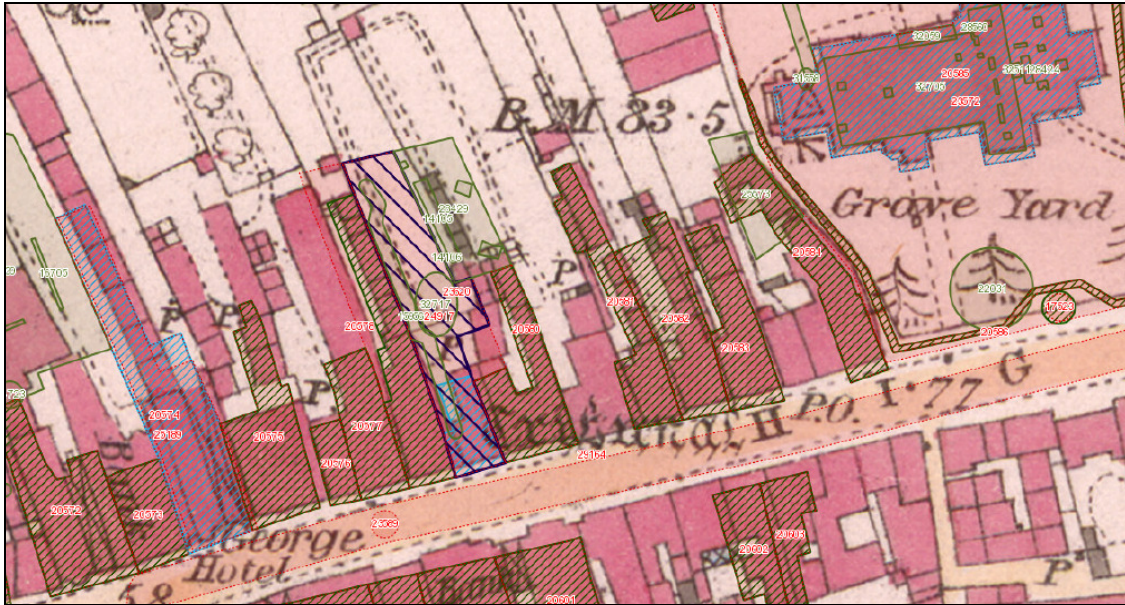
Figure 2. The building known as the Tribunal and its surrounding properties taken from the Somerset Historic Environment Records⁵. The Tribunal is marked with diagonal hatching. The background map is the 1st edition Ordnance Survey map of 1886.

2.2 The Somerset Historic Environment Record shown here illustrates the layout of the Tribunal in relation to its neighbouring properties. This shows the extent to which the Tudor kitchen block (Room 5 in Figure 8) extends beyond the expected property boundary, appearing to form part of number 11 High Street.

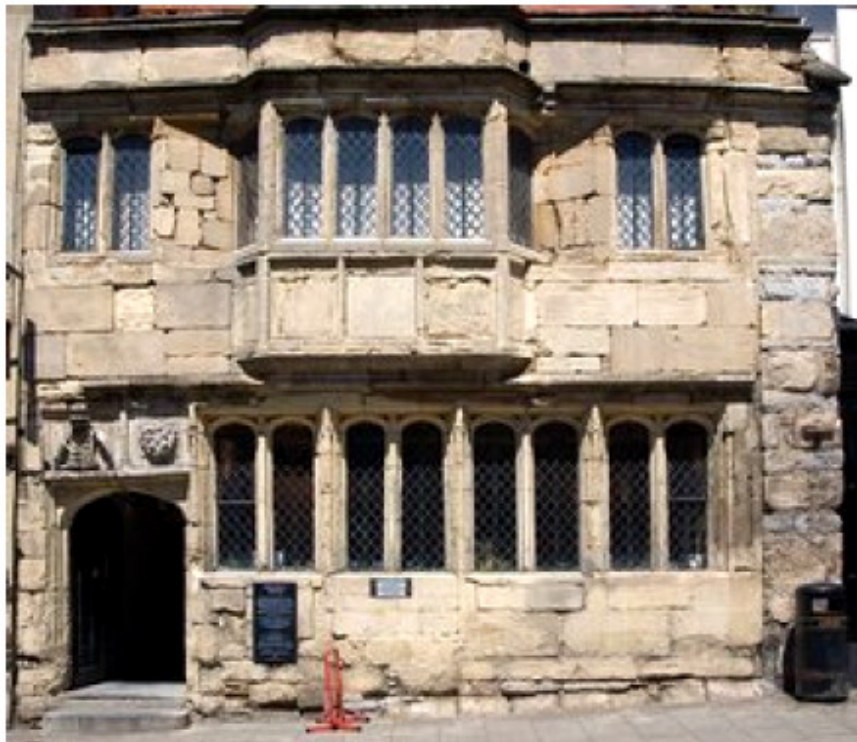
Figure 3. The street frontage of the building known as the Tribunal⁶; note the earlier masonry of the east gable wall to the right of the photograph. The facade of the building displays several additions and alterations carried out during the medieval period.

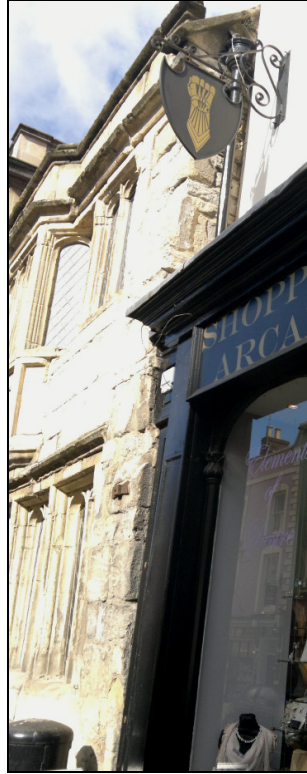
Figure 4. Detail of the join between the Tribunal and number 11 High Street.

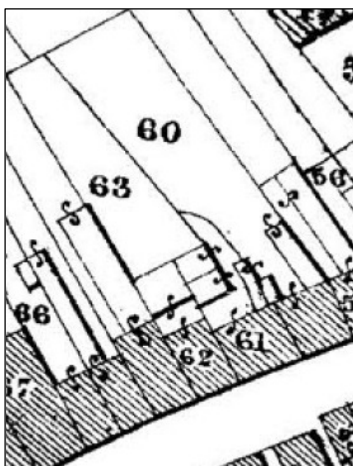
Figure 10. A detail of the tithe map. The Tribunal is plot 62 and the burgage plot is 63. The property boundary and layout suggest that Room 5, belonging with plot 62/3, impinges onto plot 61.

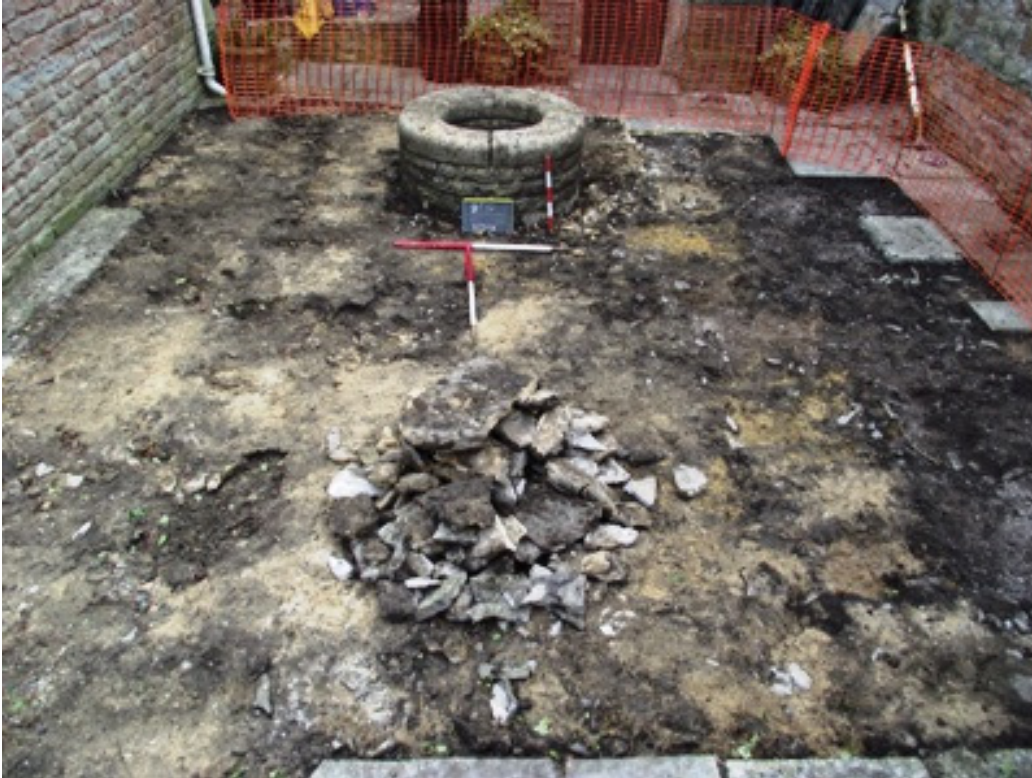
Figure 11 - Lias slabs (201) removed. Mixed surface of (202) & (203) exposed.
A pile of cement associated with (201) is in the foreground.
The trench from 1992 is visible on the right side of the photograph.
Looking south.

7.1 The archaeological excavations commenced on Monday 11th March 2013 and concluded on Wednesday 20th March 2013. The building contractors lifted Lias slabs (201) before the archaeologists arrived on site. The slabs were then placed upright in the corridor to the west of the Tribunal building. The stone slabs are just visible at the top-right corner of the photograph below.

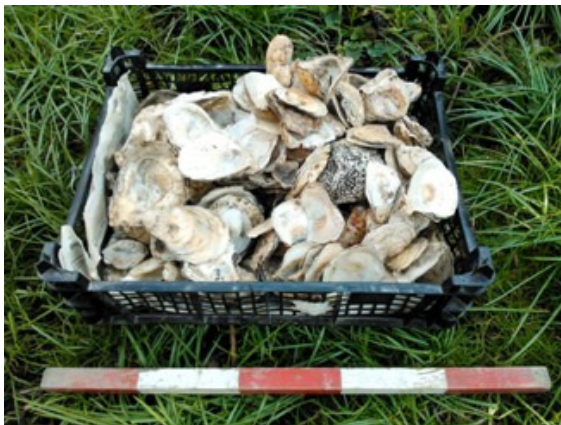
Figure 13-

Oyster shell retained from excavating the east half of deposit (203).

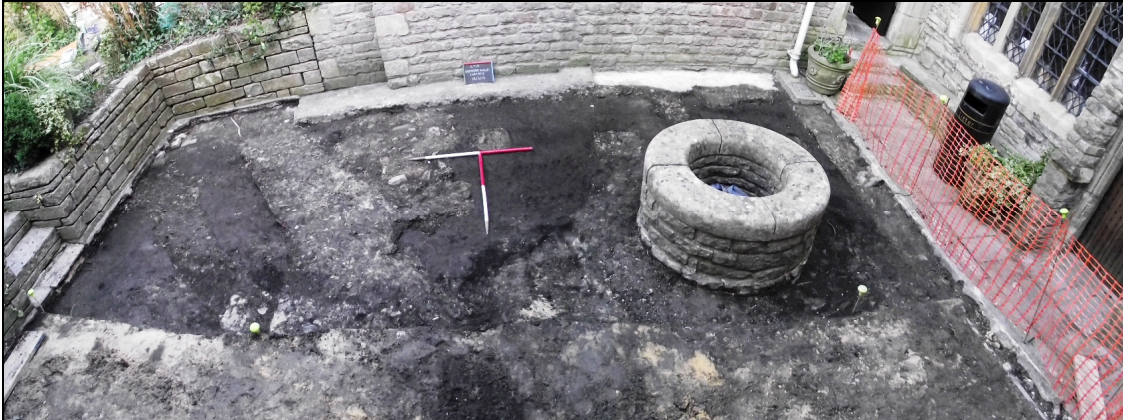
Figure 15 – Eastern side - Cleaned – sand (202) & deposit (203) visible in the foreground. Looking east.

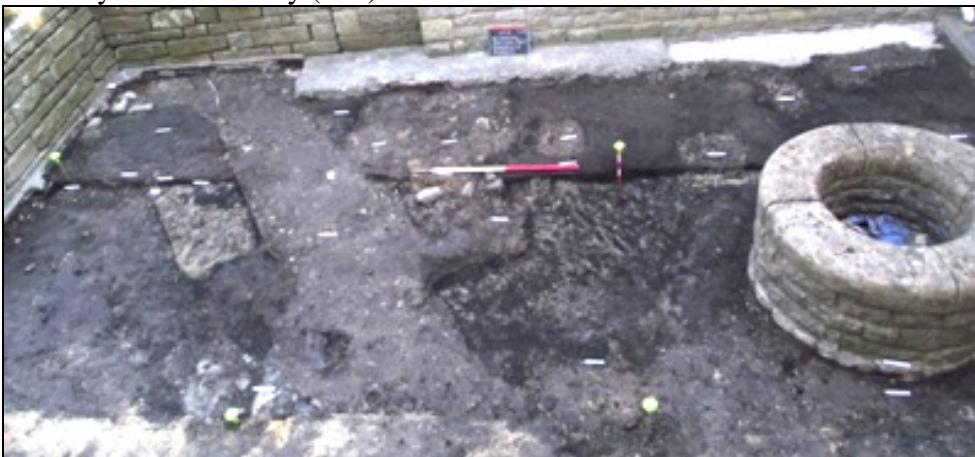
Figure 16 -west-facing section from 0mN / 2mE to 7mN / 2mE

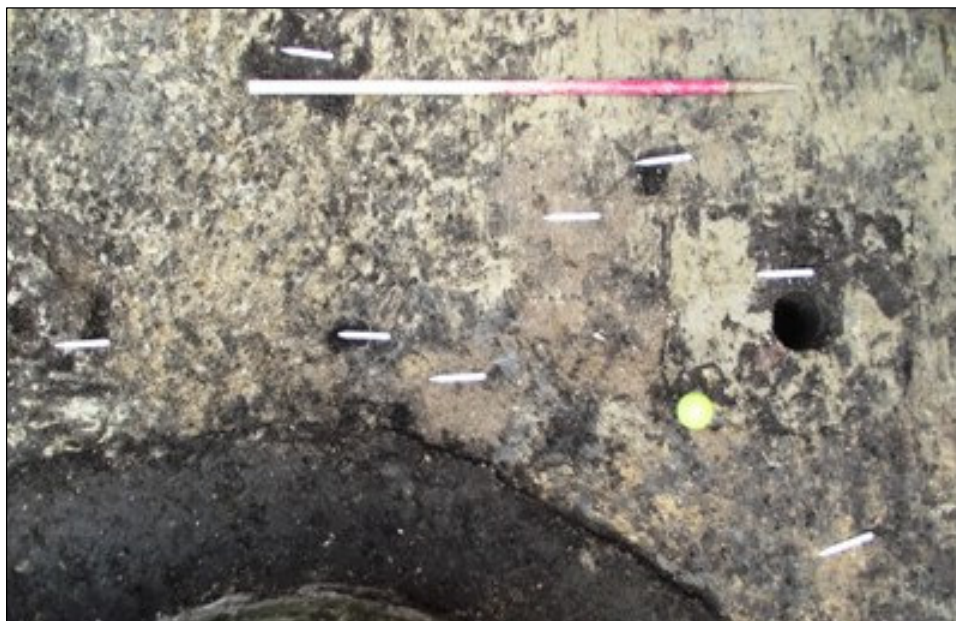
Figure 18 –
Potential Stake holes (233), (234) and (235), scaffold post pad (216) with a void on the right and (214) on the left. Light brown-orange mortar

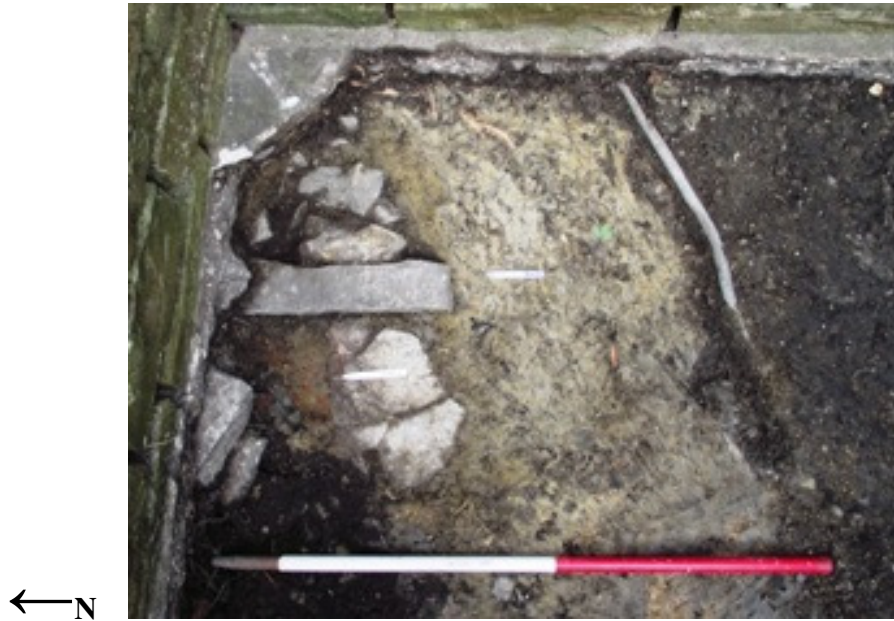
Figure 19 – from left to right – linear feature (208) at the bottom left, the fired clay and rough Lias blocks associated with (240), Lias clay (243), the lead pipe within pipe trench (207).

Directly underlying the east end of the south face of retaining wall (280) was a conspicuous area of rough Lias stone blocks. The stones were one or two un-mortared courses high, measured up to 80mm x 120mm x 520mm, and appeared as if they may have been deliberately placed. These stones were numbered (240).

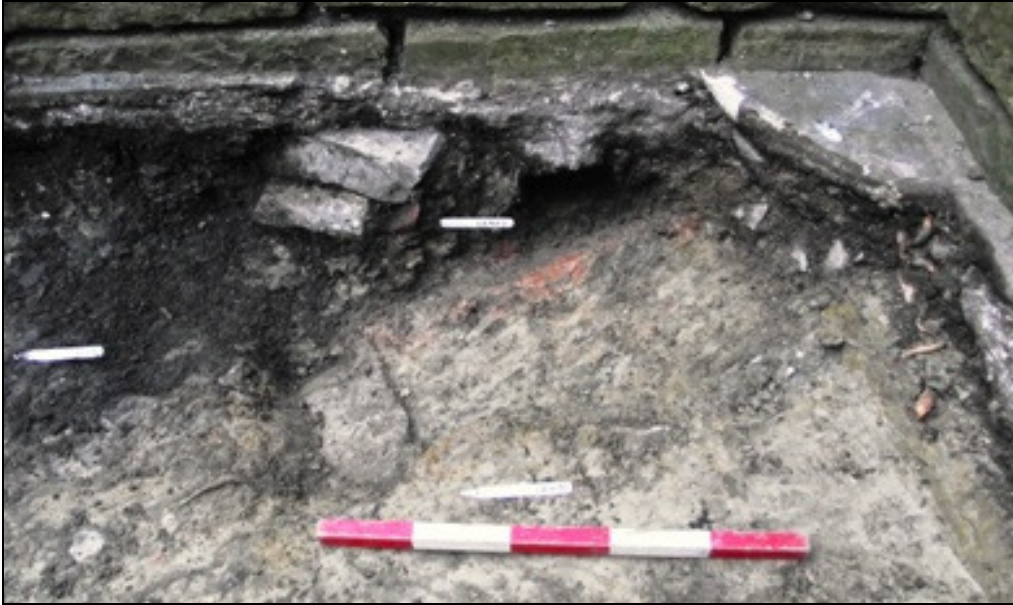
Figure 20 - Hearth (240) – most of the Lias stones and fired clay removed. Linear feature (208) is visible at the left of the photograph. Two Lias stones underlie the cement associated with Lias slabs (201) in the centre. Looking north.

7.20 The Lias stone blocks were removed by hand exposing a patch of *in-situ* fired clay which was intermittent but covered an area c.0.35m N-S x c.0.70m E-W. The fired clay was lifted and retained as it was only one layer thick (c.0.02m). The underlying Lias clay had been heat affected. A slightly concave shape was revealed when the fired clay was excavated, but not enough to confidently assign a cut number although one was probably present. Also thin sheets of local Lias bedrock (up to 5mm thick) were occasional present beneath the fired clay. It was clear if these stones were archaeological or a feature of the natural clay. They had also been heat affected. The west edge of (240) had been removed by pipe trench (208) in antiquity leaving two Lias blocks, with one stone sat upon the other, marking the west edge of a fill that probably originally extended a little further to the west

7.21 (240) represented the southern edge of a hearth. The feature continued to the north beyond retaining wall (281). Two very small pottery sherds were recovered within the fired clay which look like medieval coarsewares. Hearth (240) may be indicative of localised industrial activity such as pottery production. These excavations produced no evidence of metal working on the site.

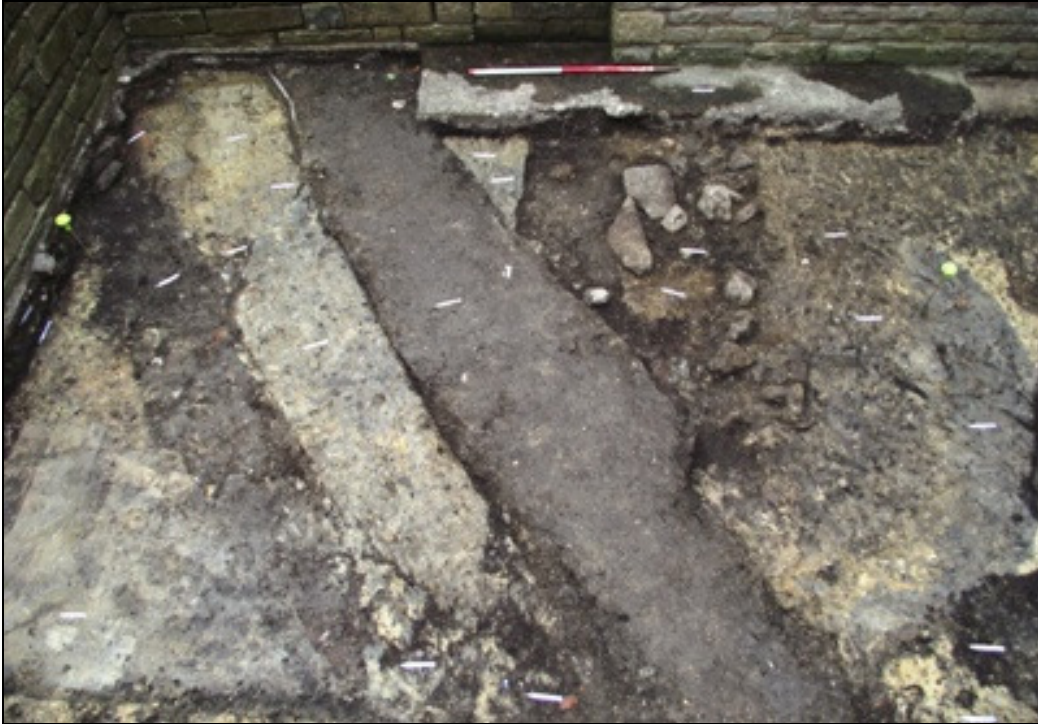
Figure 21 - Potential large oval feature. Curved south edge (238) and re-deposited Lias clay (242) are at the right of the photograph. Linear robbed out wall trench (217) / (224) is in the centre. (239) is exposed between pipe trenches (207) and (208) / (248) are to the left of centre. Fill (357) is exposed at the bottom right. The heat affected clay of hearth (240) is at the top left of the photograph.

7.23 The positions of the service trenches and square cuts around the northern half of the trench had made it impossible to be completely confident of the exact relationship of these fills. We can only make suggestions based on their material compositions, artifacts and shapes in plan. Taken together, it could be suggested that a number of contexts may represent a large oval pit c.4m long (N-S) x c.3m wide (E-W). If so, the long axis of this pit would be in accordance with the long axis of the Tribunal garden plot. Three potential fills have been identified - Central backfill (242), main silted-up fill (238) / (239) / (244), and potentially a primary fill represented by (245) and (246). The pit could have been a clay borrow pit, or it could represent a semi-permanent structure with the outer fills representing an eaves-drip gully. There may have been an association between these features and hearth (240), for example, the pit may have dealt with the waste from (240).

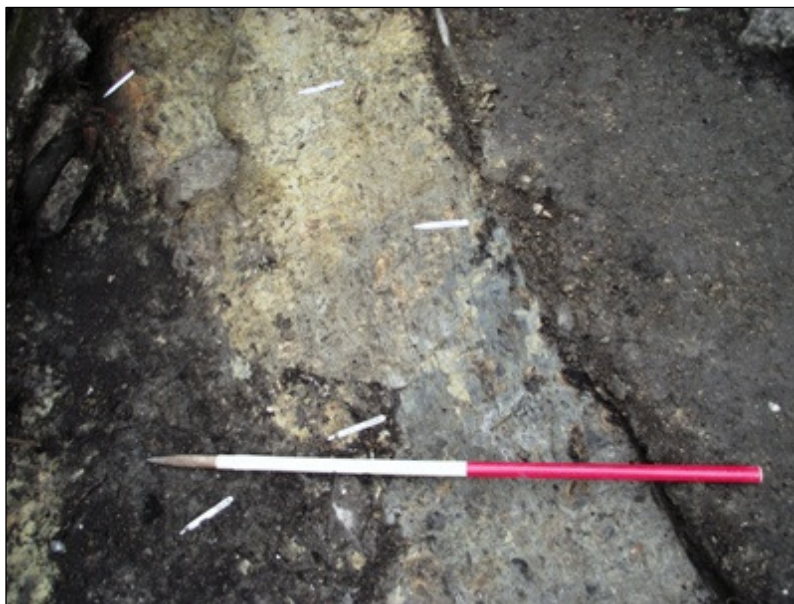
Figure 22 -

Fill (239) and (246).
Pipe trench (208) at the
bottom right.
Hearth (240) and Lias
clay (243) top right.
Pipe trench (207) on the
right.

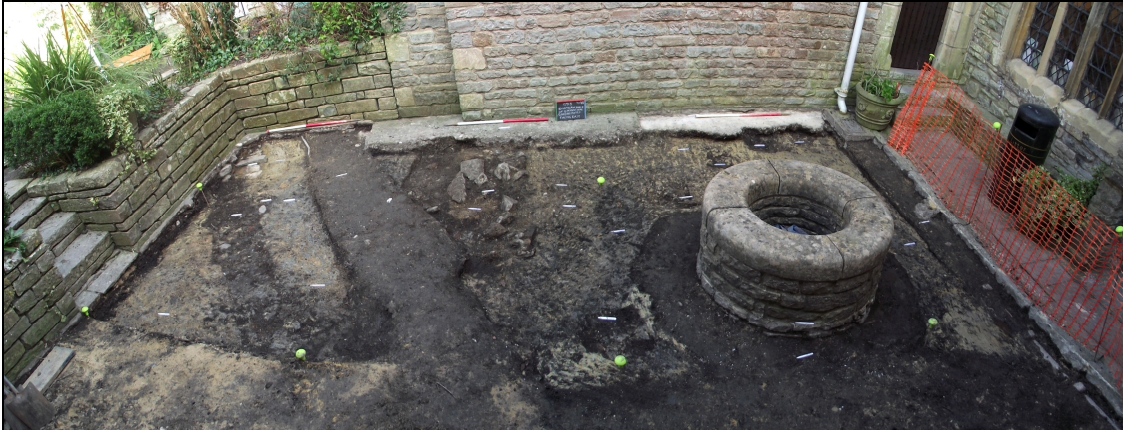
Figure 23 - The east half of site at finished reduced level – deposit (220) / (222) removed. Looking east.

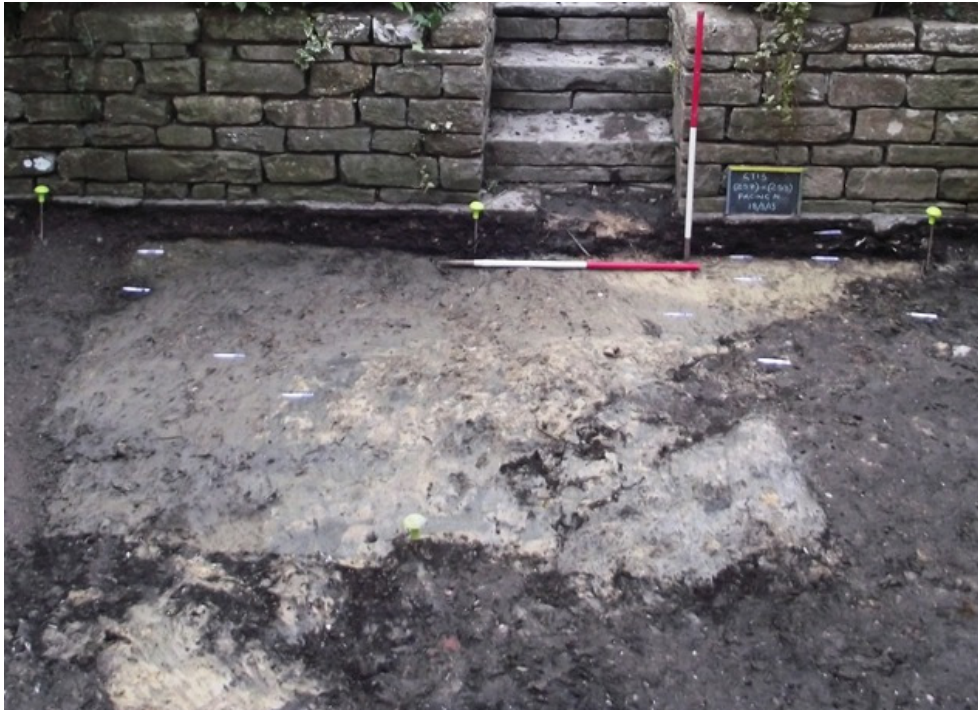
Figure 24 - The north end of site at finished reduced level – Deposit (247) / (255) removed. Fill (257) and deposit (258) exposed. Trench 1 and post holes (259) and (282) are on the left. Fill (263) is in the foreground. Pipe trench (208) is on the right. Looking north.

Mortar spread (247) was present at the north end of the east side of the site, to the north of pipe trench (208). When mortar (247) was cleared another large medieval feature, fill (257) and deposit (258) was exposed. This feature continued into the western half of the site where it underlay the same mortar spread where it was recorded as (255).

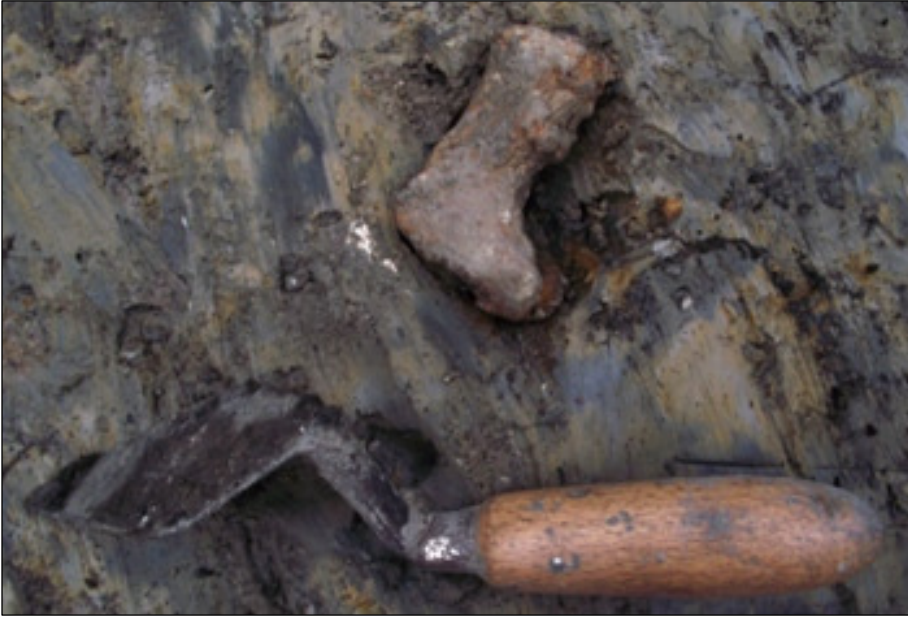
Figure 25 -

SF – 3 on the surface of Deposit (258).

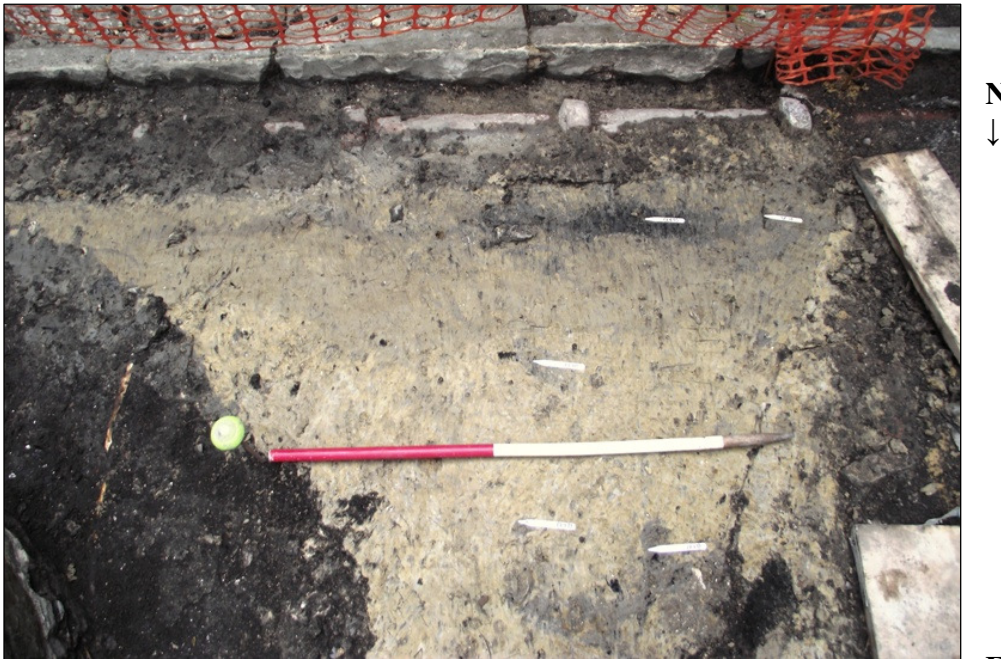
Figure 26

- From top to bottom of the photograph –
Fill (249), deposit (250), stake holes (251), (252) and (253).

In the centre of the width of (250) was a thin strip (c.0.10m N-S) of charcoal, sub-angular chert lumps. This fill – (249) - contained a large twelfth to fourteenth century pottery sherd numbered SF-1, an iron nail numbered SF-2 as well as occasional bone and frequent charcoal lumps. These inclusions were more concentrated at the western end of the feature (c.0.65m in length). The finds from fill (249) were all well sealed.

7.39 Charcoal rich fill (249) had the appearance of a small wooden structure which had been burnt *in-situ* - such as wattle fence panelling. Fill (249) did not sit in a well defined cut and its' length and did not much exceed one and a half meters in length. The staining associated with deposit (250) could have been the product of run-off from the fence. This is just one suggested scenario. Fill (249) and deposit (250) were not truncated during these ground works.

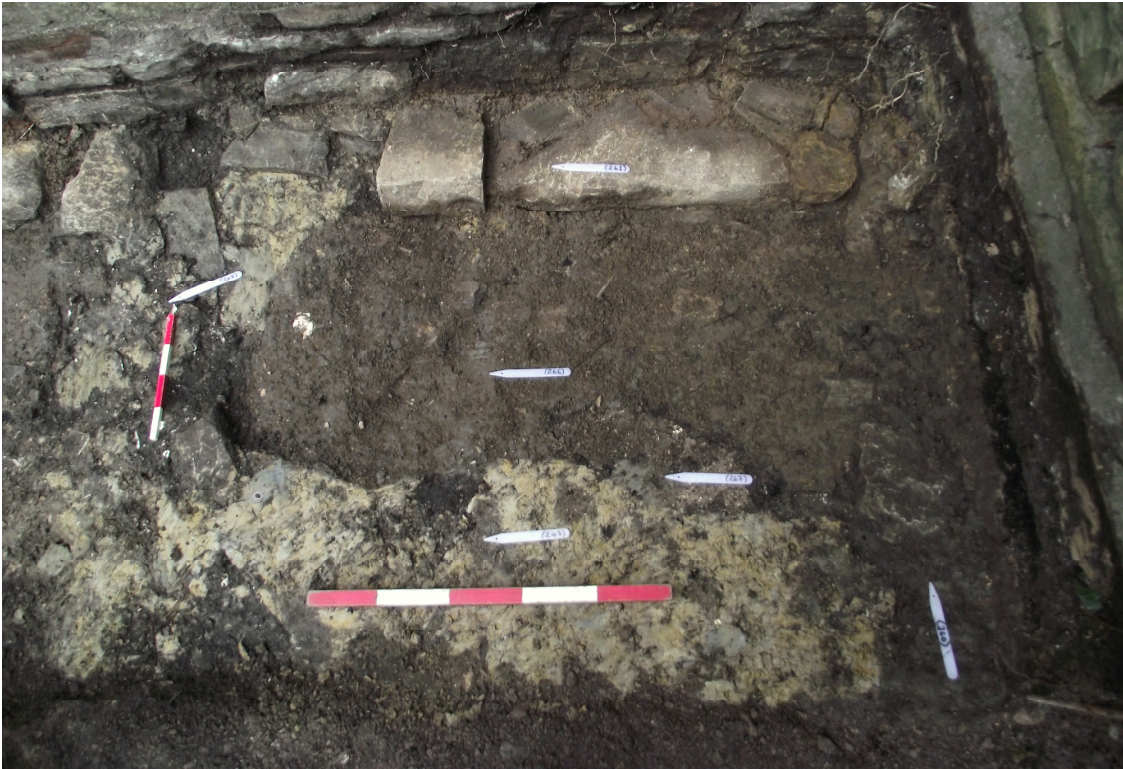
Figure 28 – Fill (266). Possible Post Hole (260) is at the bottom right corner - right of the northern terminus of (265) and cut by Trench 1 at the bottom of the photograph. Fill (268) is on the left side .Off-set foundations (261) are at the top of the photograph.

7.45 Fill (266) was the most defined of these three features. It continued to the north beneath the south face of retaining garden wall (281) and was recorded in the south-facing section of the west side of the site. Deposit (266) was sealed by compressed coal deposit (222) in this section. The west side of (266) was cut by off-set foundations (261) and the east side was cut by linear feature (265) - except at the extreme north-east corner of the exposed feature where (265) appeared to terminate.

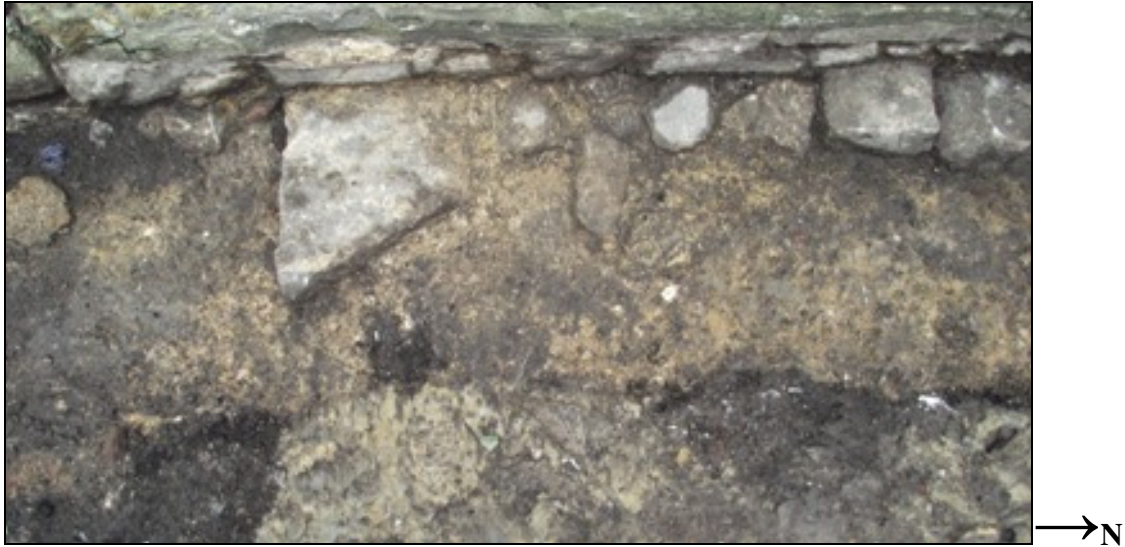
Figure 29 – The mortar spread covering Masonry (264) and Fills (273) and (274). Mortar spread (276) overlying (274) is on the left – both are cut by pipe trench (277) at the bottom left corner. Fill (265) is at the bottom and right of the photograph. Mortar (283) overlay masonry (264) in the centre and Fill (273) on the right of the photograph.

7.48 Fills (273) and (274) were located on opposing sides of robbed out wall (264) and appeared to have been cut by it, although it is also plausible that they may have once abutted up to it. These three features were mostly obscured and sealed beneath the same type of mortar spread which had been variously recorded as (231), (232), (236), (247), (255), (276) and (283). Wall (264) was the most likely origin of this mortar, and the mortar was probably distributed around the site when the wall was demolished.

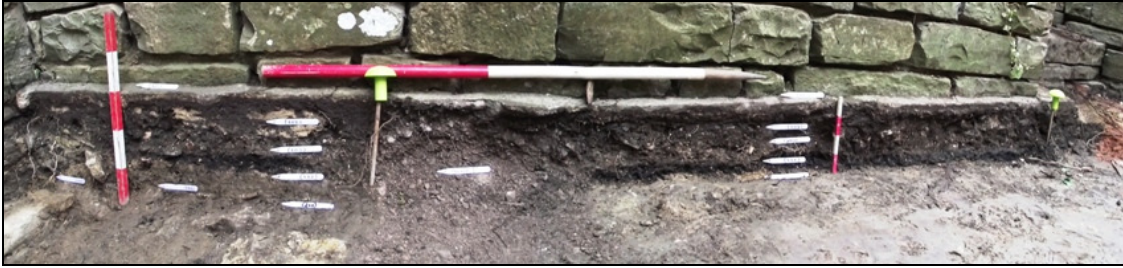
Figure 31 – Photograph of the south-facing section of the western half of the site.

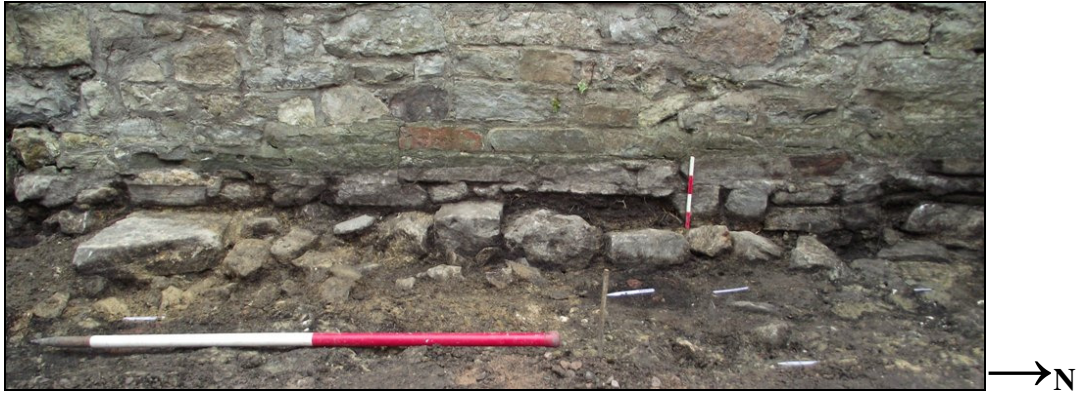
Figure 33 – Off-set foundations (261) butting up to retained masonry (264). The vertical scar line between walls (280) and (279) is visible on the left side of the photograph.

7.54 Off-set foundations (261) were built using Lias stone blocks which were probably sourced from the demolition of wall (264). If so; the good faced stone was saved for the upper course of these foundations. The stones were bonded using a mix of lime mortar and loamy clay. Up to 0.10m depth x 0.22m E-W x 2.10m N-S of the foundations were exposed. The foundations underlay make up deposit (203) and cut through (222), (266) and (273).

Where foundations (261) butted up to the retained masonry from (264) there was a levelling layer of soil deposited which measured c.0.10m thick. The foundations tend to have either brick, stone or soil levelling deposits placed on top of them throughout their length.

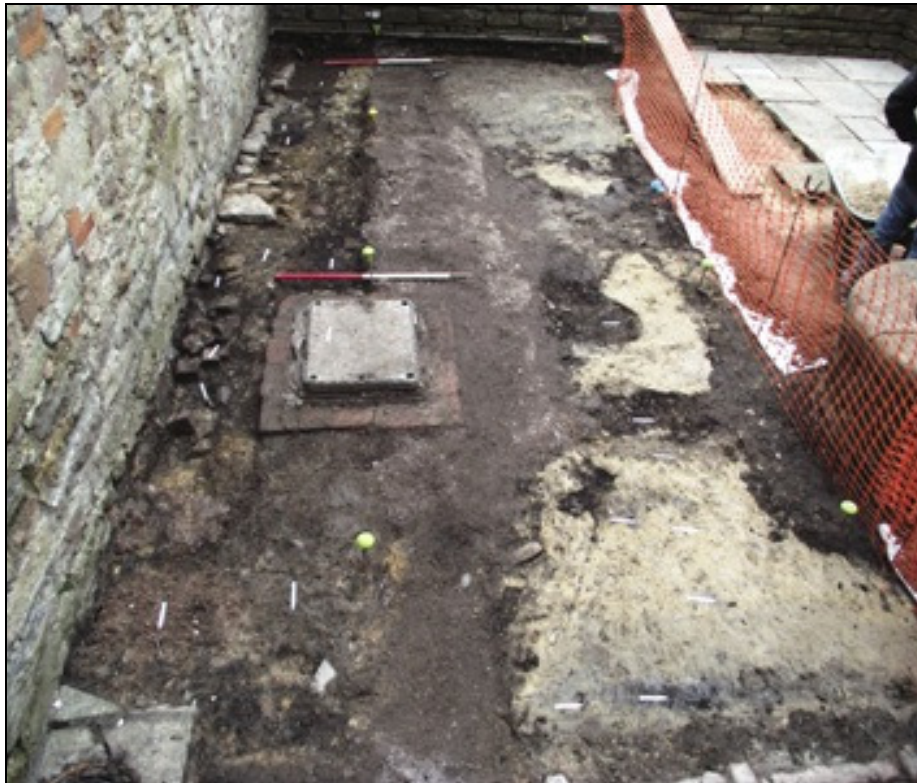
Figure 34 - The west half of site at finished reduced level – deposit (220) / (222) removed. Looking north.

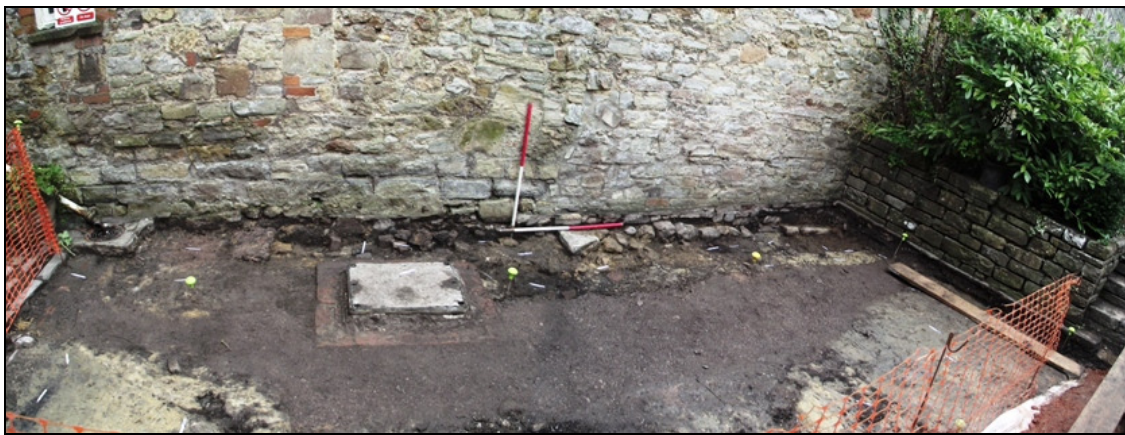
Figure 35 – The west side of site at finished reduced level.

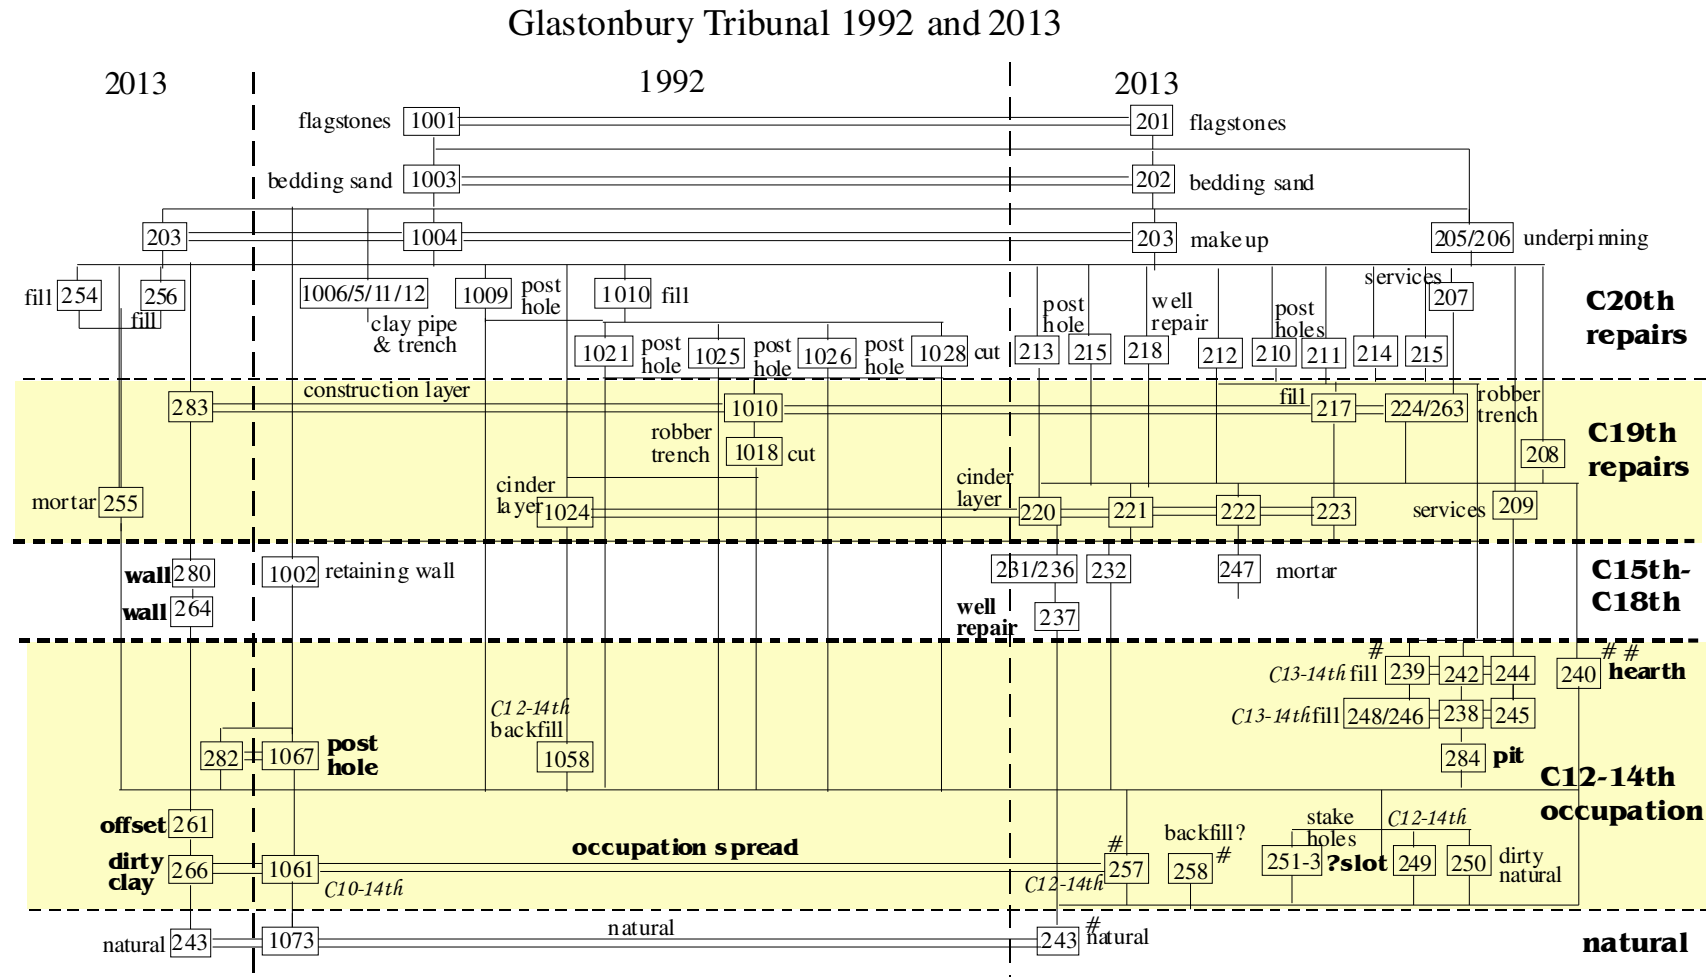
Figure 37. A matrix of the relationships of the various recorded and dated contexts demonstrates the phases of activity on the site.

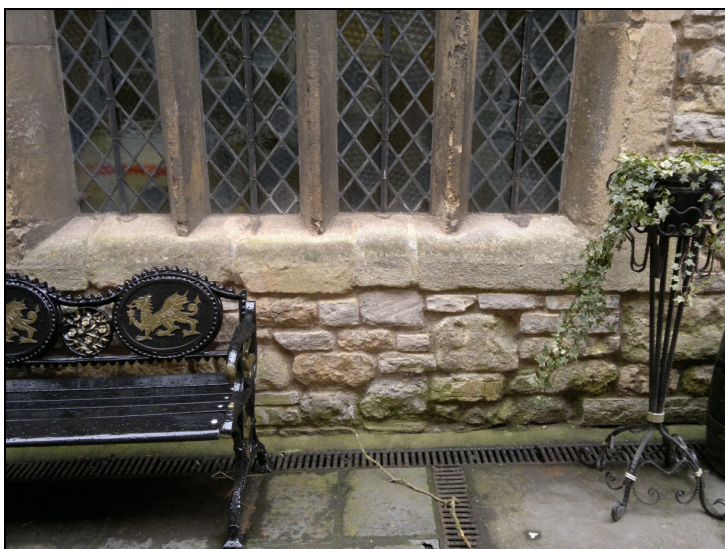
Figure 39. A blocked doorway can be seen below the east-facing window in Room 5.

The photographs showing the eastern side of Room 5, show that it pre-dates any other buildings on the property of 11 High Street. Section 2.4 discusses the evidence of a pre-Norman street grid in this part of Glastonbury. This evidence suggests a road existed along the earlier grid somewhere in this vicinity. Taken as a whole, it would appear that hearth 240 and Room 5 were constructed in an empty space, probably the road predicted from the Saxon street grid. This would also account for the doorways in Rooms 2 and 4 leading to what became 11 High Street to the east (Figure 8).

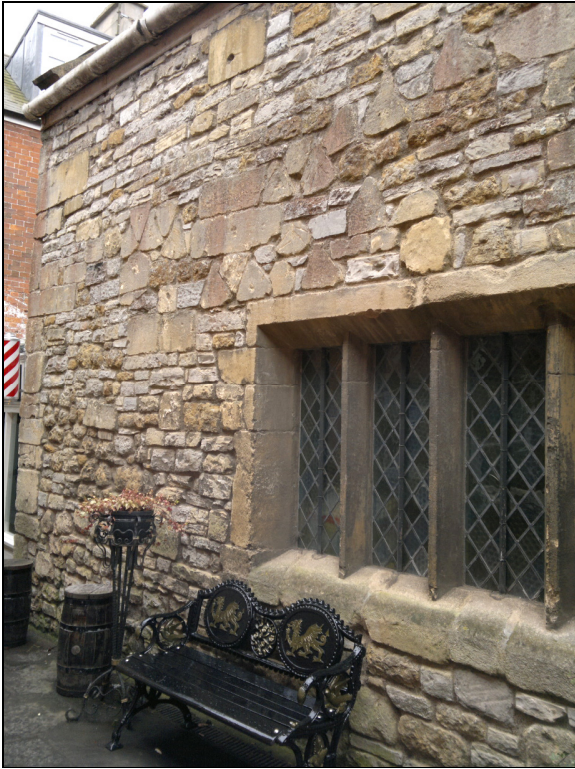
Figure 40. The distribution of re-used yellow freestone ashlar and moulded stone in the east face suggests that Room 4 may have been built in two or three phases. The lower courses contain few blocks of re-used stone, the window and much of the upper courses appear to have come from Glastonbury Abbey, and the upper-most courses are made of Lias block which are much less worn than those in the lower courses.
