CLUN CASTLE SHROPSHIRE

An Interim Report

Hereford Archaeology Series 176

**Clun Castle
Clun
Shropshire
NGR: SO 299 809**

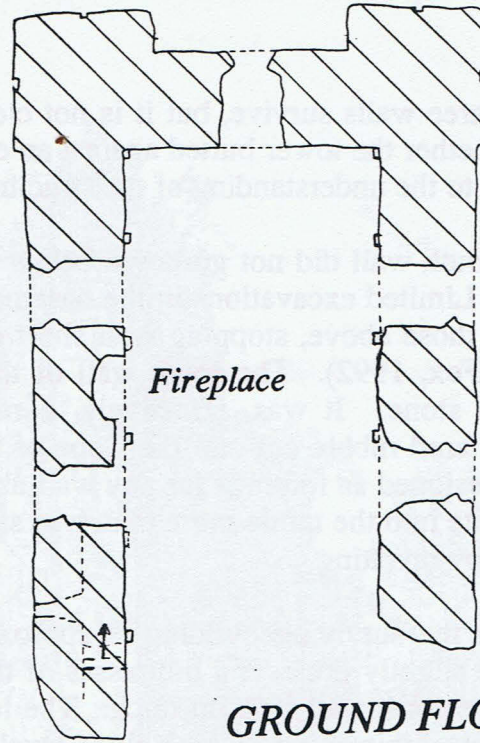
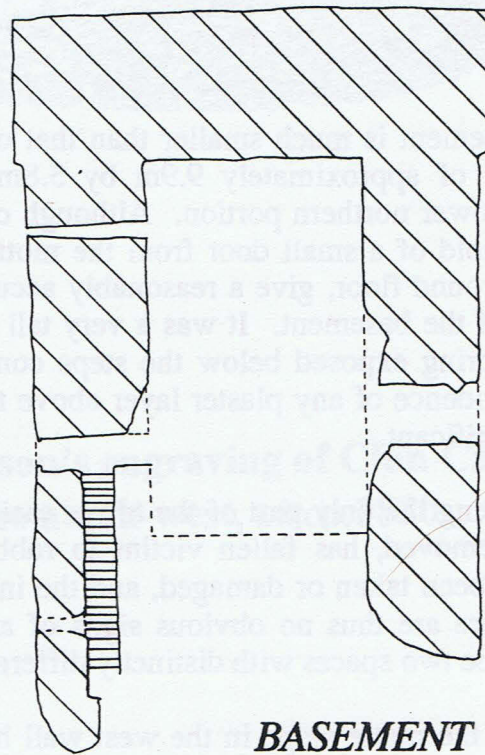
CLUN CASTLE: BASEMENT AND GROUND FLOOR PLANS

The floor area of the basement is much smaller than that of those on the floors above, with internal dimensions of approximately 9.9m by 5.8m. It appears to have been split-level, with a much lower northern portion. Although covered in demolition debris, the position of the threshold of a small door from the motte slope, and the base of the steps leading up to the ground floor, give a reasonably accurate indication of the height of the southern portion of the basement. It was a very tall apartment, some 4.3m high. The small section of flooring exposed below the steps consisted of erratic, or 'crazy', paving. There was no evidence of any plaster layer above this, but in such a small area this is not particularly significant.

The small doorway from the motte slope in the west wall has a semi-circular head that continues the tunnel vaulting of the passage through the thickness of the wall that it leads into. There are remains of drawbar sockets in the masonry inside the doorway. The

mural stairs to the ground floor lead off this passageway, but the junction of the two is more or less lost. The passage continued on to give access to what was a basement room of fairly high status. Opposite the passage, in the east wall, is a large window, complete with window seats. Its outer sill is very close to the ground level of the slope of the motte. The external head is badly damaged, but the reararch is semi-circular. The embrasure has straight sides until it narrows down in a splay to the opening. The width of the opening probably indicates that there was a single light in the window. There is no sign of any fireplace in the basement so that if it was heated, it must have been by a portable brazier.

The ground floor of the castle was roughly level with the top of the motte. Within the body of the tower the ends of the floor beams were embedded in the masonry, which was also slightly chased all around the three surviving sides. The exact design at the southern end is less clear.

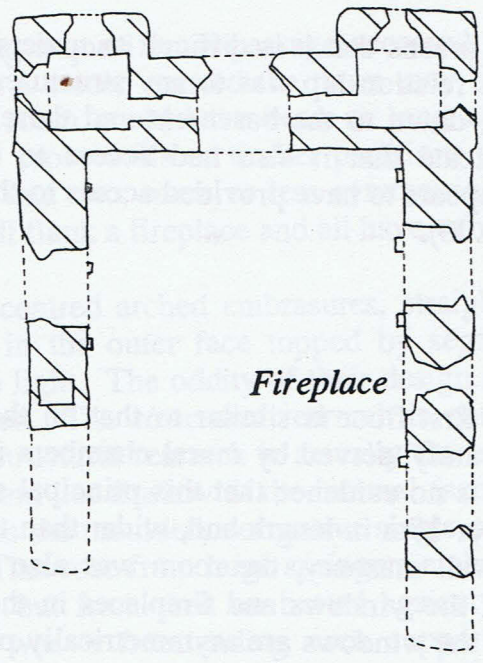
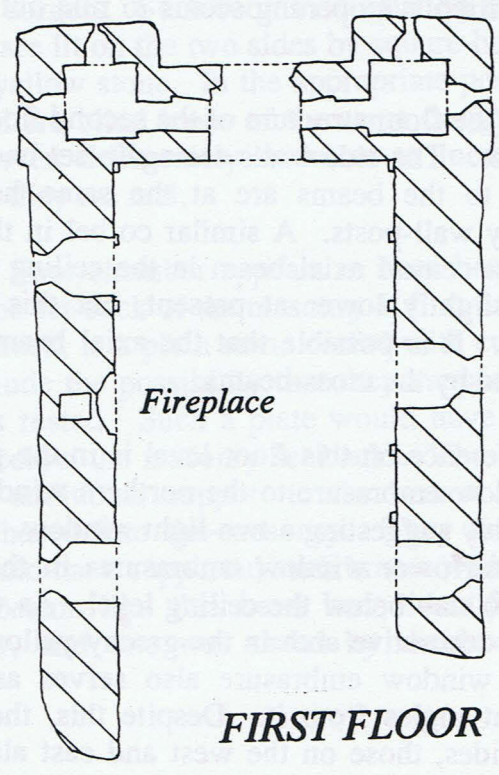
CLUN CASTLE: FIRST AND SECOND FLOOR PLANS

The main chamber of the first floor is similar to that on the floor below, but is rather grander and, more significantly, served by mural chambers in the northern corners. As on the ground floor, there is no evidence that this principal space was ever sub-divided. It appears to have been over 15m in length and, wider than the room below by virtue of the set-back of the side wall masonry, the room was also taller, being approximately 4.2m high. The layout of the windows and fireplaces in the west wall is basically the same, but on the east wall the windows are asymmetrically placed and slightly further to the south. Their details, size and status, however, are essentially the same. At this level there are traces of the original floors within the embrasures, erratic paving once covered with plaster. The flue from the fireplace rises separately from that of the fireplace below within the thickness of the west wall, although there was only a thin partition of slabs between them. They presumably ended in a two-flue chimney at parapet level. There is little room for a hearth of any width in the wall itself, so it is likely that a stone hearth was supported by the floor or possibly cantilevered out from the masonry. However, the decorative arch over the fireplace opening seems to rule out the existence of a masonry hood.

The ceiling of this room (the floor structure of the second floor) was of a different design to that of the ground floor. The side walls are again set-back, but the corbels added to give additional support to the beams are at the same height as the beam soffit - precluding the use of any wall-posts. A similar corbel in the middle of the north wall indicates that there was a central axial beam in the ceiling structure at the same level. The corbel is actually slightly lower at present, but this seems to be the result of post-ruination settlement. It is possible that the axial beam was continuous, but more probably it was interrupted by the cross-beams.

The most significant difference on this floor level is in the provision of mural rooms at the north end. The window embrasure to the northern window is much wider than that on the floor below, possibly suggesting a two-light window. As its vaulting springs from the same height as the narrower window embrasures in the side walls, it has to be a shallow segmental arch to stay below the ceiling level. As with the other openings, this arch also had an applied decorative arch in the greeny-yellow stone. The reason for the extra width is that the window embrasure also serves as a corridor access to two passages running at right-angles from it. Despite this, the window opening still has window seats on three sides, those on the west and east also acting as steps up to the slightly higher floor level of the mural passages.

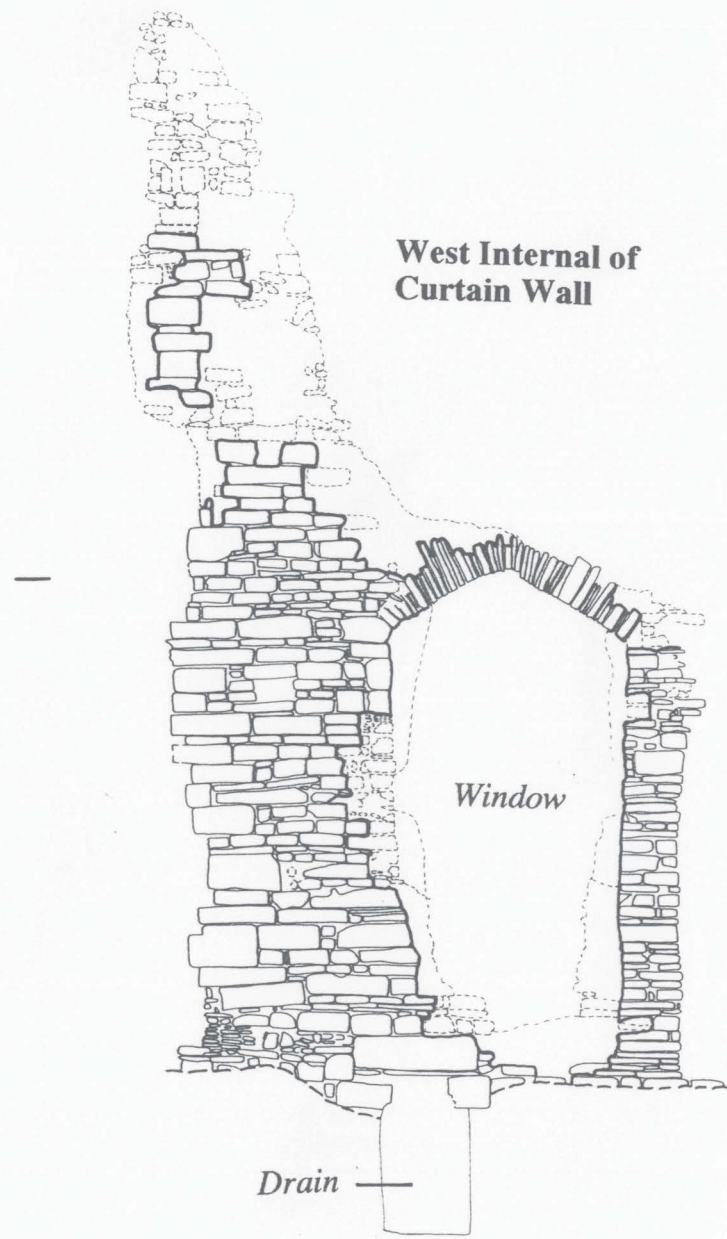
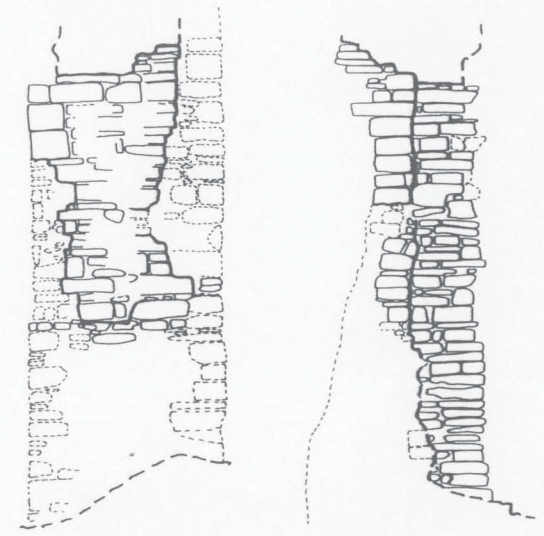
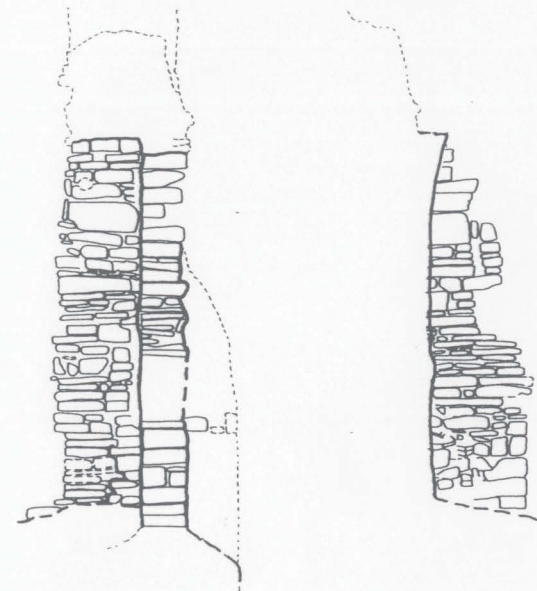
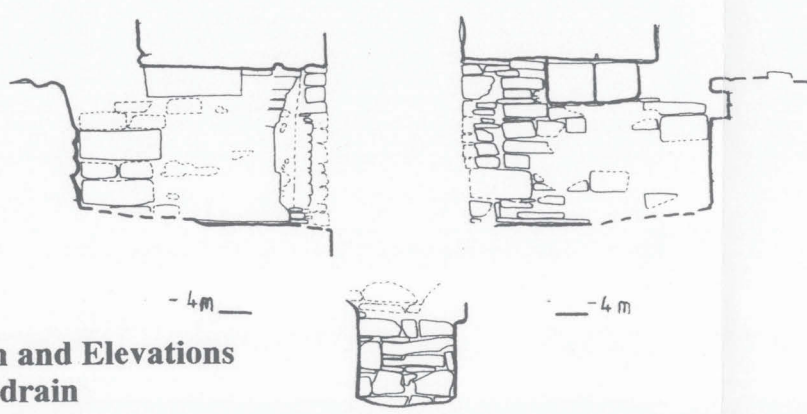
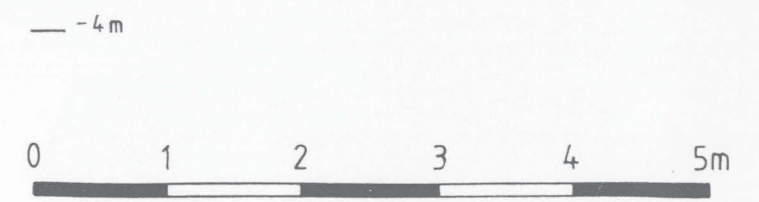
**CLUN CASTLE:
SOUTH-WEST BASTION AND CURTAIN ELEVATIONS**

Cross-Sections and Splays of Curtain and Window

Running under the window, and thus presumably under the floor level of the building, is a stone-lined drain that egresses on the outer wall face. The drain is just under 1.2m tall and 0.65m wide, topped on both wall faces by the remains of a shouldered lintel. The egress in the wall splays to a narrower opening, although this masonry has been damaged. The drain clearly once went further eastwards into the motte area than its present 0.3m from the inside of the wall. The sides were apparently limewashed or plastered, unlike the masonry blocking the drain at its east end. It presumably had to have run into the motte at least beyond the east wall of the building above it, perhaps serving structures in the middle of the courtyard area such as the kitchen.
