Highfields Farm, Cambridgeshire

Archaeological Evaluation

By
Chris E Smith BA (Hons) MA MIFA
Report No. 1017

On Behalf of: Highfield Wind Energy Ltd

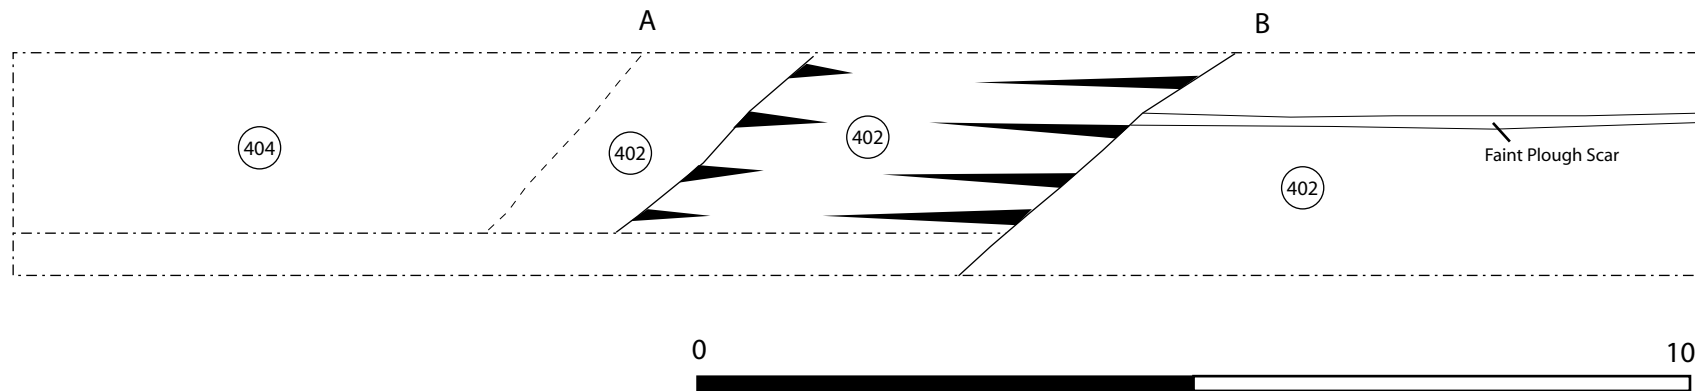
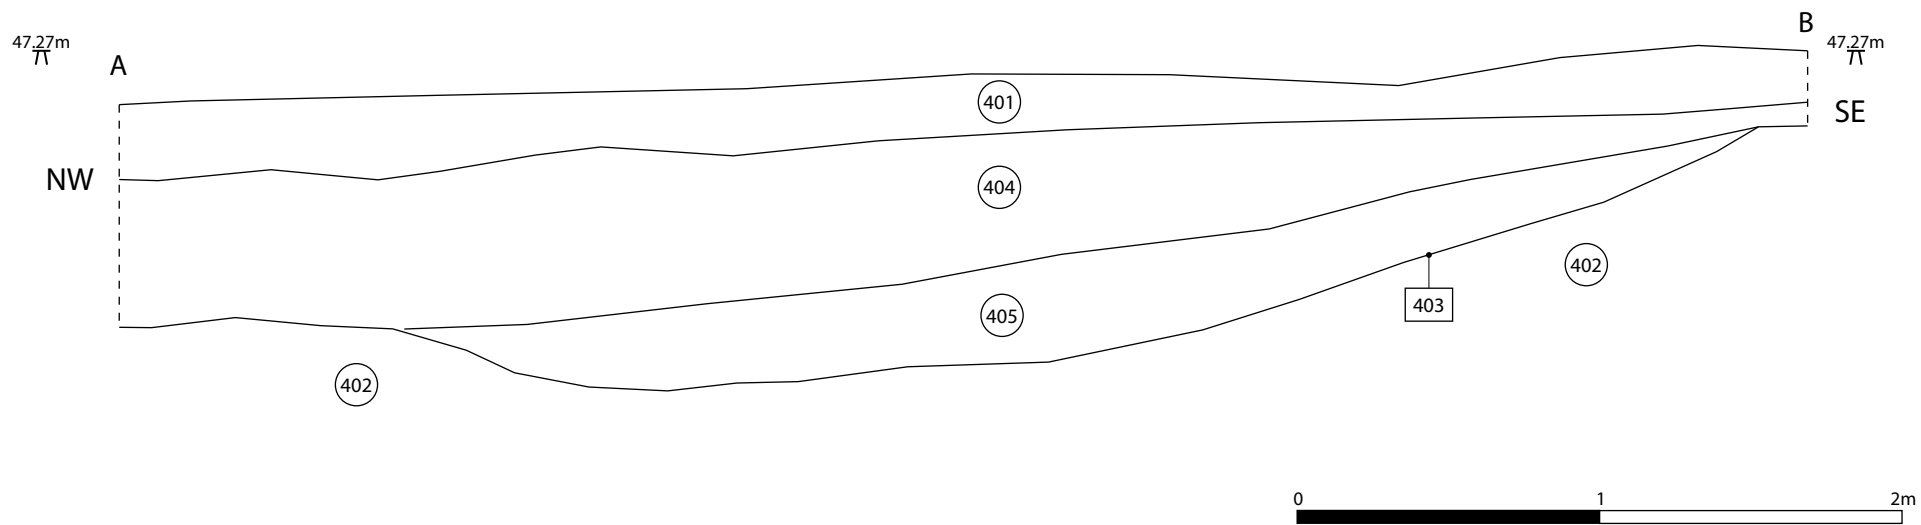
Fig 3: Plan and Section showing ditch [403] in Trench 4

- 4.3.4 Trench 4 (Figs 2&3, Plate 4-6) measured 17x2m and was excavated to a depth of 1.1m max. Removal of turf and topsoil (401) revealed chalk bedrock (402) along half the length of the trench and a mixed mid brown chalky silt layer (404) covering the other half of the trench. Excavation of the silt deposit (404) showed it to be a secondary fill located within a 7m wide ditch [403] cut into the natural chalk bedrock (402). The silt deposit (404) may once have formed a bank to accompany the ditch which has since been ploughed down. This would explain why the deposit appeared to spread beyond the confines of the ditch. Beneath (404), a primary ditch fill was noted. This primary fill (405) was composed of slightly darker silt and appeared to contain more chalk fragments than the layer above. Charcoal and CBM flecks were present in the fills of the ditch but were very few. The ditch was bottomed at a depth of 1.1m below the current ground surface. Within the very upper layers of the ditch, from deposit (404), a very small piece of highly abraded possible prehistoric pottery was located.

- 6.1.1 The environmental bulk sample taken from the primary fill (405) of the ditch cut [403] within trench 4 has not been subject to further assessment at this stage. If required this can be undertaken, however it was felt that as mitigation is likely to lead to further excavation in the area of the ditch, this will lead to further samples being taken and analysed.

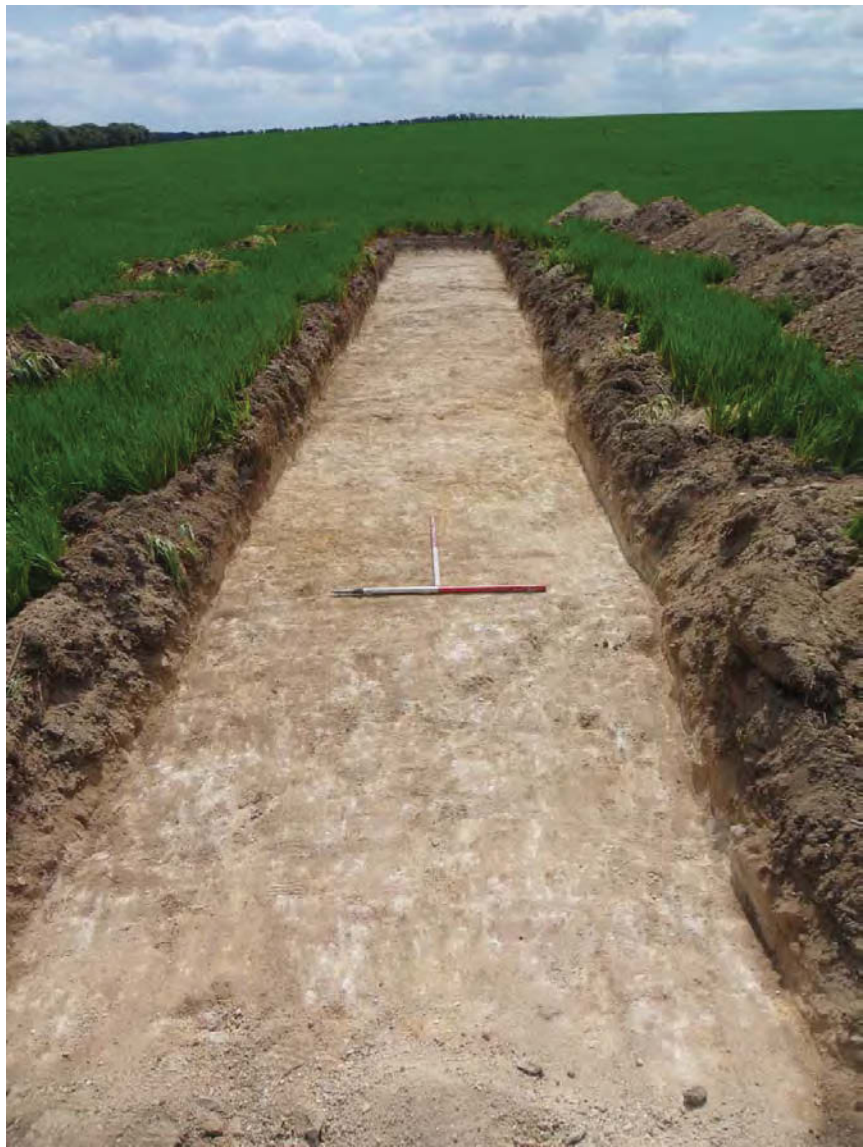
Plate 1: View along Trench 1, Looking south east
Scales 2x1m

- 4.3.1 Trench 1 (Fig 2, Plate 1) measured 17x2m and was excavated to a depth of 0.5m max. Removal of topsoil (101) revealed a mixed chalk and pale orange silt subsoil deposit (102). Excavation into (102) revealed chalk deposits becoming more frequent and solid. As the subsoil deposit (102) was very clean, containing no charcoal or artefactual objects, excavation ceased at 0.5m below the current ground surface. No features or finds of archaeological significance were encountered.

It is clear that the basal parts of this trench consist of redeposited chalk and flint. The basal unit consists of a chalky pellet gravel with flint clasts that was probably deposited in the late Devensian. Undisturbed bedrock was not present in this trench. It is possible that further stratified sediments exist beneath the base of this trench.

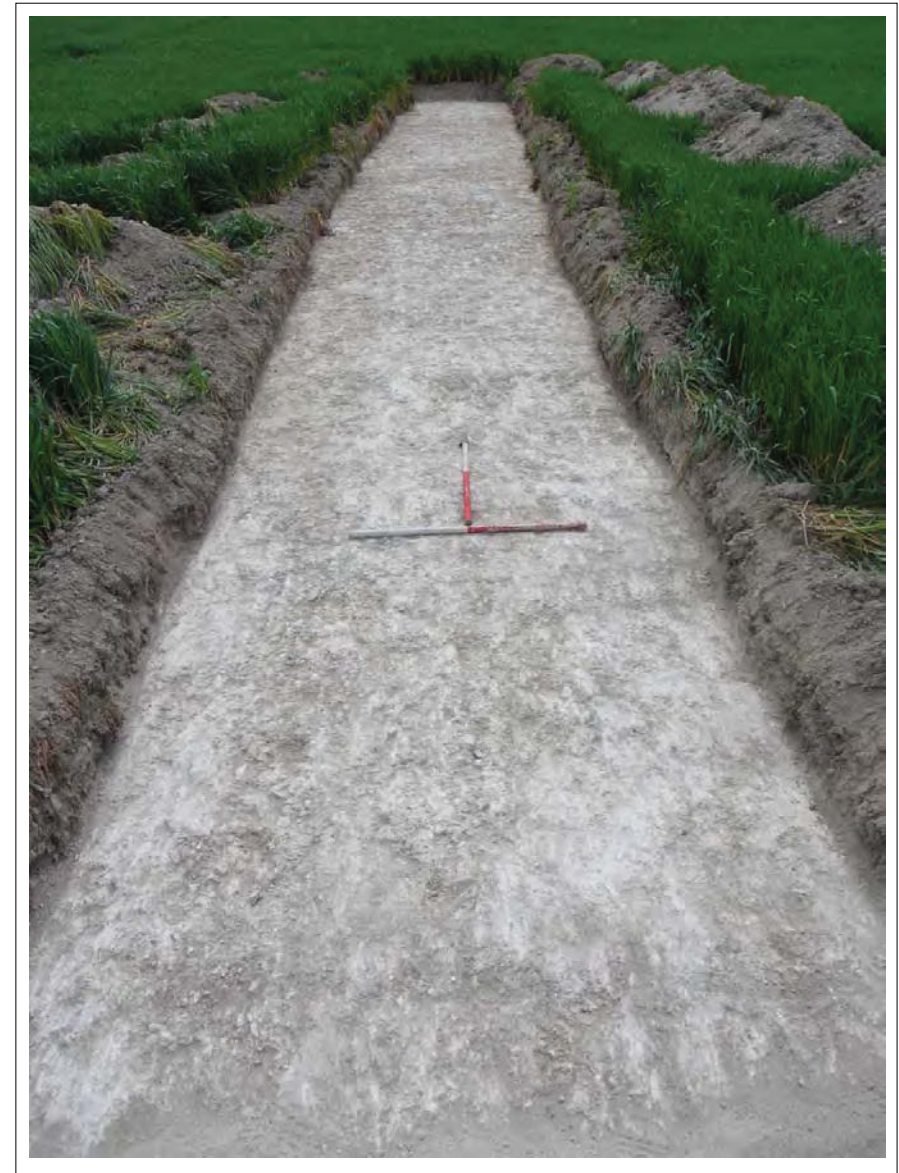
Plate 2: View along Trench 2, Looking south east
Scales 2x1m

- 4.3.2 Trench 2 (Fig 2, Plate 2) measured 17x2m and was excavated to a depth of 0.4m max. Removal of topsoil (201) revealed solid chalk bedrock almost instantly. Though small flecks of both CBM and charcoal were present within the topsoil, no features or finds of archaeological significance were encountered.

Chalk bedrock was present in the base of the trench. There is no potential for stratified sediments in this trench.

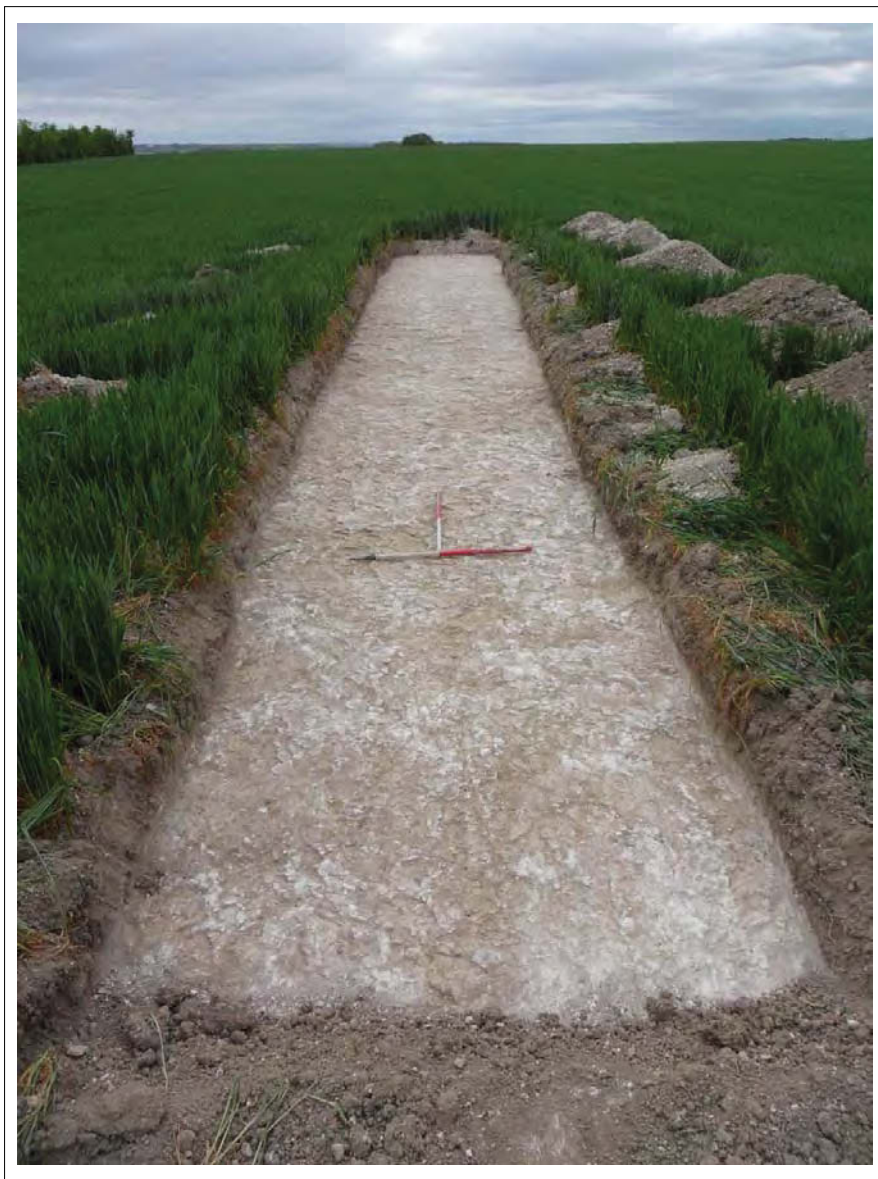
Plate 3: View along Trench 3, Looking north east
Scales 2x1m

- 4.3.3 Trench 3 (Fig 2, Plate 3) measured 17x2m and was excavated to a depth of 0.35m max. Removal of topsoil (301) revealed solid chalk bedrock almost instantly. Though small flecks of both CBM and charcoal were present within the topsoil, no features or finds of archaeological significance were encountered.

Chalk bedrock was present in the base of the trench. There is no potential for stratified sediments in this trench.

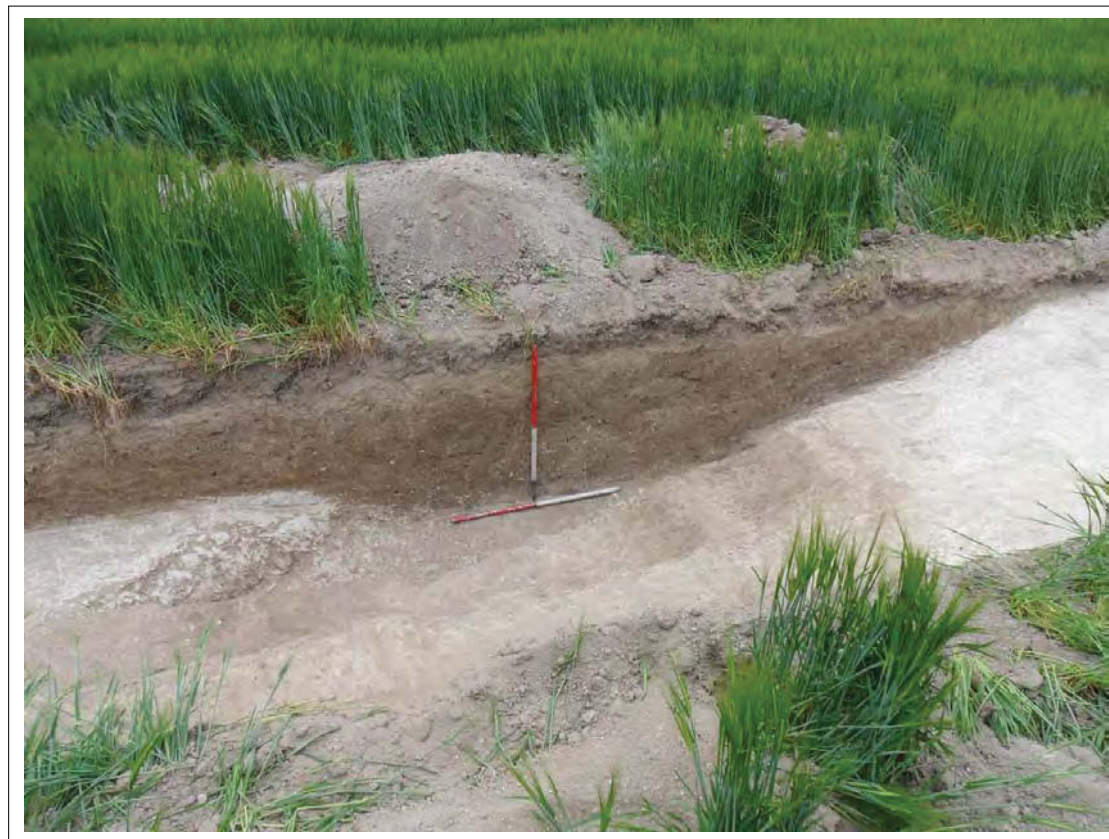
Plate 6: View of ditch cut [403] in Trench 4, Looking north east
Scales 2x1m

- 4.3.5 The ditch in Trench 4 also appeared to possibly follow the lines of a natural contour within the field which may have been utilised to make the ditch appear artificially deep. Upcast of excavated material into a bank on this higher ground would also have served to increase this appearance.

- 7.1.2 The overall interpretation gained from the evaluation is that the areas of Turbines 1, 2, 3 and 5 appear archaeologically sterile. Turbine 4, however, showed archaeology and will therefore require mitigation. On site discussions with Ms. Kasia Gdaniec and the landowner, Mr. Ralph Parker, appeared to favour larger open area excavation around turbine 4 rather than moving the turbine to a different location.

during the evaluation is not recommended as part of the current phase of work. However, if further excavation work is recommended by the Cambridgeshire County Council Archaeology Service in either of these areas, the area around Trench 4 being the most likely, then new samples should be taken, and a full assessment undertaken as appropriate.

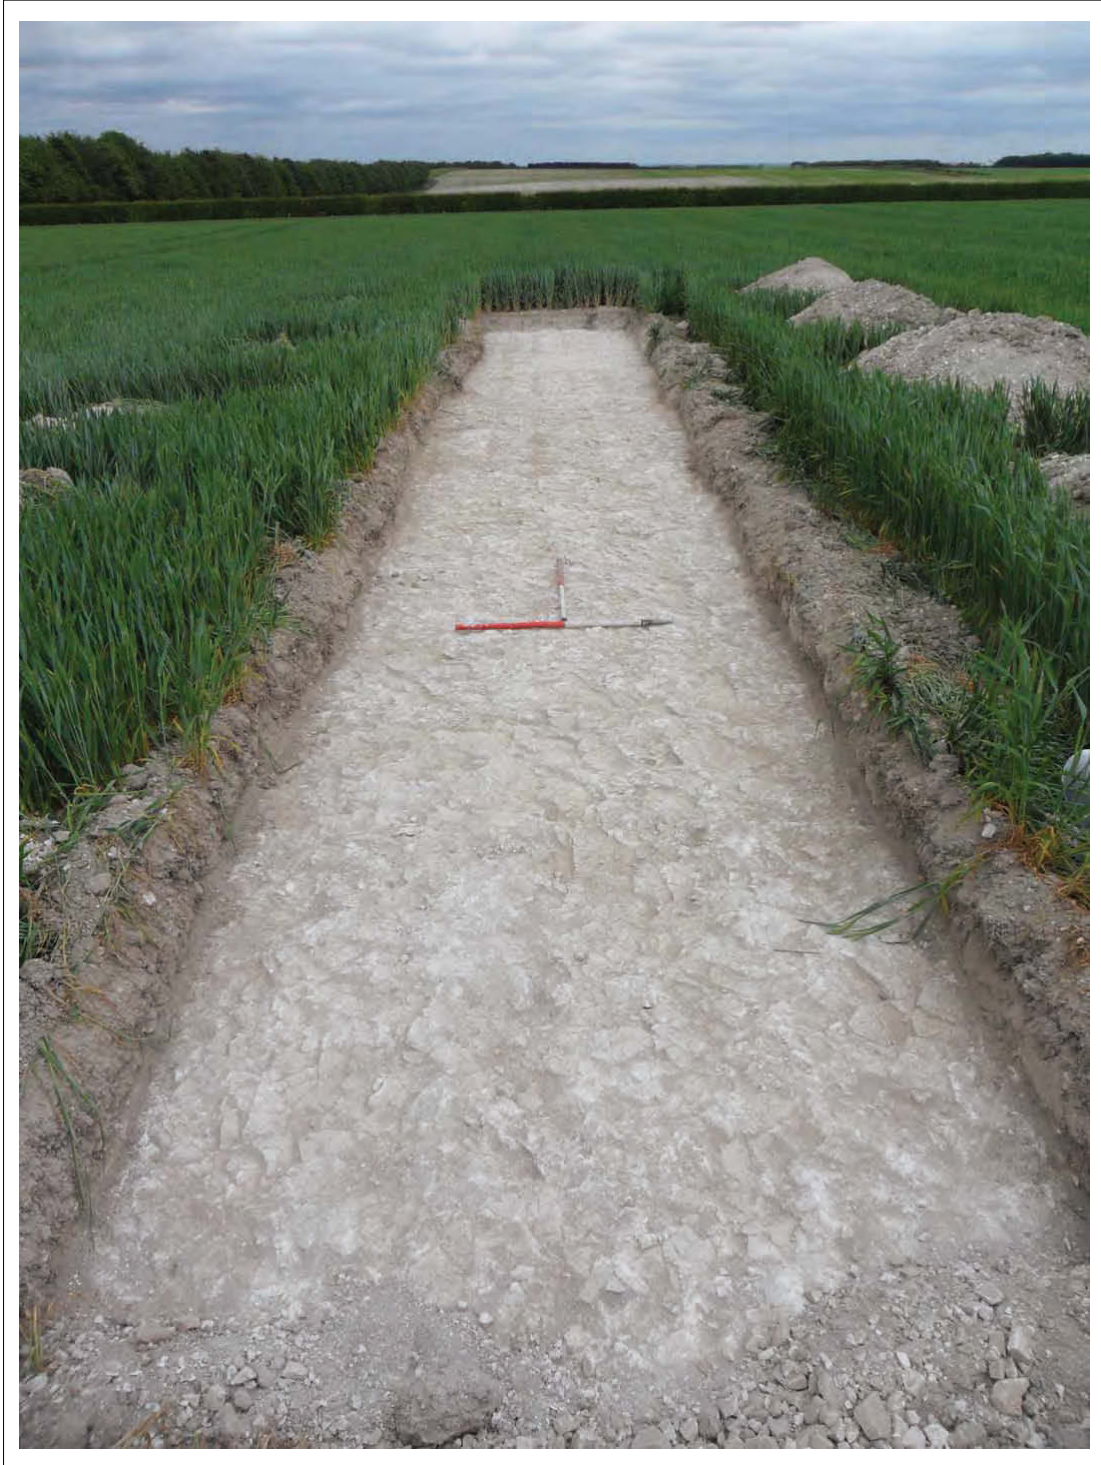
Plate 7: View along Trench 5, Looking north east
Scales 1x1m

- 4.3.6 Trench 5 (Fig 2, Plate 7) measured 17x2m and was excavated to a depth of 0.35m max. Removal of topsoil (301) revealed solid chalk bedrock almost instantly. Though small flecks of both CBM and charcoal were present within the topsoil, no features or finds of archaeological significance were encountered. Modern parallel plough scars were noted cutting shallowly into the chalk bedrock.

Chalk bedrock was present in the base of the trench. There is no potential for stratified sediments in this trench.
