Sutton Grange, Oteley Rd Shrewsbury

Archaeological Field Evaluation

By
Chris E Smith BA (Hons) MA MIFA
Report No. 1091

Report No: 1091

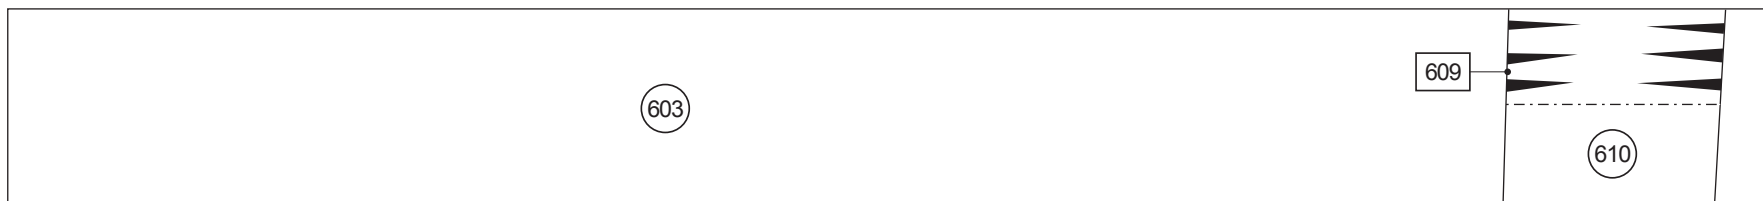
Job Title:	Oteley Rd
Drawing Title:	T6
Date:	4/12/2012
Drawn By:	CES
Scale:	See Bar
Figure 03:

- 4.2.1 Trench 6. Trench 6 (Figs 2&3, Plates 6-8) measured 30x1.8m and was aligned north-south. It was located in the centre of the eastern field of the assessment area, overlaying the line of a defunct field boundary. Mechanical excavation showed the mid brown silt topsoil (601) to be approximately 0.2m deep. It overlay a more friable orange brown clay subsoil (602). This was found to be approximately 0.3m deep. Natural orange brown stiff clay deposits (603), with no gravel inclusions, were exposed at a depth of around 0.5m below the current ground surface. At the southern end of the trench, located on a slope, only dark brown/black silt deposits (606) were exposed beneath the topsoil. Within the deposits on the slope the line of a land drain (604) was evident. It

also appeared to cut an earlier land drain (605). Owing to the presence of the land drains excavation on the slope ceased at a depth of around 0.25m. Cut into the dark brown/black deposit (606) was the line of a modern ditch [607]. This was backfilled with broken ceramic tiles and plastic material (608) and was found to be 0.4m deep. A further ditch [609] was observed within the middle of the trench, at the base of the slope. This was clearly cut through both the subsoil (602) and the natural clay deposits (603). Excavation of a section across the ditch showed it to be 2m wide with a maximum depth of 1m. The primary fill (610) was composed of a dark brown silt clay with modern inclusions whilst the secondary, upper, fill (611) was composed primarily of mixed clay, rubble and brick. Excavation of the ditch showed a natural gravel deposit (612) beneath the natural clay (603) into which the ditch was cut. No finds or features of archaeological significance were located within this trench.

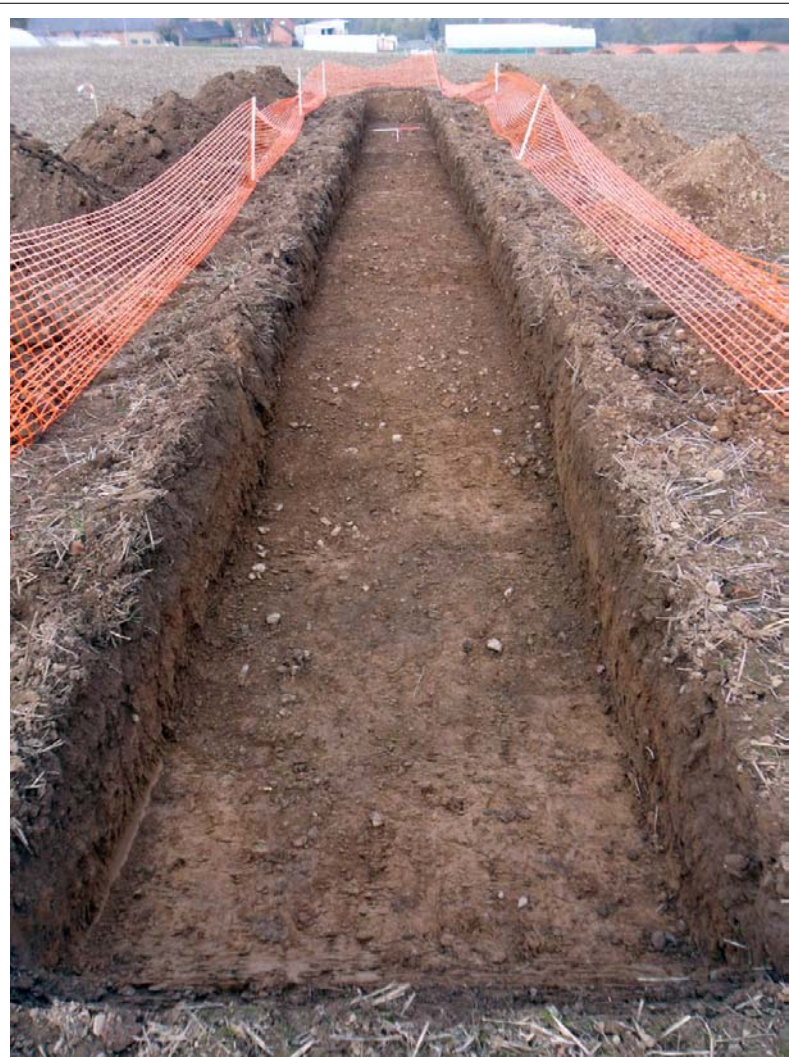
- 4.2.1 Trench 1. Trench 1 (Fig 2, Plate 1) measured 30x1.8m and was aligned north-south. It was located in the south western corner of the western field. Mechanical excavation showed the mid brown silt topsoil (101) to be approximately 0.35m deep. It overlay a more compact orange brown clay subsoil (102). This was found to be approximately 0.3m to 0.45m deep. Natural orange brown clay deposits (103), with occasional gravel inclusions, were exposed at a depth of around 0.7m below the current ground surface. No finds or features of archaeological significance were located within this trench.

Plate 1: View north along Trench 1. Scales 2x1m

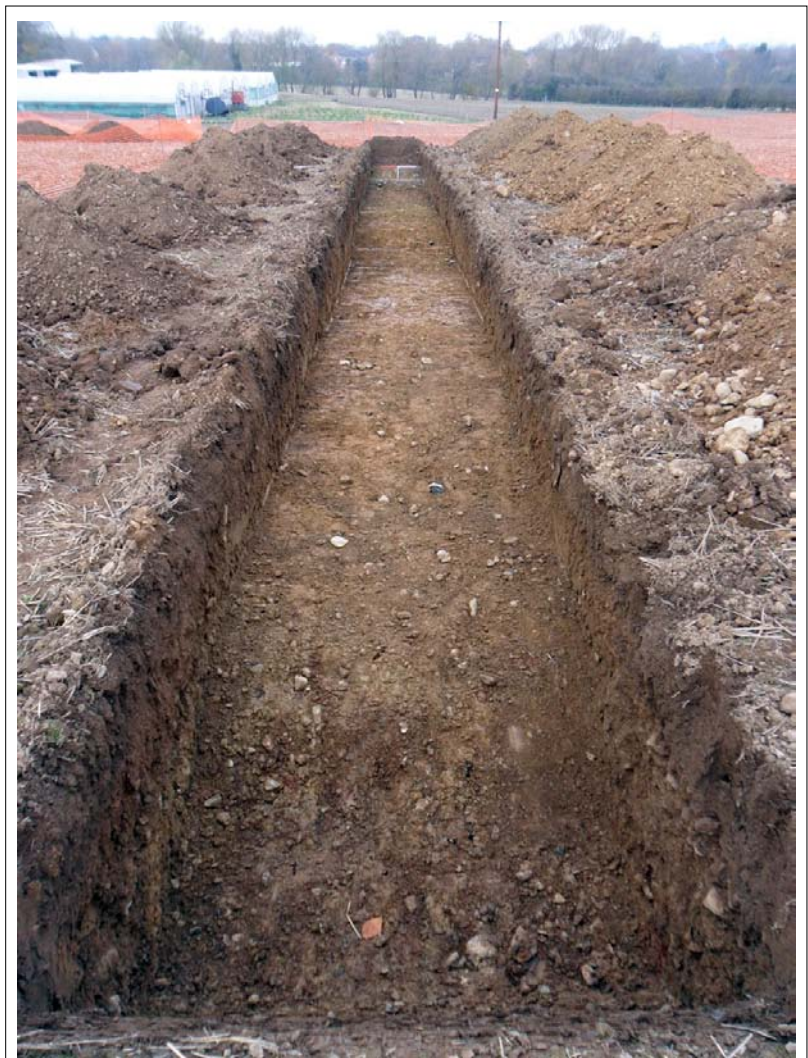
- 4.2.2 Trench 2. Trench 2 (Fig 2, Plate 2) measured 30x1.8m and was aligned north-south. It was located in the middle of the western field. Mechanical excavation showed the mid brown silt topsoil (201) to be approximately 0.4m deep. It overlay a more compact orange brown clay subsoil (202). This was found to be approximately 0.4m to 0.5m deep. Natural orange brown clay deposits (203), with more frequent gravel inclusions, were exposed at a depth of around 0.8m – 0.9m below the current ground surface. No finds or features of archaeological significance were located within this trench.

Plate 2: View north along trench 2, Scales 2x1m

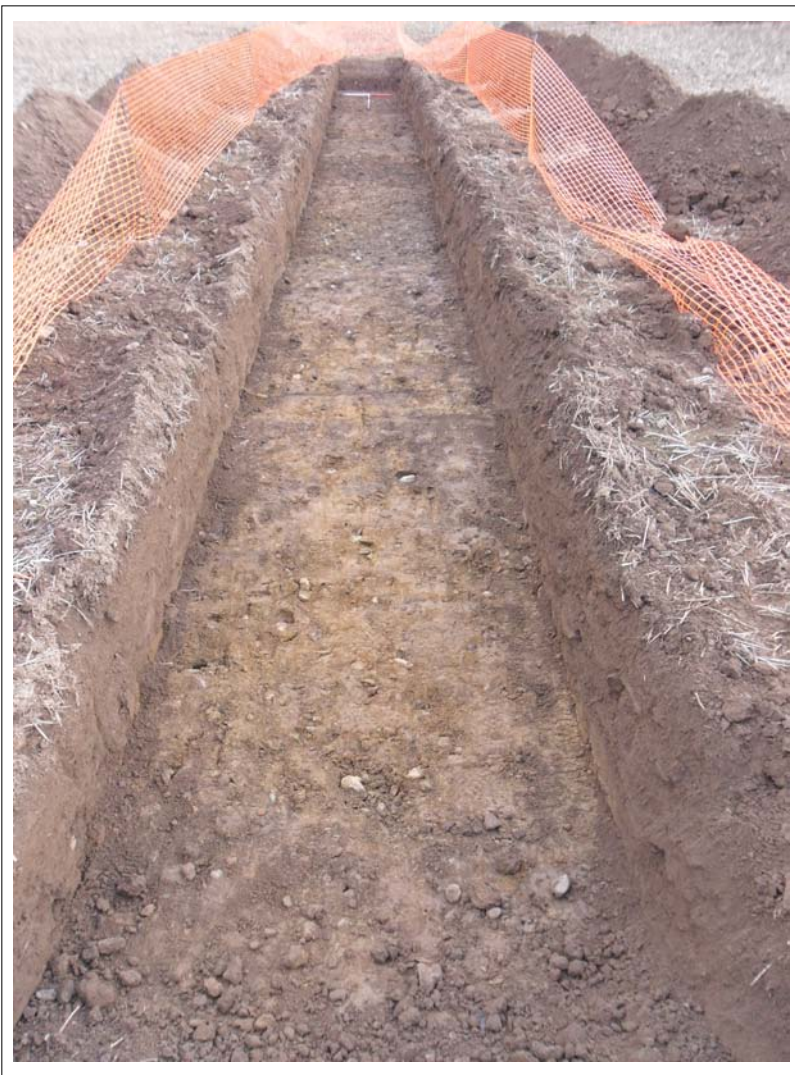
- 4.2.3 Trench 3. Trench 3 (Fig 2, Plate 3) measured 30x1.8m and was aligned east-west. It was located in the middle of the western field, to the north of trenches 1 and 2. Mechanical excavation showed the mid brown silt topsoil (301) to be approximately 0.55m deep. It overlay a more compact orange brown clay subsoil (302). This was found to be approximately 0.2m deep, significantly shallower than in trenches 1 and 2. Compact natural orange brown clay deposits (303), with frequent gravel inclusions, were exposed at a depth of around 0.7m below the current ground surface. No finds or features of archaeological significance were located within this trench.

Plate 3: View west along trench 3, Scales 2x1m

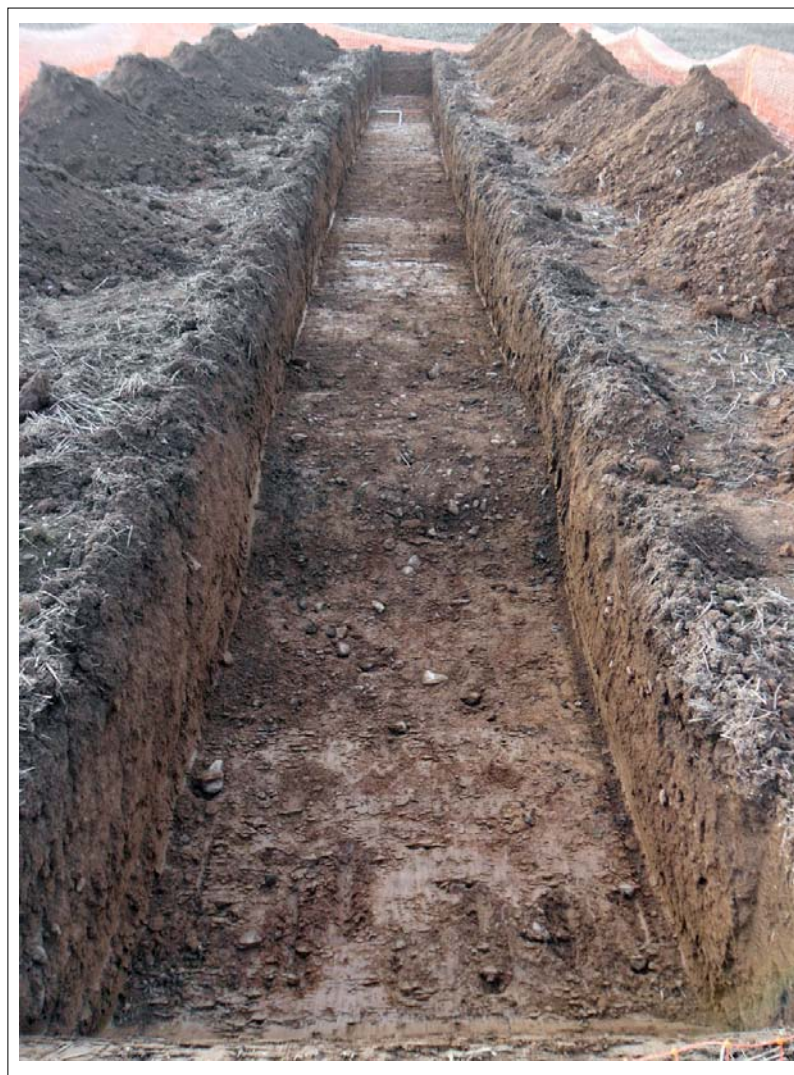
- 4.2.4 Trench 4. Trench 4 (Fig 2, Plate 4) measured 30x1.8m and was aligned east-west. It was located in the middle of the western field, adjacent to the eastern field boundary. Mechanical excavation showed the mid brown silt topsoil (401) to be approximately 0.3m deep. It overlay a compact orange brown clay subsoil (402). This was found to be approximately 0.5m deep. Natural orange brown clay deposits (403), with more only occasional, localised, gravel inclusions, were exposed at a depth of around 0.8m below the current ground surface. No finds or features of archaeological significance were located within this trench.

Plate 4: View east along trench 4, Scales 2x1m

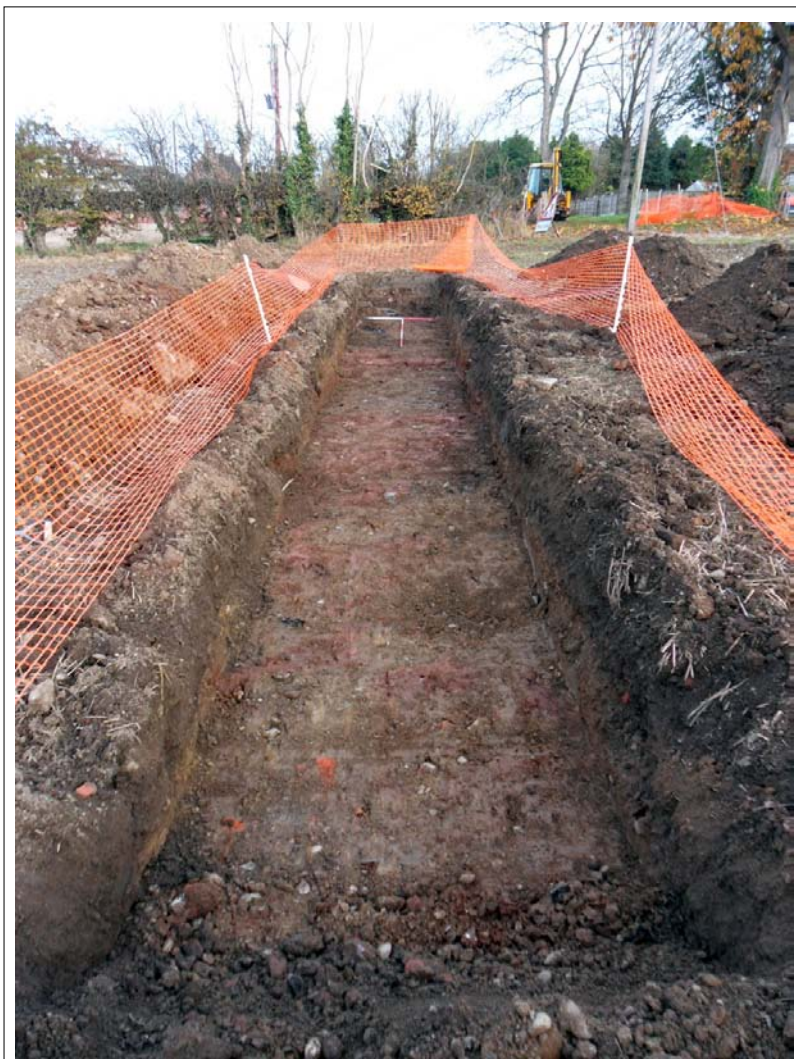
- 4.2.5 Trench 5. Trench 5 (Fig 2, Plate 5) measured 20x1.8m and was aligned east-west. It was located in the south eastern corner of the western field, adjacent to the eastern and southern field boundaries. Mechanical excavation showed the dark brown silt topsoil (501) to be approximately 0.3m deep. It contained frequent inclusions of modern material such as brick, rubble, tarmac, glass and plastic. It overlay firmly compacted orange brown clay subsoil (502) which contained further large amounts of modern material including bricks and breeze blocks. Excavation ceased at a total depth of 0.7m owing to the extremely compact nature of the ground and the obvious large dump of modern material. No finds or features of archaeological significance were located within this trench.

Plate 5: View east along trench 5, Scale 2x1m

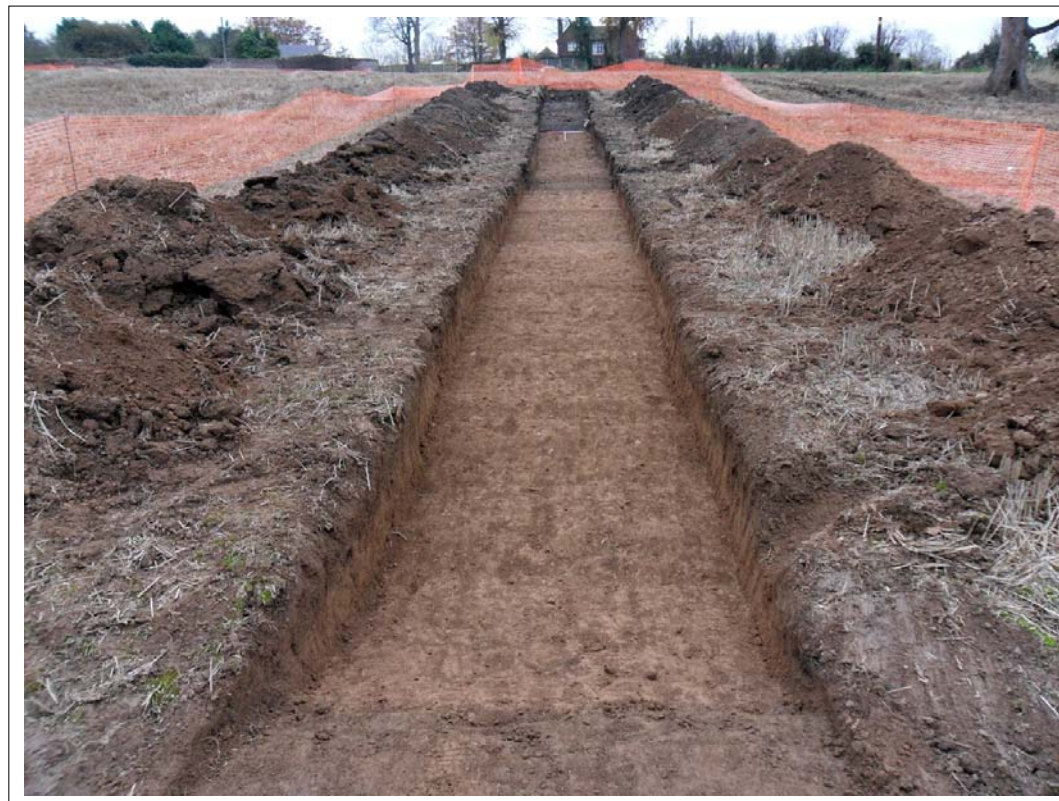
Plate 6: View south along trench 6, Scales 2x1m

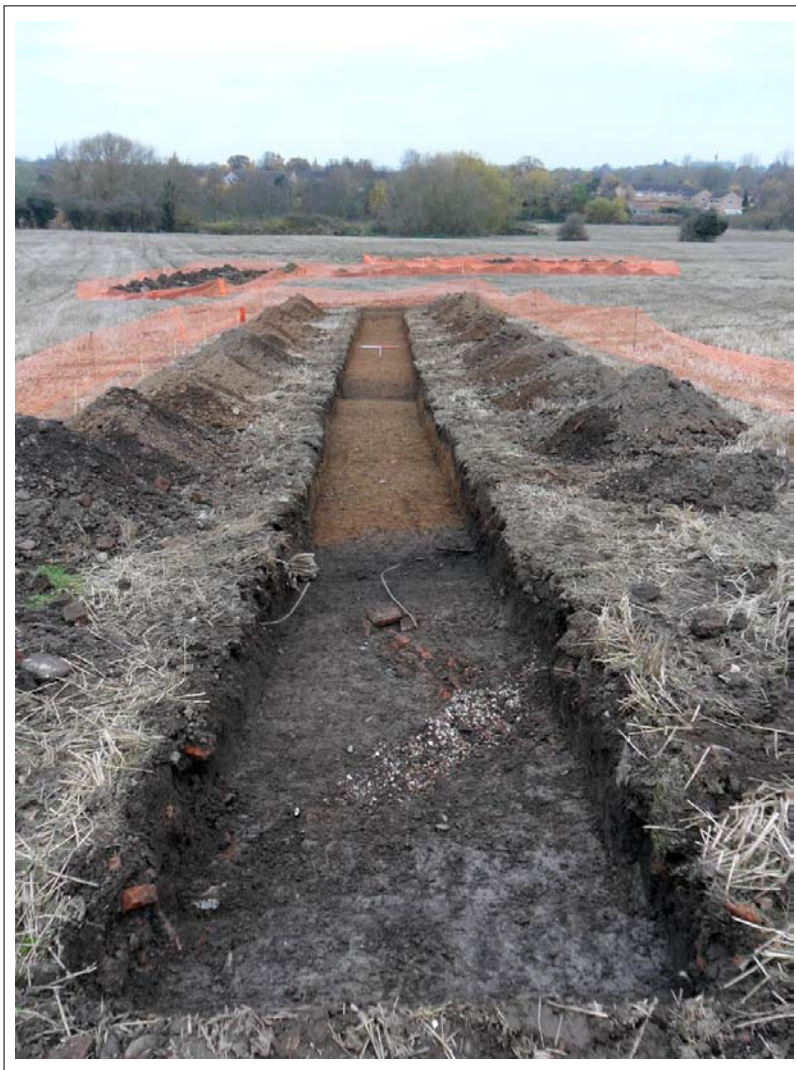
Plate 7: View north along trench 6, Scales 2x1m
Note land drains and dark deposit in foreground

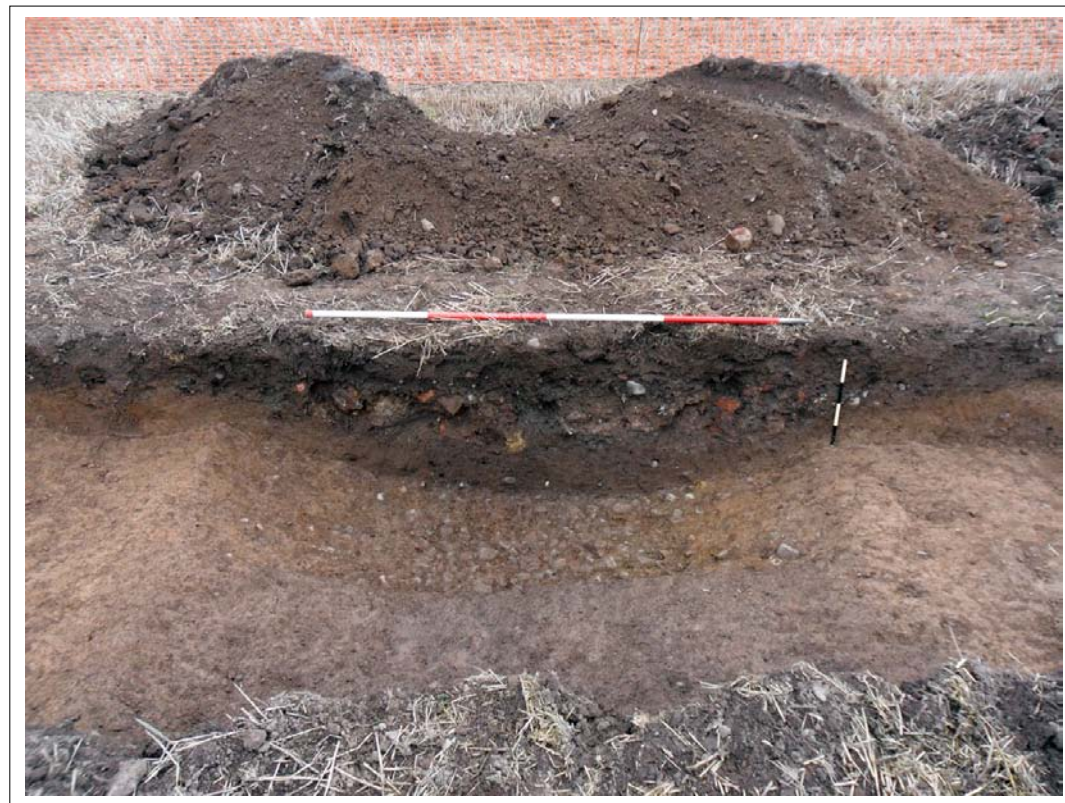
Plate 8: West facing section through ditch [609] within trench 6
Scales 1x2m & 1x0.5m

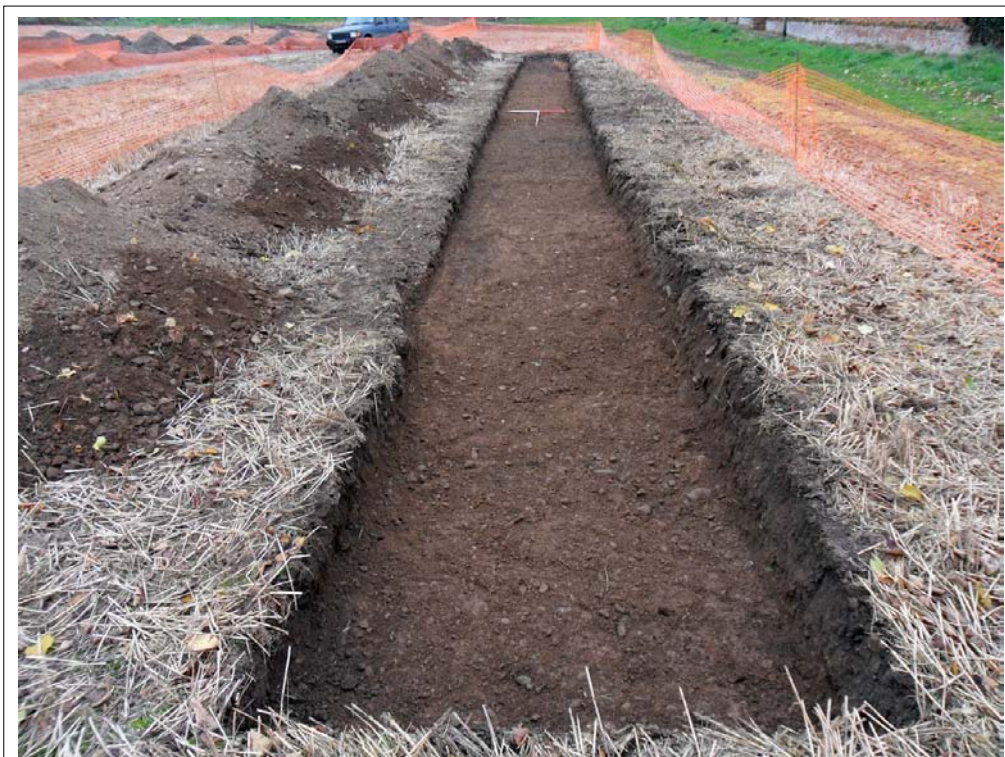
4.2.2 Trench 7. Trench 7 (Figs 2&4, Plate 9) measured 30x1.8m and was aligned east-west. It was located in the south eastern corner of the eastern field. Mechanical excavation showed the mid/dark brown silt topsoil (701) to be approximately 0.15m deep. It overlay a firmly compacted orange brown silt deposit (702) with frequent gravel inclusions (gravel making up c. 85 of the context). Excavation into this deposit ceased at a depth of 0.3m below the current ground surface owing to the presence of features cut into the gravel deposit (702). At the eastern end of the trench an area of crushed brick and rubble (703) was found to be a rough track surface of modern date, laid down to improve hearse access to the nearby Greek Orthodox church. A small (0.4m radius) pit feature [705] was located in the centre of the trench. Excavation of a half section of the pit found it to be 0.2m deep with shallow sloping sides and a flat base. It contained a single mid brown silt fill (706). Several animal bones were located within the fill including a small long bone complete with attached animal identification leg ring. The pit feature was thus deemed to be modern and represent either an animal burial or an animal's burrow. At the western end of the trench a row of three post holes [707-9] were located. Each was small, up to 0.25m in diameter, and equally spaced. Excavation of the postholes proved them to be quite shallow, the deepest being only 0.2m. Each contained a single mid brown silt fill containing coke fragments. The line of the posts matches that of the access track to the church so may represent the line of a comparatively modern boundary. The final feature located with trench 7 was a 0.3m wide linear feature [710] crossing the centre of the trench at 90°. Excavation of the feature proved it to be extremely ephemeral with a maximum depth 0.05m. It contained a single fill composed of grey brown silt (711) with no finds. No further finds or features of archaeological significance were located within this trench.

Plate 9: View east along trench 7, Scales 2x1m

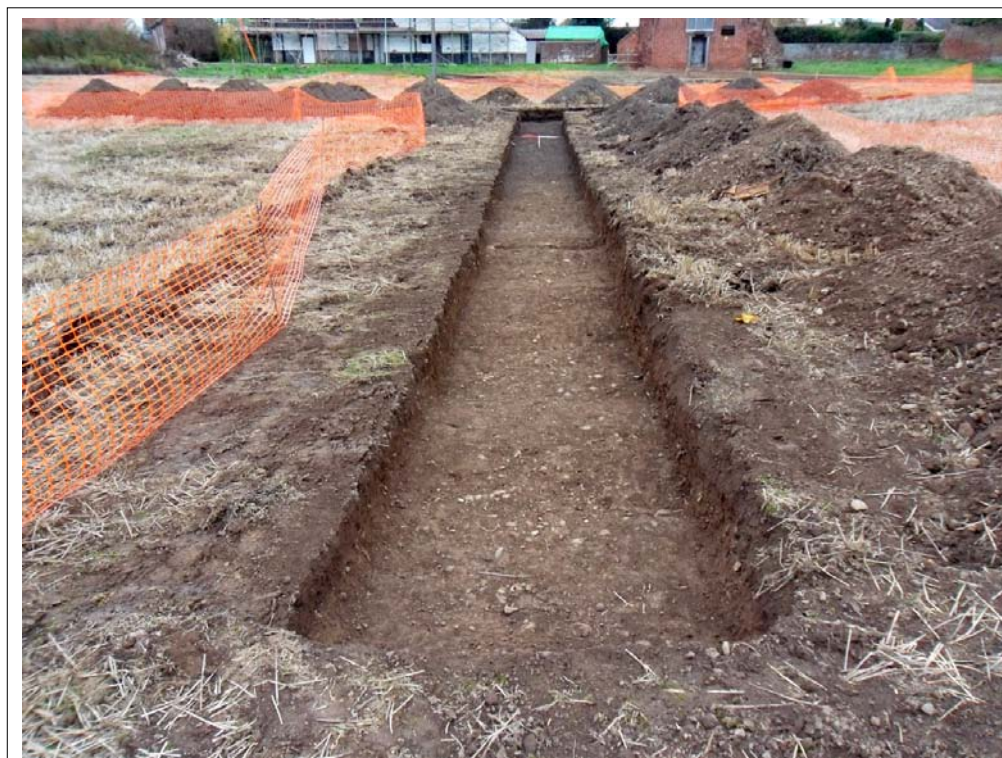
Plate 10: View east along trench 8, Scales 2x1m

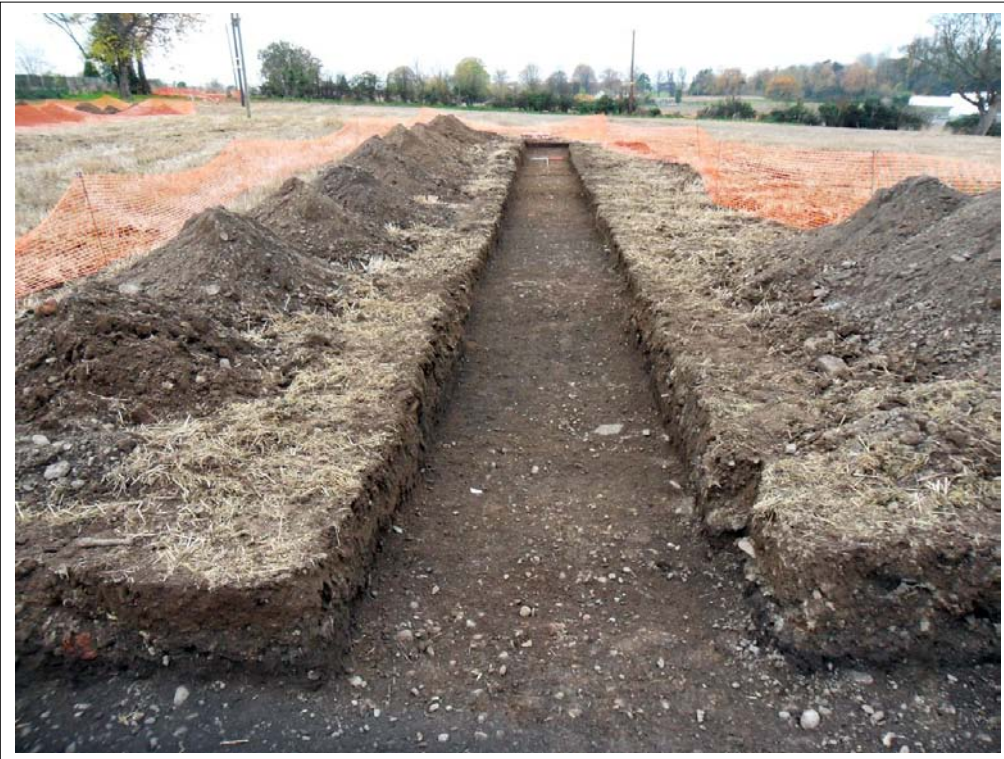
Plate 11: View west along trench 8, Scales 2x1m

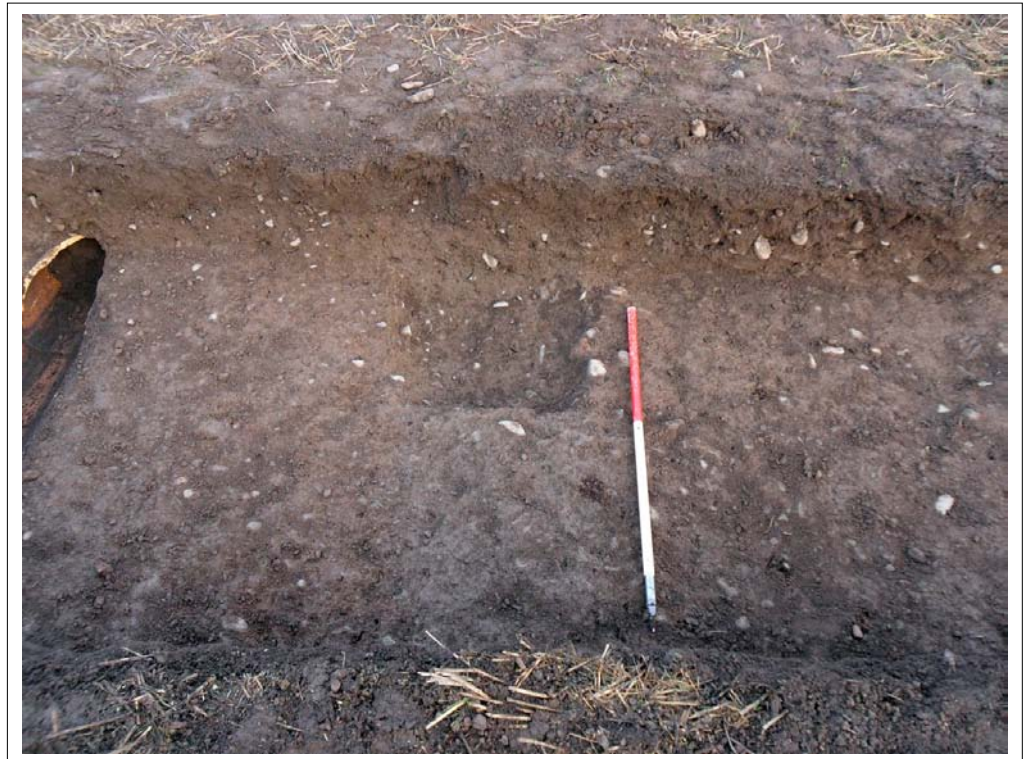
- 4.2.4 Two features were located cut into the natural deposits within the base of trench 8. The first was a linear feature [806] 0.5m wide and running north-south, crossing the trench at 90°. Excavation showed it to be 0.2m deep, contain a single silt fill (807) and no finds. The second feature [808] was roughly rectangular in shape, measuring 0.7x0.5m. Excavation showed it to be shallow (c.0.15m) and contain the skeletons of two dogs, each deliberately placed. Two sherds of medieval ceramic were recovered from the grave, one directly below the skeleton and at the base of the cut. A further feature located within trench 8 proved to be a modern drain.

Plate 12: View of gully feature [804] within trench 8, Scale 1x1m

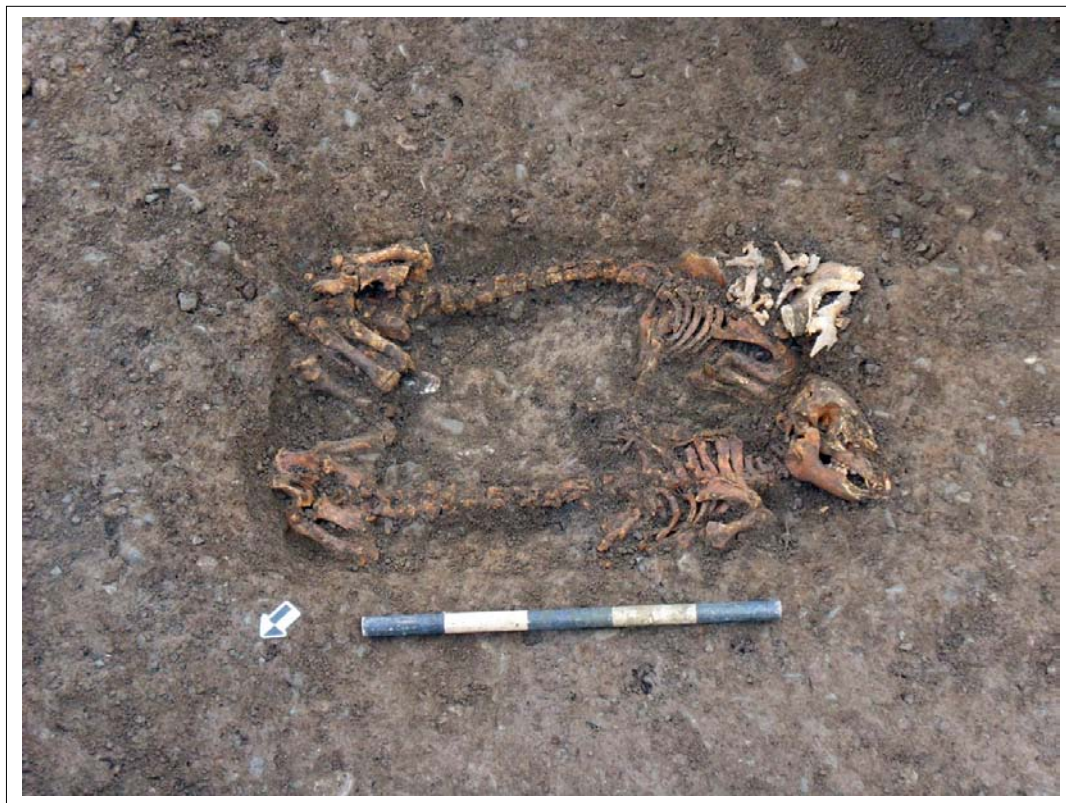
- 5.2.1 The bones from the two animal skeletons recovered from trench 8 are very poorly preserved and very friable. Initial analysis of the skulls and scapulae with comparative examples (O'Connor, 2000 & Rackham, 1994) would suggest that they were both dogs.

- 6.1.5 The two dog skeletons located in trench 8 had medieval ceramic with the grave cut. Whilst it is possible that the ceramic was residual the possibility remains that the double dog burial is medieval in date. No comparable examples could be located though the bones will form part of the archive should further study be deemed necessary.

Plate 13: View of dog skeletons within cut [805] in trench 8
Scale 1x0.5m

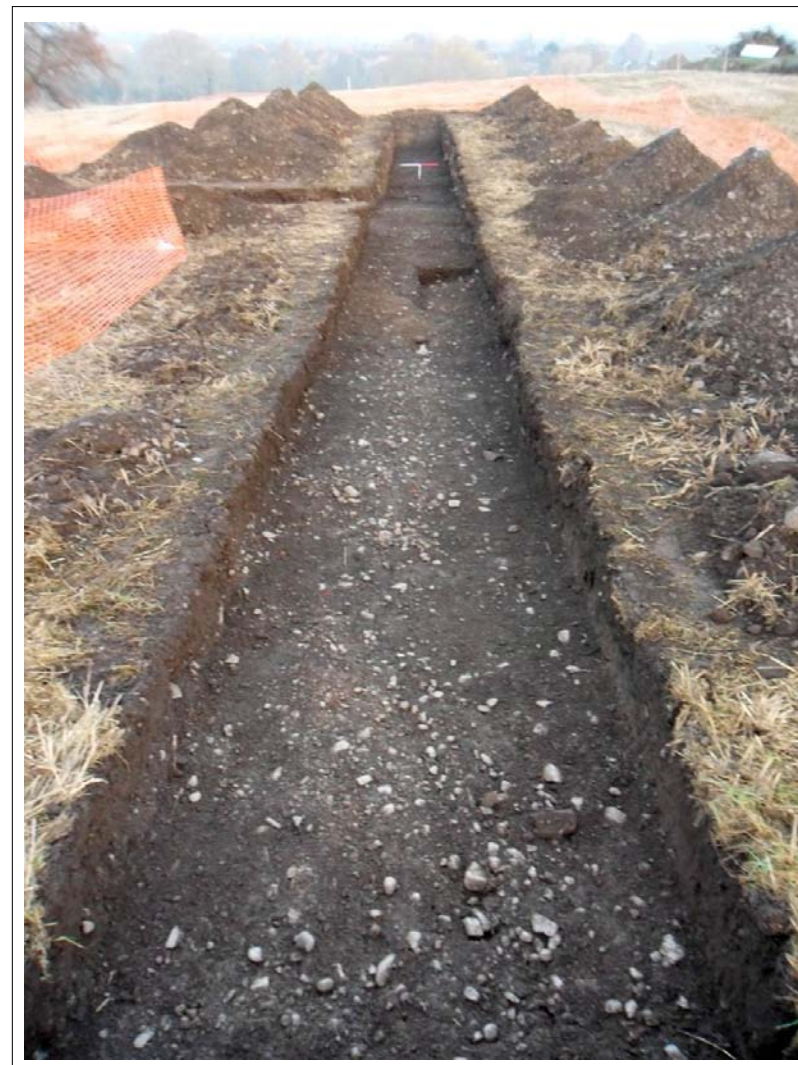
- 4.2.5 Trench 9, butting trench 8, showed the same compact natural gravel deposit (903) beneath a mixed clay and gravel subsoil (902). The gravel deposit extended across the whole of trench 9 though was partially obscured at the northern end by deep silt deposits (904) associated with a now backfilled pond feature [905]. Excavation of a sondage through the silt deposits showed the continuation of the natural gravel deposit beneath. Hand cleaning of the natural deposit (903) at the southern end of trench 9 revealed a total of 20 sherds of medieval ceramic located on the surface of the gravel. All of the sherds appeared unabraded. Further excavation of the natural gravel deposit (903) in this area located what were initially interpreted as features though, upon excavation of a sondage, appeared to be variations within the natural gravel banding which makes up the topographic ridge bounding the southern side of the assessment area.

Plate 14: View north along trench 9, Scales 2x1m

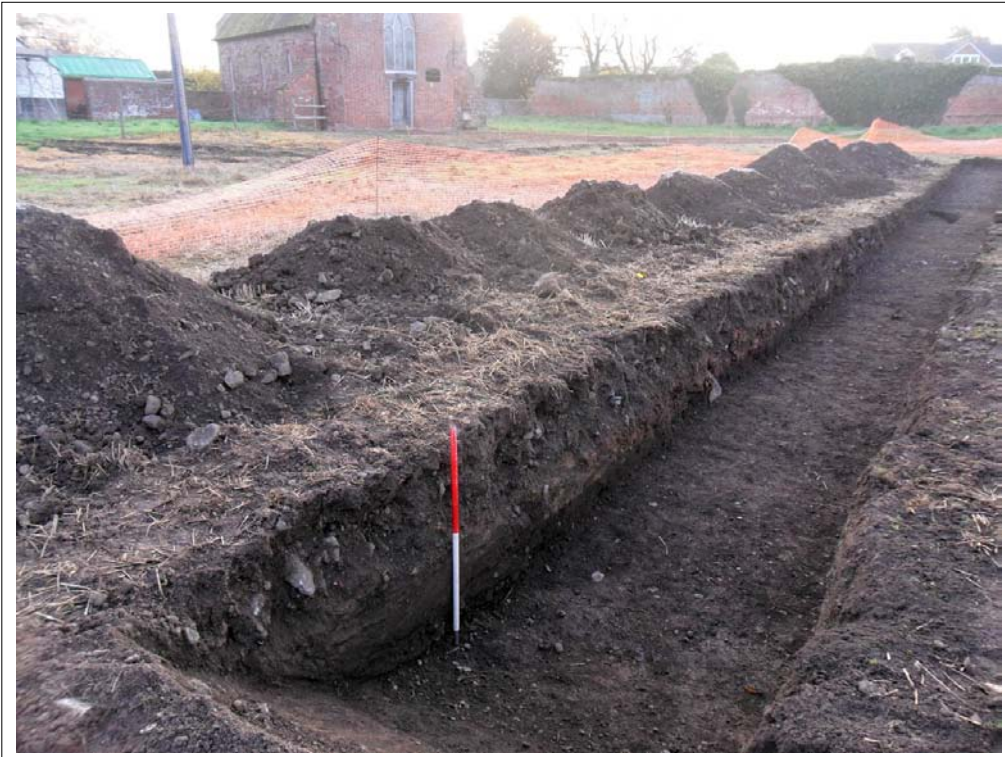
- 4.2.6 The pond feature [905], at the northern end of trench 9, appears to have covered a large area and was backfilled within the last 30 years by the landowners (Frank Pers.Comm). The evaluation trench was cut to the bottom of the pond feature and no features of archaeological interest were located beneath.

Plate 15: View south east of length of trench 9 and pond deposit in section
Scale 1x1m

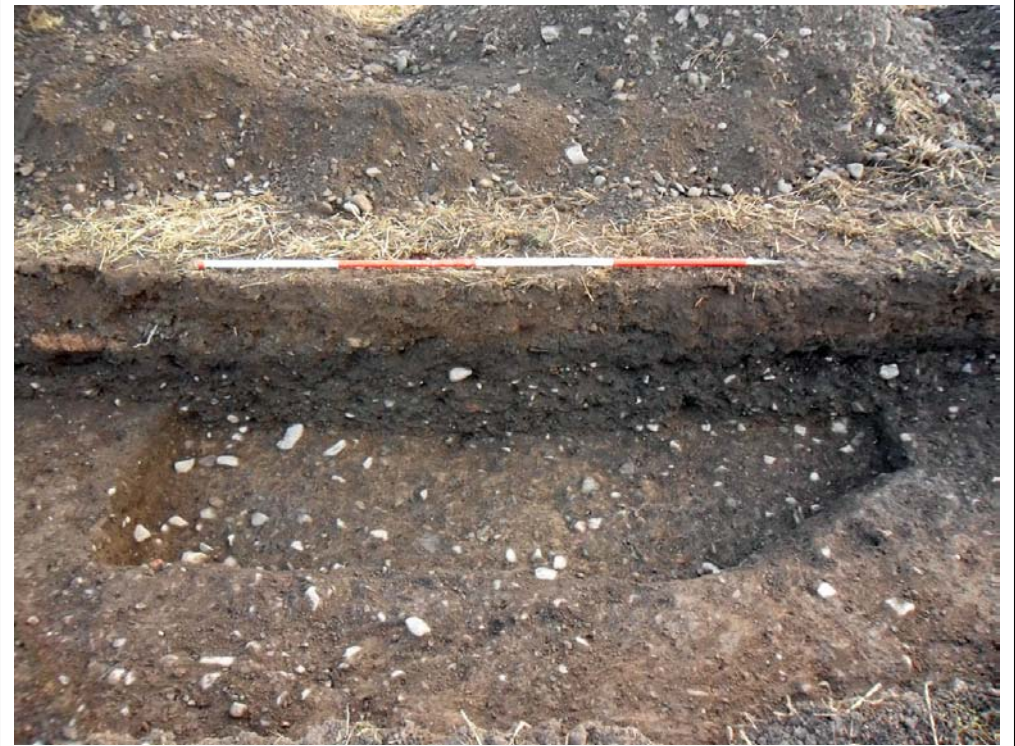
Plate 16: View of sondage excavated through gravel deposits within trench 9, Scale 1x2m

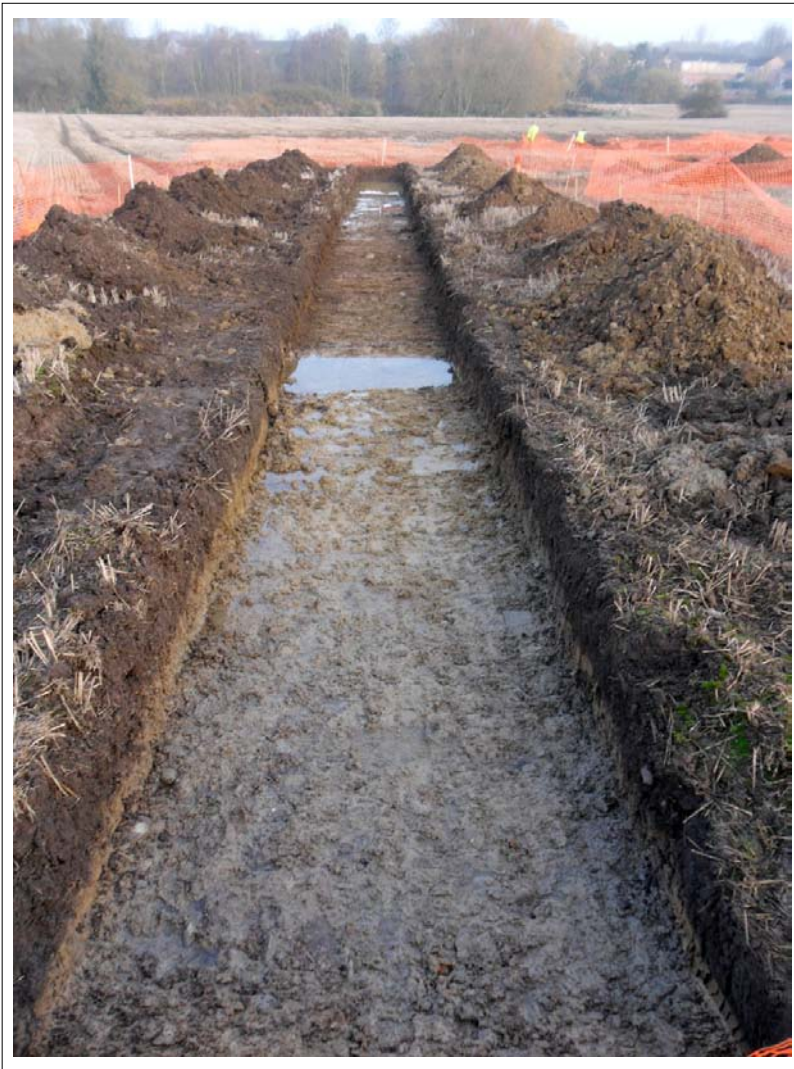
- 4.2.7 Trenches 10/11/12. Trenches 10-12 (Fig 2, Plates 17-19) each measured 30x1.8m. Trench 10 was aligned north-south whilst trenches 11 & 12 were both aligned east-west. Each were located in the northern area of the eastern field. The topsoil deposit in the three trenches was found to be reasonably uniform, being composed of dark brown silt up to 0.2m deep in each. The subsoil deposits were similarly uniform and were composed of mid brown silt with no gravel inclusions. The natural clay deposits in the three trenches were composed of a heavy mottled yellow/brown/grey and, owing to seepage of groundwater, were very waterlogged. Two very narrow (0.1m) linear features were noted cut into the natural clay of trench 12. After consultation with the landowner these were taken to represent moled land drains. No finds or features of archaeological significance were located within these trenches.

Plate 17: View north along trench 10
Scales 2x1m

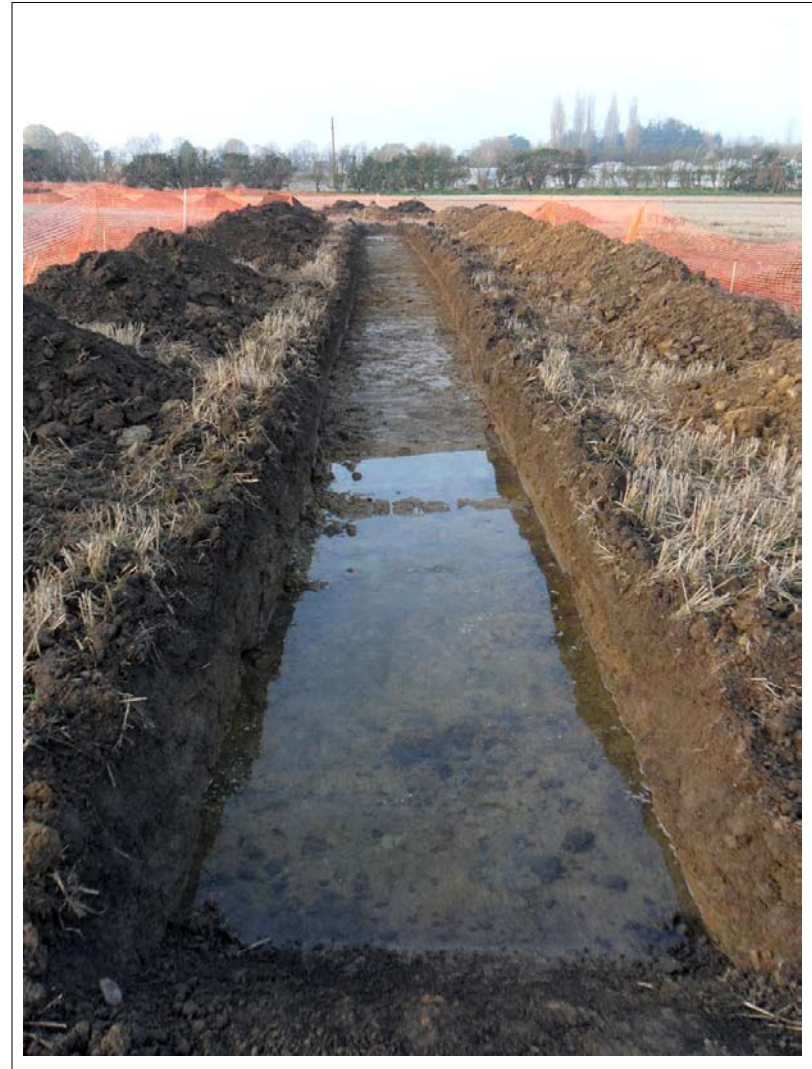
Plate 18: View west along trench 11
Scales 2x1m

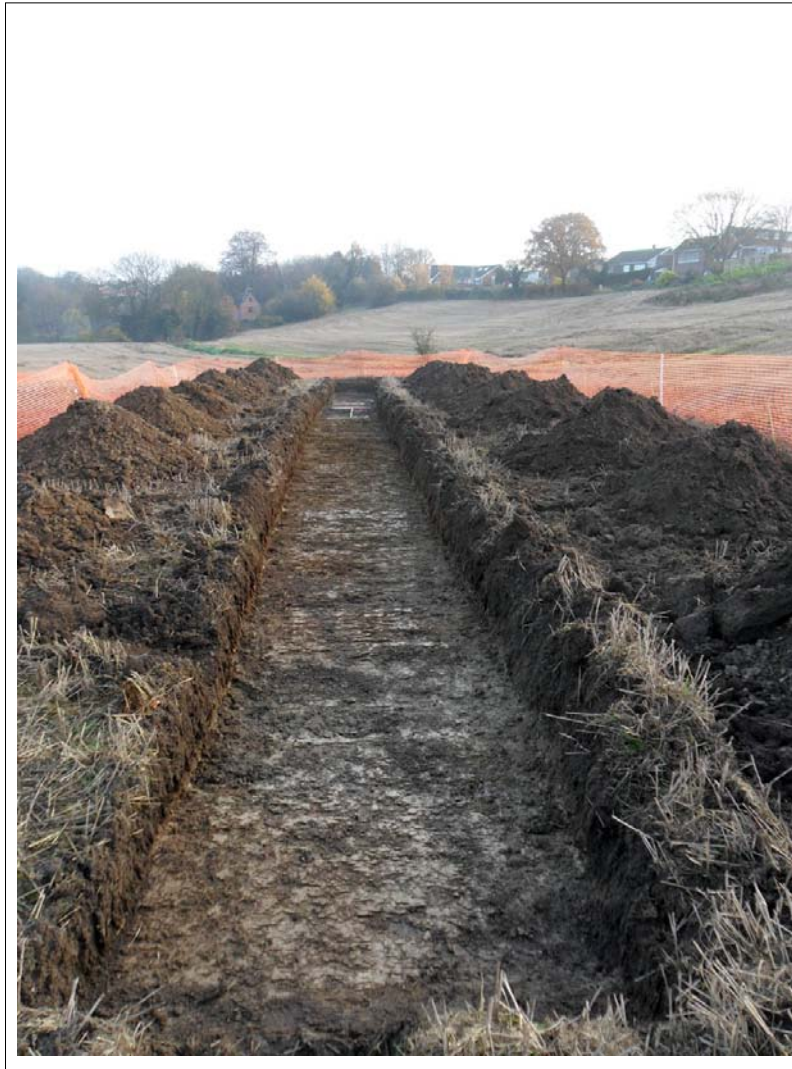
Plate 19: View east along trench 12
Scales 2x1m
