Land between Waterloo Street & The Ringway Kidderminster, Worcestershire

Field Evaluation

By
Chris E Smith BA (Hons) MA MCIfA
Report No. 1333

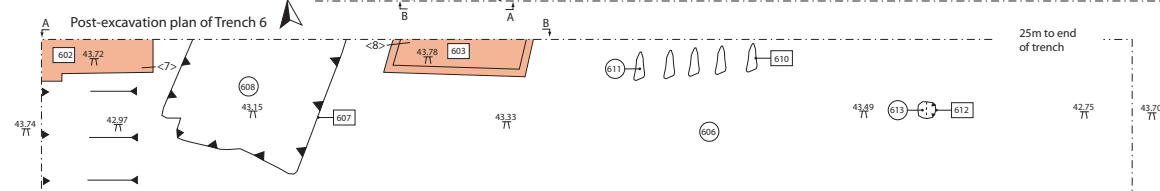
South facing section showing brick structures [602] and [603] within Trench 6

- 4.2.32 A large (3m wide) cut [607] was observed between the two brick plinths (602 & 603). This was made through the subsoil horizon (604) and into the natural (606). Modern plastic material was evident within the mixed rubble fill (608) suggestive of a relatively recent date.

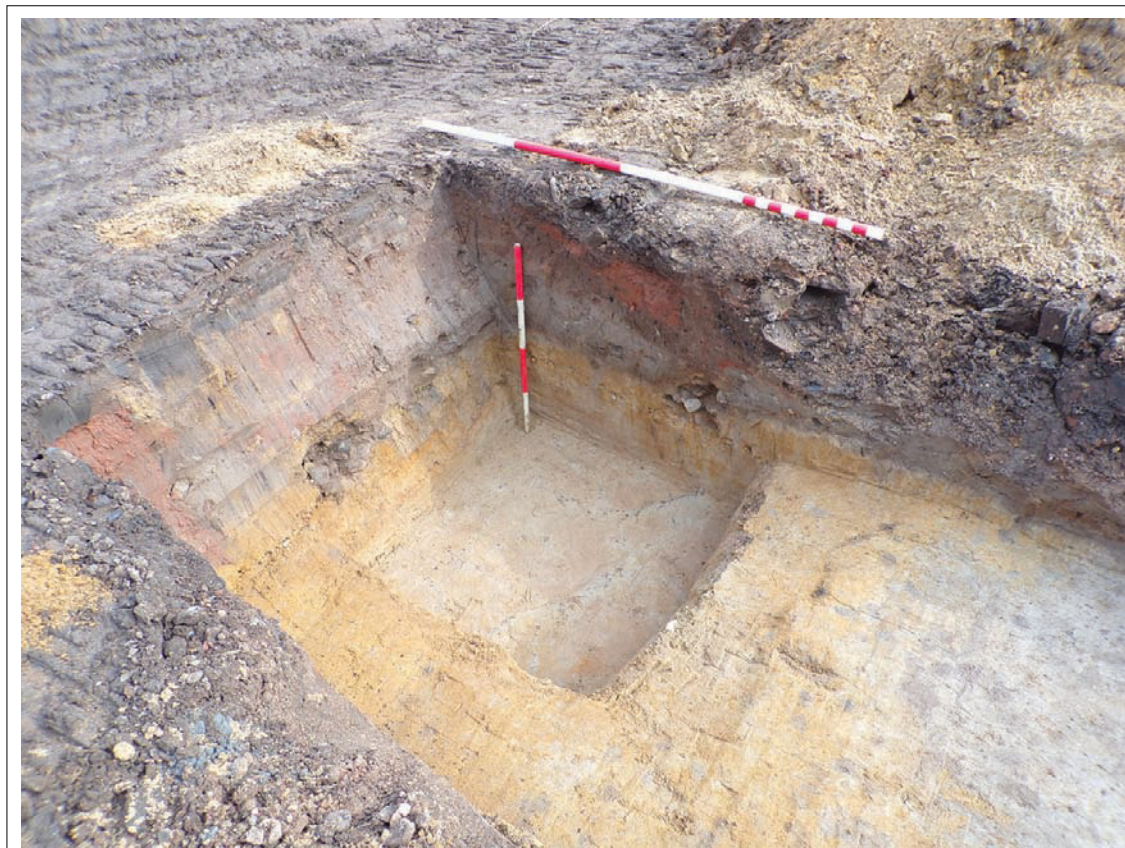
Plate 6: View of sondage in north eastern end of Trench 2. Note land drain in section. Looking south east. Scales 1x1m & 1x2m

- 4.2.6 The line of a land drain (204), filled with subrounded cobbles, was noted at the north east end of the trench running on an approximate north to south alignment.

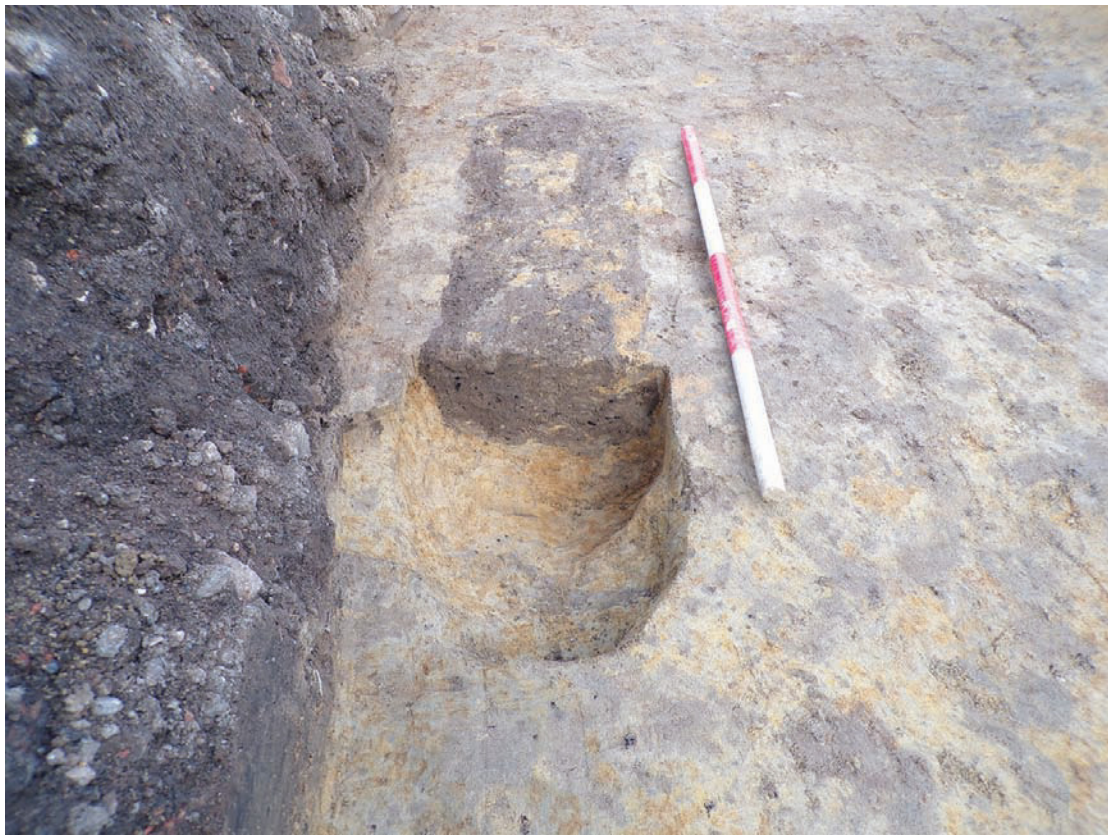
Plate 7: Post excavation view of pit [215]. Looking north east, Scale 1x1m

- 4.2.7 A single subrectangular pit feature [205] was noted cut into the natural at the base of the trench. It was 1.2m in length by 0.3m wide. Excavation showed it to contain a single dark brown silt fill and to be 0.2m deep. A fragment of clay pipe stem was recovered from within the fill (206).

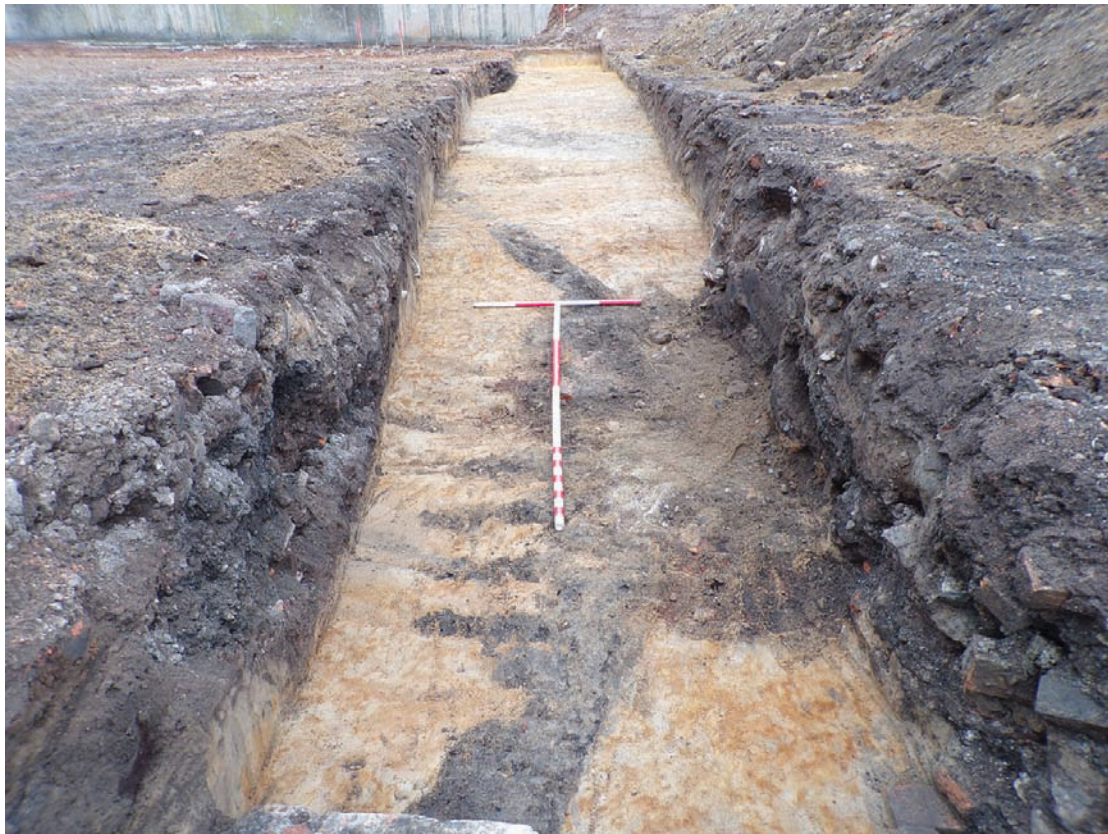
Plate 11: View along middle of Trench 3, Looking north east, showing area of removed drainage system. Scales 1x1m & 1x2m

- 4.2.13 Within the middle of the trench was evidence of a now removed drainage system. A large square area of modern disturbance (with evidence of excavator bucket teeth marks) was noted with linear features running into it. This was interpreted as a drainage feature with drains running into it removed during a previous phase of demolition earlier in the 20th century. One of the ceramic drains, within a reasonably modern concrete reinforcement, was still *in situ* running into the area of disturbance.

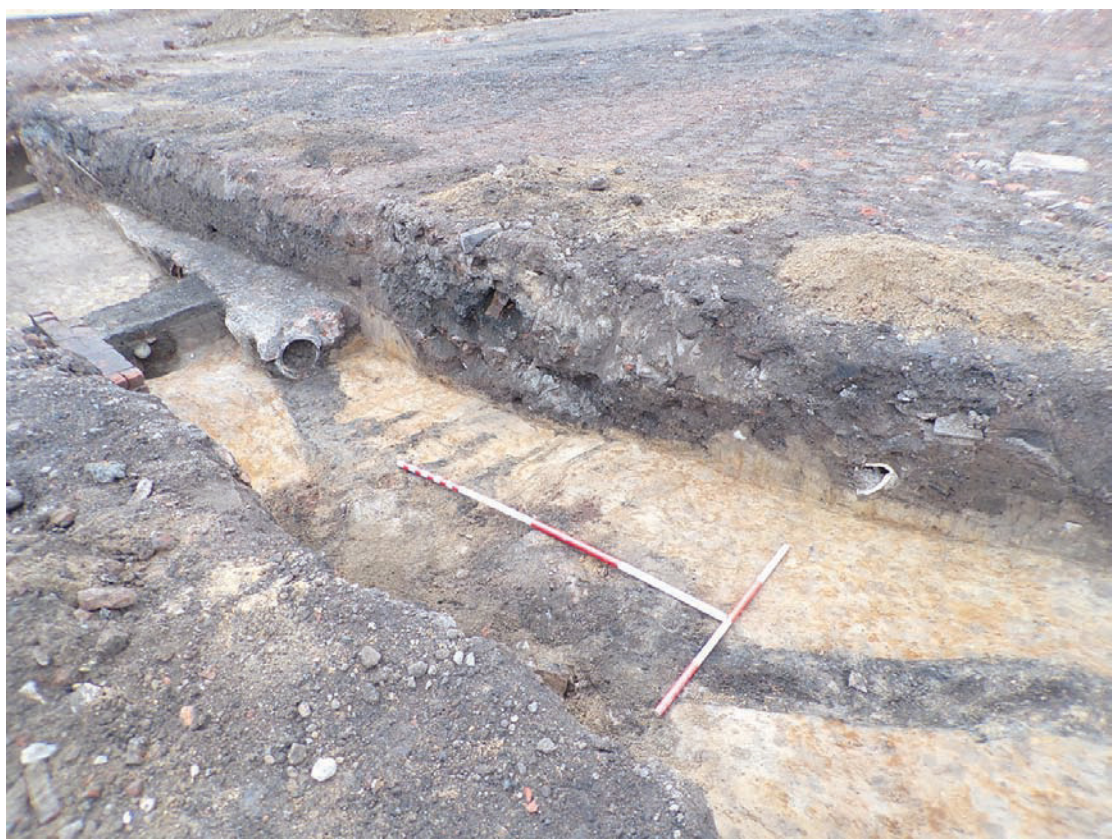
Plate 12: Oblique view of middle of Trench 3, Looking north west, showing area of removed drains. Scales 1x1m & 1x2m

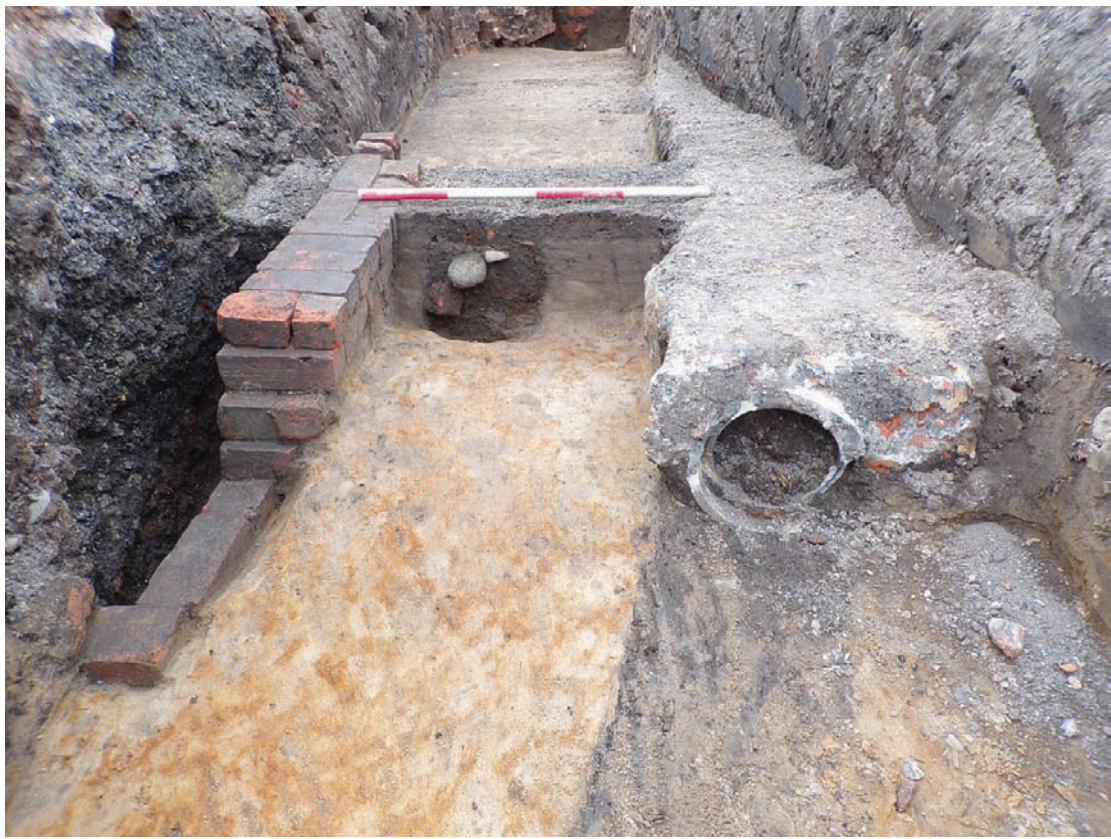
Plate 13: View of brick structure [324], posthole [328] and concrete set drain at base of Trench 3. Scale 1x1m

- 4.2.15 A single posthole [328] was noted adjacent to the brick structure. This measured 0.3m in diameter by 0.5m deep and contained a single mixed silt fill with stone and rubble inclusions.

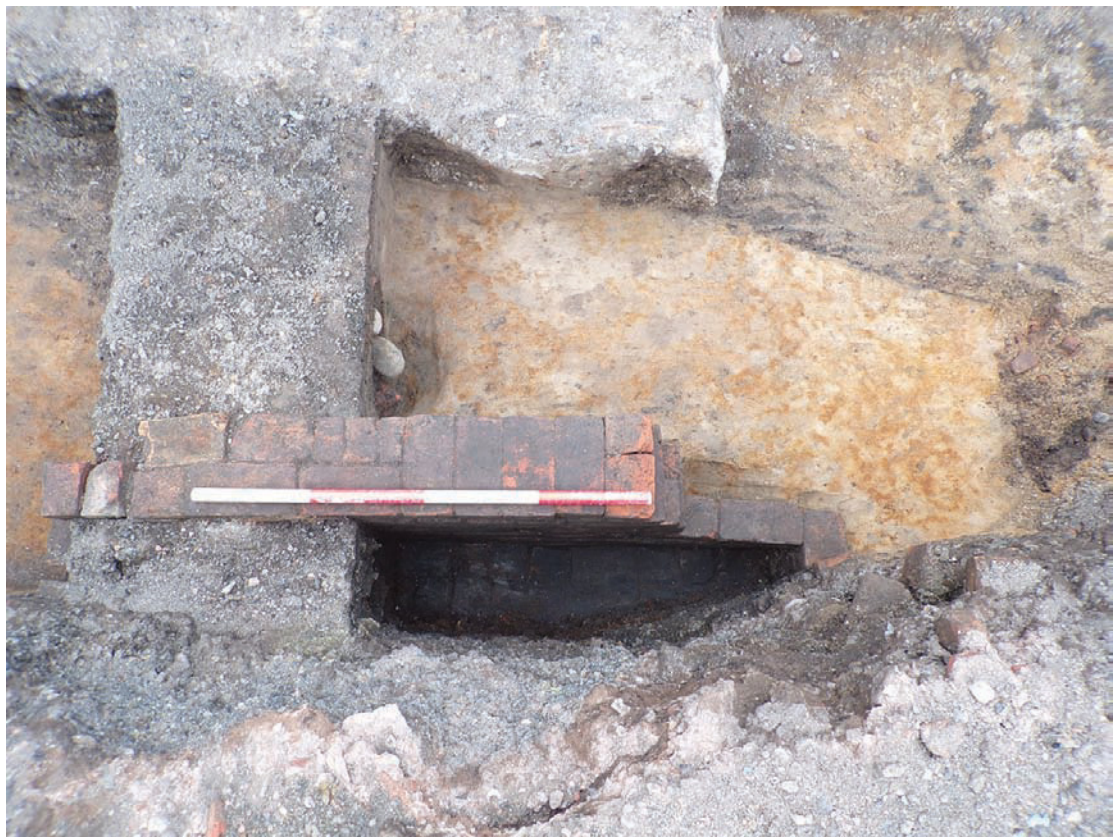
Plate 14: Plan view of brick structure [324] and posthole [328]. Scale 1x1m

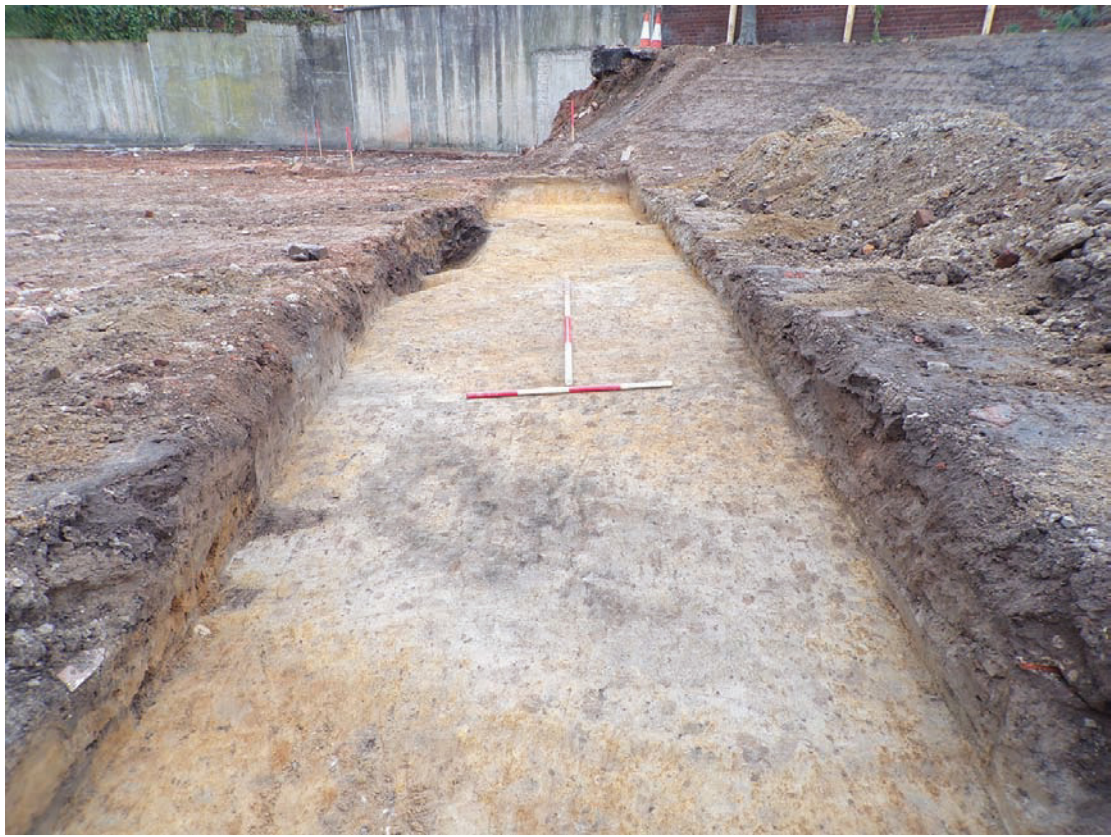
Plate 15: View of staining area on natural sand, possible remnants of field boundary within Trench 3. Looking north east. Scales 1x1m & 1x2m

- 4.2.12 A one metre wide area of staining on the natural sand running perpendicular to the trench was noted to the west of pit [318]. This was interpreted as possible remnants of an old field boundary.

8.3.3 An area of staining on the natural sand, approximately one metre wide, was interpreted as the possible remnant of a field boundary running approximately north to south across the assessment area. The 1753 John Doharty map does show the assessment area as being divided by a long, north to south, field boundary prior to any development.

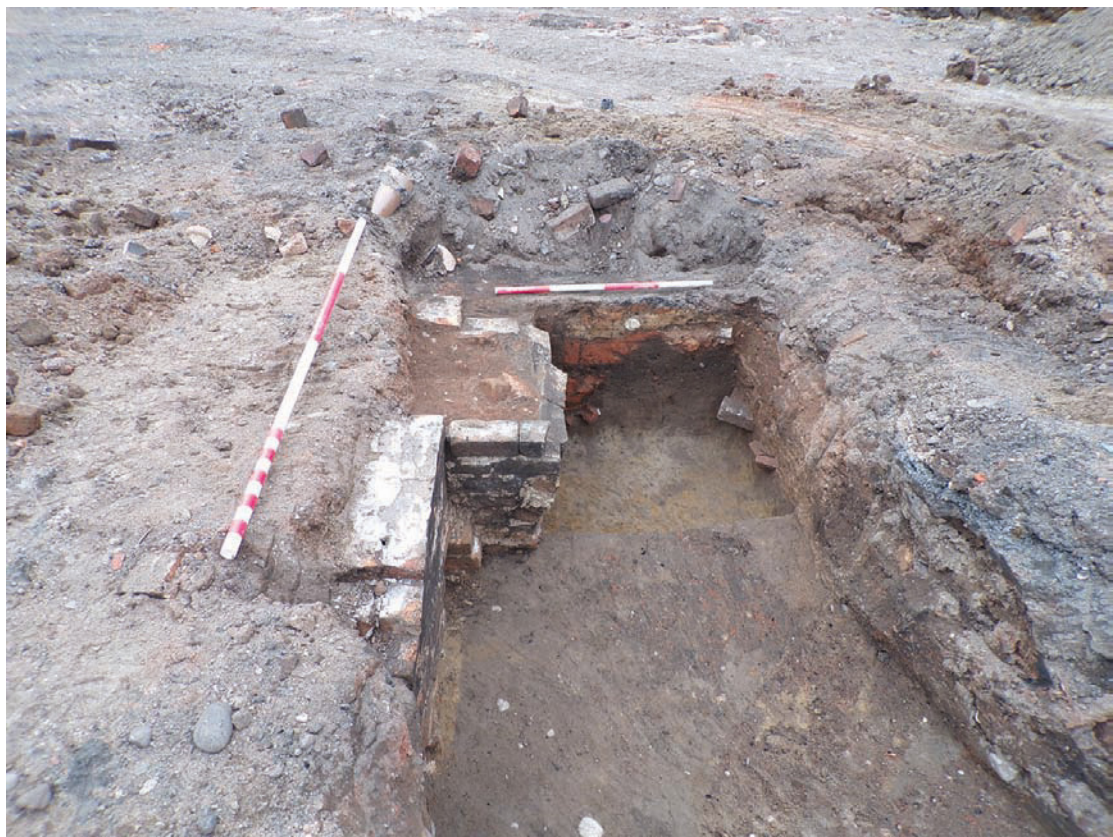
Plate 16: View of brick structure [310] at south western end of Trench 3. Scales 1x1m & 1x2m

- 4.2.16 At the very south-western end of the trench a brick structure [310] was noted. This was located beneath the overburden horizon (317/321). It was sat in a very narrow foundation cut [309], which was cut into a mixed silt/rubble horizon (315). The brick structure was composed of unfrogged bricks bonded with a lime mortar. Remains of half of a possible archway survive within the bricks, suggestive of a possible culvert. Excavation of the deposit (320) above the internal face of the arch produced a large amount of butchered animal bone suggesting disposal down a drain feature. A channel noted within the brick wall adjacent to the arch feature may also be suggestive of a drain related function to the brickwork in this area.

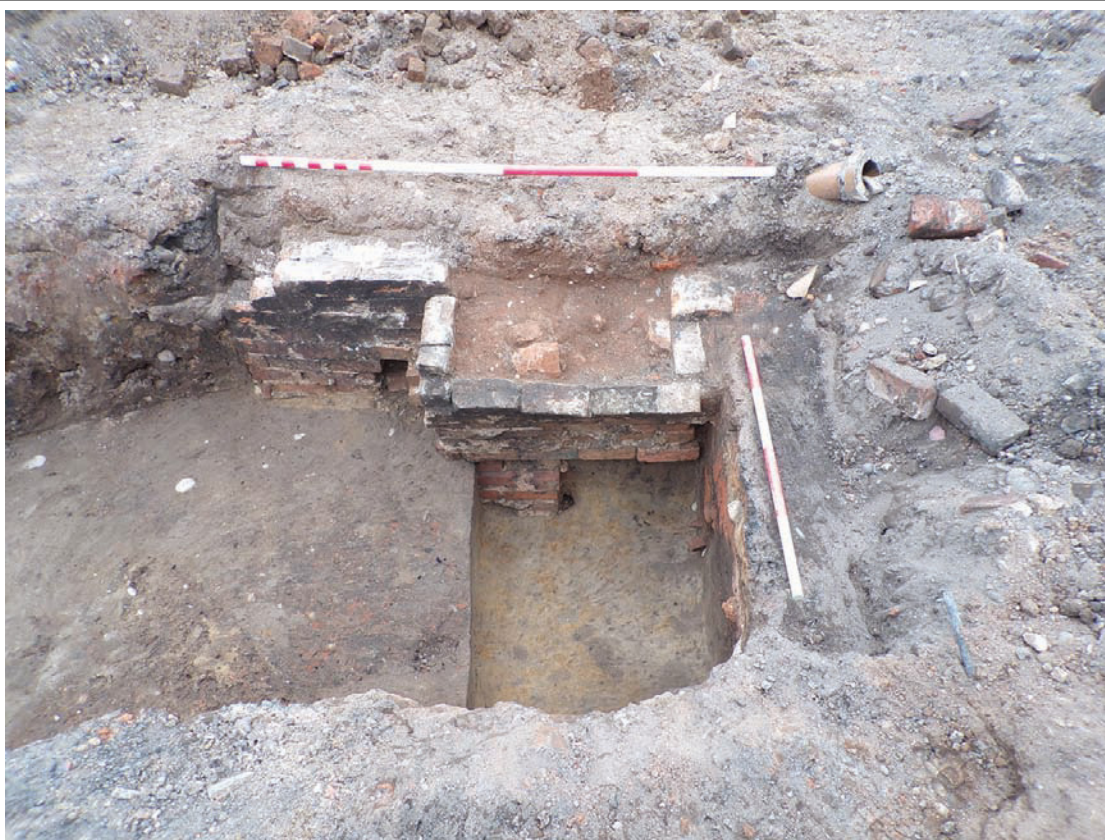
Plate 17: Brick structure [310], plan view. Scales 1x1m & 1x2m

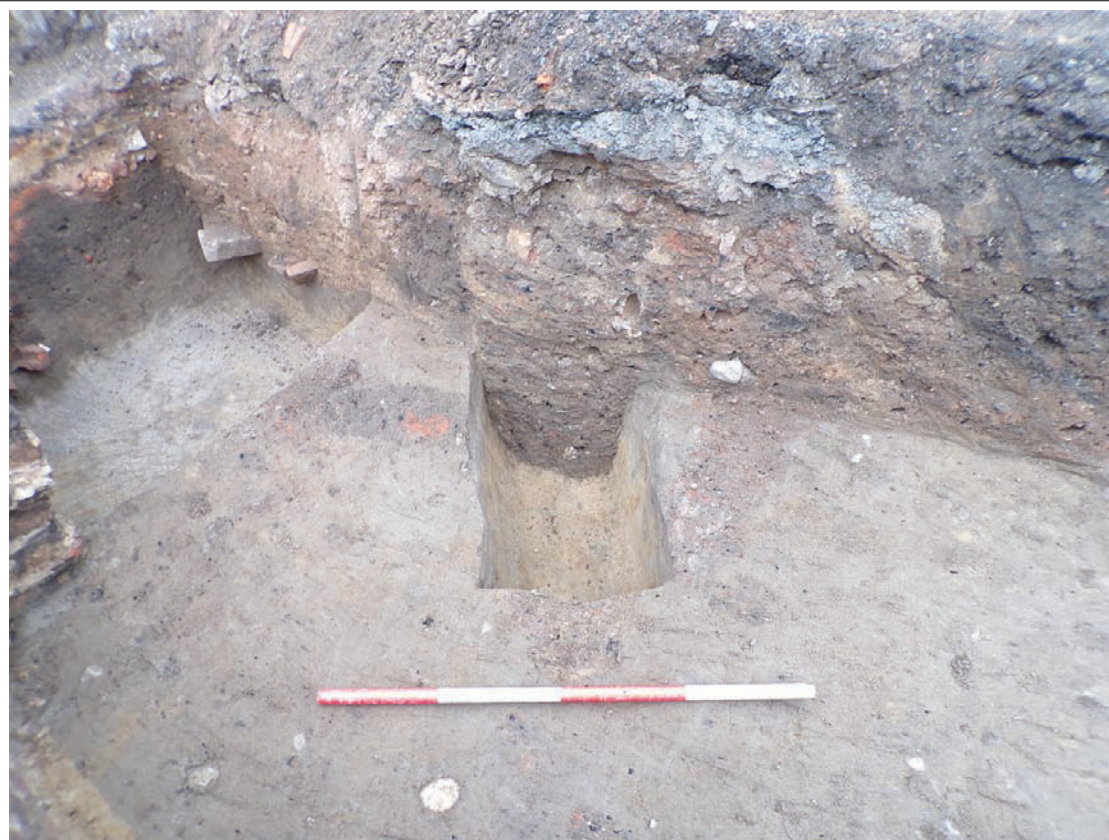
Plate 18: Post excavation view of gully terminus [316]. Scale 1x1m

- 4.2.17 The terminus of a narrow (0.5m), deep (0.9m) gully [316] was also noted adjacent to the brick structure [310]. This appeared to be cut in very high in the section through overburden layer (321). This was assumed to be a modern intrusion though was of unknown function.

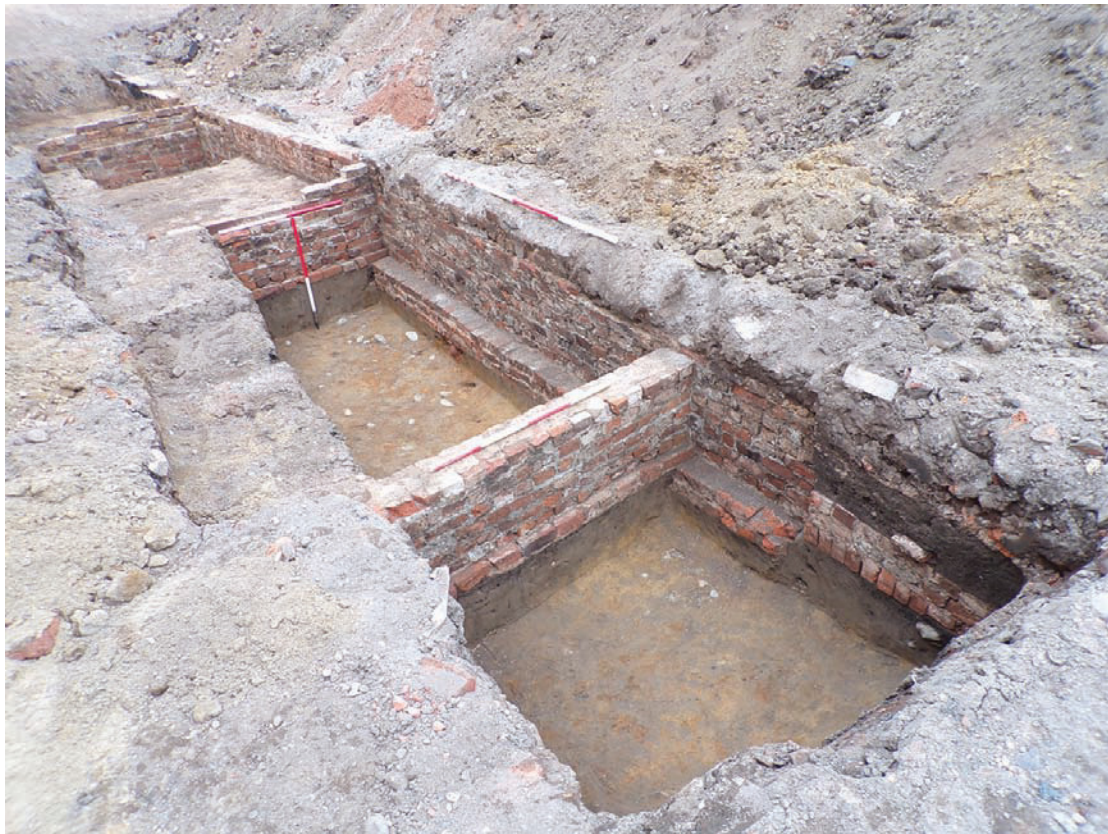
Plate 21: Oblique view of mid 19th century structural remains within Trench 4.
Scales 3x1m & 1x2m

- 4.2.19 The trench measured 15m in length by 2m in width. A dark silt overburden (401) with occasional rubble inclusions was removed by mechanical excavator revealing the line of brick walls (402). Subsequent excavation of the walls showed them to represent the largely below ground foundation courses of the 19th century housing fronting Waterloo Street.

8.4.1 The excavation within trench 4 showed good below ground survival of the mid-19th century domestic houses fronting onto Waterloo Street which stood from the mid-19th century to c.1938. All levels above the foundation courses have been demolished leaving approximately 0.5m to 0.8m intact below ground. Finds from within the demolition horizon suggest an early 20th century demolition date.

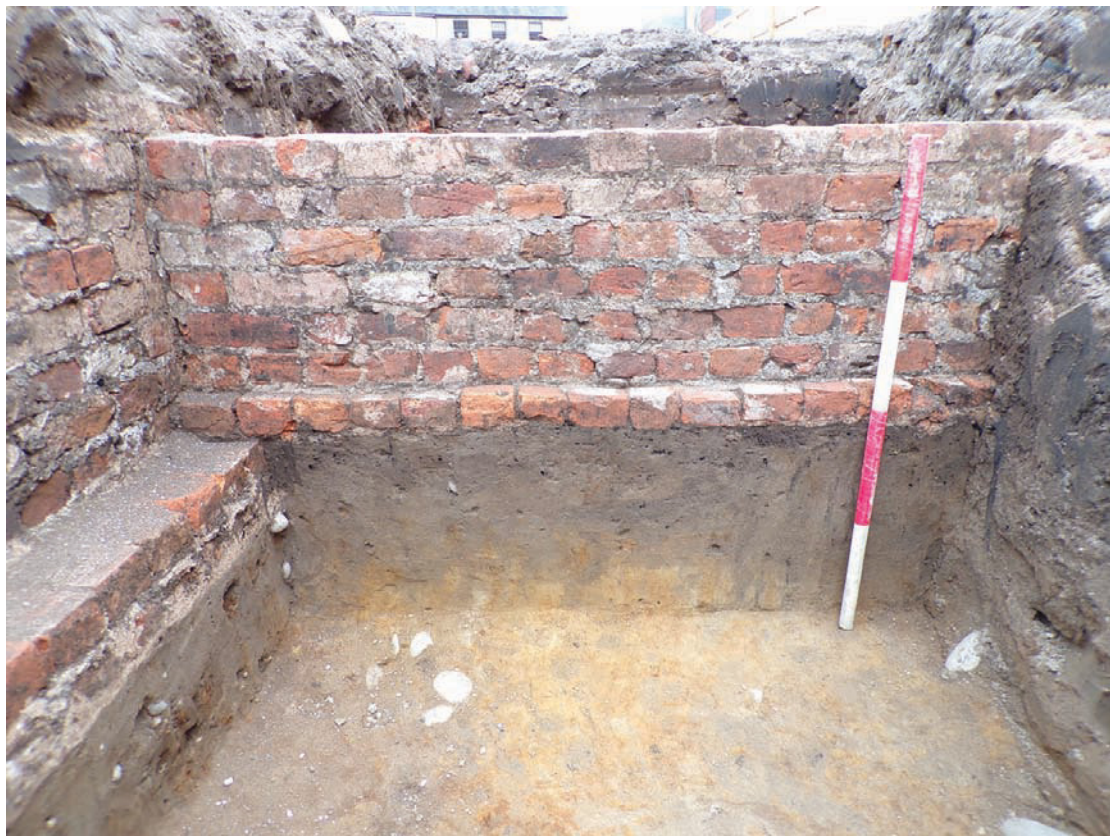
Plate 24: View of buried soil horizon (403) beneath walls (402). Scale 1x1m

- 4.2.21 The two southernmost rooms were fully excavated to below the base of the foundation walls (402) thus exposing the buried dark silt soil horizon (403) and natural sand (404) on which the houses were constructed. Numerous finds of later 17th to mid-18th century date were recovered from the buried soil horizon below the 19th century housing. The natural sand, exposed at a depth of 1.2m, contained occasional large cobblestone inclusions though no finds or features predating the housing.

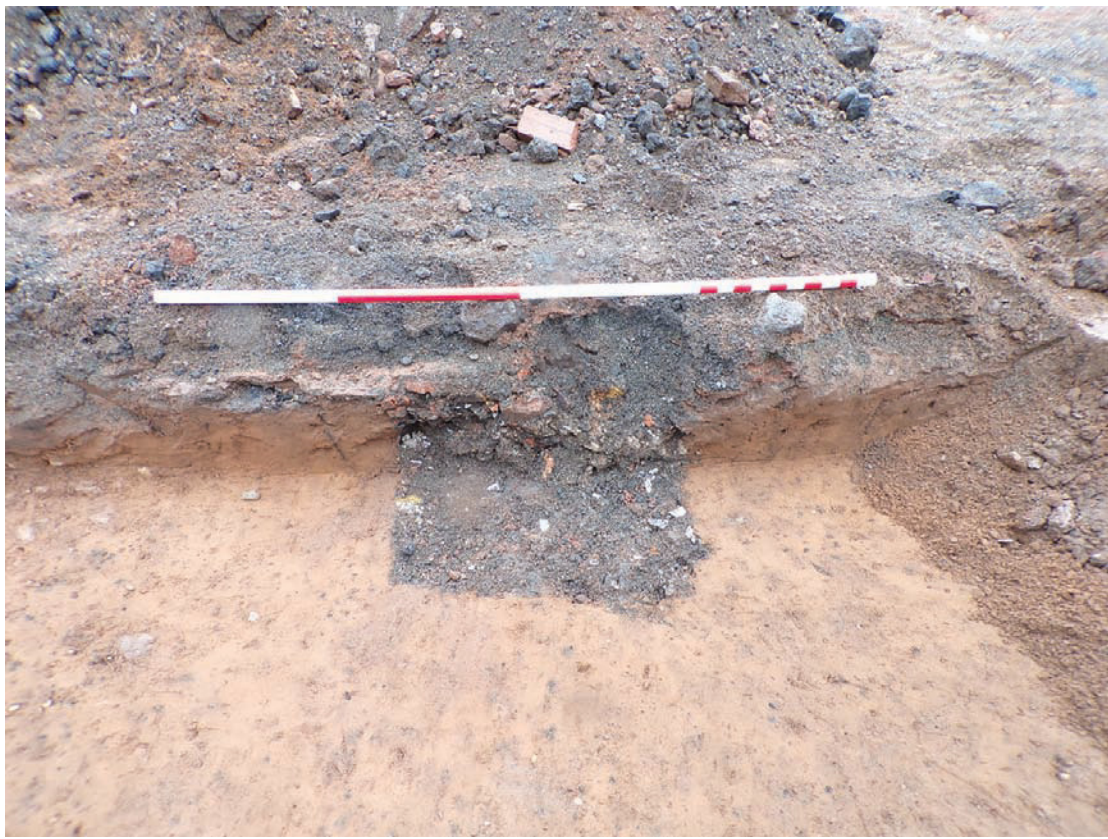
Plate 27: Pre-excavation shot of pit [503]. Looking north east. Scale 1x2m

- 4.2.27 Located immediately below the overburden (501) and cut into the natural sand (502) was a square pit [503], partially obscured by the trench edge. Excavation of the pit found it to contain a single friable fill (504) composed of loose dark silt and large amounts of late 19th and early 20th century material such as pottery, glass and clay tobacco pipes. The sides of the pit were vertical, the base was flat and the corners were very regular.

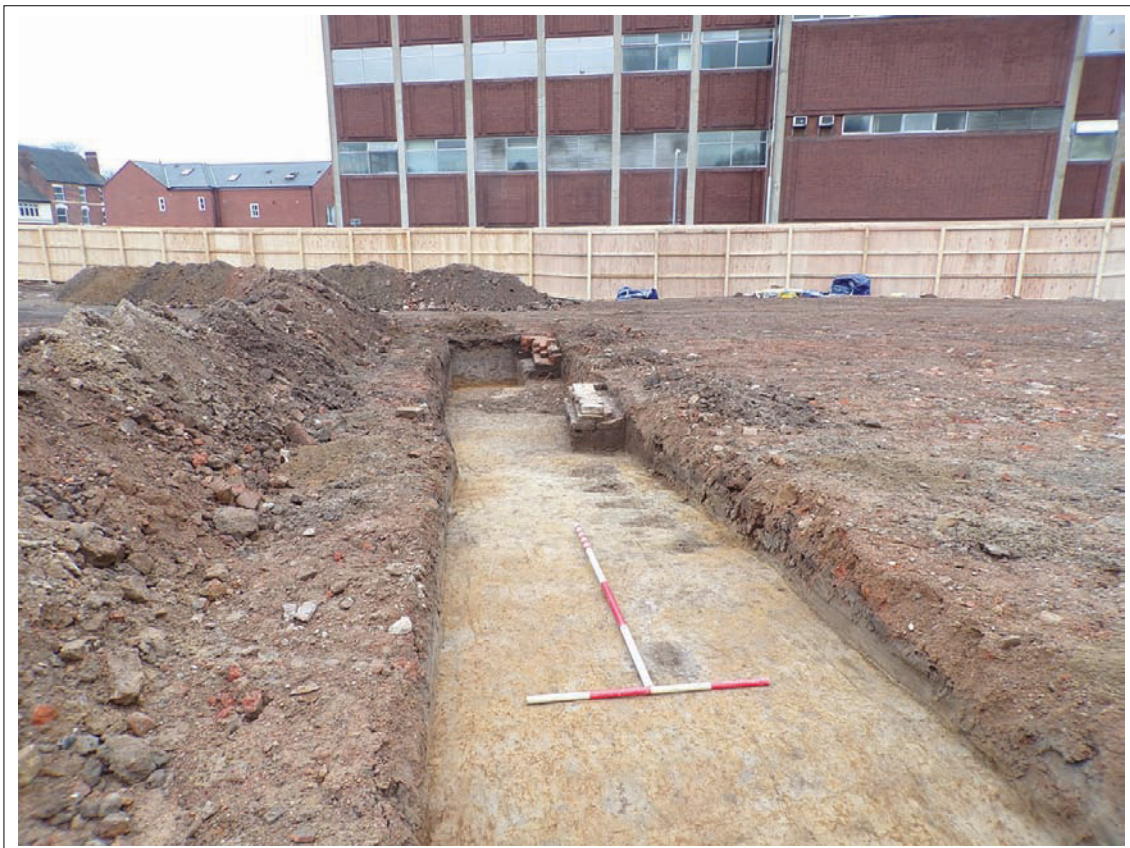
Plate 34: View along Trench 6, Looking west. Scales 1x1m & 1x2m. Note [610], group of excavator bucket teeth features

- 4.2.33 A group of five small cuts [610], originally interpreted as postholes, was located cut into the natural to the east of brick plinth (603). Upon excavation these were found to angle into the ground at 45°. Their uniform size and regular spacing lead to a reinterpretation of the features as likely made by the teeth of a large excavator bucket, likely from an earlier phase of demolition on the site.

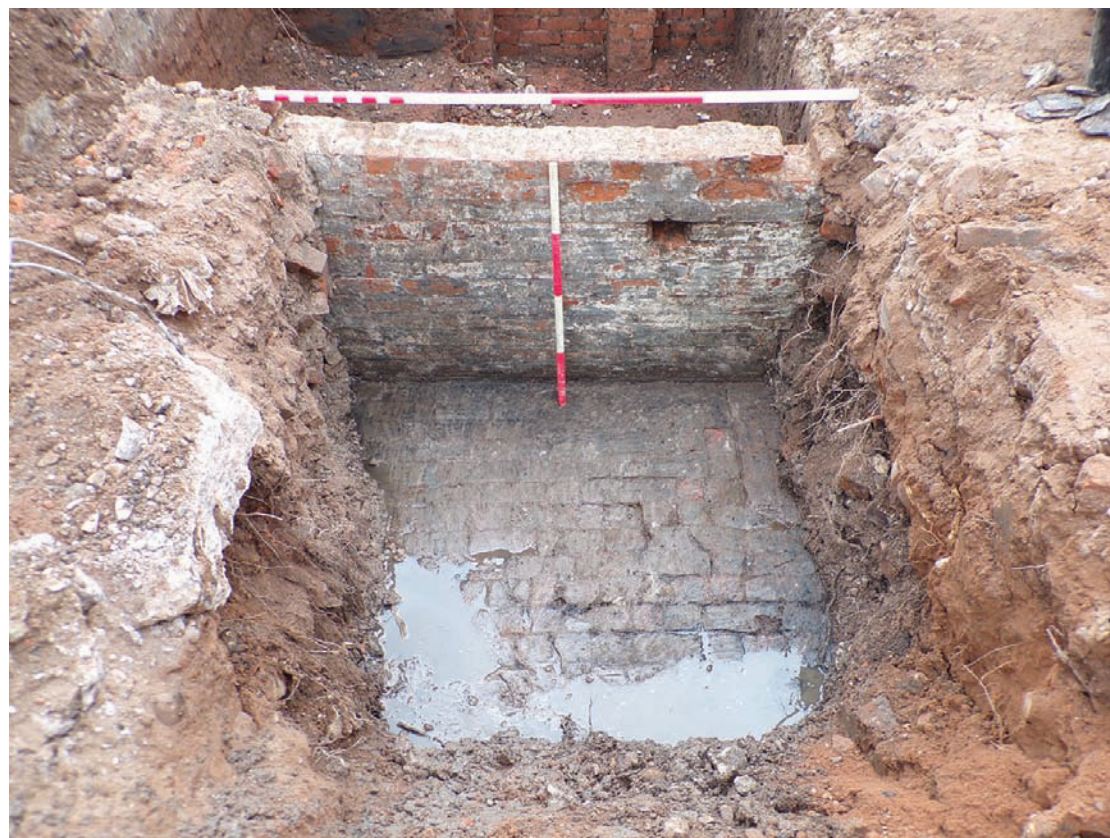
Plate 38: Cellar floor (730) post excavation shot. Scales 1x1m & 1x2m

- 5.4.4 Small Find 3, the silver pin, was recovered from context (730), the brick cellar floor within trench 7. The pin is 36mm in length, 1mm in width with a flared and convex head 2mm in diameter. Under magnification small areas of corrosion are visible suggestive of a silver coating over a base metal. The structure from which the pin was recovered is securely 19th century in date.

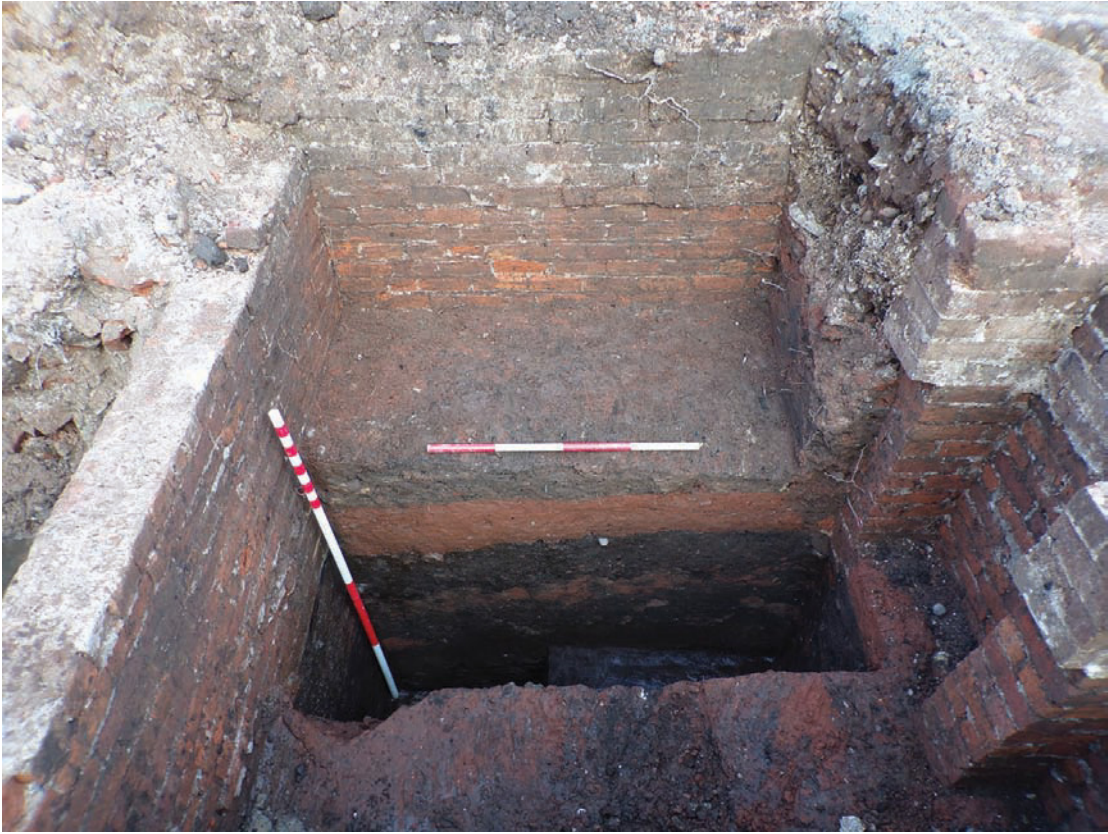
Plate 43: Post excavation view of sondage 1 (after trench widening) within Trench 7. Scales 1x1m & 1x2m

- 4.2.41 Sondage 1 was located within the northern central room between the two dividing walls [706/711]. Excavation between the walls defining the northern central room showed it to be backfilled with mixed overburden deposits (701 & 702) as well as a possible demolition horizon (703) comprised of crushed/degraded concrete fragments. The interface between (703) and (704 – a mottled clay silt made-ground deposit) likely reflects the ground height during the structures use/demolition.

- 4.2.42 Walls [706 & 711] were shown to extend to a depth of 1.5m. Wall [711] was, at its base, sat on a well preserved wooden sill beam at the base of its foundation cut [712]. The foundation cut [712] terminated within layer (713), a firmly compacted, clean, orange sand. This was a redeposit of the natural material found elsewhere on site. Excavation beneath (713) revealed six horizons beneath alternating between wet, organically rich deposits (714, 716, 717) and mixed sandy clay horizons (715, 718).

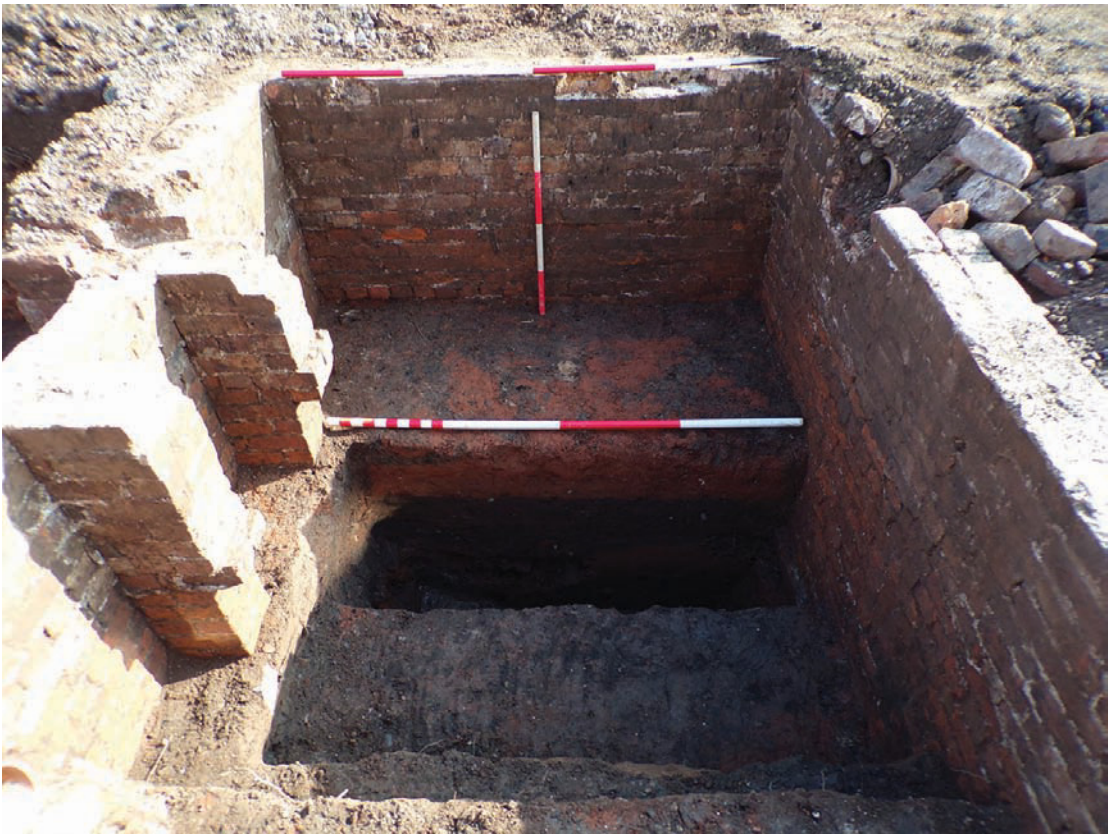
Plate 45: Post excavation view of sondage 2 within Trench 7. Scales 2x2m & 1x1m

- 4.2.44 Sondage 2, excavated within the southern central room and of the same dimensions, encountered the same natural sand redeposit horizon (713). Similarly the bottoms of the walls [706 & 728] were located at the same depth as those within sondage 1 though no wooden sill beams were observed.
