Ironbridge Power Station, Shropshire

Archaeological Watching Brief

Report No. 1431

Prepared For: E.ON Technologies (Ratcliffe) Limited

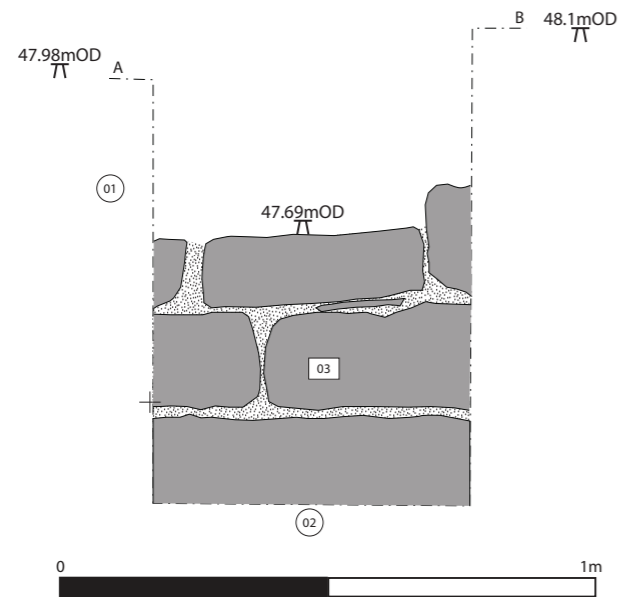
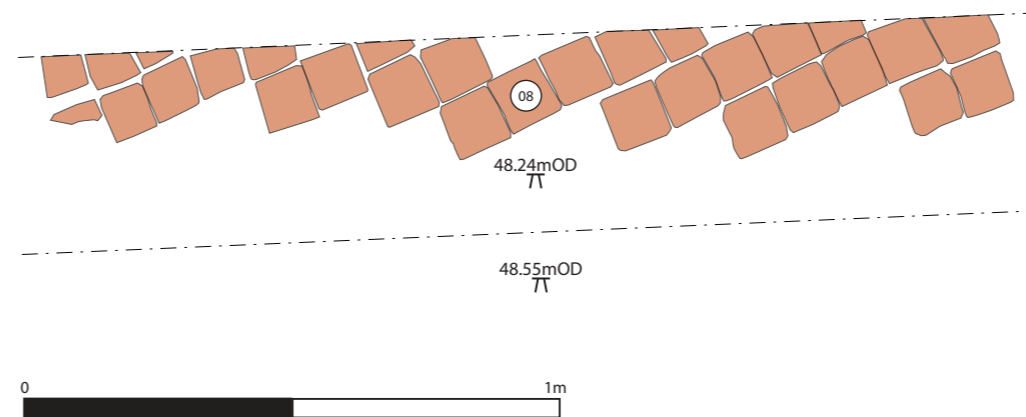
| Figure 3 |

North facing section showing elevation of wall [03]

Plan of medieval tiled floor (08) ←

Post-excavation plan of part of cable trench in car park

| Drawing Title: Plans & section of cable trench |

- 4.1.12 Approximately 4m further south of structure 07, a 1.80m long area of ceramic tiled floor (08) was uncovered some 0.35m below the tarmac surface (10). The tiled floor consisted of well-set square orangey-red tiles 0.10m across and 0.03m thick (Plates 9&11).

- 4.1.13 The removal of one tile from floor 08 for examination revealed that whilst the top of the tile was unglazed, the sides were partially covered with a mottled mid-dark brown glaze. The tiles had been laid on a bed of mid pinkish-white powdery mortar and a mid greenish-brown silty clay. The tiled floor had an uneven character to it, perhaps suggesting that it had seen frequent footfall over its life.

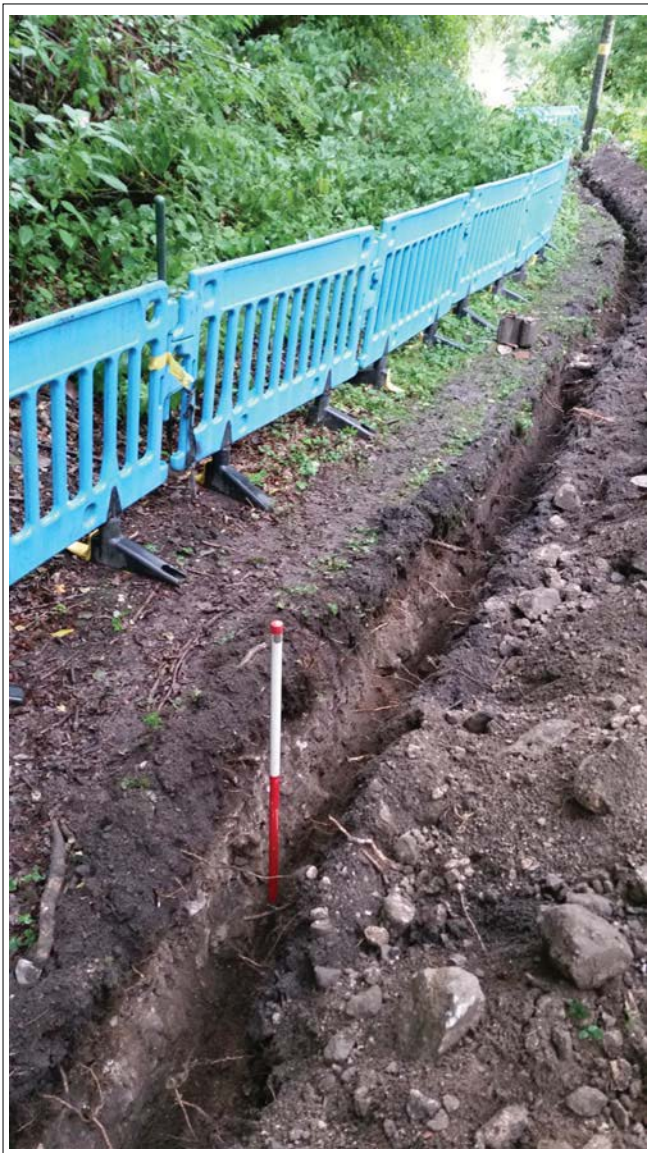
Plate 1. Rubble Deposit (02) in Woodland. Note Pylon Post in Background. Looking West. Scale 1x1m

- 4.1.1 Excavation began at the base of the electricity pylon and continued westwards. From this point on, for a distance of approximately 20m, the excavation revealed 0.30m depth of topsoil, an organic woodland soil (01), which overlay a mid-grey fine sandy silt (20). The latter is possibly a river silt (20). From approximately 20m onwards, a substantial rubble deposit (02) was encountered beneath the topsoil, 01 (Plate 1).

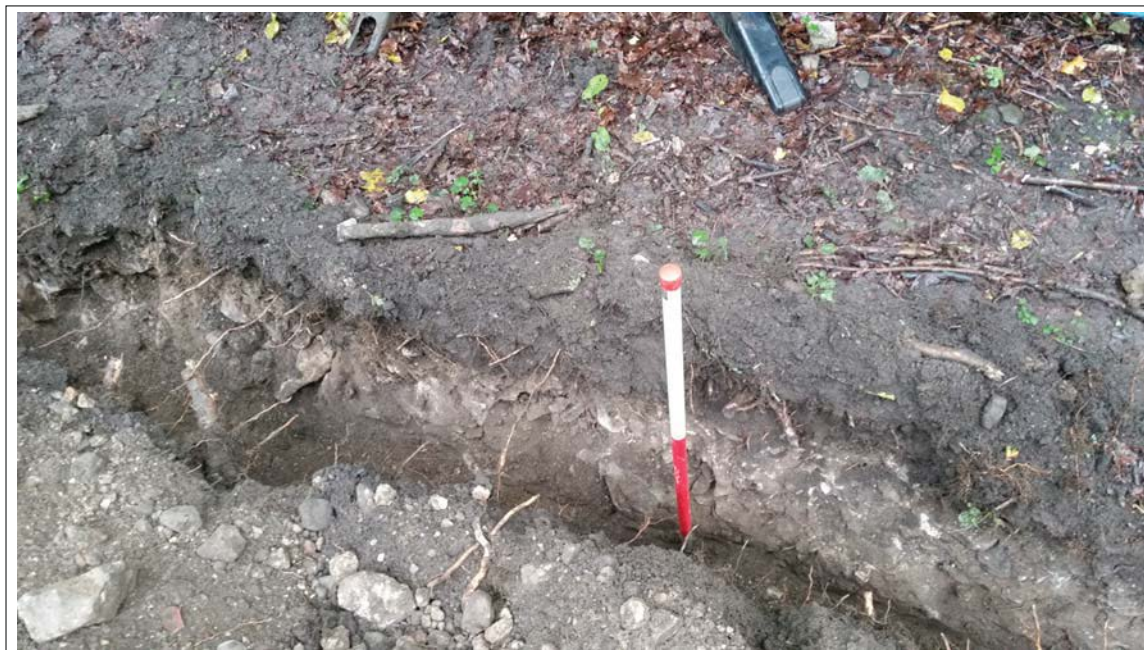
Plate 2. Rubble Deposit (02). Looking South. Scale 1x1m

- 4.1.2 Deposit (02) consisted of a very dry, powdery and loose mid whitish grey silt with very large amounts of irregular stones and decomposed mortar (Plate 2). A large fragment of medieval architectural stone and a complete (perhaps unused) medieval floor tile were recovered from this layer (02). Fragments of 18th to 19th century Staffordshire or Buckley ware pottery, and fragments of 19th century Broseley roof tiles were also retrieved from layer 02. This very mixed deposit continued underneath the woodland soil (01) up to the stone steps leading to a (woodland) footpath from Abbey House (a distance of approximately 15m). The rubble deposit (02) extended below the limit of excavation of the cable trench (some 0.60m deep).

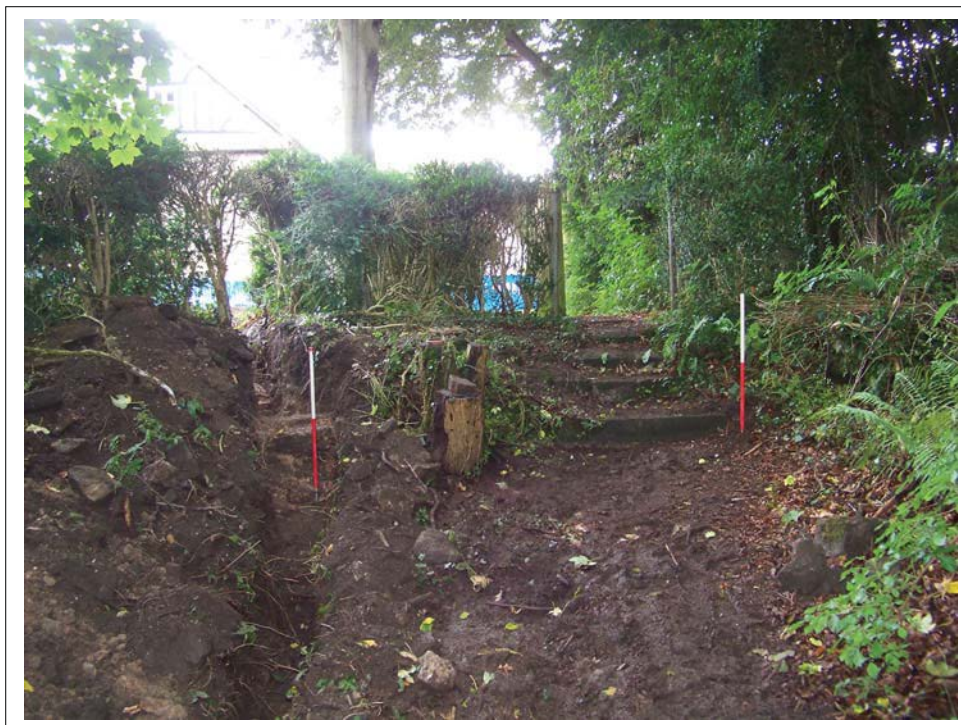
Plate 3. Overall Shot, Wall 03 on Left, Steps on Right. Looking South.
Scale 2x1m

- 4.1.3 As the excavation continued to the south, a substantial stone wall (03) was encountered below the woodland soil (01) (Figure 2a). The wall (03) was built in large, semi-dressed sandstone blocks some 0.40m long, 0.20m wide and 0.20m tall. A 0.50m high elevation of the wall was exposed across the cable trench; the structure extended below the limit of excavation. Overall the structure was 0.70m wide. The stonework was bonded by a mid greyish/pinkish-white powdery lime mortar and was aligned east-west. Further investigation of the area immediately to the west of the exposed elevation revealed more of this wall (03) above ground level, but covered with undergrowth and a large tree stump (which seemed to have caused extensive damage). The 1m wide stone steps some 2m west of the exposed elevation appeared to have been built into this wall, or at least on the same alignment. A further 1m wide stretch of overgrown and ruinous wall continued to the west of these steps before disappearing into an earthen bank (Plates 3&4).

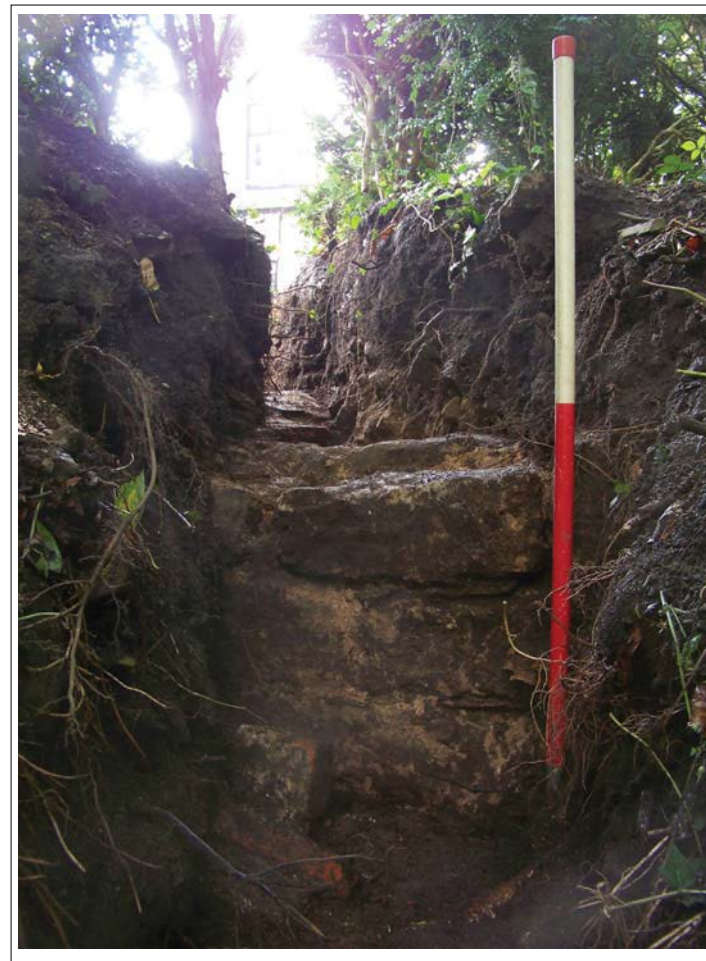
Plate 4. Wall 03. North Facing Elevation. Scale 1x1m

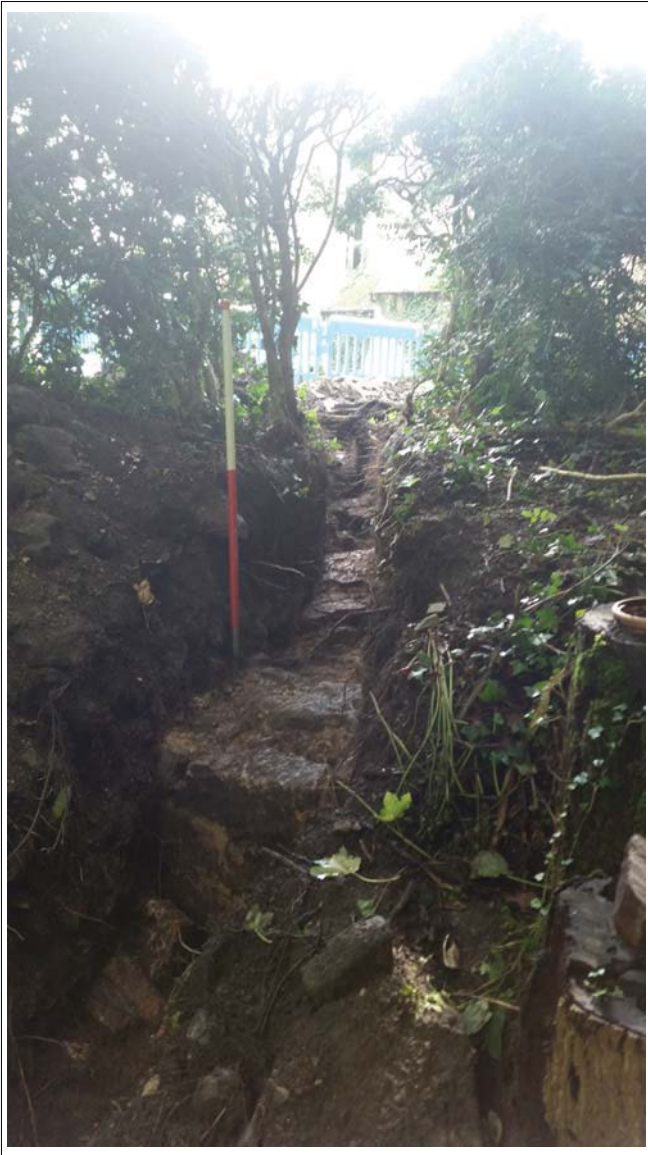
Plate 5. Wall 03, with Brick Culvert 04 behind. Looking Southeast. Scale 1x1m

The construction trench [15] for culvert 04 was irregular; the trench [15] truncated a loose, mid greyish white mortar rich deposit 14 between culvert 04 and wall 03 (Plate 5).

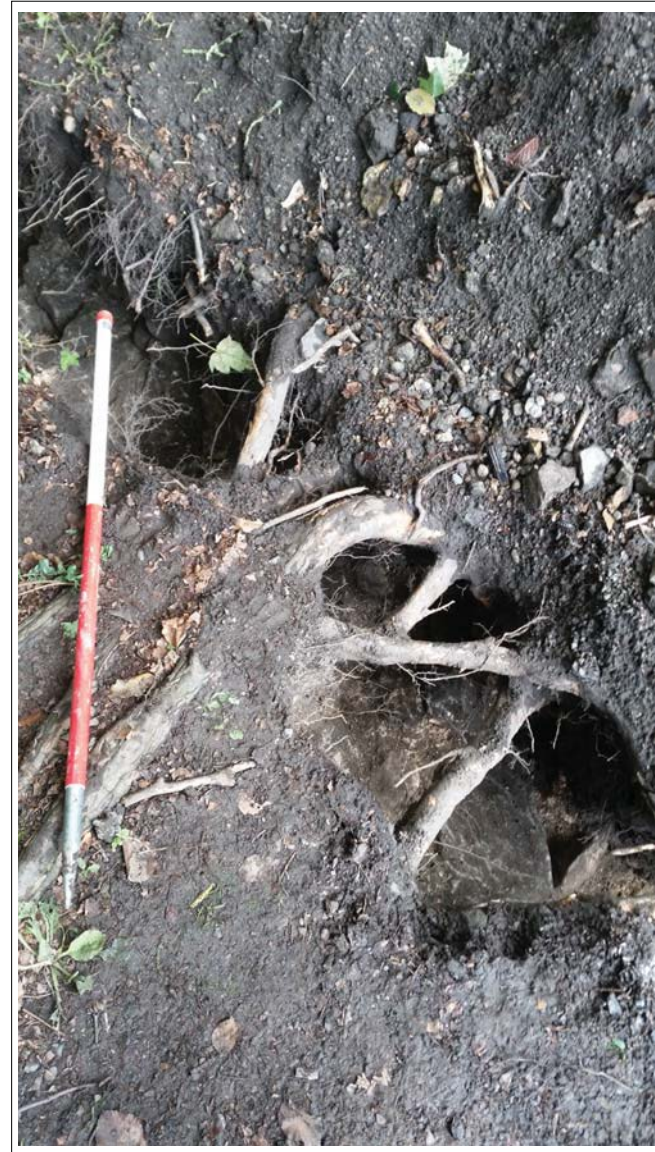
Plate 6. Wall 11. Looking North. Scale 1x1m

- 4.1.7 Wall 11 was difficult to characterise due to the large number of tree roots growing over the wall and obscuring the cable trench (Figure 2a). However, with careful widening of the trench by hand it was ascertained that wall (11) was aligned north-south and consisted of blocks of well-dressed sandstone up to 0.30m long by 0.20m wide, all bonded with a mid greyish-white powdery lime mortar. What remained of this structure was 0.70m wide and approximately 0.15m tall (Plate 6).

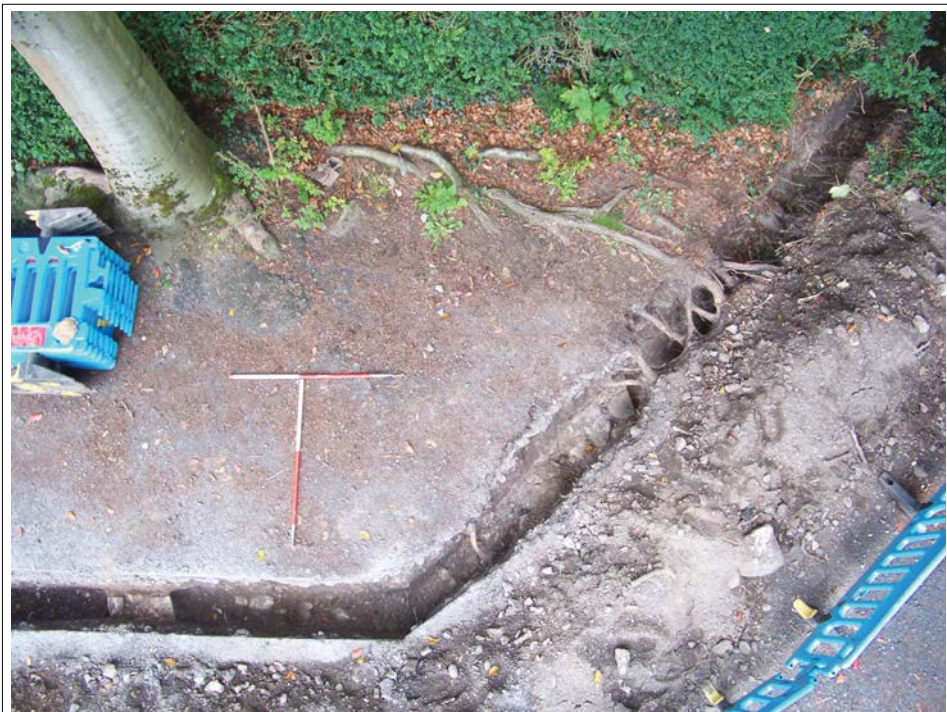
Plate 7.Overhead shot of Walls 06, 11 & 12. Scale 2x1 m

- 4.1.9 Immediately to the south of wall 11, and possibly bonded to this structure, was a much narrower wall (12) (Figure 2a). This was built in regular dressed sandstone, up to 0.20m across, bonded with a mid greyish-white lime mortar. The structure was aligned east-west and was 0.50m wide and 0.15m tall. Another wall (06), almost identical in character, was encountered approximately 4m south of wall 12 (Plates 7&8 and Figure 2a).

- 4.1.10 Between walls 06 and 12 appeared to lay a rough stone surface (05) consisting of flat and irregular mid yellowish-grey sandstones, varying between 0.10m and 0.20m across. The layer of flat stones (05) may have formed a floor surface within a building defined by walls 06 and 12. However, some of these stones were rather loose, so this context (05) may alternatively be interpreted as another demolition or dereliction layer similar to deposit 13 (Plates 7&8).

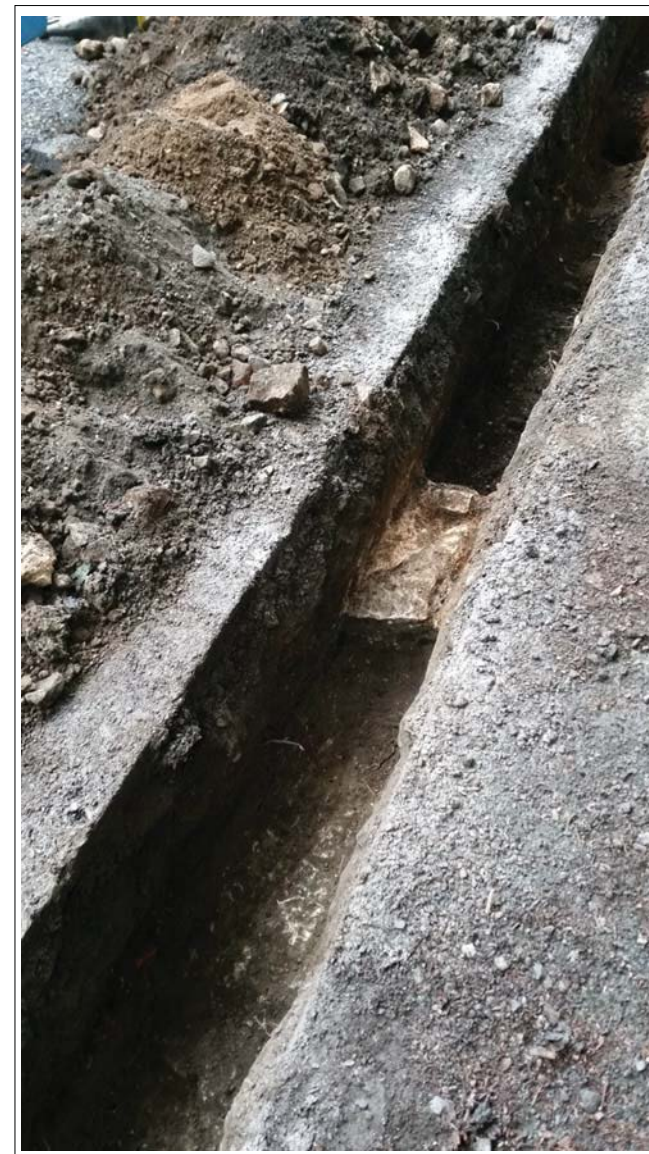
Plate 8. Wall 06 and Floor 05. Looking Southeast.

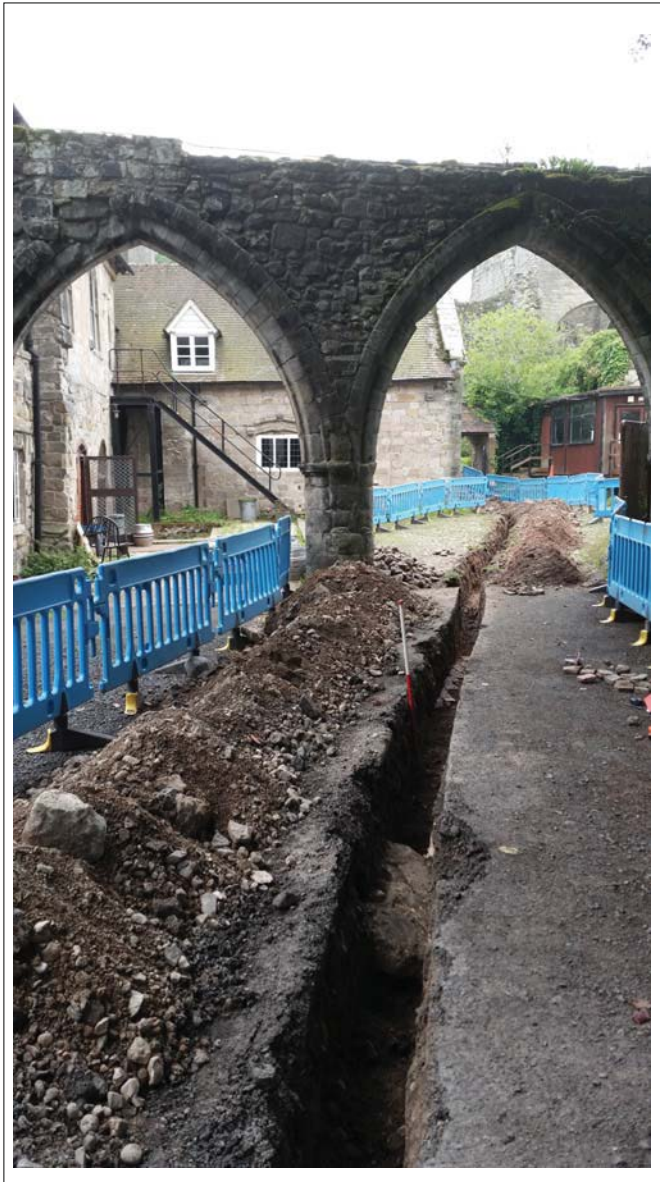
Plate 9. Possible Pillar Base (07) in Foreground and Tiled Floor (08), in Centre and Infirmary Archways in Background. Looking South. Scale 1m

- 4.1.11 Approximately 10m south from wall 06, a substantial and well-constructed stone structure (07), some 1m wide, was revealed 0.30m below the existing tarmac surface (10) (Figure 2a). Structure 07 comprised large, flat irregularly shaped sandstones ranging in size from 0.15m to 0.30m across and bonded with a mid whitish-pink lime mortar. Further examination revealed this structure to be at least two courses tall (Plates 9&10).

- 5.1.6 Structure 07 was solidly built in sandstone blocks, and appeared intended to support a substantial structural weight. If this represents a continuous and solid stone wall base in an east-west alignment, then visually structure 07 did not appear to respect the alignment of the infirmary wall, and this would most likely mean that the buried foundation (07) did not form part of the same building. Alternatively, if structure 07 formed a sub-square pier base for a lost arch column then it is possible that the stone blocks (07) and the tile floor 08, noted above, are part of the abbey infirmary.

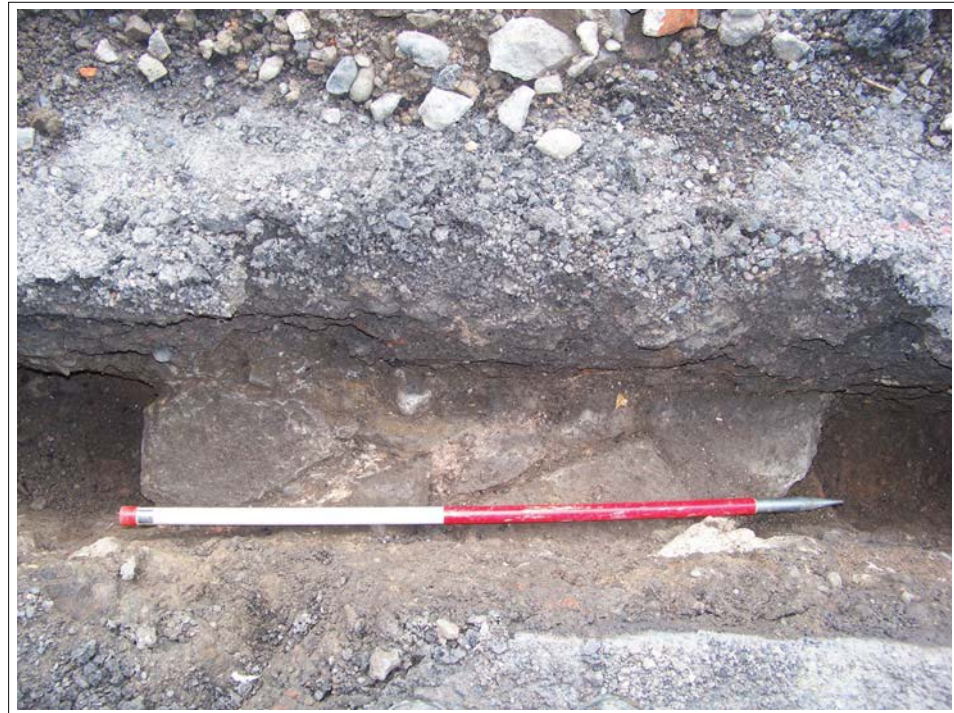
Plate 10. Overhead Shot of Possible Pillar Base (07). Scale 1m

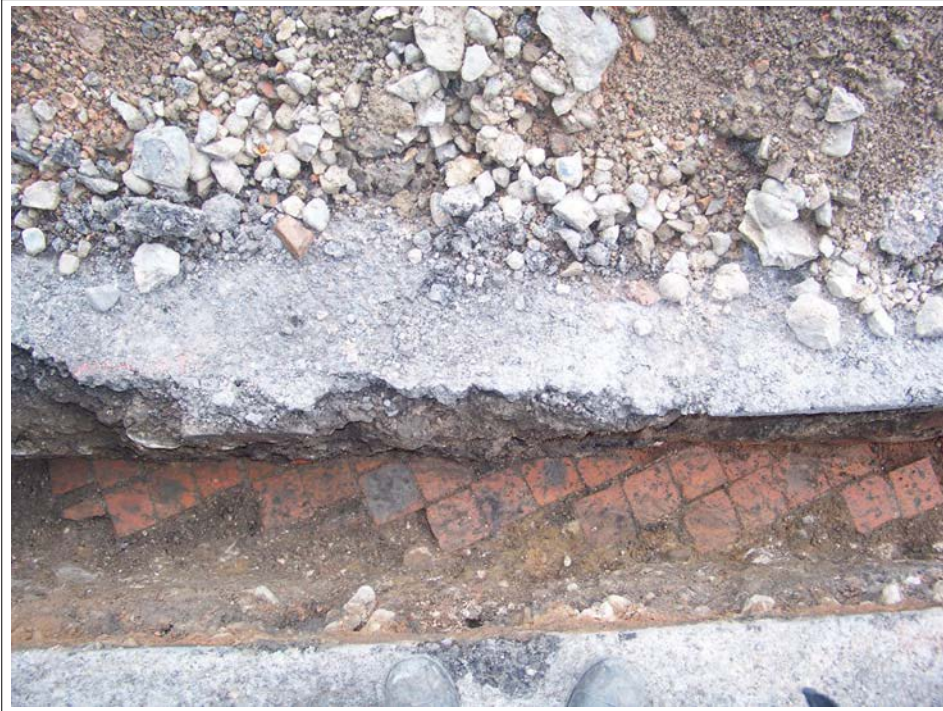
Plate 11. Overhead Shot of Tile Floor (08).

- 5.1.5 The tiled surface (08) discovered to the north of the abbey infirmary wall was heavily truncated, but appeared to be an intact medieval floor, or least a floor made up entirely of medieval ceramic floor tiles. The tiles may have originally extended up to foundation structure 07.

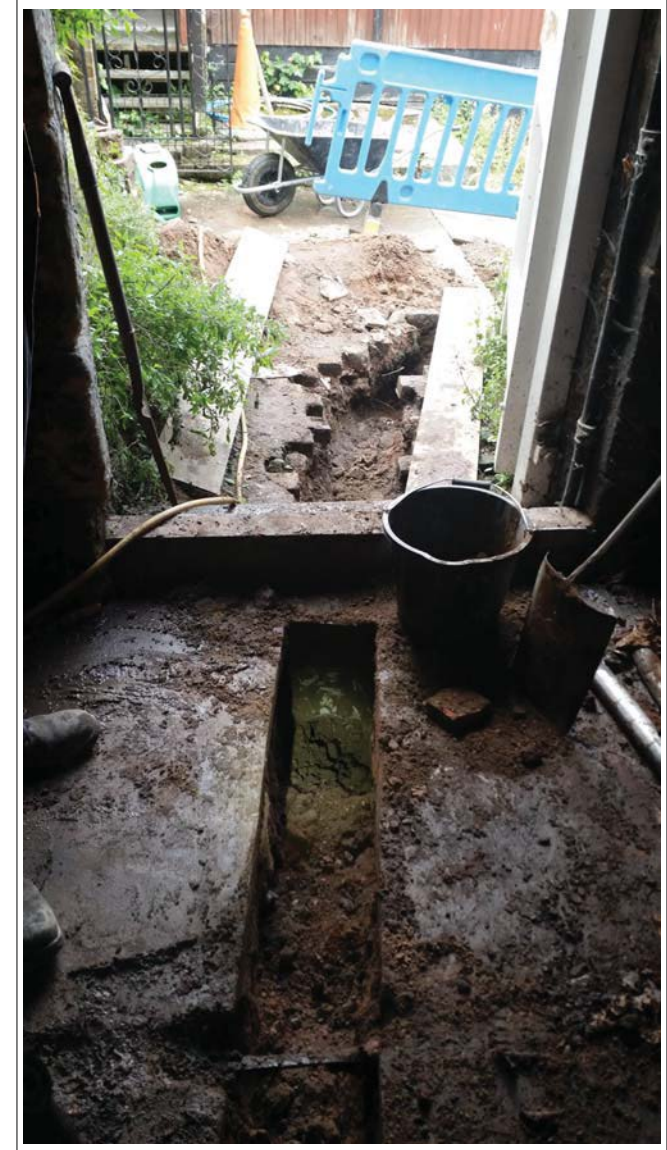
Plate 12. Transformer Room Threshold.
Looking West.

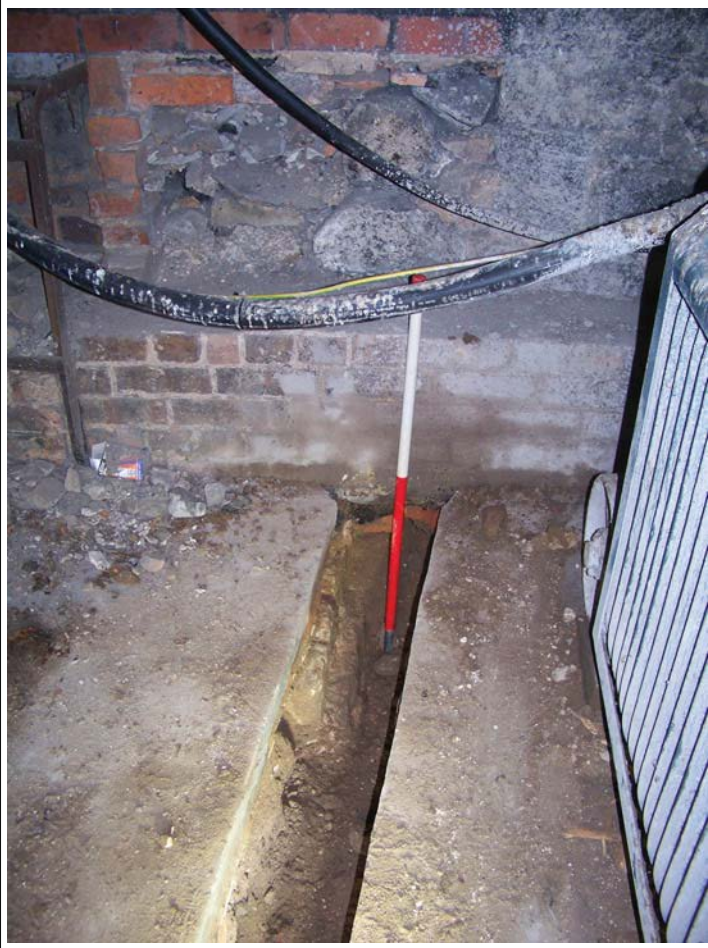
Plate 13. Possible Buttress (16) in Transformer Room. Looking East. Scale 1x1m

- 4.1.17 A stone structure (16) was encountered below soil deposit 19 in the northeast corner of the transformer room (Figure 2a). This consisted of roughly dressed but regularly sized sandstone blocks, 0.30m across by 0.20m tall, with no mortar evident. Two unbonded courses were revealed, with the bottom course stepping out by approximately 0.06m. Although no dating evidence was found in soil deposit 19 or within structure 16, the character of the latter suggests a potential medieval date. Structure 16 may have formed the footing for a wall, a buttress, or some other structure (of more formally dressed stone) which has subsequently been lost (Plate 13).

- 5.1.8 What appeared to be a buttress or buried foundation structure (16) was identified during excavations within the transformer room. The discovery was not unexpected, as there are thought to be older abbey remains beneath the current upstanding buildings in this immediate area.

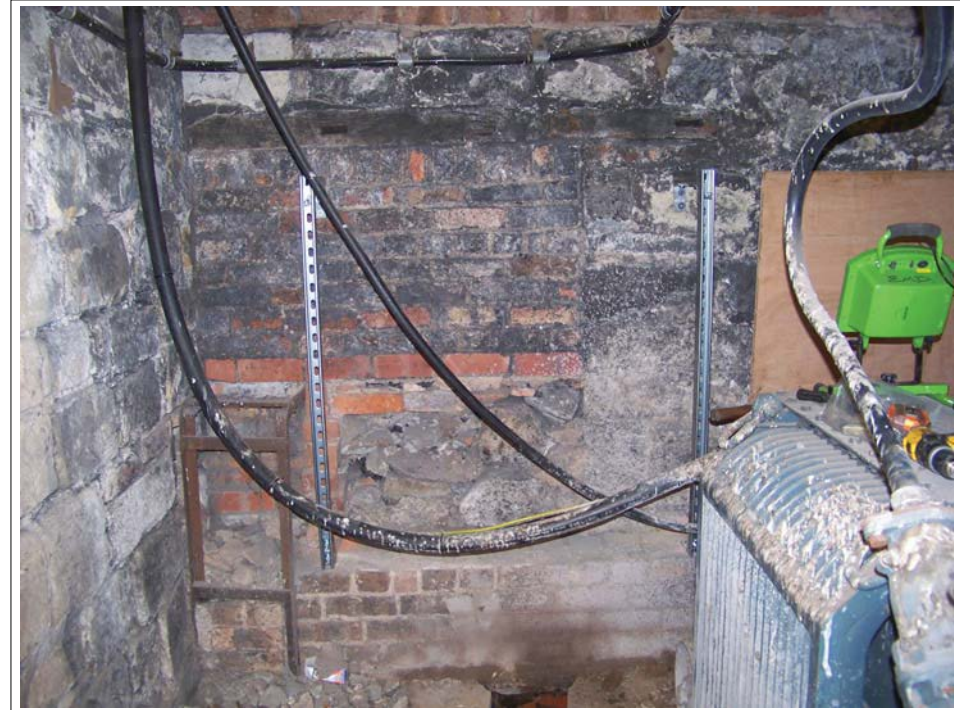
Plate 14. Transformer Room Wall with Brackets Fitted. Looking East.

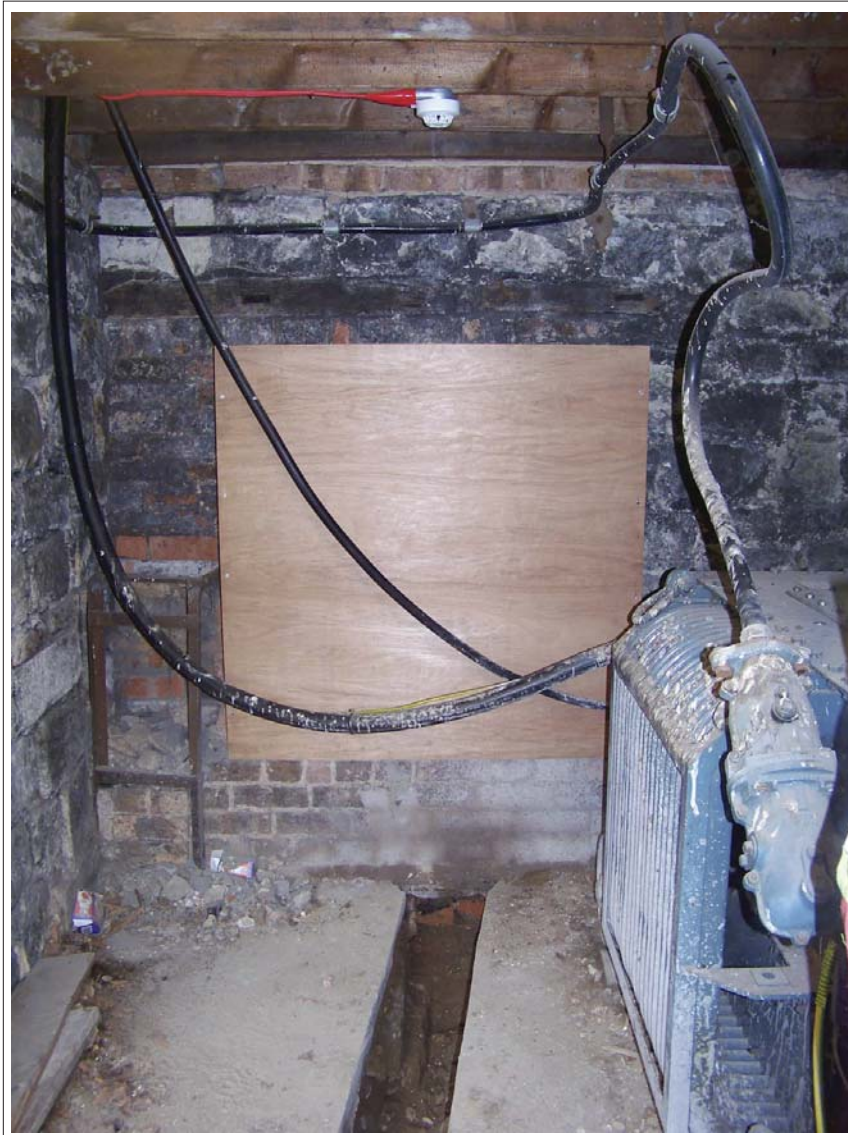
Plate 15. Transformer Room Wall with Board Fitted.
Looking East.
