**Lake House, 21 Ford Street,
Clun, Shropshire**

Archaeological Watching Brief

Report No. 1499

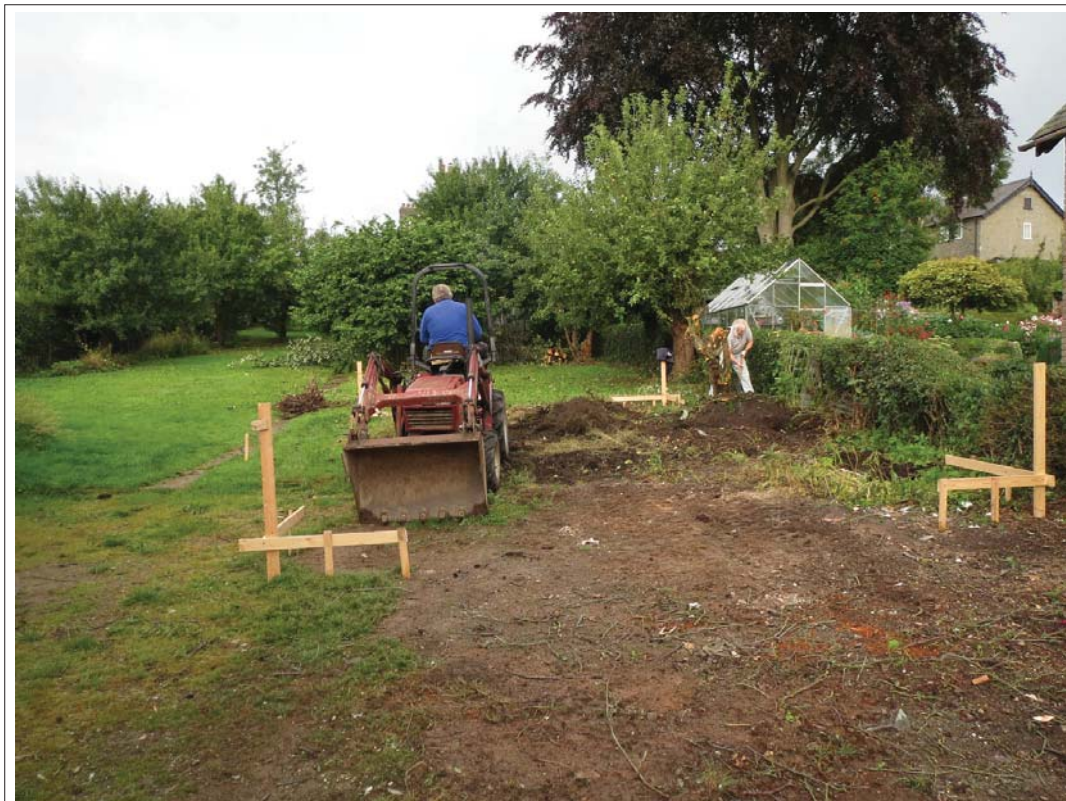
Plate 2. Area A: location of garage, showing ground level rising to the west of the house. Looking west-southwest.

4.2.1 The new garage was positioned some 5.5m to the northwest of the house. This was terraced into sloping ground across an area measuring 4.5m by 8.2m. The ground level at the back of the garage (western end) was recorded at *circa* 188.60-188.80m OD, this being higher towards the property boundary (northern side). The reduced dig for the garage required the excavation of up to 0.35m depth of garden soil (100) and up to 0.15m of subsoil (101). The limit of excavation for the reduced dig was recorded at *circa* 188.20m OD. The fall in ground level to the east necessitated a step down of 0.15m to 0.25m, some 3.5m out from the back of the garage (western end). The garden soil (100) was stripped along the remaining eastern section, some 4.7m long, exposing up to 0.10m of subsoil (101). The limit of excavation for this lower level of the reduced dig was recorded at *circa* 188.05m OD.

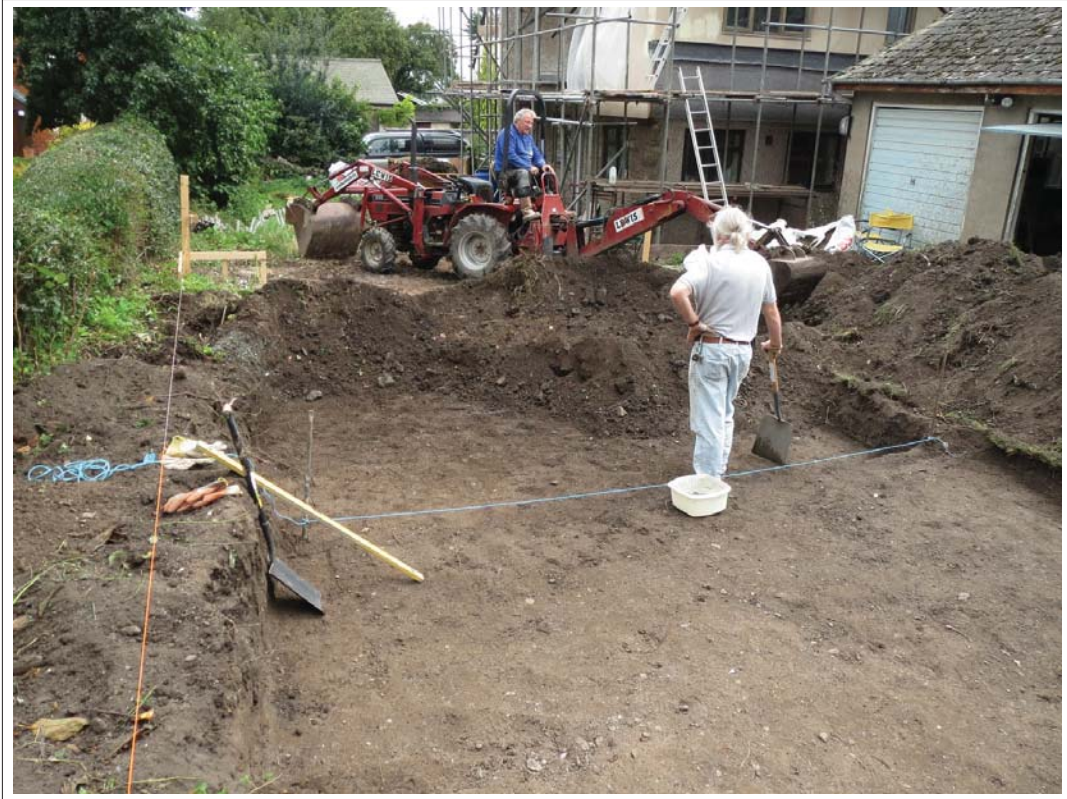
Plate 3. Area A: working shot of excavations for the garage foundations. Looking east-northeast.

4.2.3 Shallow foundations for the garage were machine excavated along the periphery of the reduced dig. These trenches were approximately 0.25m deep and 0.45m wide. The limit of excavation for the footings was recorded at *circa* 187.60m OD and 188.00m OD at the eastern and western ends of the garage, respectively. Disturbed subsoil 101 and natural deposit 102 were exposed in the foundation trenches. The subsoil (101) consisted of a mid to dark grey-brown silty clay with charcoal inclusions and finds of 19th century clay pipe stems and 19th / 20th century stoneware /

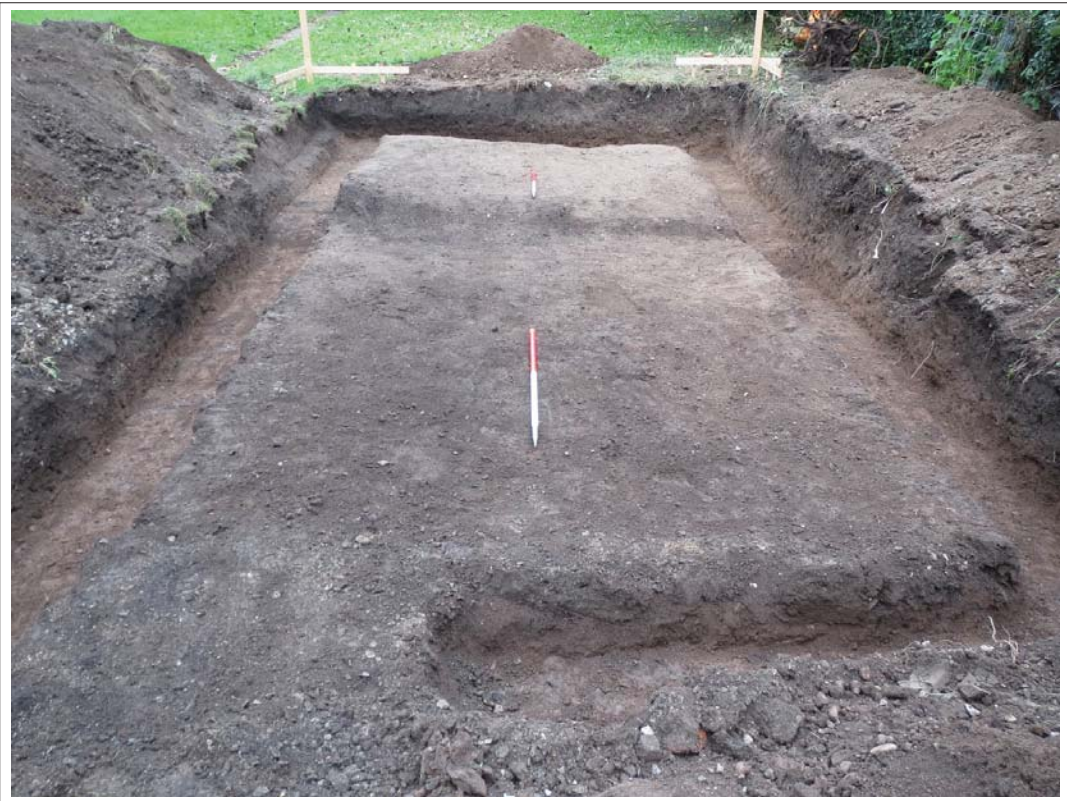
Plate 4. Area A: view of the reduced dig and footings for the garage. Scales: 2x1m. Looking west-southwest.

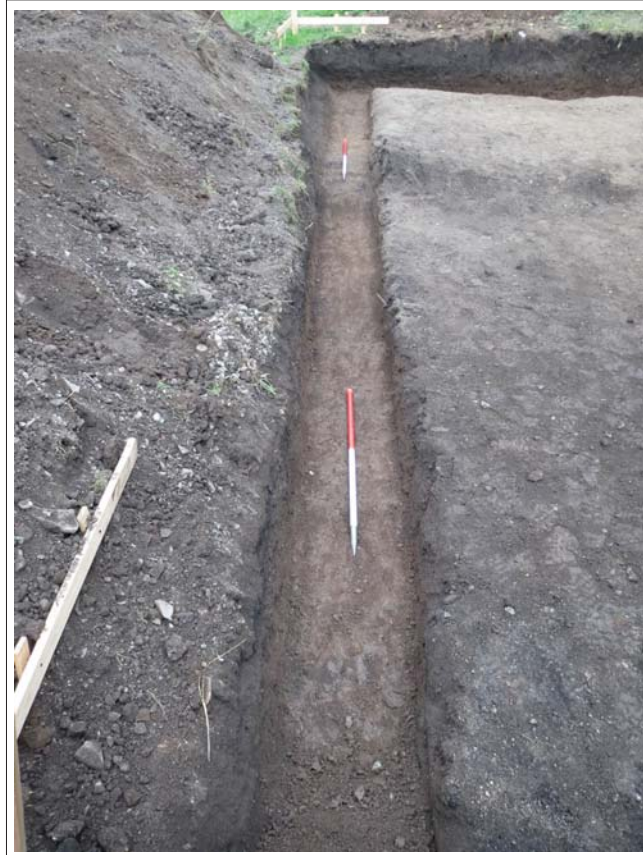
Plate 5. Area A: post-ex shot of the southern side of the of the garage foundations. Scales: 2x1m. Looking west-southwest.

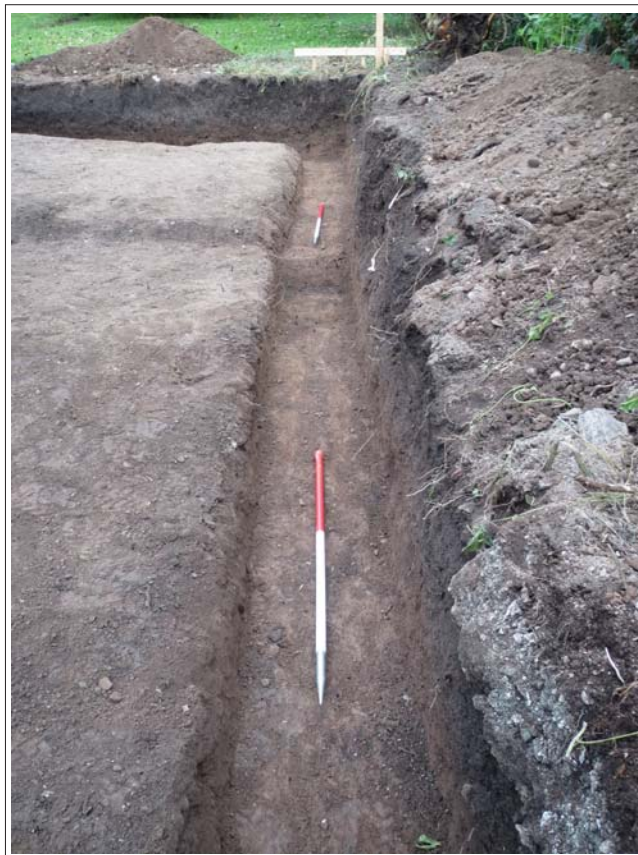
Plate 6. Area A: post-ex shot of the northern side of the garage foundations. Scales: 2x1m. Looking west-southwest.

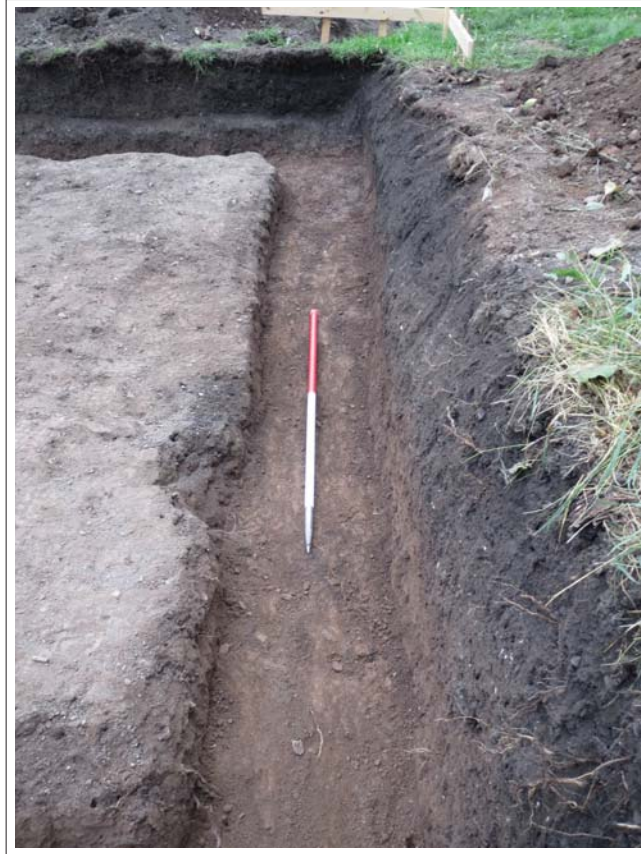
Plate 7. Area A: post-ex shot of the western end of the garage foundations. Scales: 1x1m. Looking south-southeast.

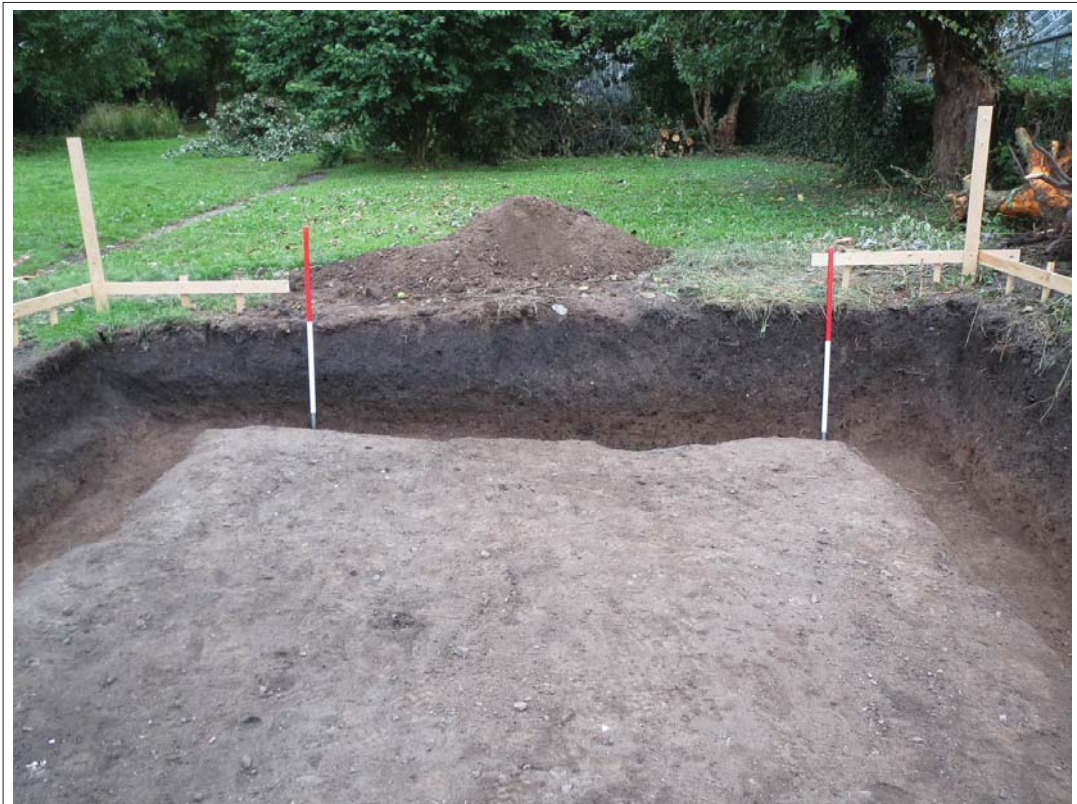
Plate 8. Area A: general view of the soil profile at the western end of garage foundations, showing the ground level rising towards the north (property boundary). Scales: 2x1m. Looking west-southwest.

4.2.4 The overall soil sequence exposed during excavations for the garage consisted of *circa* 0.10m-0.20m depth of natural (102), below a subsoil (101) *circa* 0.10m-0.35m thick, beneath a garden soil (100) recorded as *circa* 0.20m-0.35m thick. The natural (102) was encountered at 187.65 – 188.15m OD; this deposit was some 0.50m higher at the western end of the excavation. The subsoil (101) was encountered at 188.05 – 188.35m OD; this was some 0.30m higher to the west. The depths of both deposits corresponded with a general rise in ground level across the excavated area.

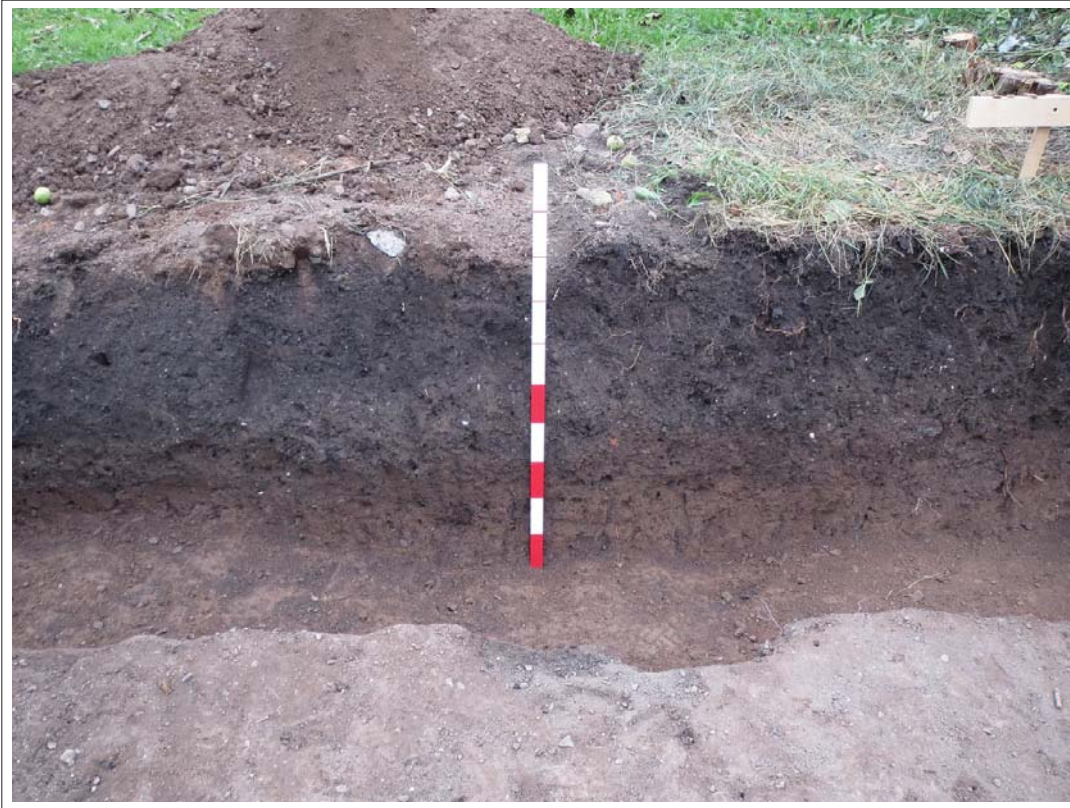
Plate 9. Area A: representative section at the western end of the excavation area for the garage, showing natural silty clay (102) below the subsoil (101) and topsoil (100). Scales: 1x1m. Looking west-southwest.

4.2.2 The garden soil (100) comprised a dark grey-black humic silty with inclusions of charcoal flecks, oyster shell and fragments of 19th / 20th century red brick. The finds retrieved from this layer during machine excavation consisted of animal bone, 19th century clay pipe stems, 19th / 20th century stoneware / china, modern glass and iron nails. The finds and inclusions were recorded analysed but not retained.

china (these were recorded analysed but not retained). The natural (102) comprised a soft light to mid brown silty clay with occasional siltstone and sandstone gravel.

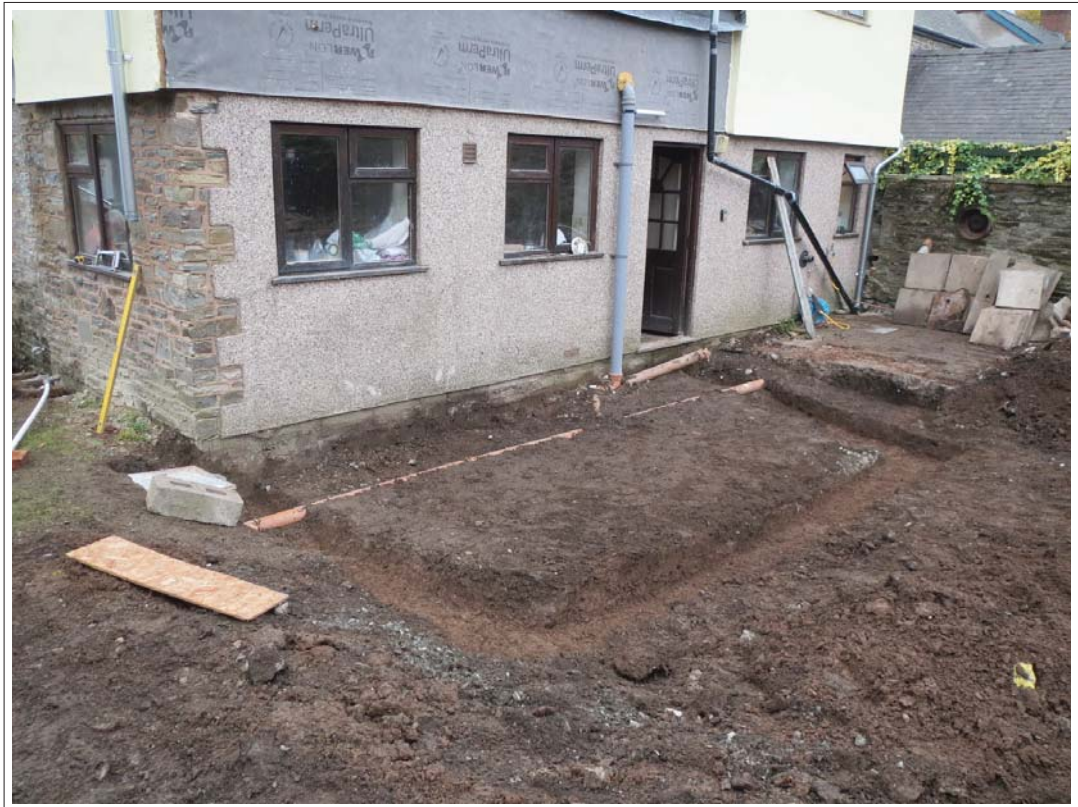
Plate 10. Area B: post-ex shot of foundations for the sunroom. Looking southeast.

4.3.1 The sunroom was built at the back of the house, to replace an existing paved area and was partly built over the footprint of the old garage (previously demolished as part of the application). The reduced dig for the sunroom measured 3m by 6m in addition to some re-grading of the site to the west (in the area of the former garage and drive). The top of the paving slabs, at the back of the house, was recorded at 187.85m OD. The paved yard (200) consisted of 0.04m thick concrete paving slabs bedded (with *circa* 0.04m of mortar) above a concrete slab some 0.10m thick.

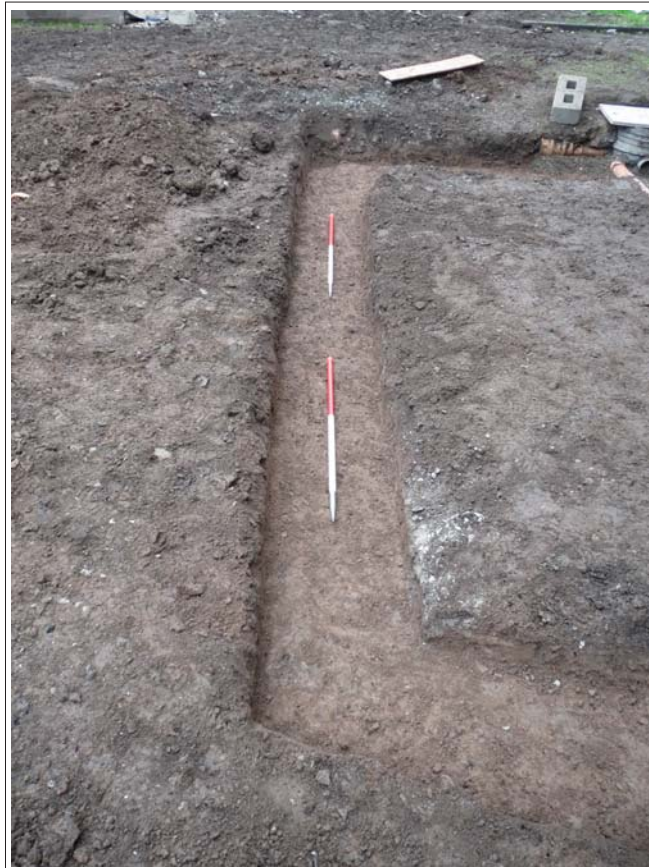
Plate 11. Area B: post-ex shot along the western side of foundations for the sunroom. Scales: 2x1m. Looking north-northwest.

4.3.3 Shallow foundations for the sun room were machine excavated approximately 0.15m deep and 0.50m wide. The limit of excavation for the footings was recorded at 187.30 - 187.35m OD. The natural (202) was exposed in these foundation trenches at *circa* 187.45m OD; this comprised a soft light to mid brown silty clay with occasional fine to coarse subangular to flat siltstone and sandstone gravel. The natural was over 0.15m deep to the limit of excavation.

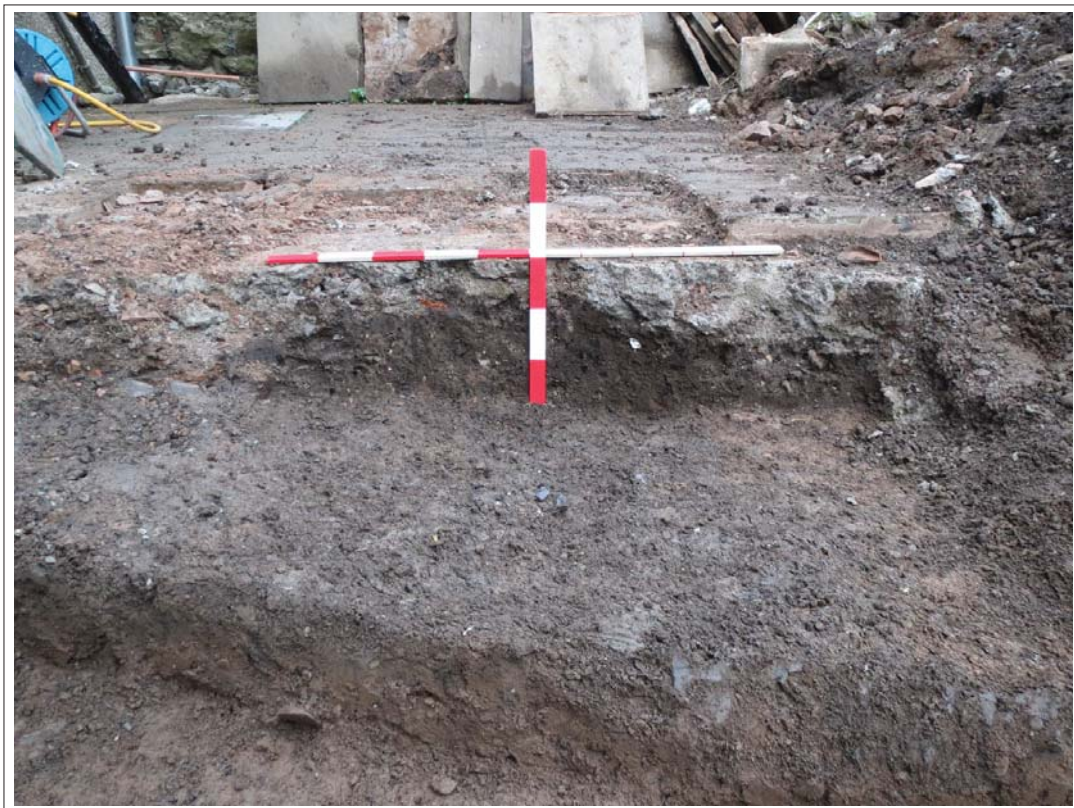
Plate 12. Area B: representative section of the excavation area for the sunroom, showing natural silty clay (202) below a disturbed soil layer (201) and concrete slab (200). Scales: 1x0.5m & 1x1m. Looking south-southeast.

4.3.2 Following removal of the slabs and the underlying sub-base, a layer of disturbed ground (201), 0.20-0.25m thick, was excavated to form a level area at *circa* 187.50m OD. This disturbed soil consisted of a dark grey silty clay with inclusions of charcoal and lime mortar. The finds from this layer comprised animal bone, 19th century clay pipe stems, 19th / 20th century stoneware / china (these were recorded analysed but not retained). This deposit was interpreted as a heavily disturbed subsoil, equivalent to layer 101 recorded during excavations for the garage.

4.3.4 The soil sequence encountered during excavations for the sunroom, consisted of disturbed subsoil (201) over natural (202); similar to the deposits recorded in the garage footings. However, the natural (102) recorded in the sunroom footings was some 0.20m lower, and this may indicate the natural has been truncated to the rear of Lake House (perhaps associated with the construction of the patio) and/or the depth of natural reflects a fall in the original ground level (prior to historic or modern re-grading).

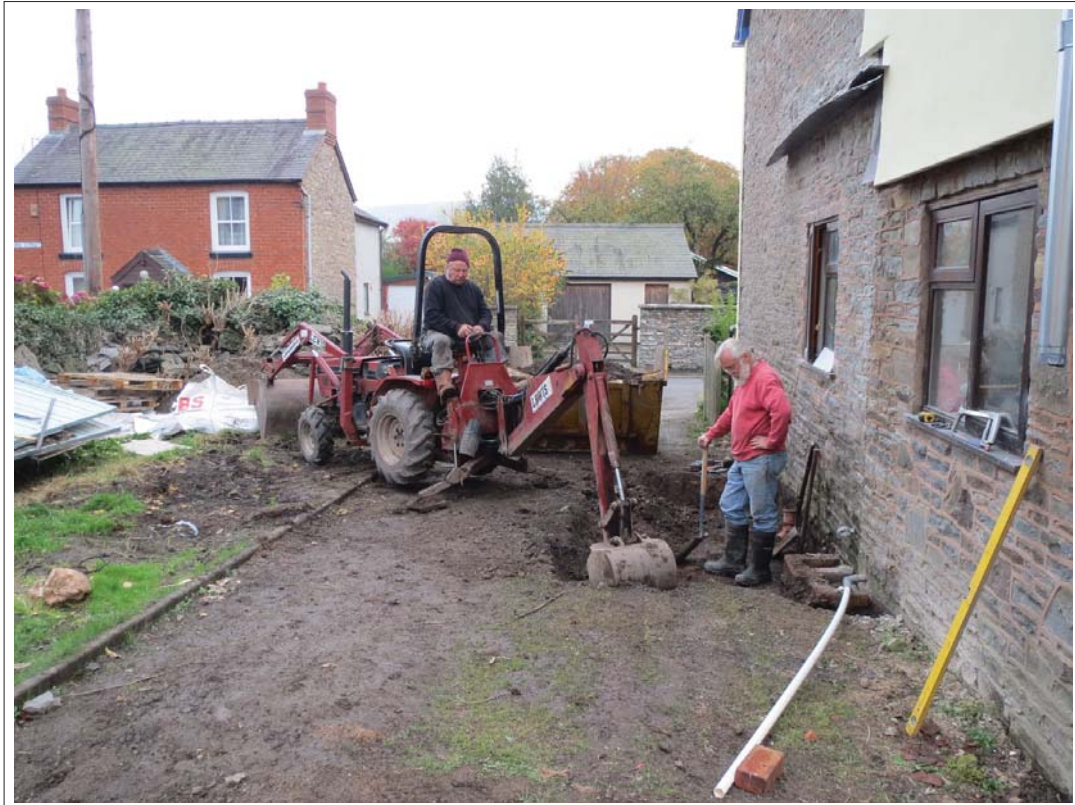
Plate 13. Area C: working shot of excavations for the porch. Looking east-northeast.

4.4.1 The new porch was positioned on the northern side of the house, within the existing driveway. The ground level at this location was recorded at 187.70m OD. The

reduced dig for the foundation slab measured 1.75m by 3.4m. This foundation was approximately 0.50m deep. The soil sequence encountered comprised a disturbed or redeposited soil layer (301) below the driveway (300) construction. The foundations cut in to the underlying natural (302), excavated down to *circa* 187.20m OD.

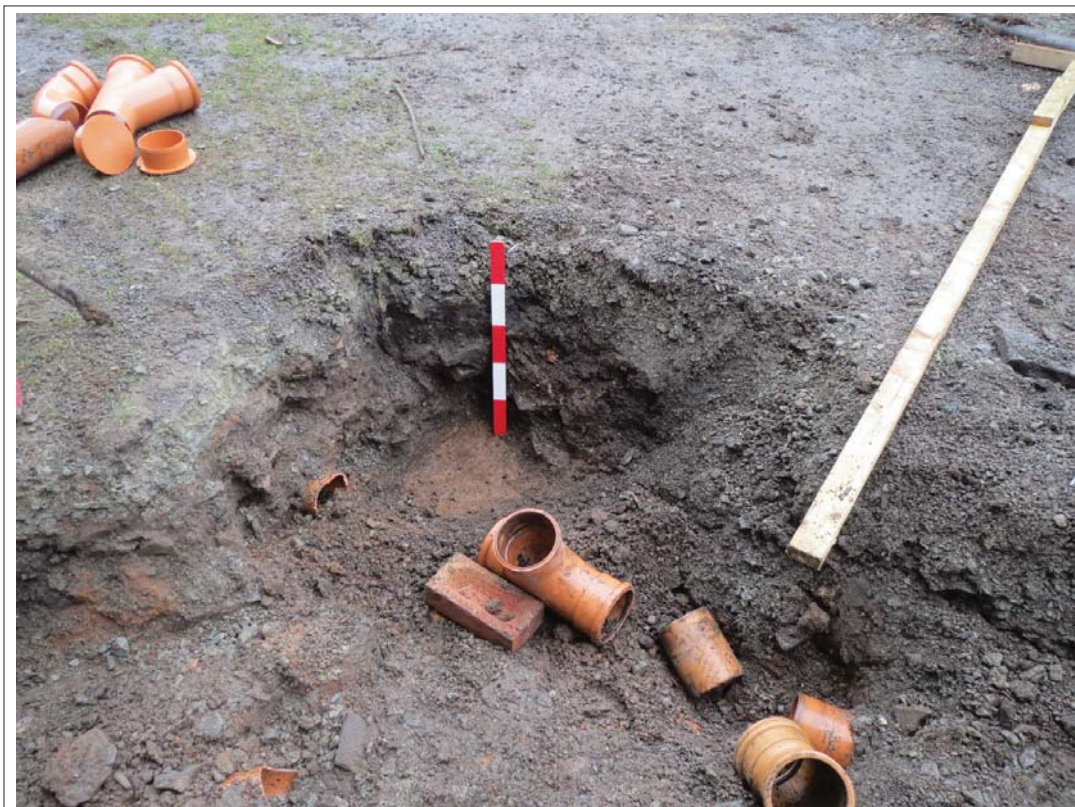
Plate 14. Excavations for drainage to the west of the porch, showing natural (302) below made ground (301) and driveway gravel (300). Scales: 1x0.5m. Looking northwest.

4.5.2 The same soil sequences were encountered along the drainage trenches as those recorded within Areas A to C. These comprised the topsoil (100) and subsoil (102) deposits adjacent to the garage, the disturbed soil layer (201) near the sunroom, and made ground (301) within driveway.

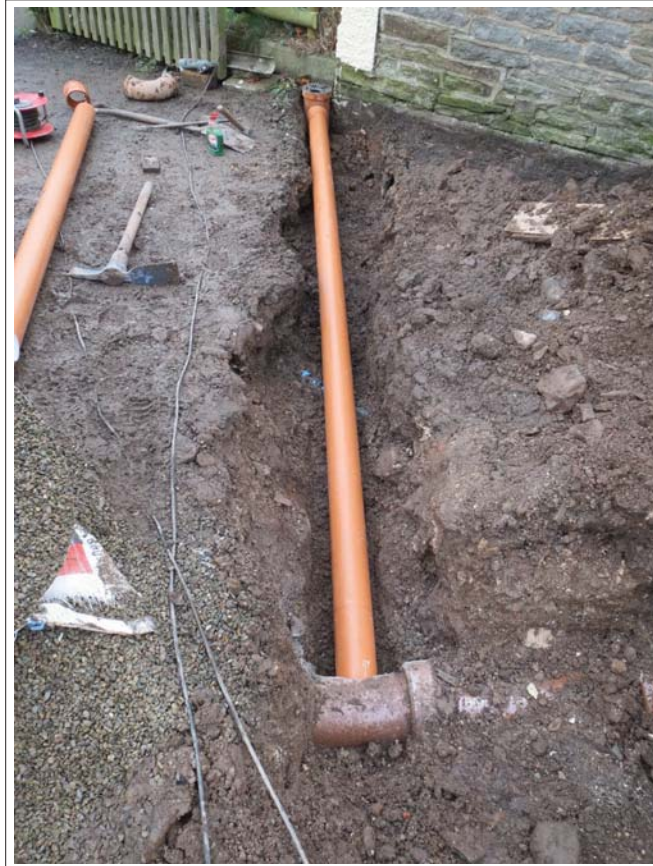
Plate 15. Excavations for drainage towards the front of Lake House. Looking southeast.

4.5.1 Trenching for new drains was minimised by connecting new surface water drains to the existing drainage system. Approximately 15m of drainage trenches were excavated between the garage and the porch. These trenches were excavated some 0.15m wide and 0.30m deep. Another 3.5m of drainage was re-laid within driveway from front corner of house. An additional 1.5m square excavation was required near the porch to locate and connect the new pipes to existing drains.

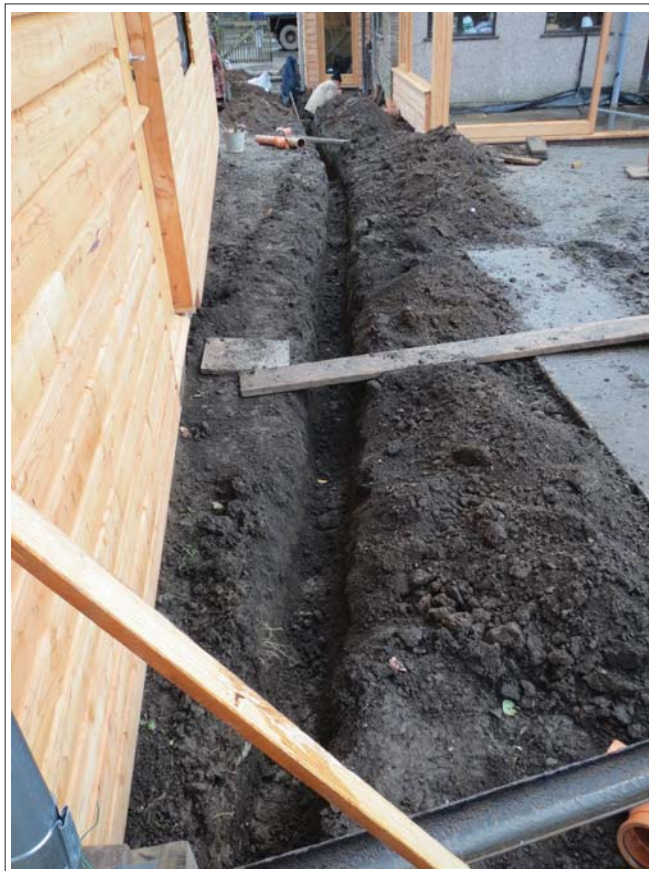
Plate 16. View of excavations for drainage extending along the new garage and sunroom. Looking east-northeast.
