# Middlewick Wind Farm Essex

Archaeological Field Evaluation

Report No. 584

Date: **August 2009**

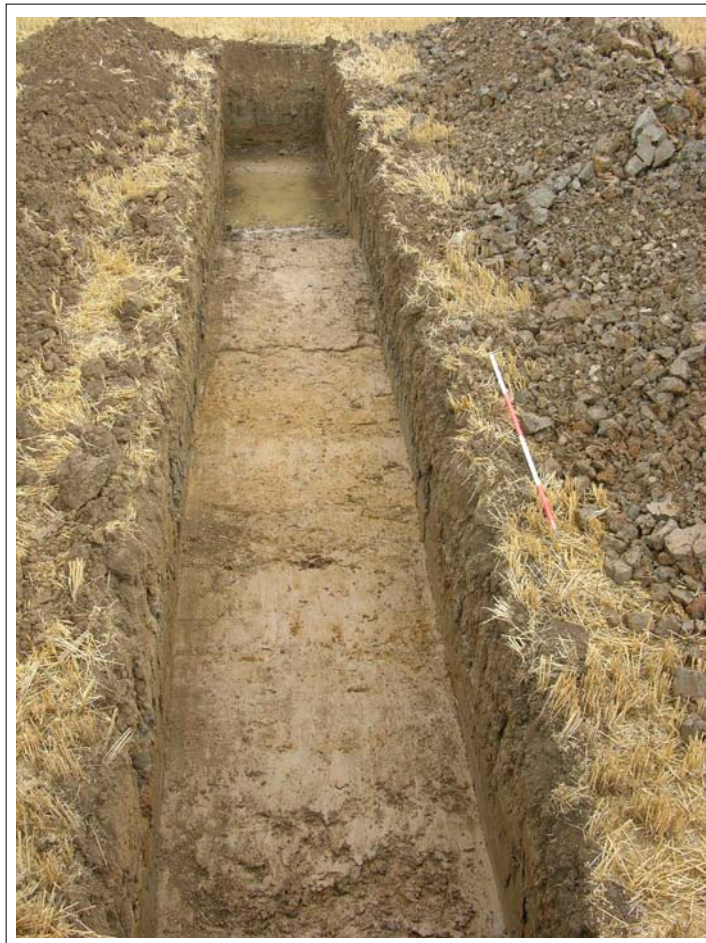
Plate 2: View along Trench 4, Looking north, Scale 1x2m

- 3.3.5 Trench 4 (Plate 2) measured 17m x 2m and was aligned north south. Removal of topsoil (401) and subsoil (402) within Trench 4 showed a clay natural at a depth of around 0.5m below the current ground surface. Excavation through the clay (403) revealed sandy lenses at varying depths. Excavation down to 1.8m showed further heavy clay deposits becoming darker in colour towards the base of the trench. No archaeological features were noted within this trench.

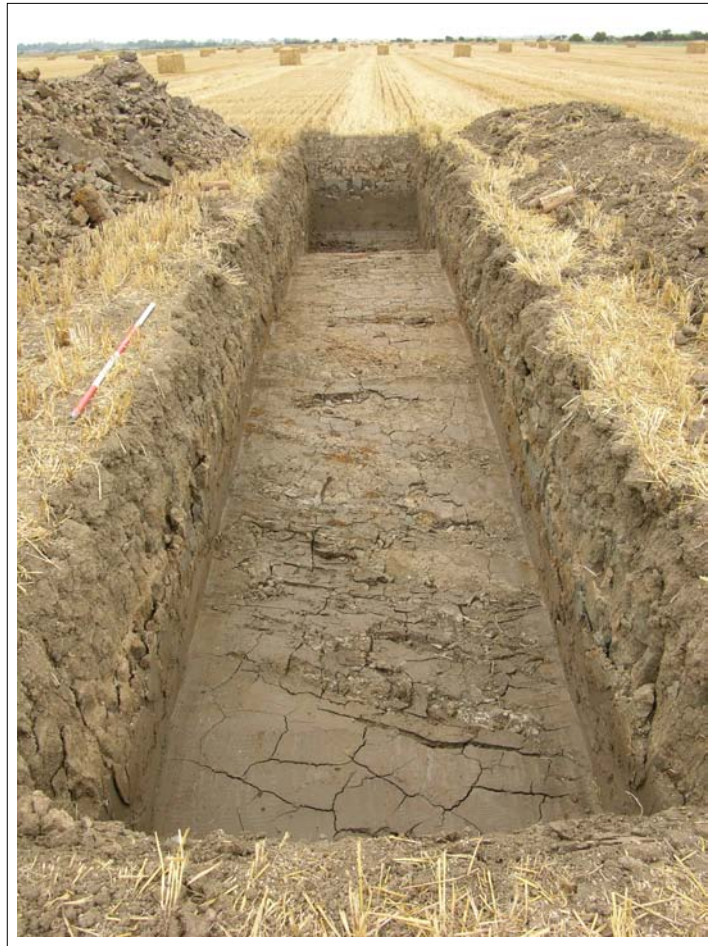
Plate 3: View along Trench 6, Looking north, Scale 1x2m

- 3.3.7 Trench 6 (Plate 3) measured 17m x 2m and was aligned north south. Removal of topsoil (601) and subsoil (602) within Trench 6 showed a clay natural at a depth of around 0.5m below the current ground surface. Excavation through the clay (603) revealed sandy lenses at varying depths. Excavation down to 1.8m showed further heavy clay deposits becoming darker in colour towards the base of the trench. No archaeological features were noted within this trench.

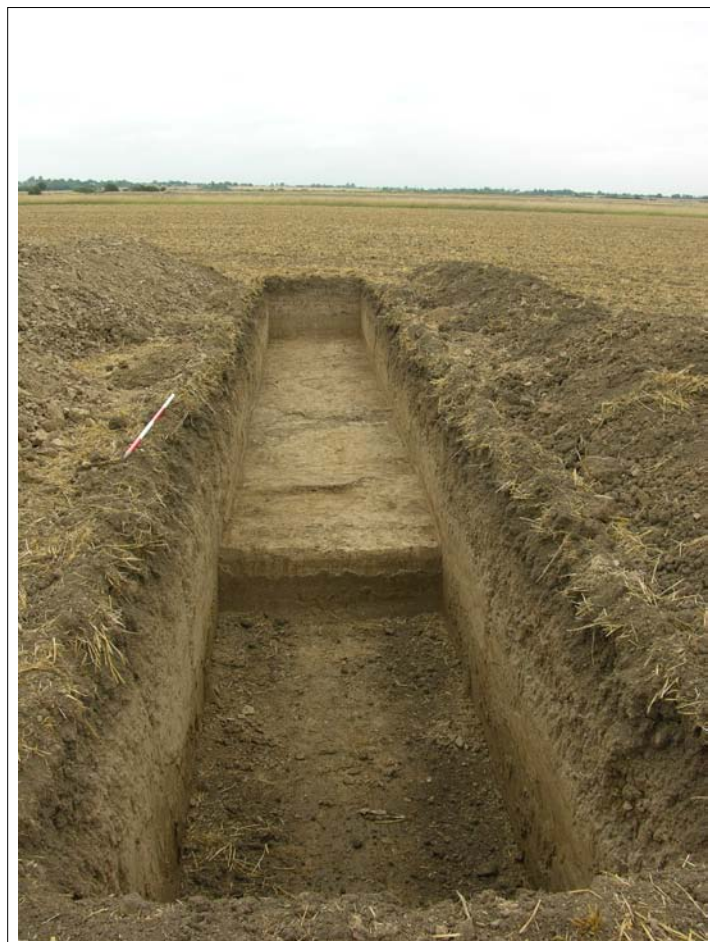
Plate 4: View along Trench 8, Looking north, Scale 1x2m

- 3.3.9 Trench 8 (Plate 4) measured 17m x 2m and was aligned north south. Removal of topsoil (801) and subsoil (802) within Trench 8 showed a clay natural at a depth of around 0.5m below the current ground surface. Excavation through the clay (803) revealed sandy lenses at varying depths. Excavation down to 1.8m showed further heavy clay deposits becoming darker in colour towards the base of the trench. No archaeological features were noted within this trench.

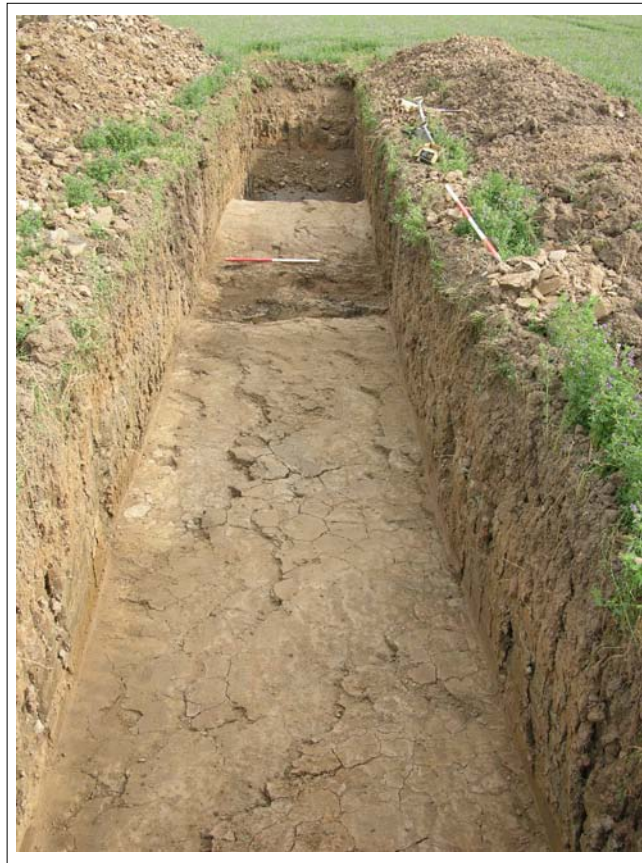
Plate 5: View along Trench 9, Looking north  
Scales 1x1m & 1x2m

- 3.3.10 Trench 9 (Plates 5-8) measured 17m x 2m and was aligned north south. The desk based assessment had highlighted the fact that a Post medieval Windmill was located nearby. Removal of topsoil (901) and subsoil (902) within Trench 9 showed a sandy natural at a depth of around 0.5m below the current ground surface. Excavation through the sandy natural (903) revealed a ditch cut at 1.2m below the current ground surface. The ditch was running east west across the trench and was approximately 1.5m in width. Excavation of a section across the ditch showed it to be approximately 0.3m deep with a probable clay lining. The fill of the ditch was a largely organic black silt containing

pieces of wood, brick, glass and iron. Nineteenth century ceramics were also recovered from within the fill of the ditch. Later oxidation of the trench section showed a further ditch located above this one. This additional ditch also showed as a faint linear cropmark and ran on the same alignment as the earlier ditch. The additional ditch contained a dark brown silt fill with similar 19<sup>th</sup> century cultural items to those recovered from the first ditch. Excavation of a sondage down to 1.8m at the southern end of the trench showed further heavy clay deposits becoming darker in colour towards the base of the trench. No archaeological features were noted within this trench.

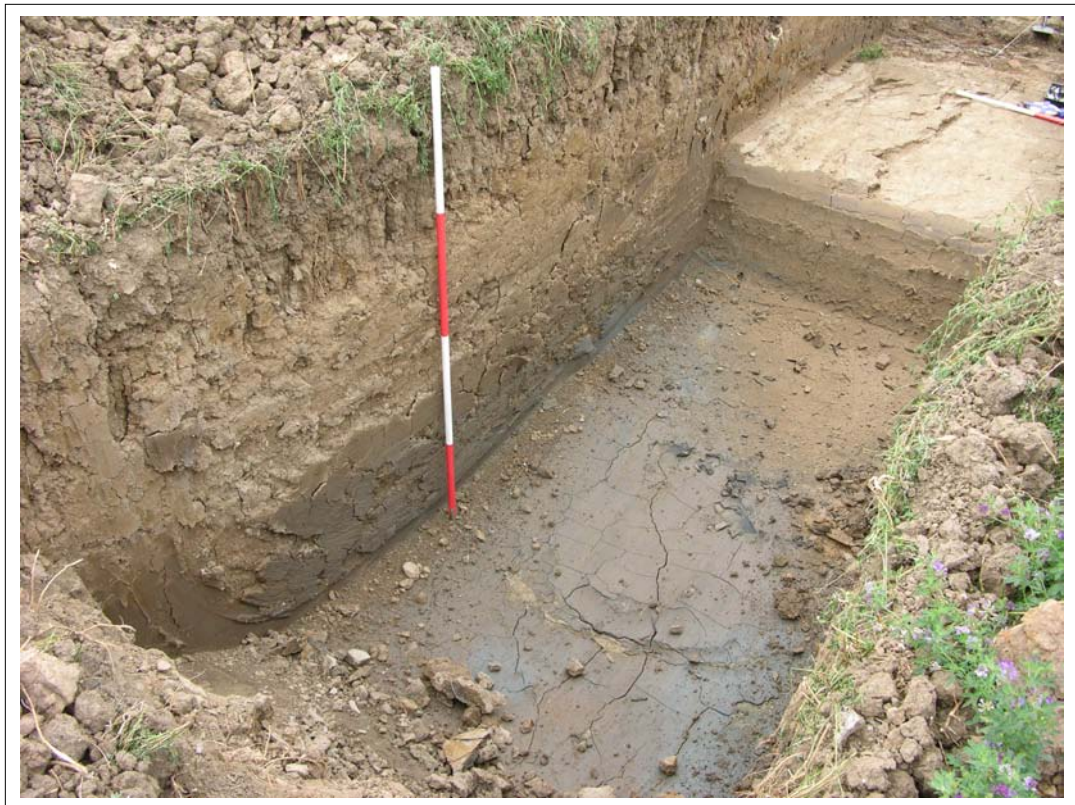
Plate 6: View of 1.8m deep section within Trench 9, Looking south east  
Scale 1x2m

Depth (m from surface)	Description
0.00-0.40	10YR 4/2 dark greyish brown; clayey silt, blocky and crumby; very common modern root remains; pieces of CBM, slate, glass and chalk; well-marked transition to:

0.40-1.10	10YR 4/2; clayey silt; blocky; common modern root remains; worm burrows; gradual transition to:
1.10-1.40*	10YR 5/6 yellowish brown; clayey silt with closely spaced partings and thin beds of grey (10YR5/1) fine sand, becoming increasingly closely spaced downward; worm burrows; gradual transition to:

1.40-1.63	2.5Y 4/3 olive brown; clayey silt with widely spaced partings and thin beds of grey (10YR 5/1) fine sand; worm burrows; sharp contact with:
1.63-1.90	Dark bluish grey clayey silt with thin widely spaced partings and thin beds of sand.

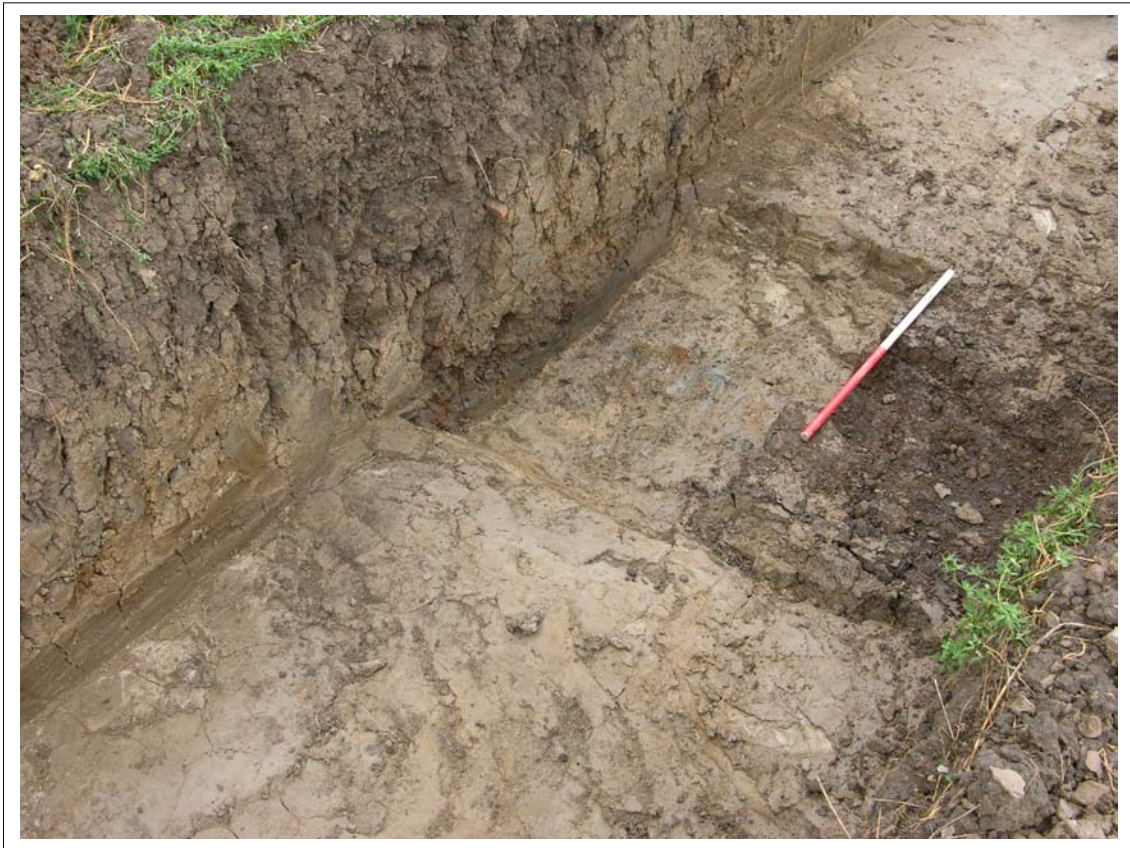
Plate 7: View of excavated ditch within Trench 9, Looking north west. Scale 1x1m

* Cut into this unit was a channel/ditch-like feature about 1.8m in width, extending across the trench, with fairly steeply sloping sides and occupied by a patchy mixture of silty and sandy sediment incorporating varying amounts of organic material - peaty in places. Pieces of brick and worked timber were also present.

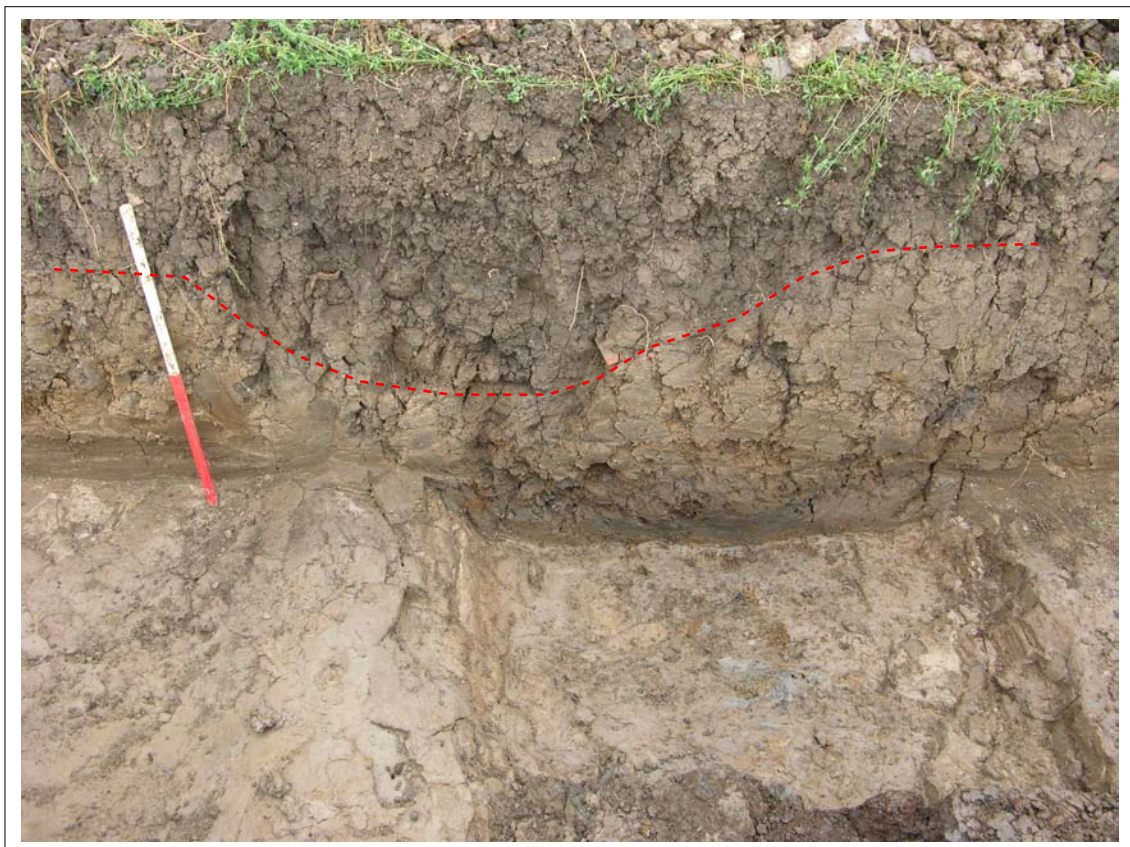
Plate 8: View of additional ditch noted within section, Looking west, Scale 1x1m
