Land to south of Rocks Green, Ludlow, Shropshire

Archaeological Field Evaluation

Report No. 1746

Prepared For: Pickstock Homes

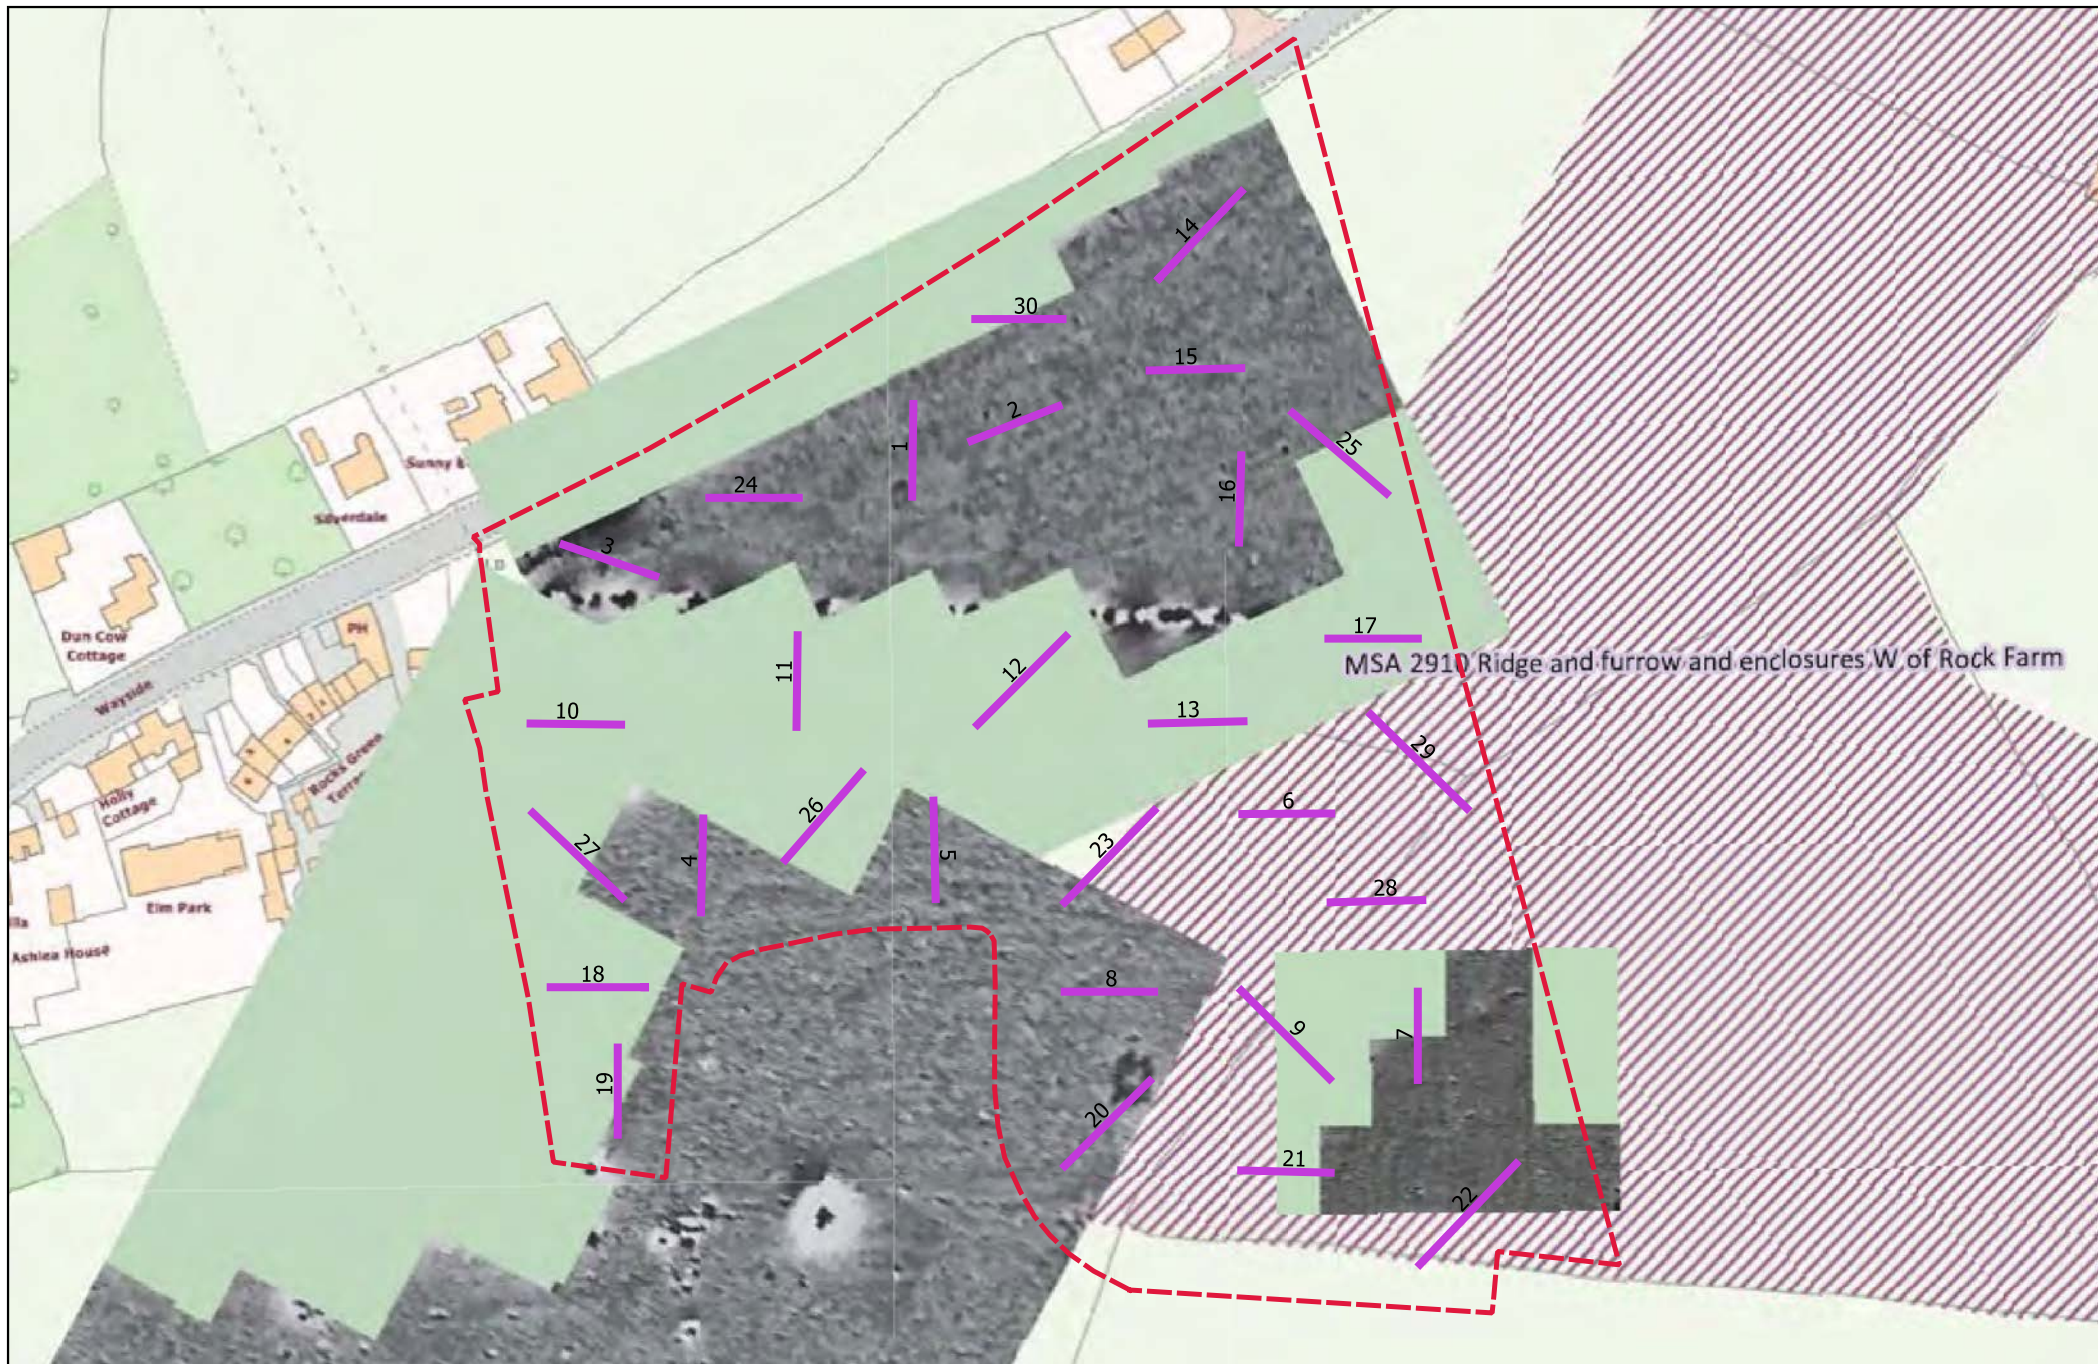
Figure 2. Proposed trench location.

It was proposed that thirty trenches, 20 metres in length and 1.8 metres in length, were machine-excavated within the planned development area (Figure 2). The locations and dimensions of the trenches were agreed with SCHET-DC prior to the commencement of works.

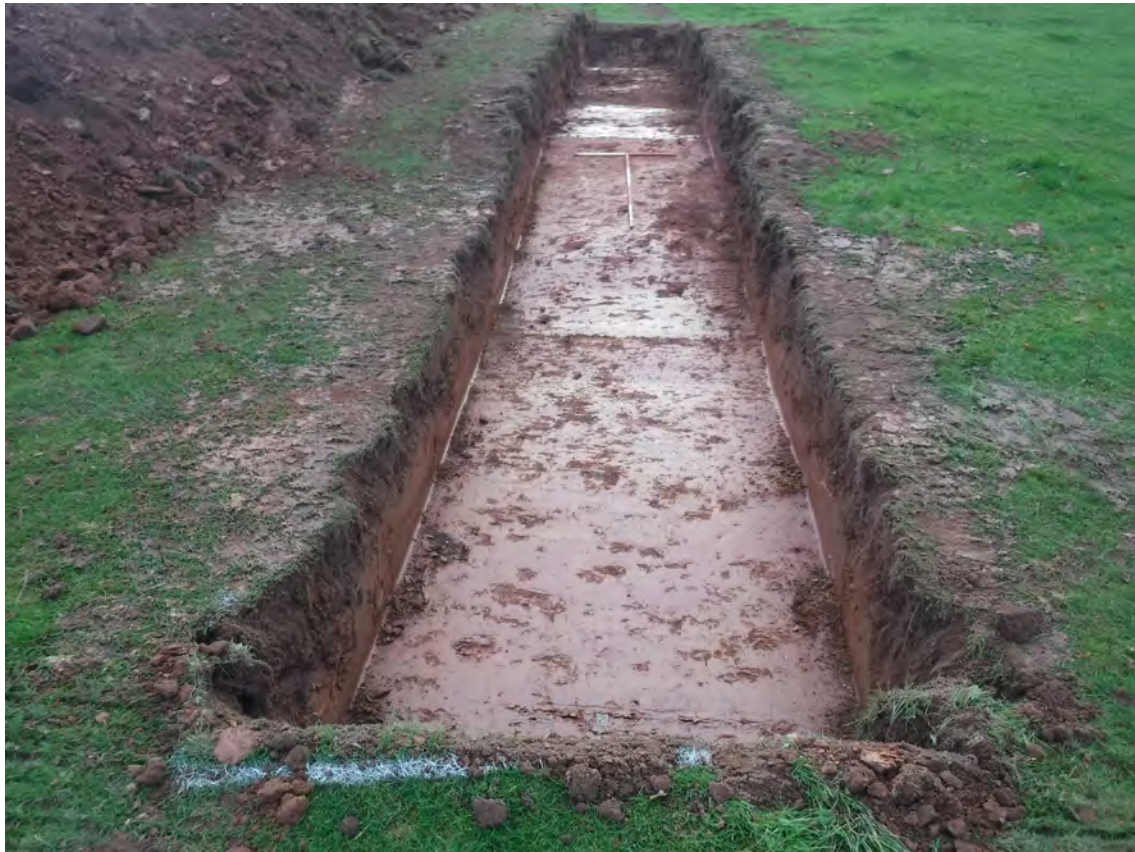
Plate 1. Trench 1, looking south. scales 1m & 2m

Trench 1 measured 20m in length, 1.8m in width and 0.72-0.98m in depth.

The natural substrate (1003) was found 0.98m below ground level and was comprised of mid-brown-red clay with green splotches and frequent large, angular stones. (1003) was overlain by the subsoil (1002) which began 0.5m from ground level. (1002) was mid-orange-brown in colour and clayey silt in composition and contained frequent sub-angular stones. It contained some charcoal and ceramic material. (1002) was overlain by the topsoil (1001) at 0.1m. (1001) was mid orange-brown loam. No finds or features were encountered in this trench.

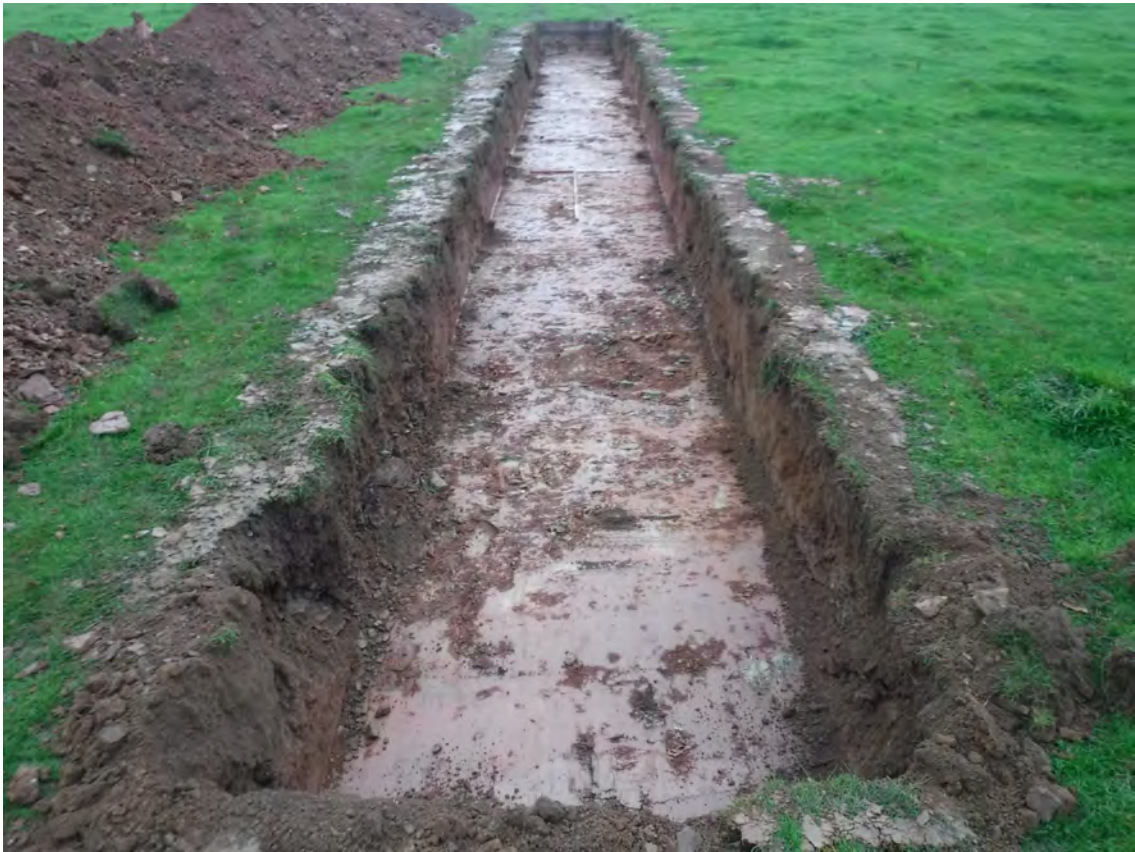
Plate 3. Trench 2, looking east. Scales 1m & 2m

Trench 2 measured 20m in length, 1.8m in width and 0.93m in depth.

The natural substrate (2004) was found 0.93m below ground level and was defined by mid-brown-red clay. (2004) was overlain by a layer (2003) of mid-red-brown clayey silt which began 0.75m from ground level. (2003) was overlain by the subsoil (2002), which was light-red-brown silt and began 0.39m from surface. (2002) was overlain by the topsoil (2001), a mid-orange-brown loam at 0.22m deep. No finds or features were encountered in this trench.

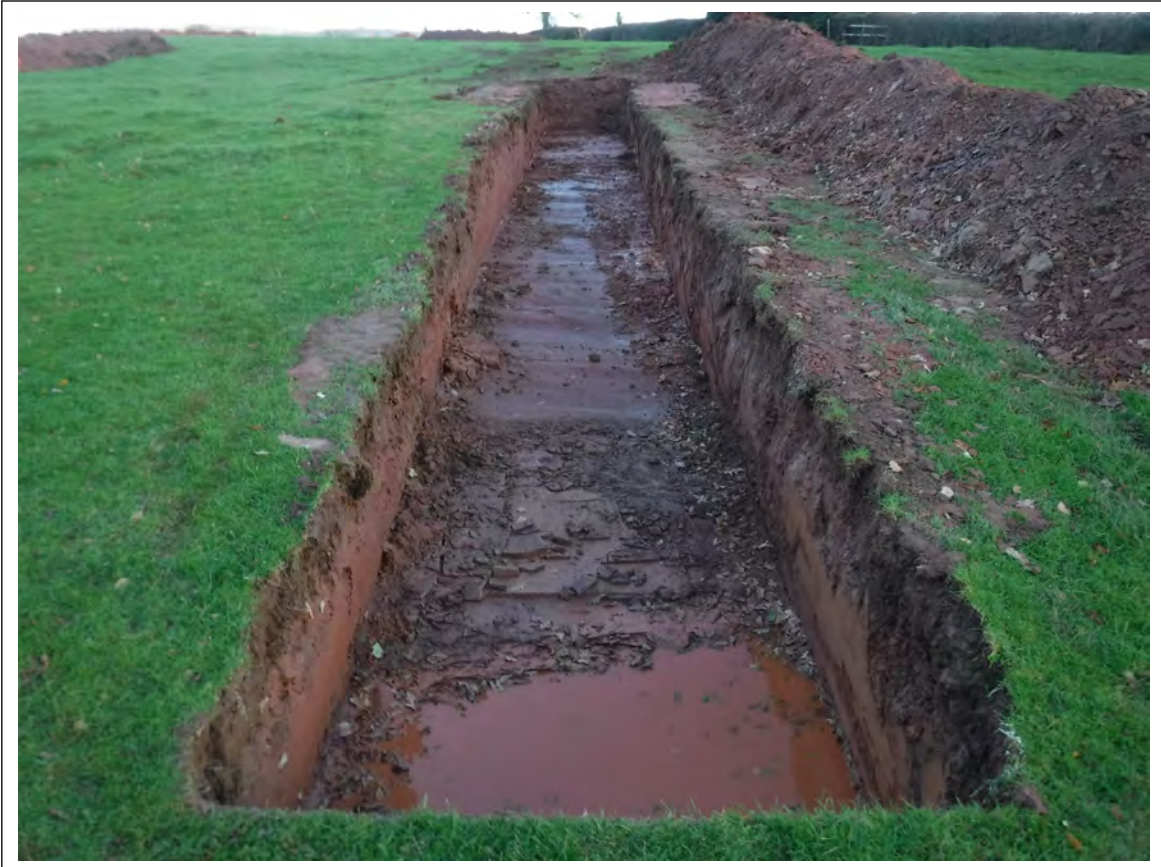
Plate 5. Trench 3, looking southeast. Scales 1m & 2m

Trench 3 measured 20m in length, 1.8m in width and 1.14m in depth.

The bedrock (3005) consisted of brown-grey stone 1.1m from ground level. (3005) was overlain by natural substrate (3004) which is mid-brown-red clay also 1.1m from ground level. (3004) was overlain by a layer (3003) of mid-brown-red clayey silt which began 0.98m from ground level. (3003) was overlain by the subsoil (3002), a light-orange-brown silt which began 0.47m from surface. (3002) was overlain by the topsoil (3001) which was mid-orange-brown loam at 0.3m. No finds or features were encountered in this trench.

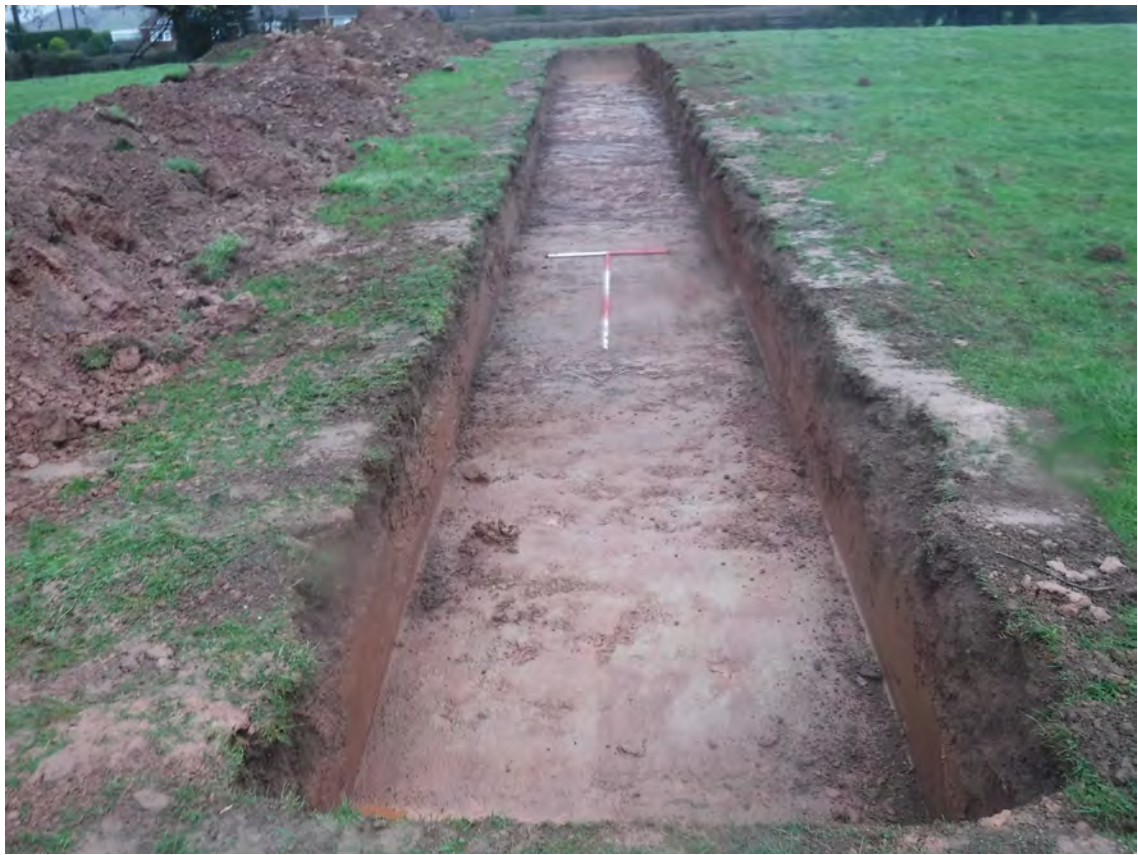
Plate 7. Trench 4, looking northeast. Scales 1m & 2m

Trench 4 measured 20m in length, 1.8m in width and 1.8m in depth.

The natural substrate (4003) was defined by mid-orange-red clay and was revealed at 0.62m from ground level. Approximately 2m from the northern end of the trench was a layer of bedrock (4004) also at 0.62m from ground level. (4003) and (4004) were overlain by the subsoil (4002), which was mid-orange-brown clayey silt and rested 0.32m from ground level.

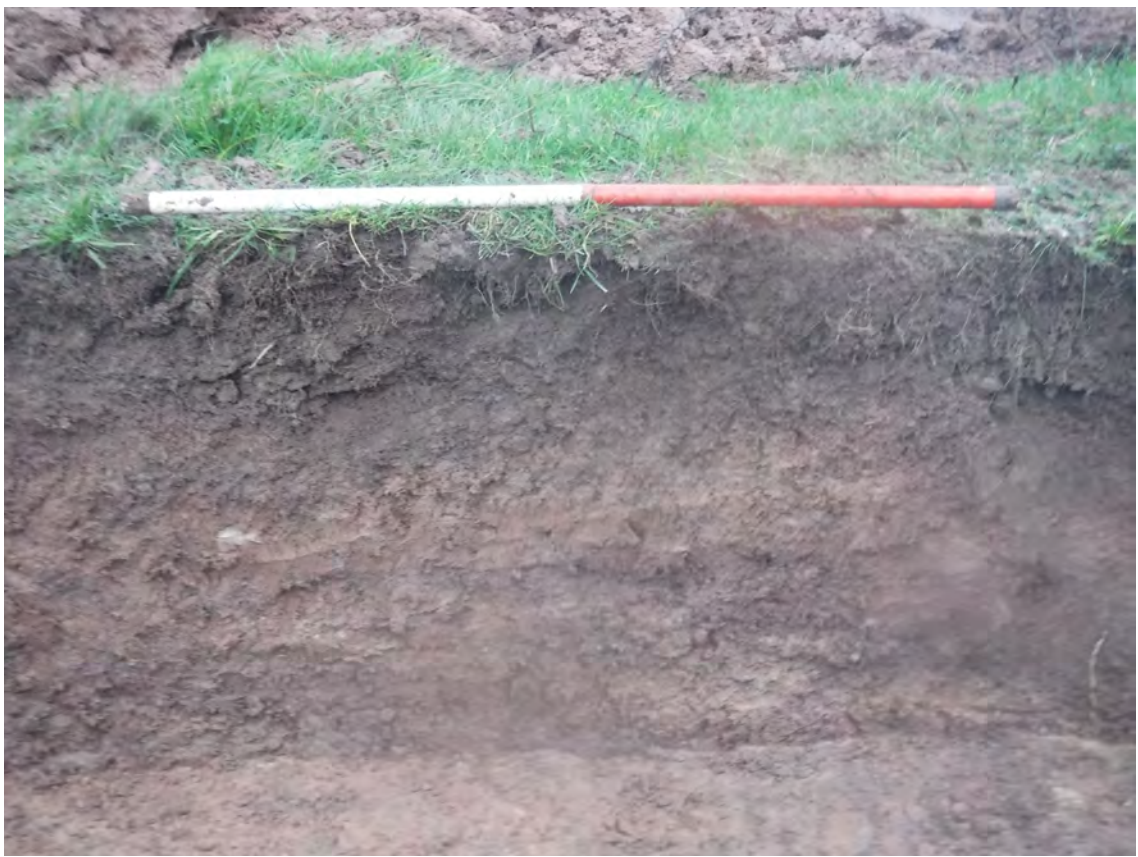
Plate 8. East facing section in Trench 4. Scale 1m

Several fragments of pottery occurred in this level. (4002) was overlain by the topsoil (4001), a mid-orange-brown loam which occurred at 0.12m deep.

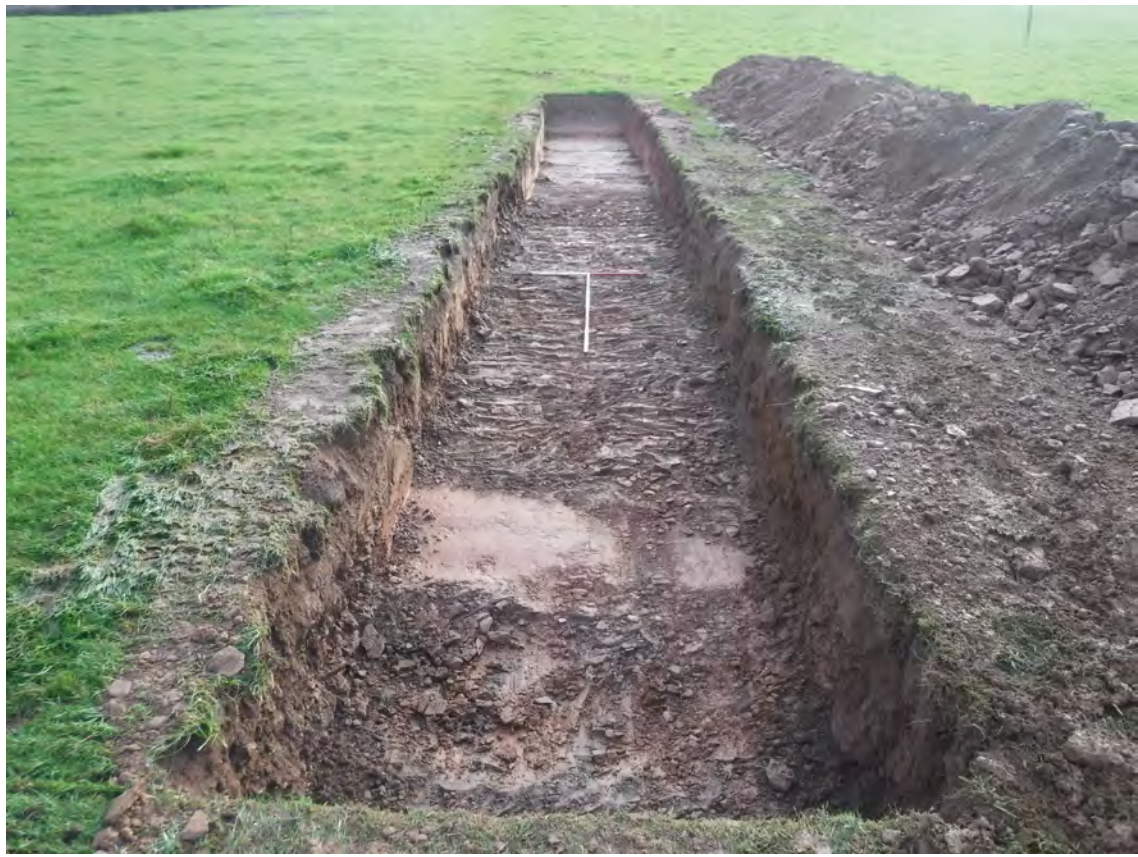
Plate 9. Trench 5, looking south. Scale 1m

Trench 5 was 20m in length, 1.8m in width and 0.86m in depth.

The natural substrate, (5004), was found 0.86m below ground level. (5004) was defined as mid-orange-red clay. At the same level, the natural bedrock (5005) occurred at the northern end of the trench. Overlaying (5004) and (5005) was a deposit of mid-brown-orange silty clay (5003) that sat 0.7m below ground level. (5003) was overlain by the subsoil (5002), which was a mid-orange-brown clayey silt containing occasional sub-angular stones. This layer contained several finds, including pot, glass, iron, charcoal and clay pipe, and was 0.3m from ground level. Overlaying (5002) was the topsoil (5001), a mid-orange brown loam at 0.1m deep.

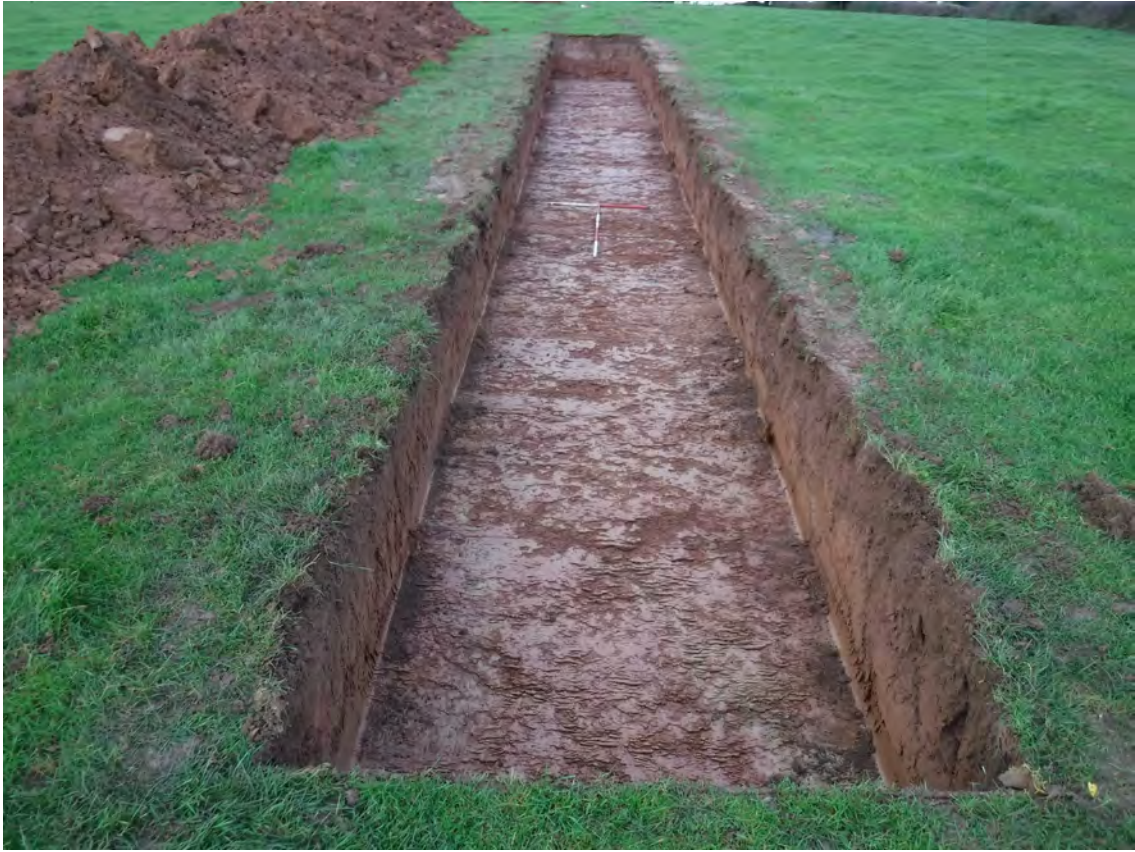
Plate 11. Trench 6, looking west. Scales 1m & 2m

Trench 6 was 20m in length, 1.8m in width and 0.7m in depth.

The natural substrate (6004) was encountered at 0.74m below ground level and consisted of mid-orange-red clay with occasional green splotches. Overlaying (6004) was a deposit of mid-red-orange silty clay (6003) which was revealed at 0.6m from ground level. (6003) was overlain by the subsoil (6002), which measured 0.23m from ground level. (6002) contained large amounts charcoal and finds, including: pot, CBM and clay pipe fragments. (6002) was overlaid by (6001), a mid- orange-brown loam at 0.07m.

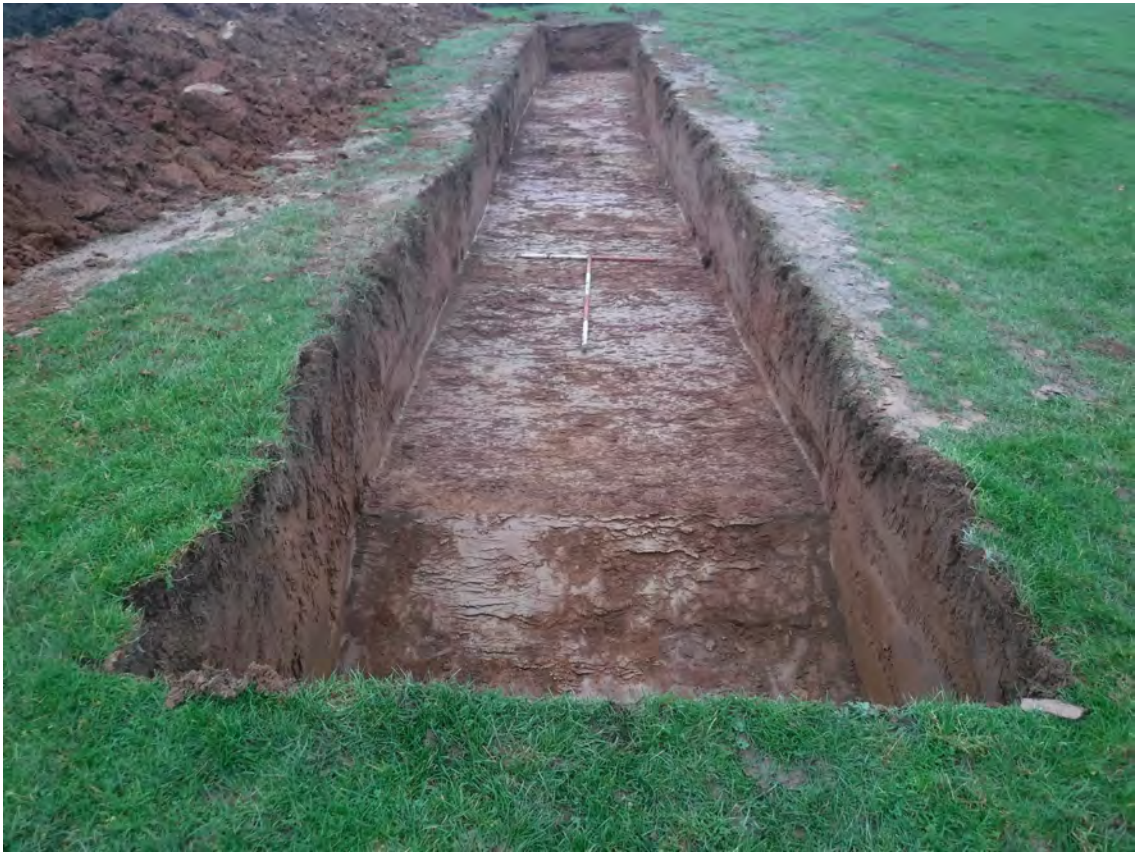
Plate 13. Trench 7, looking west. Scales 1m & 2m

Trench 7 was 20m by 1.8m and 0.96m in depth. The trench was relocated further north due to its proximity to overhead cables.

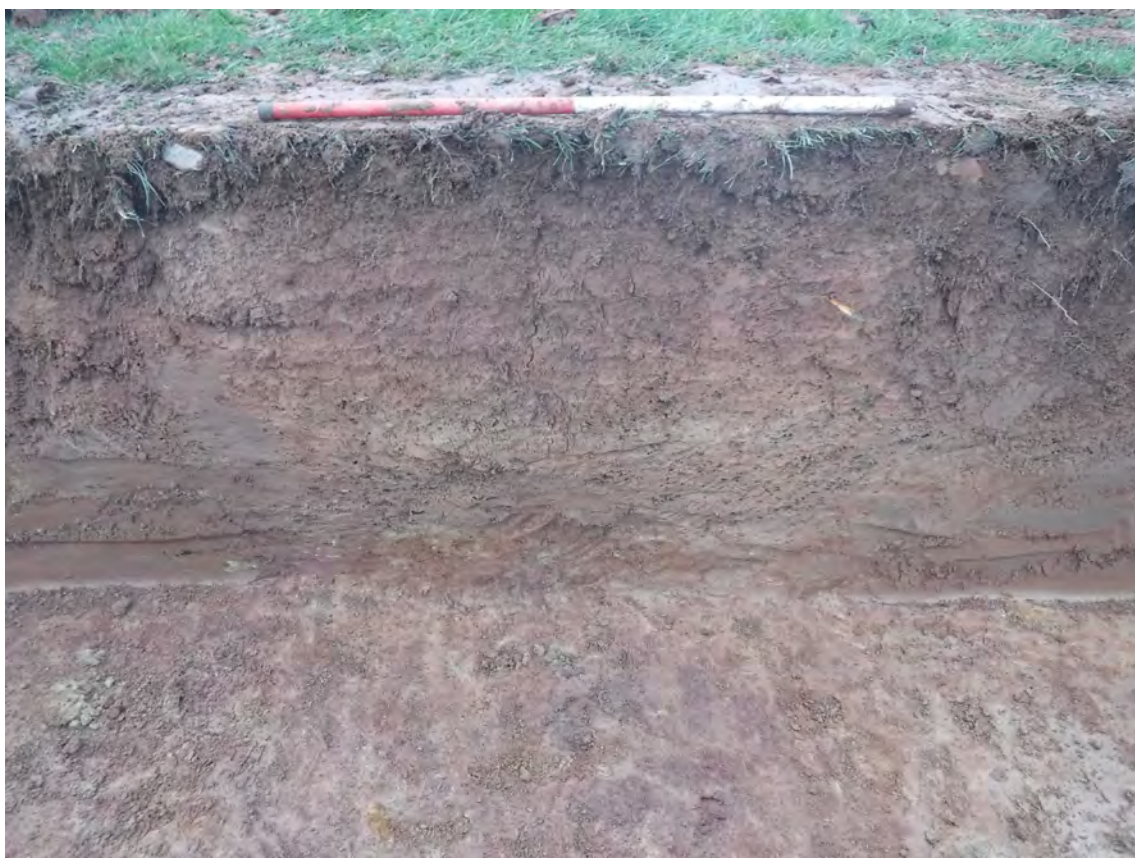
Plate 14. South facing section in Trench 7. Scale 1m

The natural substrate (7004) was mid-orange red clay with some green/pale deposits and sat 0.91m below ground level. Cutting (7004) was [7005], which was 0.77m below surface and sub-circular in shape. [7005] is possibly the outline of a tree bole and was filled with a mix of mid-orange-red clay and rotting wood (7006). (7004) was overlain by (7003), a deposit of mid-brown-orange clay which lay 0.81m from the surface. Above (7003) sat the subsoil (7002), which was mid-orange-brown clayey silt and contained some charcoal. (7002) sat 0.46m below surface level. Overlaying (7002) was the mid orange-brown loam topsoil at 0.09m deep.

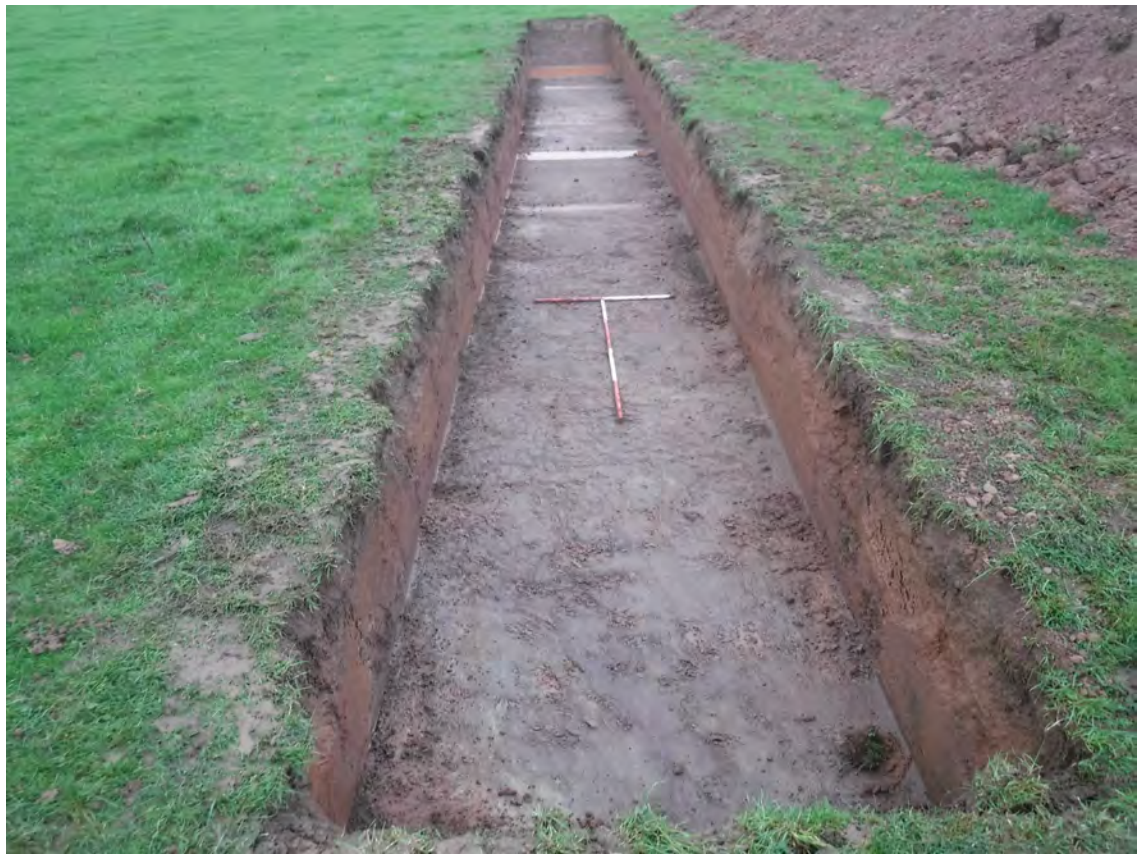
Plate 17. Trench 8, looking north. Scales 1m & 2m

Trench 8 was 20m in length, 1.8m in width and 1.06m in depth. Trench 8 had to be relocated further west due to proximity to overhead cables.

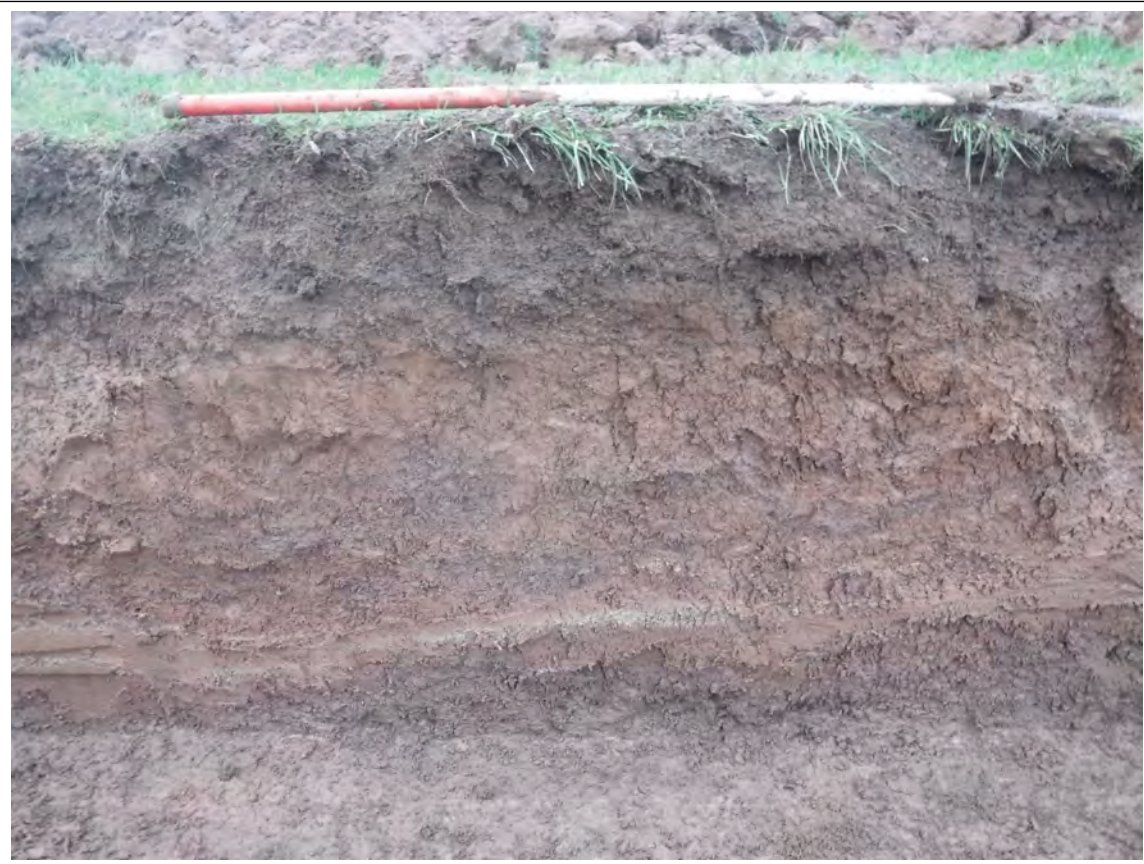
Plate 18. East facing section in Trench 8. Scale 1m

The basal deposit (8004) was located 1.06m from ground level and was a mid-orange-red clay. (8004) was overlain by a mid-brown orange clay deposit (8003), beginning 0.86 from ground level. Laying above (8003) was (8002), the mid-orange brown clayey silt subsoil. (8002) was 0.26m from surface level, and contained pot, charcoal and clay pipe fragments. At 0.11m deep (8002) was overlaid by the topsoil (8001), a mid-orange brown in colour and loam in consistency.

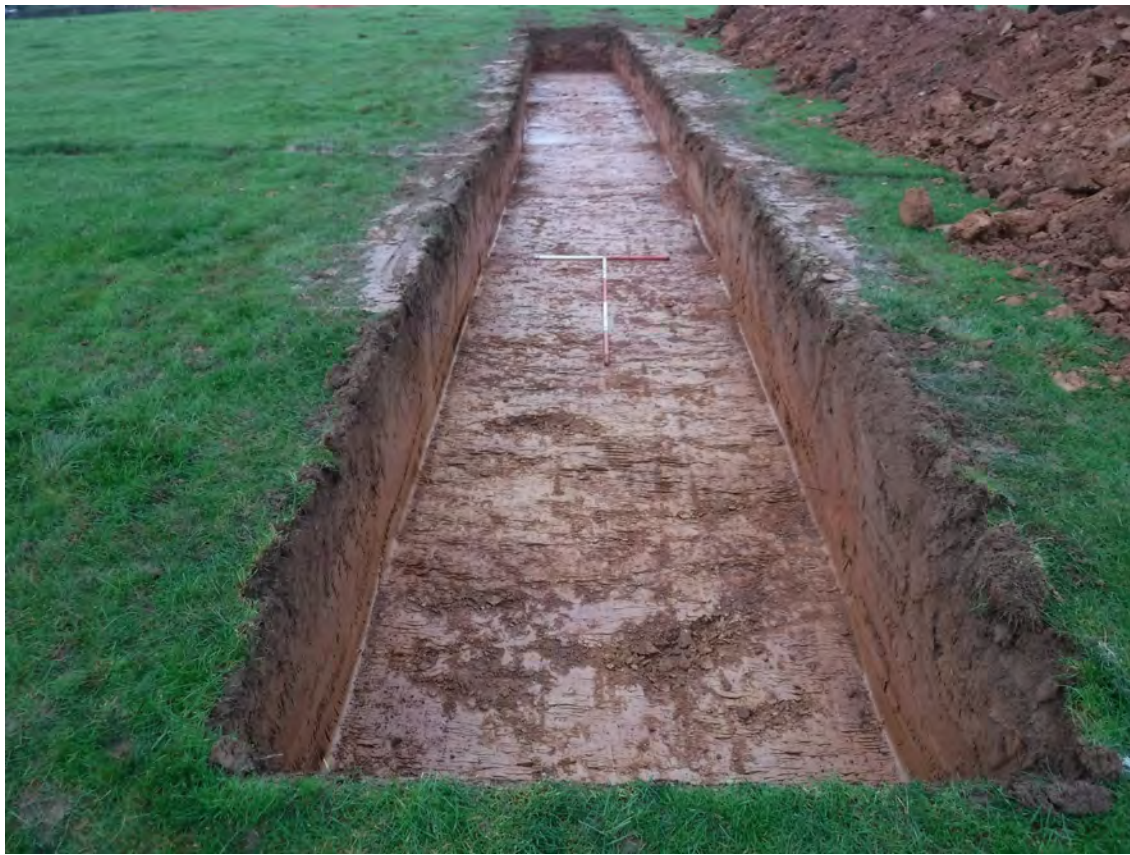
Plate 19. Trench 9, looking north. Scales 1m & 2m

Trench 9 was 20m in length, 1.8m in width and 0.8m in depth. Trench 9 was relocated northwest of its original position to avoid bisecting the boundary hedge.

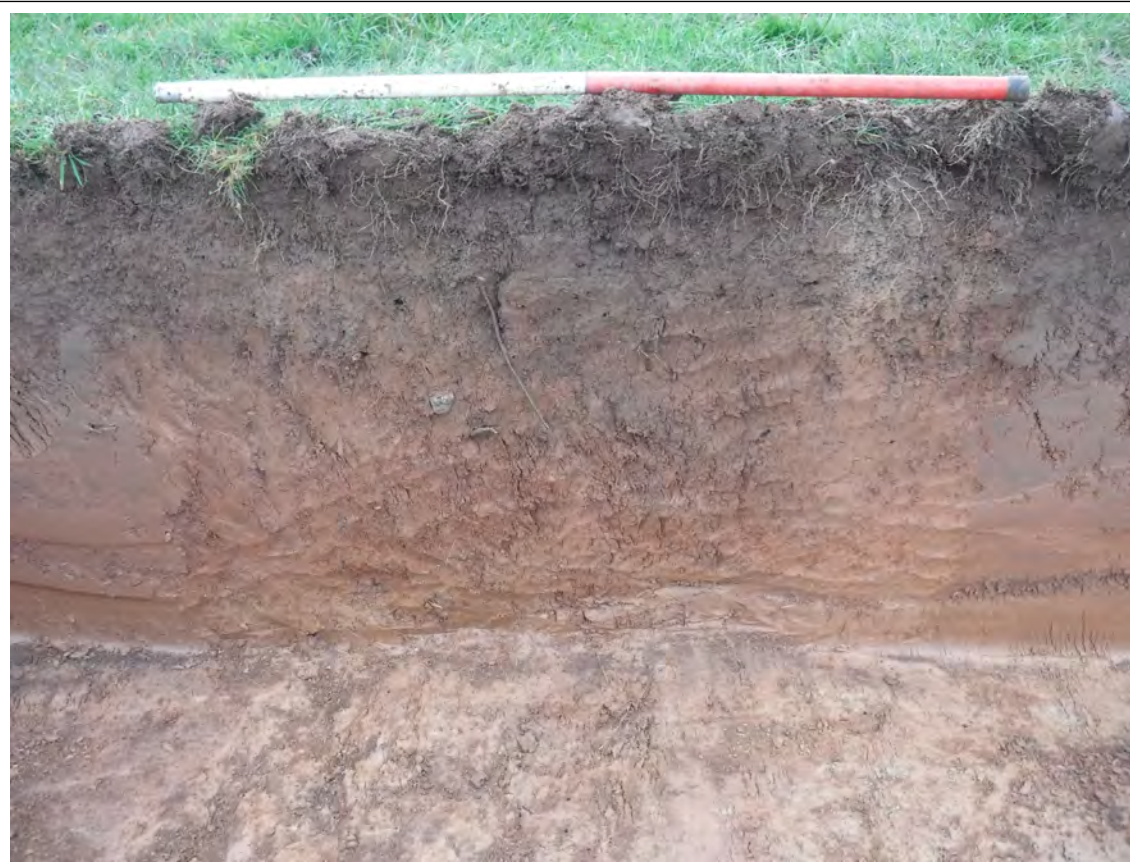
Plate 20. East facing section in Trench 9. Scale 1m

The natural substrate (9004) was mid-red-brown silty clay and sat 0.8m below ground level. Above (9004) lay (9003), a deposit of mid-red brown silty clay that sat 0.7m below ground level. Above (9003) lay the subsoil (9002), which was a mid-red brown silt and contained pot sherds, CBM and clay pipe fragments. (9002) sat 0.26m from ground level. (9002) was overlain by the topsoil (9001), which was a mid-red brown silt and occurred at 0.09m deep.

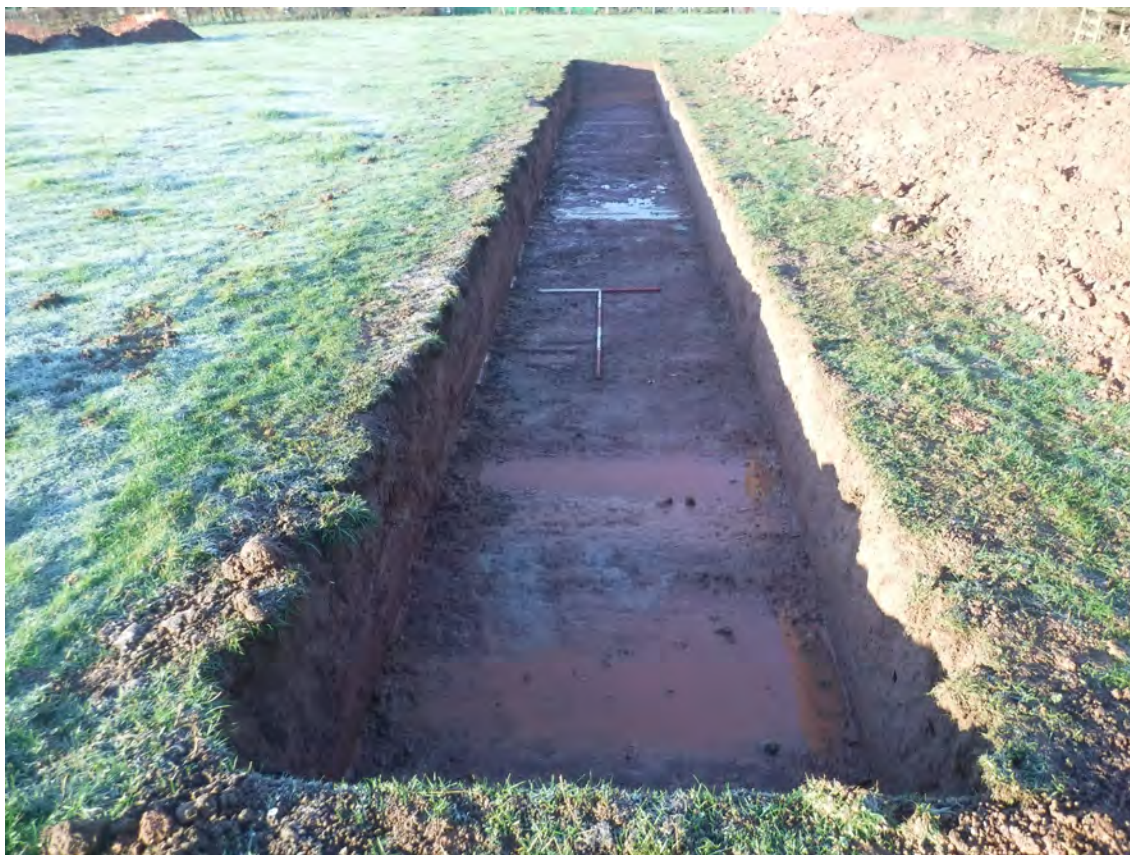
Plate 21. Trench 10, looking west. Scales 1m & 2m

Trench 10 was 20m in length, 1.8m in width and 0.85m in depth. Trench 10 had to be relocated southeast of its original location due to its proximity to a tree.

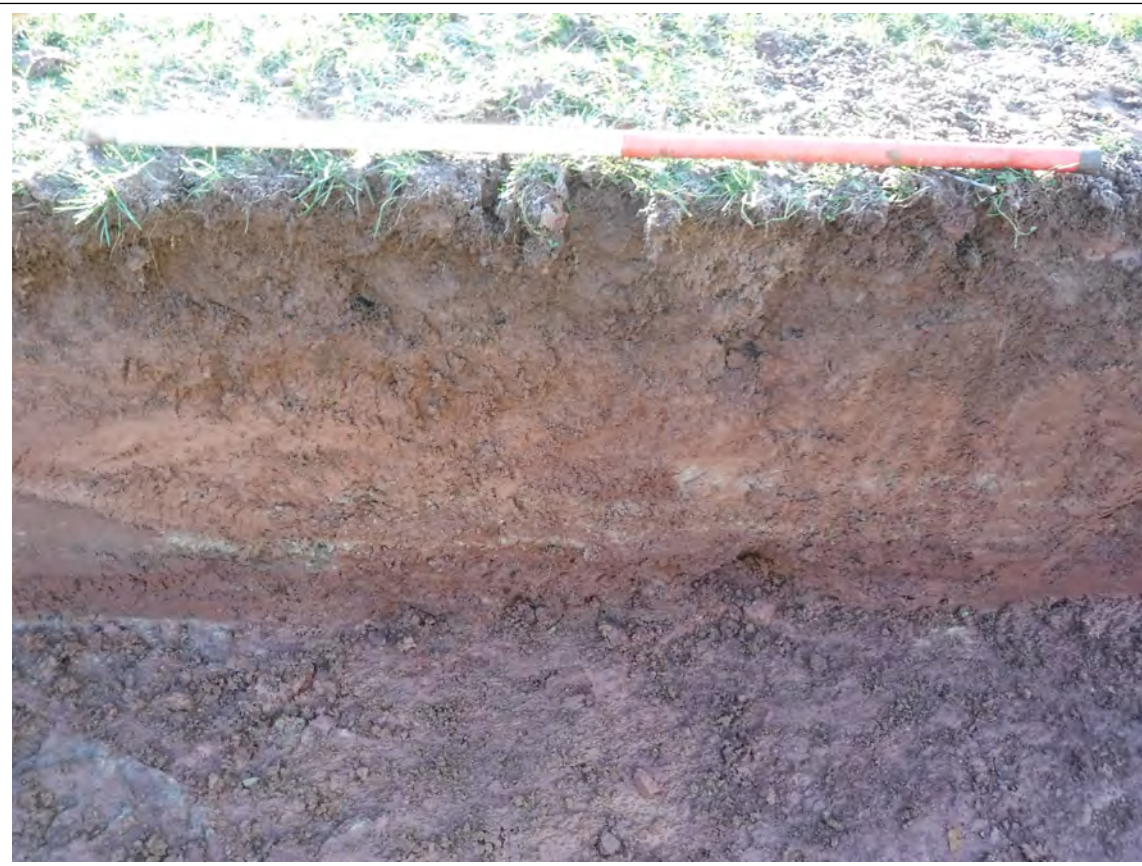
Plate 22. South facing section in Trench 10. Scale 1m

The natural substrate (10004) was a mid-orange pink/red clay with green splotches that sat 0.85m below ground level. Above (10004) lay (10003), a deposit of mid-orange-red clay that sat 0.67m below ground. (10003) was overlain by the subsoil (10002), a mid-orange clay silt that sat 0.27m below ground. (10002) contained some pot sherds. Above (10002) lay the topsoil (10001), mid-orange-brown loam, at 0.14m deep.

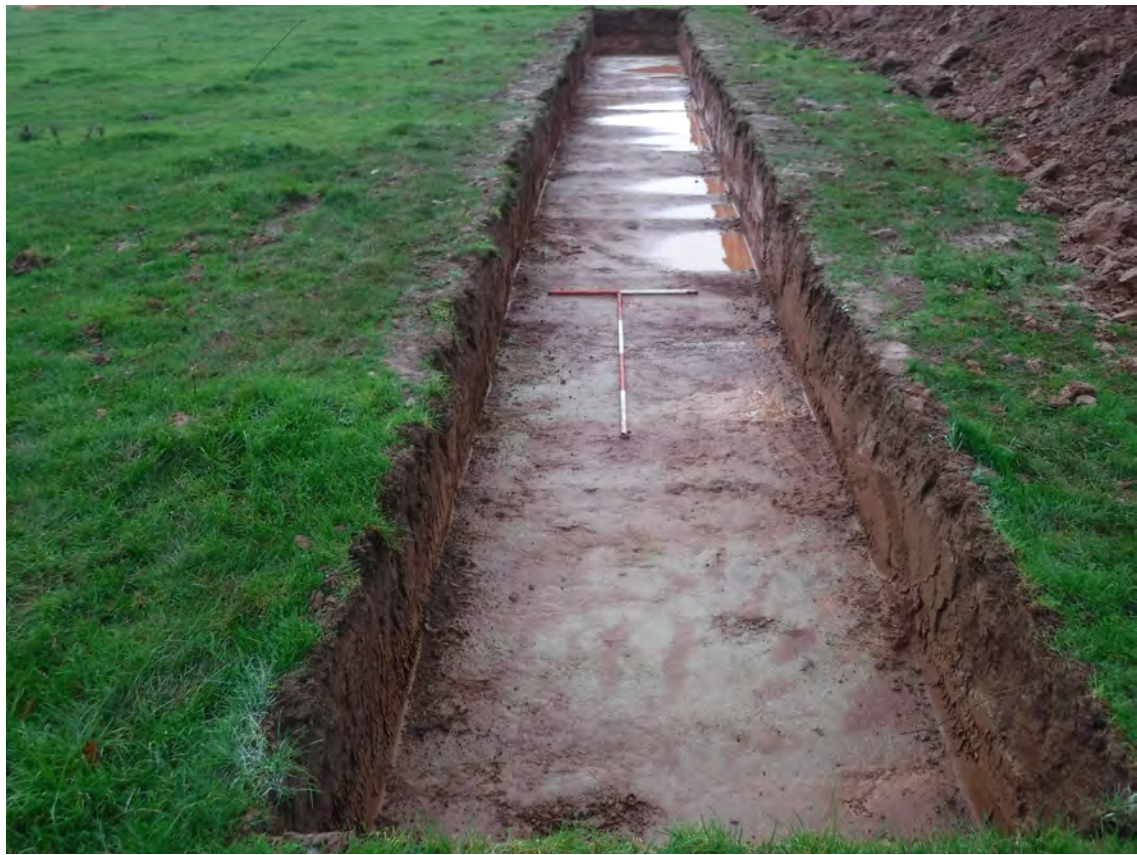
Plate 23. Trench 11, looking west. Scales 1m & 2m

Trench 11 was 20m in length, 1.8m in width and 0.78m in depth. Trench 11 had to be relocated further southeast to avoid bisecting the boundary hedge.

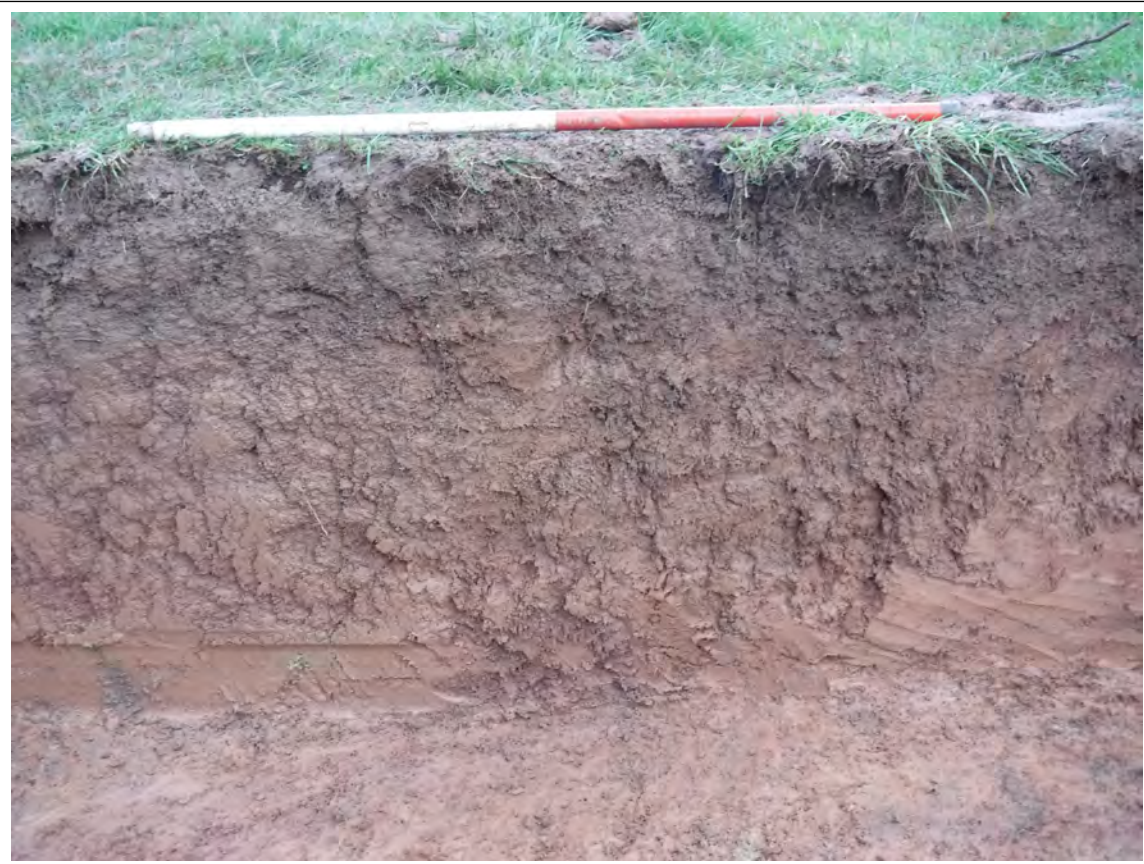
Plate 24. North facing section in Trench 11. Scale 1m

The natural substrate (11004) was 0.73-0.85m below ground level and was a mid-orange pink clay with green splotching. Above (11004) lay (11003), a deposit of mid-brown-orange silty clay which was 0.53-0.65m from surface level. (11003) was overlain by the subsoil (11002),

which was mid-orange brown clay silt. (11002) contained some pot sherd, clay pipe fragments, glass and charcoal. (11002) was 0.25m from surface level. Above (11002) was the topsoil (11001), a mid-orange-brown loam occurring at 0.08m deep.

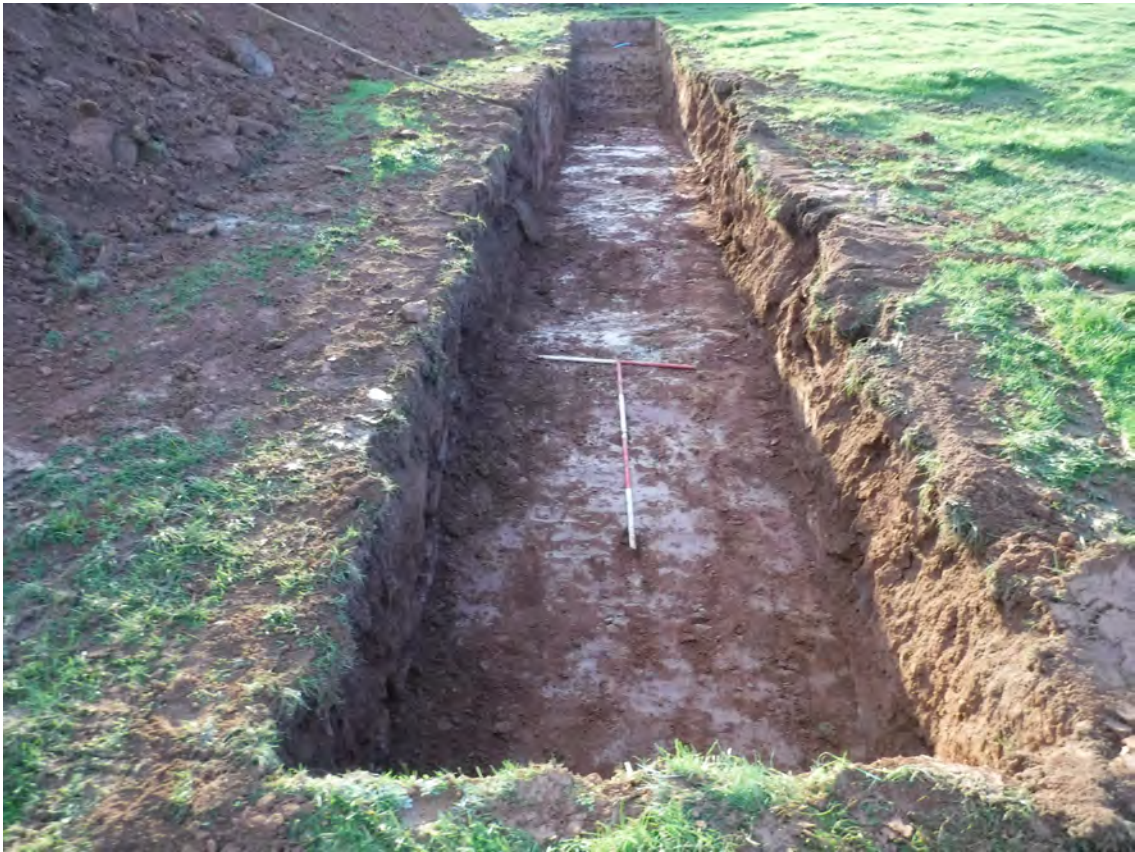
Plate 25. Trench 12, looking southwest. Scales 1m & 2m

Trench 12 was 20m in length, 1.8m in width, and 1.53m in depth. The trench was relocated further northeast to avoid bisecting the boundary hedge.
