Land to south of Rocks Green, Ludlow, Shropshire

Archaeological Field Evaluation

Report No. 1746

Prepared For: Pickstock Homes

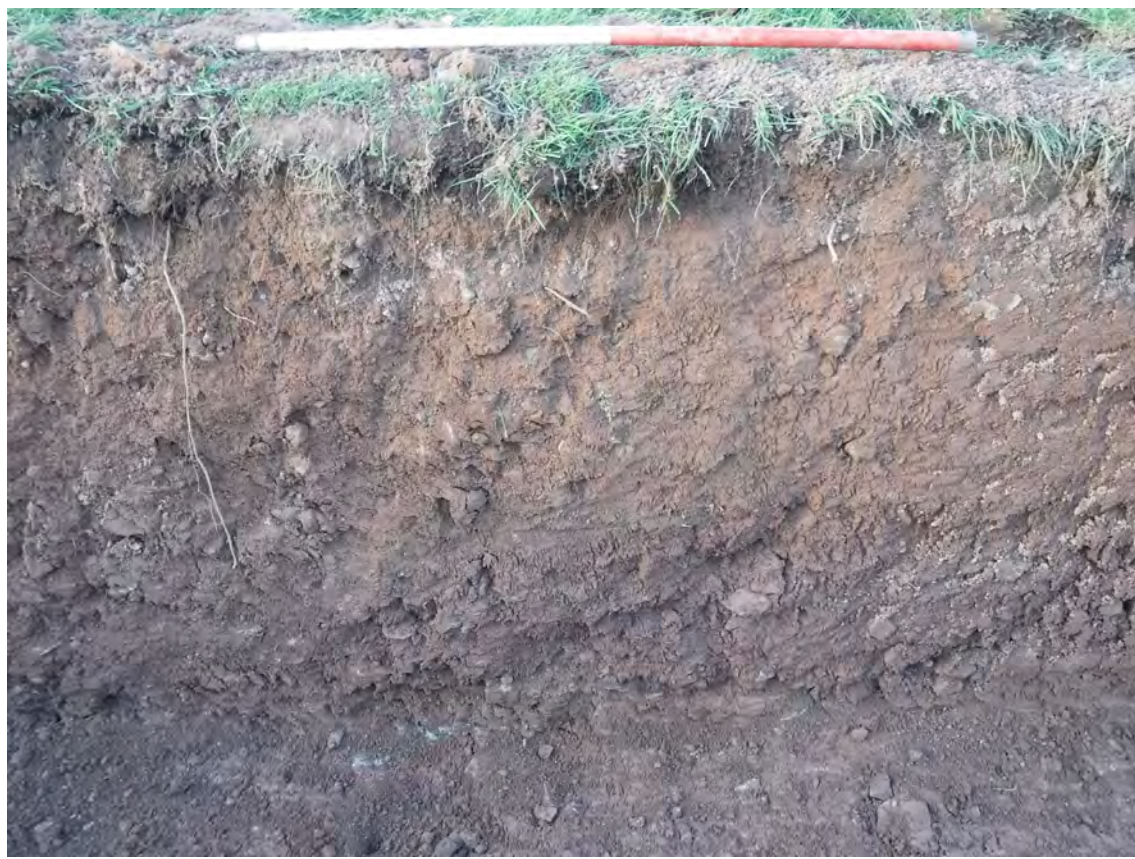
Plate 26. Southeast facing section in Trench 12. Scale 1m

The basal deposit (12004) was at 1.53m below the surface and was made up of a mid-brown-red clay with green splotches with sub-angular stones. Above this was (12003), a mid-brown-orange silty clay with occasional sub-angular stones. This deposit was loose and likely re-deposited over services that occurred at this level. Within (12003) were two water pipes, one currently used {12007}, found at the southwest end of the trench about 0.6m deep. The other was older, lead and no longer used {12010}, and was found further northeast in the trench about 0.55m deep. {12010} was expected due to its evidence in the previous geophysical survey (Smith & Pitt 2016). Both pipes were running east-west. Above (12003) was the subsoil (12002) at 0.38m deep. This consisted of a mid-orange-brown clayey silt. Overlying (12002) was the topsoil, a mid-orange-brown loam, at 0.16m deep.

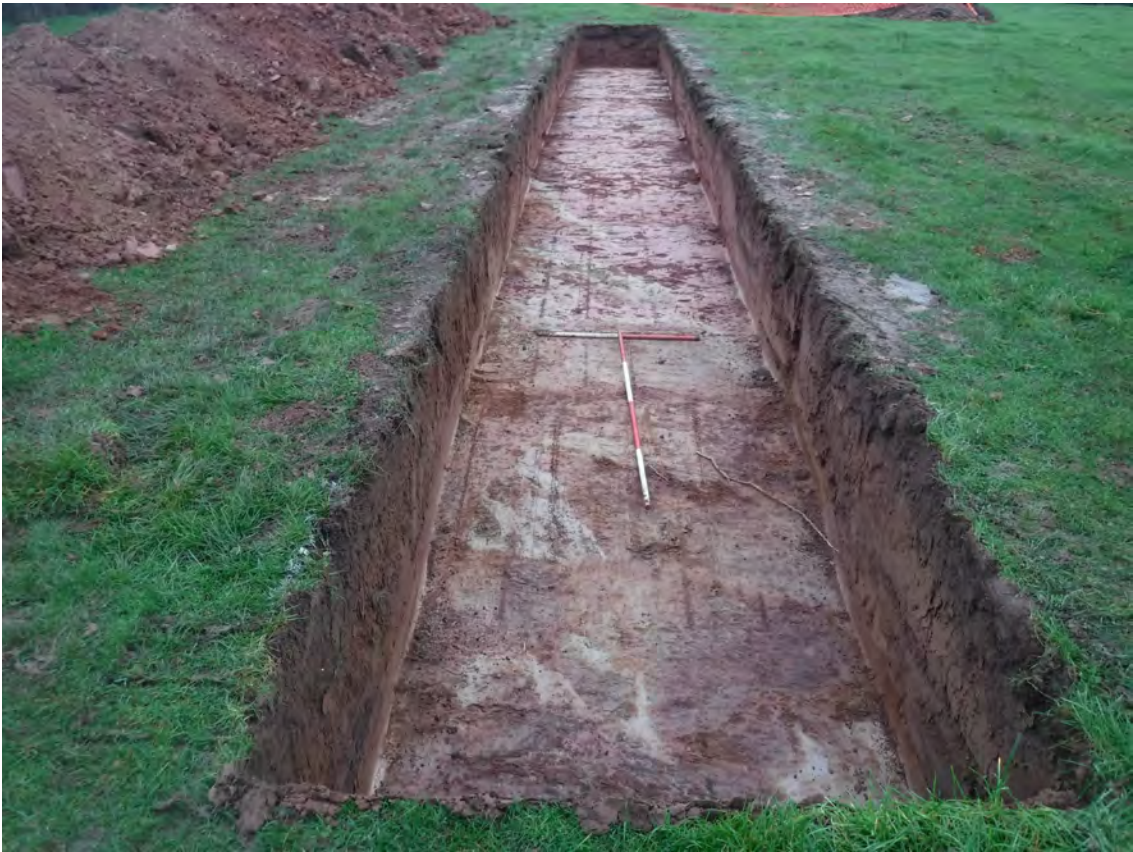
Plate 27. Trench 13, looking south. Scales 1m & 2m

Trench 13 was 20m in length, 1.8m in width, and 0.83 meters in depth. Trench 13 had to be relocated to the south to avoid bisecting the boundary hedge.

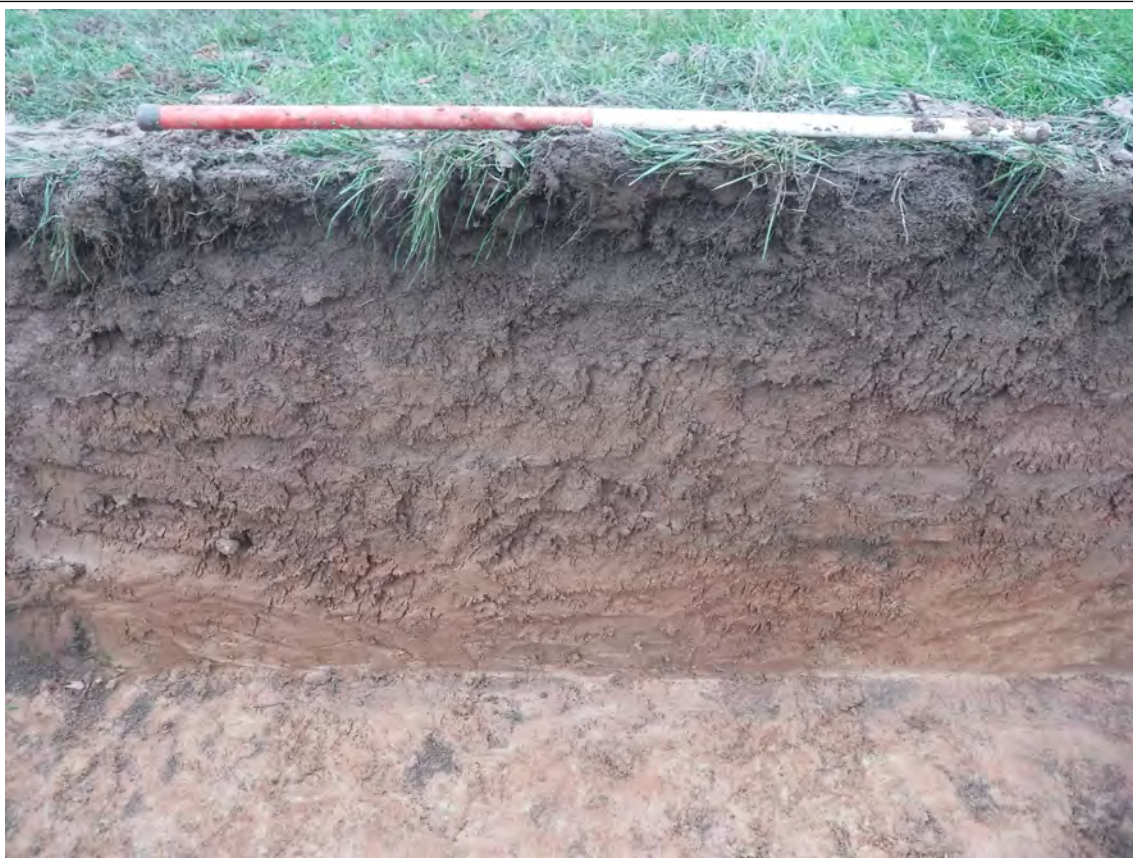
Plate 28. East facing section in Trench 13. Scale 1m

The natural substrate (13003) was located 0.83m below ground level and comprised of a mid-brown-red clay with lenses of lighter grey clay material running through it. Above the substrate (13003), the subsoil (13002) was located at a depth of 0.6m below ground level. This subsoil (13002) was comprised of a mid-red-brown clay silt and contained a variety of artefacts including pot sherds and shards of glass. Above (13002) the topmost layer was the topsoil (13001), a mid-red-brown silt, at 0.32m deep.

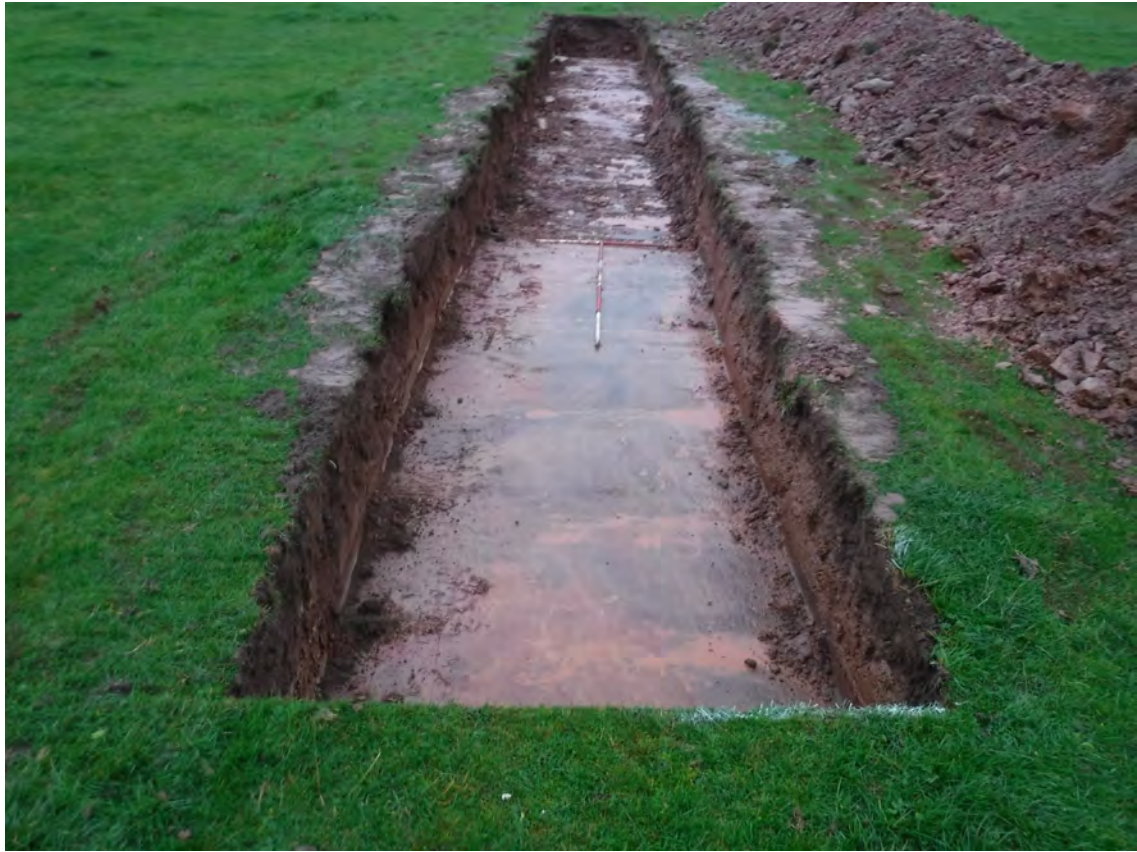
Plate 29. Trench 14, looking southwest. Scales 1m & 2m

Trench 14 was 20m in length, 1.8m in width, and 0.86m in depth.

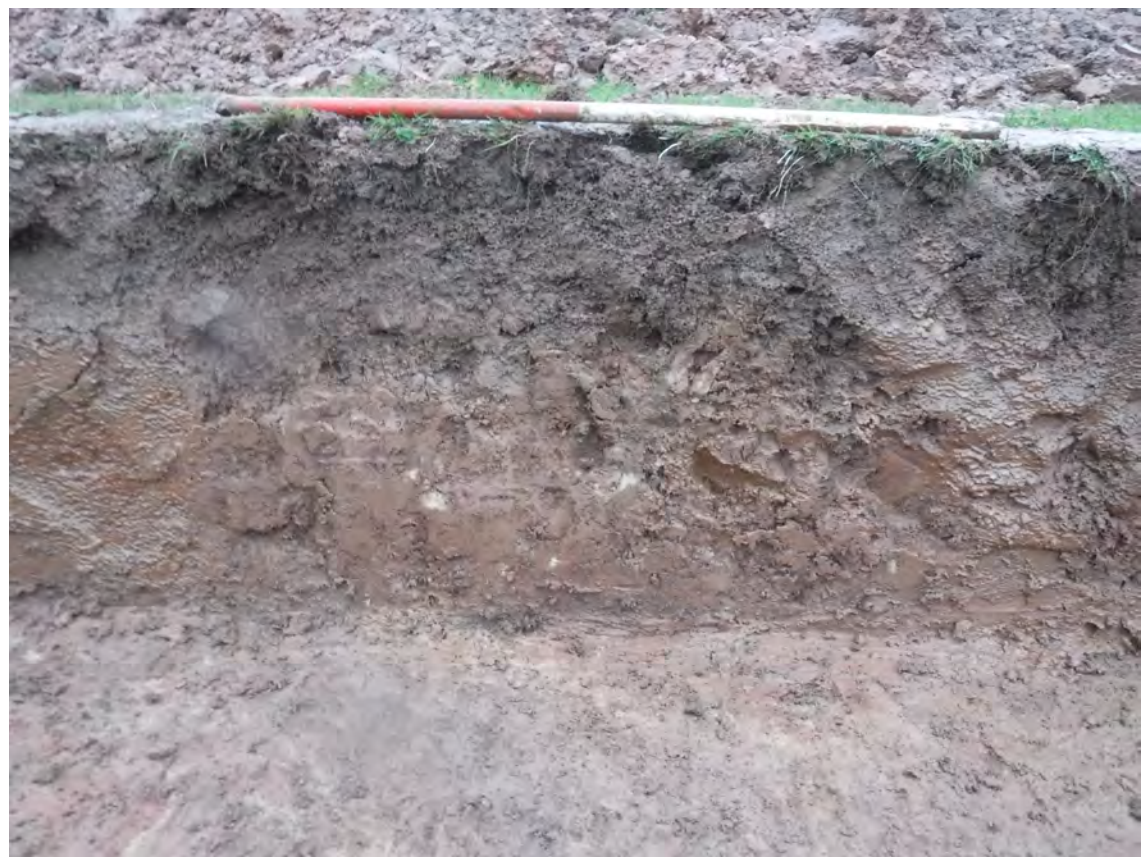
Plate 30. Southeast facing section in Trench 14. Scale 1m

surface. Above this layer (14003) was the subsoil (14002), a light-orange-brown silt at a depth of 0.37m. It was in the subsoil (14002) that several pot sherds were found as well as a metal artefact interpreted as a pitchfork tine. Overlaying the subsoil (14002) was the topsoil (14001), a mid-red-brown silt at 0.23m deep.

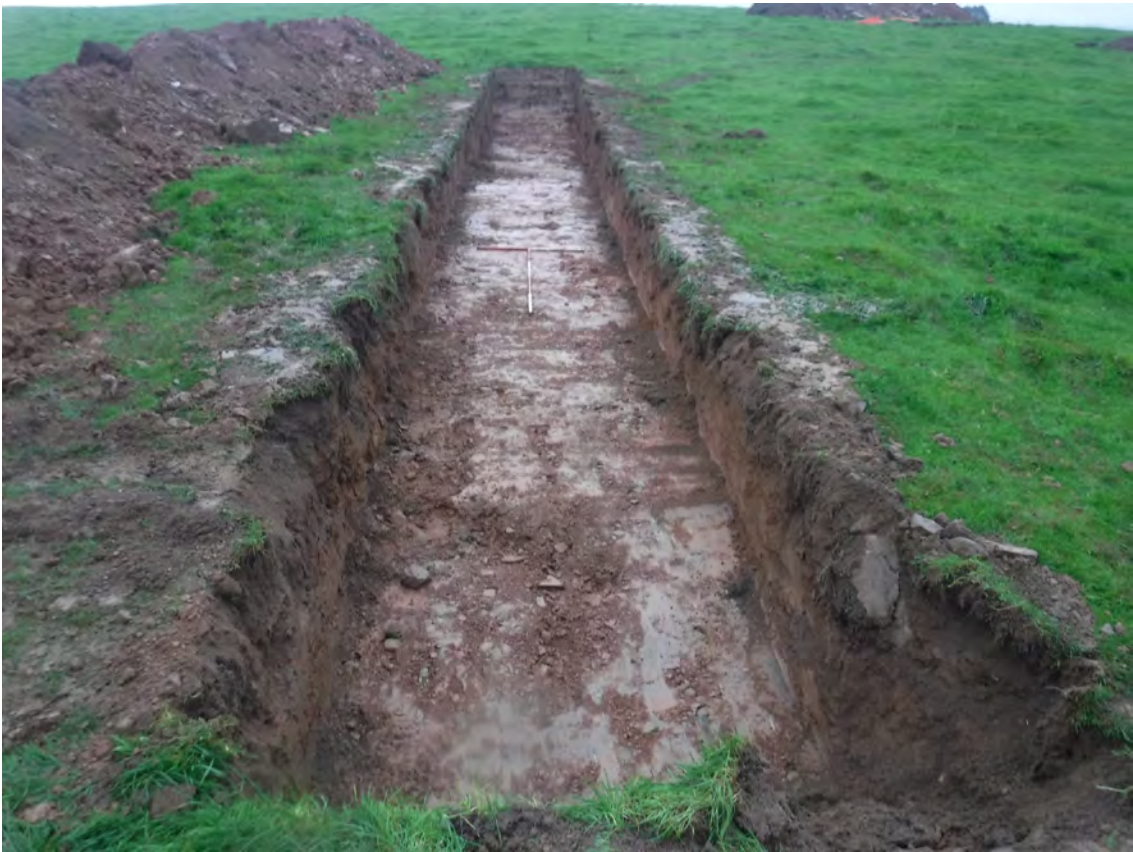
Plate 31. Trench 15, looking east. Scales 1m & 2m

Trench 15 was 20m in length, 1.8m in width, and 1.02m in depth. The site topography meant that this trench was significantly deeper at its eastern end.

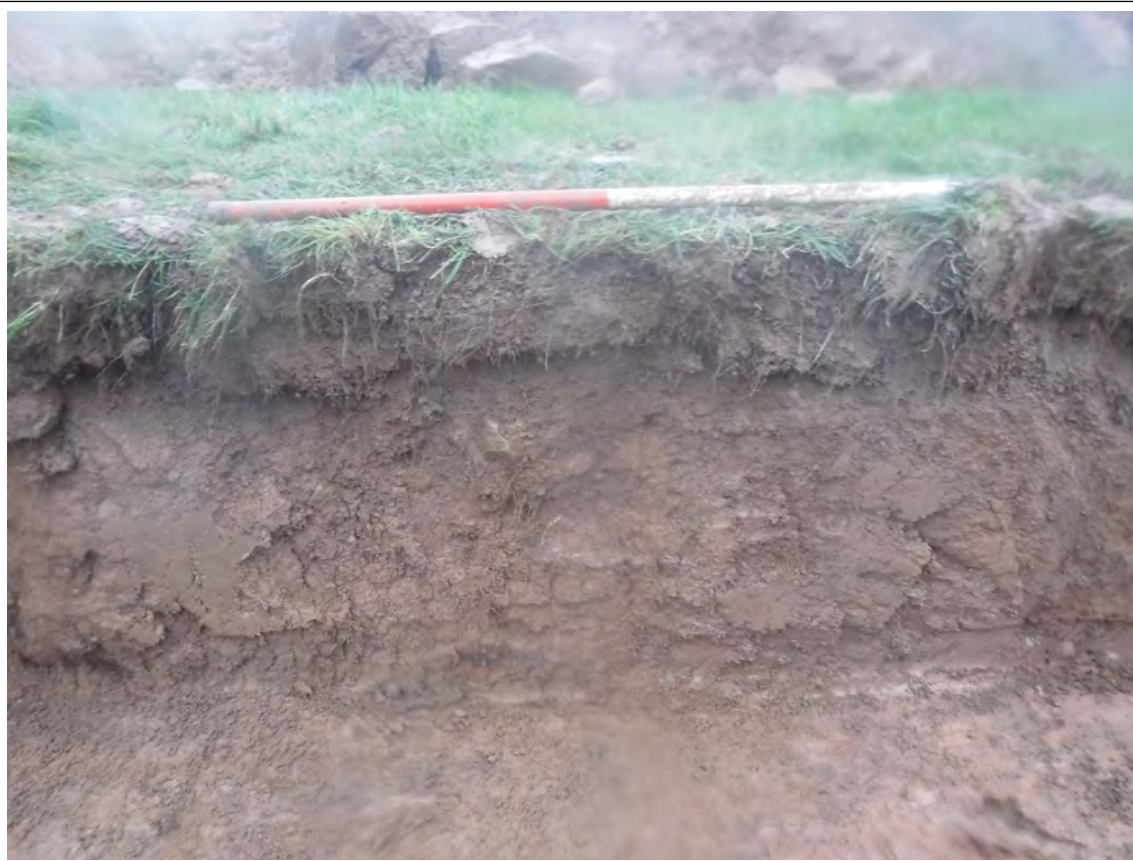
Plate 32. South facing section in Trench 15. Scale 1m

The bottommost layer present was the grey-brown natural stone bedrock (15005), which could be found in the eastern end of the trench at a depth of 1.02m. In the central and western portions of the trench a dark-brown-red clay natural substrate (15004) present at a depth of 1.02m. Above the substrate (15004) there is a layer of dark-orange-brown clayey silt that contains a high proportion of stone inclusions (15003). This layer (15003) was present at a depth of 0.97m. Overlaying (15003) was the subsoil (15002) which consisted of a mid-orange-brown clayey silt present at 0.67m. The topmost layer was the layer above (15002), the topsoil (15001), which consisted of a mid-red-brown silt that was found above the depth of 0.32m. No finds were present in this trench.

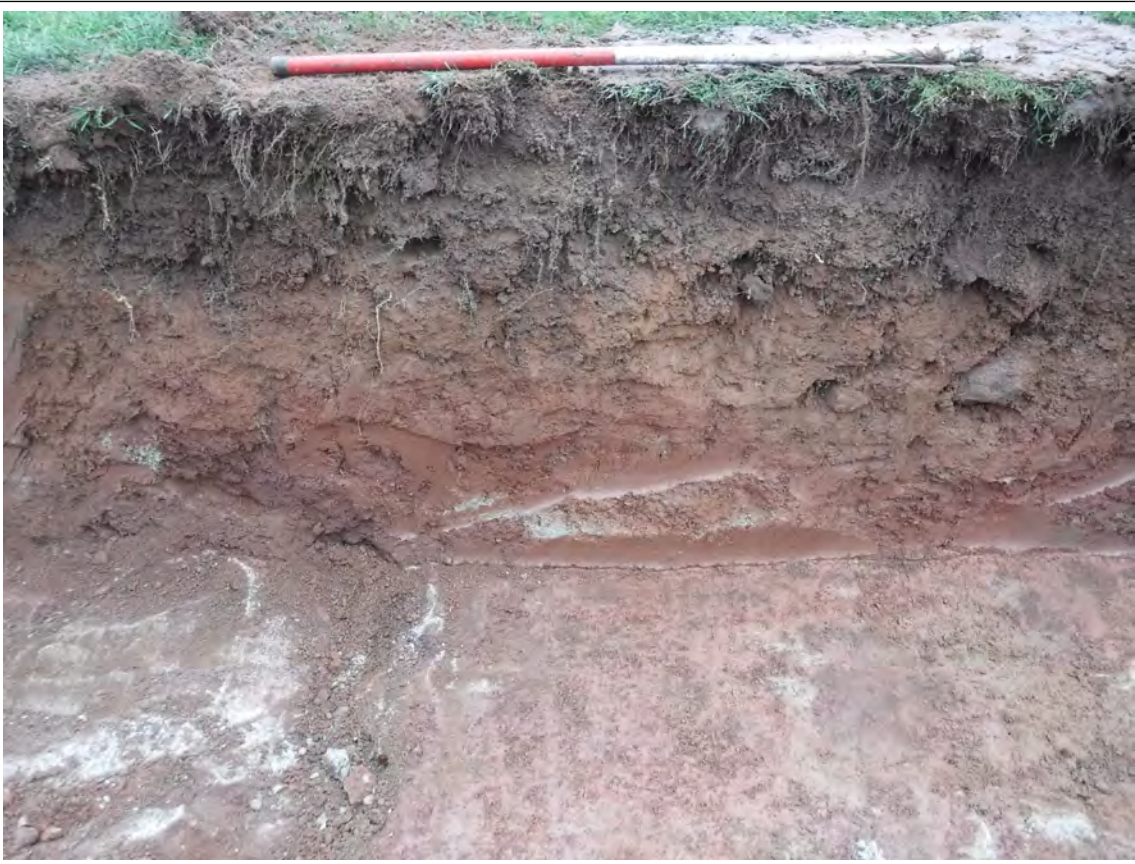
Plate 36. South facing section in Trench 17. Scale 1m

clay with patches of grey clay also present. This substrate (17004) was also present at a depth of 1.07m. Above the substrate (17004) was a layer of mid-brown-orange clay silt, with lenses of darker brown material scattered throughout (17003). This layer (17003) was present at 1.07m. Overlaying this layer (17003) was the subsoil (17002), comprised of mid-orange-brown silt with numerous stone inclusions at a depth of 0.57m. The topsoil (17001) was comprised of a mid-red-brown silt found at a depth of 0.28m. No finds were present in this trench.

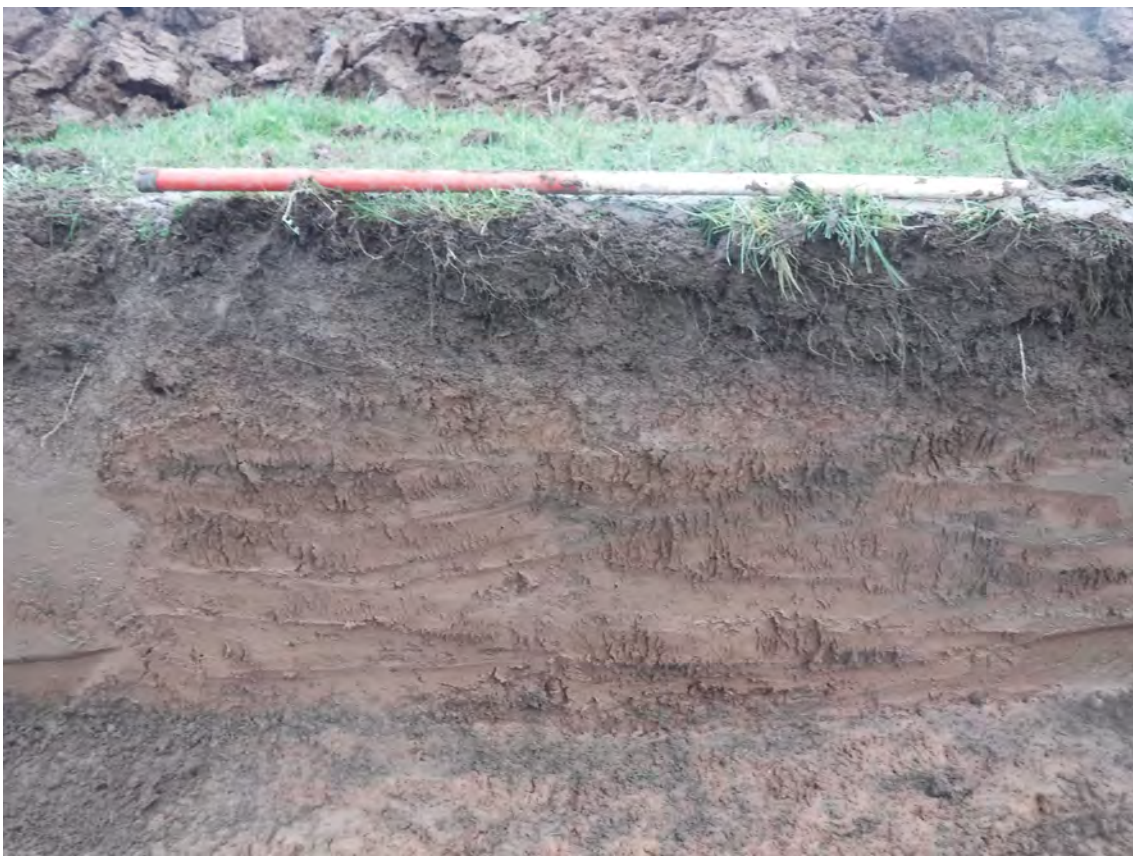
Plate 38. West facing section in Trench 18. Scale 1m

The lowest stratigraphic layer of Trench 18 was the natural substrate that comprised of a mid-orange-red clay with black deposits (18003) at a depth of 0.7m. Overlying (18003) was the subsoil (18002), a mid-orange-brown clayey silt present at 0.3m. In this layer (18002) a spread of charcoal and pot appeared around 7 meters from the eastern end of the trench. It was also in this layer (18002) that finds of pot sherds, glass, charcoal and clay pipes were found. Above this layer (18002) was the topsoil (18001), a mid-orange-brown loam, at 0.18m deep.

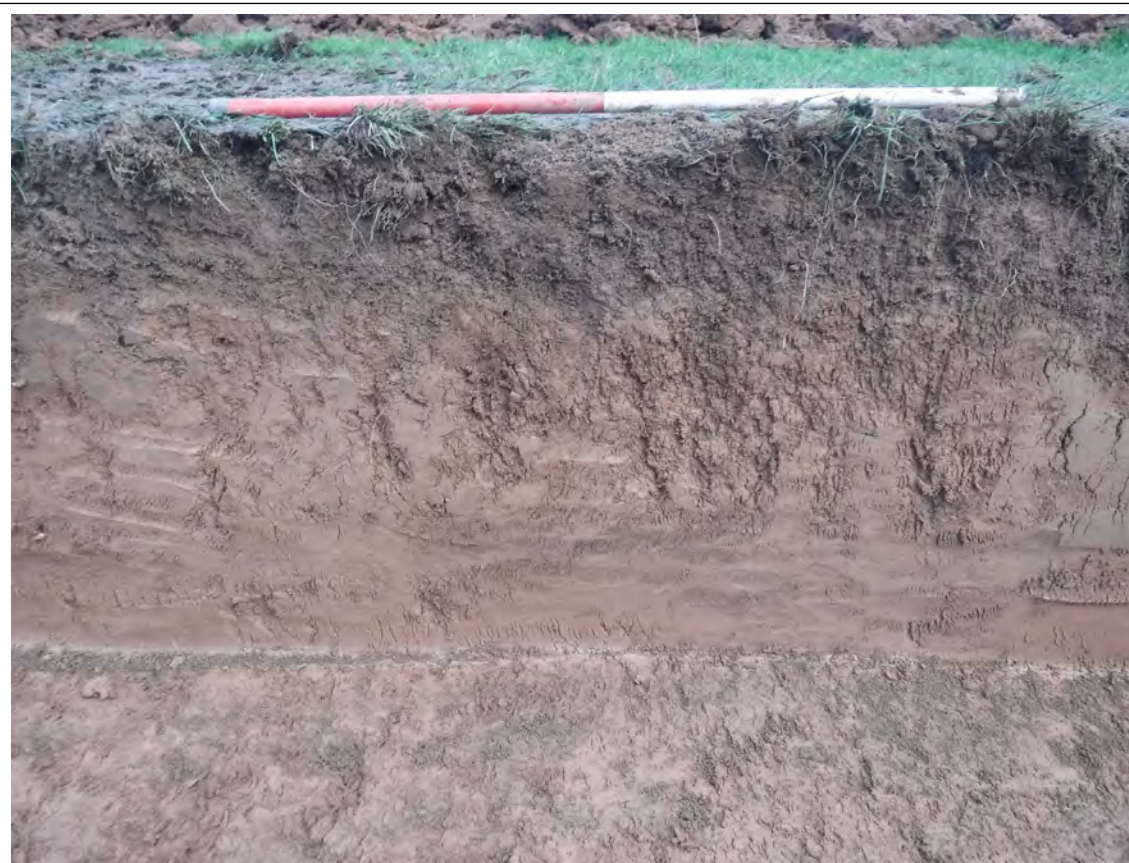
Plate 40. South facing section in Trench 19. Scale 1m

The lowest stratigraphic layer of Trench 19 was the natural substrate comprised of a mid-orange-pink clay (19004) at 0.76m deep. Above the substrate (19004) was a layer of mid-red-orange silty clay (19003), present at 0.57m. Above this layer (19003) was the subsoil (19002), a mid-orange brown clay silt found at 0.3m. (19002) contained finds of CBM, pottery, glass, charcoal, and clay pipes. The topsoil (19001) was located above (19002) and comprised of a mid-orange-brown loam present at depth of 0.1m.

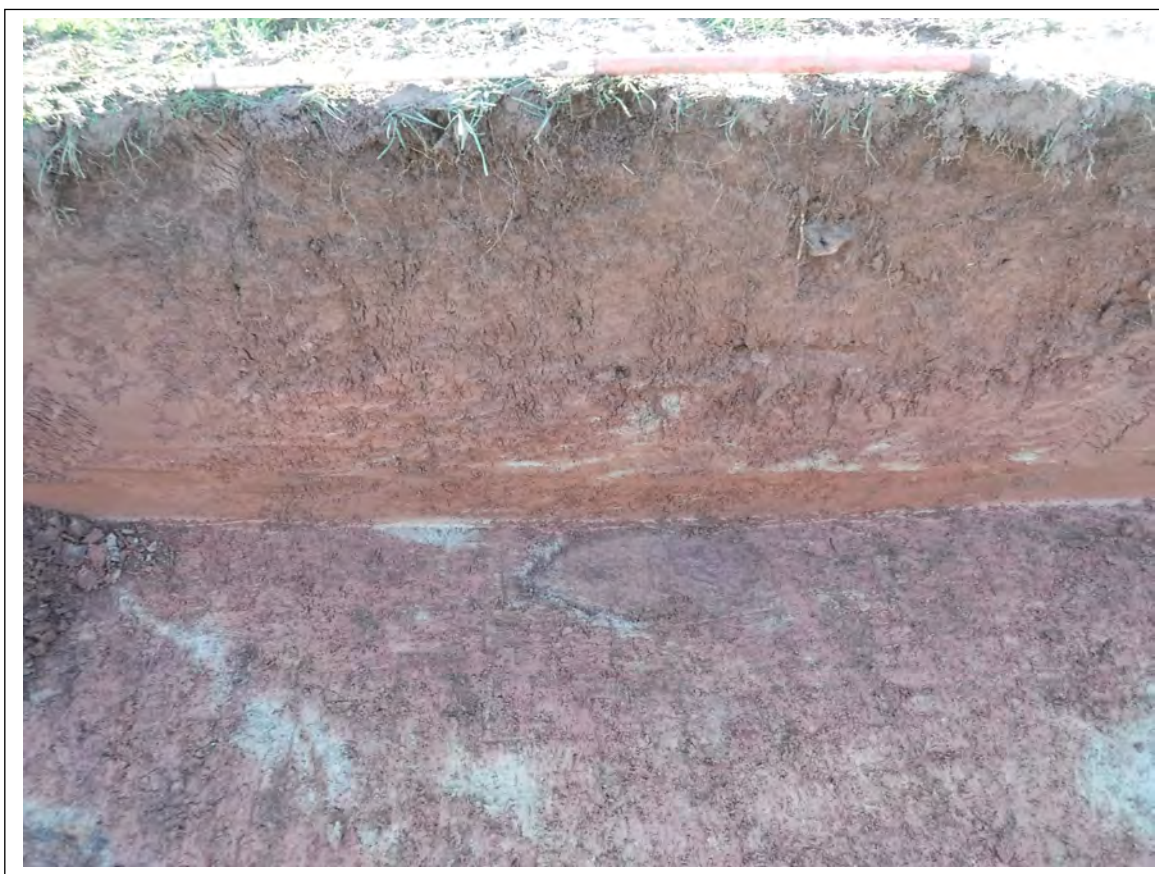
Plate 42. West facing section in Trench 20. Scale 1m

in this layer that finds of pottery sherds, glass, and charcoal were found. (20002) was overlaid by the topsoil (20001) which was a mid-orange-brown loam at a depth of 0.1m.
