**Worsley New Hall**

**Archaeological Excavation of  
Worsley New Hall, Salford,  
Greater Manchester**

**Document Title:** Archaeological Excavation of Worsley New Hall, Salford, Greater Manchester

**Document Type:** Excavation Report

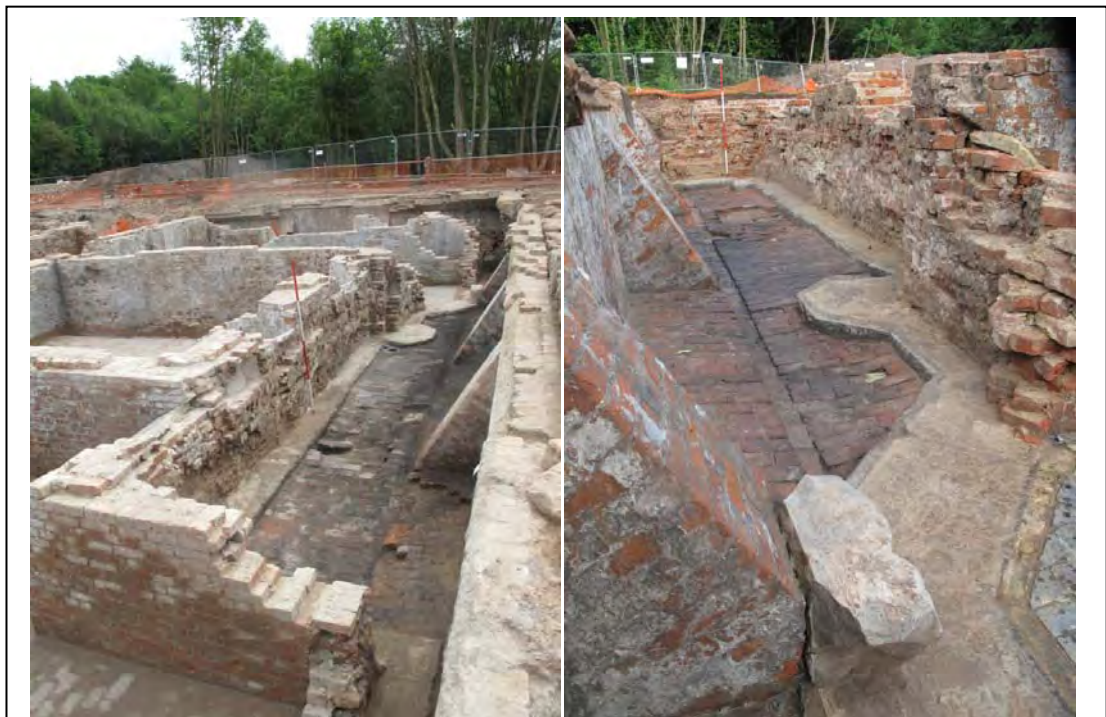
**Figure 3:** Aerial view of the east/west wing of Corridor 5. looking east.

The southern and eastern walls of the Corridor formed part of a retaining wall (**140**), which surrounded the entire footprint of the Halls eastern wing. The wall was constructed from handmade red bricks laid in English Garden Wall bond, which had been whitewashed. The wall survived to a height of seventeen courses (c1.30m), and at its summit were the remains of a brick vaulted roof which was two courses (c0.24m) in thickness. At the top of (140), directly outside Room B8, the end of a cast iron pipe, 0.15m in diameter was identified. Abutting the southern wall of (140) were a series of six, triangular brick buttresses (**143**) which measured 0.65m x 0.46m at their base and stood the full height of the wall. The buttresses stood c3.35m apart and the most westerly of the buttresses, outside Room B6 had been truncated during machine excavation. Similarly abutting the eastern wall of (140) were an additional four buttresses, the most southerly of which abutted the eastern buttress of the southern wall. The most northerly two of which outside Room B9 had been truncated during machine excavation.

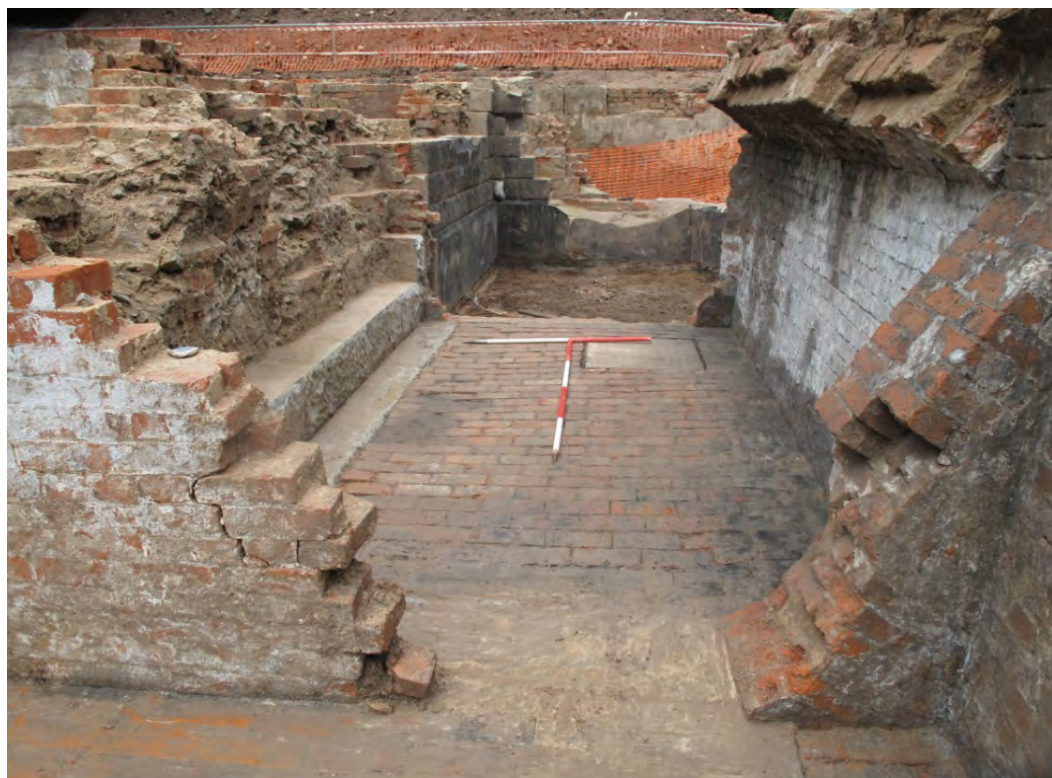
*Figure 9: View of north/south wing of Corridor 5, looking north.*

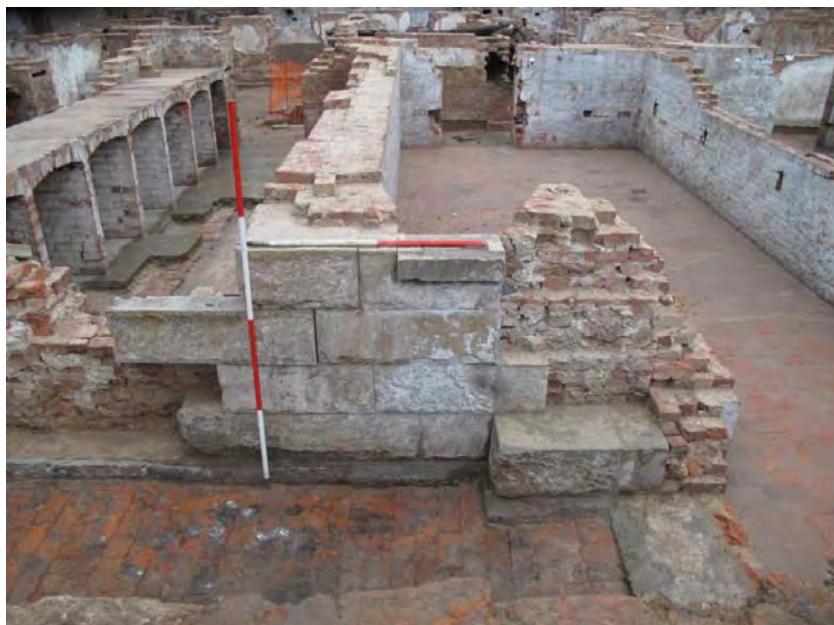
**Figure 10:** Detail of ashlar facing stones (144) on northern wall (004) of Corridor 6, looking north

As described in Corridor 5, the southern wall of Corridor 6 formed part of a retaining wall (140), which surrounded the entire footprint of the Halls eastern wing. The wall was constructed from handmade red bricks laid in English Garden Wall bond, which had been whitewashed. The wall survived to a height of seventeen courses ( $c1.30\text{m}$ ), and at its summit were the remains of a brick vaulted roof which was two courses ( $c0.24\text{m}$ ) in thickness. Abutting the wall a series of four, triangular brick buttresses (14) were exposed, which measured  $0.65\text{m} \times 0.46\text{m}$  at their base and stood the full height of the wall. The buttresses stood  $c3.35\text{m}$  apart and the most easterly of the buttresses, outside Room B5 had been truncated during machine excavation.

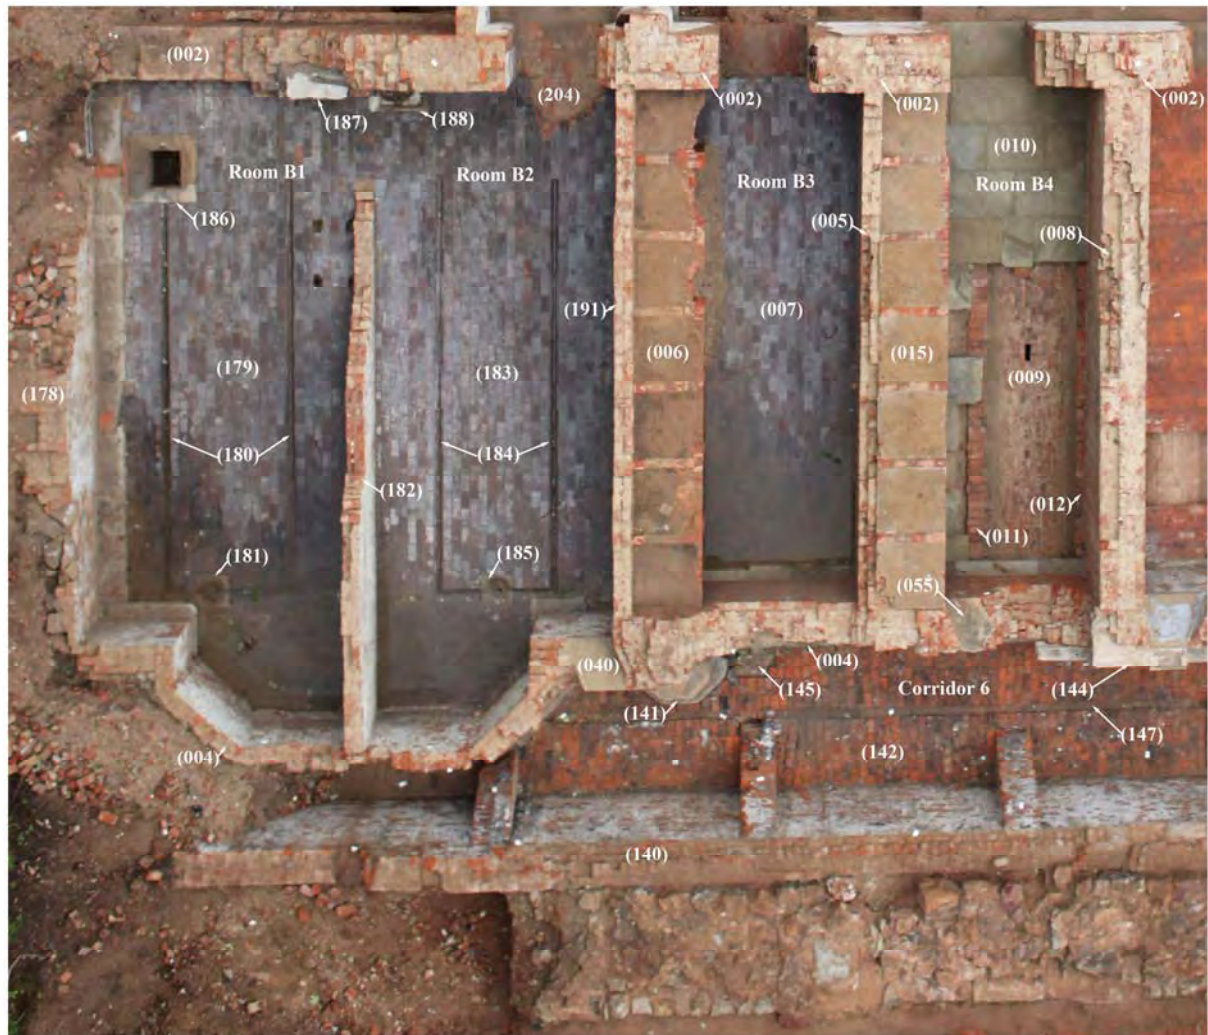
**Figure 12:** Aerial view and location of Rooms B1, B2, B3, B4 and Corridor 6 with significant contexts marked.

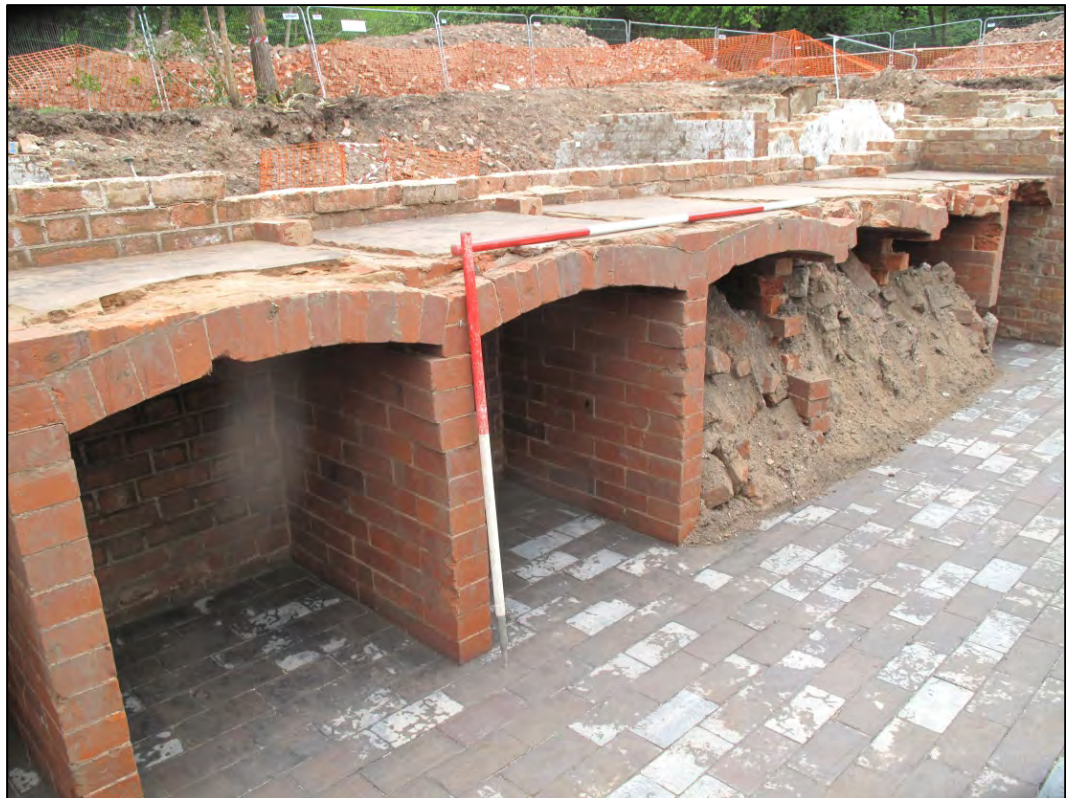
*Figure 13: Storage bays (006) within Room 3, looking northwest.*

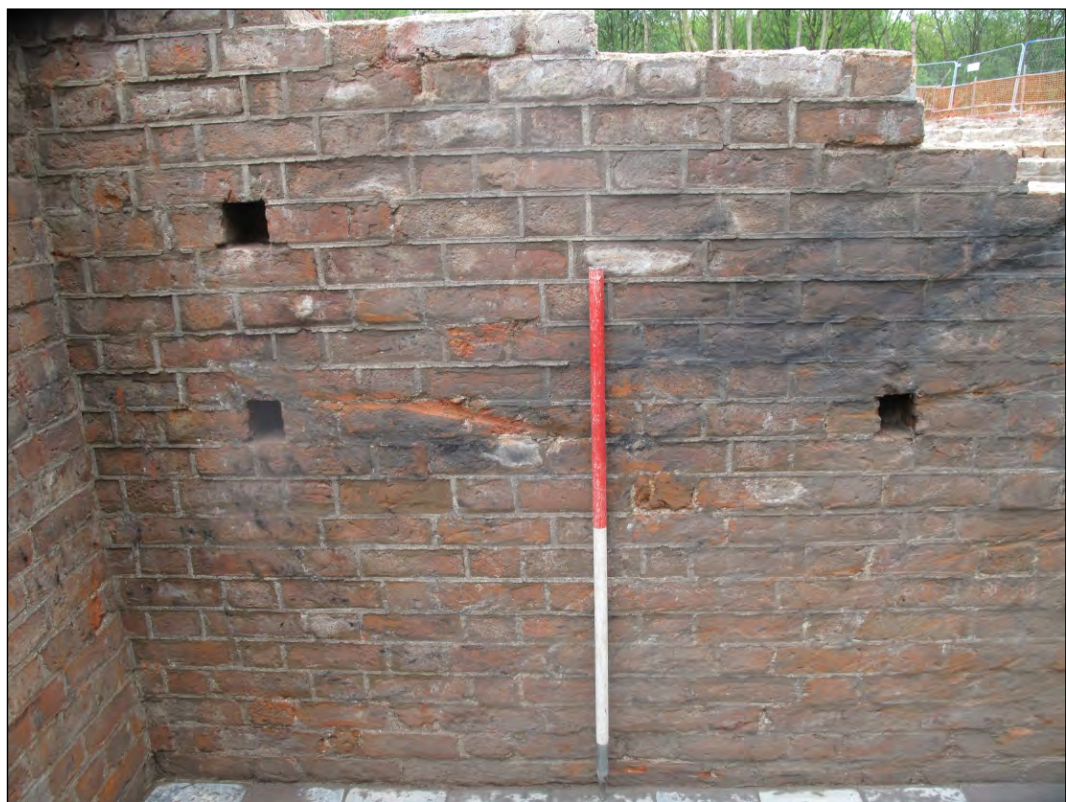
*Figure 14: Voids within the eastern wall (005) within Room 3, looking east.*

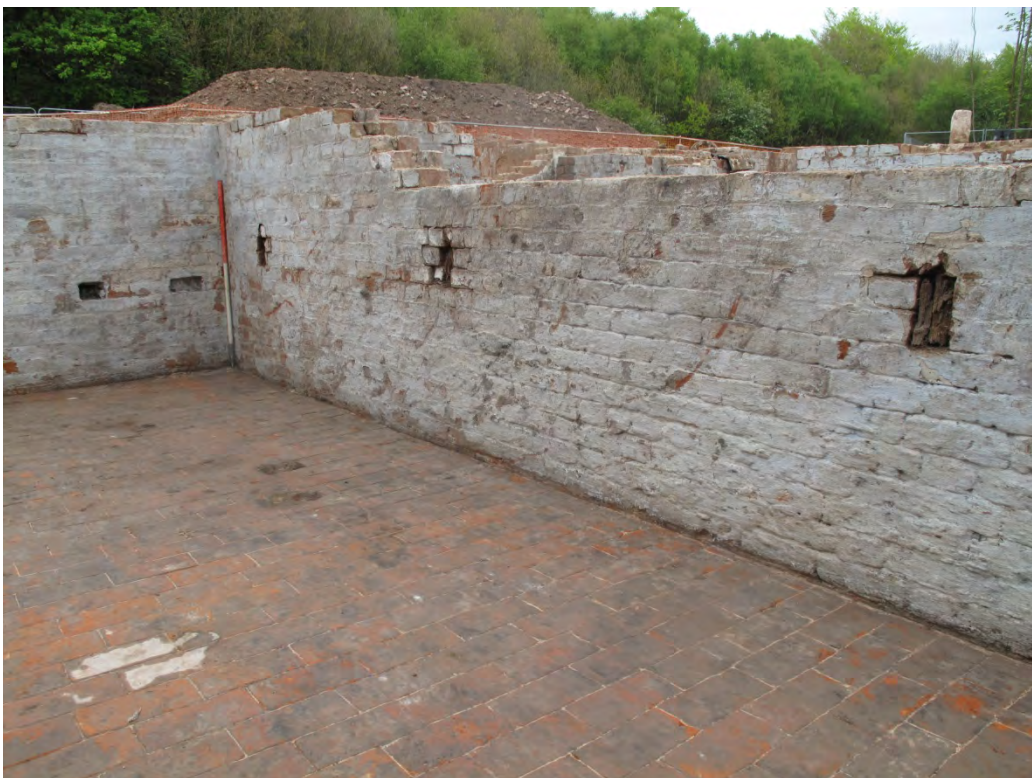
*Figure 22: The remains of three voids containing timber remains within the eastern wall (070) within Room B5.*

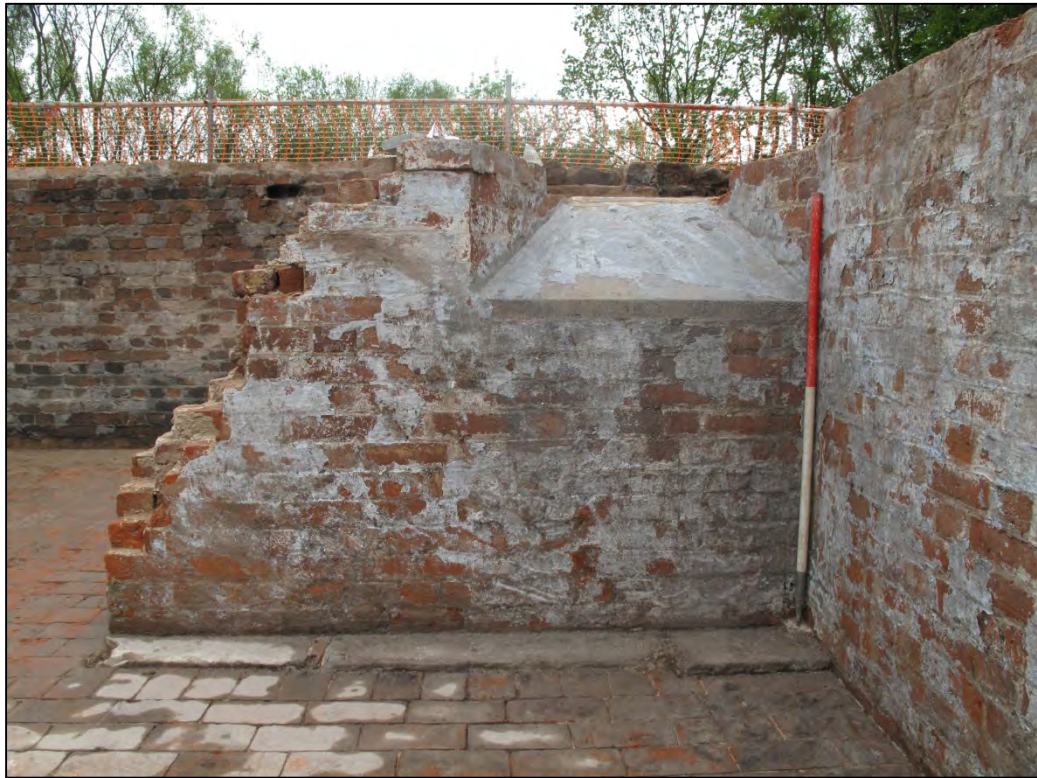
*Figure 23: Detail of tapered sandstone window sill in southern wall (004) of Room B5, looking south.*

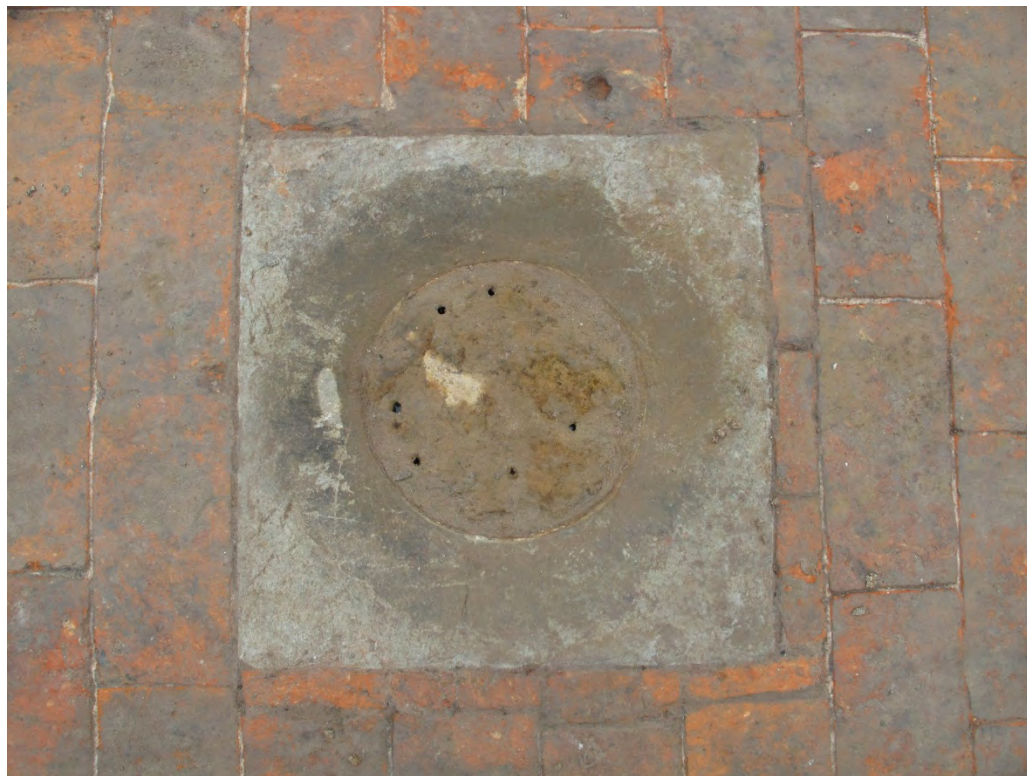
*Figure 24: Detail of floor drain (072) in floor of Room B5 looking north.*

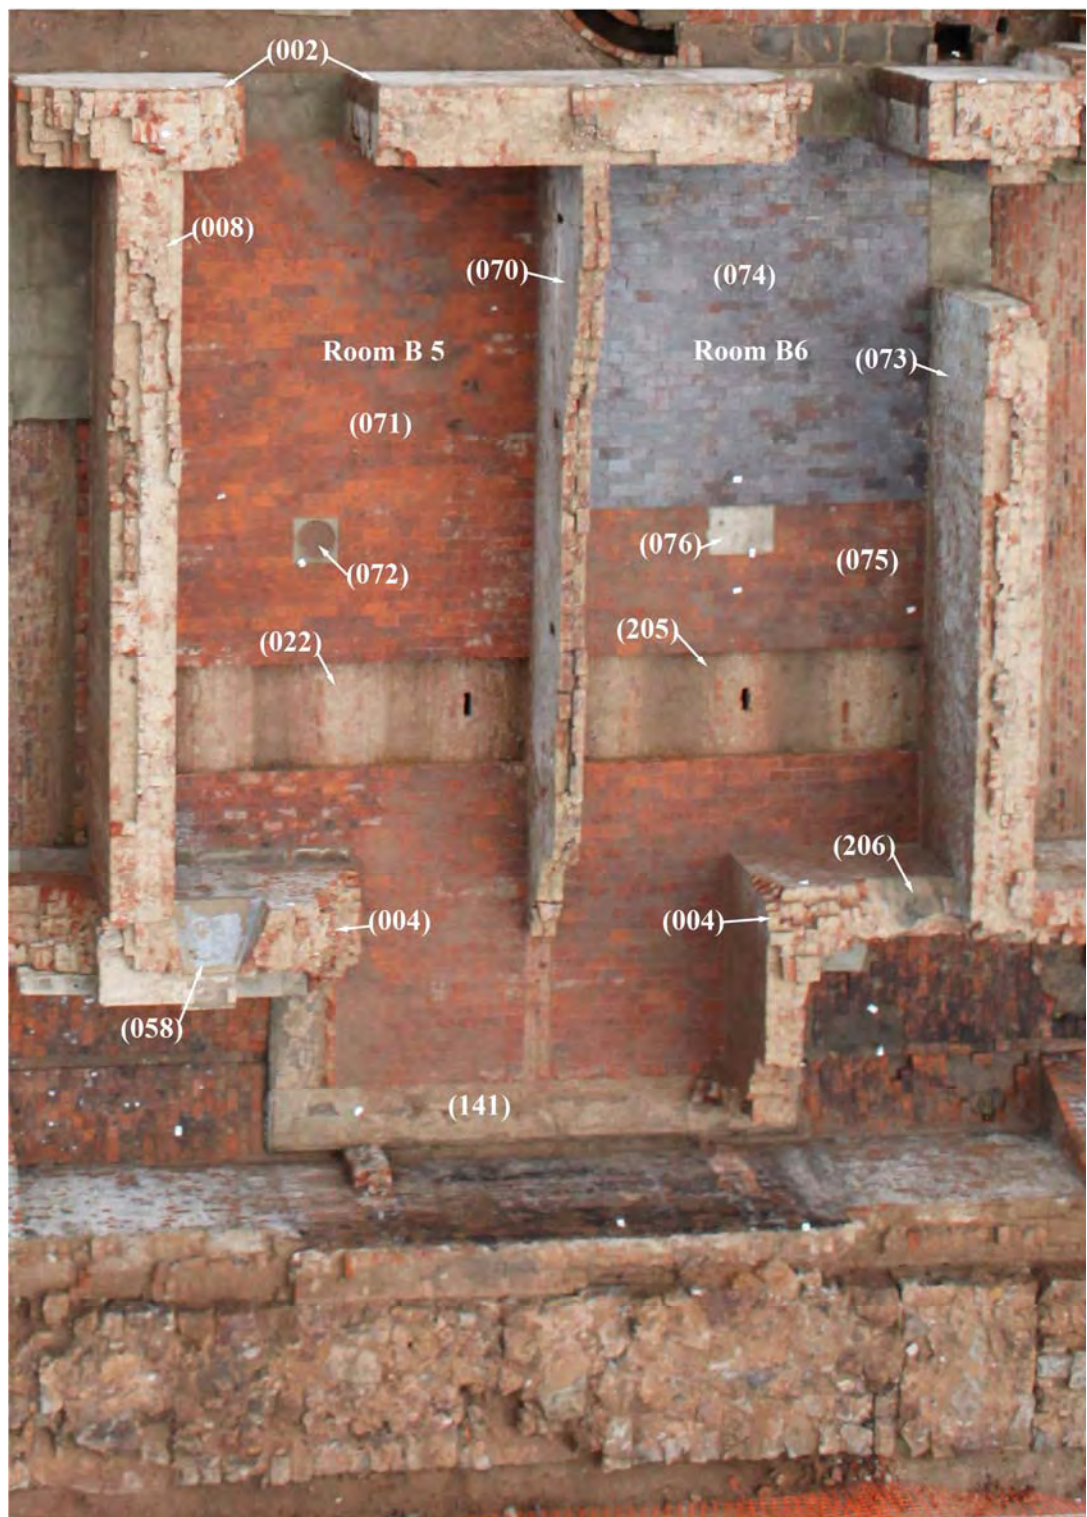
**Figure 28:** Aerial view of Rooms 5 and 6 with significant contexts marked.

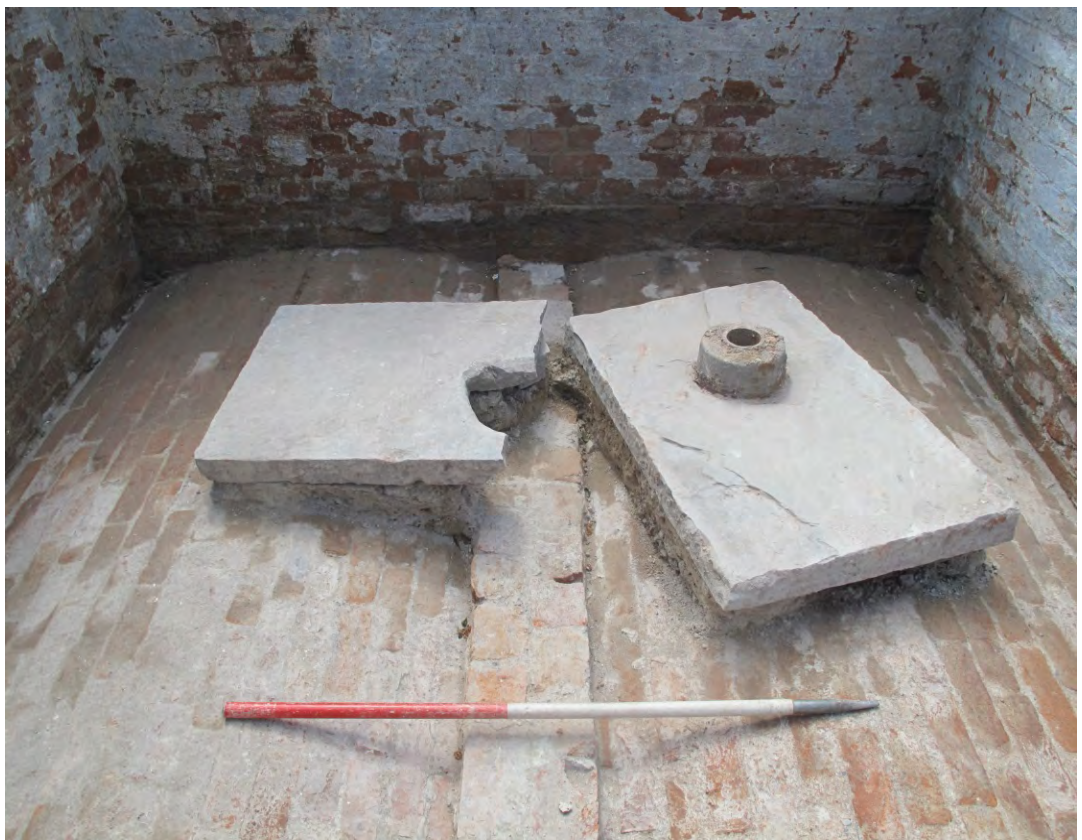
*Figure 35: Detail of stone flags (083) on floor of B7b, looking south.*

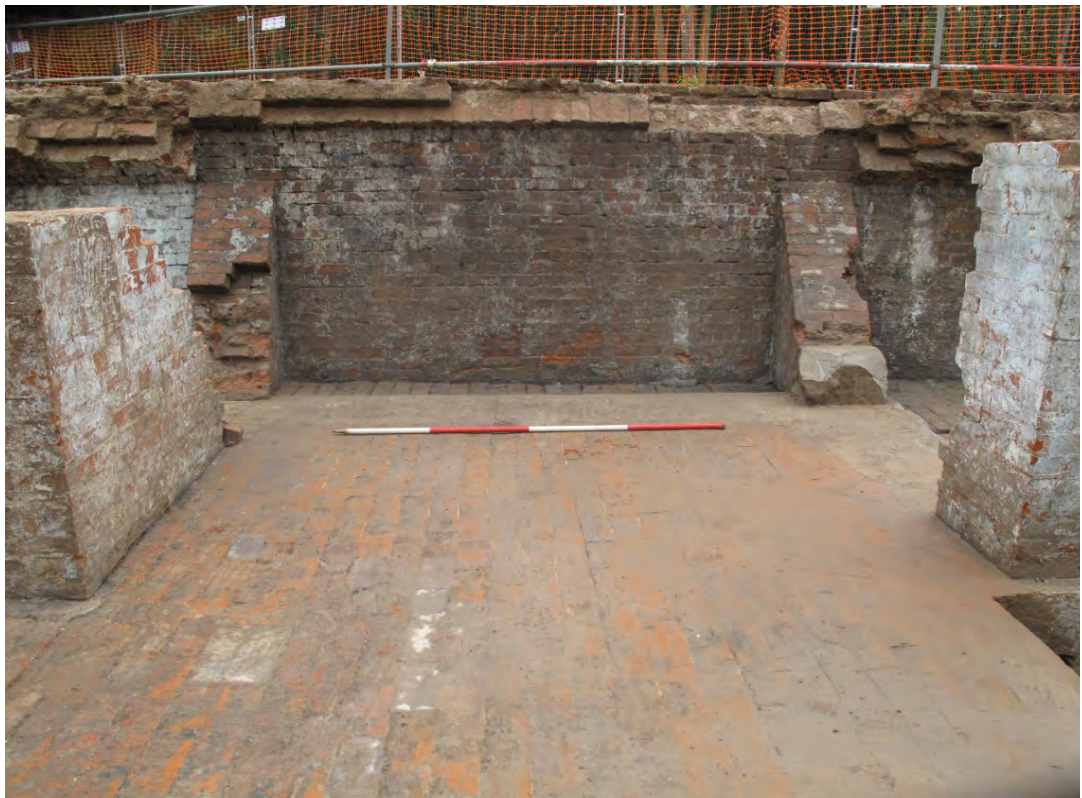
*Figure 40: Detail of western projection in B9, looking east.*

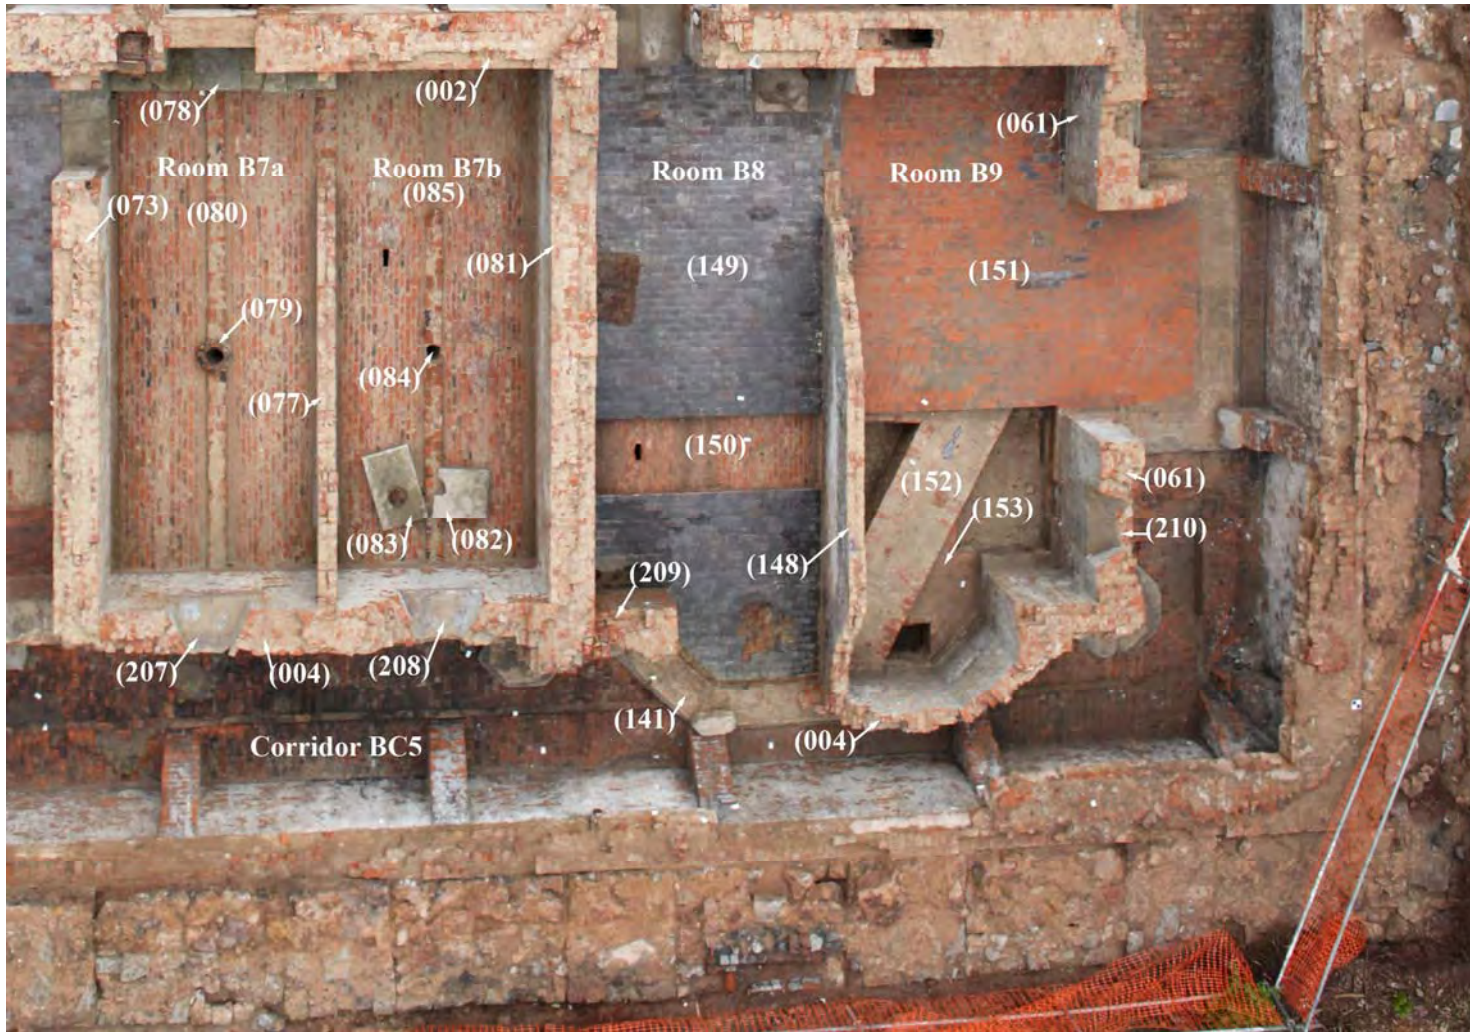
**Figure 42:** Aerial view of Rooms B7a, B7b B8 and B9 with significant contexts marked.

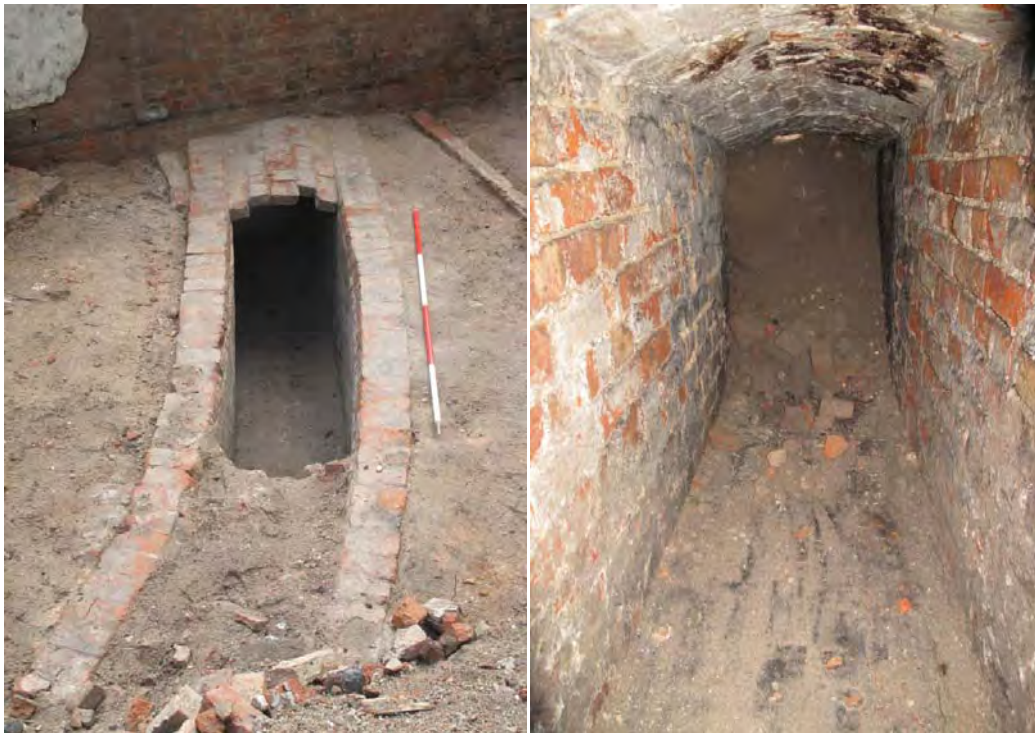
**Figure 44:** Detail of brick tunnel (166) in B10, looking east.

The internal area of the room was dominated by a sunken handmade brick tunnel (166) with a vaulted top at floor level. This feature was identified running in a broad curve from west to east and continued beyond wall **(160)**. The tunnel was constructed of handmade bricks measuring 0.23m x 0.11m laid in English bond with a black brick floor surface lying 1.00m below the floor. The north eastern corner of the room contained a cast iron fireplace **(163)** with evidence of whitewashed wall plaster to either side of it. The feature comprised a handmade brick hearth at floor level, a cast iron grate and surround and a marble mantelpiece. Black mortar could be seen next to the surround, however the tiles/stonework that this deposit was designed to hold were not present. White glazed bricks were found behind the fireplace which continued upwards to line the chimney. The chamfered white marble mantelpiece measuring c.1.50m was broken at the northern end but well preserved along the visible remains. The feature stood at a height of 1.50m from the excavated surface.

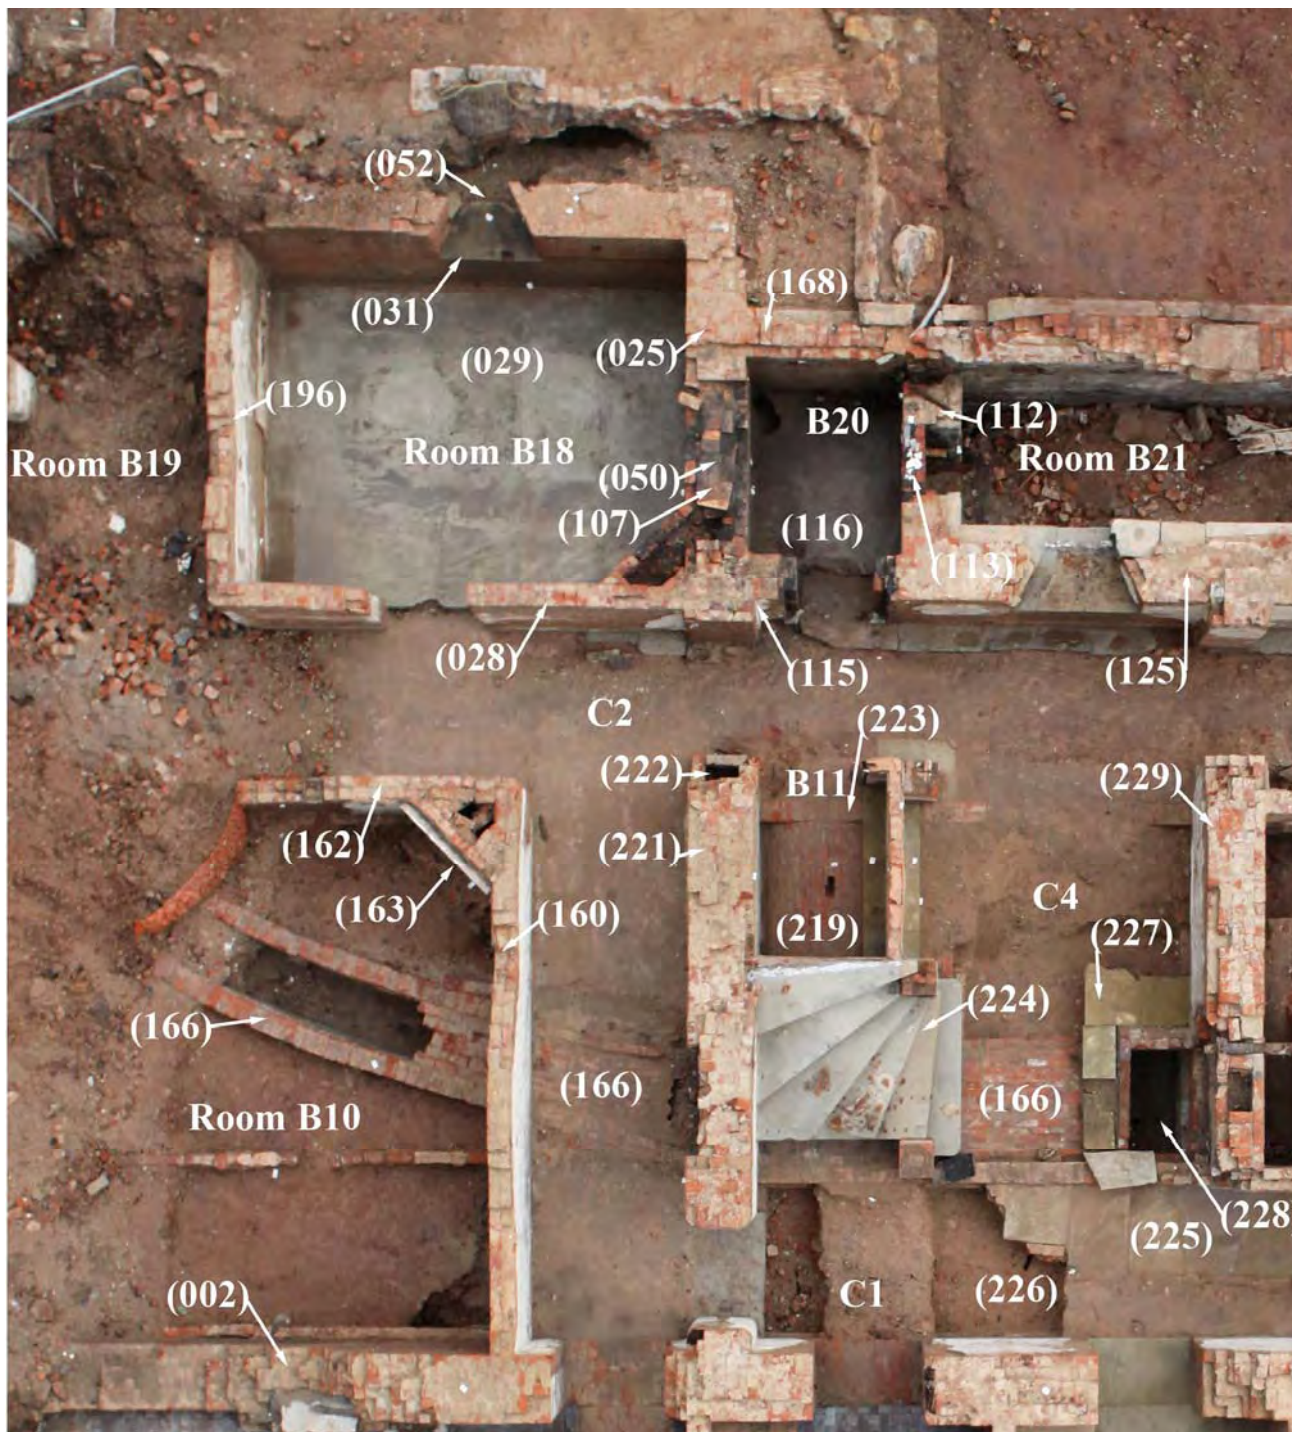
**Figure 49:** Aerial view and significant contexts for Rooms B10, B11, B18, B20 and Corridors C1, C2 and C4.

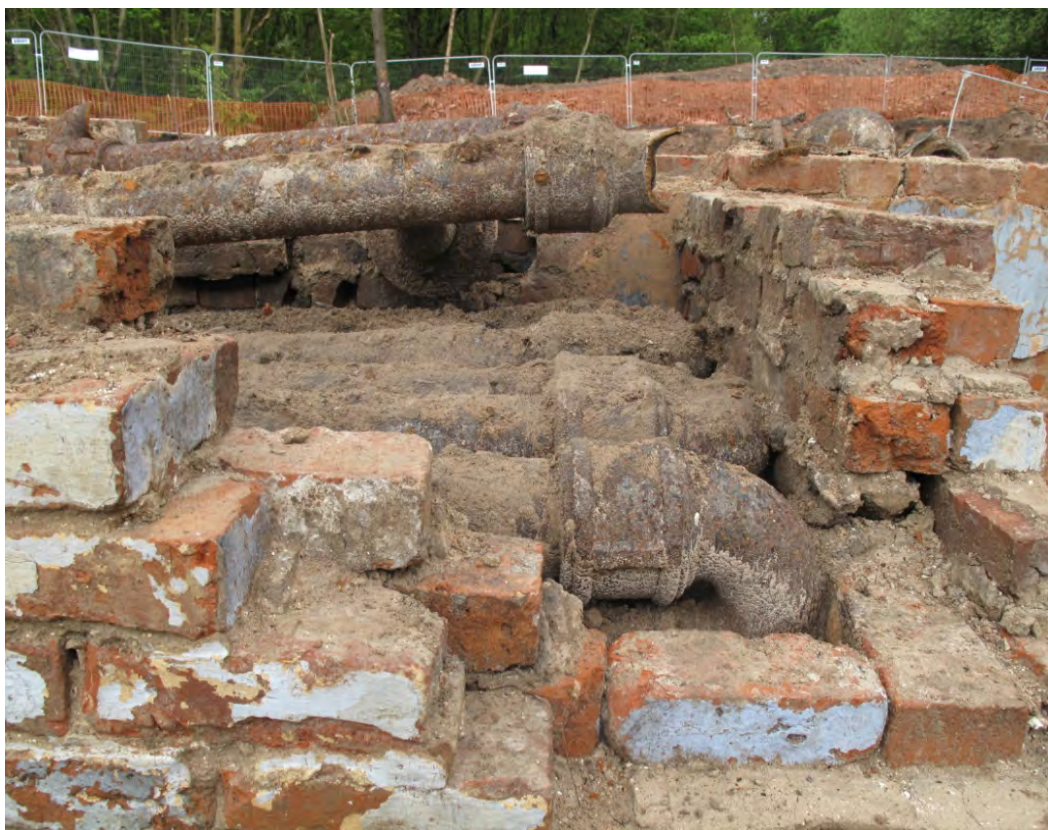
**Figure 50:** Cast iron pipes within the heat exchanger (231) in Room B12.

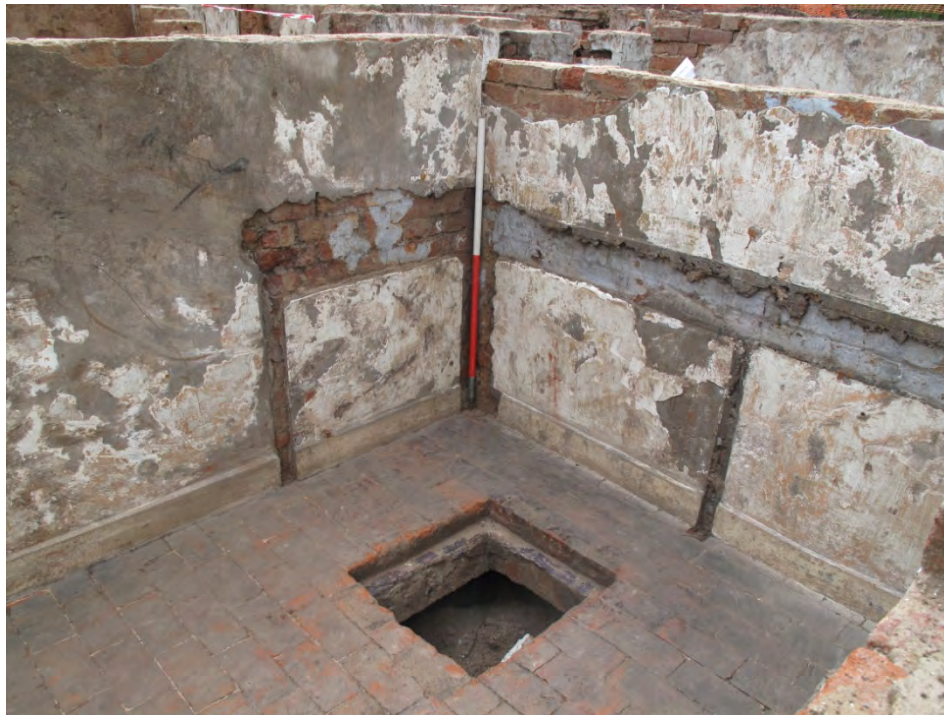
*Figure 52: north-west quadrant of Room B12, sub-basement access hatch (252)*

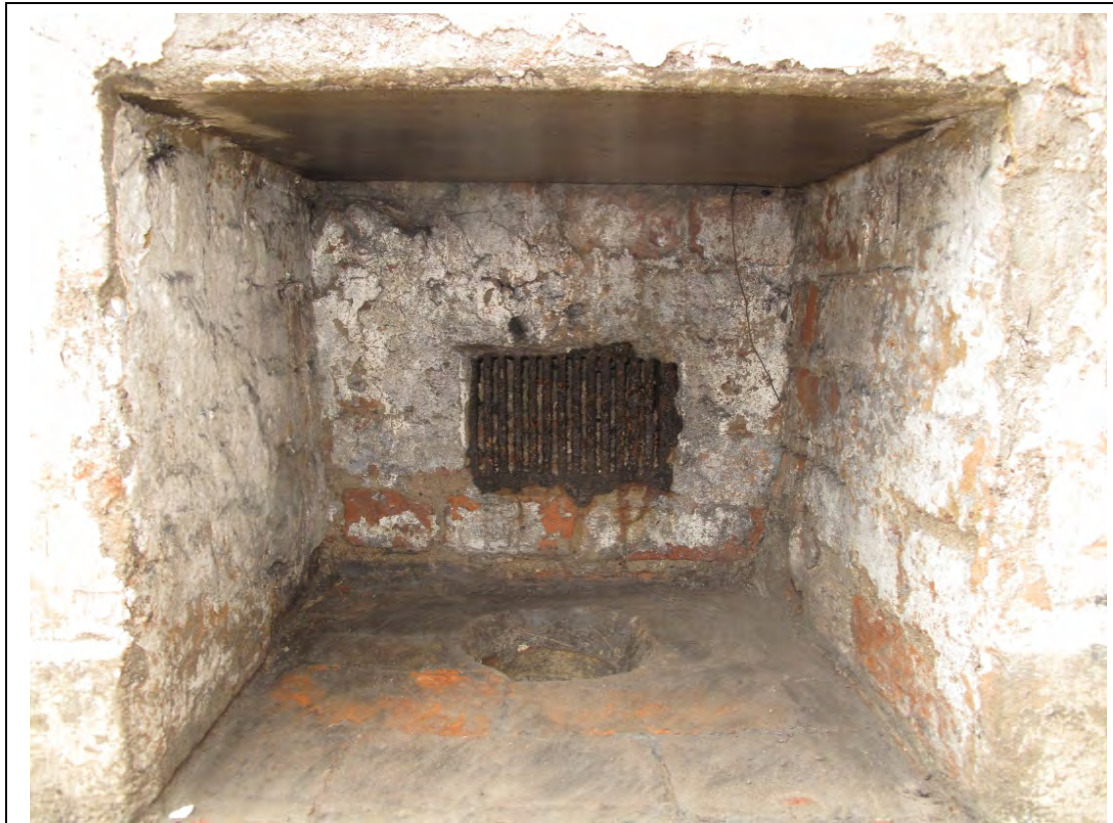
*Figure 53: Access point to heat exchanger (253) within Room B12.*

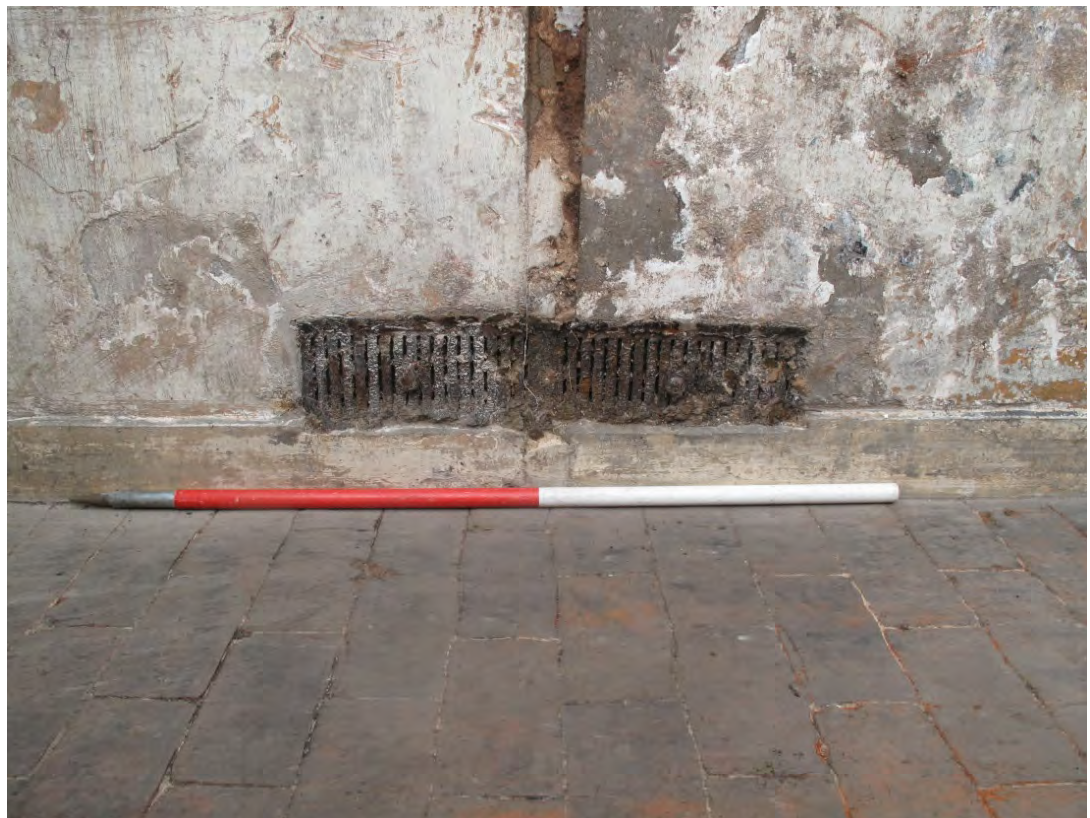
*Figure 54: Cast iron ventilation plates leading to the heat exchanger (253) within Room B12.*

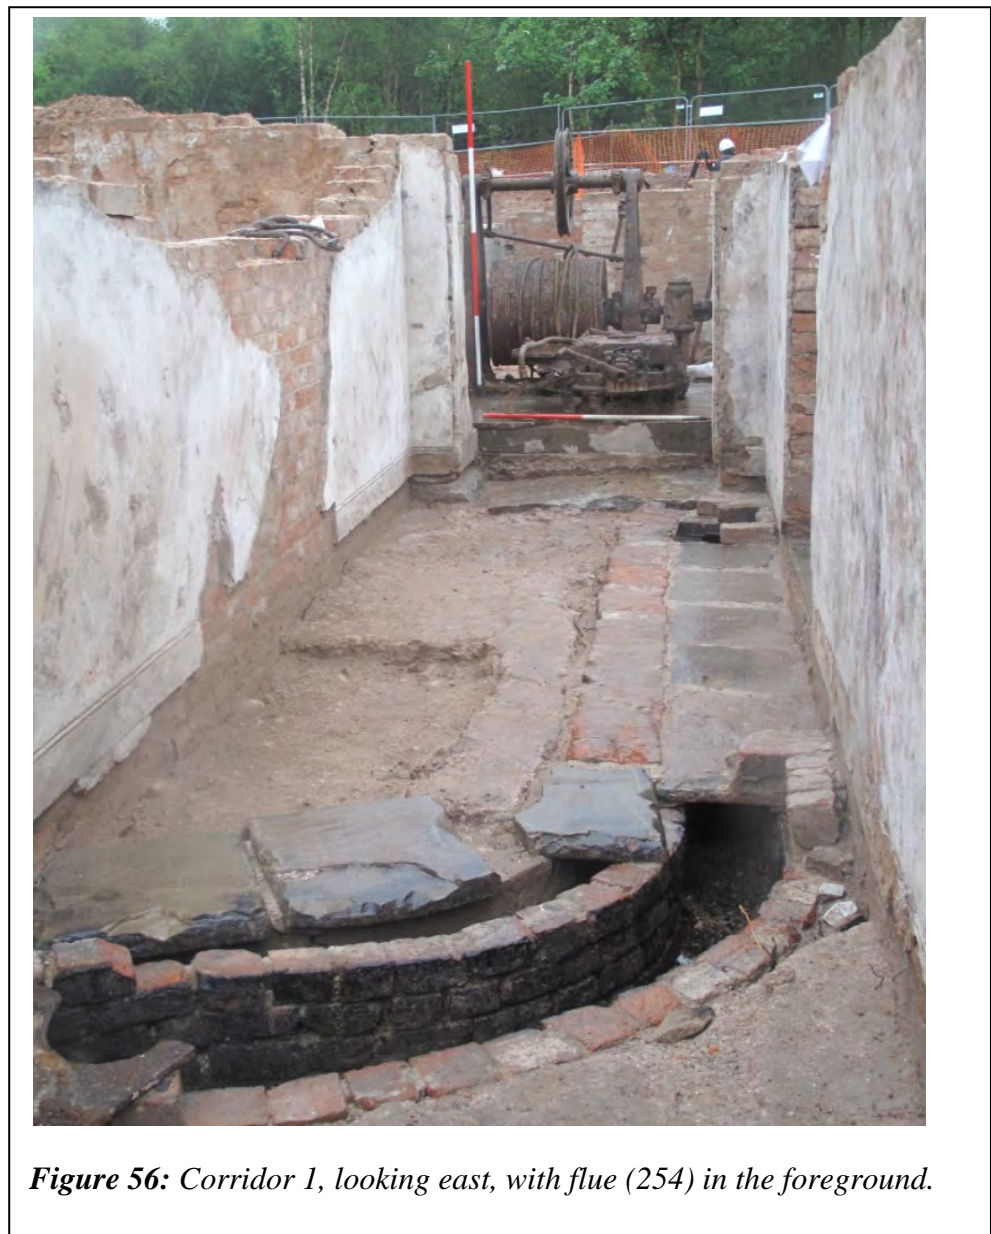
**Figure 56:** Corridor 1, looking east, with flue (254) in the foreground.

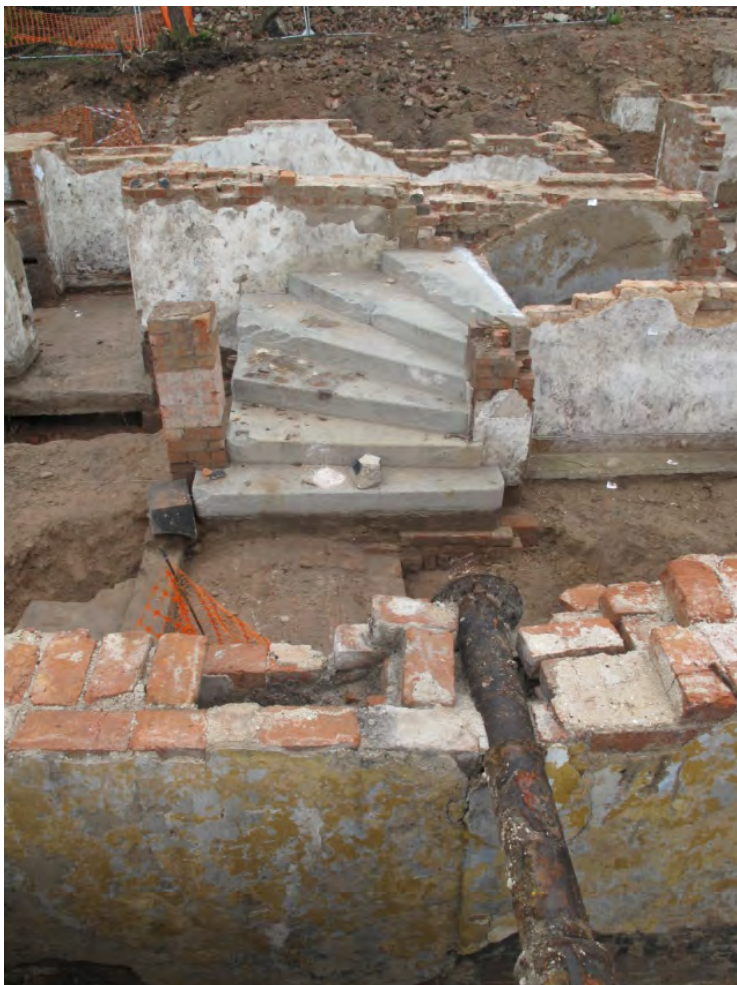
**Figure 60:** Corridor 4, with steps leading from the basement to the ground floor.

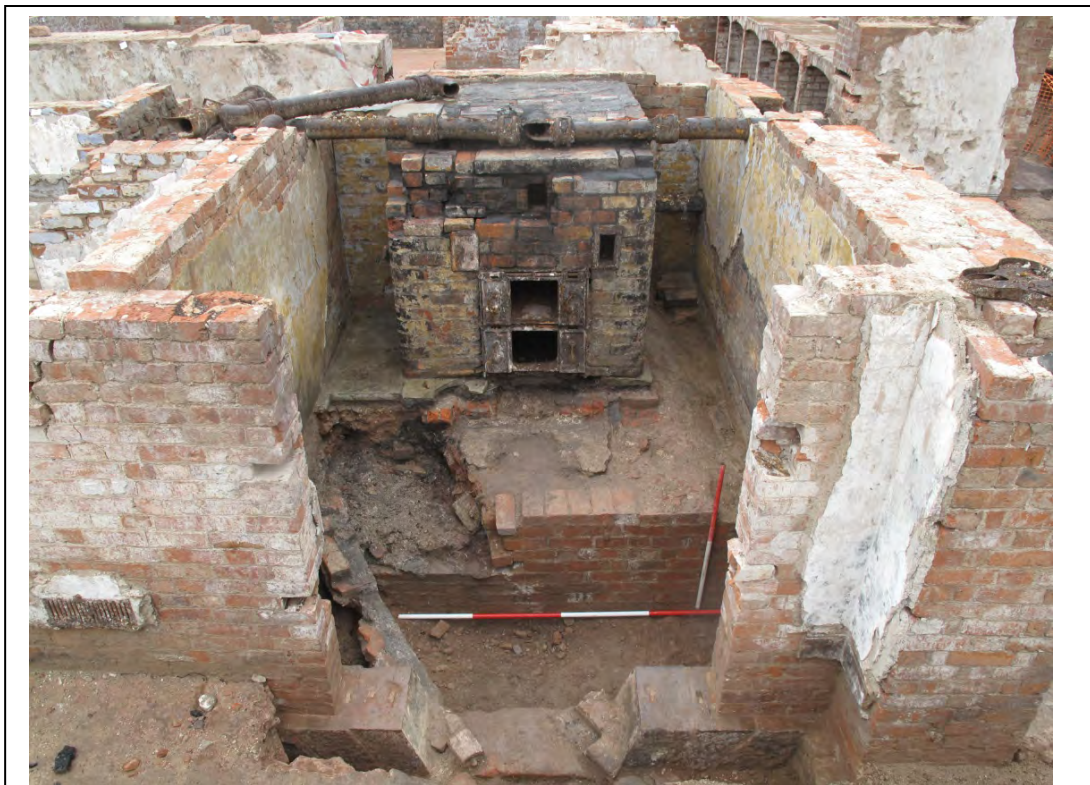
*Figure 61: Boiler (240) located within Room B14, looking south.*
