**Worsley New Hall**

**Archaeological Excavation of  
Worsley New Hall, Salford,  
Greater Manchester**

**Document Title:** Archaeological Excavation of Worsley New Hall, Salford, Greater Manchester

**Document Type:** Excavation Report

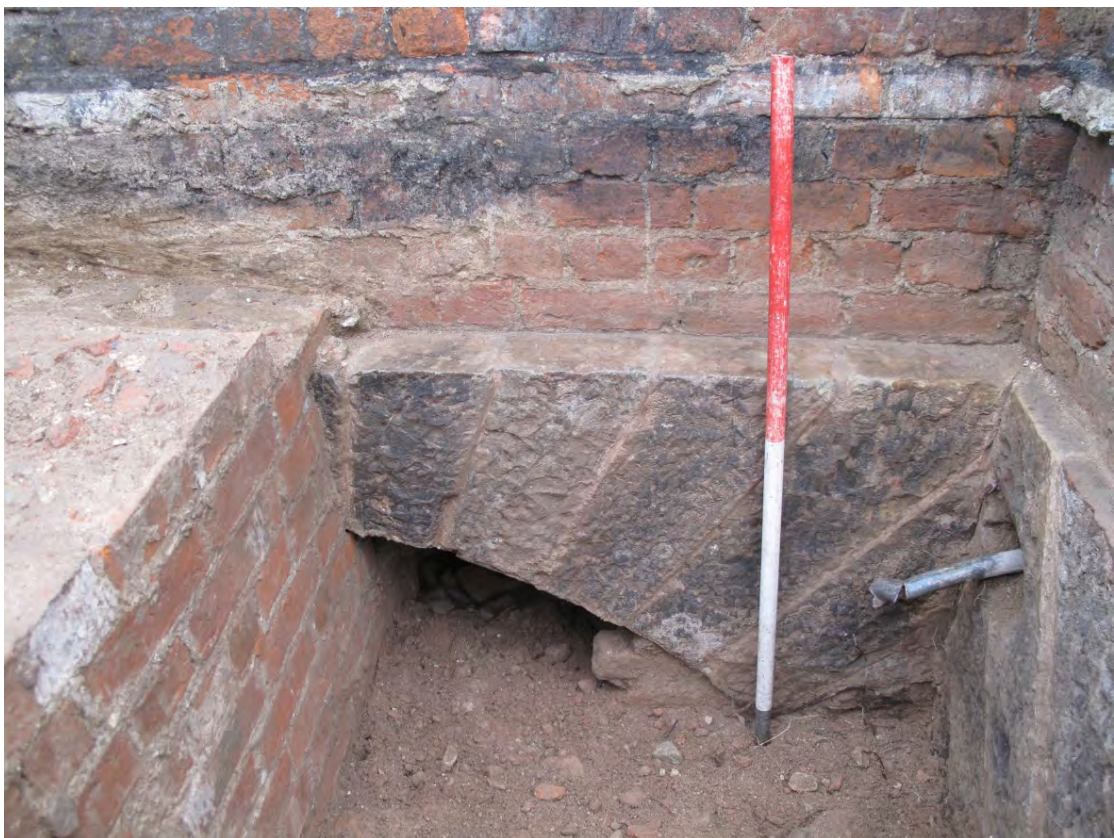
**Figure 64:** Ashlar stone archway (242 ) within the sub-basement beneath Room B14.

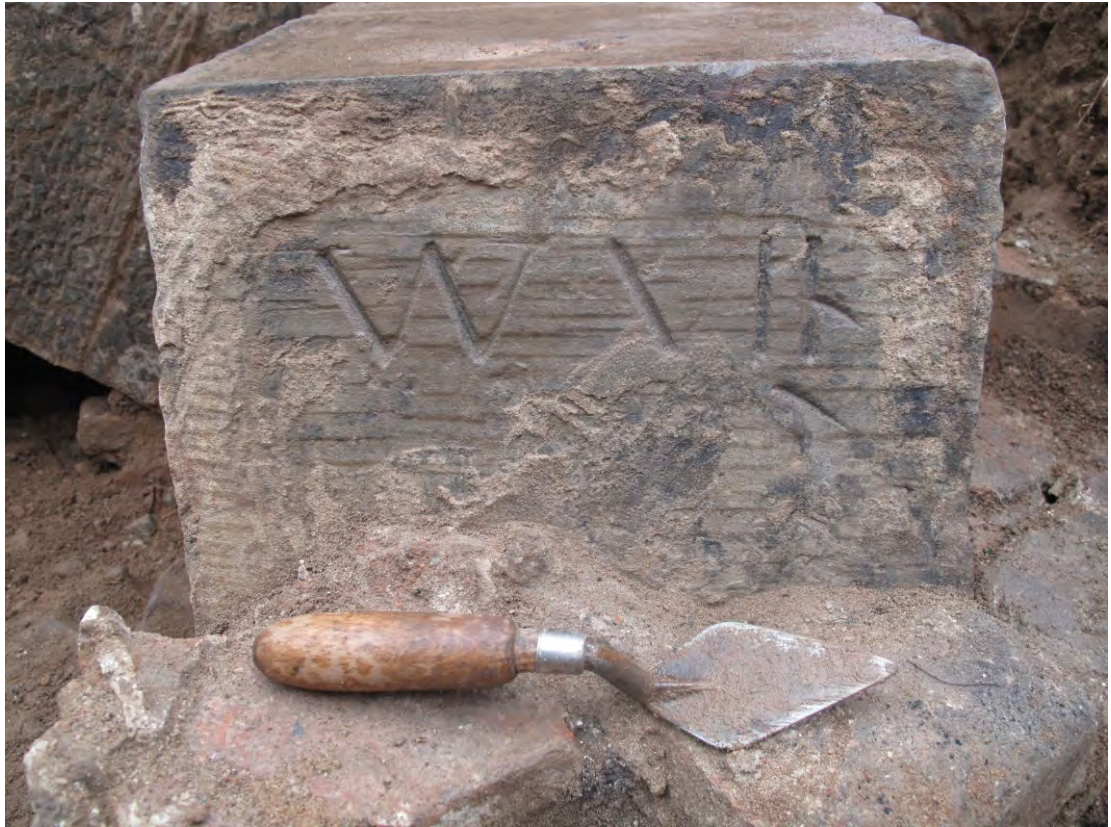
*Figure 65: Masons mark carved into end of ashlar block within wall (241), beneath Room B14.*

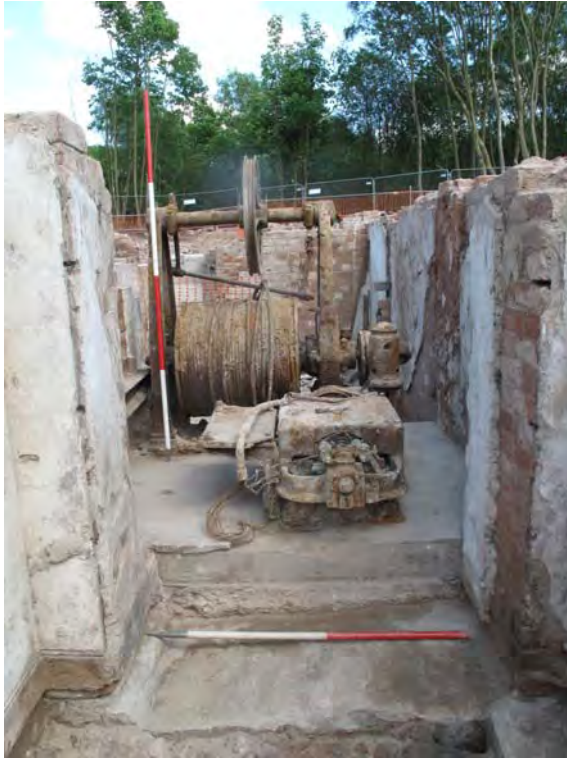
*Figure 66: Mechanical remains of lift within lift shaft, Room B15.*

Progressive clearance of the rubble within Room 15, revealed a motor room drive assembly, which apart from rusting was relatively undamaged. The assembly comprised:

- Direct current type with oil lubricated sleeve bearings.
- Rating plate info; Serial No 22219; Type 1.5; Volts 400; Amps 15; RPM 950.
- Dimensions ; Length 840mm; Height and Width 490mm.
- A heavy duty cranking handle was also found which fits the extended and squared non-drive end shaft.

- Single groove 6 spoke pulley wheel.
- It would appear the whole assembly is mounted on a single integrated bedplate.
- The floor of Room 15, adjacent to the drive equipment had been altered to form a well to accommodate the bottom of the passenger car.
- A shard of thick glass found within Room 14 was characteristic of a type used in early lead-acid storage batteries.

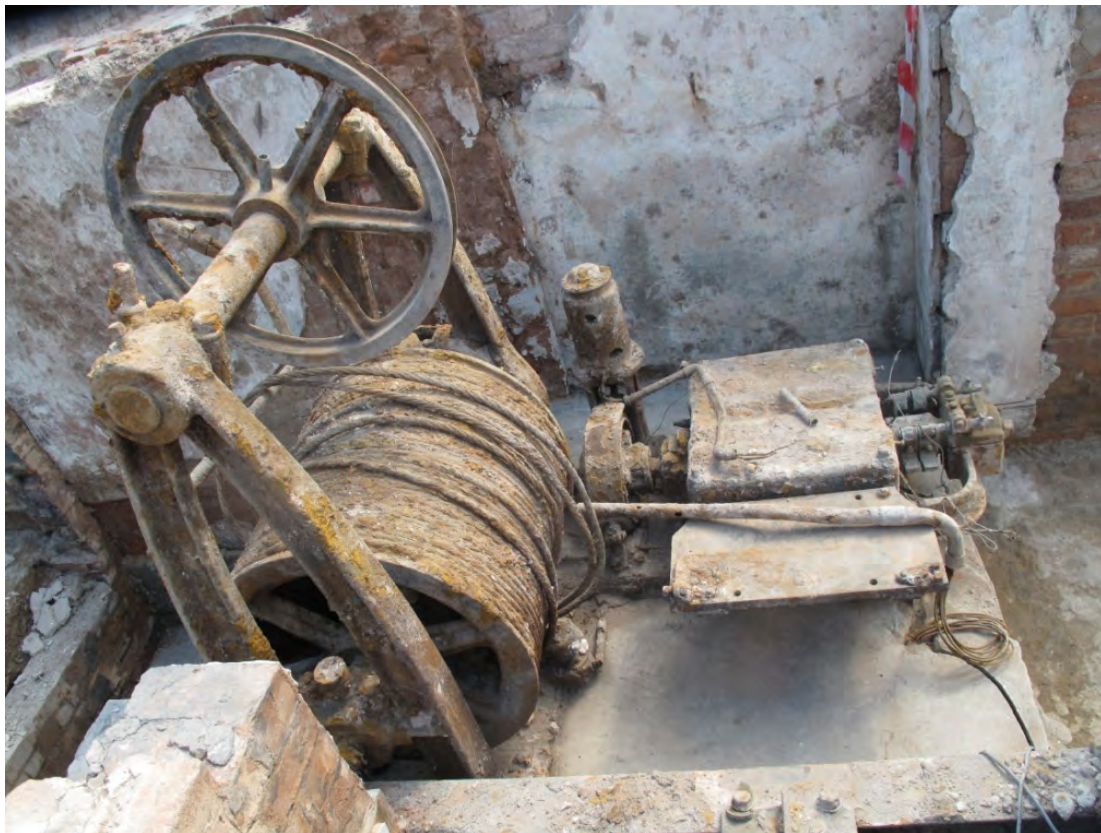
*Figure 67: Mechanical remains of lift within lift shaft, Room B15.*

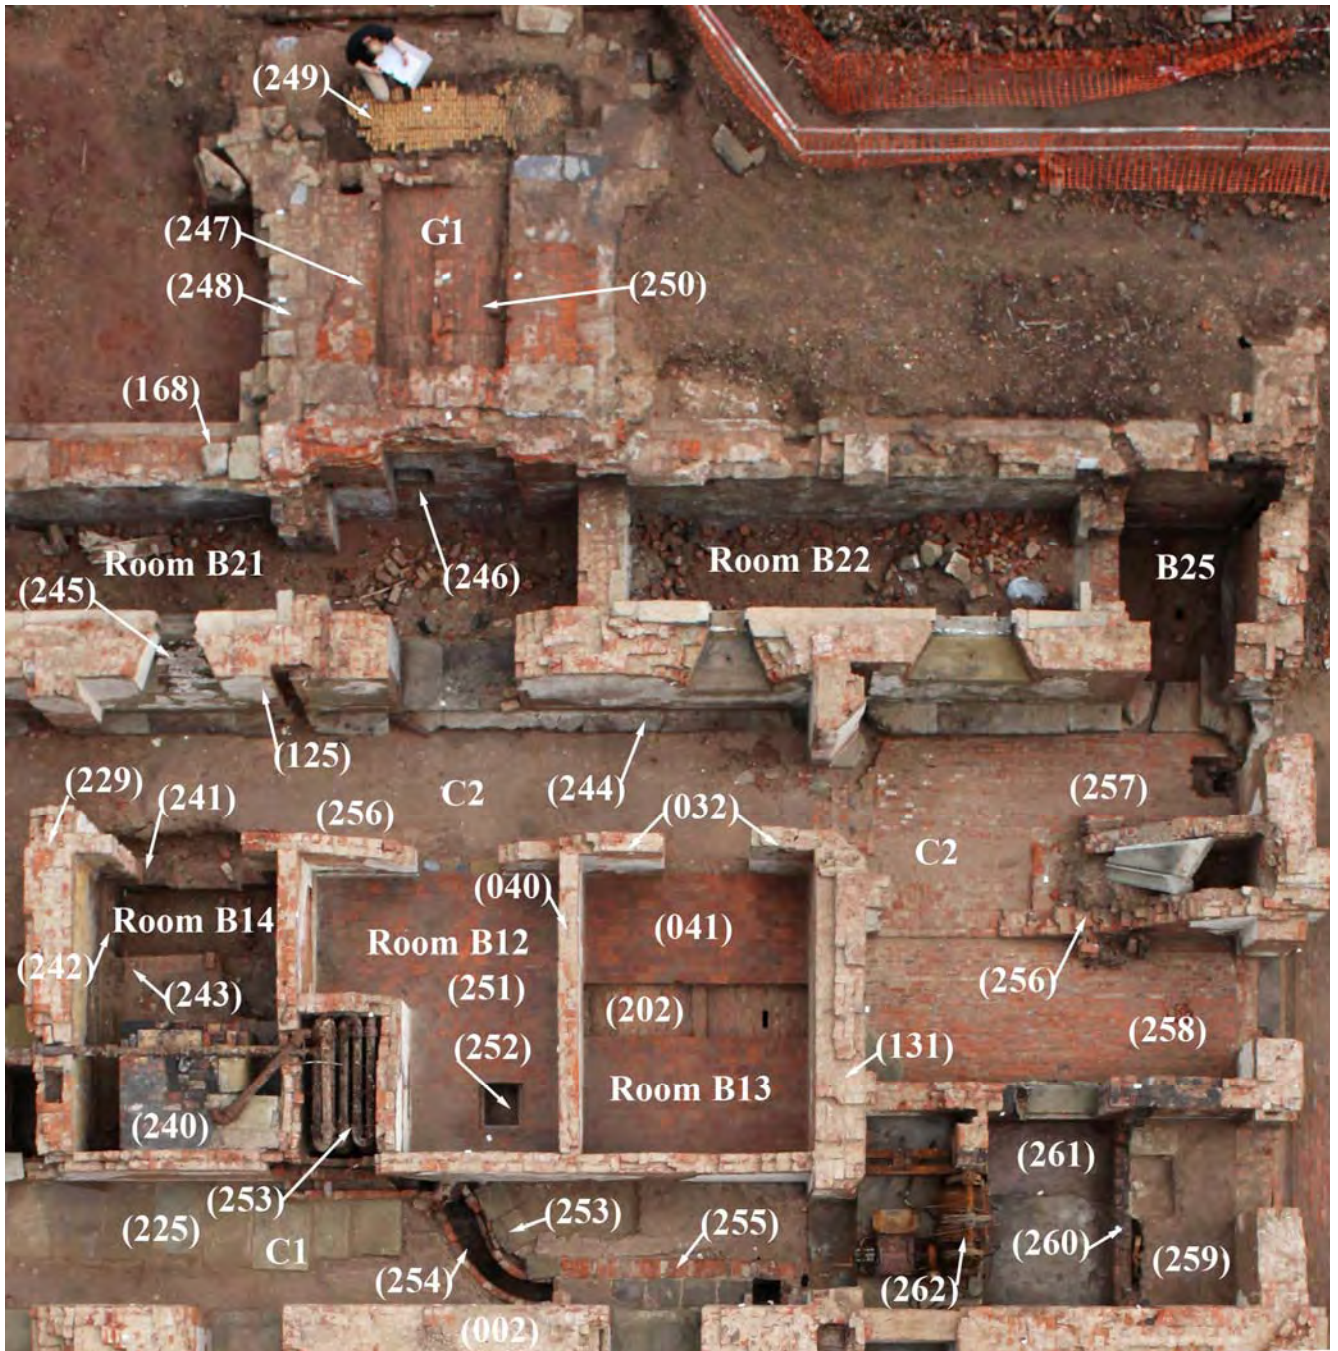
**Figure 68:** Aerial view, location plan of Rooms B12, B13, B14, B21, B22, C1, C2 Showing key contexts.

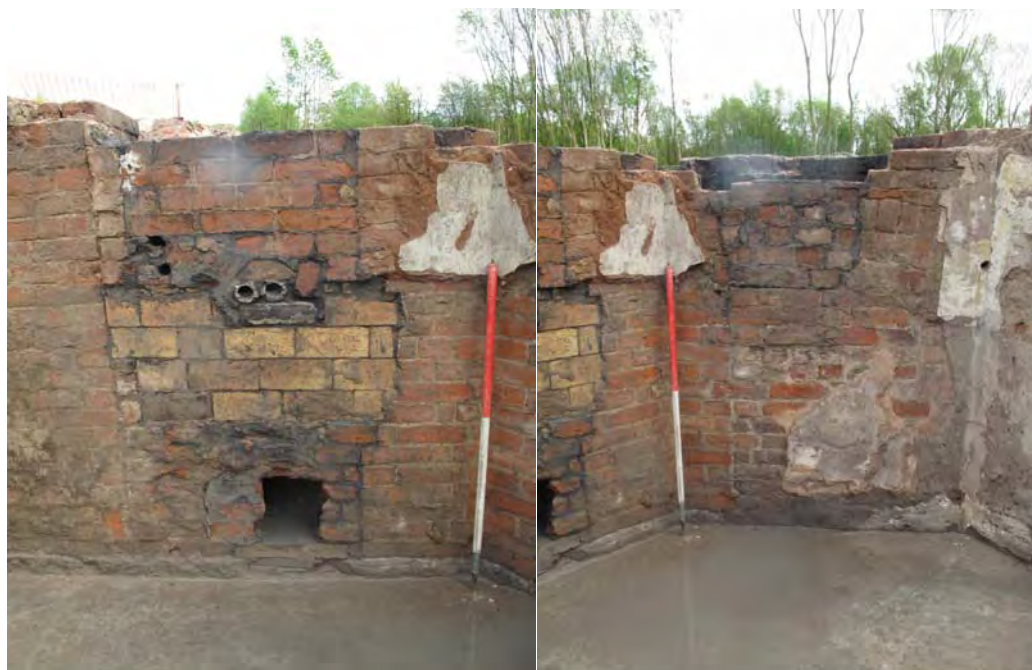
**Figure 74:** Blocked up doorway  
Within Room B18.

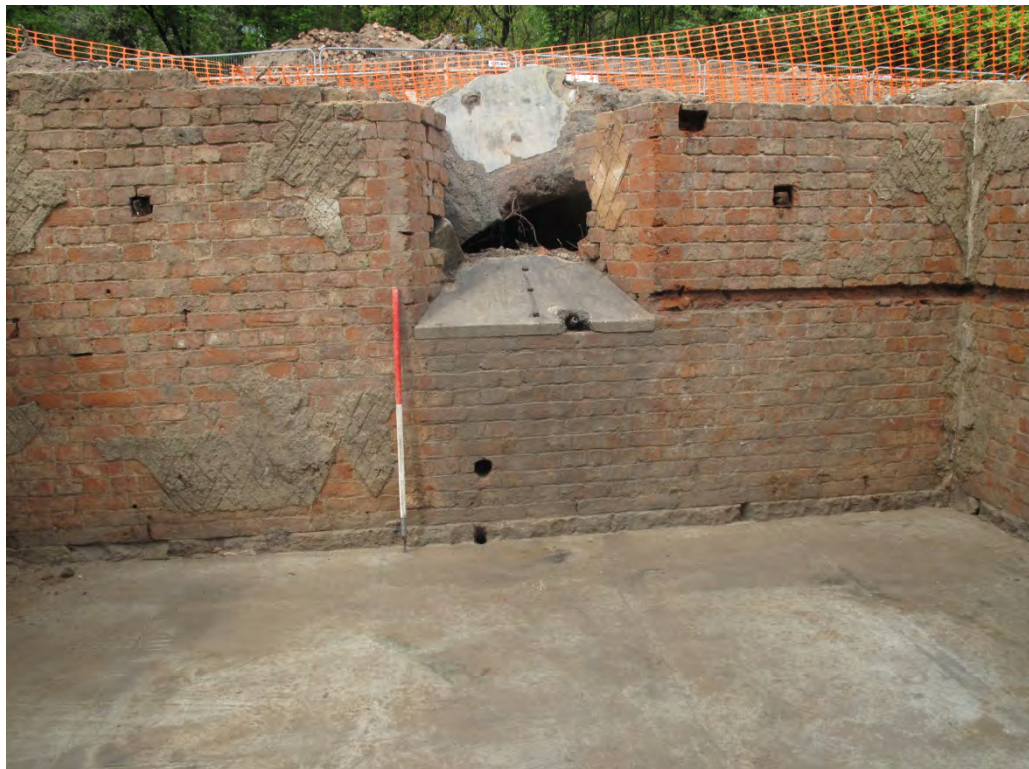
**Figure 76:** Blocked up cellar light within room B18.

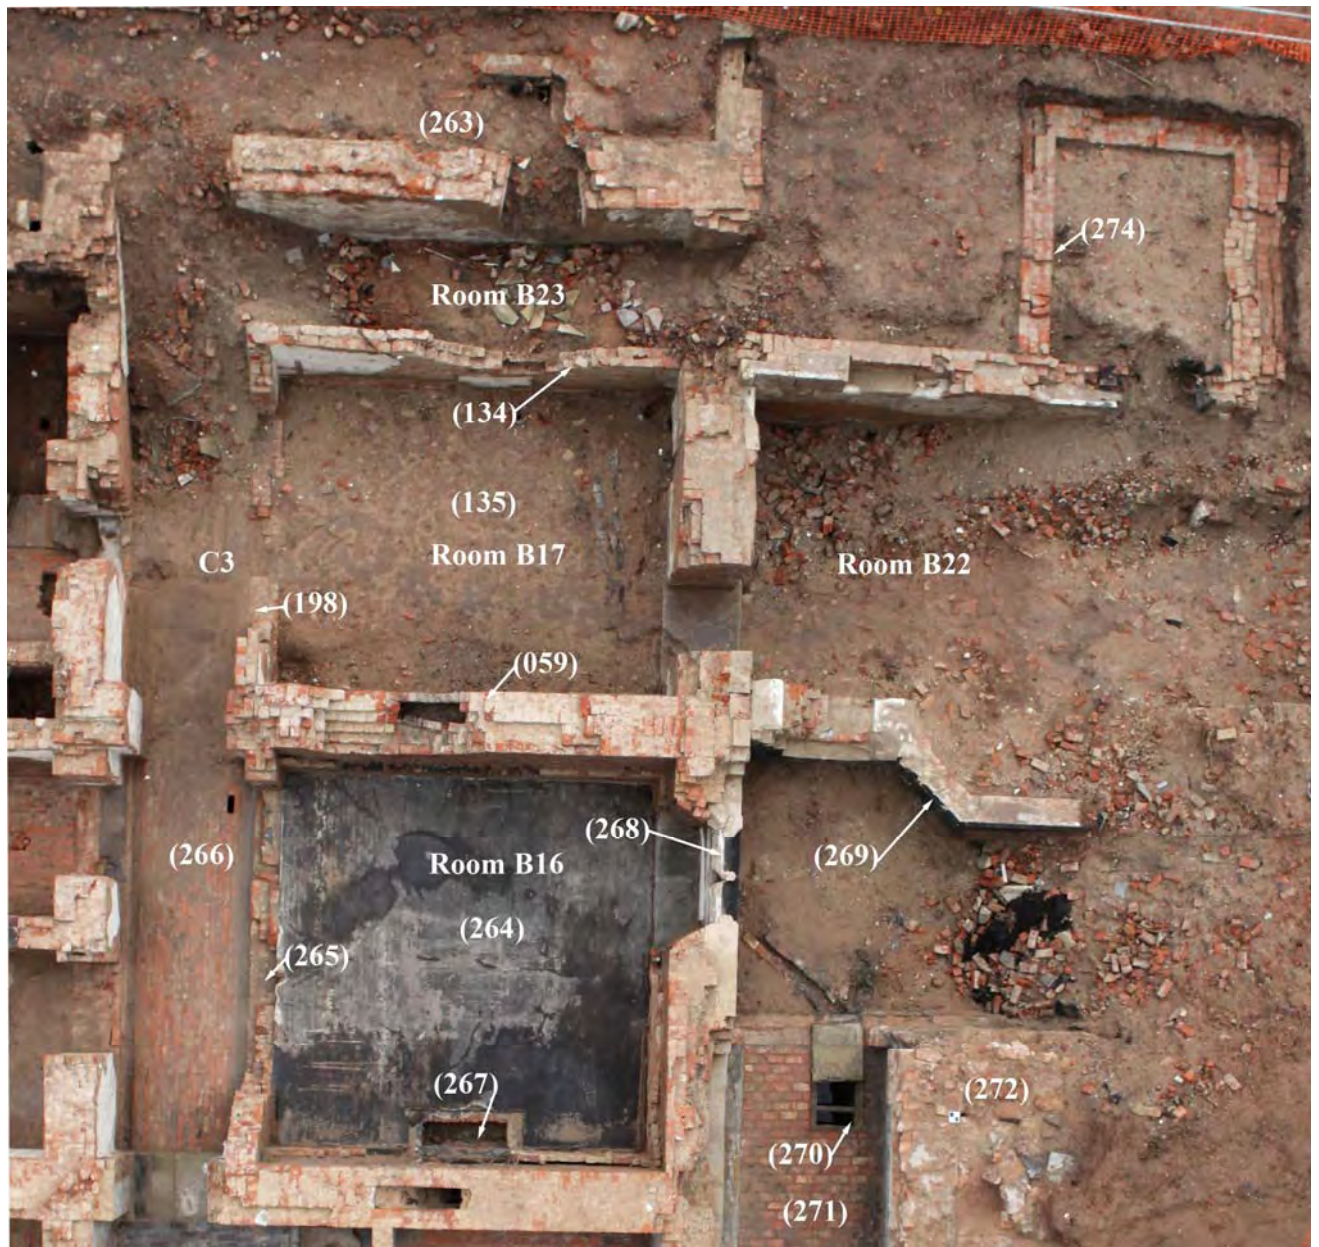
**Figure 82:** Aerial view, location and key contexts within Rooms B16, B17, B23 and Corridor C3.

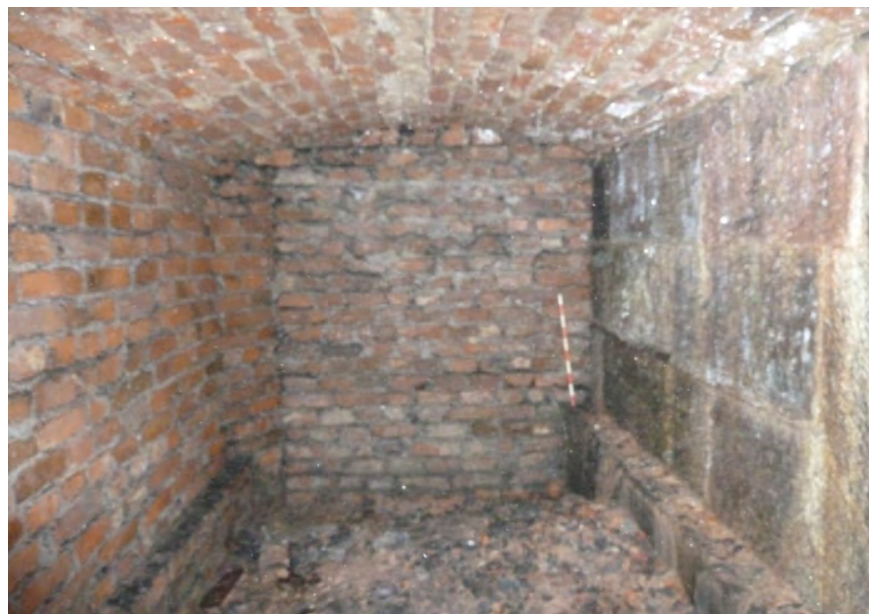
**Figure 85:** Blocking at southern end of Room C2. Looking south.

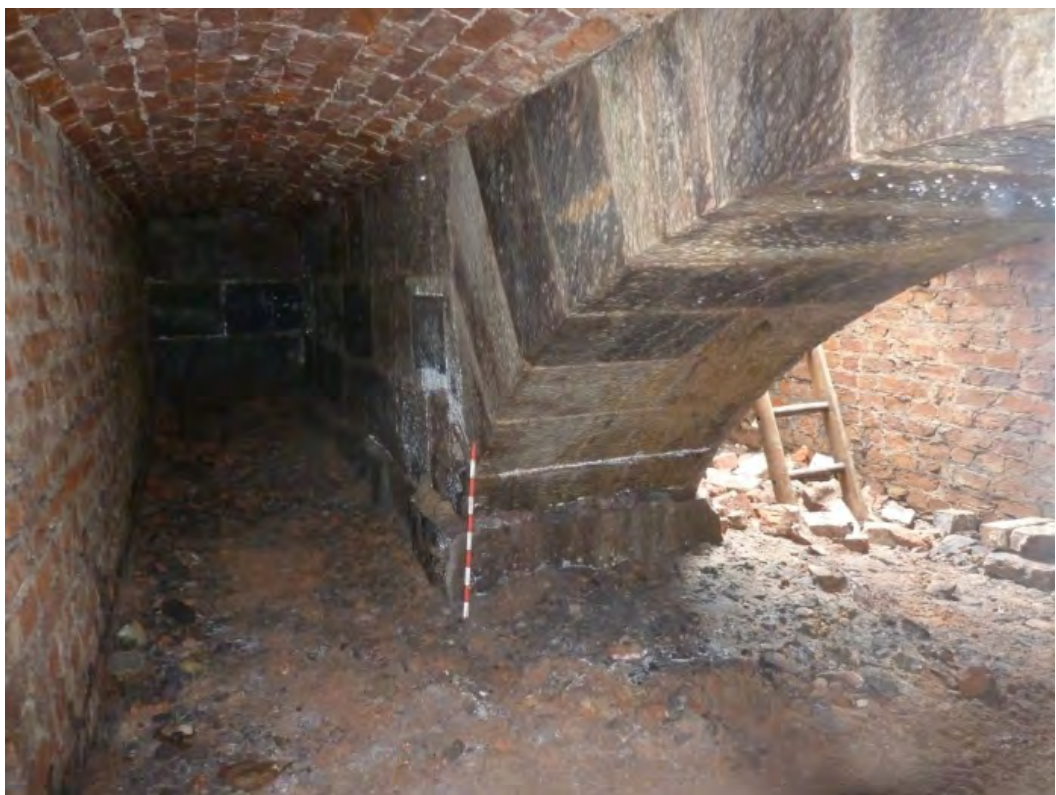
**Figure 99:** Stone archway in Room C16. Looking southwest.
