**Archaeological
Excavation**

Site of Collyhurst Old
Hall

Technical Report:
Kirsty Whittall

Report No: SA/2017/13

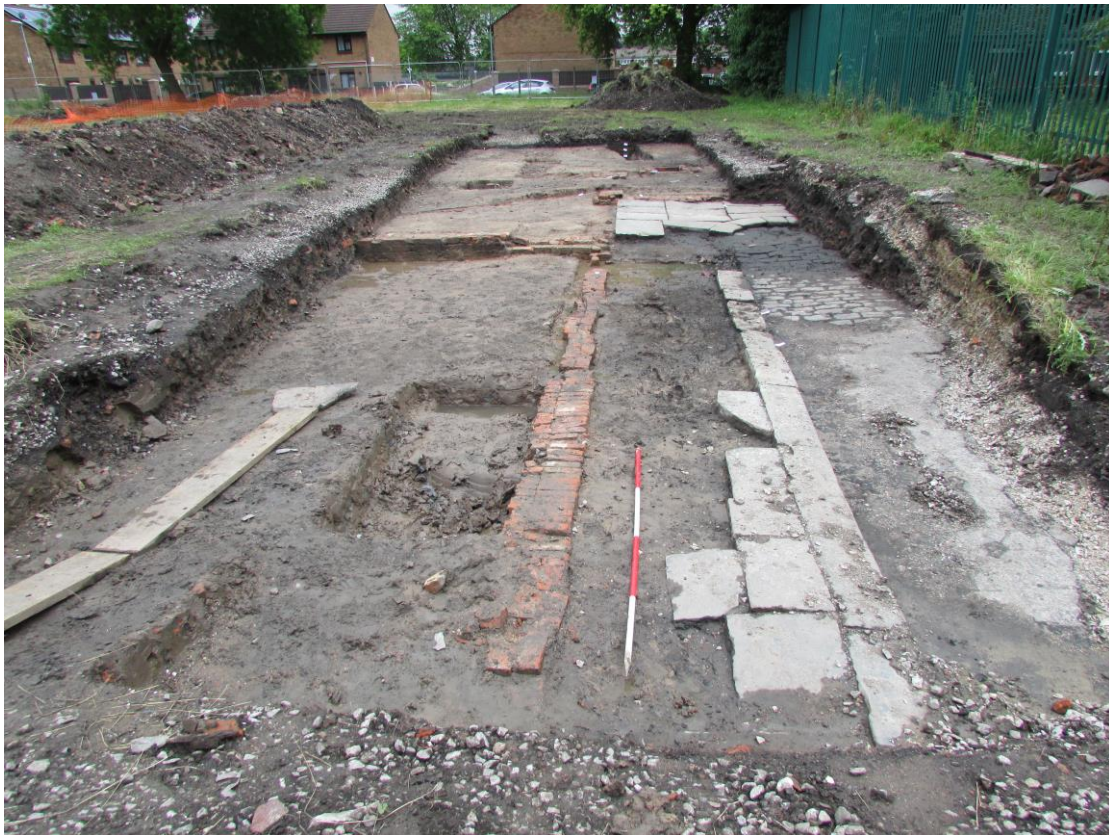
Fig 4: Overview of Trench 1 looking East.

This was the most south westerly of the trenches excavated and measured 10m x 5.50m orientated northwest / southeast. Following the removal of the turf and topsoil, a loose gravel based levelling layer (002) was revealed which had frequent inclusions

of modern stone and gravel. This in turn overlay **(003)** which was mid-greyish brown clayey silt below **(002)** in T1, which contained broken brick and stone, with inclusions of 19th and 20th century ceramics, metal, glass and wood. This demolition layer had a maximum depth 0.35m. Below this was **(004)** which was light yellowish brown clay layer which was possibly the natural. This layer was cut by linear **[008]** which was aligned northwest/southeast filled by **(009)**, **(012)**, **(013)**, **(026)** and **(027)**. The cut was 0.60m wide, 0.27m deep and 3.80m long. It continued through the baulk and ran into drain **(014)**. **(009)** was the upper fill of **[008]** and **[025]**. It was a dark blackish brown gritty clinker layer with burnt material and frequent inclusions of broken brick and stone. The layer had a depth of 0.05m and sat above **(012)** which was the lower fill of both **[008]** and **[025]**. It was a mid-orange brown sandy deposit that had no inclusions and a varying depth of 0.03m and 0.10m. Below this was **(013)** which was the fill of both **[008]** and **[025]**. This was a dark black compacted gritty coal tip burnt material which had an oily consistency. It contained frequent inclusions of mortar, charcoal, glass, animal bone and 19th and 20th century ceramics.

(026) was the upper fill of drain cut **[008]**. It was a mid-greyish brown gritty sand/silt that had frequent inclusions of small stones/slag, mortar and brick. This layer sat directly above **(027)**. **(027)** was the bottom fill of **[008]** and was made up of dark blackish brown clinker material which had frequent inclusions of 19th and 20th century pottery, glass and bone. **[025]** was a linear cut aligned northeast/southwest that was filled by **(009)**, **(012)** and **(013)**. It truncated **[008]** and also cut into **(004)** and **(024)**. It had an excavated length of 3.00m and an excavated width of c0.30m, continuing beyond both the southern and western baulks. The cut had a depth of 0.45m with steep sides and a flat base and was probably a drain cut.

At the northern end of **[008]** was **(014)** a brick lined drain/sump. Composed of machine made brick measuring 22x11x7 cm some of which were frogged. It measured 1.02m by 1.20m being 2 bricks wide on the northern and southern sides and 3 bricks wide on the eastern and western sides. In the centre there was a void which measured 0.65m by 0.48m. The drain was excavated to a depth of 1.00m but continued beyond this. **(015)** was a brick feature at the southern end of the trench and to the north of **(014)**. The feature was constructed from handmade bricks and measured 0.59m by 0.59m. There was a void in the centre of the feature, measuring 0.24m by 0.24m, in

which sat a ceramic drain down pipe which had a diameter of 0.15m and was 0.02m thick. The feature was excavated to 0.11m. **(016)** was a ceramic drain which was aligned north/south and had an excavated length of 3.40m, continuing beyond the eastern baulk, and a diameter of 0.07m. **(017)** was a handmade brick wall aligned northeast/southwest, abutting the southern extent of **(018)**. It measured 2.09m in length, continuing beyond the western baulk, and was 0.43m wide. It had a return to the north that had a length of 0.60m. The wall was excavated to 1 brick high. **(017)** was the school yard wall.

(018) was a York stone flag floor/pavement which made up the east side of Laverack Street. It was located in the northwest area of the trench, was truncated in places and had kerb stones along the western edge. The flags were sat on top of **(003)**. The flags varied in size, the smallest being 0.46m by 0.72m and the largest being 0.90m x 0.90m. The flags continued beyond both the northern and western trench edges and had a total excavated length of 9.26m and an excavated width of 2.50m. The kerb was 0.29m wide. North of **(018)** was **(019)** which were stone setts, measuring 0.30m by 0.10m, making up the road of Laverack Street. The setts were covered by both **(003)** and **(021)**. They had an excavated length of 8.34m and an excavated width of 1.24m, continuing beyond the northern baulk. Overlying part of **(019)** was **(020)** which was layer of concrete which had bitumen in some places and was 0.03m thick. **(021)** was light grey/yellowish gravel which was the infill of a modern service trench cut that truncated **(003)**. It was visible in the northern baulk and had a maximum depth of 0.55m. Within the eastern half of the trench was **(022)** which was another handmade brick wall that was aligned northeast/southwest and truncated **(004)**. The wall was 0.52m wide and had an excavated length of 3.21m which continued beyond the eastern baulk and had an excavated depth of 0.30m. To the east of **(018)** was **(023)** which was a handmade brick wall aligned northwest/southeast which is probably part of the school yard wall. It had a total excavated length of 11.15m and continued beyond the northern baulk. In the south west corner of the trench was **(024)**, an amorphous spread of brick rubble which say within **(004)**, was truncated by **[008]** and **[025]** and was below **(002)**. It has a depth of 0.08m and a width of 1.04m. It continued beyond the southern, eastern and western trench edges.

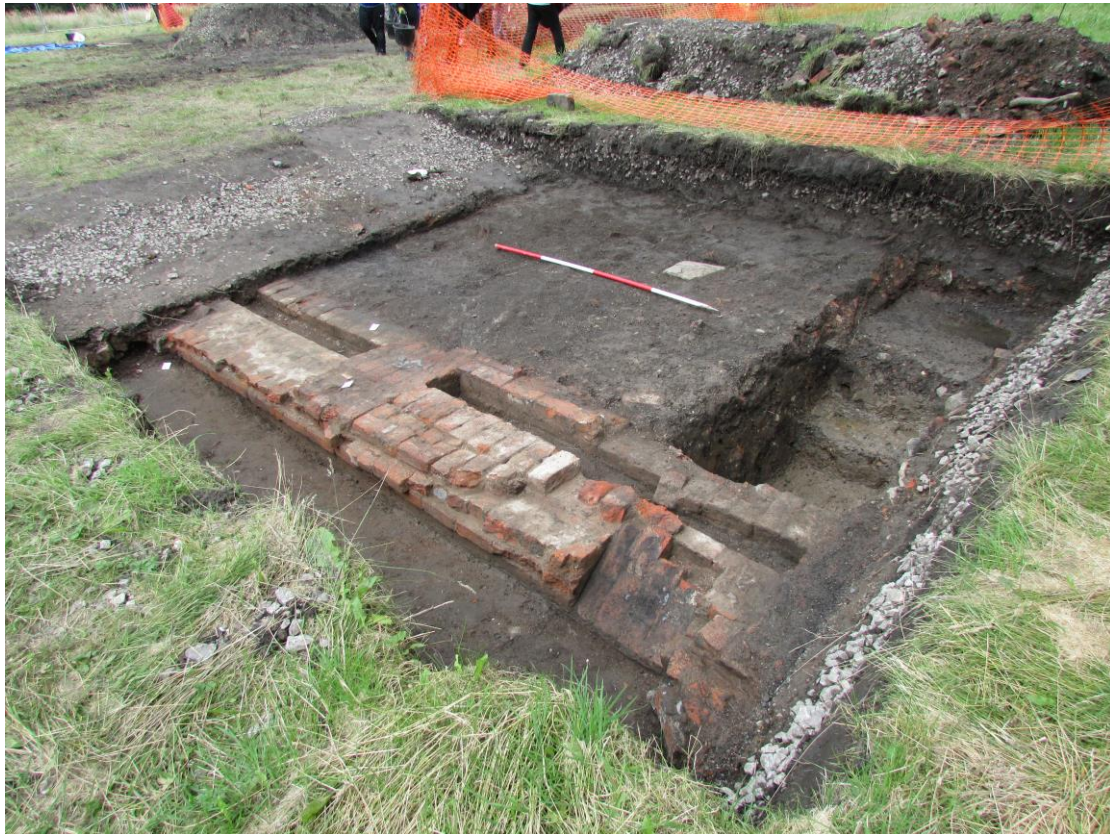
Fig 5: Trench 2 Overview looking North

This was the most easterly of the four trenches and measured 4.0m X 5.0m. Following the removal of the turf and topsoil, a loose gravel based levelling layer (002) was revealed which had frequent inclusions of modern stone and gravel. Underneath (002) was a band of mid greyish brown sandy silt (007) that was found along Ryder Street. The layer had a minimum depth of 0.10m and a maximum depth of 0.20m. Also below (002) was dark blackish brown silt (005) that contained infrequent inclusions of broken bricks and 19th century ceramics and glass. It was possibly a demolition layer with an average depth of 0.15m. Below (005) was a gravel/coal tip deposit (006) that had inclusions of small stones and slag. The layer appears to cap the remains of the 19th century School and houses. (029) was a handmade brick wall that was aligned northwest/southeast. The wall was 0.51m wide and was excavated to a depth of 4 bricks. It continued beyond both the northern and southern trench edges. Between (029) and (031) was a brick tie (030) that measured 0.58m by 0.80m by 0.14m. To the east of (029) was a handmade brick wall (031) 0.23m wide and 9 courses deep.

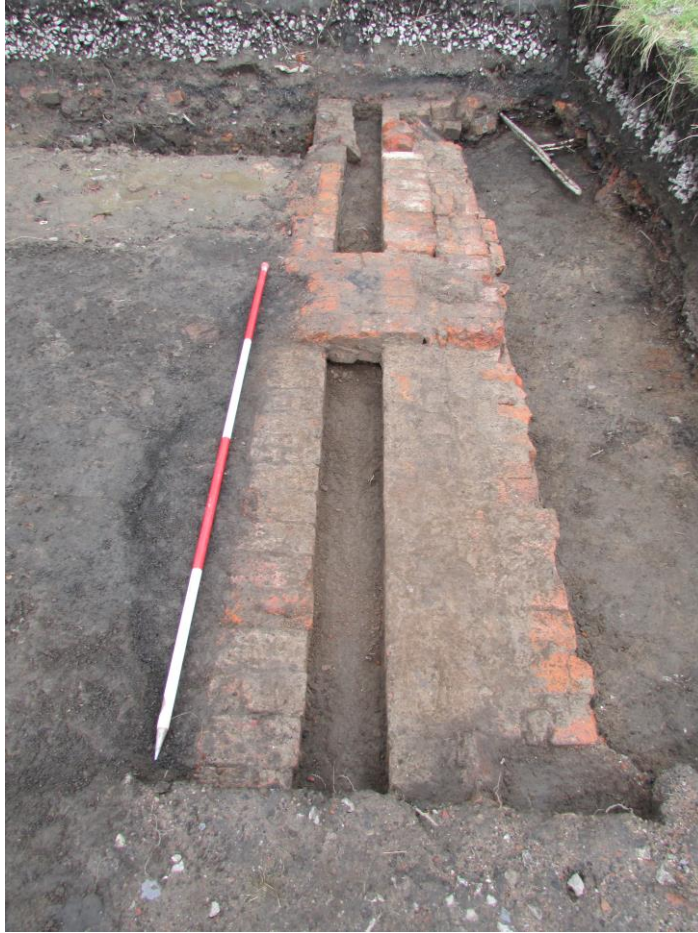
Fig 6: Trench 2 showing (031)

Upon excavation Trench 2 held further evidence of the later phase of occupation by way of (029) a handmade brick wall and (031) brick wall (outer) to the east of (029) which gave the rest of St James School exterior wall.

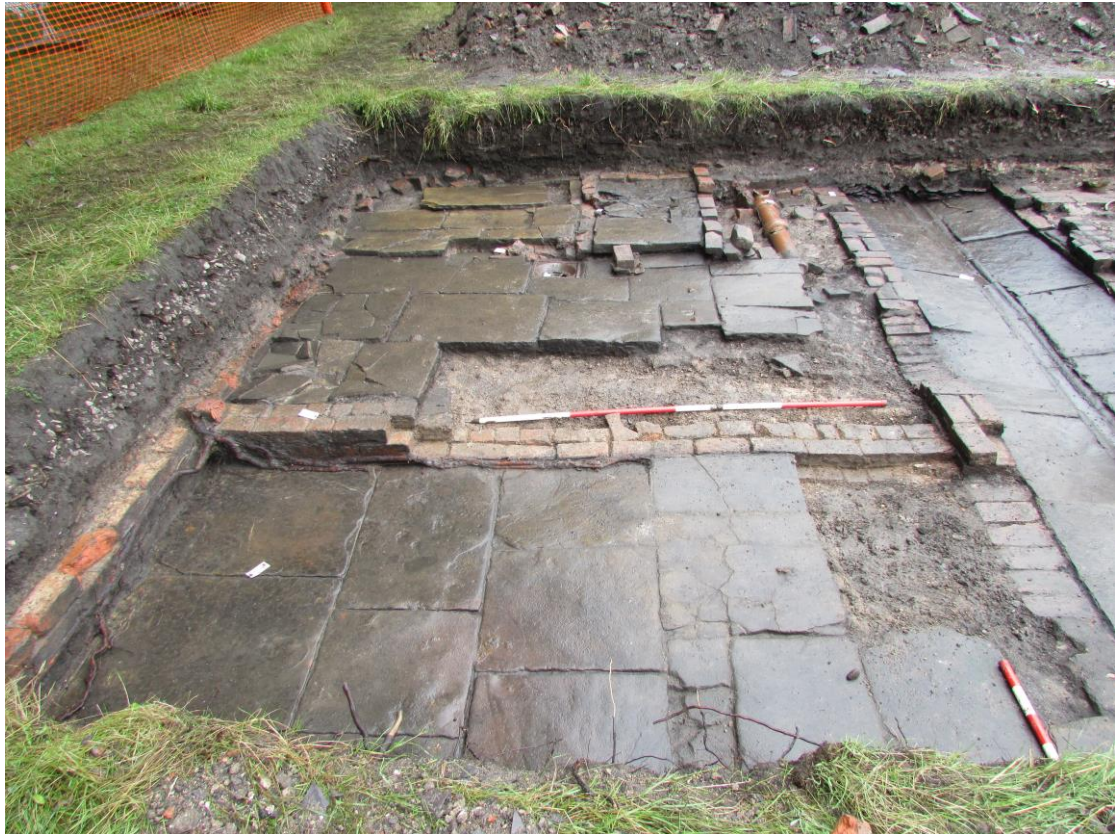
Fig 7: Trench 4 showing houses 16 +18 Collyhurst St

This was the most northwesterly of the four trenches and measured 8.0m x 5.0m. Following the removal of the turf and topsoil, loose gravel based levelling layer (002) was revealed which had frequent inclusions of modern stone and gravel. In the north corner of the trench there was a layer of light yellow grey sand (032) which overlied (033). It contained frequent inclusions of slate, mortar and broken brick. (033) was a York stone flag surface which probably made up the rear yard of Collyhurst Street and measured 3.22m by 2.95m. The flags were of varying size and some of them were broken. They lay beneath (006). Running through (033) was a ceramic drain (034). The diameter of the drain was 0.20m and the drain grate measured 0.30m by 0.30m. Abutting the eastern end of (033) was a handmade brick wall (035) aligned northwest/southeast. It survived to 4 courses in height and has an excavated length of 5.50m, continuing beyond both the northern and southern baulks. It sits within the eastern baulk of the trench and has a possible doorway at its southern end with a stone door jamb. Abutting both (033) and (037) was handmade brick wall (036) which was aligned northeast/southwest, located in the south east corner of the trench. The wall was 2 courses wide and 0.80m long. (037) was a brick lined coal store that had an

internal flag floor surface which was badly broken. The brick surround survived to 4 courses in height and was 2 bricks wide at its foundations. The overall length was 1.30m and the overall width was 0.75m. Within **(028)** was a privy **(038)** for Collyhurst Street. It was a ceramic glazed drain that had a diameter of 0.13m and was 0.02m thick.

(039) was a handmade brick wall that was aligned northwest/southeast abutting **(040)**. It was 0.23m wide and had an excavated length of 5.55m, continuing beyond the northern and southern baulks. It survived to 2 courses in height, constructed from handmade bricks measuring 0.23m x 0.10m by 0.07m. There was also a possible doorway which had a width of 0.80m. It was probably the rear yard wall of Collyhurst Street houses.

Between **(039)** and **(041)** was a stone flag alley **(040)** which was between the Collyhurst Street houses and the Ryder Street houses. The alley was 1.17m wide and had an excavated length of 5.55m, continuing beyond the northern and southern baulks. There was a central drainage channel that was 0.18m wide. **(041)** was the same as **(039)**.

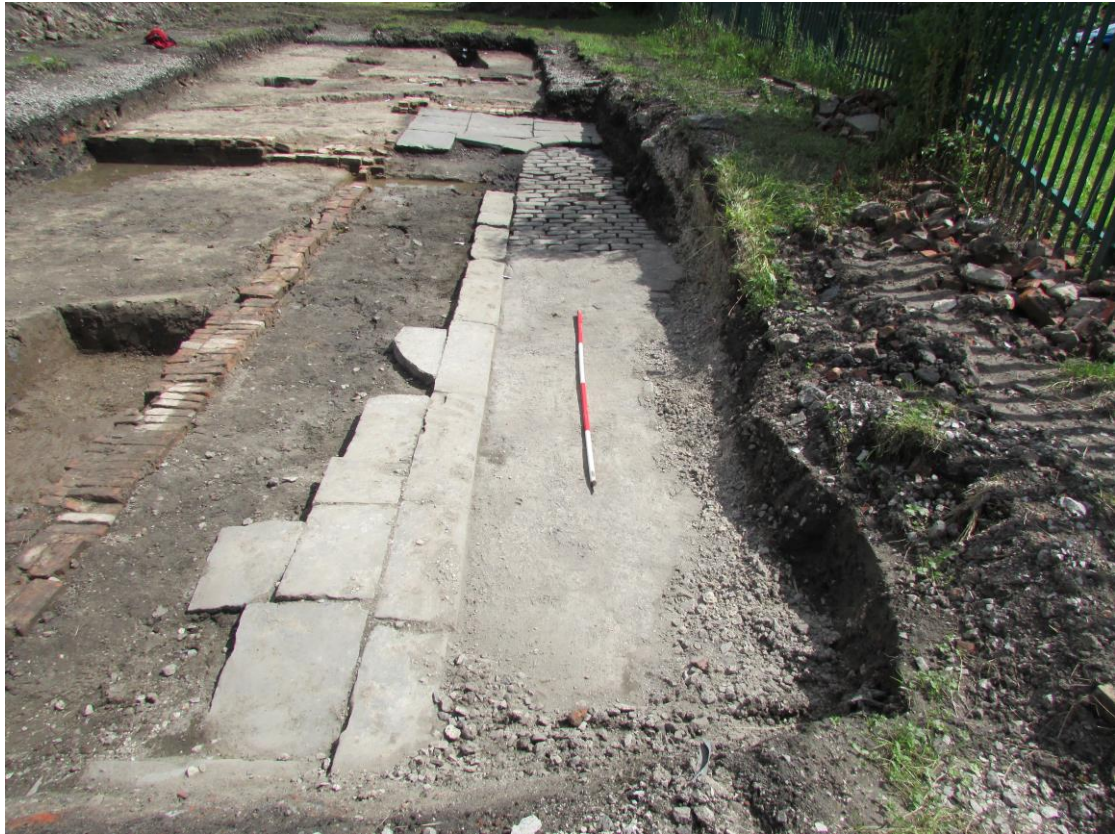
The archaeological remains which were uncovered in trench one, appear to be consistent with the cartographic evidence of St James Primary School, particularly brick feature (015) at southern extent of Trench 1 (016) the red ceramic drain aligned north/south and (017) Handmade brick wall, aligned northeast/southwest. Abuts southern extent of the flag surface (018), which all appear to represent the school yard area. (018) and (019) to the northwest of trench one, appear to be consistent with the remains of Laverack Street, particularly the curve where Laverack Street terminates at St James Primary School.

Fig 8: Trench 1 Showing Laverack St to the right and St James School wall to the left at the Western end.

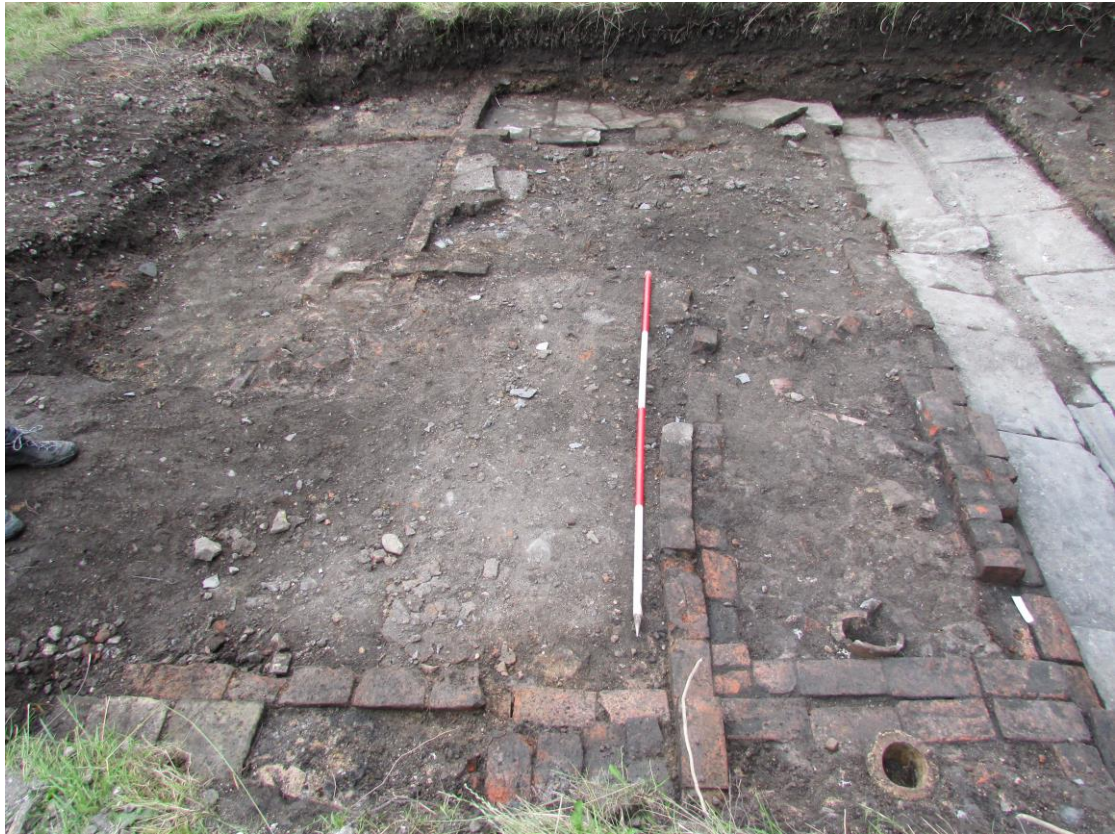
Trench four held substantial archaeological remains of these houses, including (033), (040), (043), (044), (047) and (048) all of which consisted of York stone flag floors consistent with the rear yards of these houses.

Along with the stone flag floors there were also privy toilets (038) and (045) and handmade brick walls (029),(035),(036),(039),(046),(049),(053) with trench four, which further supported the evidence of the back to back houses at Collyhurst St and Ryder St. Trench four, however, did not provide any evidence of Collyhurst Old Hall.

Fig 9: Trench 4 showing the ear yards of 21+23 Ryder St (left) and the alley between Ryder St and Collyhurst St (right)

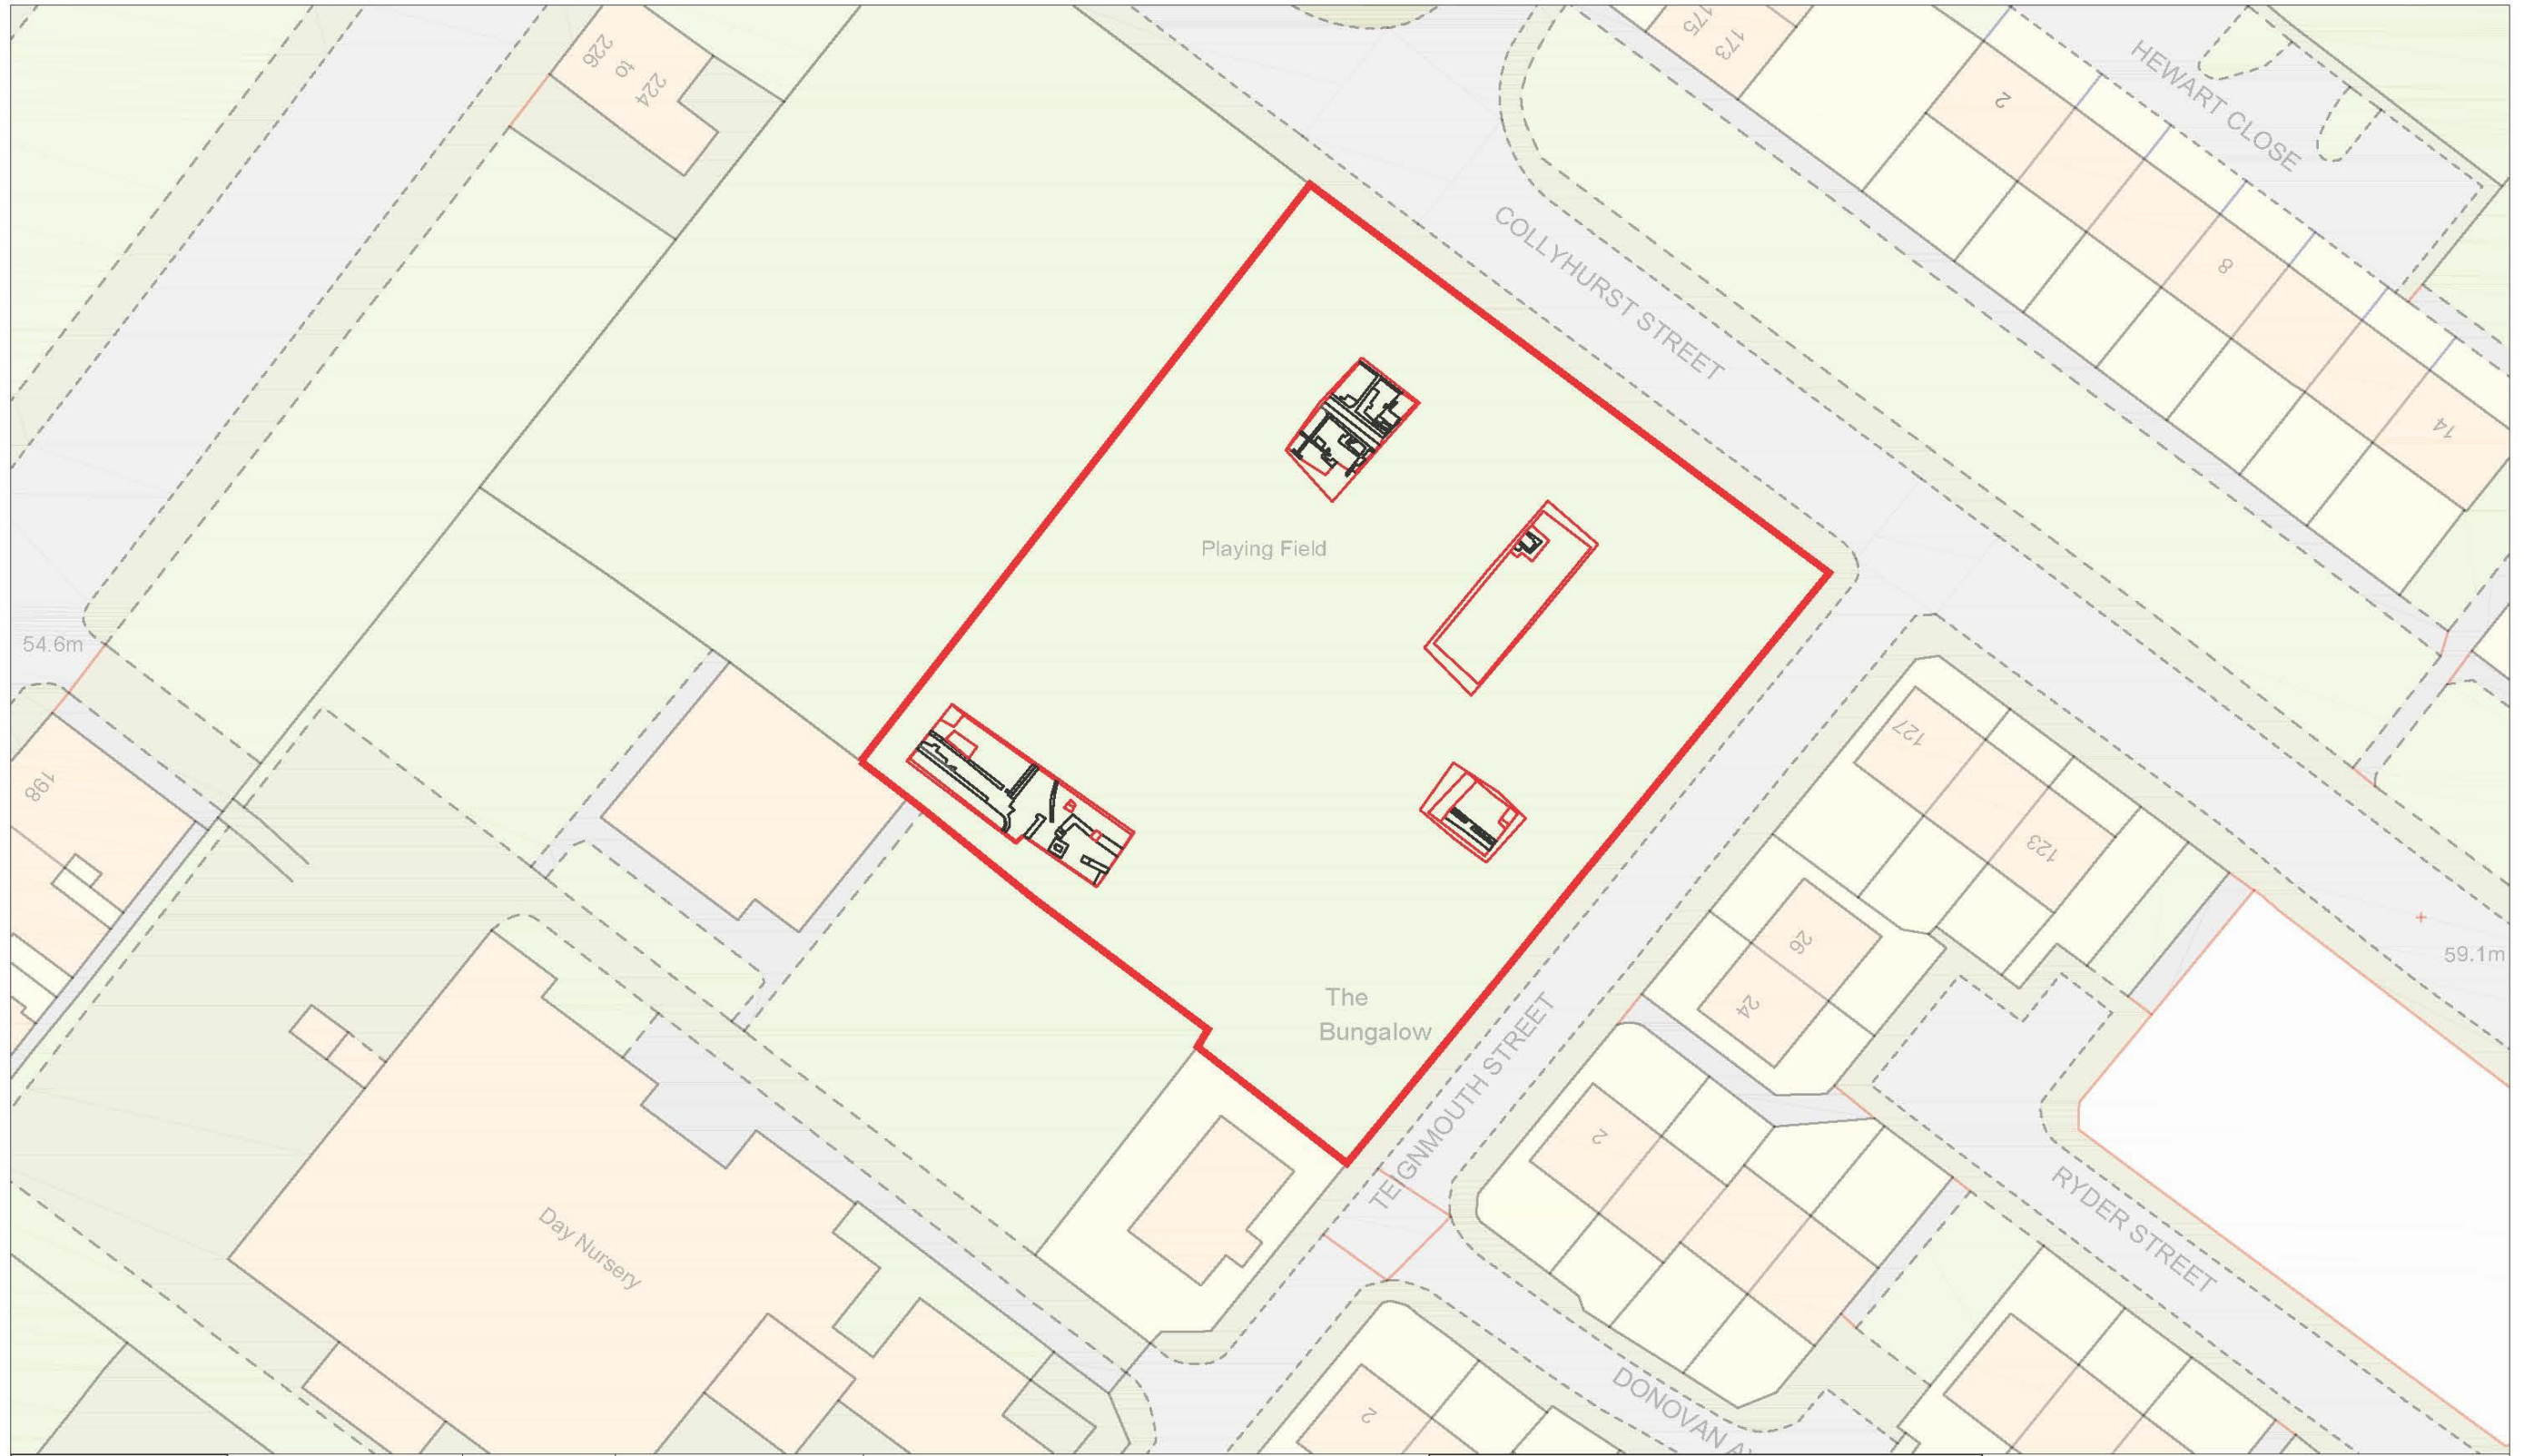
<p>University of Salford MANCHESTER</p>	<p>Salford Archaeology</p>	<p>The Centre for Applied Archaeology Peel Building University of Salford Salford M5 4WT</p>  	<p>Title: Collyhurst Community Excavation Site Survey</p>	<p>0 20 m Scale at A3 1:500</p>  	<p>Key: Site boundary and trenches</p>  
--	---------------------------------------	--	---	---	--
