The George and Dragon Hotel Cheadle, Stockport PPS5 Historic Building Assessment

A report by Dr Michael Nevell
CfAA 2011 (1)

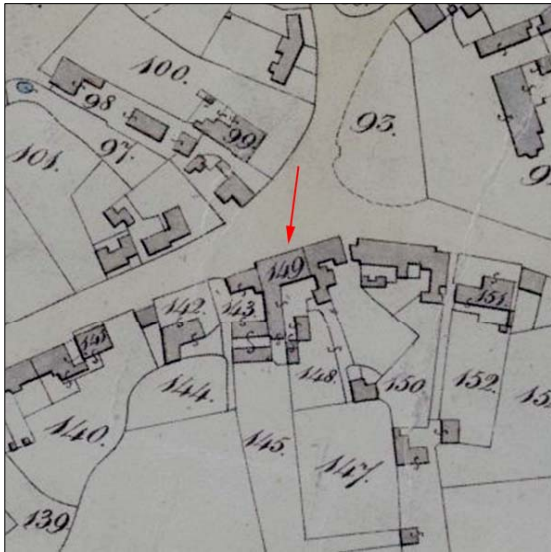
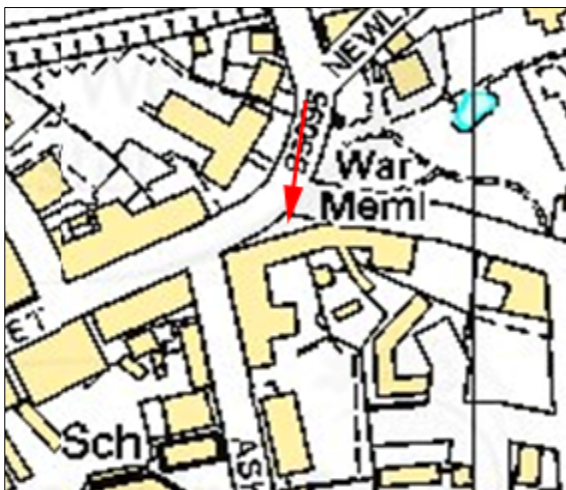
Fig 1: A historic map sequence for the George and Dragon Hotel (arrowed). Clockwise from top left: the Cheadle Bulkeley tithe map of 1846 (CRO EDT 90/2); OS Cheshire First Edition Six Inch map, Sheet 19, surveyed 1875, published 1882; OS Cheshire 2500 Series, 1910 Edition Sheet 19.2, surveyed 1907, published 1910; OS 1:10000 Series, revised 2002.

Later mapping shows a similar-sized complex. The 1882 Ordnance Survey six inch map for the area shows the complex in less detail but broadly with a similar layout (**Fig 1**), whilst the 1910 Ordnance Survey 25 inch mapping for the area names the northern range as a hotel and shows a covered passageway at the eastern end of the building (an addition of the period 1875-1907) leading into the south yard area, now defined by a wall to the east and buildings to the south. The south-western wing, shown as a single unit, formed the western side of the yard (**Fig 1**). The 1934 OS 1:2500 series map described the northern wing as a public house and showed a porch on the rear, southern, elevation. The 1962 OS 1:2500 series map shows the south-western wing on a slightly different alignment compared to the 1934 OS 1:2500 series map, suggesting that this wing had been rebuilt in the mid-20th century.

The second bay from the east was added sometime after the mid-18th century (encompassing the eastern end of room GF1, and rooms GF5, FF7 and FF9), but before the 1846 tithe map (**Fig 1**). This tithe map also shows the western wing, which in its original form was probably a carriage house and stables.

The carriage way and the room-space above (FF9) are only shown on the late 19th century mapping (**Fig 1**) and the tithe map of 1846 suggest that a range of buildings in separate tenancy occupied this site in the mid-19th century. This part of the building complex appears to be a late 19th century rebuild and addition to the hotel, hence the use of machine-bricks. These are similar machine-made bricks to the western wing and suggest that the western wing was rebuilt at the end of the 19th century or early in the 20th century.

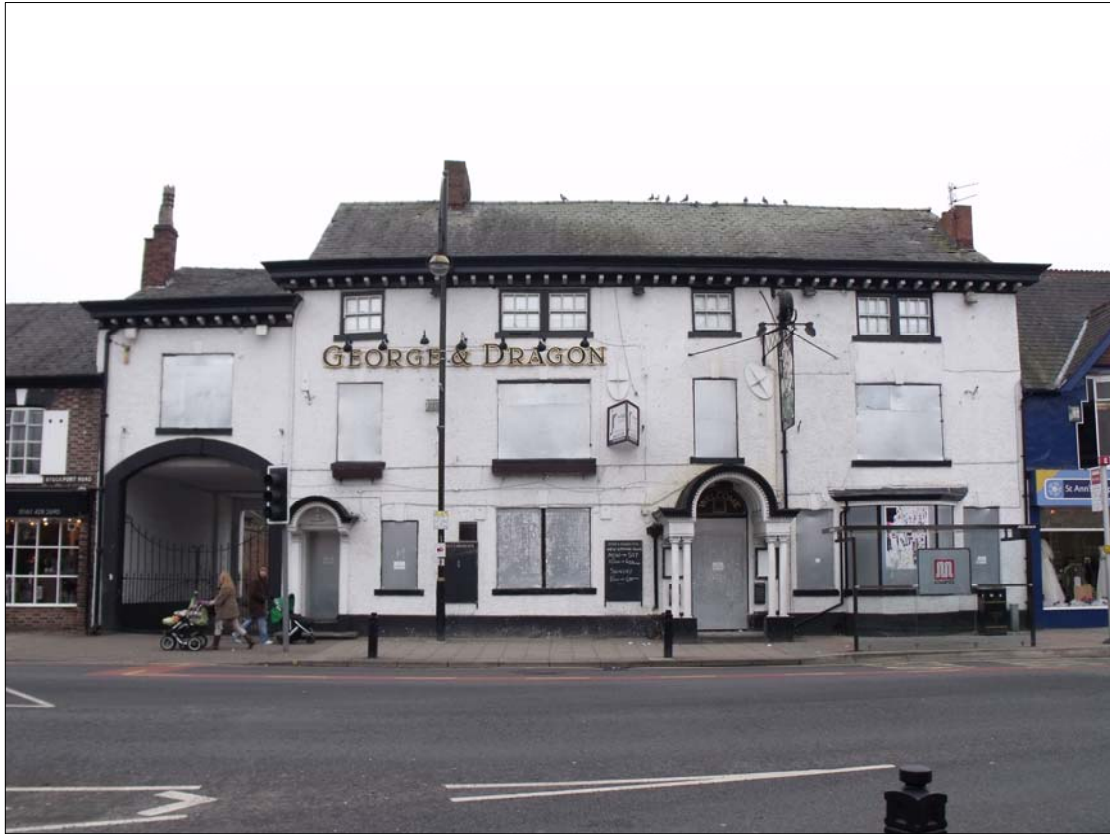
The George and Dragon Hotel forms the middle of a range of buildings on the southern side of the High Street, Cheadle, running from Ashfield Road in the west to Oak Road to the east. It is a three storey, brick-built and stone structure two bays deep with pitched slate-covered roofs. The northern elevation (**Fig 2**) is rendered, three storeys, and five bays long with a carriage entry occupying the two-storey eastern-most bay. This elevation sits on a stone plinth and has a bracketed eaves cornice, and a steeply pitched, thin-slate covered, roof. The carriage entrance has a segmental keystone arch with a tripartite sash window above. In the remaining four bays, the windows alternate between paired and single horned sashes, whilst the ground and first floor windows of the three-storey range have tripartite keystones. The door in the second bay has a Queen Anne-style canopy springing from corbels, the fourth bay from the east has a second Queen Anne-style canopy on paired Ionic columns, although the precise date of this feature is unclear, whilst the fifth bay has a ground floor canted bay window. The roof had a ridge chimney stack between the second and third bays and a gable-end chimney stack at the eastern end of the building.

Fig 2: The northern elevation of George & Dragon Hotel.

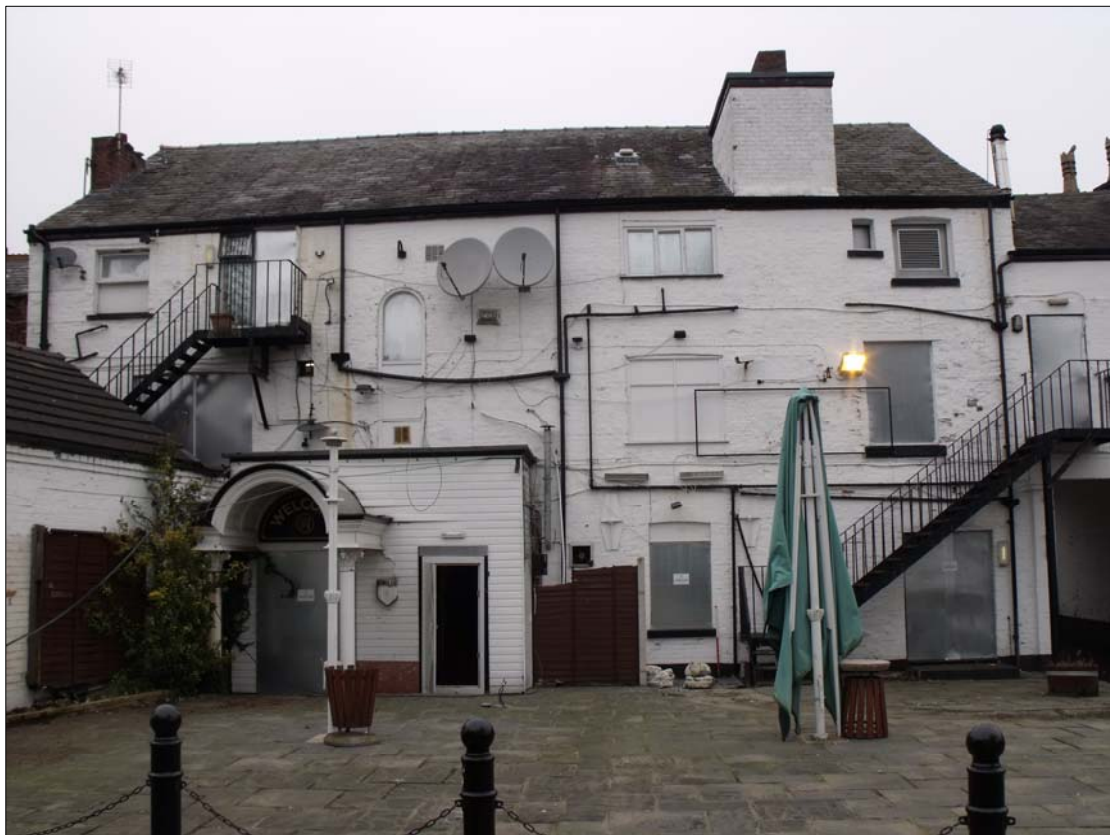
The rear, southern, elevation, (**Fig 3**) was three-storeys high and comprised five bays and a single-storey western wing. It was built in English-Garden-Wall-bonded handmade brick for the most part and was white-washed. To the east of the main elevation was a carriageway with a first floor room above. This was built in machine-brick and there was a building break with the main elevation. The southern five-bay elevation was much altered with a variety of window openings and doorways in the ground floor including a machine-brick porch that covered the second and third bays from the west which had an arched canopy supported by concrete columns. The windows on the first floor were also of different sizes, as were those on the second floor. The earliest windows appeared to be a three-light mullion window in the fourth bay from the west on the second floor, and a round-headed stair window, the lower part of which was obscured, in the third bay from the west.

The pitched roof was covered in thin blue slates and there was a large machine-brick chimney stack between the fourth and fifth bays and a gable-end chimney stack at the western end of the elevation.

Fig 3: The southern elevation of George & Dragon Hotel.

It is proposed to build a freestanding marquee/pagoda in the rear yard which would partially block the view of the porch, room GF6 (**Fig 3**), the western wing and the lower part of the southern elevation. The western wing was rebuilt in the late 19th or early 20th century, the porch a 20th century addition, whilst the rear ground floor bays of the main range, bays two to five, have been heavily altered by the insertion of later windows. This proposal does not directly affect the historic fabric of the southern elevation which is partially preserved at first and second floor level, and as a removable single-storey structure within the courtyard has limited impact on the setting of the rear part of the building.

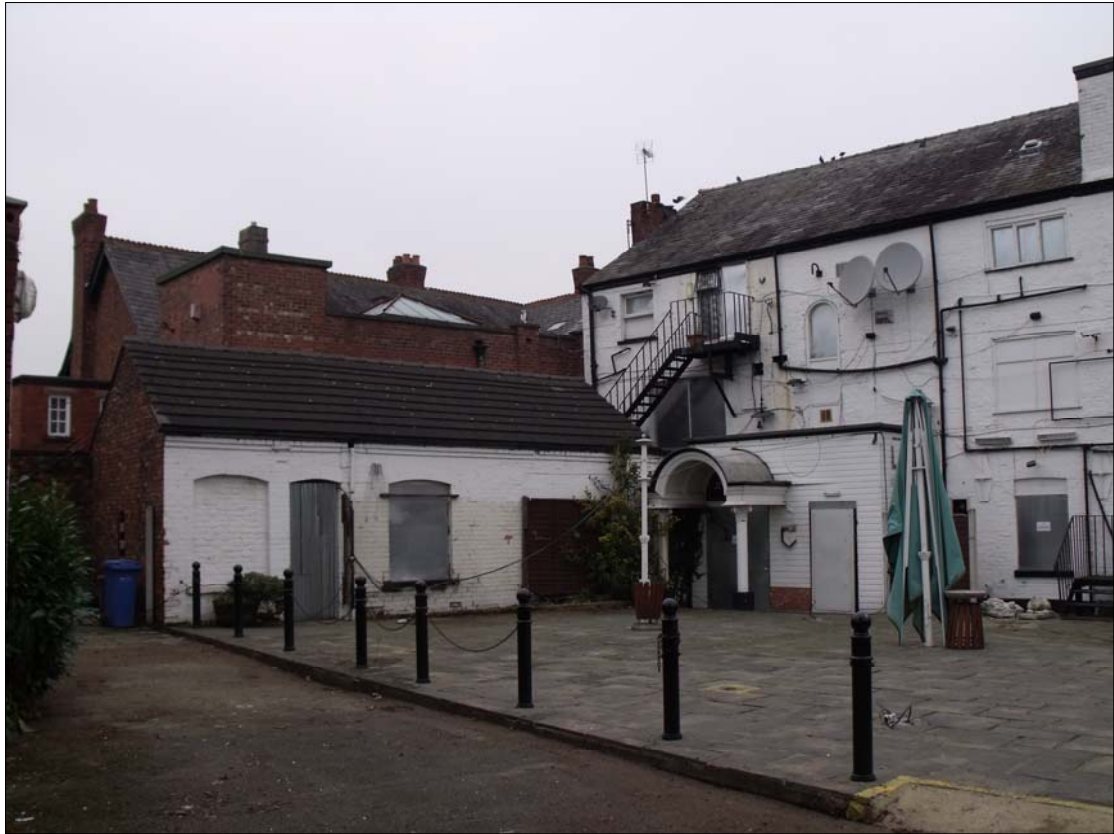
The western wing (**Figs 4 & 5**) was a single-storey structure built in machine-made brick in English garden wall bonded brick. It had five openings, the northern two of which were blocked, as was the southern opening. There was a doorway in the second bay from the south. The pitched roof was covered in 20th century grey tiles.

Fig 4: The single-storey south-western wing of the George & Dragon Hotel.

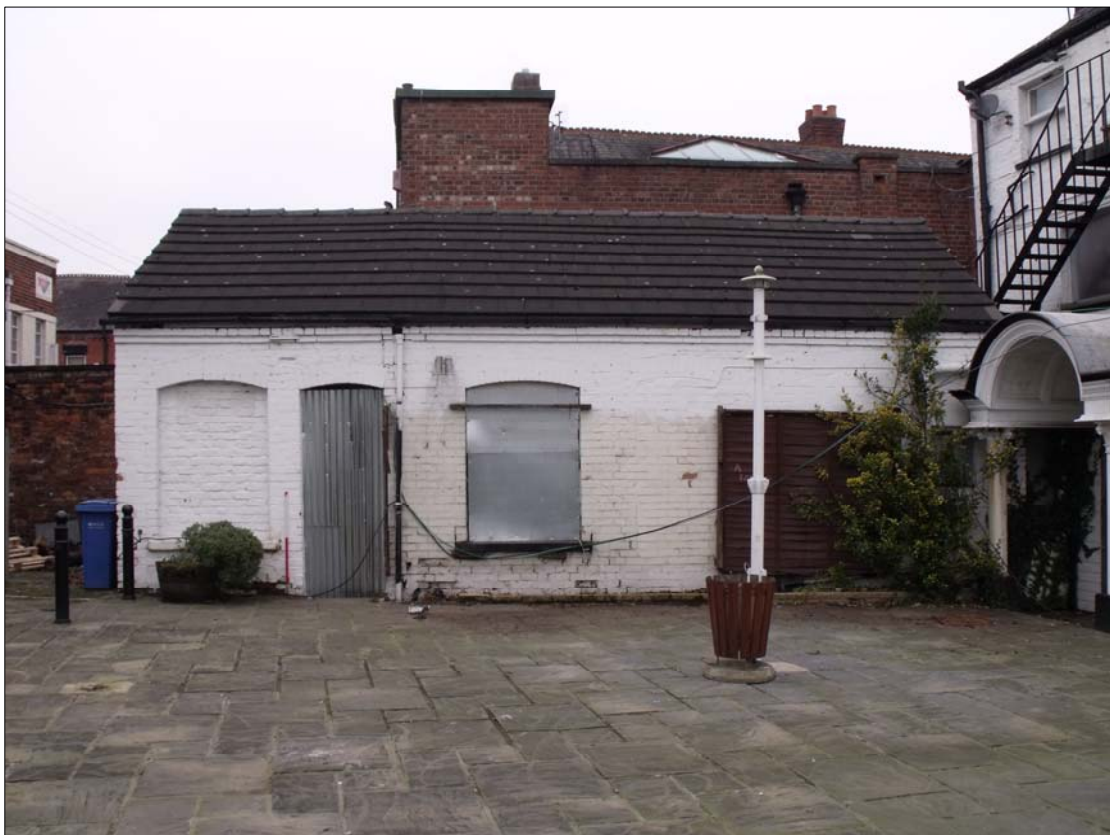
Fig 5: The south-western wing of the George & Dragon Hotel showing the blocked openings. The blocked window on the left will be knocked through.

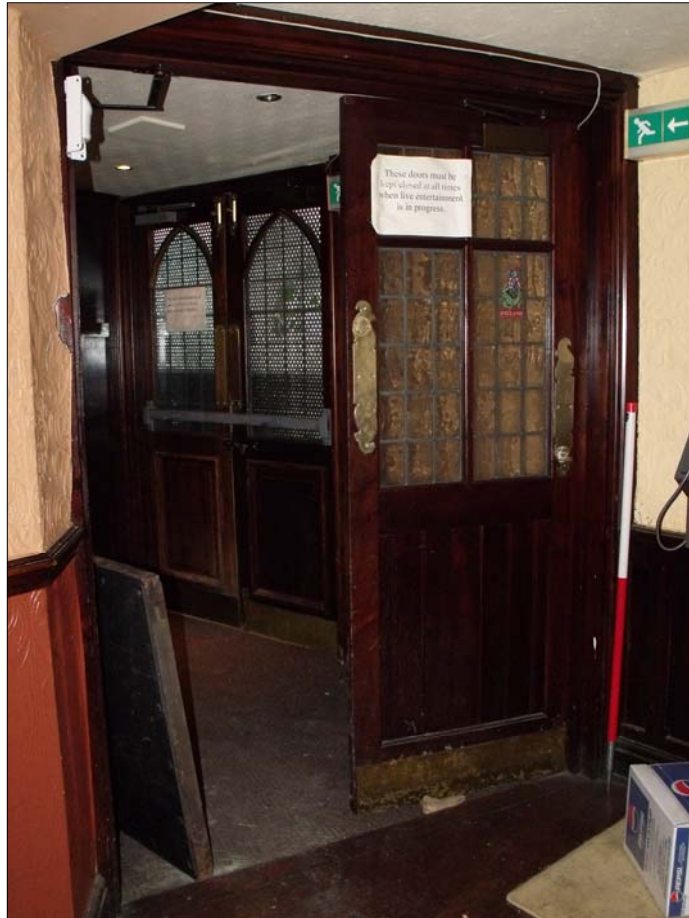
Fig 6: George & Dragon Hotel GF6 looking at the lobby doors which will be replaced.

It is proposed to alter the position of the internal doorway in the porch, room GF6 (**Fig 6**), and to insert a new entrance into the toilet area (GF9; **Fig 7**). Since the porch is a 20th century addition and a link corridor with the late 19th/early 20th century western wing, there is no significant impact on the historic fabric of the building.

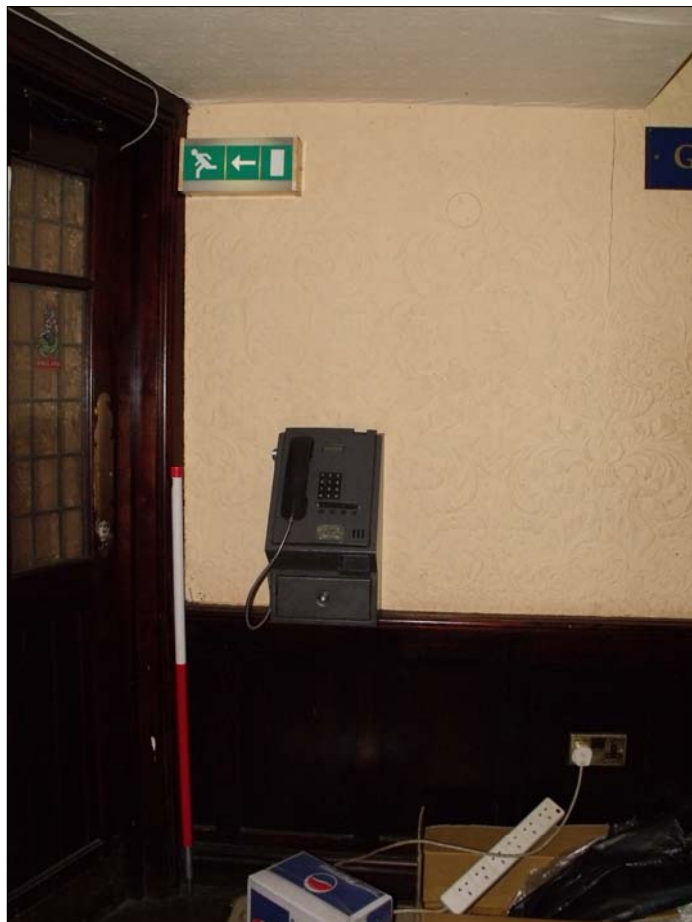
Fig 7: George & Dragon Hotel GF6 looking at the southern wall into the toilet area (GF9) which will be knocked through.

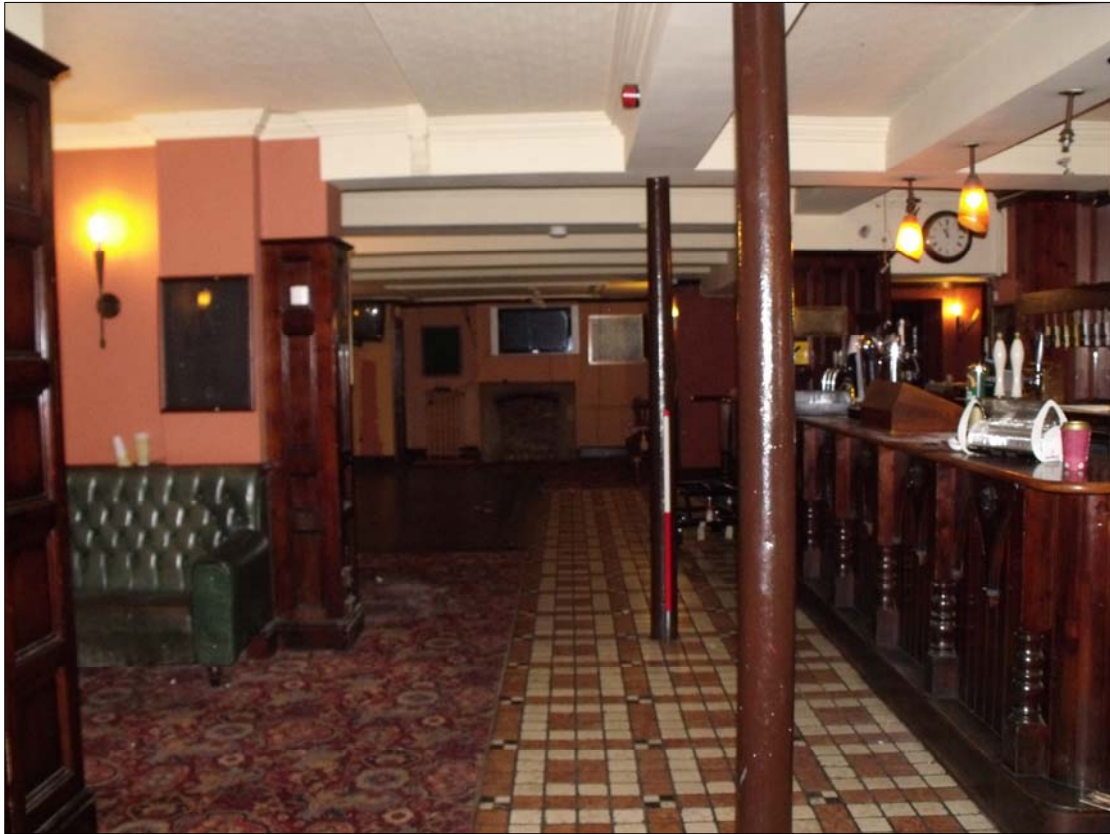
walls in two of the rooms (GF 1 and GF2). GF2 contained the bar and GF1 (**Fig 8**) formed the lounge area which ran the full five-bay length of the road frontage. There was a fireplace (**Fig 9**) and external doorway (Fig 10) at the eastern end of this room. A second bar area lay at the southern, rear, end of the floor, GF4, with a function room in the south-eastern corner of the floor, GF5. All the fixtures and fittings in these rooms were later 20th century, whilst a fireplace in the eastern-most fifth bay, opposite a doorway, was formed by a re-used stone surround. At the rear of the ground floor was a centrally placed staircase which led down to a cellar area (not investigated in the current study) and up to the first floor. The rear porch led to a staircase (GF3), whilst a corridor in the rear porch (GF6; **Figs 6 & 7**) provided a ground-floor link with the western wing. The western wing had two toilet areas (G8 to GF11; **Fig 11**) accessed from a western corridor (GF7). All the fixtures and fittings were late 20th century. The northern bay (GF12) was a store room accessed from the courtyard only.

Fig 8: George & Dragon Hotel GF1, looking east towards the eastern fireplace.

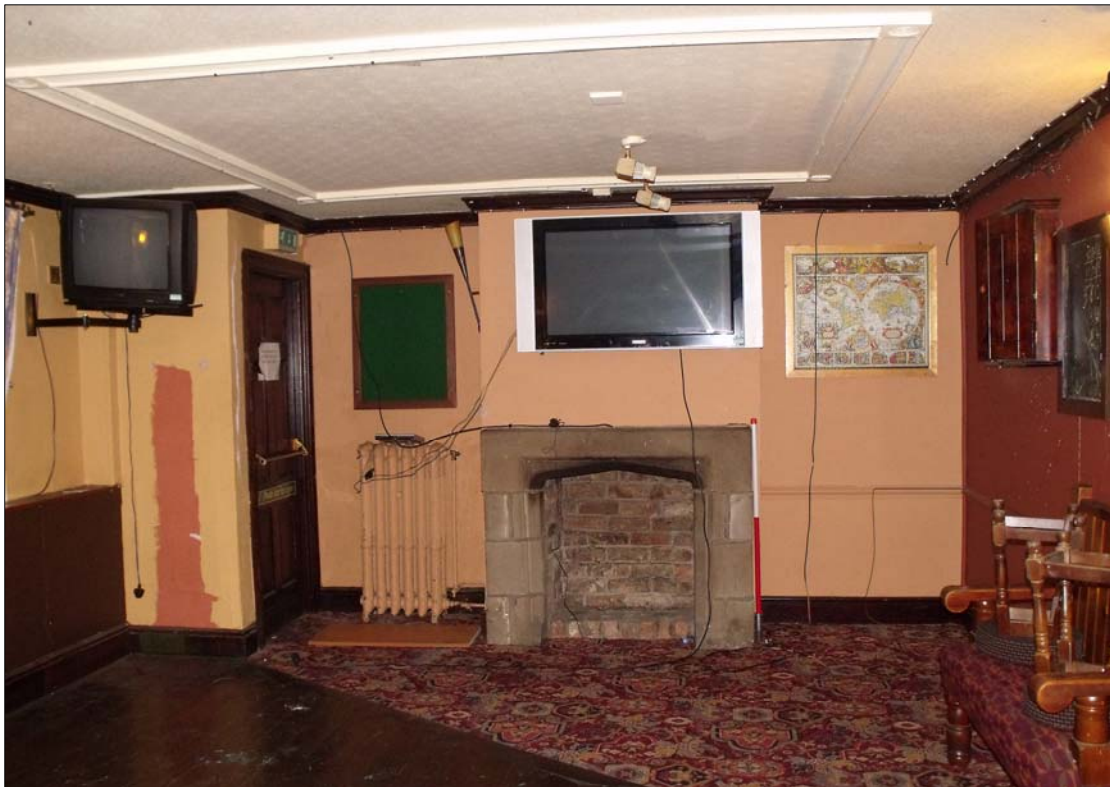
Fig 9: George & Dragon Hotel GF1, showing the eastern fireplace bay with to the left (north) the north-eastern entrance. This is intended to be the site of a new staircase which will involve the removal of the fireplace.

The proposals involve the insertion of a new staircase at the eastern end of room GF1, the removal of the fireplace in this area and the blocking of the doorway in this area (**Figs 9 & 10**). The fireplace is a 20th century insertion, whilst the eastern gable wall of this room was built in machine-made bricks when this bay was added to the structure. The floor of room FF7 above (**Figs 13 & 14**), which would need to be removed to insert the staircase, is made from softwood timbers and is 20th century in date. The impact of this aspect of the refurbishment is therefore very limited on the fabric and historic importance of the building.

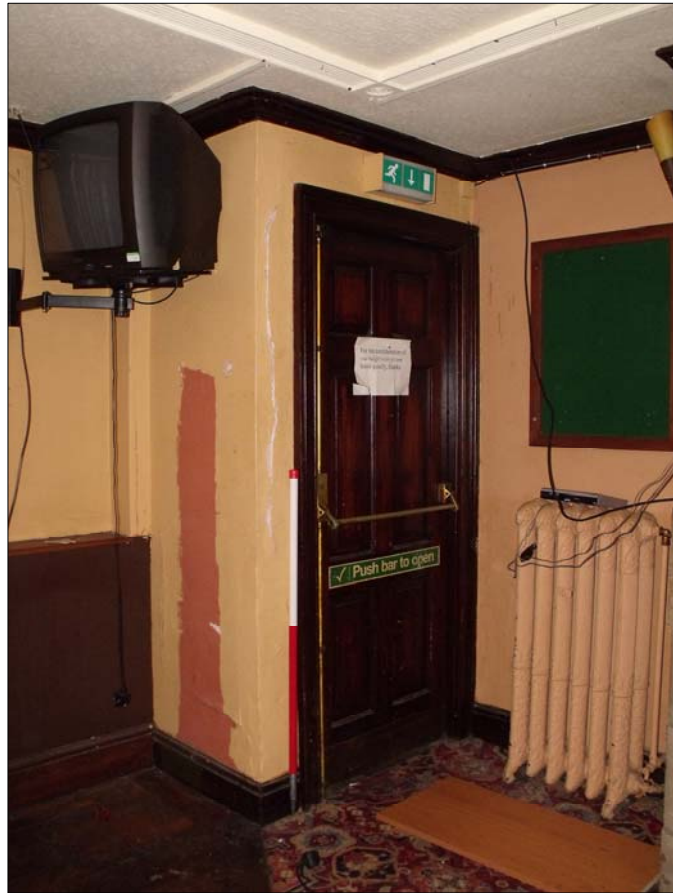
Fig 10: George & Dragon Hotel GF1 showing the, rear of the north-eastern entrance. The new staircase will be to the right and this doorway will be blocked.

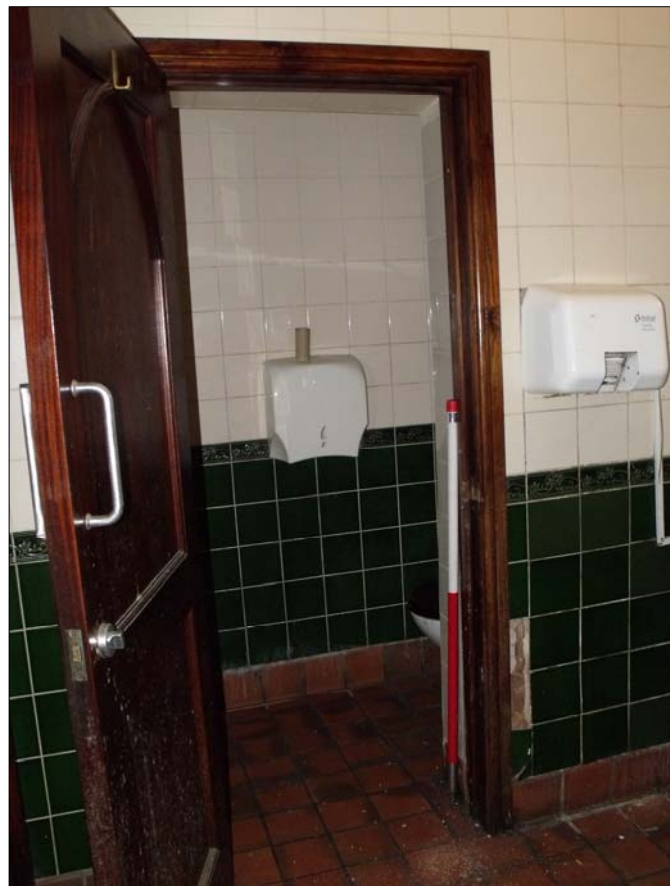
Fig 11: George & Dragon Hotel GF10 looking into room GF9 where a new doorway for a disabled toilet will be made giving access to lobby GF6.

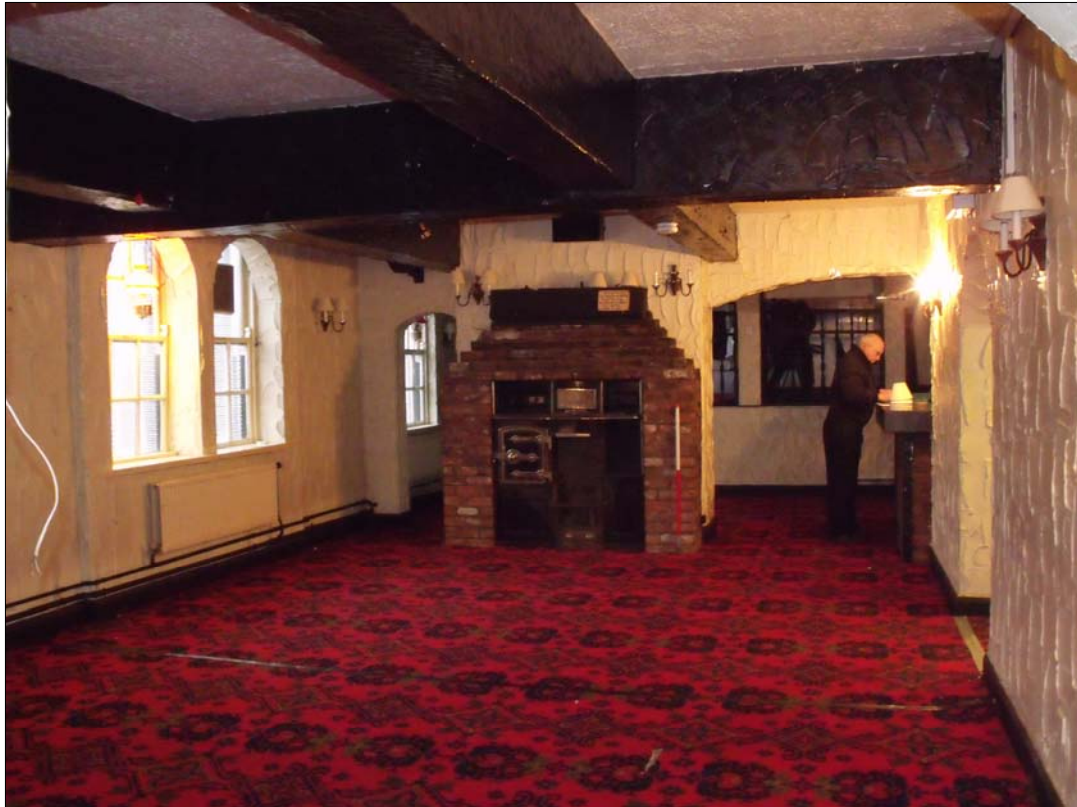
Fig 12: George & Dragon Hotel room FF6 looking eastward towards room FF7 and the site of the new staircase behind the inserted fireplace.

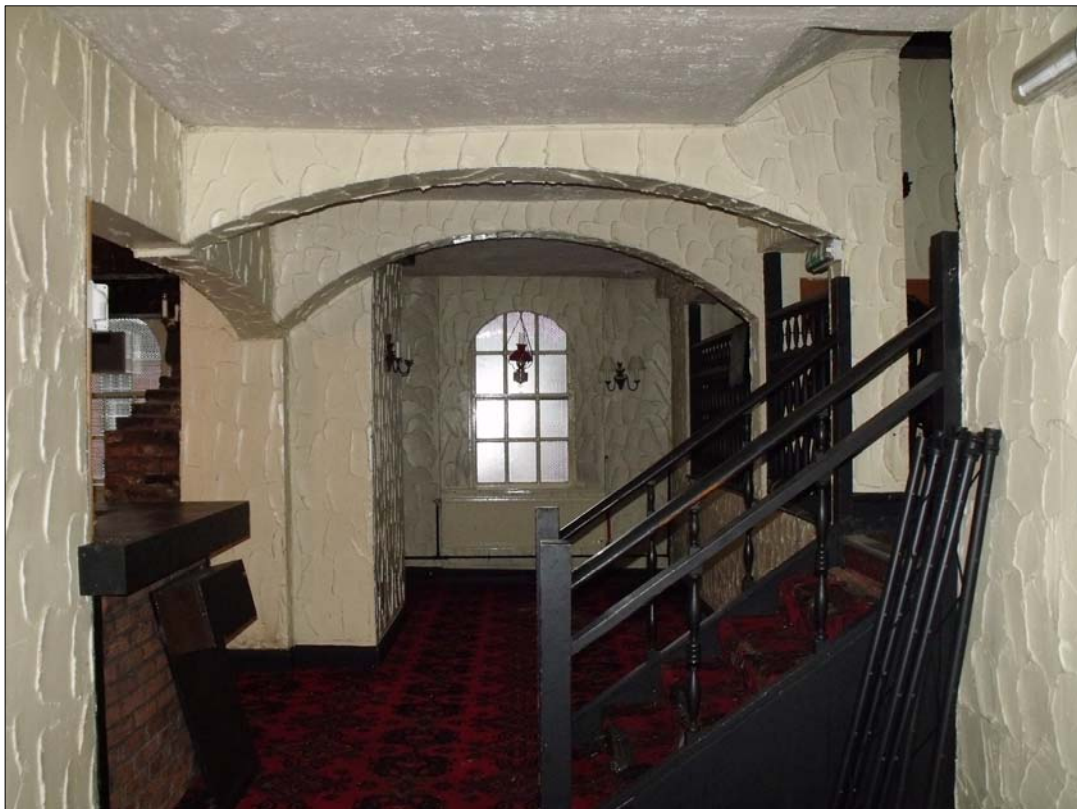
Fig 13: George & Dragon Hotel room FF7 looking north the window where the new staircase will be inserted.

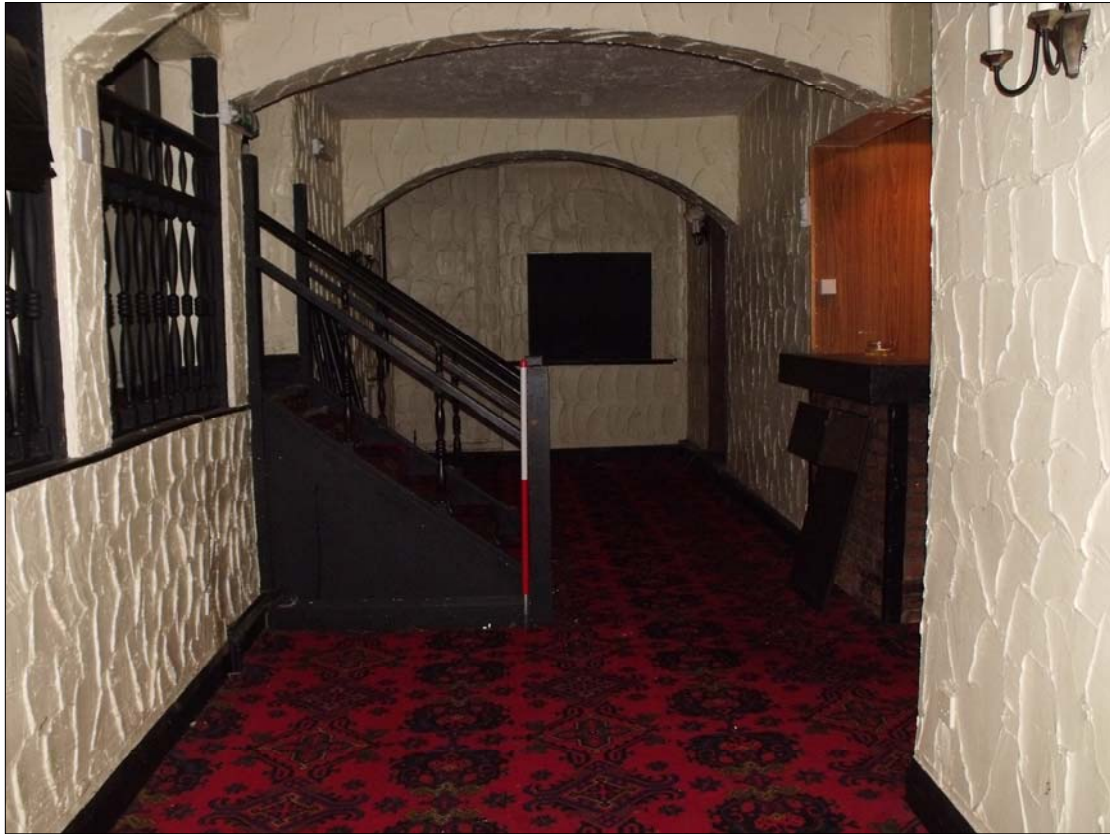
Fig 14: George & Dragon Hotel room FF7 looking south.

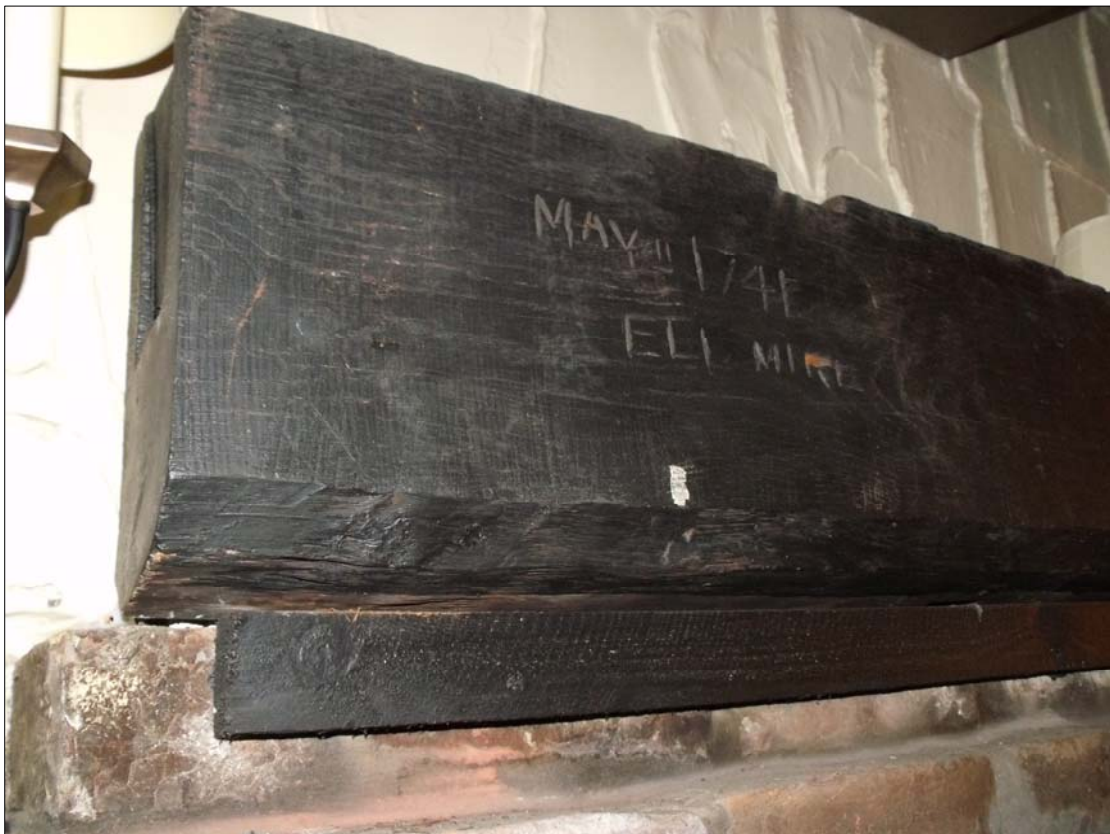
Internally, it was unclear what material formed the ground floor flooring, but the first floor was covered in narrow pine floorboards. A large section of re-used oak purlin in FF6 sat above the western face of the fireplace. This had the inscription 'May II 1741 ELI MIRE' (**Fig 15**) and a note stating that this had been retrieved from the roof during restoration work.

Fig 15: George & Dragon Hotel room FF6 looking at the inscription on the re-used purlin, dated '1741', above the fireplace.

The roof structure was not investigated as part of the current survey, although a brief inspection indicated that the rafters above the eastern three bays were 20th century softwood timbers, indicating that part of the roof had been replaced in the 20th century and supporting the note by the re-used purlin in room FF6. A large gable-end wall was also visible between the second and third bays (that is room FF1 to the east and FF8 and FF6 to the west).

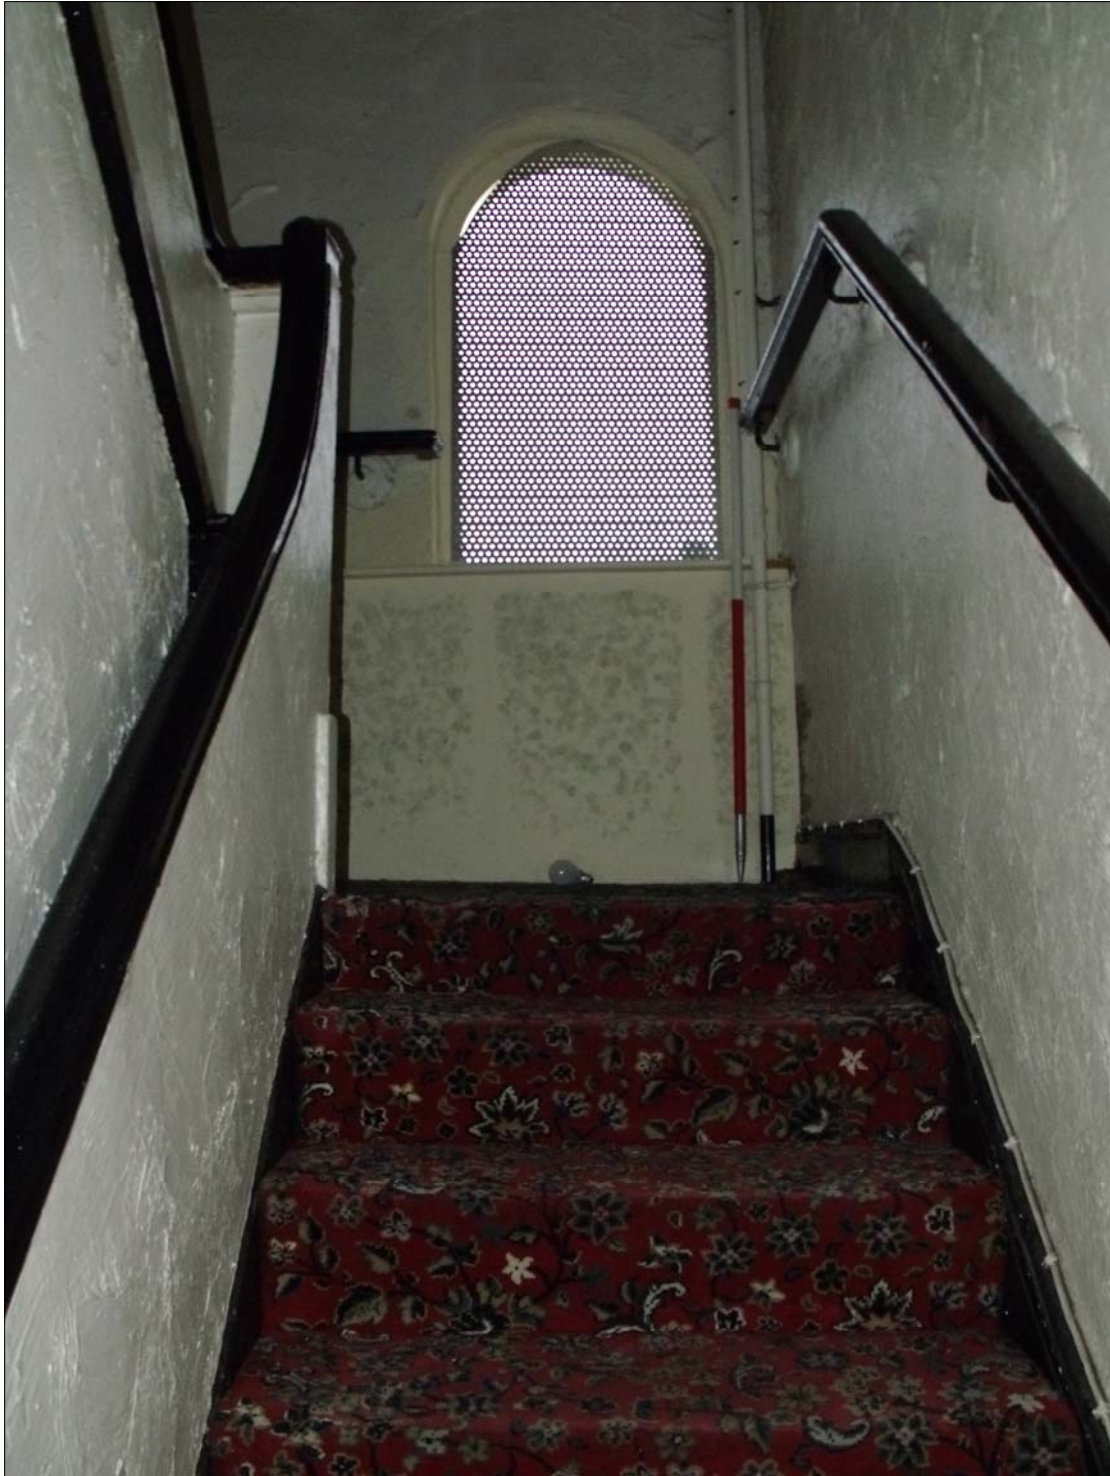
The second floor and roof structure of the main northern range were not investigated for the present study, although it was noted that the staircase (**Fig 16**) contained a curved banister rail and the second floor retained some six inch skirting, both of which might be earlier features.

Fig16: George & Dragon Hotel FF1 looking southwards up the Georgian-period staircase to the second floor.
