## Archaeological Excavation

Chimney and Privy  
Tower Excavation,  
Ditherington Flaxmill,  
Ditherington,  
Shropshire

SA/2019/79

**Project:** Chimney and Privy Tower, Ditherington Flaxmill: Archaeological Excavation

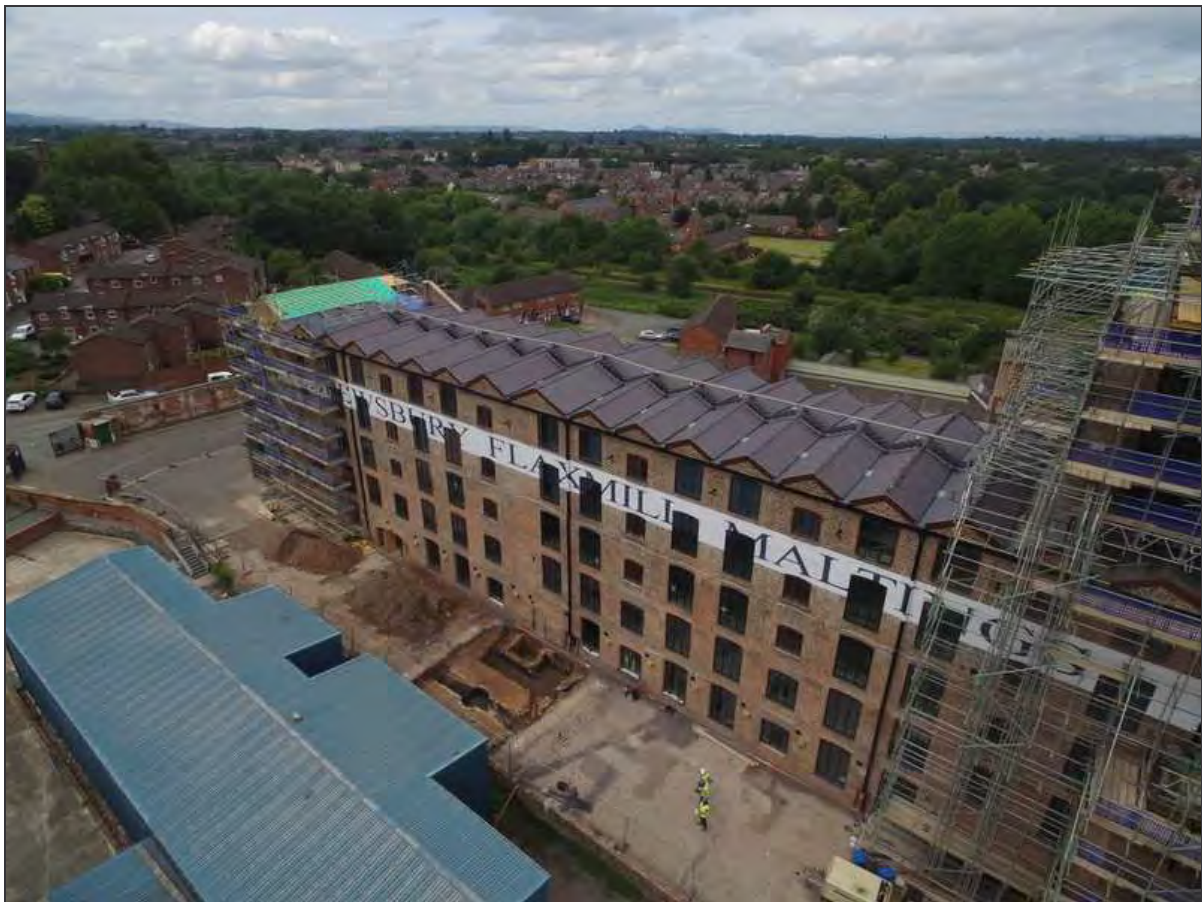
*Plate 1: Recent aerial view across the Main Mill and excavation area*

This most recent scheme of works comprised a full examination of two small but intriguing elements of the mill; the Main Mill privy tower; and the adjacent boiler-house chimney. The excavation was situated on the east side of flax mill complex, immediately adjacent to the late eighteenth-century Main Mill (Plate 1; Figure 1). This area saw initial development in the late-eighteenth century but remained largely undeveloped until the creation of two new detached boiler houses in the mid-nineteenth century. These changes were prompted by both the installation of new textile machinery in the mill and improvements to steam plant, which necessitated larger and more efficient boilers. Earlier archaeological test pits undertaken by Oxford Archaeology North in 2016 (OA North 2018) revealed remains of the chimney base, and poorly-preserved elements of the north boiler house.

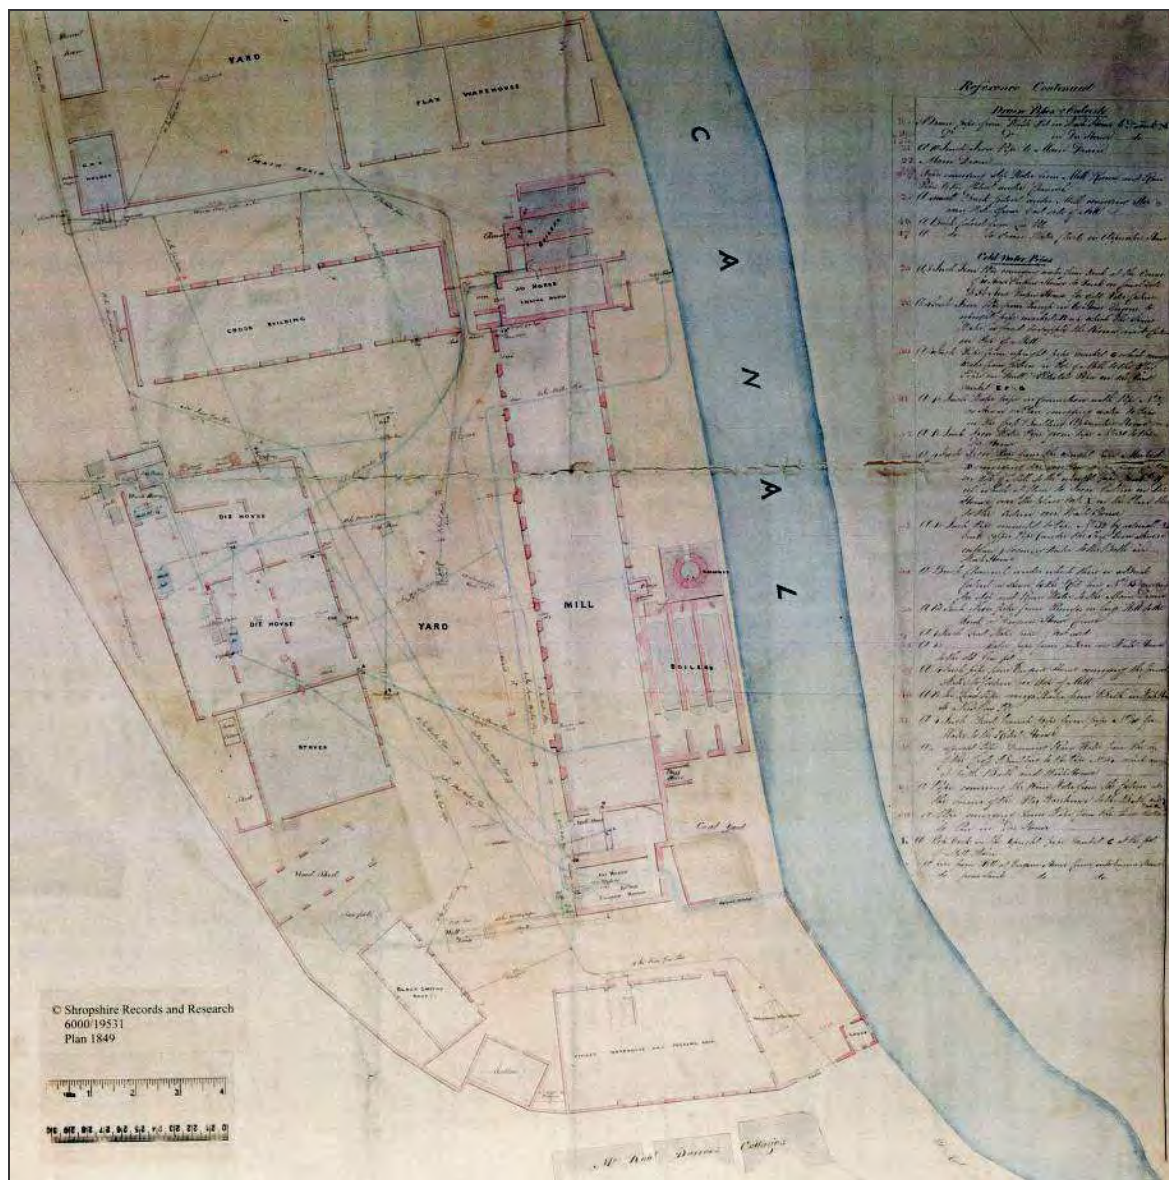
A plan of the site dated 1849 shows only the portion of the mill site including and south of the flax warehouse (Plate 2). The plan is quite detailed, showing internal divisions within the buildings, and the positions of boilers, engines and other features. The gas holder and thread room are shown to the west of the flax warehouse, and to the west of these 'Rack Poles' are marked. Rack poles were structures to enable drying the thread and yarn outside, this took place in this area for a number of years, until the railway sidings were constructed in 1858 (MacLeod *et al* 1988, 42). To the south of the dye house and stove, a woodshed is marked, with a saw pit to its south. A well is marked in the yard to its east. Stables, privies, and the office, warehouse and packing shop, are shown along the southern boundary of the site. A lodge and gateway are depicted in the south-east corner of the site, and a weighing machine is marked just inside of this site entrance.

Plate 2: Extract from the 1849 plan of the mill

The base of the vertical shaft of the chimney initially appeared to have been positioned slightly off-centre, on its western side (Plate 20). However, the removal of the original western part of the chimney base plinth, and its refacing with a stepped wall of refractory brick suggests that the chimney base was originally of similar width, with the vertical shaft placed centrally, as shown in original drawings of the mid-nineteenth century (Plates 2 and 3).

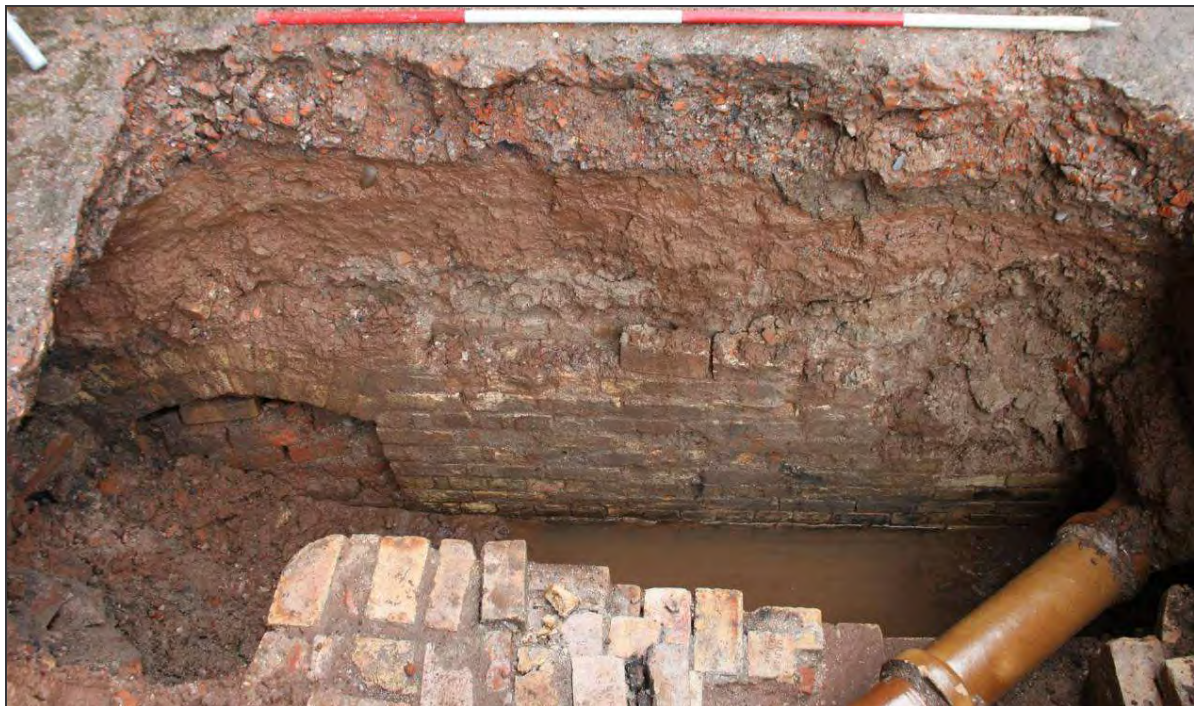
*Plate 5: Watching brief trench showing remains of the flue located to the north of the chimney*

A rectangular test pit measuring 2.5 x 1.8m was placed to the east of the Main Mill, in the position of a large double boiler house, shown on plans from 1849. The trench was targeted on the central chimney between the two boiler houses, in order to assess levels of preservation to inform the position of drains required by the refurbishment of the mill complex. Excavation revealed substantial, well-preserved remains of the south wall of northern boiler house were revealed, 0.8m below the present concrete ground surface, and surviving to a depth of 1.85m below ground level (Plate 5). The partial floor of a flue of 0.56m width butted its southern side, and formed a surface to the north-west corner of chimney. This had a rounded corner and return into a further flue along its north face, which continued beyond the limit of excavation, where it appeared to have a bull-nosed return to the south, presumably into the base of the chimney. The northern boiler house wall was also of refractory brick with a 30" wide, segmentally-arched aperture at the western side of the trench (Plate 6), presumably into the western boiler bed. This was blocked subsequently with plain with red brick, demonstrating different phases of activity within the power system of the second half of the nineteenth century.

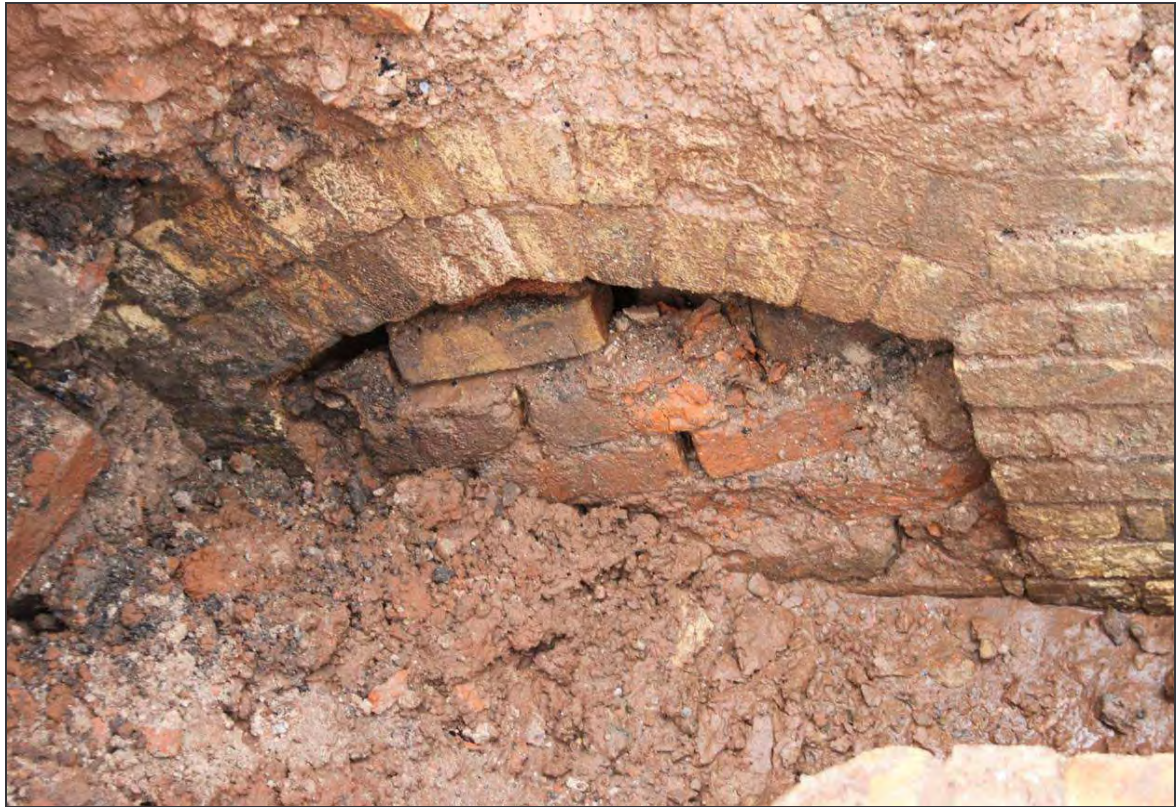
*Plate 6: Blocked aperture within the north wall of the flue leading to the north boiler house*

A sloping fire-brick base extended from the chimney into the east/west-aligned flue, which directed the exhaust gases from the three boilers into the chimney. An arched flue entrance set within an additional parallel wall located to the north of the chimney base, identified during the earlier watching brief (OA North 2018), represents one of three probable openings through which the exhaust gasses passed from the boilers into the flue (Plate 6).

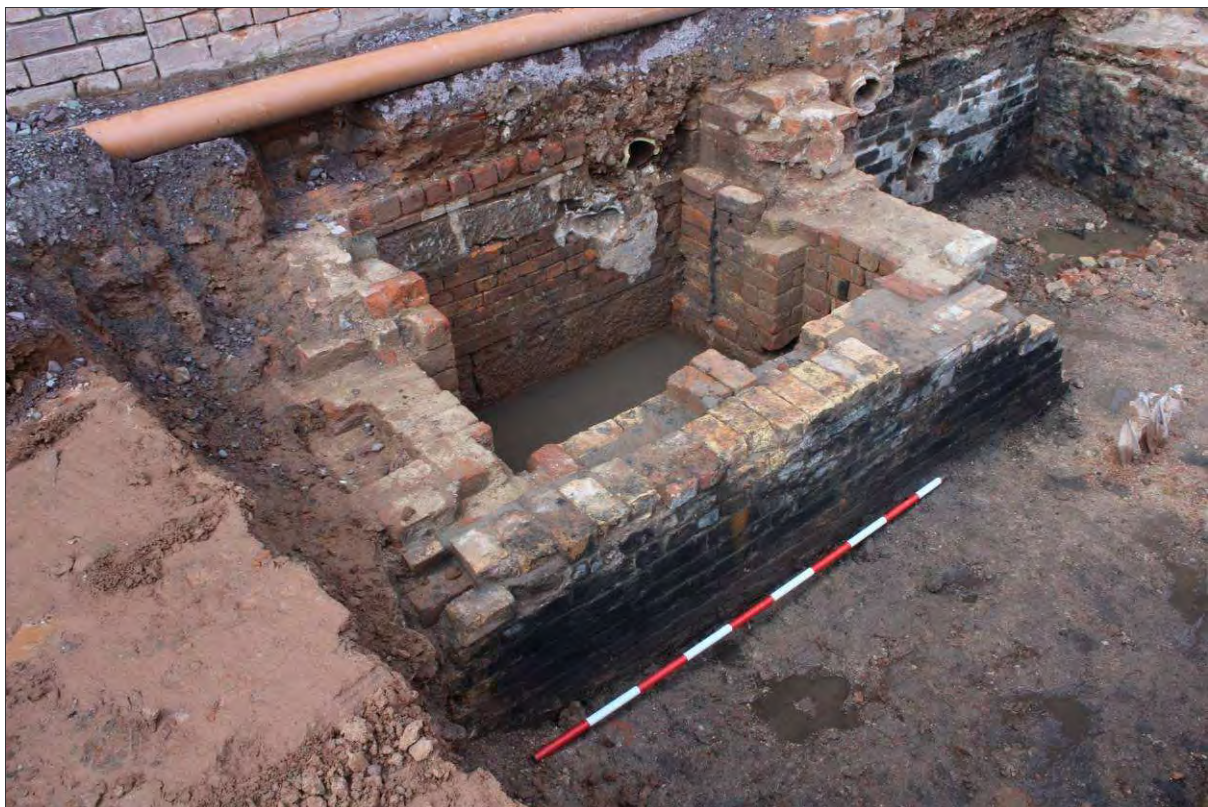
*Plate 8: General view of the privy tower. Note the soot-staining on wall 018 (2m scale)*

The earliest structural remains encountered belong to the privy tower and adjacent Main Mill, located in the south-west corner of the excavation. The tower was a three-sided structure positioned on the eastern side of the mill (Plate 8), measuring approximately 1.50 x 2.88m. Its interior footprint covered an area of 1.27 x 1.95m. The foundations of two walls (**016** and **017**) were identified as original components of the tower. The foundations had been subject to several phases of building and adaptation, occurring with updates to the privies, the creation of the adjacent boiler houses and the subsequent conversion and use of the site as a maltings.

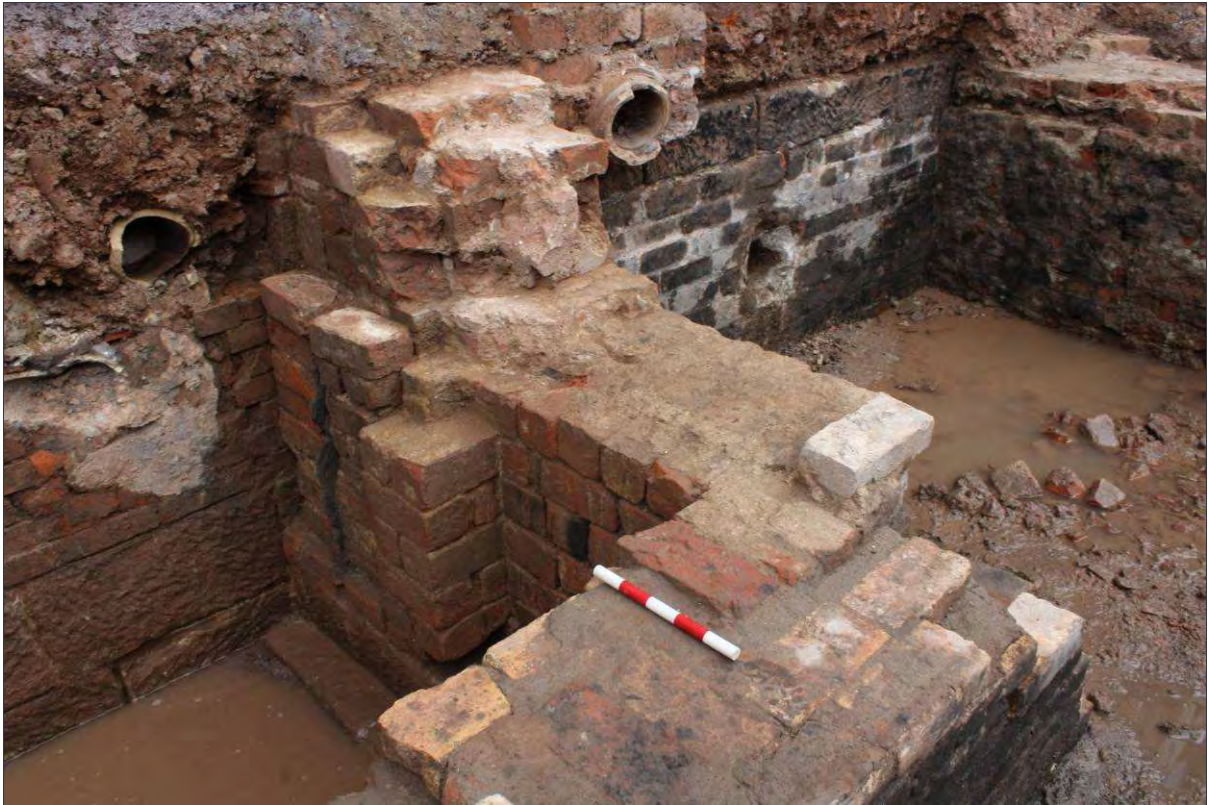
*Plate 9: The south-western returning pier of wall 017 around which wall 018 had been constructed (0.25m scale)*

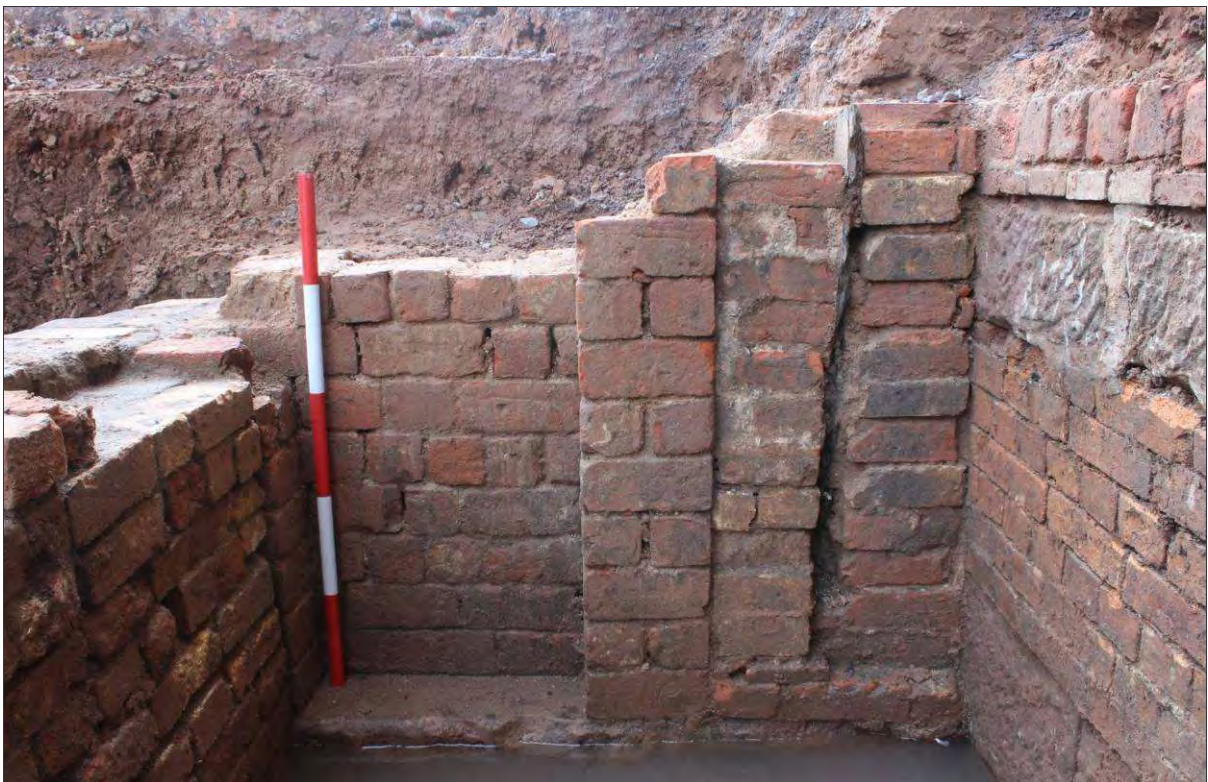
*Plate 10: South-west elevation of wall 016 (1m scale) Note the position of the projecting brick piers and later infill*

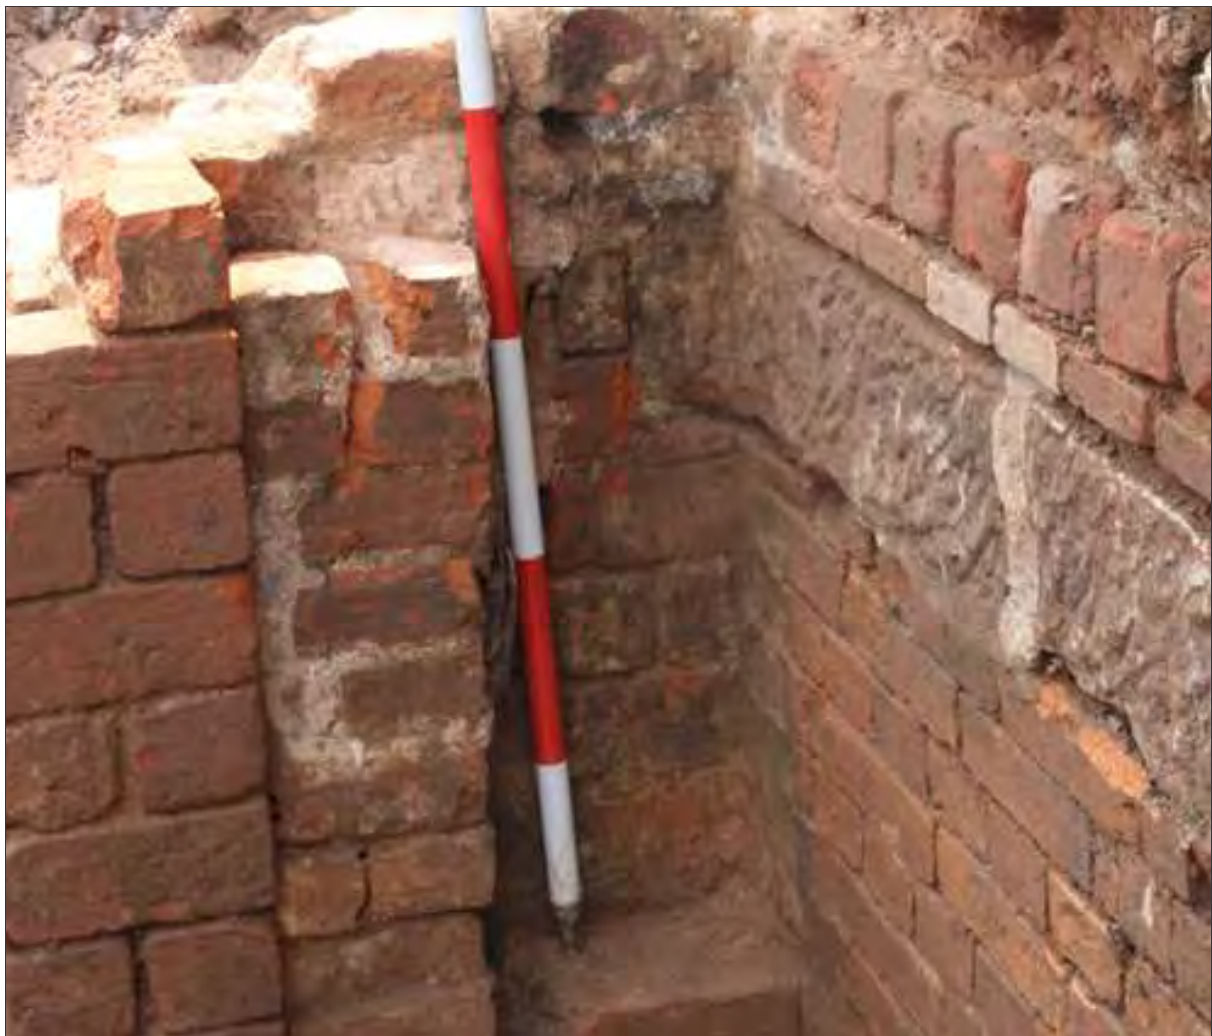
*Plate 11: Walls 016 after removing the brick infill (022) to reveal the rebated stone block*

A section of the infilled brickwork (**022**) in the south-west corner of the structure was carefully removed in order to examine the relationship between the privy tower and the Main Mill at foundation level (Plate 12). This demonstrated that the original fabric of the privy wall clearly continued behind the later brick infilling (**020**) in the Main Mill foundation (Plates 11 and 12), continuing below the upper stone course within the external wall of the mill (Plate 12). Removal of the infill between the pier and the Main Mill also importantly revealed that this course of dressed stonework had a projecting return into the side wall of the privy tower, carved within a single stone block in the exposed southern rebate (Plate 12), confirming that the privy tower formed part of the original construction of the Main Mill.

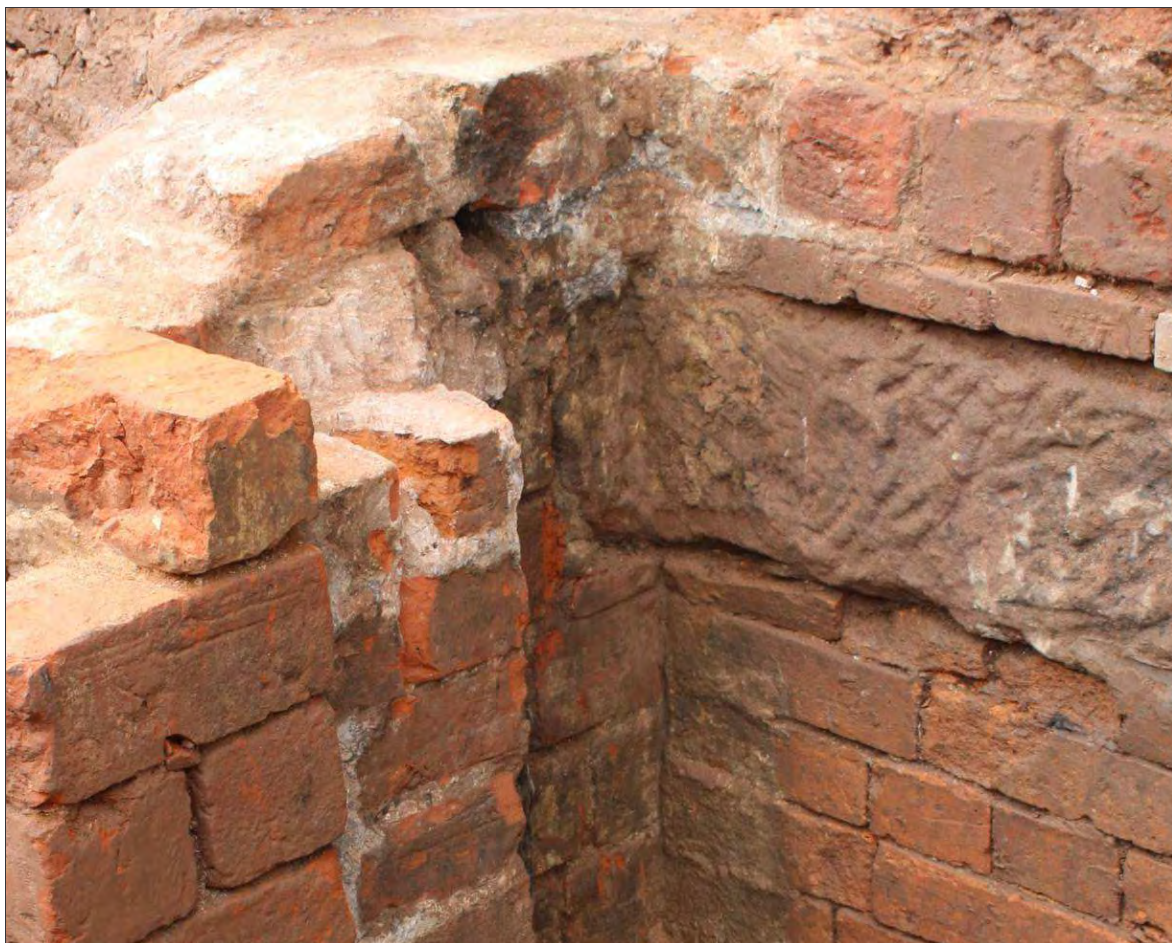
*Plate 12: Detail of rebated stone block. Note the tile packing added below the stone.*

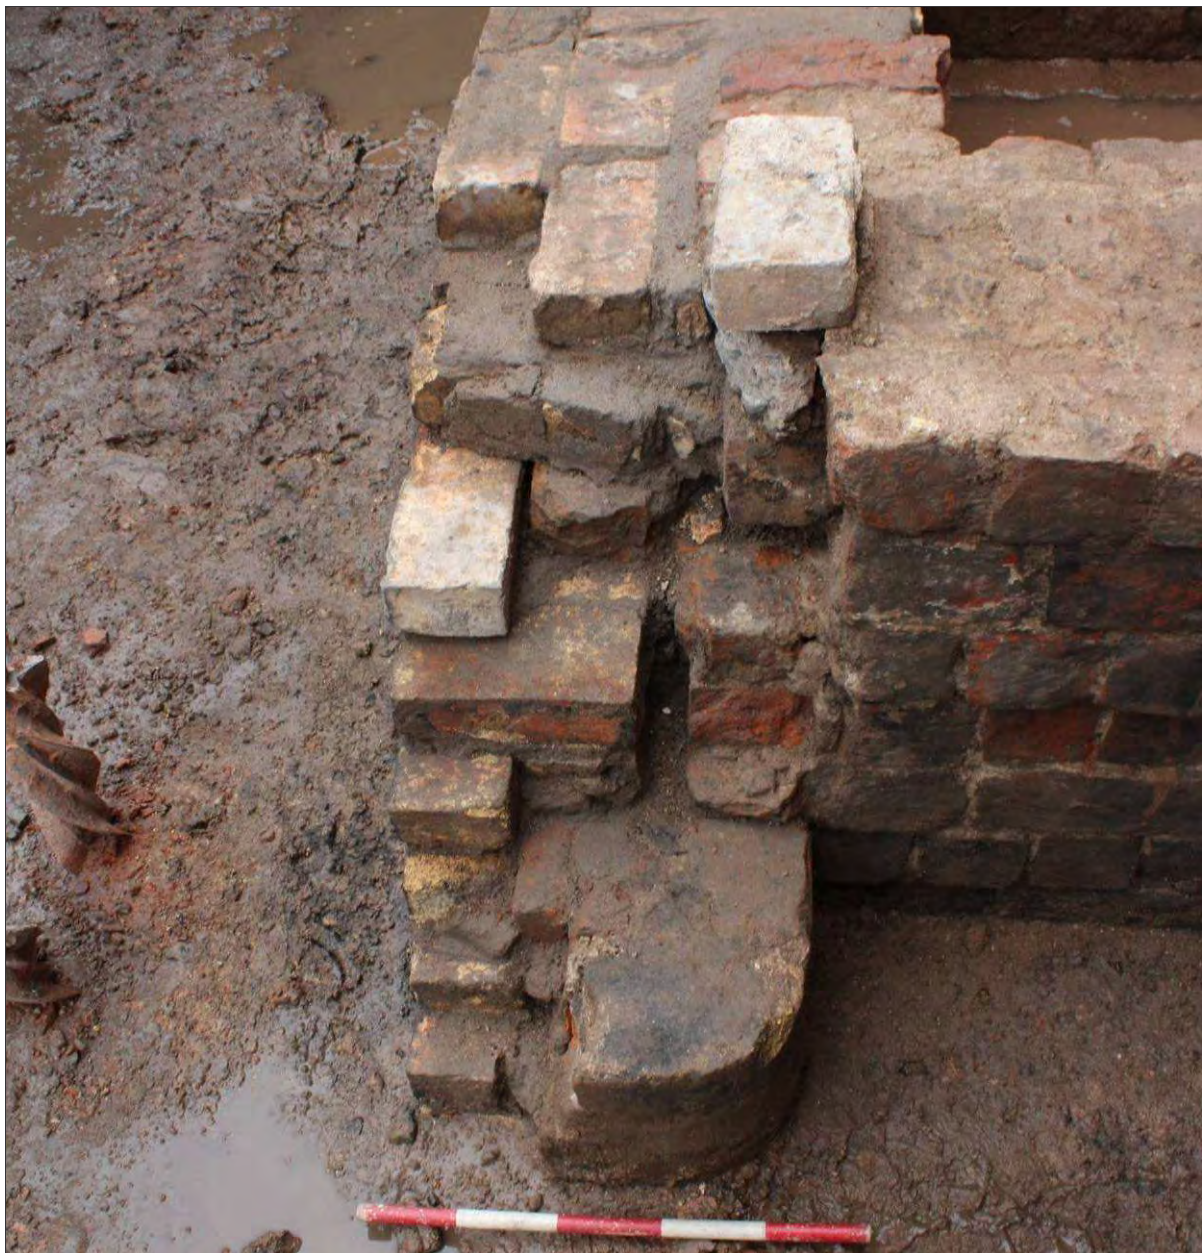
*Plate 13: North-eastern end of wall 017, looking south-west (0.50m scale)*

It was constructed using a mixture of hand-made brick and refractory brick, bonded with a grey, ash-rich mortar, indicative of a late nineteenth-century date. Whilst the northern and southern walls of the privy tower were of two brick thickness, it is unclear whether the remodelled eastern wall represents the addition of a one-brick thick wall to an existing wall of similar thickness, or the refacing of a wall of similar thickness to the side walls, presumably to protect it from the heat of the exhaust gases that were being channelled into this space during the later phase of the boiler house operation. The northward extension beyond the privy tower was faced with bull-nosed bricks around its north-western corner (Plate 13), suggesting that the damaged north-eastern face was also bull-nosed to aid airflow through the chamber (Fig 2).

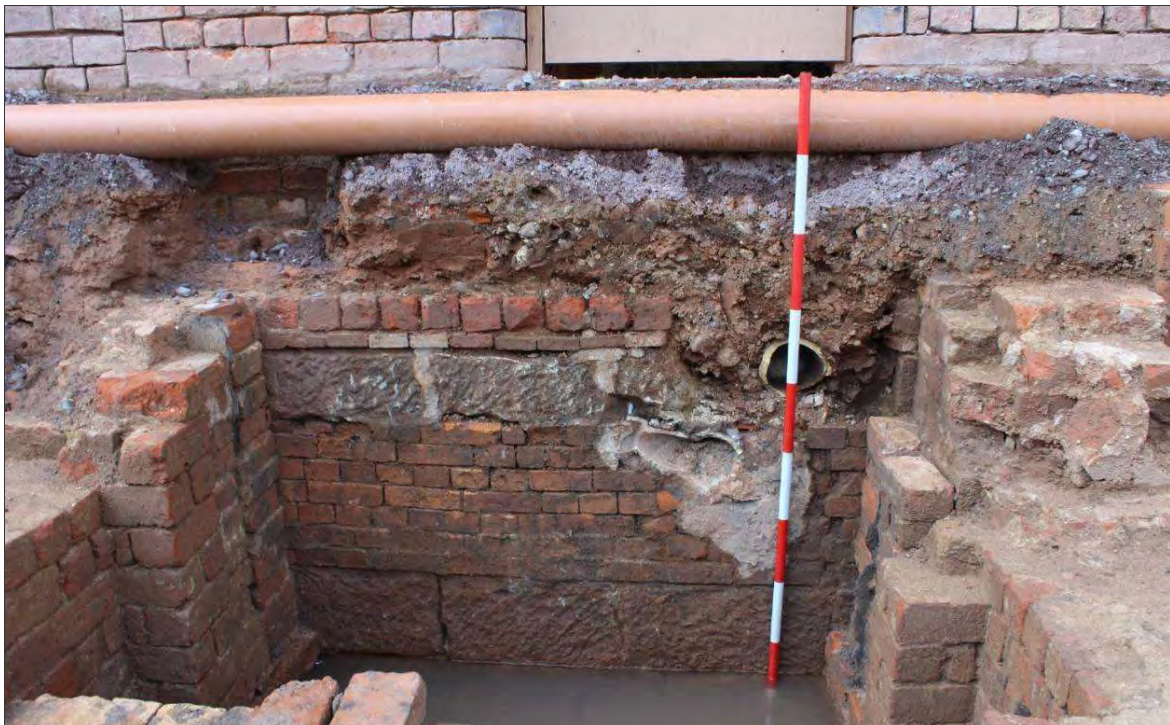
*Plate 14: North-west elevation of the foundation of the Main Mill, wall 019 (2m scale, 20cm increments) Note the stone courses, brick infill and later truncations*

Within the area of wall exposed at the rear of the privy tower, the base of the exposed wall comprises two courses of roughly-dressed and tooled, rectangular stone blocks, each 1' (0.30m) tall, the lower being submerged below the water table (Plate 14). This differed markedly to the area of exposed plinth to the north of the privy tower, which although not excavated to the same depth, did not have any evidence for a stone footing to the plinth at a similar level, instead having a continuation of the face of great' bricks (Plate 15). Both sections of the wall face have a further course of 8" (0.20m) thick dressed sandstone, placed 2'6" (0.76m) below ground level, and similarly cut to that within the privy tower below (Plates 14 and 15). As described above, the exposed stone block at the southern end of the privy tower was cut to project beyond the wall face of the Main Mill, keying it into the brick wall of the privy tower (Plate 12). Within the area of the privy tower, the space between the two elements of stone courses within the Main Mill wall plinth was infilled with seven courses of brickwork. This included both hand-made and machine-made brick, with all but the lower course, which was of stretcher facing, comprising a mixture of headers and stretchers (Plate 14). It was tightly bonded in a grey cementitious mortar, clearly representing a refacing, or rebuilding of this part of the wall, but continued behind the two areas of infilling (**023** and **025**) within the side walls of the privy tower (Plate 14).

Both the upper band of stone and the brick and tile course above were cut by a late ceramic drain, placed within a clay fill of its trench (Plate 14), and presumably dating from the later phases of malting occupation of the site. Below this, and cut through the brick infill between the two stone elements of the wall was an irregular cut retaining the broken section of a ceramic elbow reducer pipe from a water closet. This almost certainly dates from the installation of flushing toilets within the privy tower, possibly predating the closure of the flax mill in the 1880s. The pipe lies within the upper part of a cut infilled with concrete, which extends into the cut for the pipe above, and has the later ceramic salt-glazed pipe embedded within its upper surface (Plate 14), demonstrating that the concrete is contemporary with the later pipe, that almost certainly replaced the earlier plumbing for water closets. The concrete has large brick inclusions, similar to late floors within both the north and south engine houses, suggesting a date around the turn of the twentieth century for its insertion, corresponding to the earliest phase of the use of the complex as a maltings.

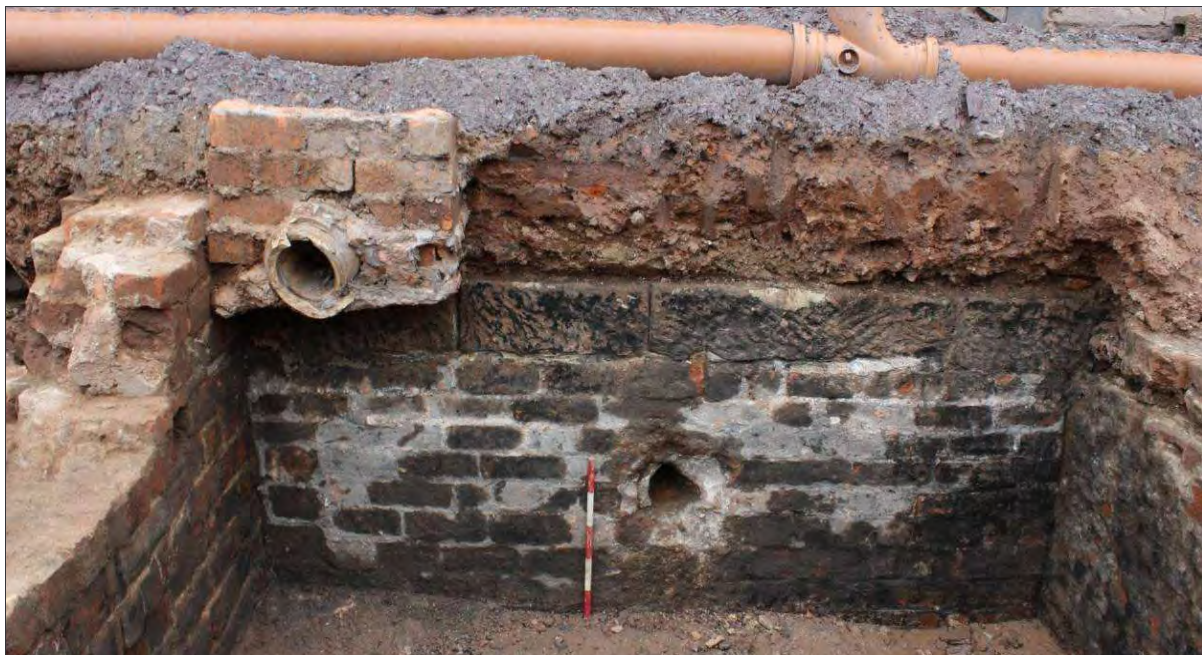
*Plate 15: North-west elevation of the mill foundation visible to the north of the privy tower. Note the soot-staining on the face of the wall*

Two further pipes were cut through the east wall of the mill in the western section of the excavation trench to the north of the privy tower (Plate 15). The lower of these was a cast-iron pipe, placed within a round cut through the brick wall, with concrete infill around the pipe similar to that observed within the wall to the south (Plate 15), suggesting that it related to the early maltings phase around the turn of the twentieth century. A ceramic pipe set within a brick surface drain projected from the wall above the height of the plinth (Plate 15), and appears to be of much later twentieth-century date.

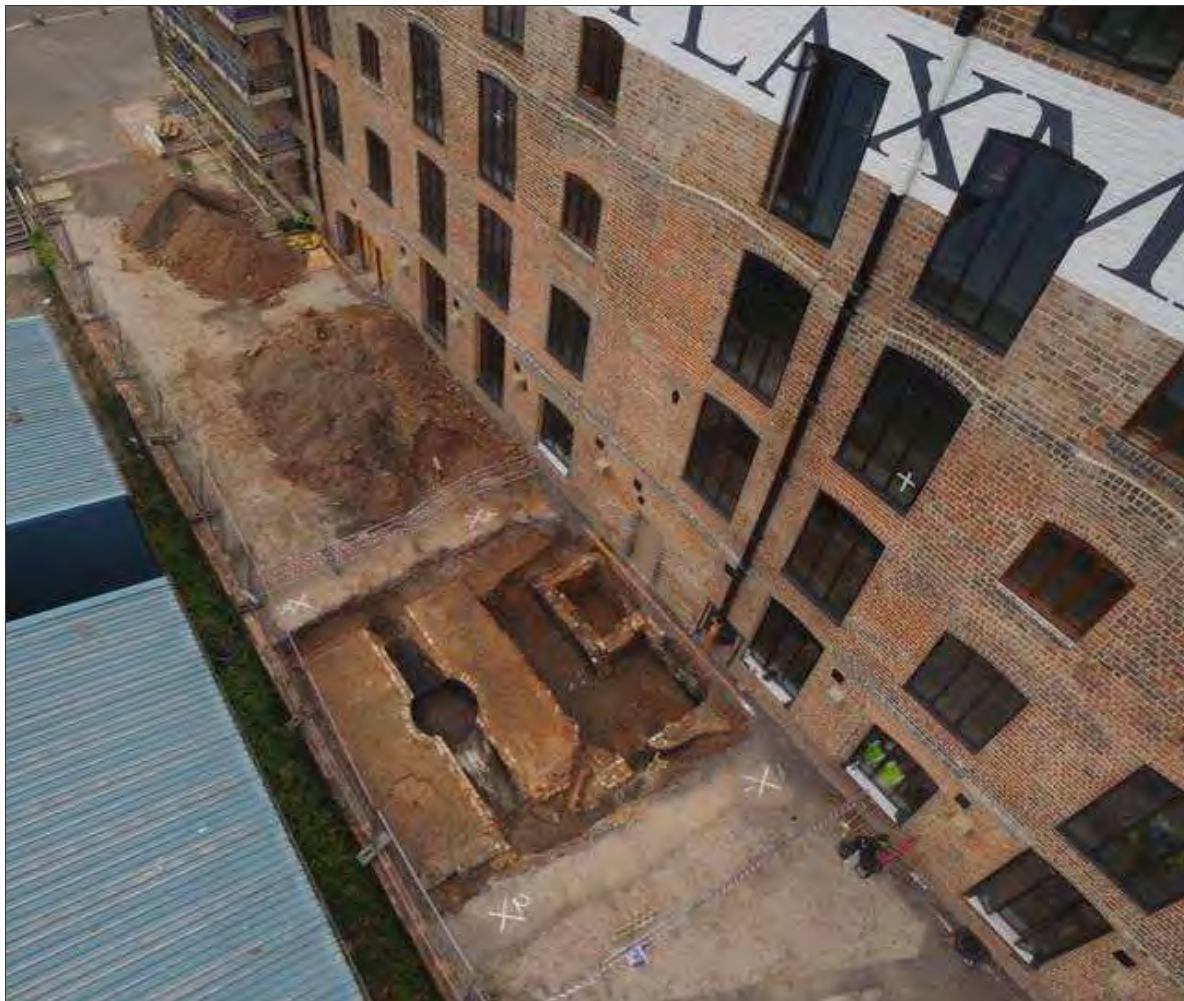
*Plate 16: Chimney base revealed in the eastern half of the excavation, looking north-east (2m scale)*

The base of the chimney was exposed in the eastern part of the excavation trench, at the relatively shallow depth of 0.55m below present ground level (Plate 16). The broadly rectangular structure had maximum dimensions of 6.73 x 5.28m and survived to a maximum depth of 1.15m below its upper extant surface. It had four main components, comprising a stone base, a brick superstructure, a vertical shaft, and two horizontal flues (Fig; Plate 16).

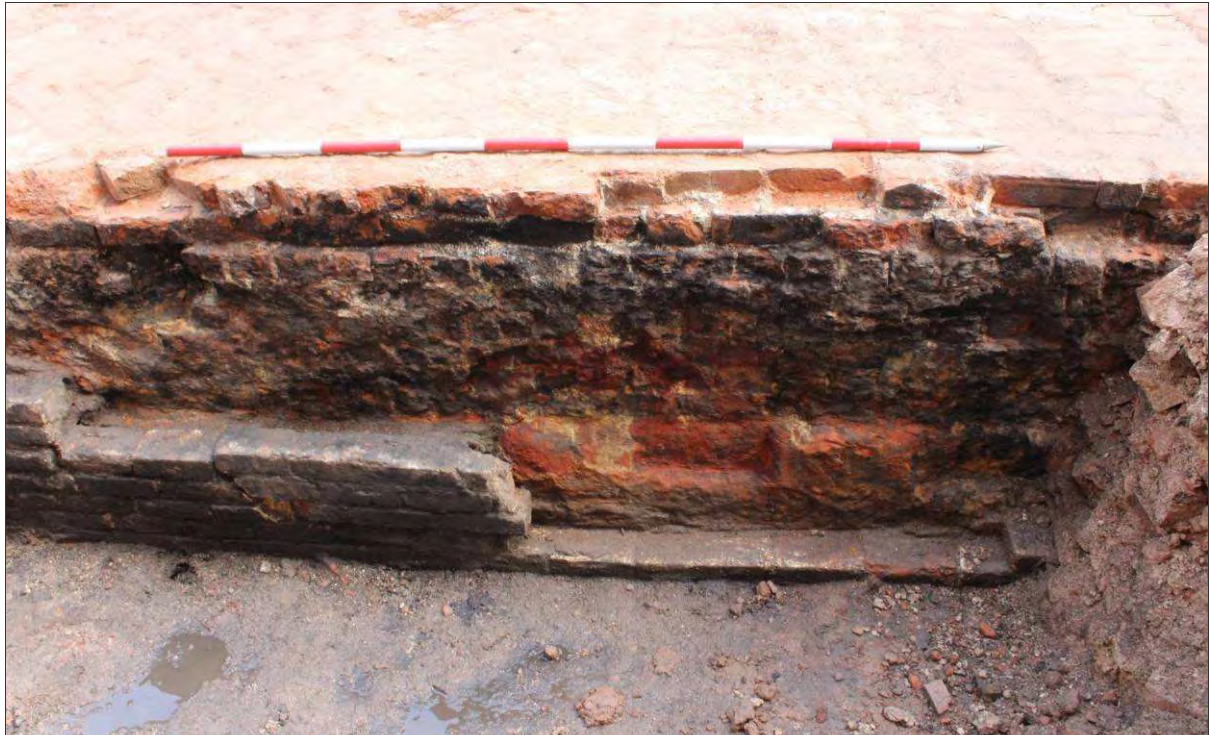
*Plate 17: West elevation of the chimney showing exposed courses of stone base, partially obscured by a later skin of firebrick (2m scale)*

At the base of the chimney was a stone footing, presumably forming a solid base across the entirety of the structure. Two courses of sandstone blocks, each of approximately 0.18m height, were visible in the western elevation of the chimney base (Plates 17 and 18). The upper course of stone had been exposed to extreme heat, following remodelling of the chimney base in the 1870s, causing both discolouration and deterioration, making it hard to determine its natural hue, which varied from light orange to yellow. The lower course of masonry appeared less damaged. The remainder of the stonework was obscured by a skin of refractory bricks (**015**), which faced the remainder of western side of the chimney base (Plate 17).

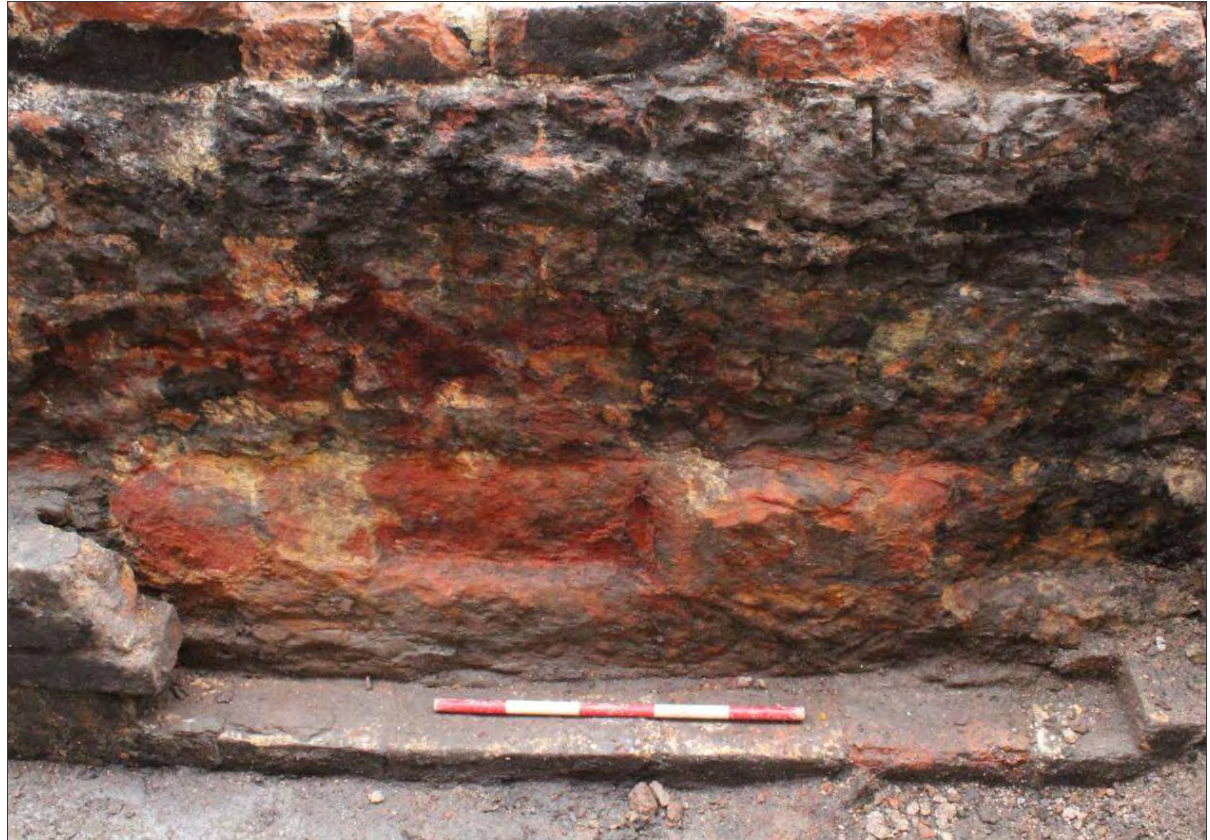
*Plate 18: Close-up of exposed stonework at the foot of the chimney base (0.50m scale)*

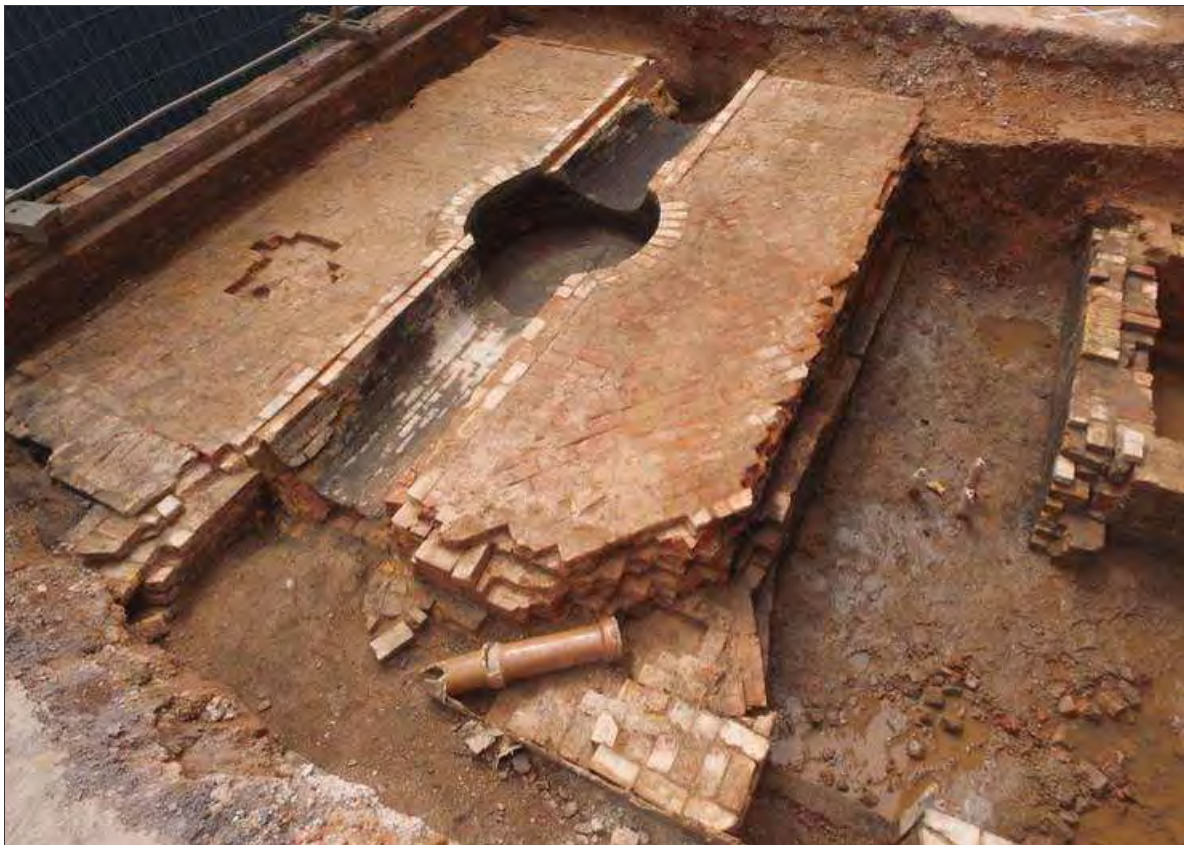
*Plate 19: The chimney base from the north, with remodelled flue from the boiler house in foreground*

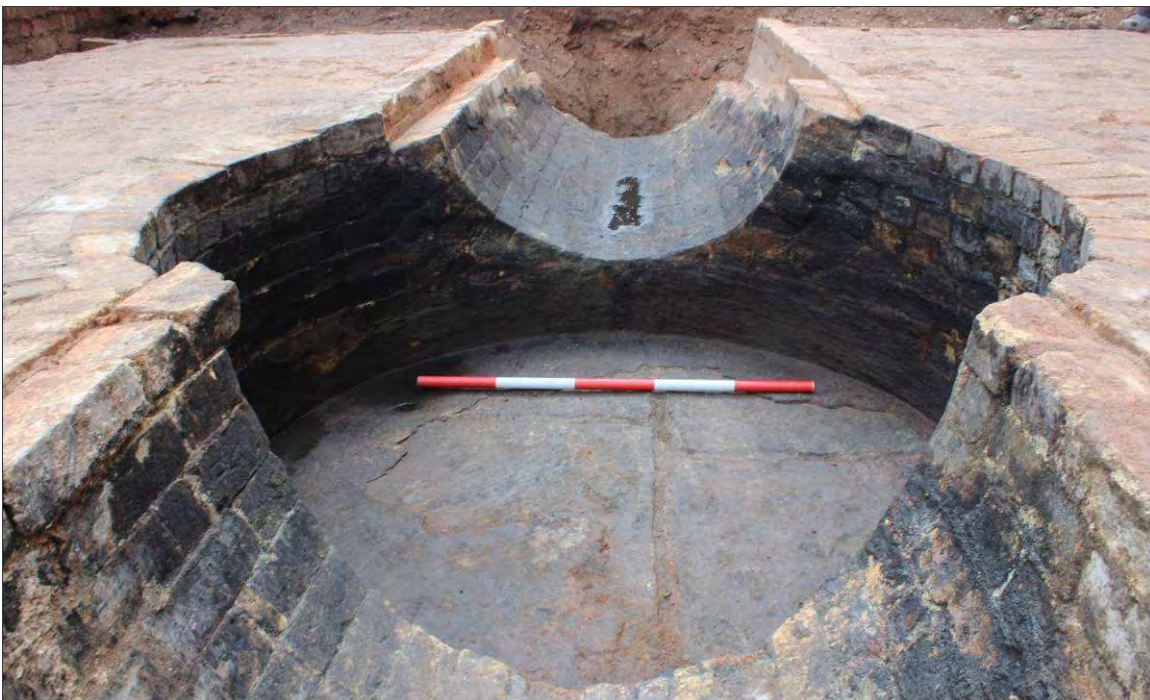
*Plate 21: Profile of horizontal flue, with stone base of vertical shaft*

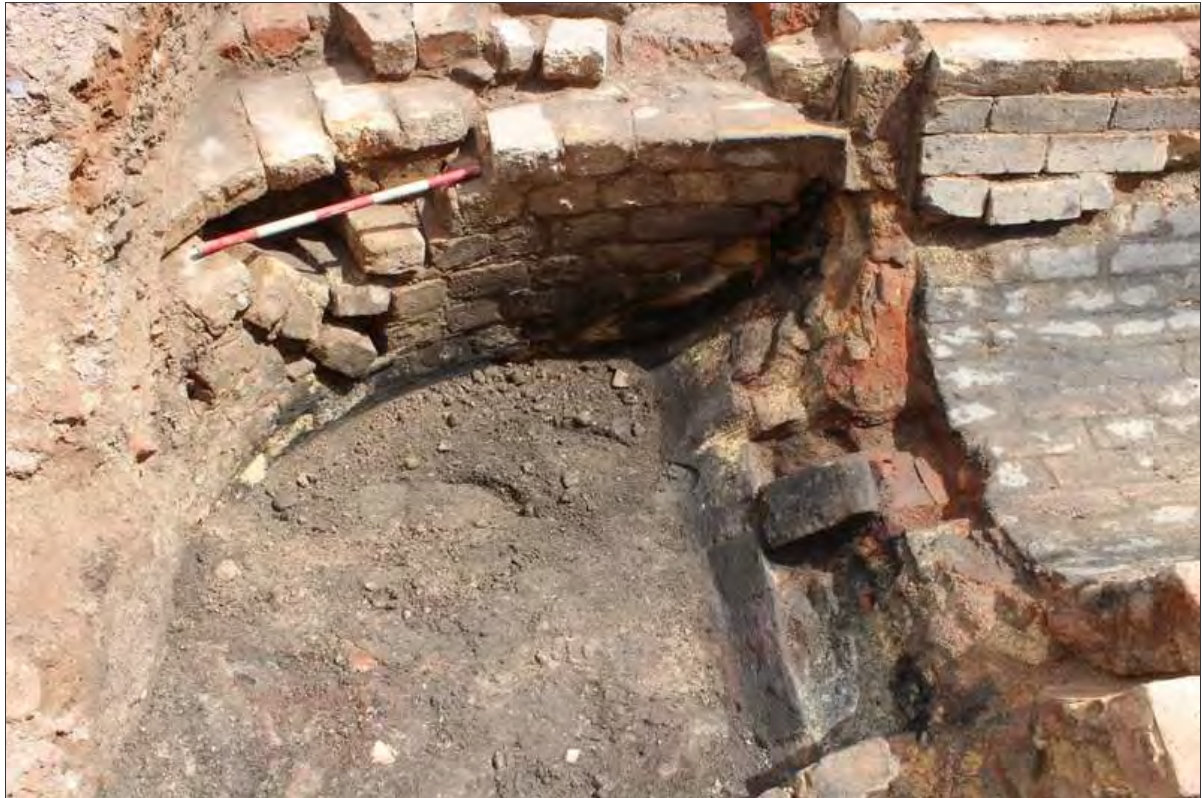
*Plate 22: Ramp at northern end of horizontal flue, with position of possible damper surround at junction with chimney base*

The flue was badly damaged at its northern end, but retained remnants of a steeply sloping ramp of heavily degraded and sooted refractory brick (Plate 22), demonstrating that the flue from the rear of the boilers was placed at a lower level. The curving wall of the flue also survived on the western side of this ramp, providing a smooth curve for gases from the rear of the northern boiler house into the base of the chimney (Plate 20).

The eastern side of this flue aperture had been remodelled, but retained a rebate in its eastern wall at the top of the ramped section of wall, suggesting the position of the cast-iron housing for a damper (Plate 22). The ramp at the southern end began within the main body of the flue, with sooted sloping refractory bricks continuing immediately to the south (Plates 7 and 23). Furthermore, there was no evidence for a damper, as at the northern end of the chimney base, suggesting that it formed a seal on the northern side of the chimney in the period between the construction of the southern and northern boiler houses.
