## Archaeological Excavation

Chimney and Privy  
Tower Excavation,  
Ditherington Flaxmill,  
Ditherington,  
Shropshire

SA/2019/79

**Project:** Chimney and Privy Tower, Ditherington Flaxmill: Archaeological Excavation

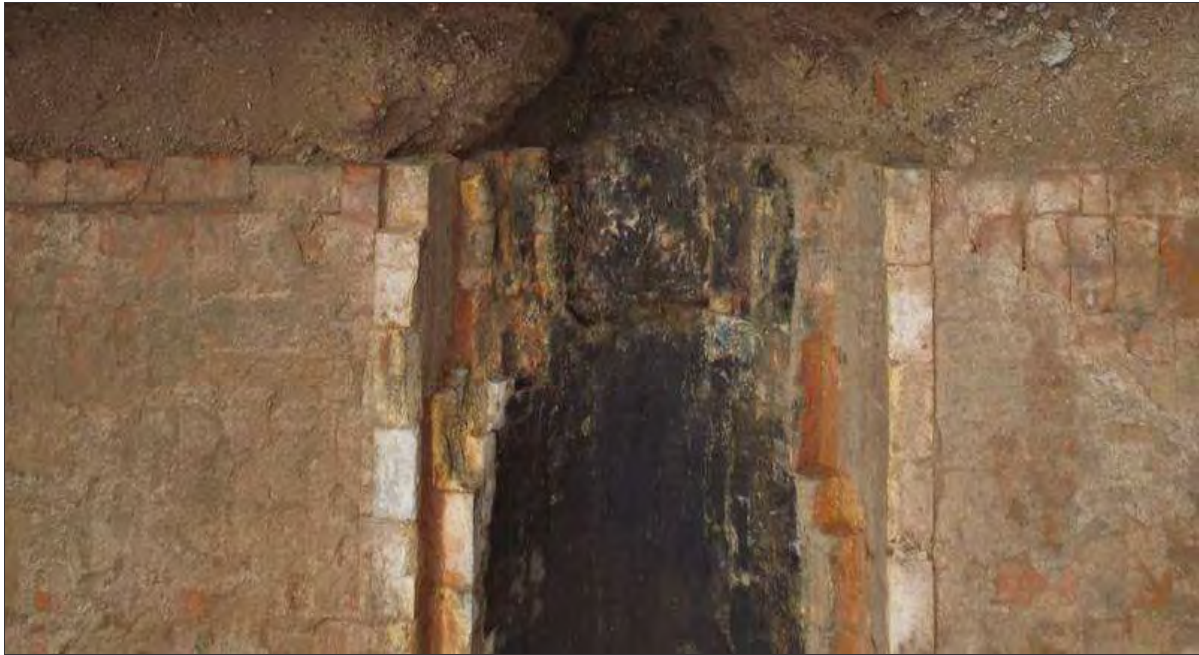
*Plate 23: Ramp at southern end of horizontal flue, beginning within the chimney base*

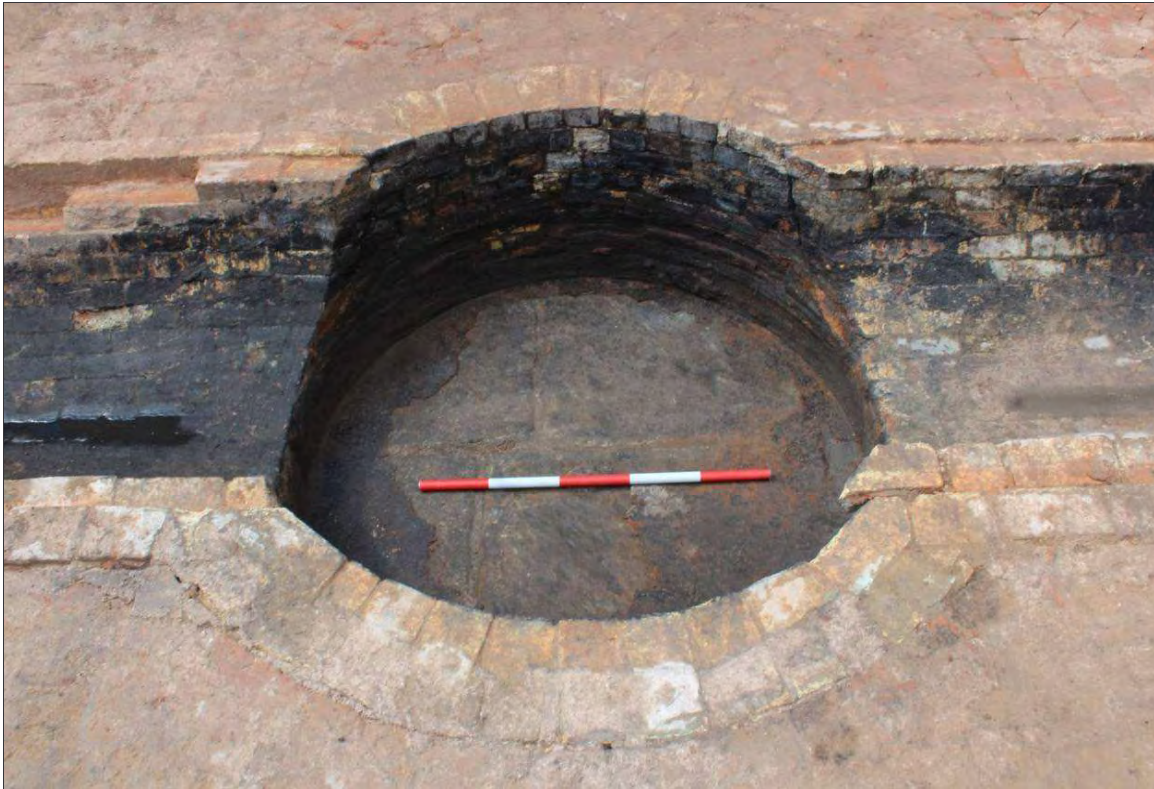
*Plate 24: Base of vertical shaft of the chimney looking north-west (1m scale)*

The base of the shaft, at a depth of 0.67m below its upper survival level was of large, dressed, rectangular sandstone blocks, placed at a similar level to those observed in the western elevation of the base (Plates 21 and 24), and bonded with a light yellowish-white, sandy lime-based mortar.

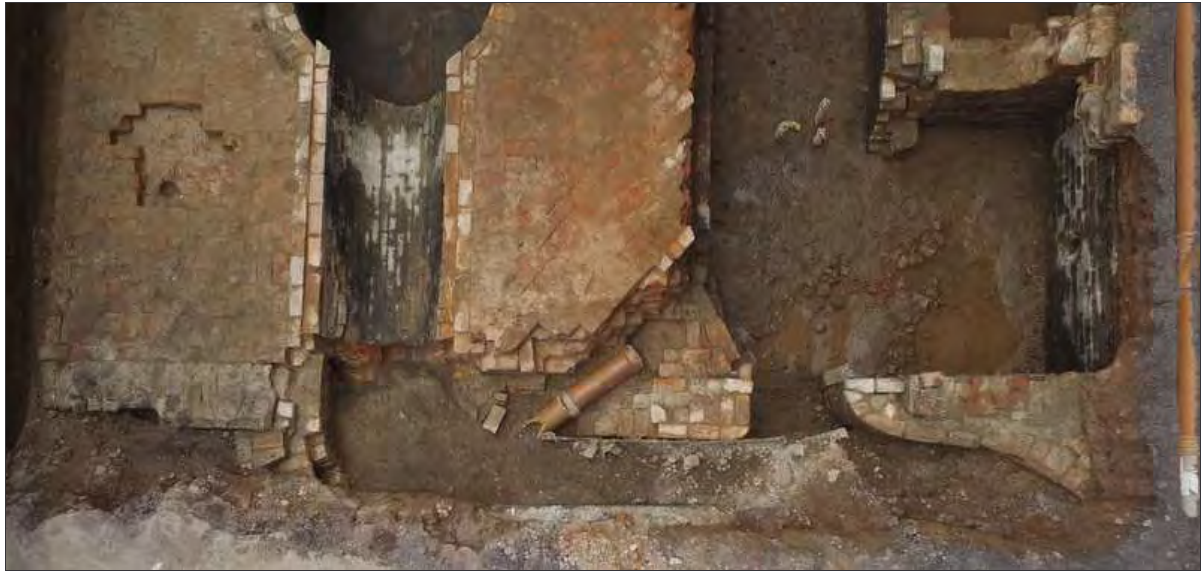
*Plate 25: Flues to the north of the chimney, partly forming the south gable of the northern boiler house*

A series of flues of more than one phase of construction survived to the immediate north of the chimney base (Plate 25) To the north-west of the chimney base, a remodelled wall (**010**) represents the rear wall of the flue from the northern boiler house to the chimney (Plates 25 and 26). The original element survived to a height of 0.83m and length of 1.75m from the east wall of the Main Mill, with its southern edge placed level with the northern extent of the chimney base (Plate 25). It appears to have been of 1'8" (0.51m), two-brick thickness, although much of this was removed from the northern side during the subsequent remodelling. It comprised hand-made brick, of similar dimensions to those within the chimney base, and was bonded with light, greyish-white lime-based mortar, strongly suggesting a mid-nineteenth-century date, consistent with the construction of the northern boiler house.

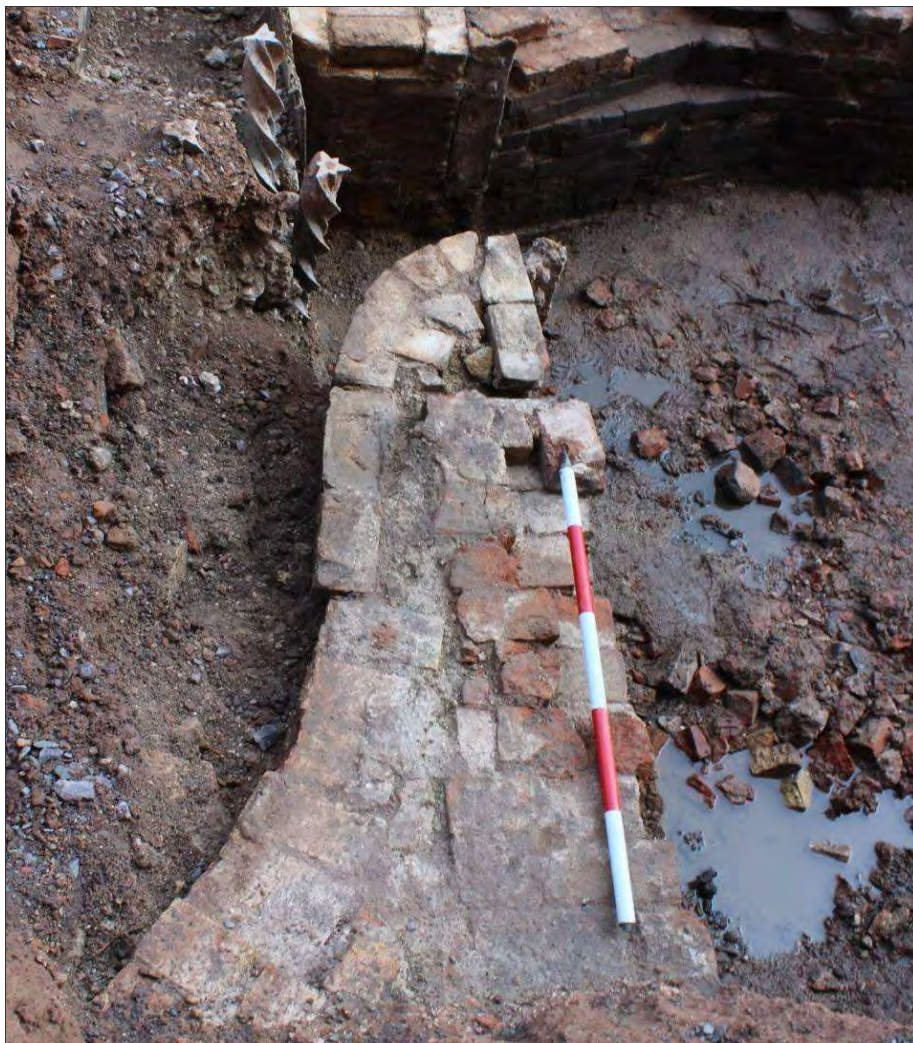
*Plate 26: Walls **010** and **013** looking south-east. Note the crude joint of wall **010** at the south-east end of wall **013** (1m scale)*

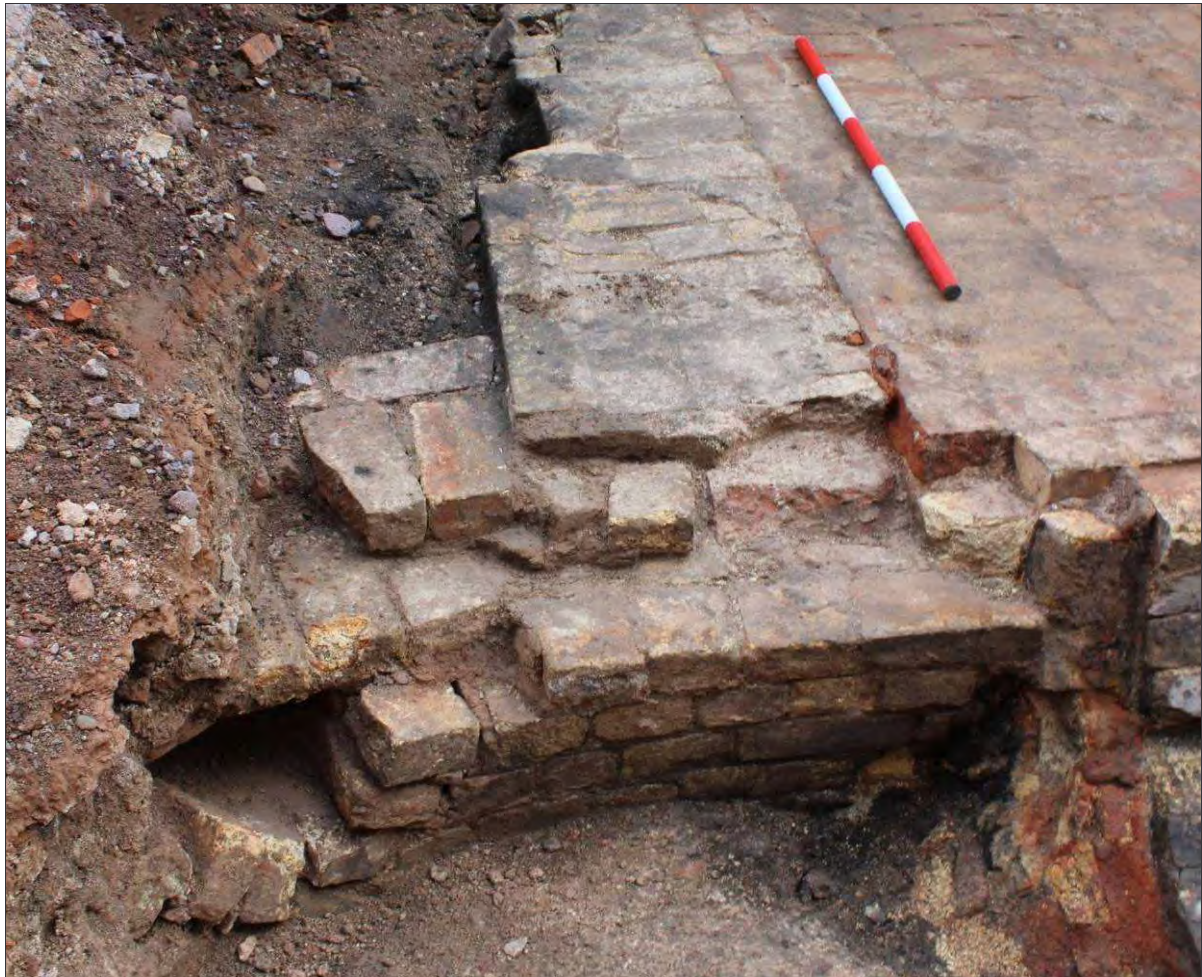
*Plate 27: View of walls **008** and **009** constructed to the south of the chimney base **006** (1m scale)*

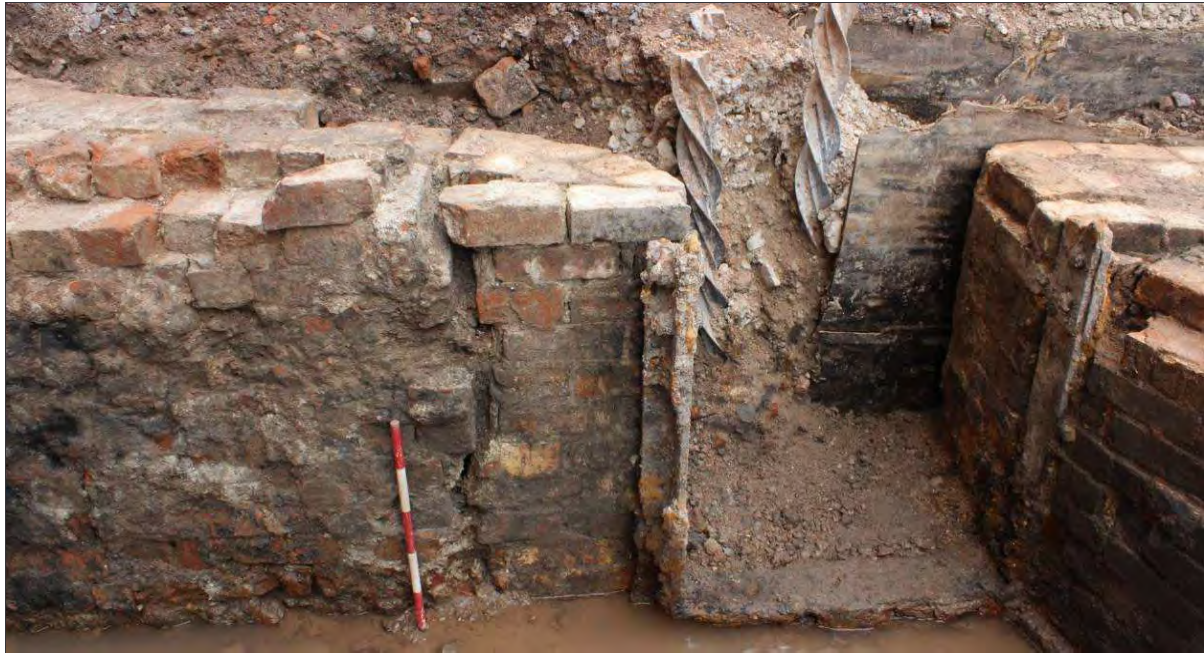
*Plate 28: Walls 010, 013 and 014 and iron damper frame (0.50m scale)*

The opening between walls **010** and **014** was 2'6" (0.75m) wide and housed the framing for a cast-iron damper, with parts of either side and the base surviving *in-situ* (Plate 28). Two bolts to either face suggest that the upper part was either formed as part of a separate casting, or had been repaired or modified at some point (Plate 29).

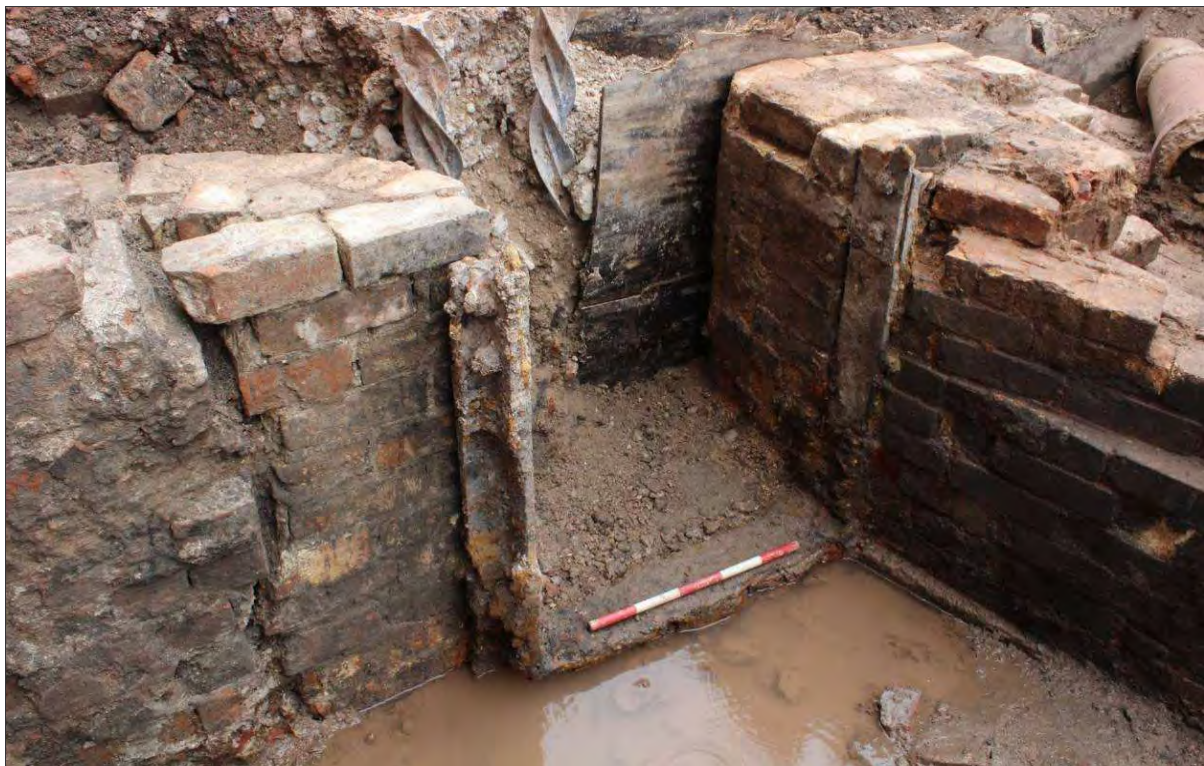
*Plate 29: Metal damper constructed against the opening on the south-east side of walls 010 and 014 (0.50m scale)*

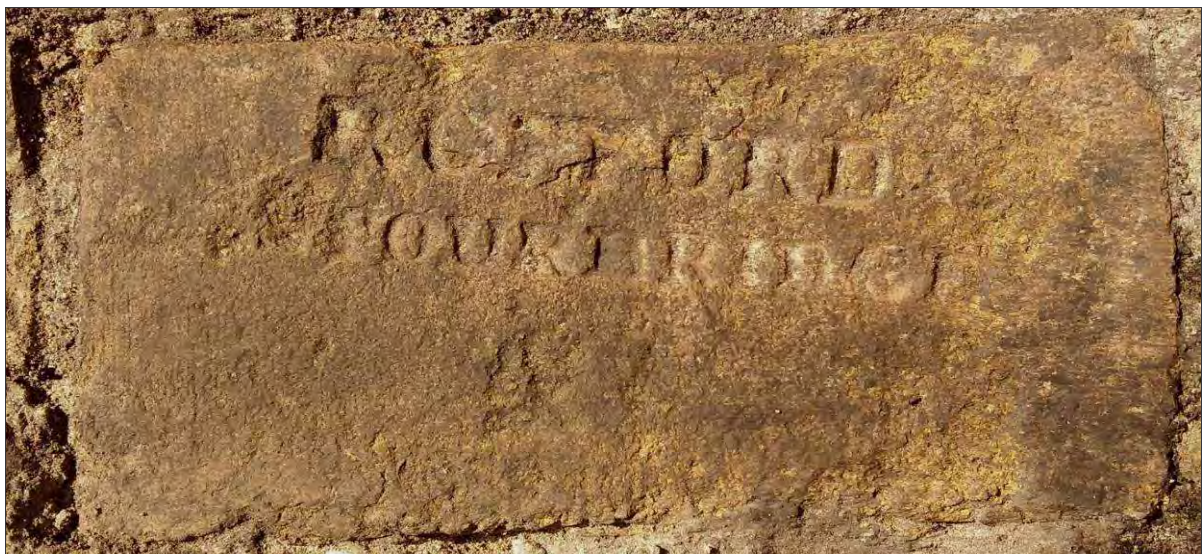
*Plate 30: An example of a stamped firebrick, product of 'Rufford, Stourbridge' found within wall 008*

Several of the refractory firebricks used in the linings of the modified flues bore a 'RUFFORD STOURBRIDGE' stamp (Plate 30). The Stourbridge fireclay industry has a long and illustrious history, counted among a handful of regions (including Strathclyde, Scotland, South Wales and Yorkshire) for the production of firebrick and refractory materials. A brick works was opened by Francis Rufford in Stourbridge in 1812 and was operational throughout the nineteenth century, ceasing production in 1936. It is unclear whether this remodelling was contemporary with that to the direct west of the chimney base, or formed a later alteration, once the demand for steam power reduced in the later part of the nineteenth century.

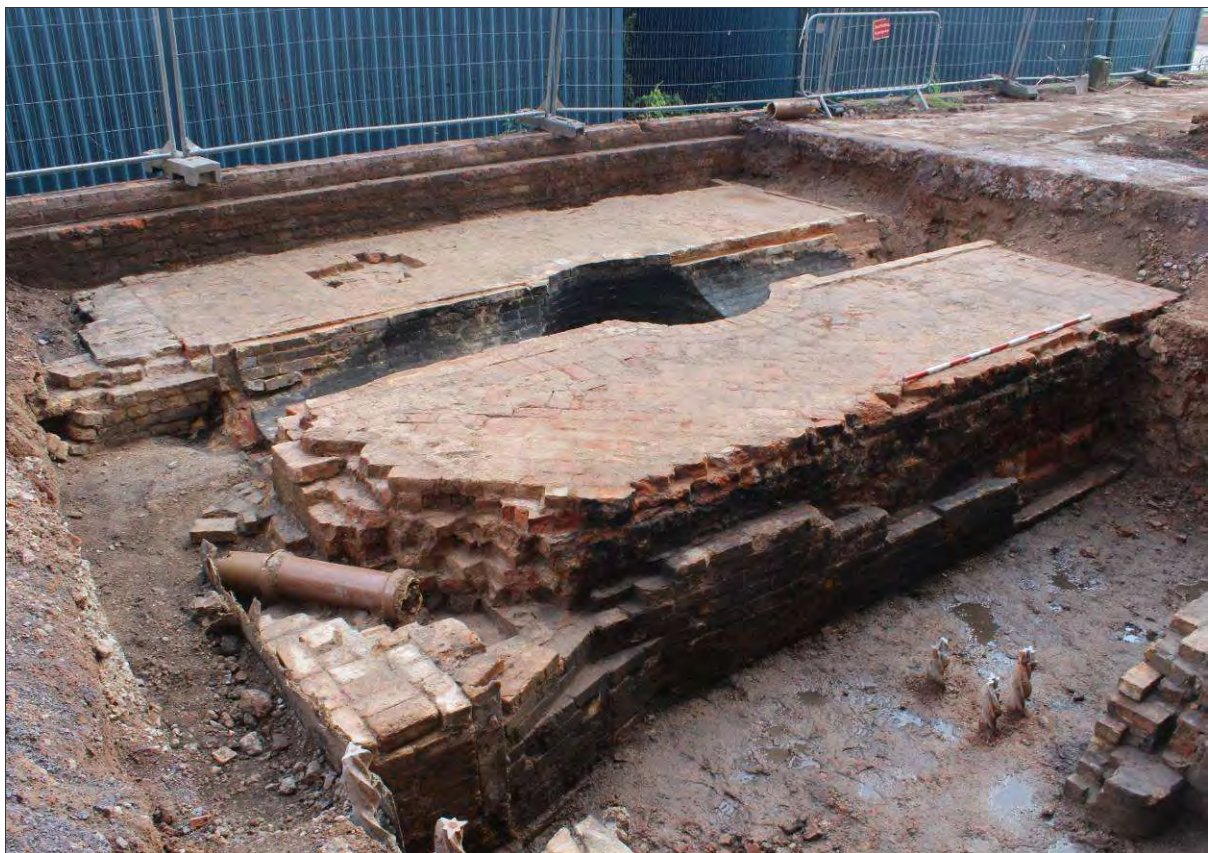
*Plate 31: General view of the north-west side of the chimney base, looking over the economiser bed*

The upper extant course continued for an additional 0.42m on the alignment of the chimney base, before returning at a greater 27° return to butt the cross wall flush with the internal face of the cast-iron damper (Plates 25 and 31). This upper angle is very diagnostic of the walls carrying an economiser base, where the exhaust chamber below is expanded to the width of the economiser house. To the south, the remodelling of the chimney base is represented by a stepped re-facing, following the removal of the original outer part of the structure on its western side, to facilitate the insertion of an economiser into the space between the chimney and privy tower. It appears that part of the base was left exposed, as seen in the excavation, explaining the severe heat damage (Plates 17, 18 and 31), not seen elsewhere.

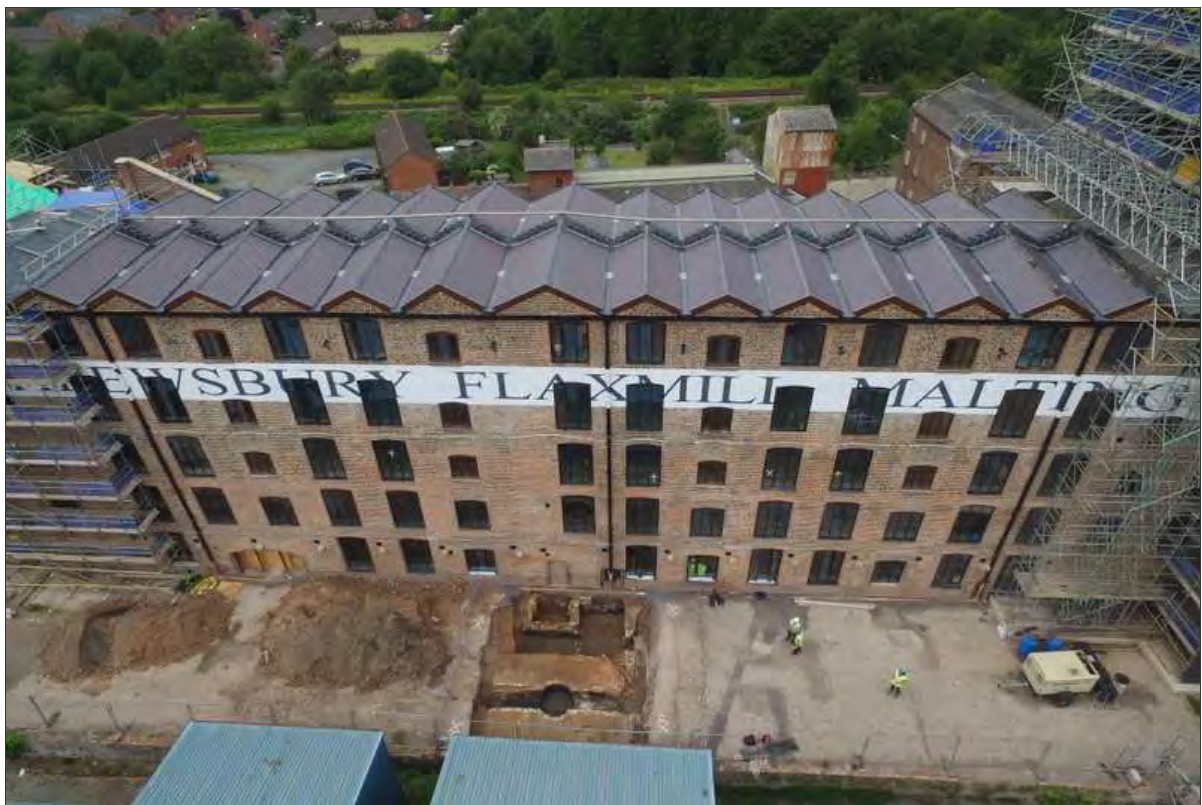
*Plate 32: General view of the east face of the Main Mill, with the excavated privy tower and chimney base in foreground*

The northern bay of this proposed original phase was much narrower than the adjacent bays, and has blocked apertures in the east wall (Plate 32). The upper brick vault of the bay is spanned by the pitched roof of the adjacent bay (Plates 32 and 33), being seen as a single wide bay externally (Plate 32), with the narrower bays of the northern part of the mill, and slightly wider bays to the south clearly identifiable following the refurbishment of the roof (Plate 32).

The demolition of the privy tower and boiler houses, surmised from cartographic and photographic sources, had occurred by the turn of the century. The structural remains were reduced to below ground level and was built up to the present level with redeposited clay subsequently. It was through this layer that a late drain had been cut; this also cut through the upper part of the mill foundation and the northern corner of the chimney. The position of the privy tower can be seen as a building scar, visible within the eastern external elevation after the demolition of the tower (Plates 32 and 42).

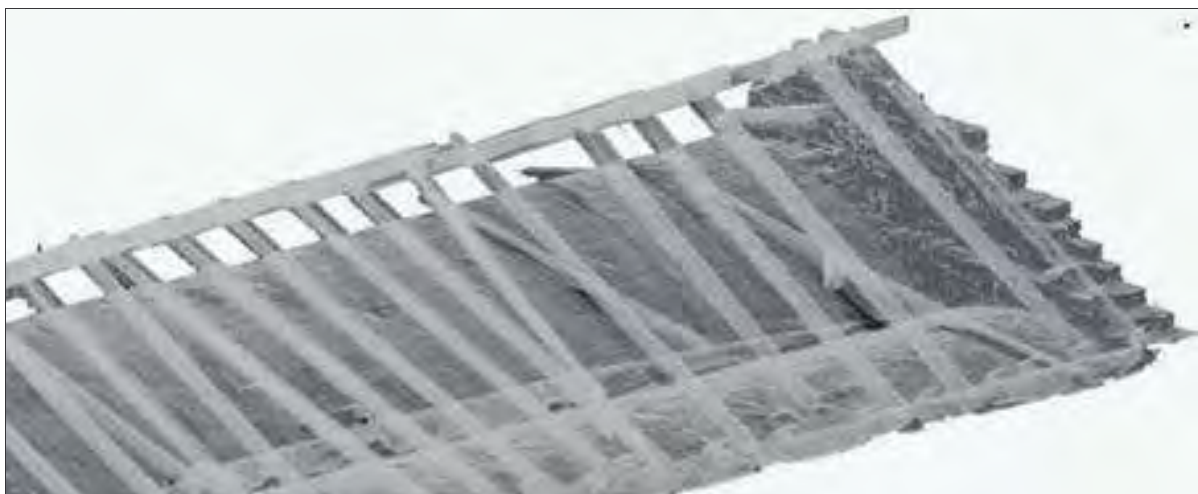
*Plate 33: Extract from point cloud model showing the pitched roof spanning two brick vaults at the junction between the original and extended mill*

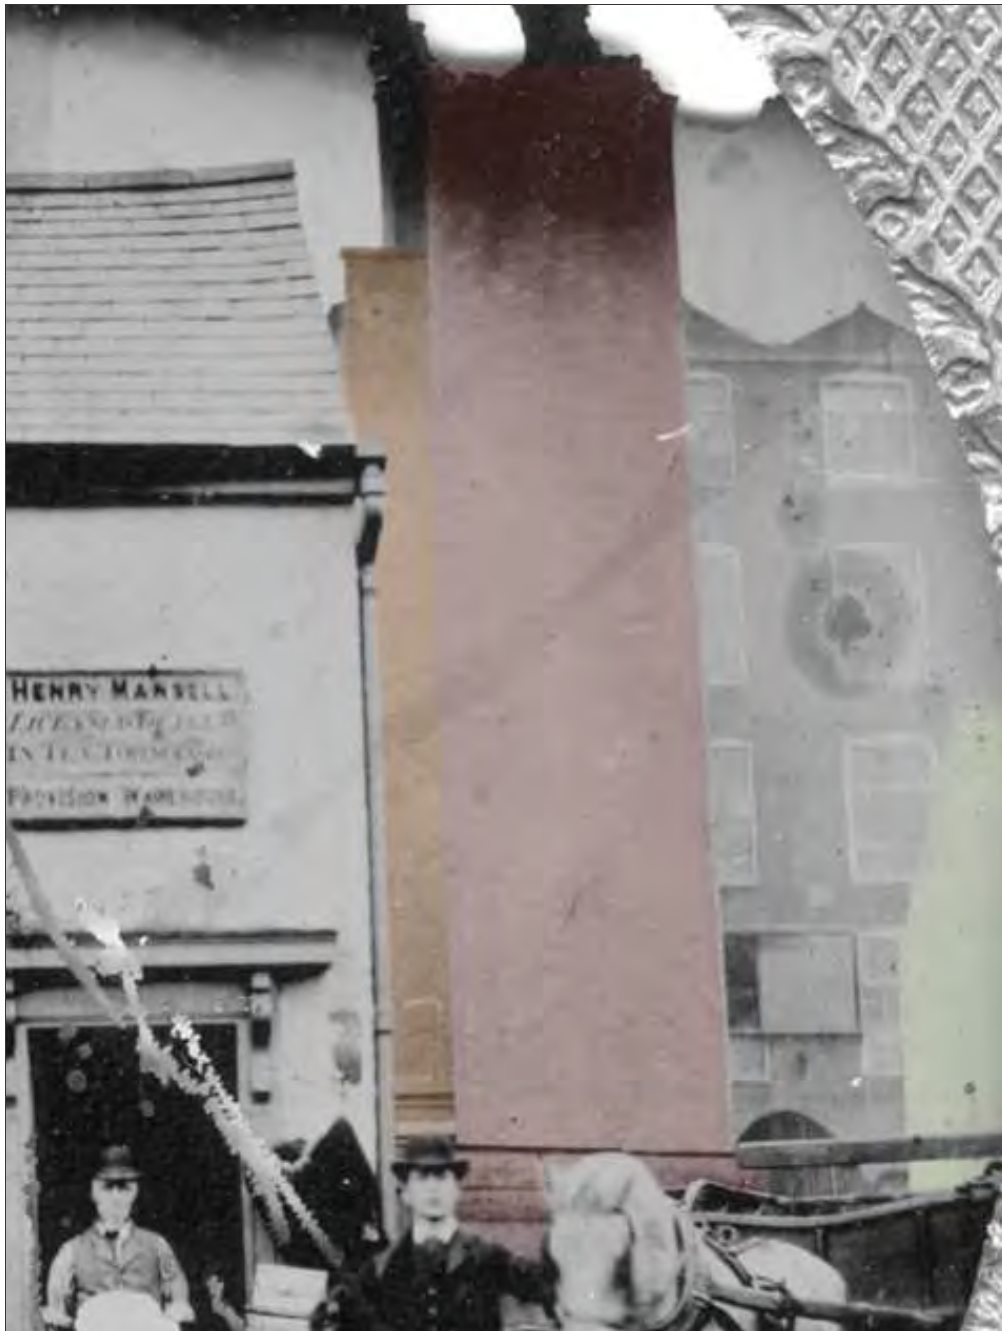
The layout of the privy tower can be seen from the detailed plans of 1849 and 1855, and from a photograph taken in the very late nineteenth century, shortly before its demolition (Plate 34). The image shows the privy tower, partially obscured by the chimney, but being of very plain brick construction to the full height of the elevation, where it was capped with oversailing sandstone copings (Plate 33). It also appears that the main east face was devoid of windows, again suggesting an early date of construction. This is confirmed on the plans of 1849 and 1855 (Plates 35 and 36), which show no openings to any of the external elevations.

*Plate 34: Photograph from the late nineteenth century showing privy tower (orange), chimney (red) and boiler house (green) positioned in front of the Main Mill*

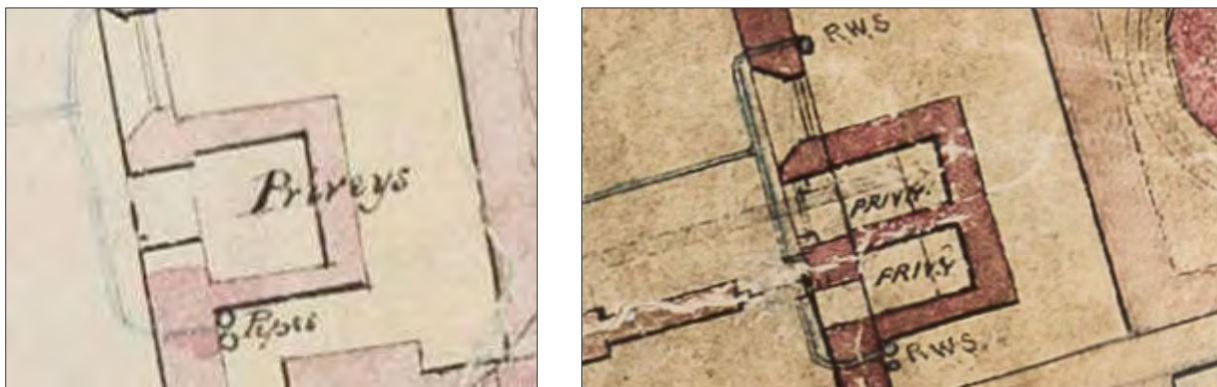
Plate 35: Extracts from the 1849 and 1855 plans showing the privy tower

A major overhaul of the steam-production plant was necessitated by the construction of a new dye house in the 1840s. Although the demand for steam engine power was decreasing within the complex at this time, the new dye house, constricted to the west of the Main Mill, had a much greater demand for hot water, heating pipes and steam. The solution was to erect a large boiler house in the gap between the eastern side of the spinning block, and the canal. It comprised two buildings, each housing three large 60'-long boilers, with a tall free-standing chimney placed between the two. The boilers, which would have been Cornish boilers in the southern house, and possibly relatively newly-patented Lancashire boilers in the later 1850s house, were charged from their outer end, with coal presumably delivered directly from the adjacent canal, with the southern coal yard being marked on the detailed plan of 1849 (Plate 2). This plan shows that only the southern of the two boiler houses had been erected by this date, as well as the chimney, although it clearly depicts the flue in the northern side of the chimney base, built in preparation for subsequent addition of the northern boiler house (Plates 2 and 35).

The plans produced in 1849 and 1855 show that the footings of the chimney were broadly square in plan, measuring approximately 20ft x 20ft (Plate 35). The extant remains confirm the details of the plans, with the foundations having a maximum recorded length of 6.2m (20'4") along its north/south axis. The internal configuration of the chimney was largely omitted from the plans, however, and it was only through excavation that the morphology and arrangement of the flues was established. The base of the vertical shaft was circular, fed by two horizontal flues positioned to the north and south. The horizontal flues had concave bases and would have had vertical sides below a round-headed roof. The north flue is indicated on the plan of 1849, demonstrating that, although the southern boiler house was built over ten years earlier, the intention was always to add a further structure to the north, the flue apparently being closed with a damper in the intervening period.

Excavation revealed that any evidence for the above-ground chimney stack had been removed during ground reduction in the late nineteenth century. Both plans show it to have had a dodecagonal shaft above a circular tiered plinth to a square base, and with a central cylindrical shaft (Plate 35). The late nineteenth-century photograph, taken from the road looking west (Plate 33), reveals that the base of the above-ground structure was relatively ornate. Although partially obscured, it shows that the circular offsets were of rolled stone below the slightly tapering faceted brick shaft.

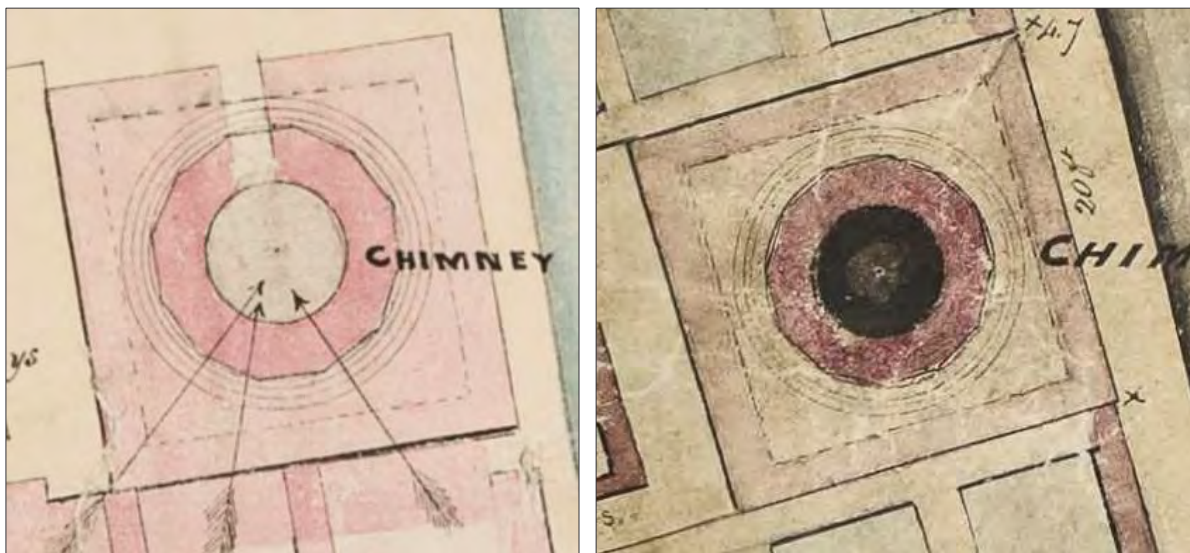
*Plate 36: Extracts from the 1849 and 1855 plans showing the cross section of the chimney base*

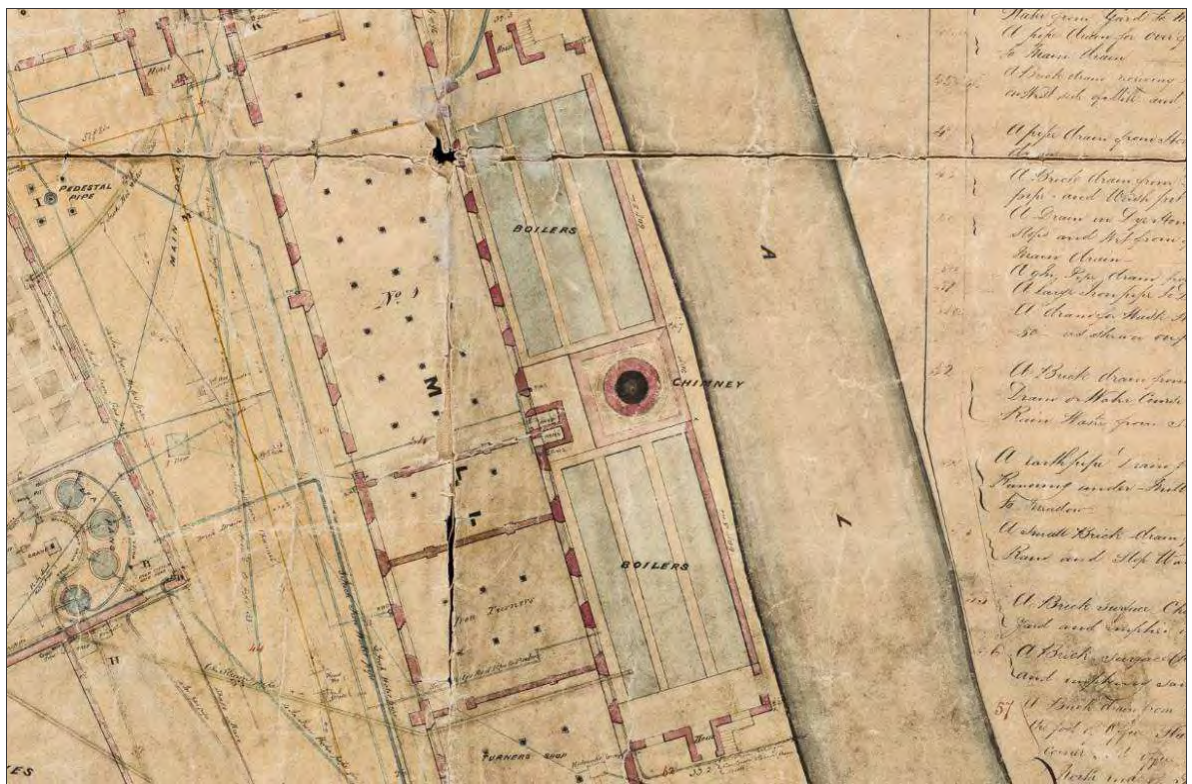
Plate 38: Extract from the 1855 plan showing the completed boiler-houses

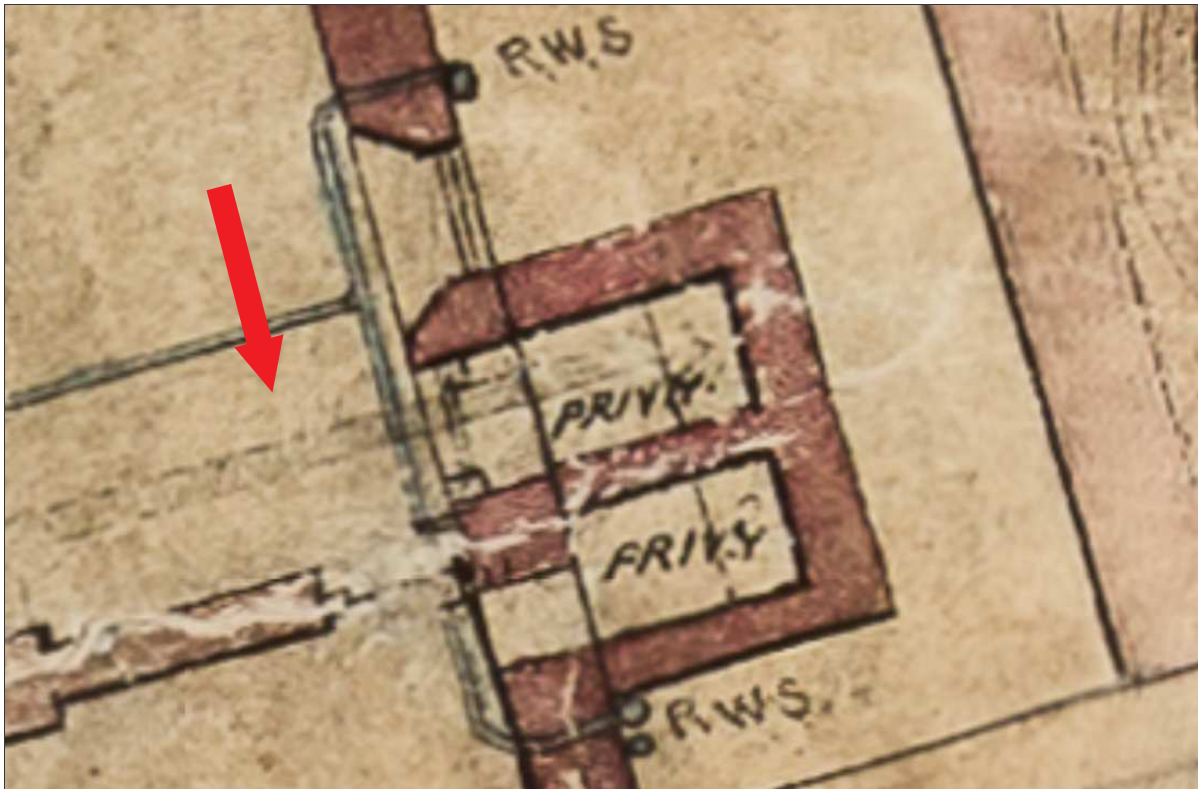
Plate 39: Extract from 1855 plan indicating the 'earth pipe' entering the privy tower below the mill floor

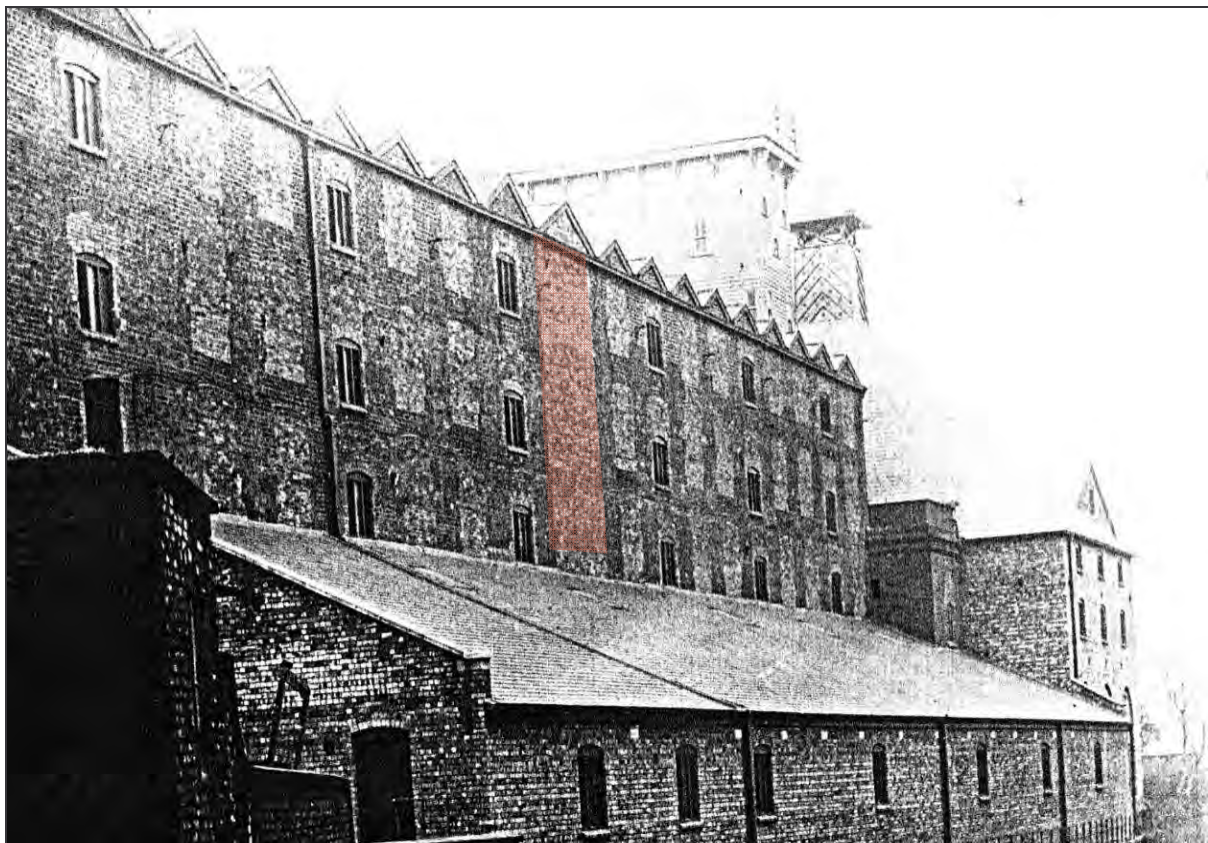
*Plate 42: View of the eastern wall of the Main Mill; the scar-line of privy tower is highlighted in pink*
