## Archaeological Excavation Report

Hoghton Tower,  
Hoghton,  
Lancashire

**Project:** Hoghton Tower Community Excavation

**Document Type:** Community Excavation Report

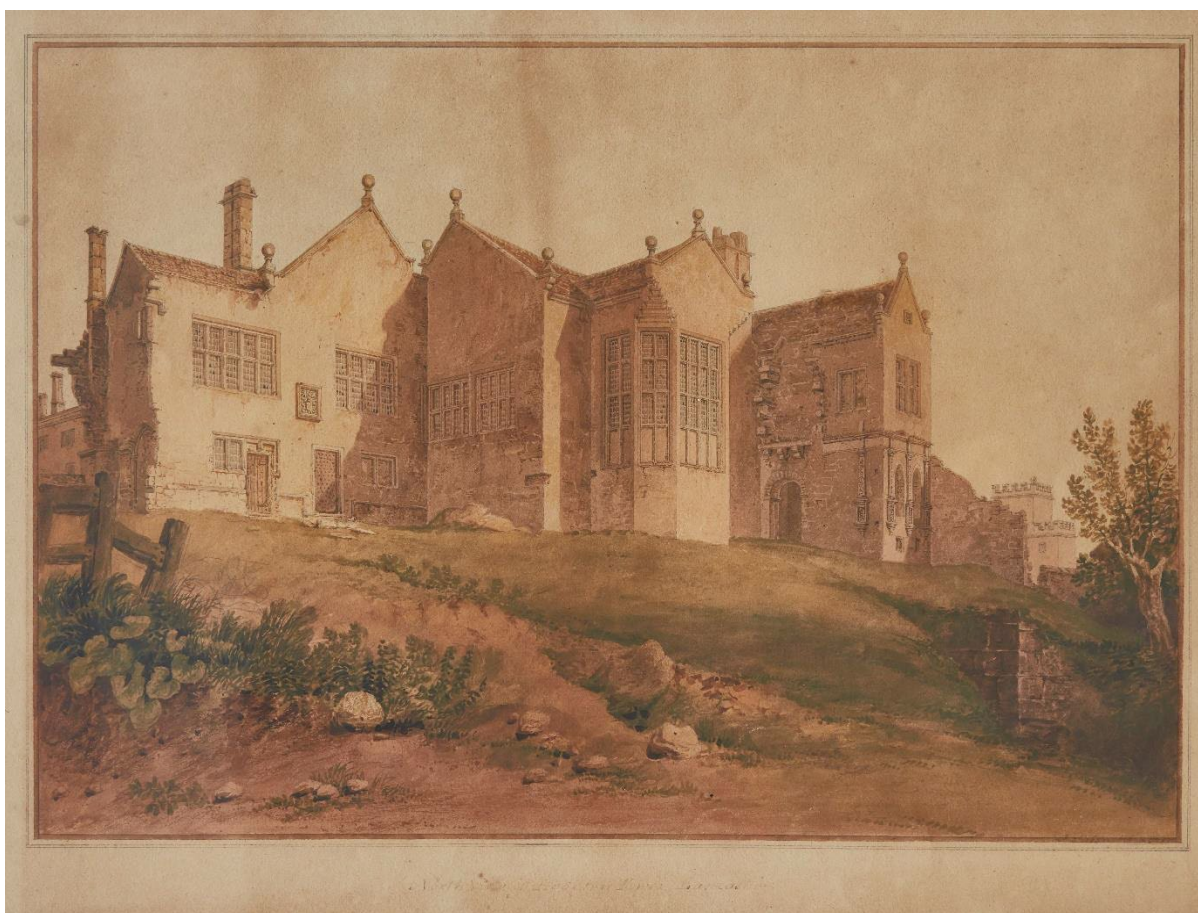
**Plate 2.** 18<sup>th</sup> century watercolour painting showing the northern side of Hoghton Tower. ©Private Collection - de Hoghton Family (photographed by Thomas de Hoghton) This image may be copied for personal and classroom educational use as part of this report only. Any other reproduction whether in print or digitally requires specific permission from the de Hoghton Family.

- **TP5:** measured 1.50m x 2.00m and was located to investigate the potential for features at the eastern end of the platform.
- **TP6:** measured 1.00m x 2.00m and was placed to investigate the northern end of the return of the platform retaining wall, seen on historic sketches (Plate 2).

Test Pit 6 was located at the sloping far eastern end of the platform, in line with the southern return of the retaining wall and was excavated to investigate the continuation of the retaining wall to the south as seen in one of the Hoghton archives images (Plate 2). The test pit measured 2.00m x 1.00m and was aligned east-west.

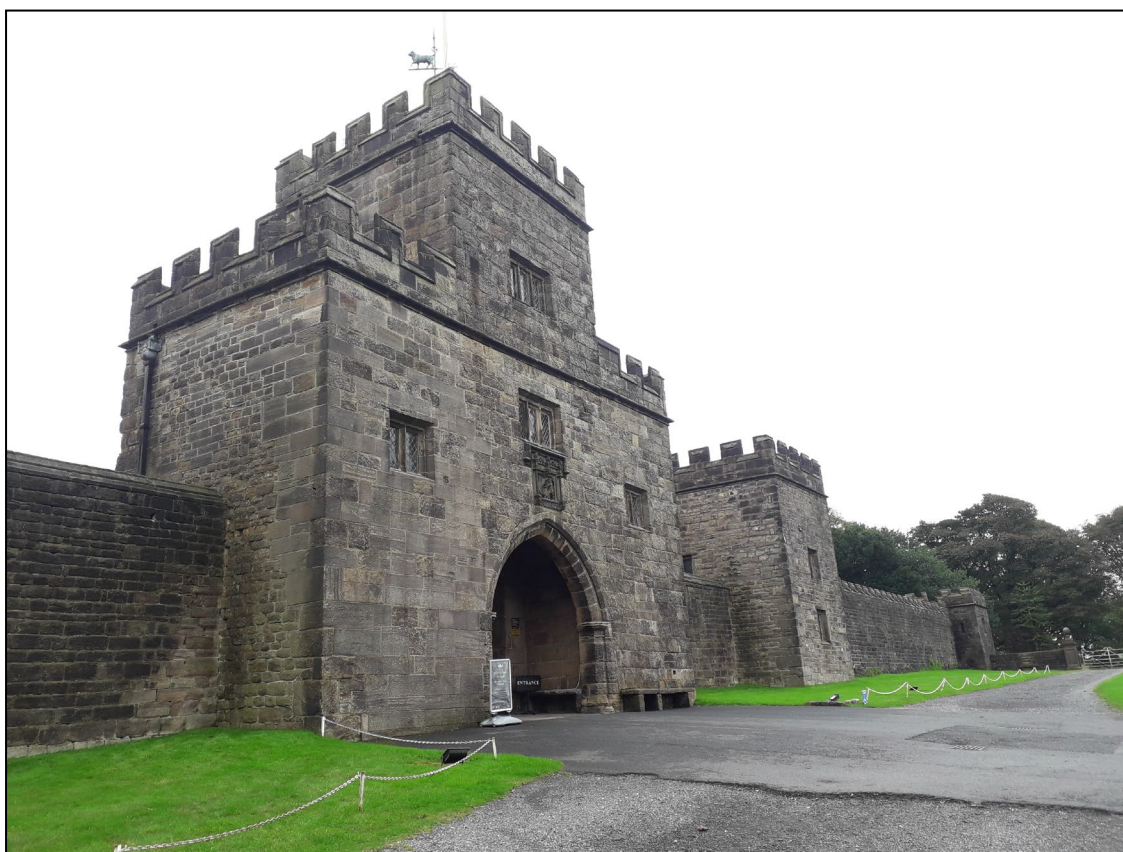
**Plate 8.** *Western elevation of the gatehouse as seen from the north.*

The western, external, elevation has on the ground floor a central two-centred arch with chamfering, supported by chamfered half-columns. The first floor has a central, three-light, mullioned with chamfered surrounds and two chamfered mullions. Below this is a carved frieze. Flanking this window are two, two-light openings each with a central chamfered mullion. A horizontal string course separates the first floor of the two from the upper storey and also marks the base of the crenelations to the flanking two-storey wings. The upper storey of the central tower has second, three-light, mullioned with chamfered

surrounds and two chamfered mullions. Above this is a second string course from which rises the crenelated top of the gateway tower. The whole elevation has quoining to the northern and southern corners. There is a clear vertical building break between the eastern flanking wing and the central tower. The crenelations are built from machine-cut stone, whilst much of the ground and first floor of this elevation has been re-surfaced in machine-cut stone.

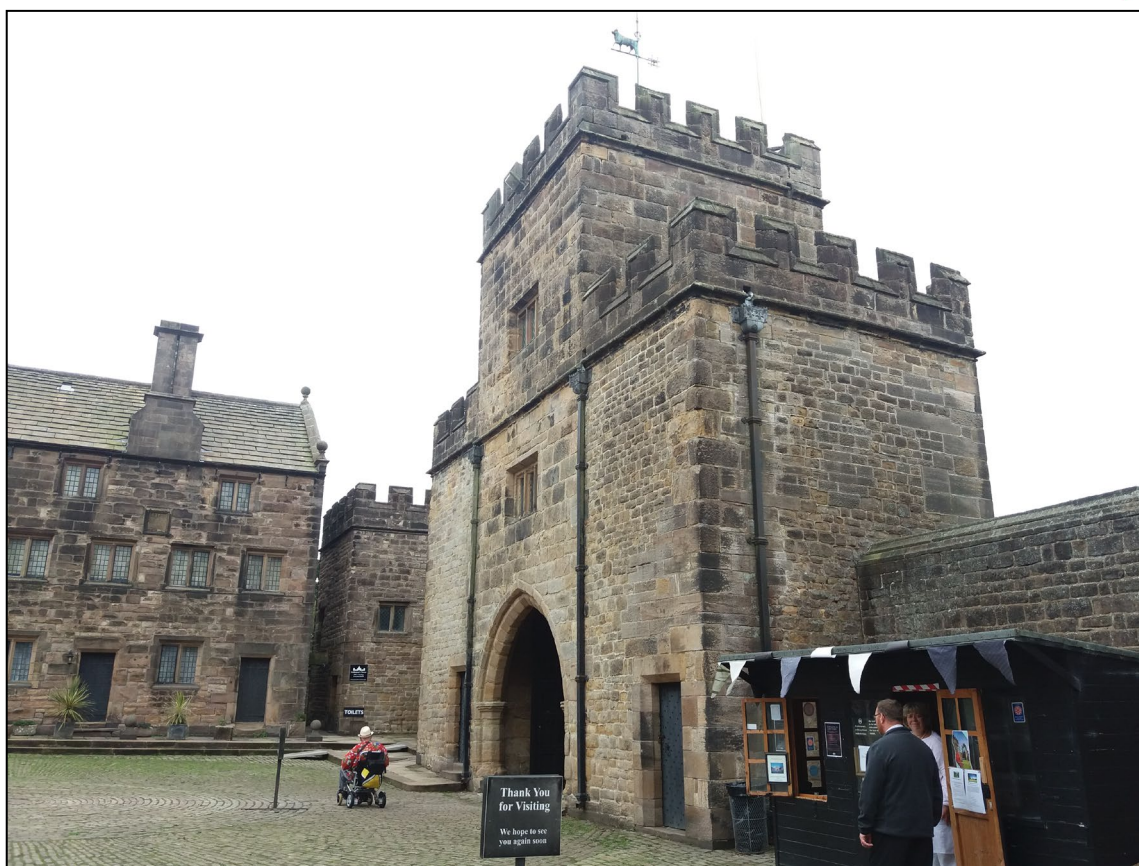
*Plate 10. Eastern elevation of the gatehouse as seen from the north.*

The Gothic architectural style of the primary phase of the outer gatehouse at Hoghton can be paralleled in the 15<sup>th</sup> and early 16<sup>th</sup> century religious architecture of Lancashire, particularly the chamfered columns which occur in the aisled naves of several medieval parish churches in the area such as Heysham, Middleton, Prestwich, Ribchester, and Whalley. This provides a possible date-range for the outer gatehouse at Hoghton Tower, and hints that the fabric of the outer gatehouse might contain earlier material and was no later than 1560/65 and might well be earlier.

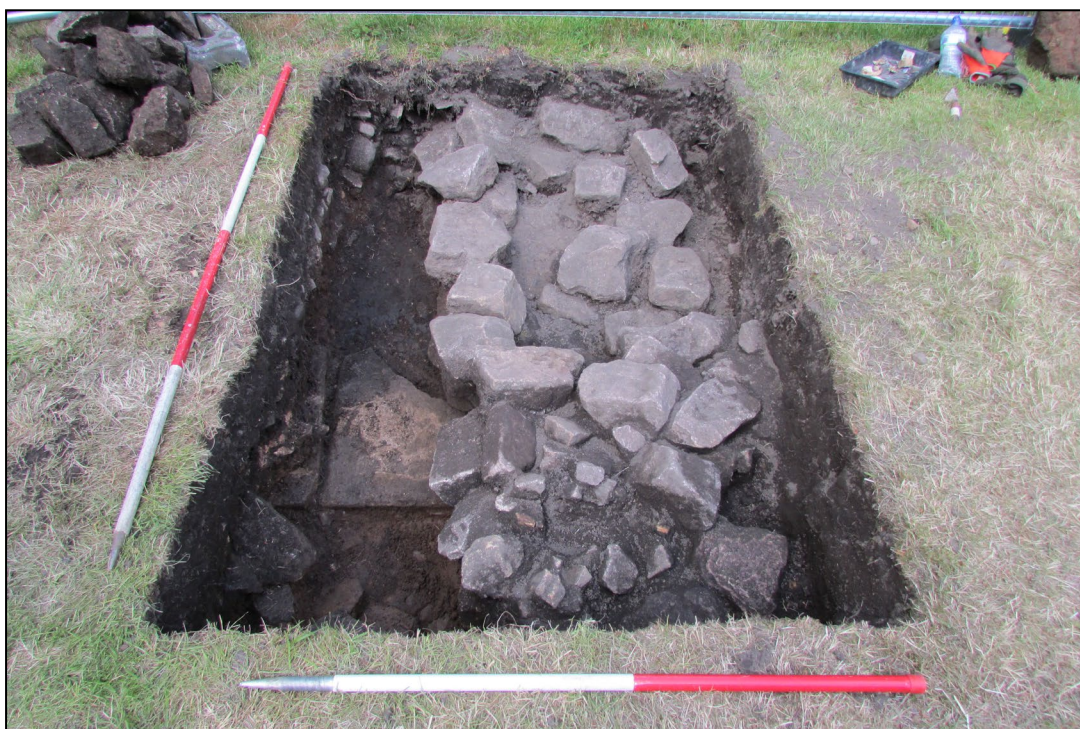
*Plate 11 Test pit 1 following excavation, showing the possible wall 007. Looking north.*

The pit initially measured 1m x 1m but was extended to 1.25m x 2.00m. Following the removal of the turf and topsoil, the demolition layer 002 was identified at a depth of c.0.15m and

comprised small fragments of sandstone and gritstone (< 0.15m) and occasional pieces of mortar. Below this, an alignment of larger stones (>0.15m) 007 was identified running north-south along the western side of the test pit with an area of rubble to the east. Although not formally coursed, 007 appeared to comprise at least two layers of stone to a depth of 0.35m, where it was abutted to the west by an alignment of flagstones, 012. This measured 0.50m x 0.60m and continued westwards beyond the edge of the test pit. The layer surrounding 007 was 003 which comprised small stone fragments in a mid-brown sandy silt.

It was thought that the alignment 007 may have been the remains of the rubble core of a larger wall running north-south across the platform. The row of flags is similar to those found in Test Pits 2 and 4 and may represent a larger surface.

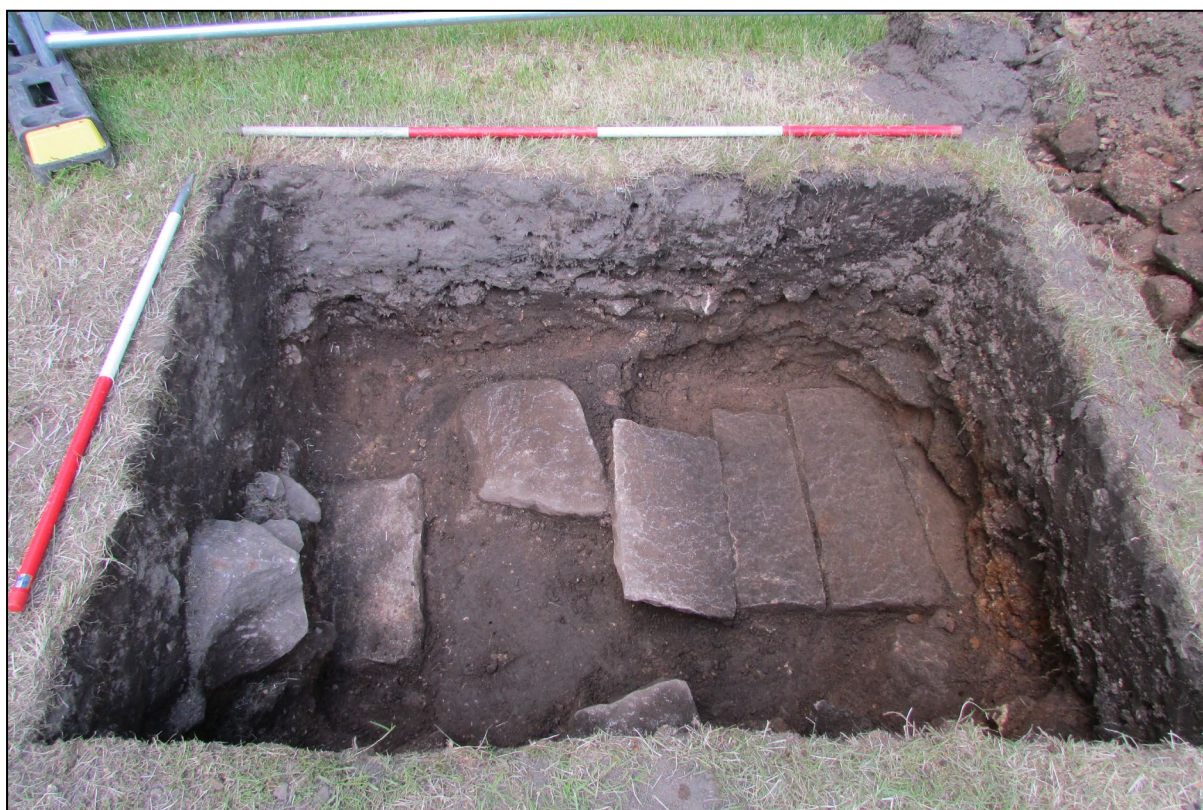
**Plate 12.** Test Pit 2 showing flagstones 014. Looking north.

Like Test Pit 1, this pit was also enlarged to further investigate the feature revealed below the rubble layer 002. This was an alignment of narrow flagstones, 014, which ran across the pit from east to west at a depth of 0.50m. The flags measured between 0.20m-0.30m in width and 0.60m-0.70m in length and were set within a pinkish-brown sandy silt deposit 015. To the east, there was a considerable amount of degraded yellow mortar lying over the flag stones, which thinned and disappeared to the west.

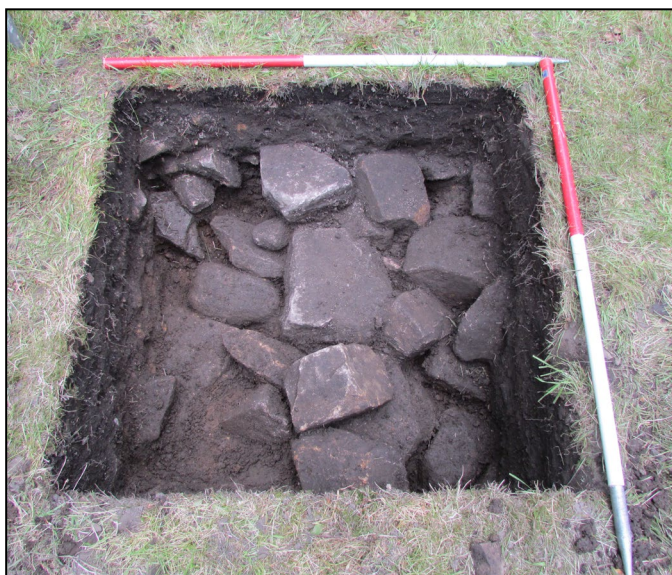
**Plate 13.** Rubble layer 002 in Test Pit 3, during excavation. Looking north.

Again, the rubble layer 002 was encountered at a depth of 0.51m and contained fragments of medieval-19<sup>th</sup> century pottery. This layer was excavated to a depth of c.0.55m, whereupon more, larger blocks of stone were revealed, including a broken flagstone, similar to those uncovered in Test Pits 1, 2 and 5. Although the pit was extended to the east by 0.50m to ascertain if other flags were present, no features were revealed.

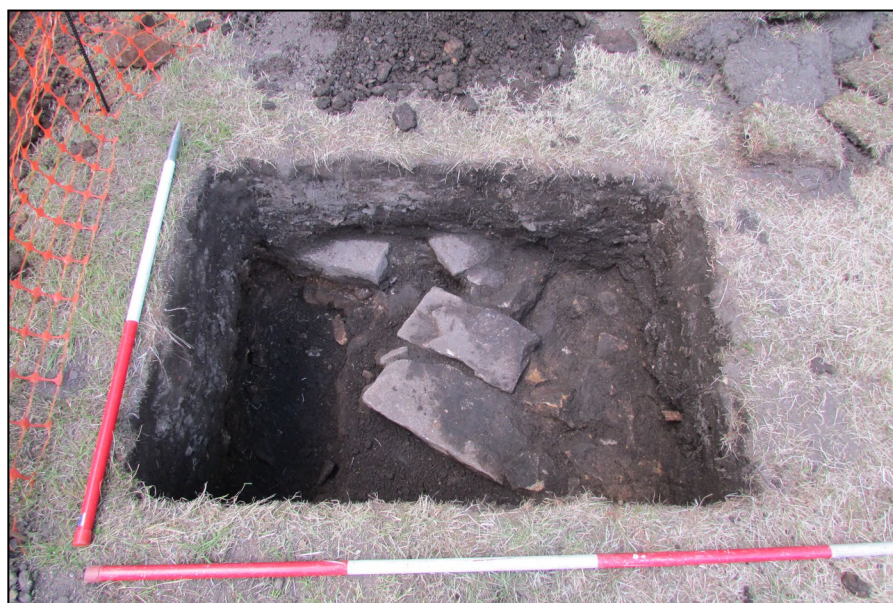
**Plate 14.** Test Pit 3 showing the broken remains of flagstones in the base of 002. Looking west.

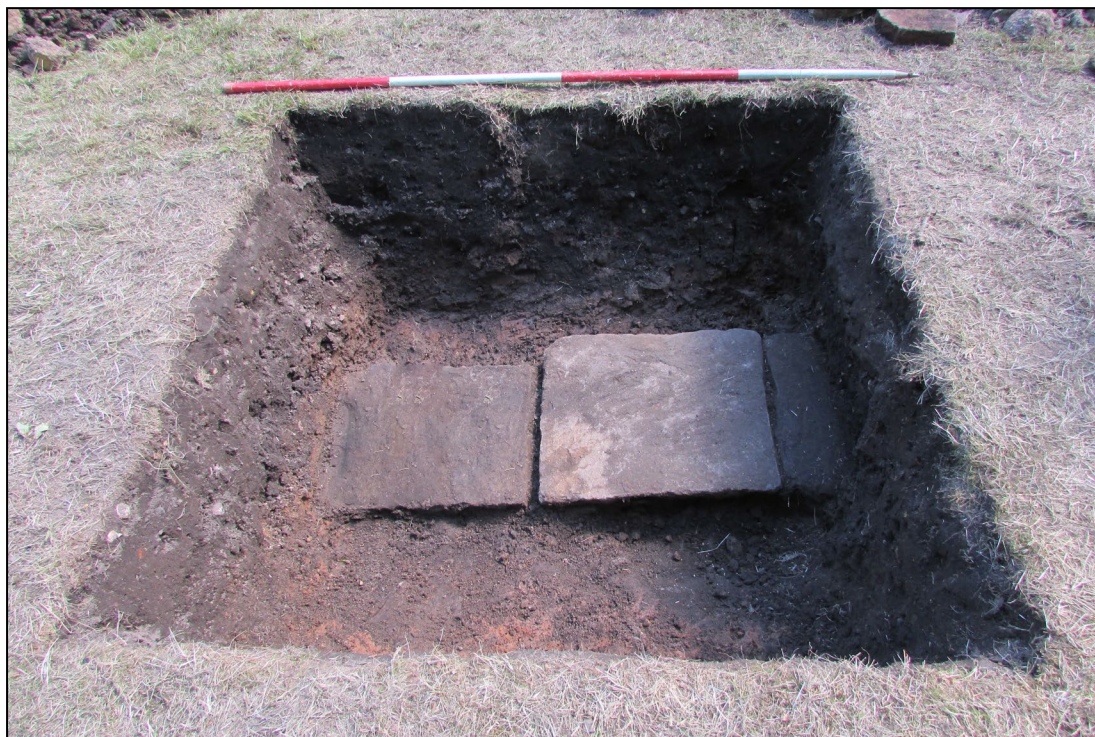
**Plate 15.** Test Pit 4 showing flag stones 016 surrounded by deposit 017. Looking south.

Again, the rubble layer 002 was encountered at a depth of approximately 0.50m and overlay the subsequent features revealed. Directly below this layer lay a mid-reddish brown silt 017, similar to 015, seen in Test Pit 2, which was 0.10m thick. It was below this silty layer that another alignment of stone flags 016, were identified, again running in an east-west orientation. Three flags were revealed, measuring between 0.40-0.50m square, which appeared to continue both east and westwards beyond the trench edges.

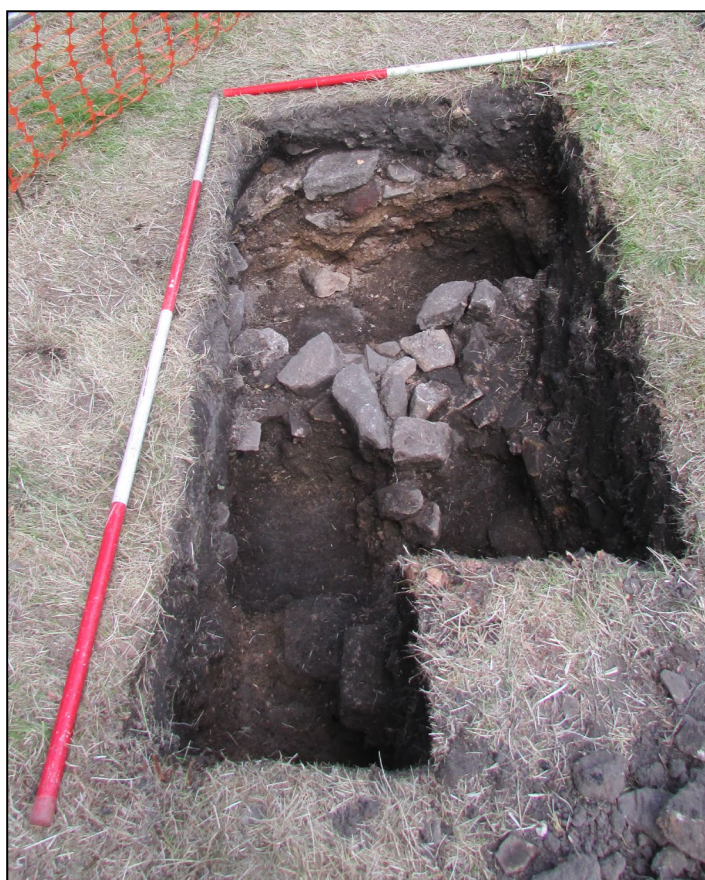
**Plate 16.** Test Pit 6 showing rubble deposit 013 and mortar layer 008 in section. Looking east.

This test pit was initially opened as a 1m square and revealed a concentration of undressed stone fragments 013 to the west, with evidence of a pinkish-grey mortar on many of the stones. This was abutted to the east by a light brown mortar layer 008, with lenses and inclusions of charcoal and clinker. Two larger stone blocks were identified along the eastern edge of 013 and so it was decided to extend the pit to the west to locate and assess the western side of this deposit. The western edge of 013 had been heavily truncated and disturbed, however two large stones were revealed that lay at the same level and in line with those to the east. The stones to both the east and west were set within a dark brown silty deposit similar to 003.

Due to the alignment and location of the rubble deposit 013, this was interpreted as a fragmentary remnant of the southern return of the retaining wall, probably destroyed some time during the 18<sup>th</sup> or 19<sup>th</sup> century.

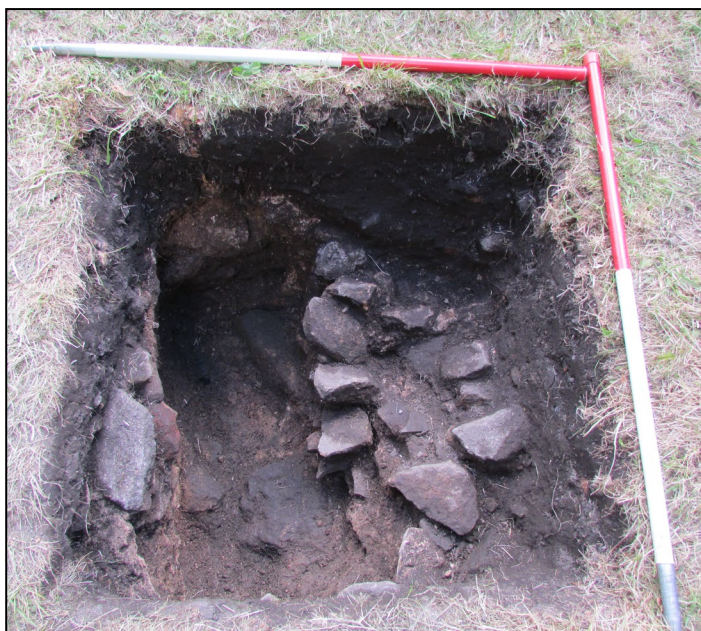
**Plate 17.** Test Pit 6 before extension, showing 013 to the west with the two larger stones at the base of the pit to the east. Looking south.

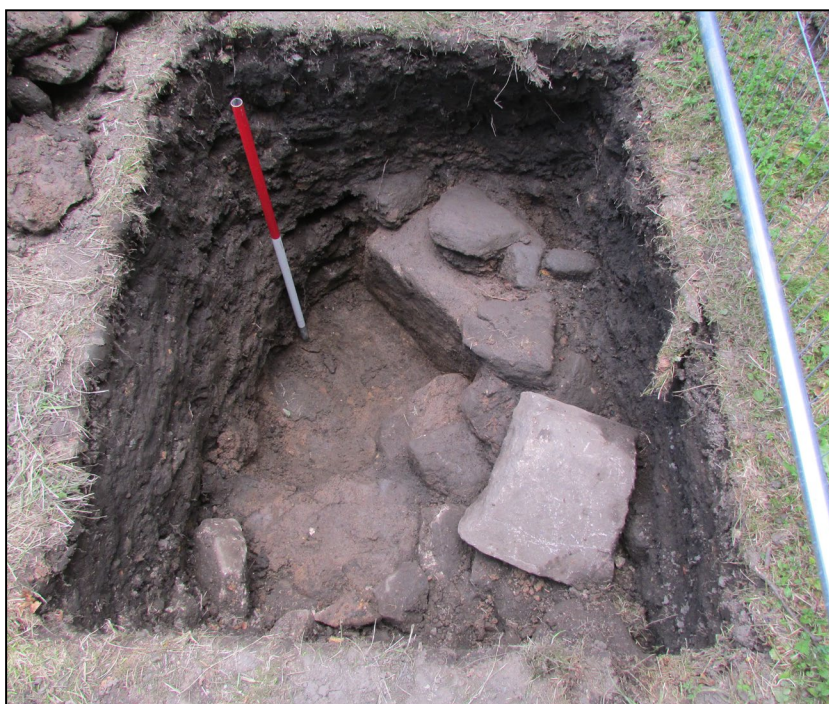
**Plate 18.** Test Pit 7 showing the depth of deposit 002 and some of the larger stone blocks identified. Looking south.

Following the removal of the turf and topsoil, the rubble layer 002 was again encountered at a depth of approximately 0.45m. In this test pit, this layer was comprised of a much wider variety of stone fragment sizes between 0.10m-0.45m, with a higher concentration of larger blocks than any of the other test pits. In particular, a dressed block was identified at the base of the deposit which measured c.0.50m x 0.38m, which lay on top of a second stone could not be excavated. Layer 002 was also considerably deeper than in other test pits, lying at a maximum depth of 0.80m, where it overlay a pinkish-red sandy silt 010, with a high moisture content.

Although no *in situ* structural remains were revealed in this test pit, the nature of the rubble deposit does suggest that the platform required greater foundations in this area, possibly due to a slope in the natural ground beneath. The large blocks also suggest the presence of more substantial structures in this area, such as external, load bearing walls or foundation deposits.

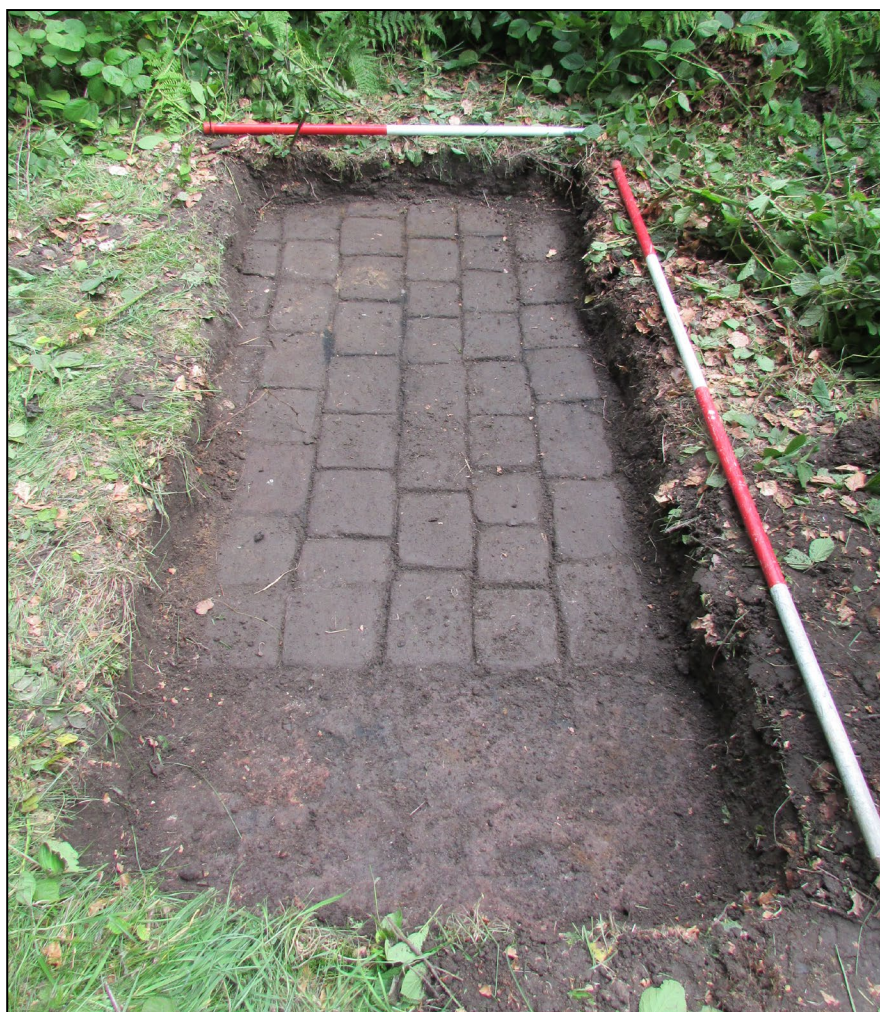
**Plate 19.** Test Pit 8 showing surfaces 004 and 005. Looking east.

The segregated nature of the area to the west of the dividing wall meant that the soil horizons identified to the east were not present in this test pit. The topsoil lay at a depth of 0.15m and

directly overlay a cobbled surface 004 to the east and a compacted pinkish-brown sandy silt 005 to the west. Surface 004 was composed of stone setts running east-west which were relatively uniform in size, measuring 0.17m x 0.13m, with one larger stone measuring 0.41m x 0.14m. The surface measured 1.00m x 1.50m overall and abutted 005 to the west. This was found to lie 0.03m deep with frequent inclusions of chipped stone fragments and burnt stones. A second compacted deposit, 006, lay below 005 and was composed of a very dark blackish-brown silt with a high volume of clinker, which again lay only 0.03m thick. This in turn lay over a very compacted layer of stone rubble, 011, similar to 002 but containing much smaller stone fragments, between 0.05m-0.10m. This deposit was too heavily compacted to excavate further.

The style of the cobbled surface and its association with the later building addition to the south indicated that it was likely to have been laid down as part of the 19<sup>th</sup> century restoration work at the Tower. Conversations with Sir Bernard de Hoghton confirmed that the surface had only been covered within the last 50 years and had previously had dog kennels constructed on it.

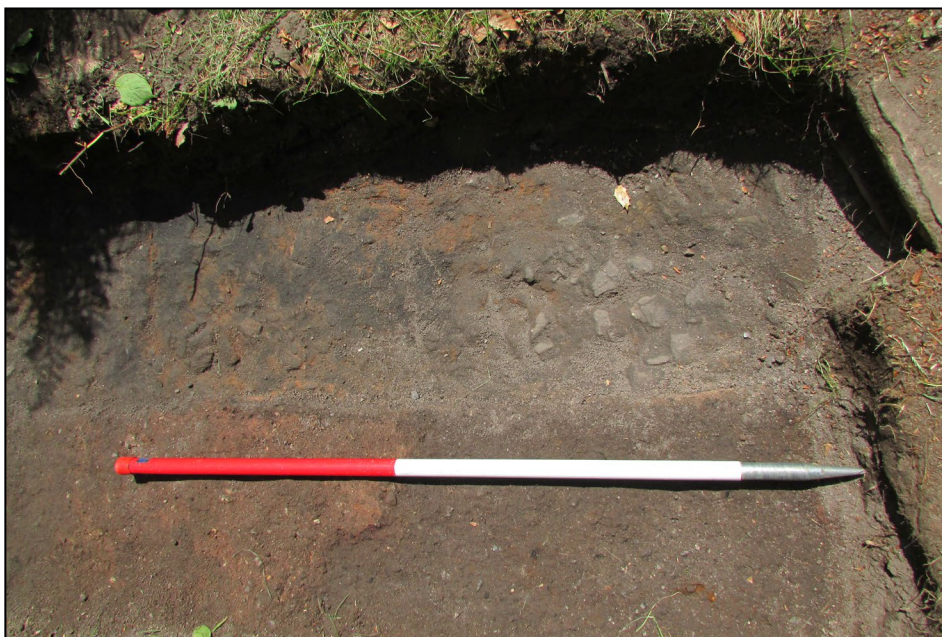
**Plate 20.** Detail of sondage excavated through 005, showing 006 to the left and the rubble layer 011 to the right. Looking west.

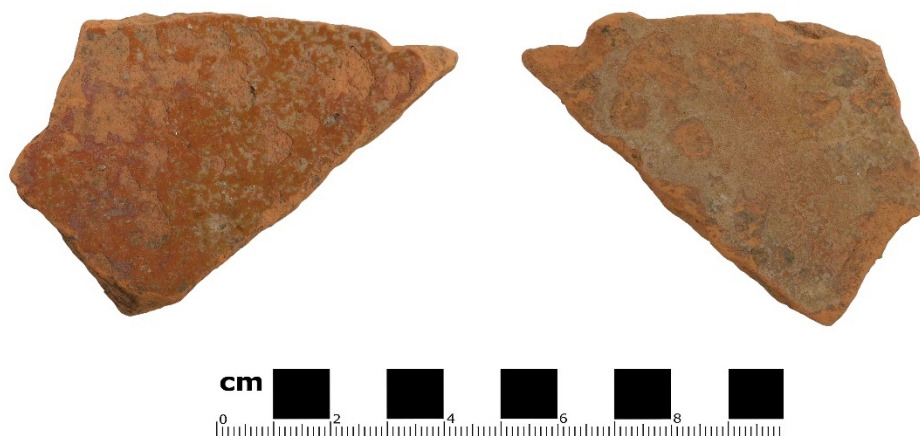
Figure 1: Oxidised glazed earthenware, test pit 4 (002), 15<sup>th</sup> century (fn 51)

A total of three sherds of late medieval pottery was retrieved from test pit 4 (002). These are an oxidised earthenware with patchy orange glaze (figure 1). They are likely to date to the 15<sup>th</sup> century.

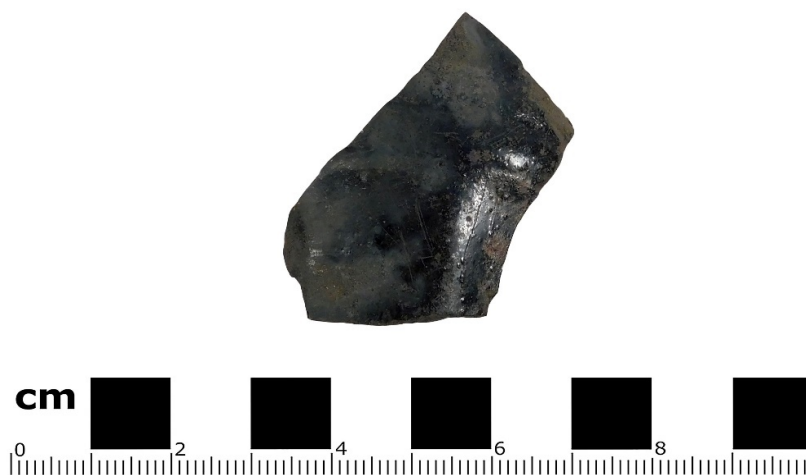
Figure 2: Facetted cup sherd, test pit 2 (002), mid-17<sup>th</sup> century (fn 48)

A total of 20 sherds of dark-glazed fineware were recovered from the test pits, including 17<sup>th</sup> century Blackware sherds and 18<sup>th</sup>-19<sup>th</sup> century finewares. Test pit 2 (002) included a small fragment of mid-17<sup>th</sup> century faceted tyg or drinking cup (figure 2). This type of vessel is a distinctive product of Rainford potters and seem to have been an uncommon form from potters elsewhere. Other examples have been found in Prescott, Warrington, Liverpool, Bury and Burslem (Philpott *et al* 2015, 136).

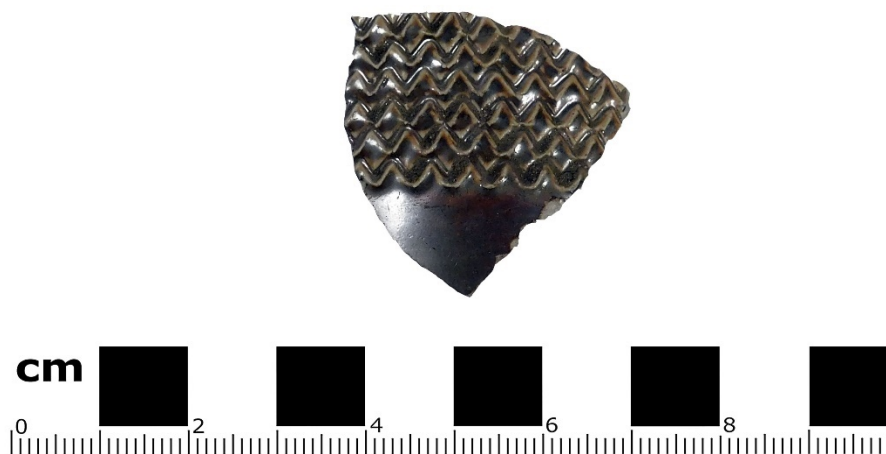
Figure 3: Brown stoneware with wavy decoration, U/S (fn 114)

Six sherds of stoneware were recorded from the test pits. This includes three sherds of brown salt-glazed stoneware including a sherd with wavy incised decoration (figure 3). Test pits 5 and 6 also included sherds of a blue and purple stoneware which is likely to be a Westerwald German import dating to the mid-17<sup>th</sup> century. This stoneware involved the application of manganese dioxide and cobalt oxide to produce a purple and blue glaze effect. The sherds from the site are likely to have come from an imported jug and are decorated in a geometric pattern including an acorn motif (figure 4).

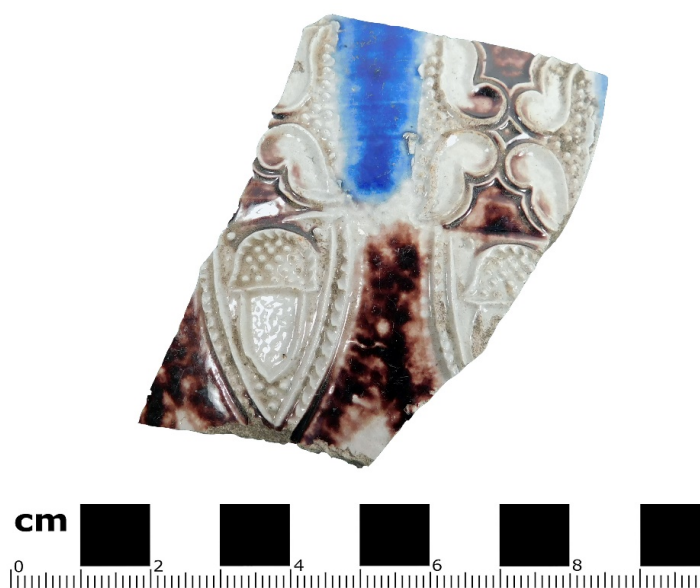
Figure 4: Jug sherd of Westerwald German stoneware import, test pit 6 (002), mid-17<sup>th</sup> century (fn 79)

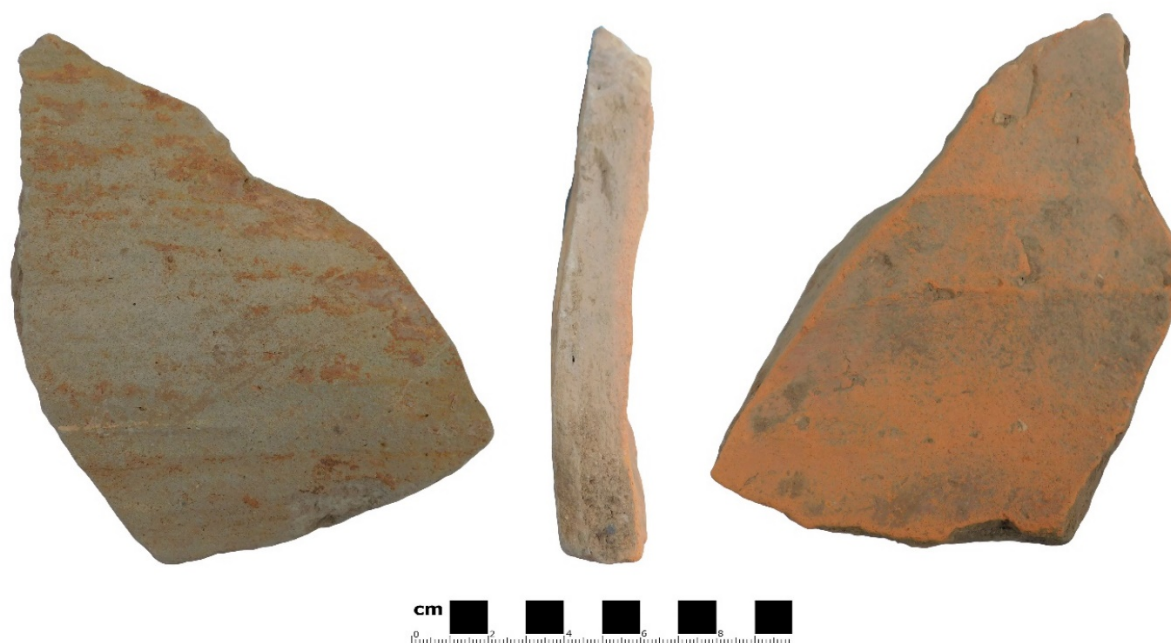
Figure 5: Medieval roof tile, test pit 4 (002)

Fragments of four medieval roof tiles were retrieved from test pits 1, 4, and 7. These exhibit a reduced grey soft core and oxidised interior surface with a patchy olive-green external glaze. Though the tiles are fragmentary, the curvature suggests they may be curved or hip roof tiles from an earlier building on the site (figure 5). They are likely to date to the 13<sup>th</sup>-14<sup>th</sup> centuries.

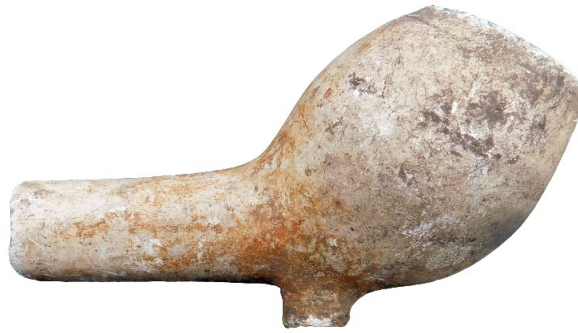
Figure 6: Complete pipe bowl, AD1640-1680 (fn 3)

Context	Identification	Date	Description
TP 1 (002) Fn 3	Complete pipe bowl (figure 6)	AD 1640-1680	Bulbous bowl with spur, stamped 'IB'
TP 2 (003) Fn 21	Almost complete pipe bowl (figure 7)	AD 1640-1680	Bowl with spur, stamped 'IB'
TP 4 (002) Fn 57	Plain bowl	AD 1880-1940	
TP 7 (002) Fn 88	Partial bowl (figure 8)	AD 1850-1920	Decorated bowl with winged angels on both sides and three leaf clover border
TP 9 (001) Fn 104	Partial pipe bowl	AD 1690-1750	Plain bowl
TP 10 (001) Fn 110	Partial bowl	AD 1620-1660	'IB' heel stamp

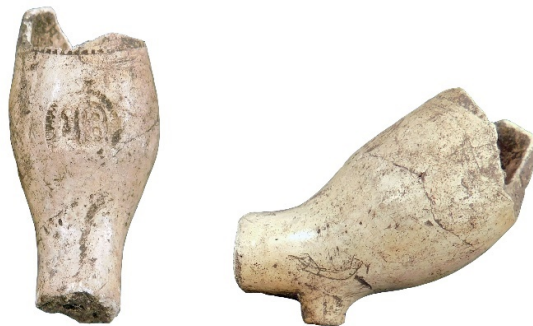
Figure 7: Clay pipe bowl with 'IB' makers' stamp, AD1640-1680 (fn 21)

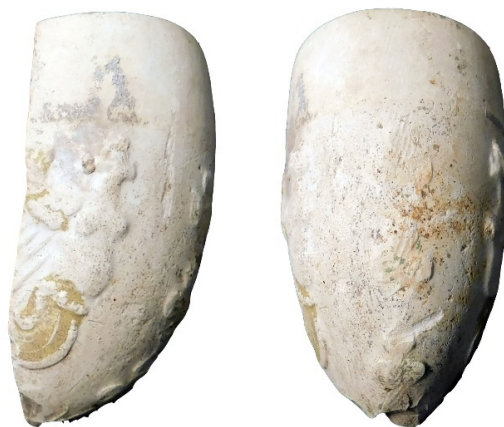
Figure 8: Clay pipe bowl depicting winged angels and a three-leaf clover border, AD1850-1920 (fn 88)

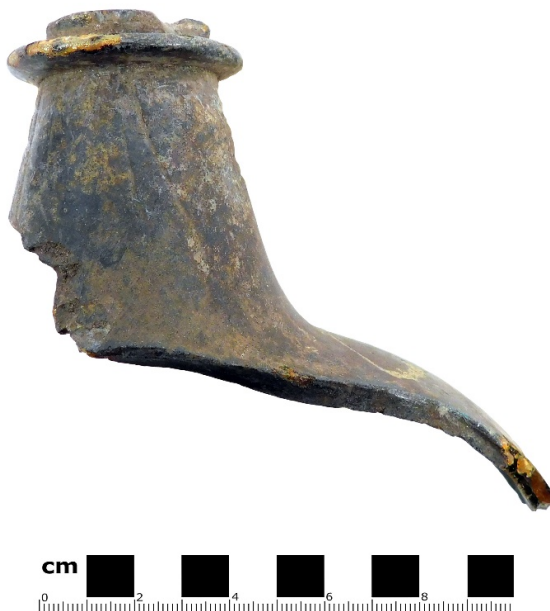
Figure 9: Top of onion bottle from test pit 6 (002), late 17<sup>th</sup> century (fn 76)

The glass retrieved from the site was very fragmentary and consists of 103 sherds. This includes 40 small sherds of window glass and 63 sherds of bottle glass. Of the bottle glass, 16 sherds are 19<sup>th</sup>-20<sup>th</sup> in date and 47 are 17<sup>th</sup> century in date. The 17<sup>th</sup> century glass includes fragments of onion bottles which are in poor condition and exhibit corrosion leaving them in a degraded state (figure 9). Most of this glass appears to date to the late 17<sup>th</sup> century. A small black glass bead was also recovered from test pit 7 and is post-medieval in date.

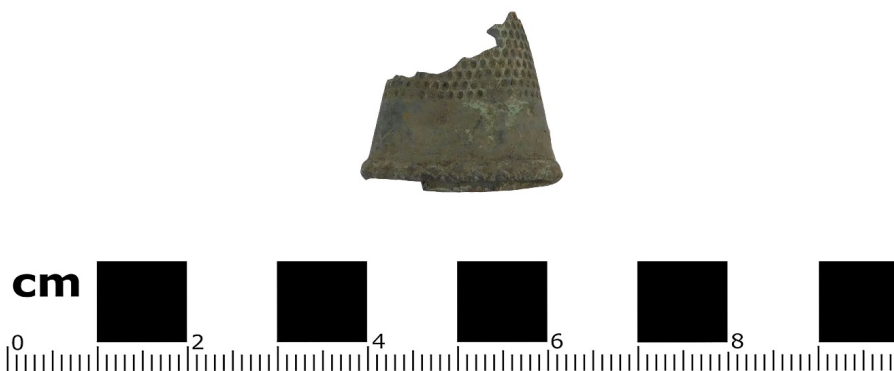
Figure 10: Partial thimble from test pit 2 (002), AD1850-1900 (fn 22)

A small quantity of metal finds was retrieved from the test pits. This includes two copper objects; a copper loop, probably from a chain or fitting, and an incomplete sewing thimble which exhibits a foot ring and machine stamped pits arranged in horizontal rows, likely to date to AD1850-1900 (figure 10). A corroded piece of ironwork was recovered from test pit 7 which may have been part of modern agricultural machinery. A waste lead strip and a musket ball with a possible impact scar was also recovered from test pit 5 which is likely to date to the late 17<sup>th</sup> century (figure 11).

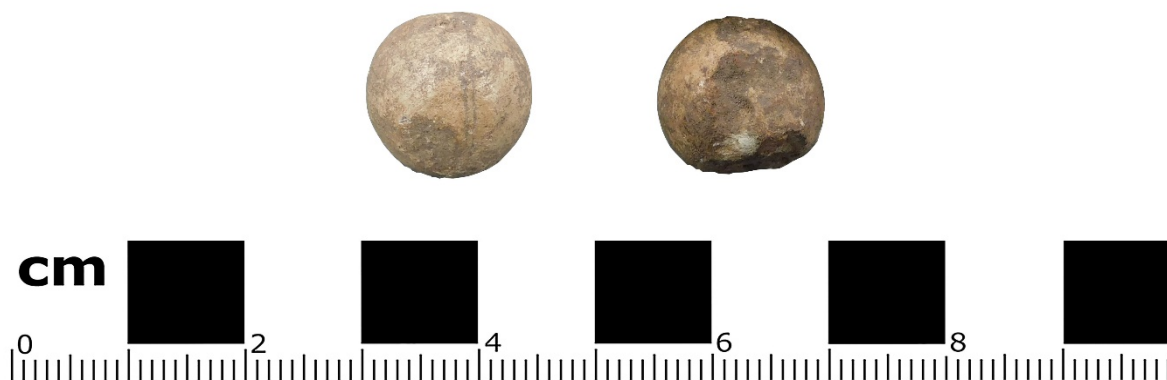
Figure 11: Lead musket ball from test pit 5, 17<sup>th</sup> century (fn 62)

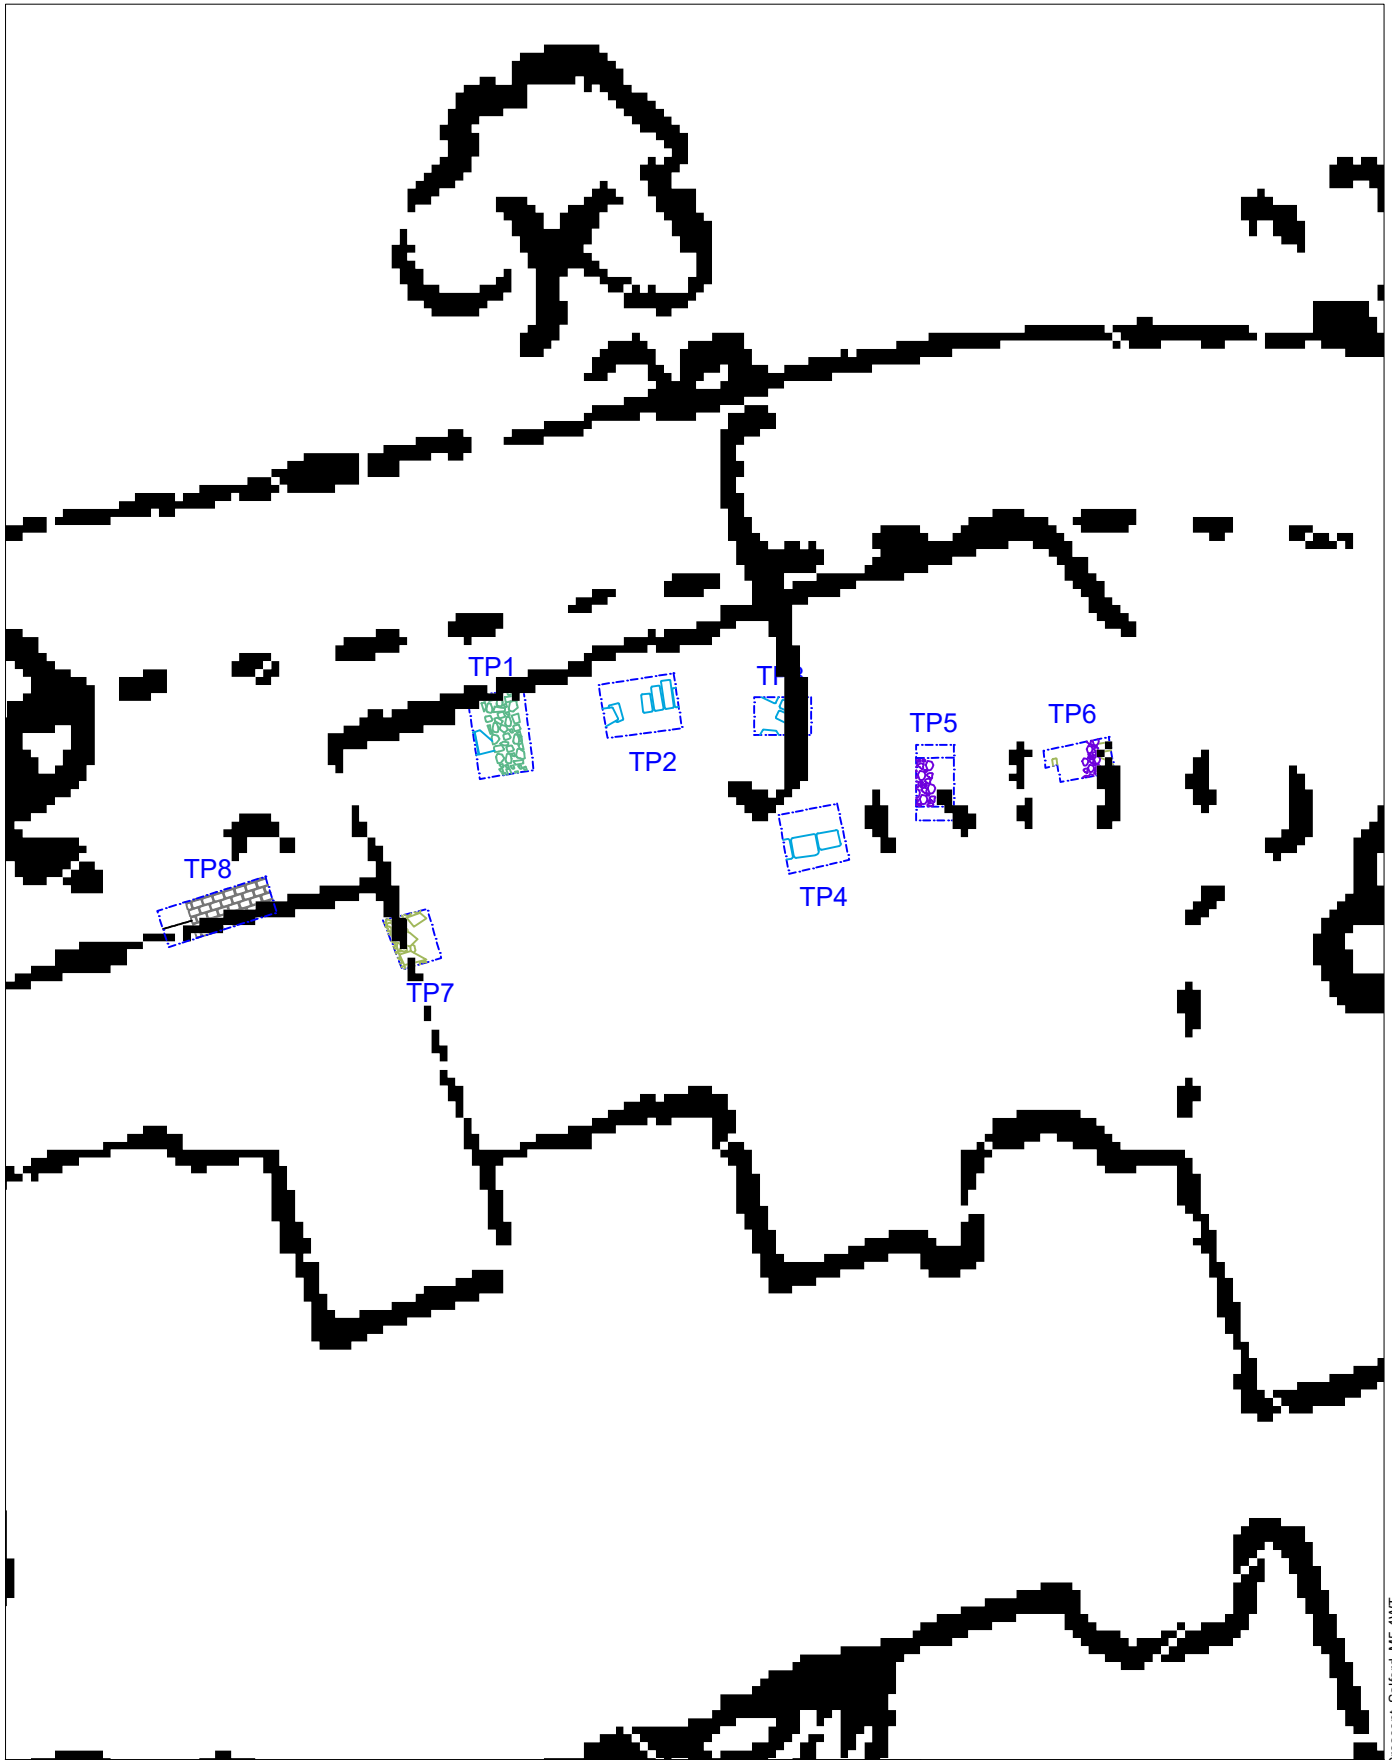
Figure 3:  
Trenches Superimposed onto the 1:2500 County Series Map of 1892

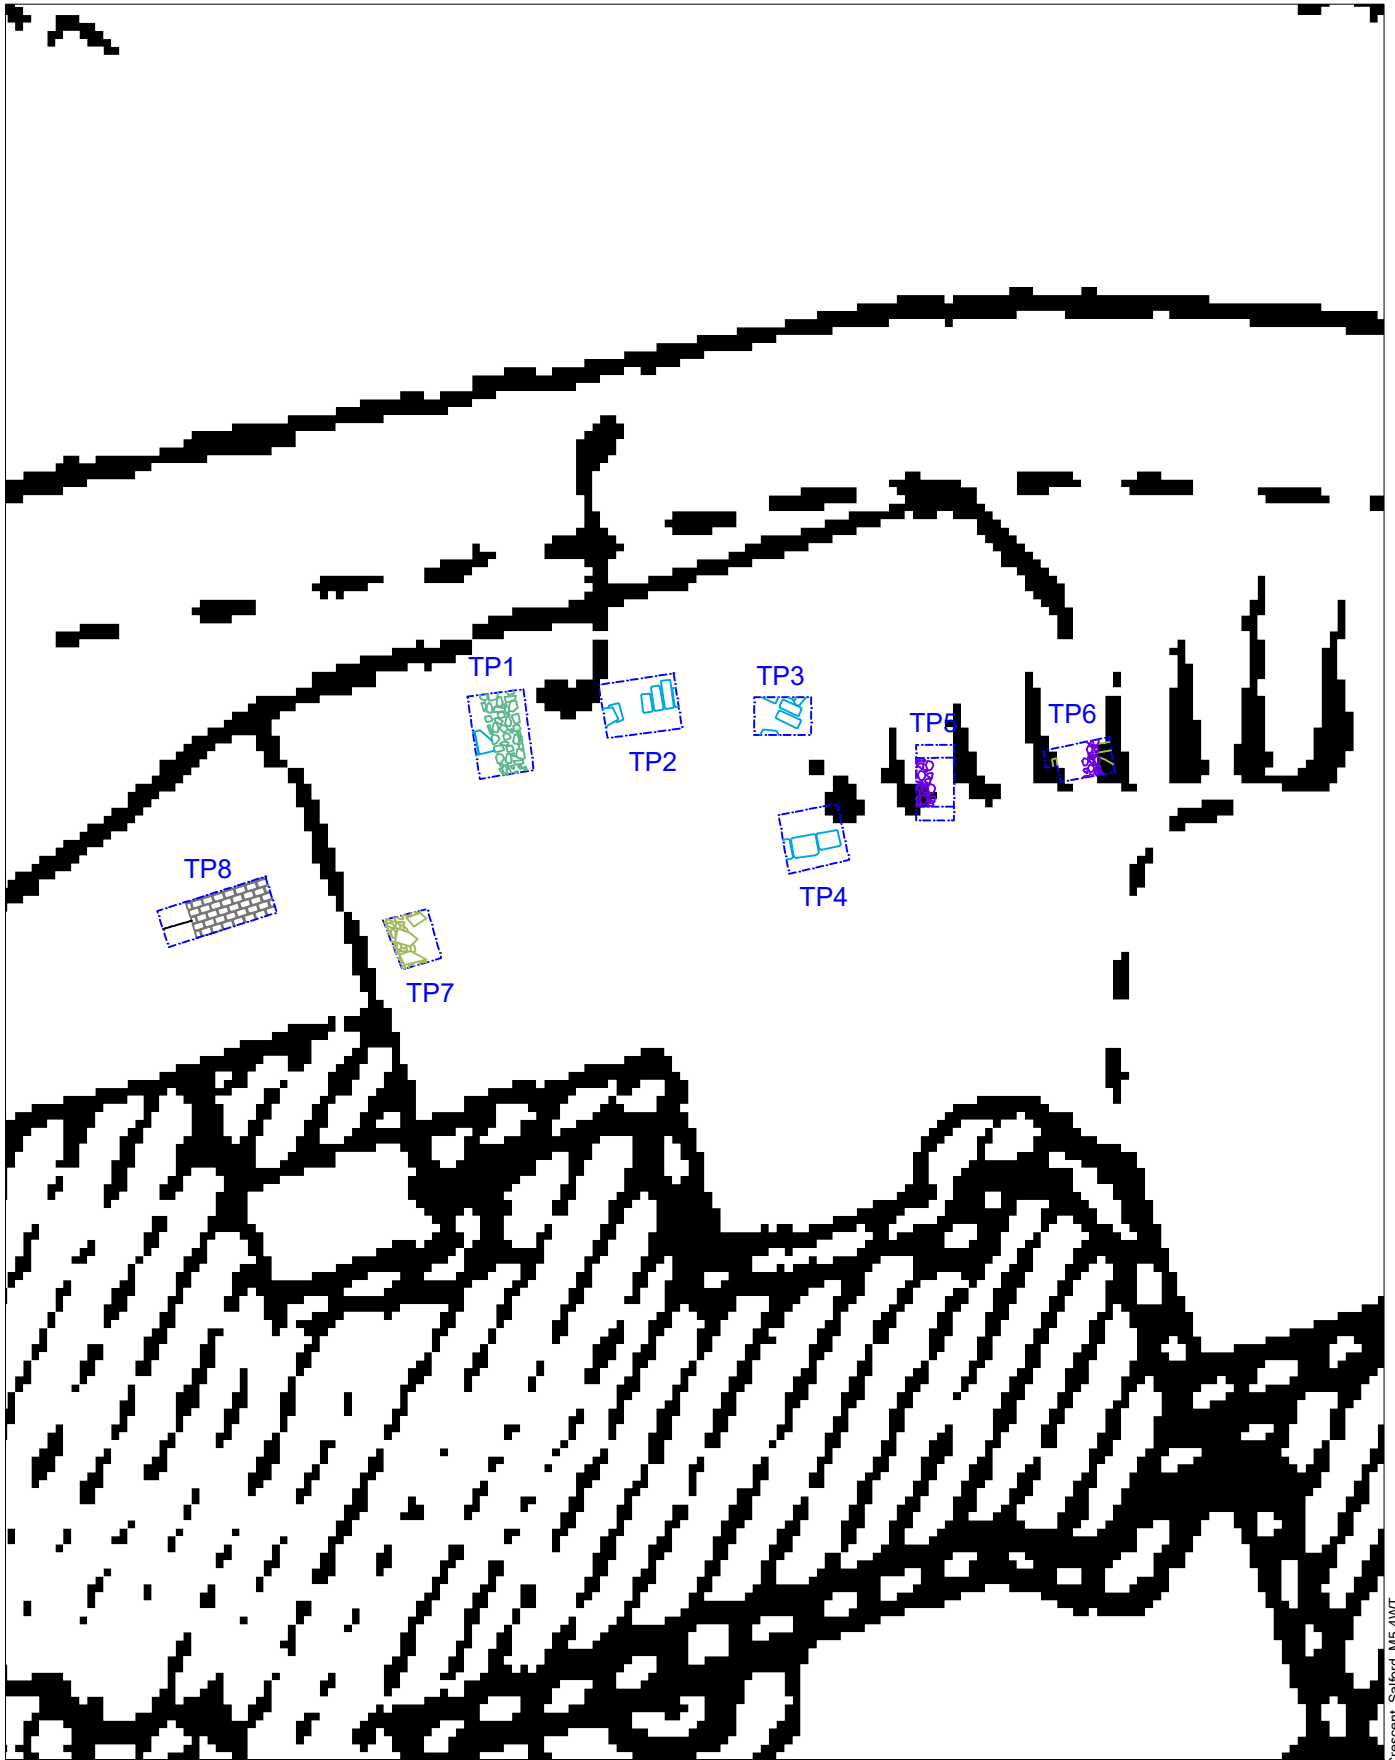
Figure 4:  
Trenches Superimposed onto the 1:2500 County Series Map of 1931
