## Archaeological Excavation Report

Hoghton Tower,  
Hoghton,  
Lancashire

**Project:** Hoghton Tower Community Excavation

**Document Type:** Community Excavation Report

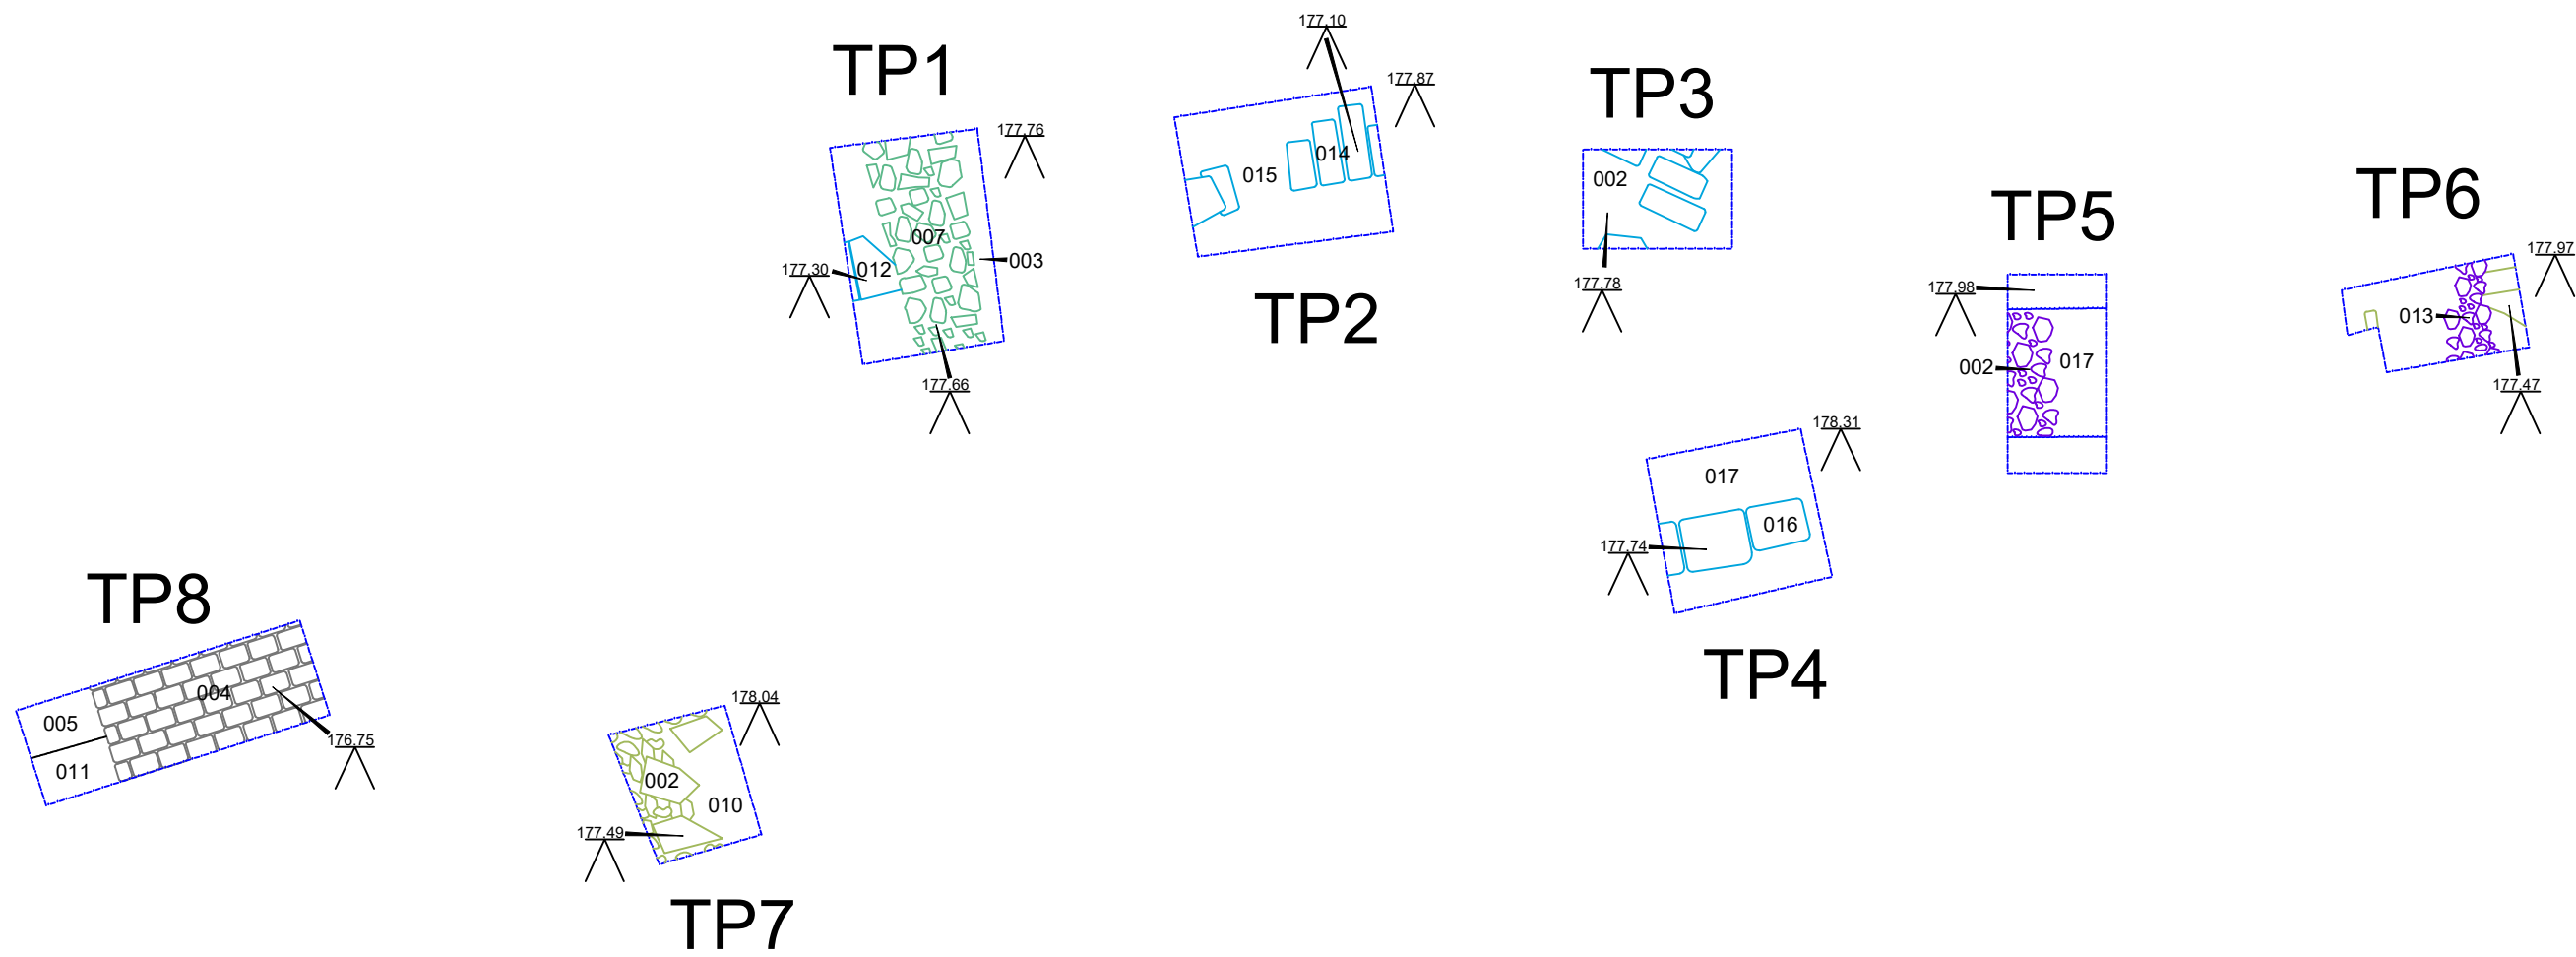
Flags
-   Stone
-   Stone Wall
-   Rubble

Figure 5:  
Trench Plans
