Post-Excavation Assessment

**Grasmere Avenue,
Farington,
South Ribble,
Lancashire**

Technical Report:

SA/2022/36

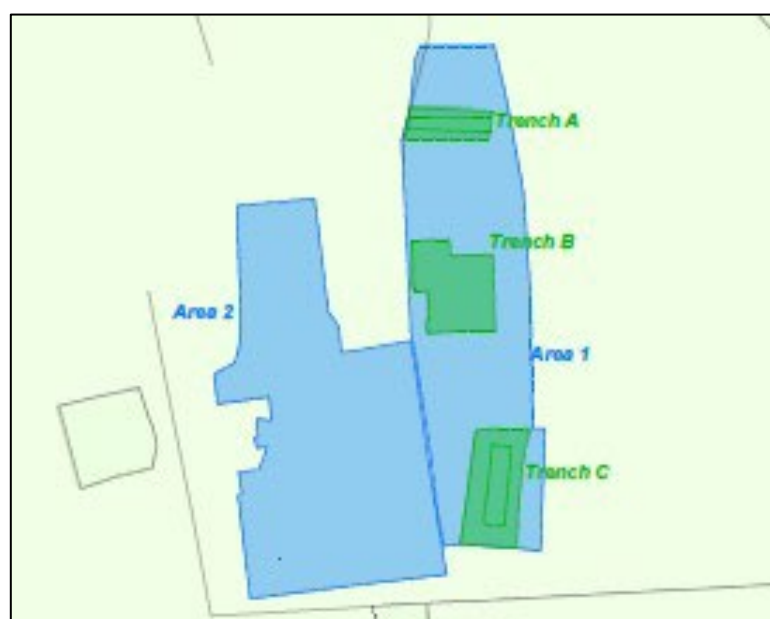
Plate 10: excerpt of Figure 3 showing excavation areas and trench locations, north at top

- 5.1.1 The site was densely overgrown with scrub and trees, which needed to be cleared before excavation could commence.
- 5.1.2 Two open areas were excavated (Figure 3). Area 1, located in the eastern part of the site measured c. 60 north-south by c. 15m east-west. Area 2 was located in the western part of the site and measured c. 24m north-south by 10m east-west

- 5.1.6 Three slots were excavated through the moat (Figure 3). Trench A was located in the northern part of Area 1; Trench B was located in the centre of Area 1; and Trench C was located in the southern part of Area 1.

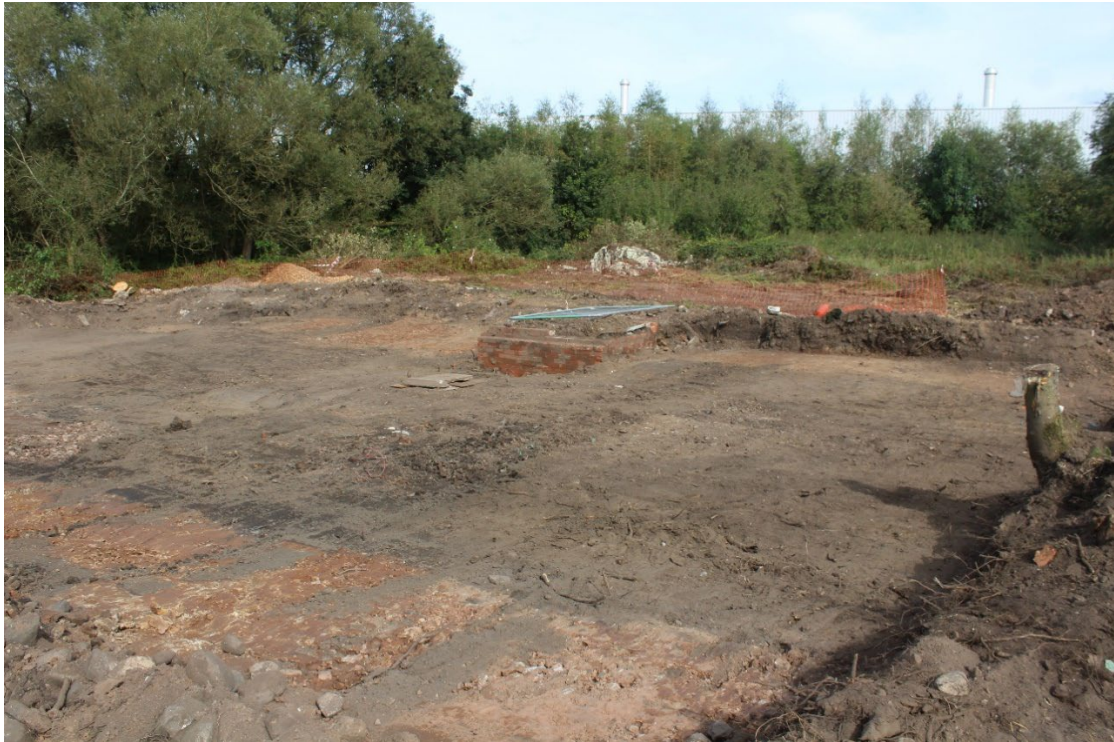
Plate 11: Initial exposure of the moat, which can be seen as a dark band running through the centre of the photo, to the north of the causeway, looking northwest

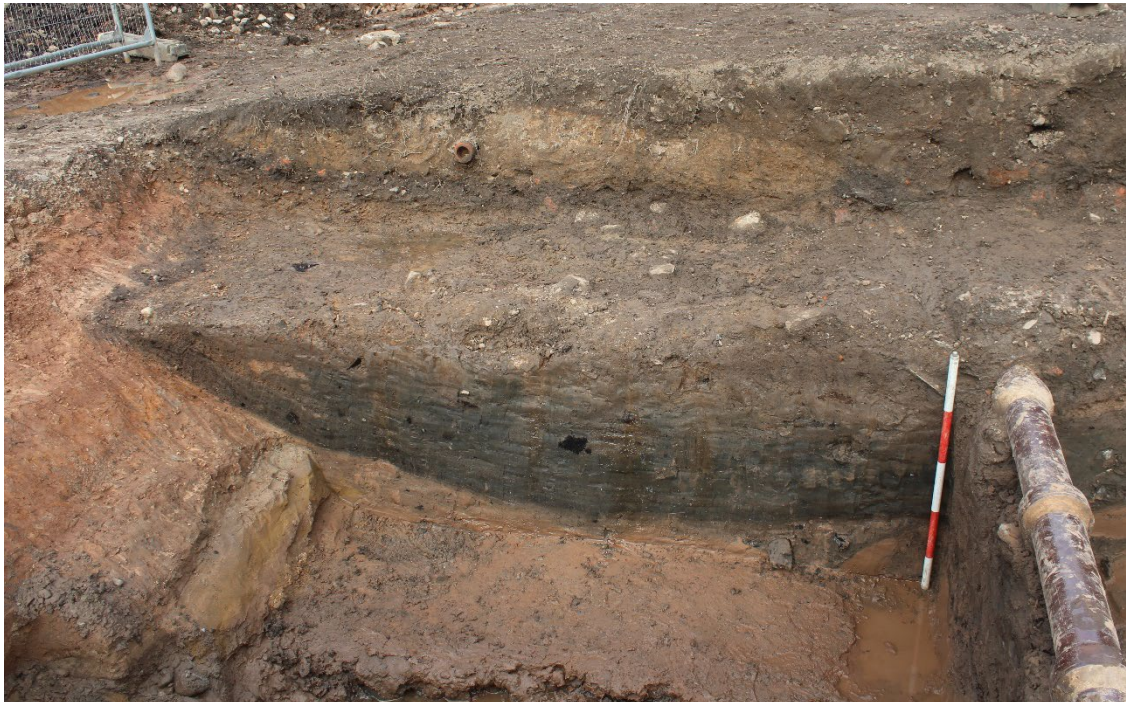
Plate 12: South-facing section through moat in Trench A (see Figure 4 for context numbers), showing the western side of the moat. The pinkish-brown clayey silt [255] can be seen at the bottom of the left side of the cut [251]. looking north, scale: 1m vertical

- 6.4.3 The cut [251] was filled with soft light pinkish-brown clayey silt [255] and may have served as a lining of the moat. The clayey silt [255] had a maximum width of 1.46m and a thickness of 0.08m. The clayey silt [255] was sealed by a friable, light greyish-brown medium sand [254] with occasional flecks of charcoal. The brown medium sand [254] was deposited over an area of 1.95m x 0.39m across the base of the cut and had a thickness of 0.13m. The uppermost fill within cut [251] was soft, light greyish-brown silty sand [253] with occasional small organic inclusions. This was deposited over an area of 1.95m x 0.75m and had a maximum thickness of 0.20m.

- 6.4.4 The cut [243] forming the eastern side of the moat was represented by cut [243] which was filled with firm light brownish-grey clayey silt [241] with fragments of redeposited light pinkish-brown clayey sand and occasional small sub-angular stones. The clayey silt [241] was covered by moderately compact, light greyish-brown silty sand [242].

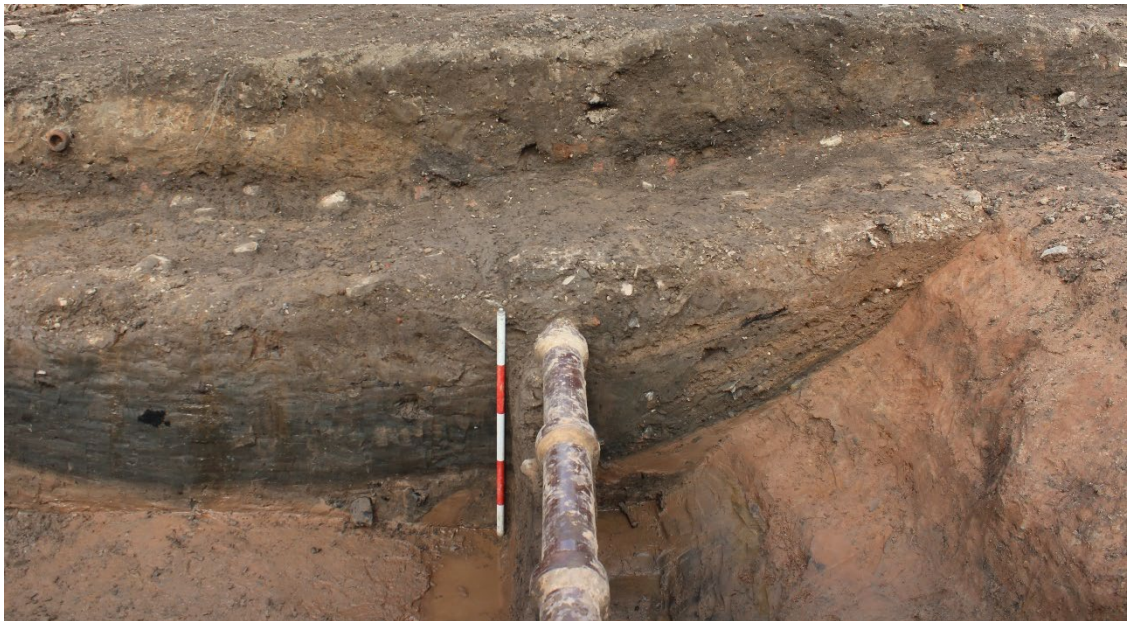
Plate 13: South-facing section through moat in Trench A, showing the eastern side of the moat. The light pinkish-grey sand [239] can be seen in a narrow cut [240] just to the left of the scale, looking north, scale: 1m vertical

- 6.4.6 The cut [240] was filled by soft, light pinkish-grey silty sand [239] with moderate fragments of worked wood and small to medium stones. This contained a single sherd of medieval pottery (Appendix 2).
- 6.4.7 **Trench B** (Figure 5; Plate 14)
- 6.4.8 In the southern part of Trench B the natural geology was truncated by a linear, north-south oriented cut [179], recorded at a maximum level of 25.40m AOD. It was traced for 3.68m along its length and had a maximum surviving width 2.80m and depth of 1.24m, extending down to a level of 24.16m AOD. The profile on the eastern side was characterised by gently sloping sides becoming concave with an imperceptible break of slope to the base.

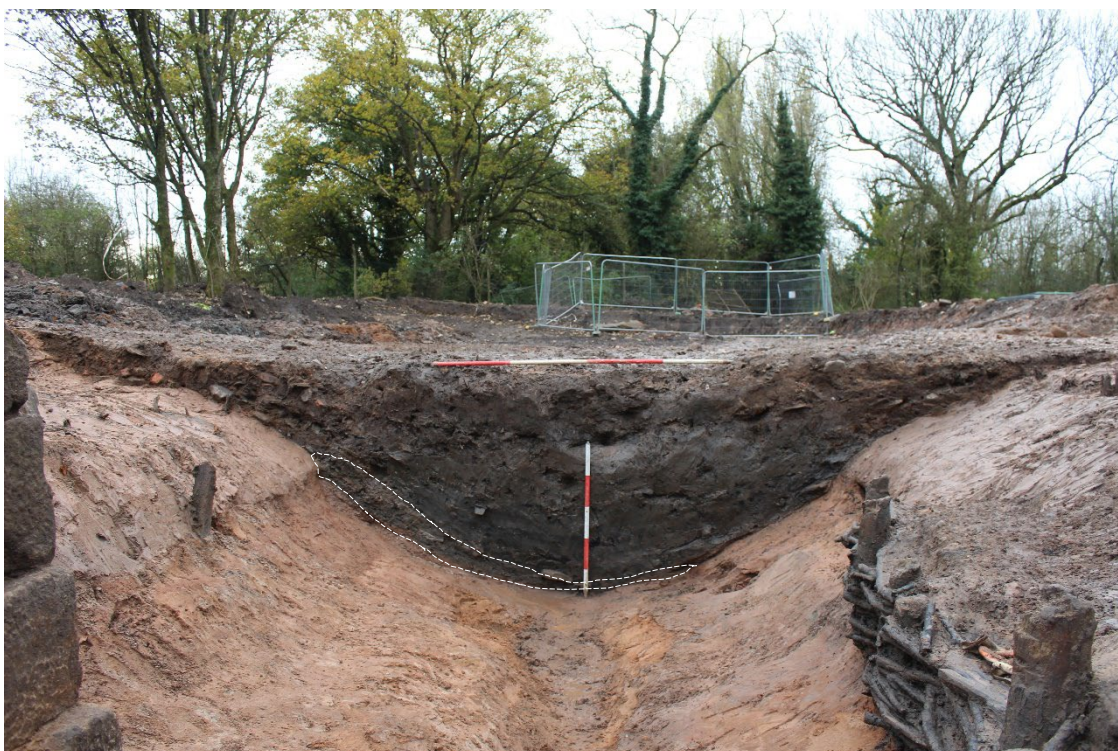
Plate 14: Trench B looking south, fill [277] highlighted, scales: 1m vertical, 2m horizontal

- 6.4.9 The earliest fill of the cut [179] was friable, light brownish-grey silty sand [277] recorded at a highest level of 25.16m AOD. The silty sand fill [277] had a maximum thickness of 0.25m. The silty sand fill [277] was encountered over an area of 5.14m x 2.36m and contained leather and worked wood. Shoes recovered from the fill [277] were dated typologically to the early 16th century (Appendix 2).

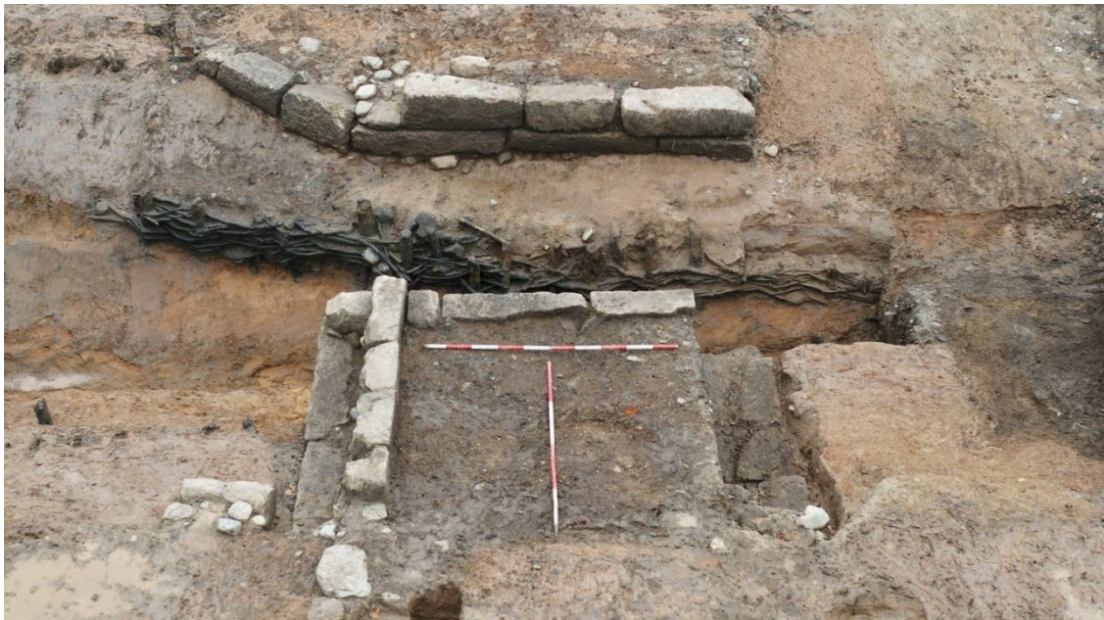
Plate 15: Aerial view of masonry bridge abutment, looking west. Wall [175] is visible to the left of the scales and wall [340] is at a lower level to the right of the scales, scales: 2m horizontal, 2m vertical

6.5.5 Two substantial freestanding masonry walls [175]/[340], representing the southern and northern foundations of a bridge abutment, located on the eastern side of the moat, were built within cut [174]. The walls were aligned east by west and were formed of large, dressed gritstone blocks. The wall stepped out at each course towards the base was therefore self-supporting. The outer faces of walls [340] and [175] were built closely up to the edges of cut [174] suggesting both structures were built from the interior of the construction cut. The abutment did not appear to have been originally enclosed at its western side by a wall facing into the moat. A north-south aligned wall

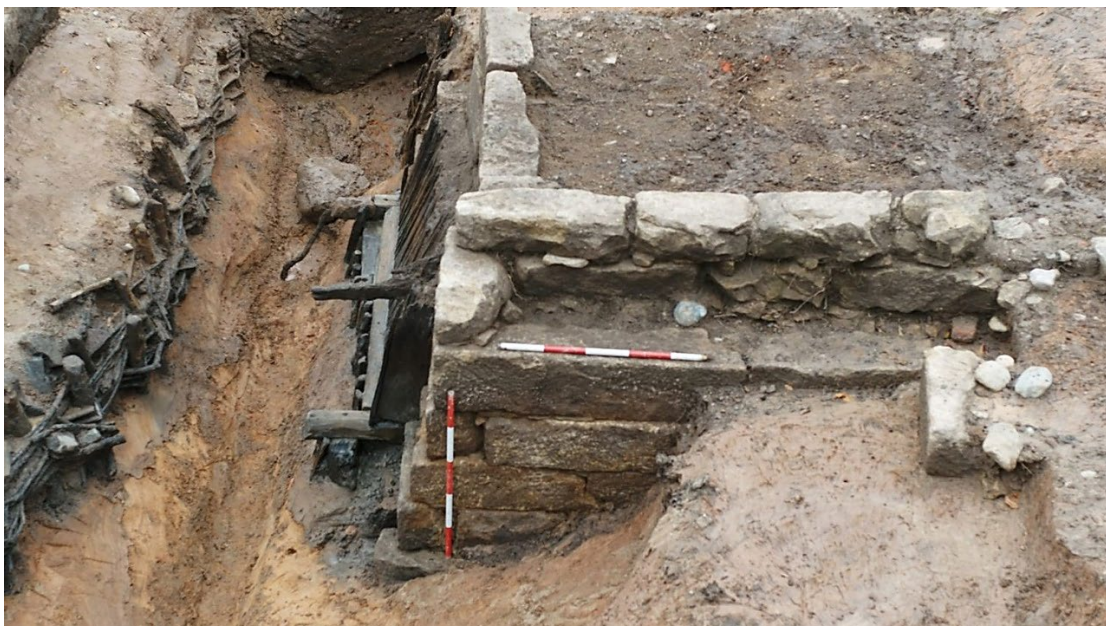
Plate 16: Aerial view of the moat, looking north. The scales are resting on the southern wall [175] of the abutment, scale: 1m horizontal, 1m vertical

- 6.5.8 Also, within the construction cut [174], situated 2.27m to the north of the wall [175] described above, was another east-west aligned wall [340] forming the northern side of the abutment on the eastern side of the moat. This survived to a lesser extent than wall [175] but was nonetheless exposed along its full length, measuring 3.10m east-west with a width of 0.80m, surviving to a maximum height of 1.62m with the highest level of survival at 25.88m OD. The upper courses of the wall [340] appeared to have been removed. The wall [340] was constructed of gritstone blocks, ranging in size from 600mm x 300mm x 295mm to 1200mm x 427mm x 320mm.

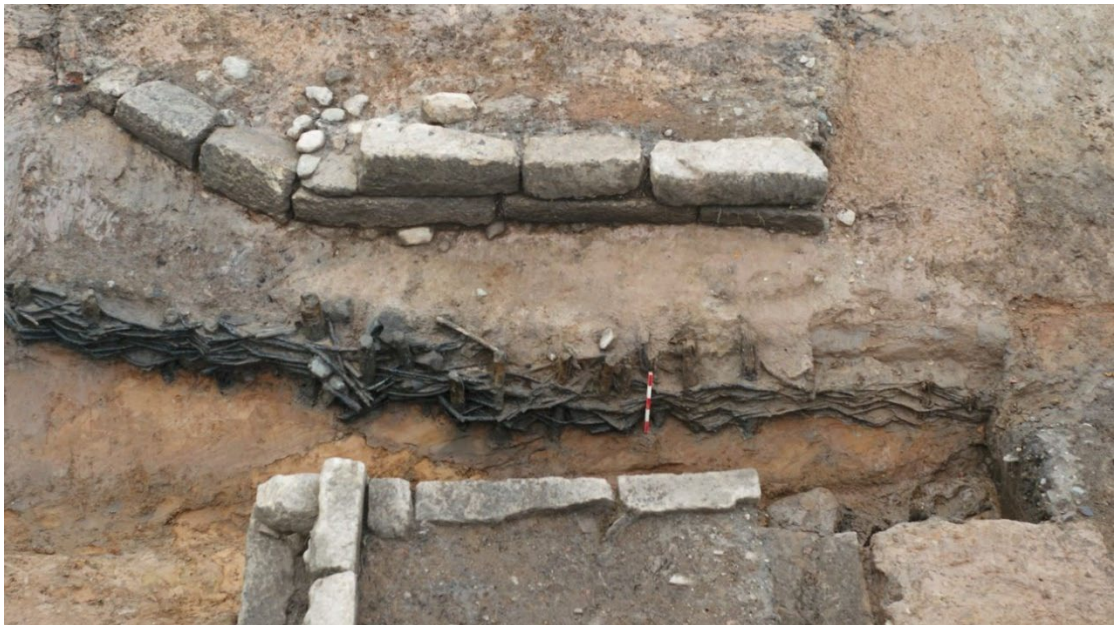
Plate 17: Aerial view of the revetment [246], looking west, scale: 0.50m vertical

- 6.7.11 A wattle revetment structure [246] recorded on the western side of the moat was the better preserved of the two structures. It comprised a north-south orientated line of stakes driven into the natural sand. The stakes were unmodified roundwood, some retaining bark, which were identified as primarily being from the alder species (Arnold and Howard 2022); a single stake [324] was identified as holly (ibid). The lower portions of the posts were tapered to a point. Around the posts were woven a series of coppiced alder rods. The highest level of survival for the structure was 25.34m AOD. The lowest level of the wattling [246] was situated at 24.40m AOD, suggesting the structure was built within the recut [262] of the moat.

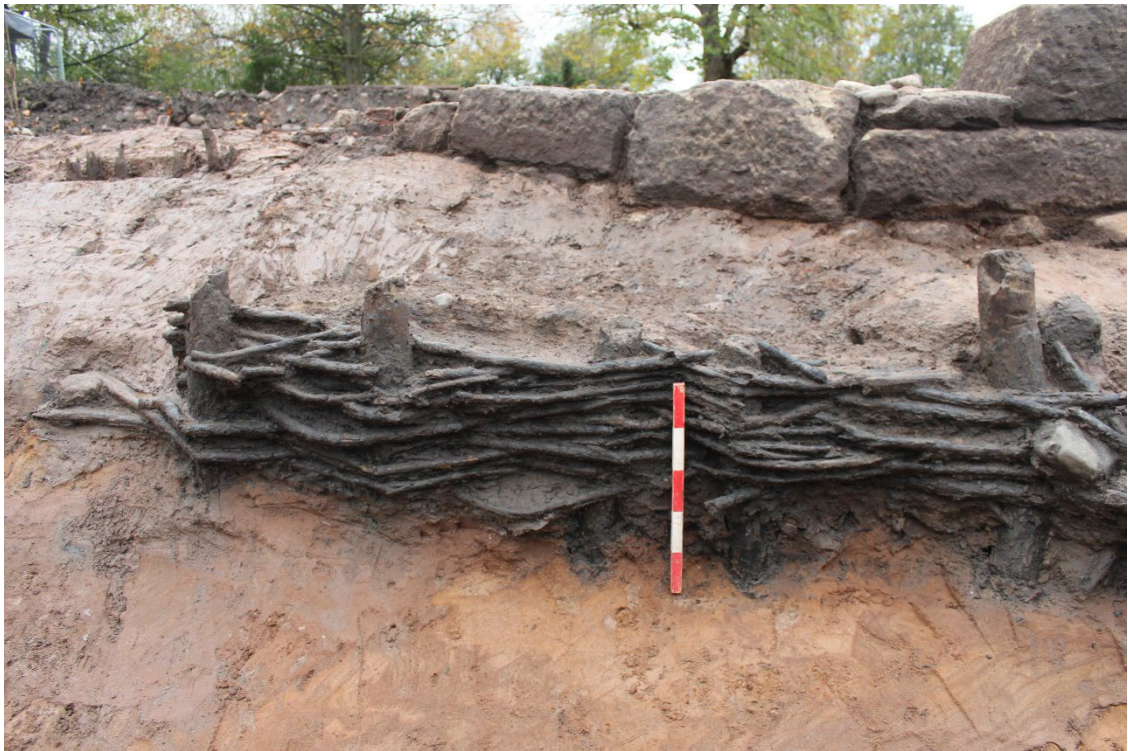
Plate 18: The southern end of revetment [246], looking west, scale: 0.50m vertical

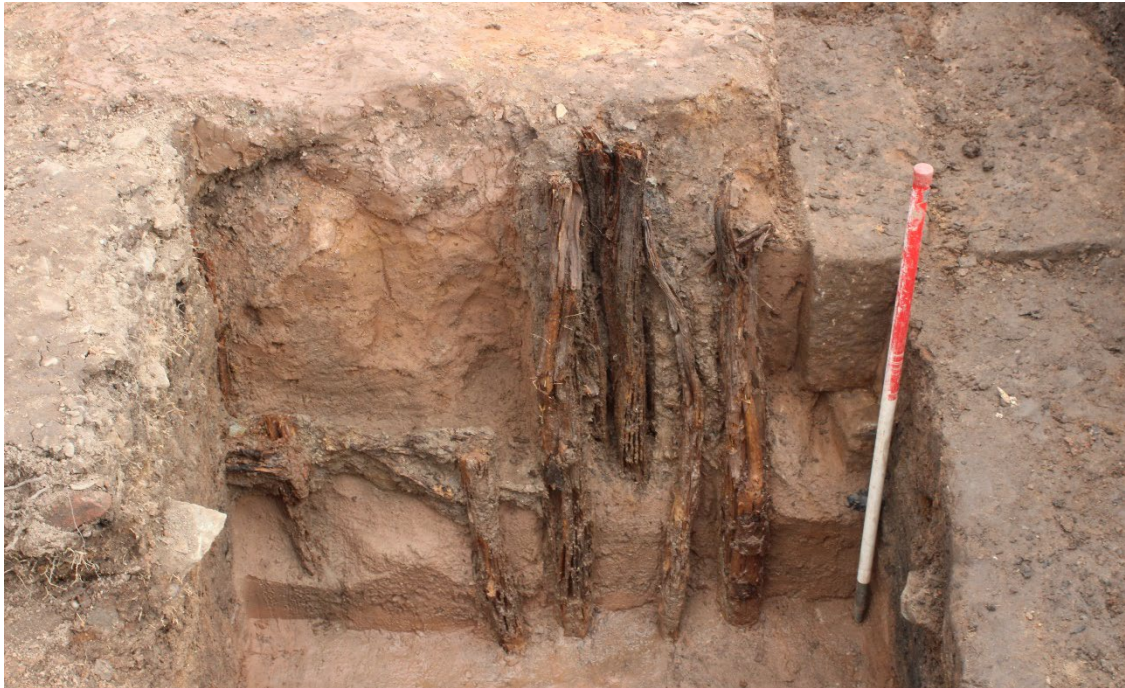
Plate 19: Revetment [247]. The masonry structure to the right of the scale is wall [340], looking east, scale: 1m vertical

- 6.7.13 The majority of the stakes forming the wattle structure [247] were degraded, possibly owing to the greater proportion of sand within the fills in this part of the ditch. Only three rods of wattle were recorded *in situ*. As with the wattle structure on the western side [246], the stakes were unmodified roundwood, tapered to a point. None of the stakes were selected for species identification due to their poor condition but were visually similar to the alder posts used in wattle revetment structure [246] on the western side of the moat.

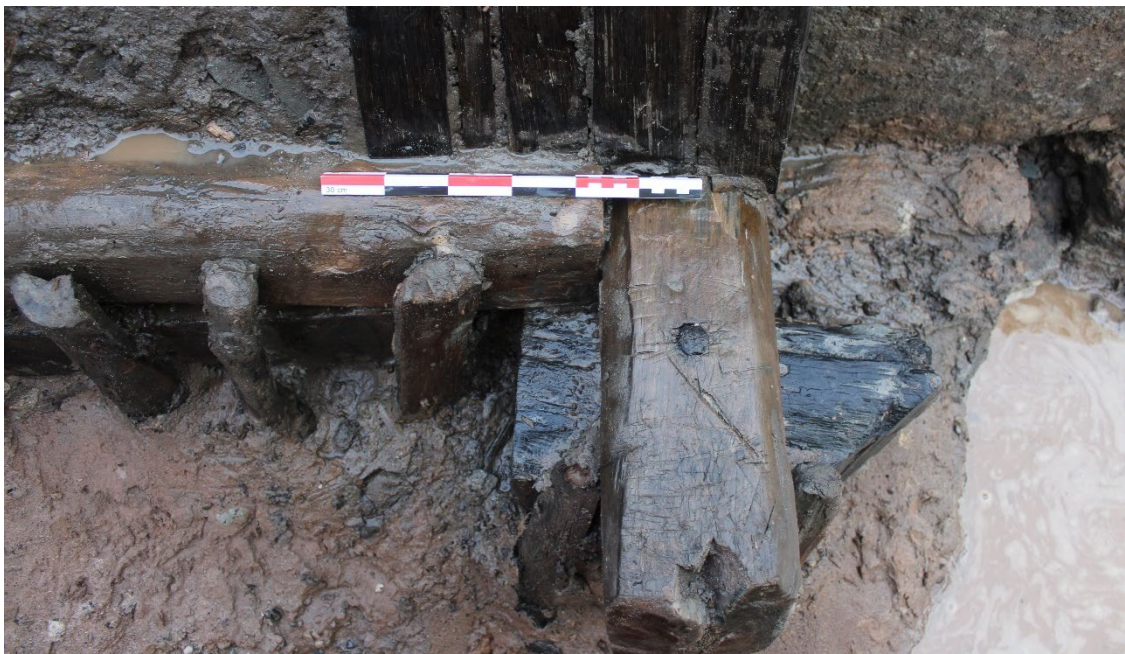
Plate 20: Detail of the lap-joint securing timbers [283]/[310] on the bridge base frame, scale: 0.30m horizontal

- 6.7.19 The ground frame was founded on a north-south orientated beam acting as a base plate [312]. Above this, lay a mid-plate [283], also aligned north by south. These were held in place by a row of vertical stakes located to the west of the beams [312] and [283] within the moat. On either side of the mid-plate [283] were two east-west orientated base plates [310] and [314]. The base plates [310] and [314] were secured to the corresponding mid-plate [283] by means of lap-joints (Plate 20 & 22).

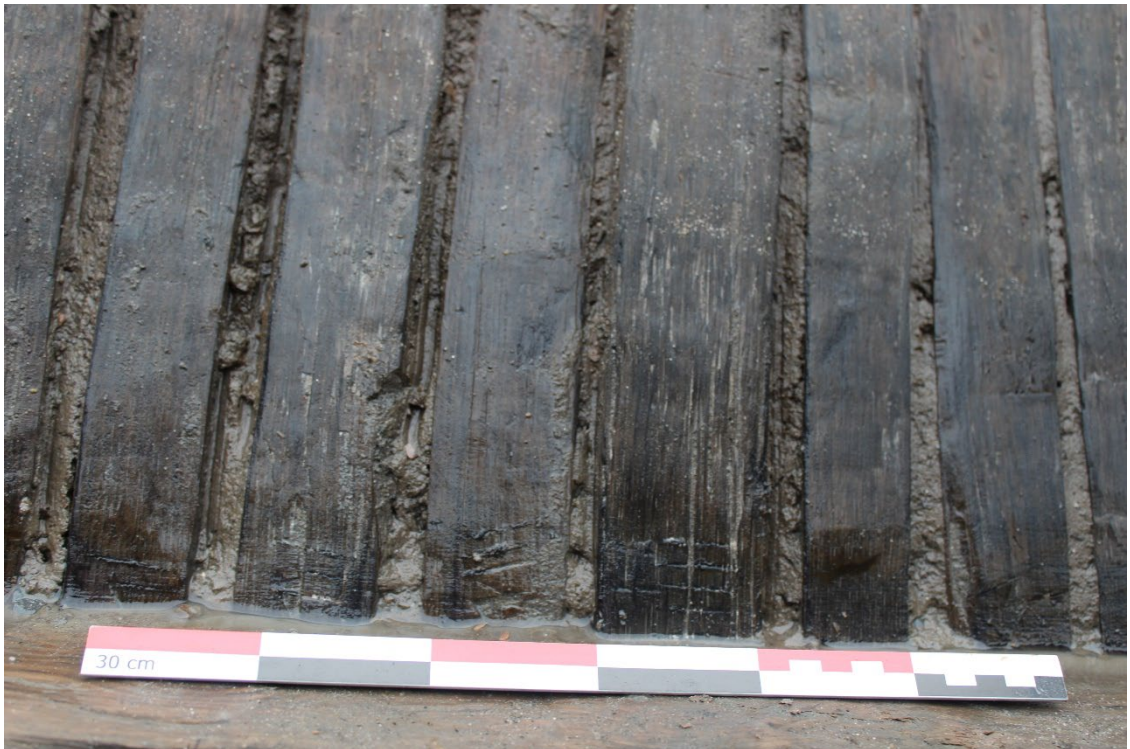
Plate 21: Trench B, an example of the assembly marks on the upright laths, bridge base frame [333], looking east, scale: 0.30m horizontal

- 6.7.22 Running behind the mid-plate [283] were a series of upright laths [278]-[282] / [285]-[309], inclined diagonally. The surviving laths were typically rectangular in cross-section, ranging in width from 25mm to 80mm, though primarily 40mm to 65mm wide and up to 780mm long. The majority of the laths bore carpenters' marks in the form of a sequence Roman numerals that appeared to be related to the assembly of the structure. The southernmost laths [308]/[309] were jointed to the upper face of base plate [310]; both timbers were worked to a narrow cylindrical point (resembling a dowel) at their base, which had been inserted into a round hole of similar dimensions in the upper surface timber [310]. A firm, light greyish-brown puddling clay had been applied around the base of the structure. The structure was abutted on the western side by moat fill [237] and on the eastern side by deposit [342].

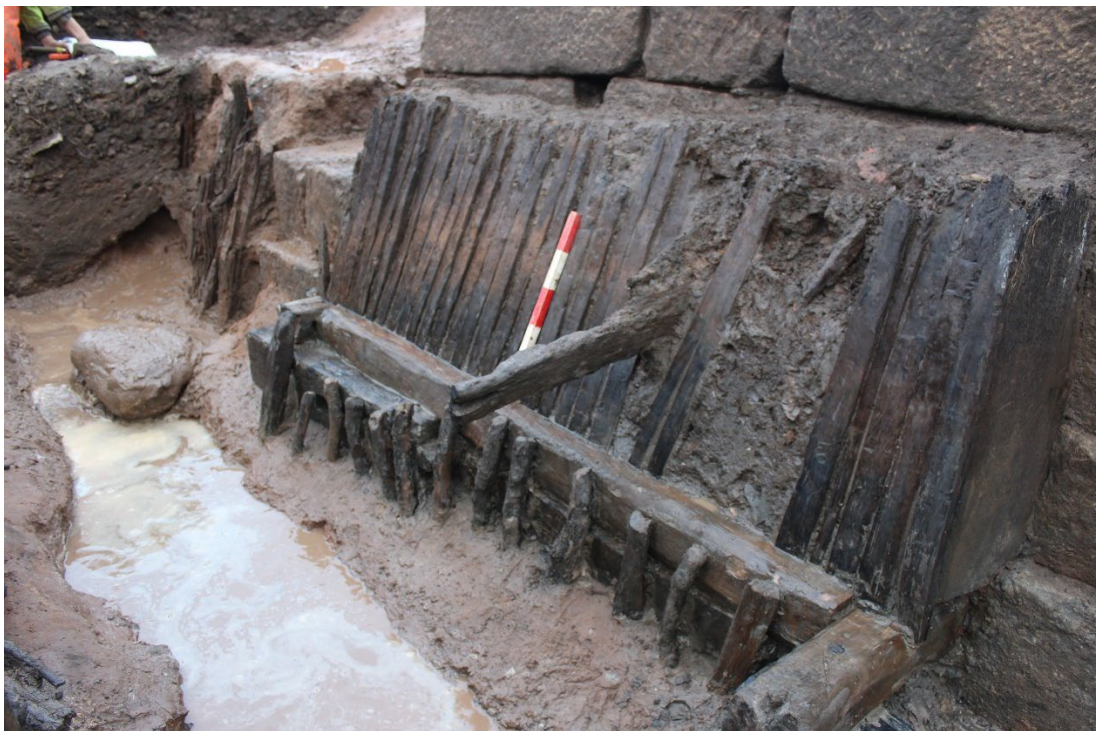
Plate 22: bridge base frame [333], looking north-east, scale: 0.5m

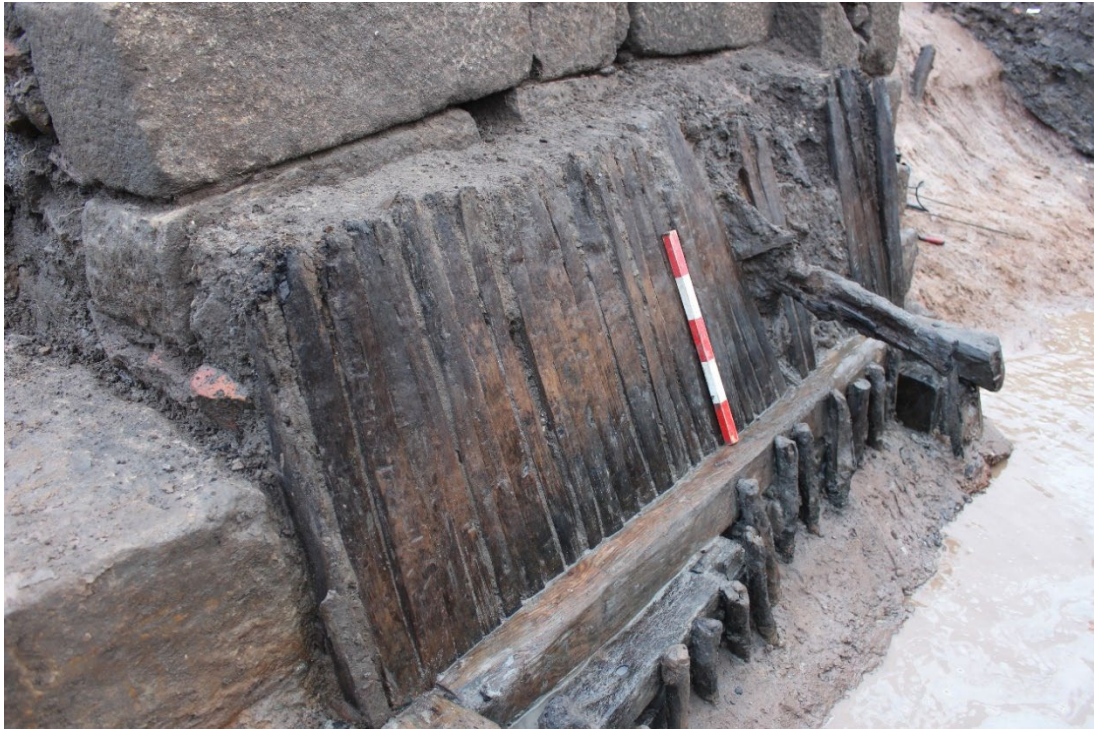
Plate 23: bridge base frame [333], looking south-east, scale: 0.5m

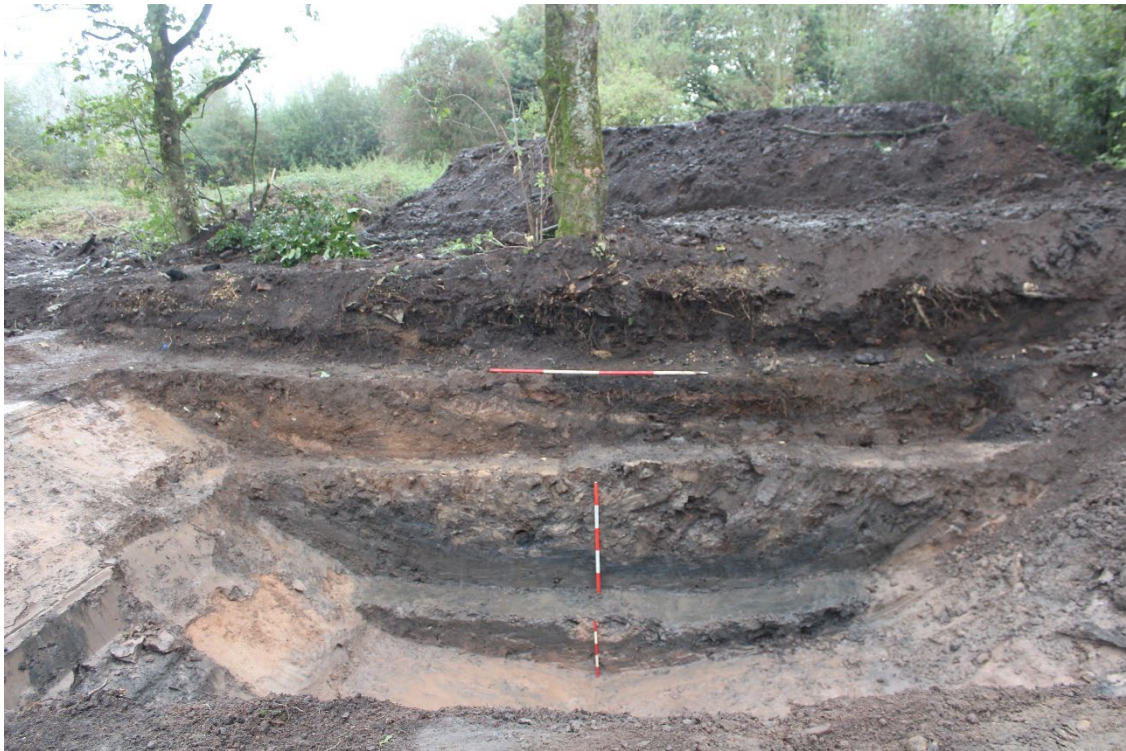
Plate 24: West-facing section through moat in Trench C, looking east scale: 0.50 and 1m vertical, 2m horizontal

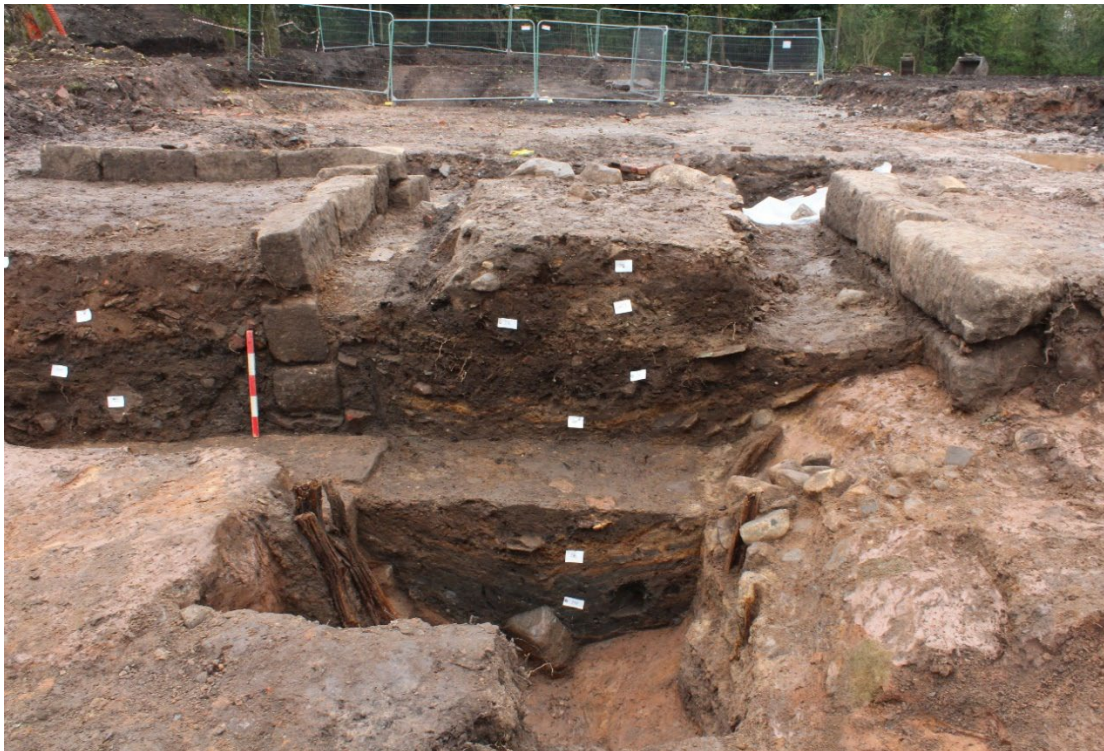
Plate 25: Section through the causeway and moat showing wall [339], looking south, scale: 0.50m vertical

the north-south oriented wall [339]. The wall [339] was founded on thin flat stones, above which were constructed three regular courses of blockwork. The southern end of the wall [339] abutted the northern side of the wall [175] that formed the southern side of the bridge structure.

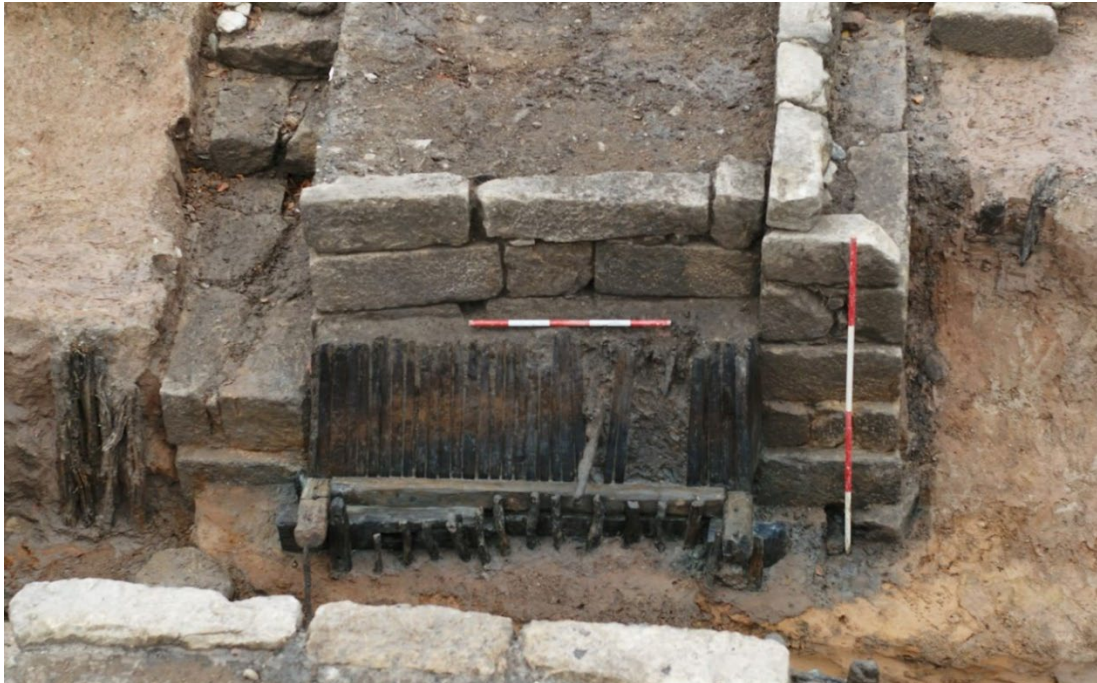
Plate 26: Masonry bridge abutment [175]/[340]/[339], looking east, scale: 1m horizontal, 2m vertical

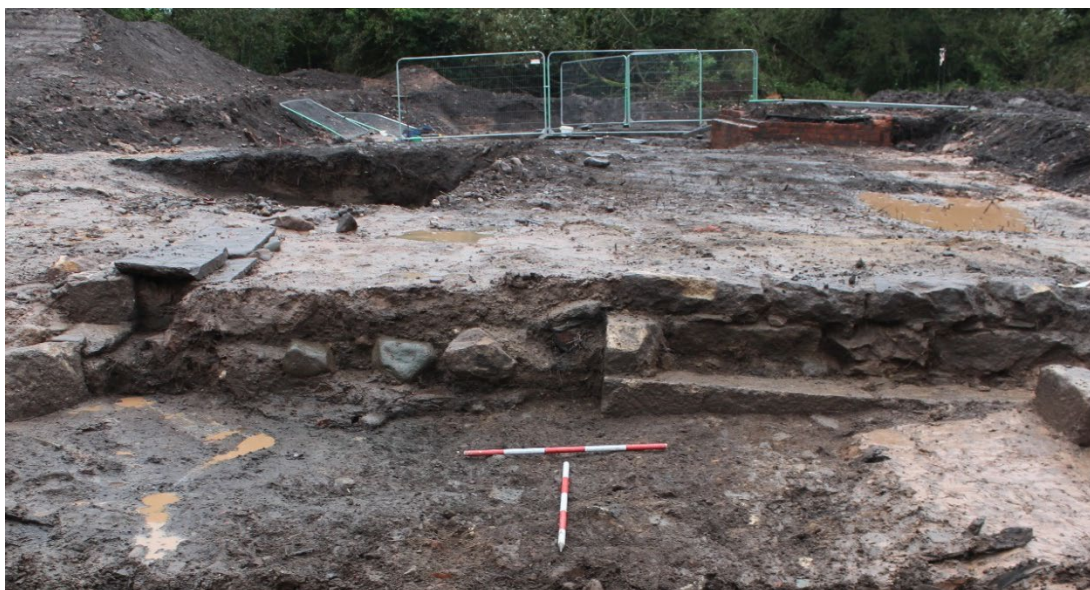
Plate 27: Trench B (Area 1) looking north, a mid-excavation shot of the causeway, scales: 1m horizontal, 1m vertical. Note the row of stones running east-west along the southern limit of the causeway

6.12 Causeway construction (18th century) (Figure 6; Plate 25 & 27)

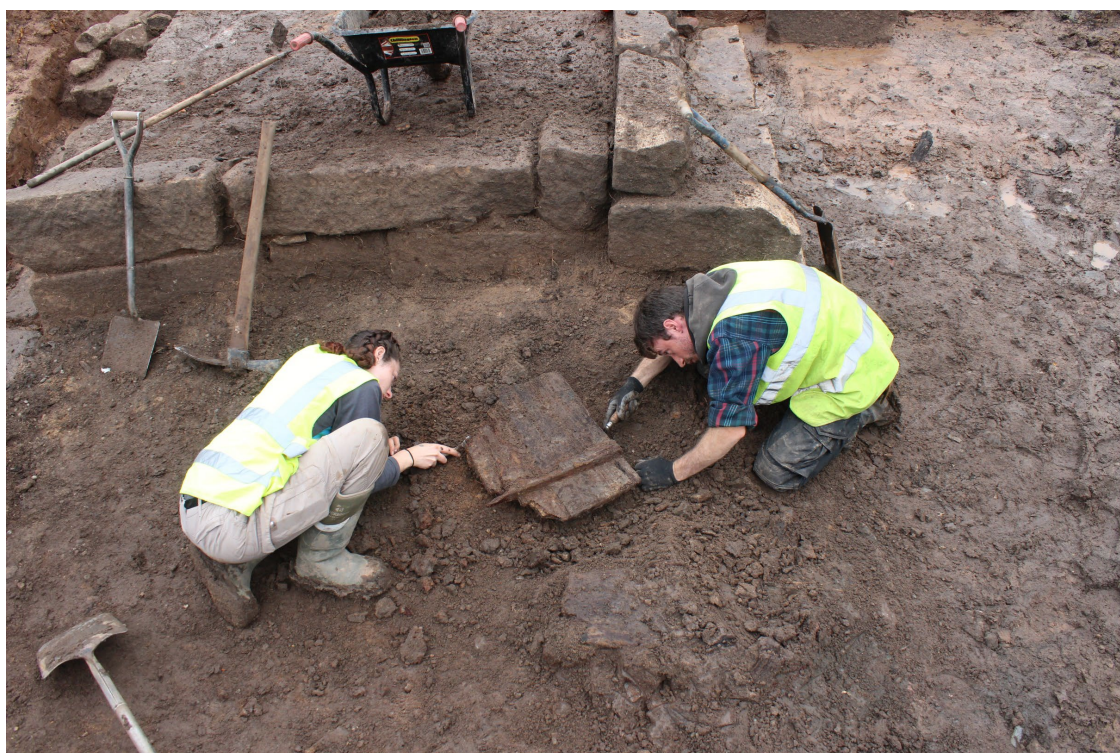
Plate 28: Working shot looking east showing remains of a wooden door lift being exposed, prior to lifting

6.12.6 The sandy clay layer [217] was covered by a layer [218] formed of loose, light brown sandy silt with occasional small fragments of stone, ceramic building material, frequent timber fragments. Covering an area of 2.89m x 1.30m, this deposit [218] had a maximum thickness of 0.37m. Finds recovered from [218] included pottery, clay tobacco pipes and wooden artefacts; these had a date range of the late-17th to early 18th century (Appendix 2). Of particular interest were the remains of wooden panel in the form of a door or lid recovered from fill [218] (Plate 28).

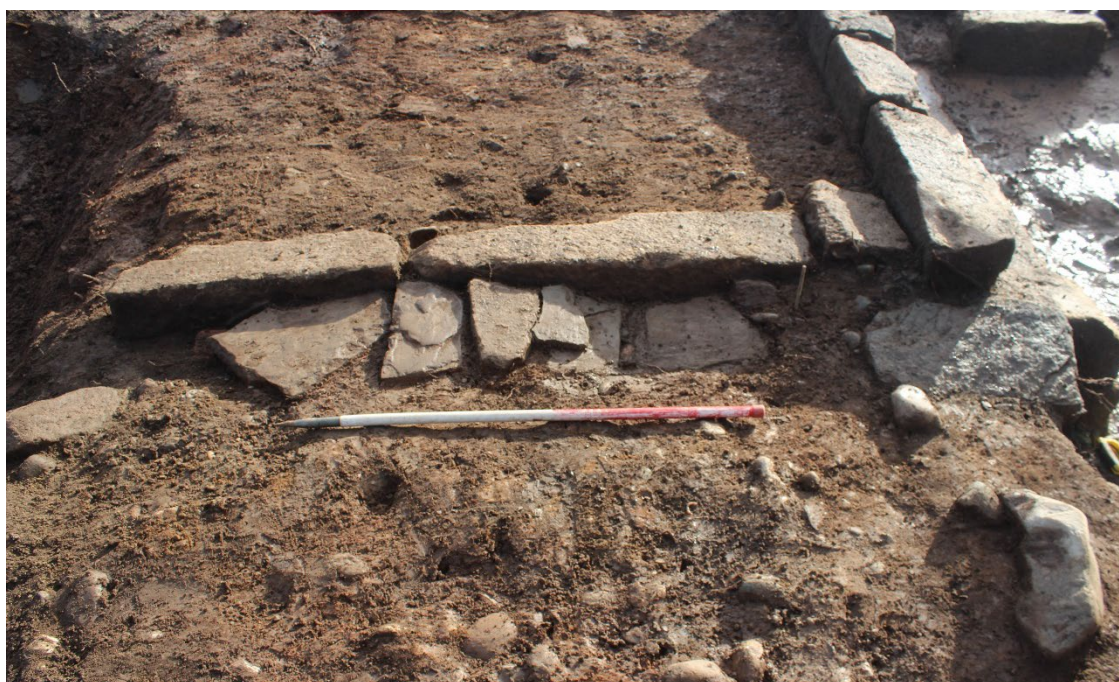
Plate 29: Drain [210]/[207] looking east, scale: 1m horizontal

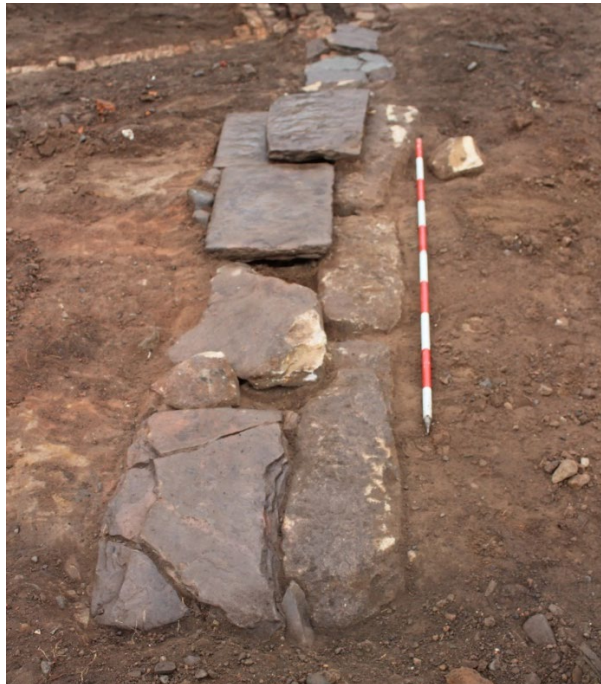
Plate 30: Area 1, looking north, drain [139] looking south, scale: 2m vertical

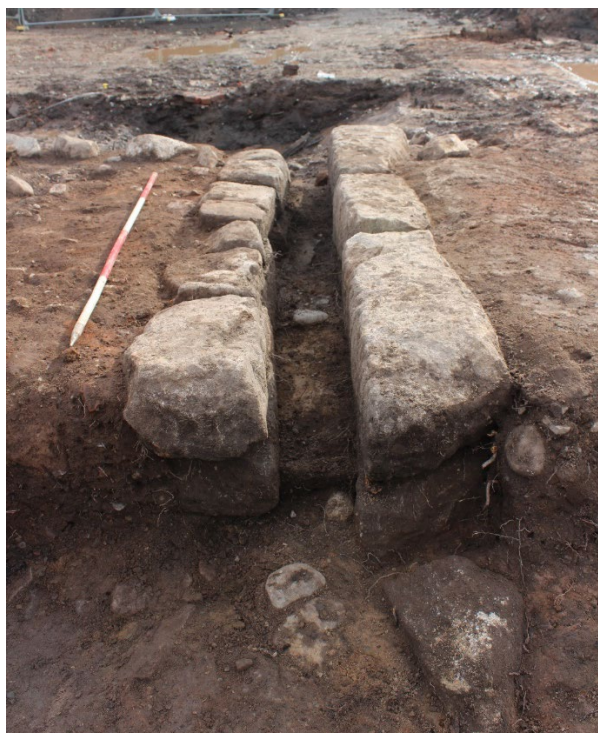
Plate 31: Area 1, looking north, drain [139] after the removal of the capstones, looking south, scale: 2m vertical

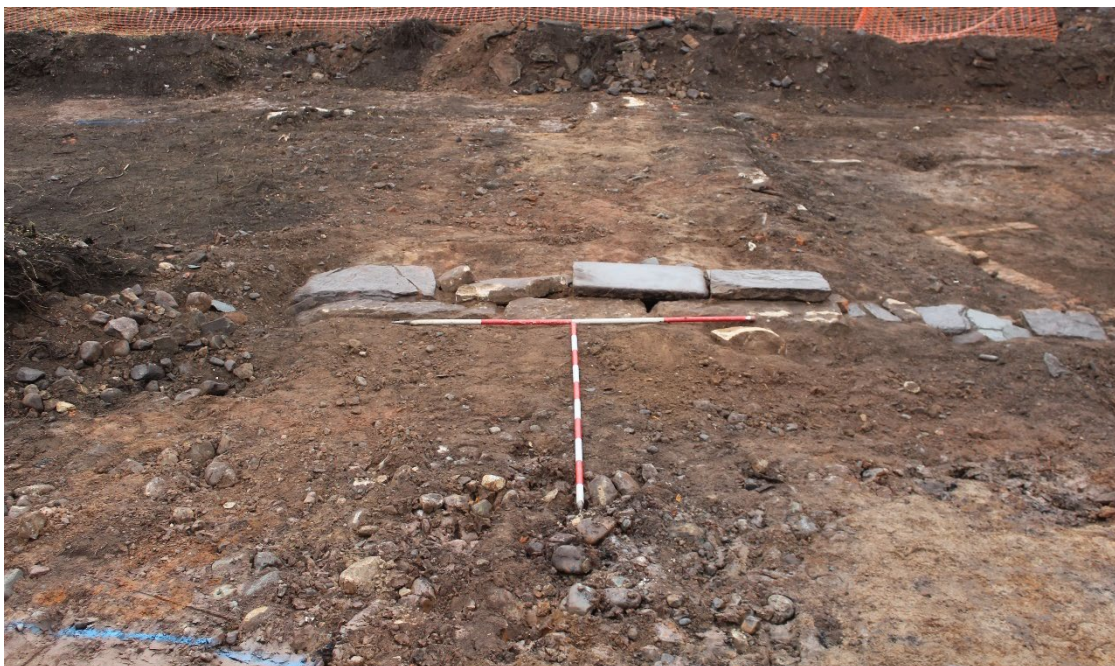
Plate 32: Area 1 looking east, a mid-excitation shot of the causeway after the removal of surface [133], bedding layer [137] and partial excavation of [172], scales: 2m horizontal; 2m vertical

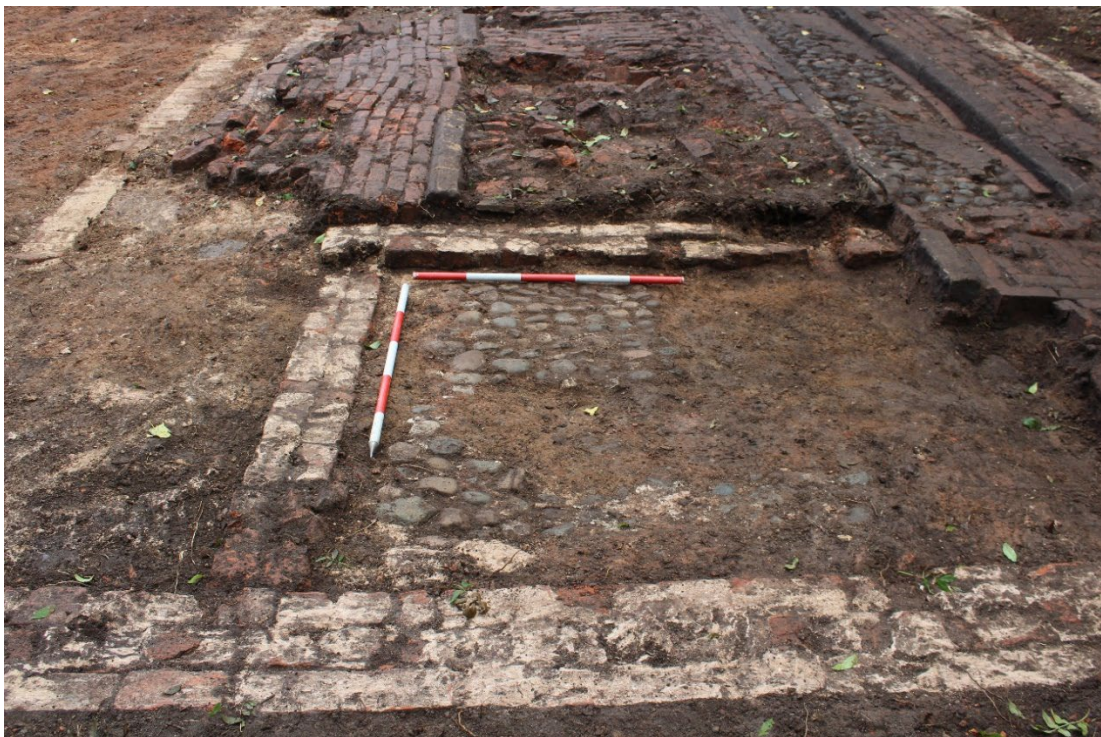
Plate 33: Cobble surface [015] looking east, scales: 1m horizontal, 1m vertical

6.17.3 An external floor surface [015] survived over an area of 1.35m x 0.87m and was comprised of cobbles measuring 90mm-130mm in diameter (Plate 33). The surface [015] pre-dates the surrounding structural sequence and was visibly truncated by construction cuts [018] and [020] associated with the construction of Building 6 (Rooms 6.3/6.4).

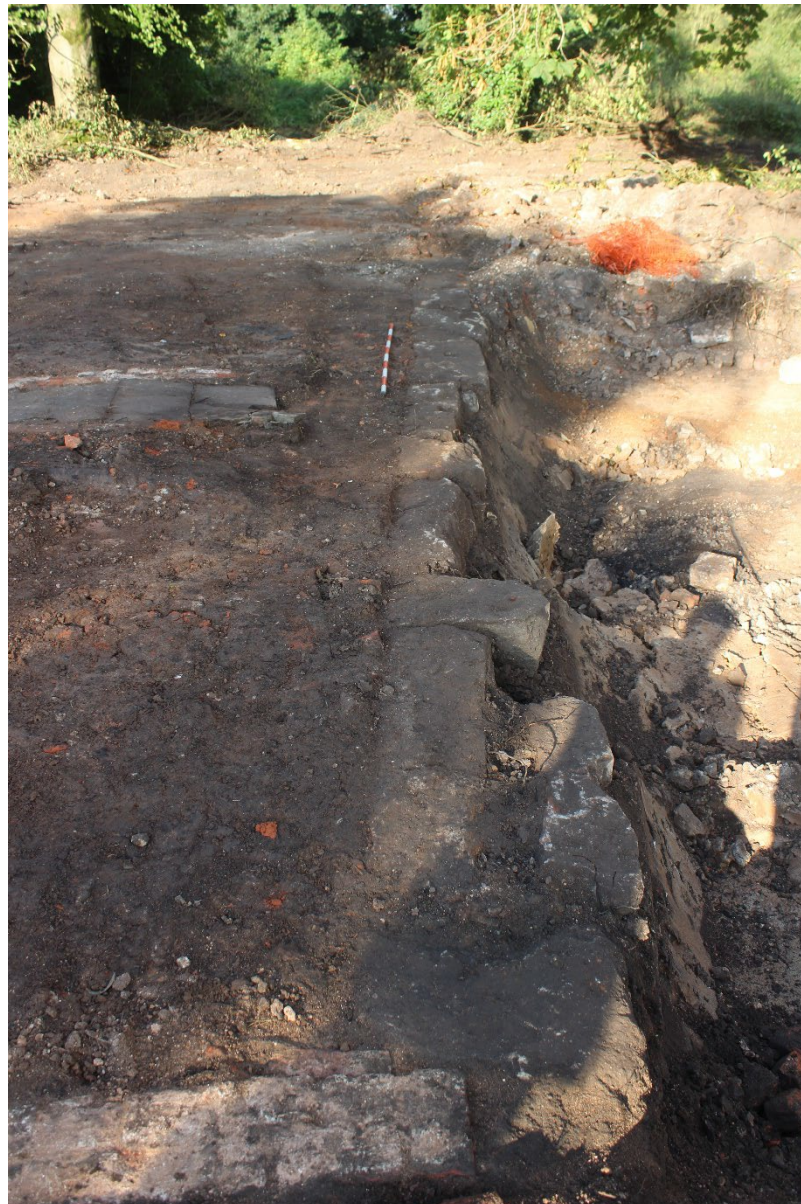
Plate 35: Wall 88, Building 2 looking west, scale: 2m vertical

- 6.19.2 The wall [088] measured 9.68m east-west by 0.58m wide and was constructed from large gritstone blocks. Remnants of the construction cut backfill [415] were identified as a friable, mid greyish-brown silty sand.

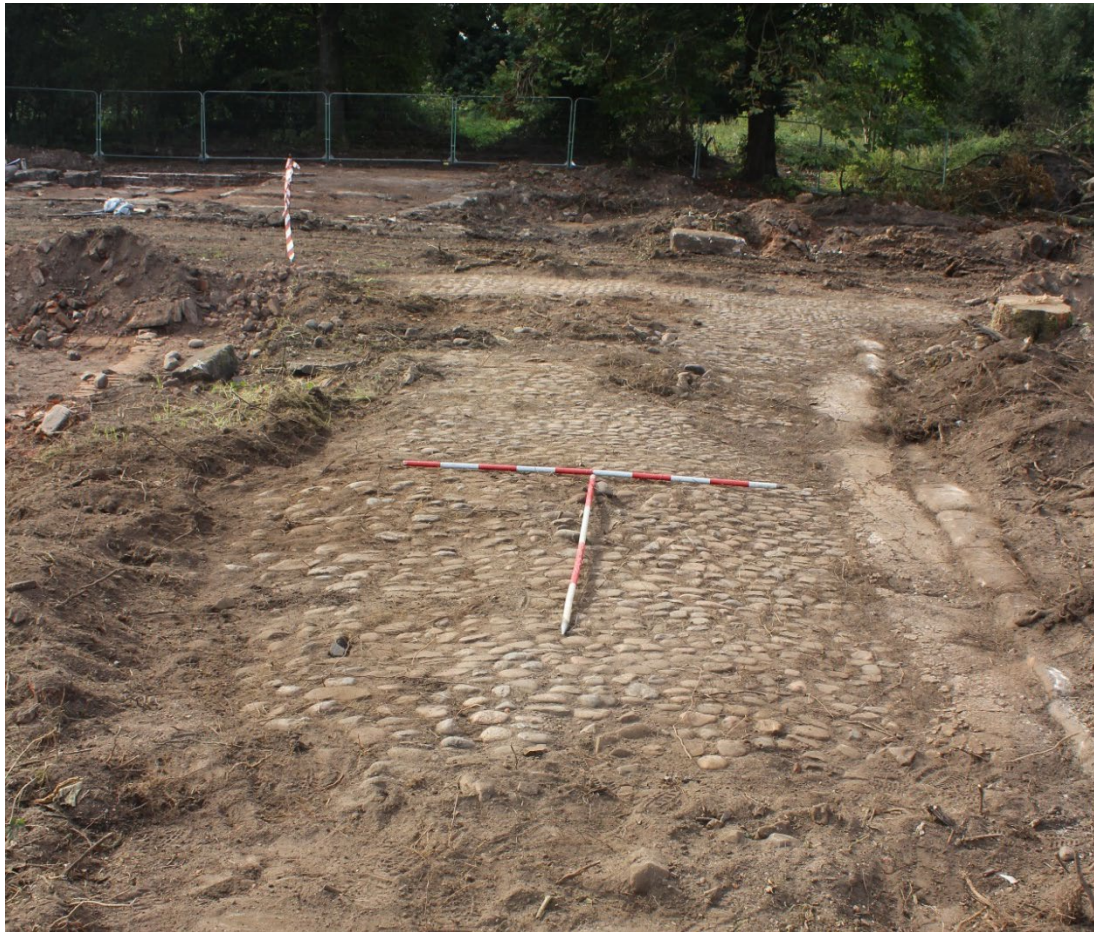
Plate 36: Cobble surface [133] extending across the moat causeway, looking west, scales: 2m horizontal, 1m vertical

6.24.3 Surface [133] extended for approximately 43m north-south and 10m east-west forming a trackway, which was left *in situ* within Area 2. Surface [133] also extended across the causeway (Area 1), where it was laid above bedding layer [137]. Within Area 1 it covered an area of 12.13m x 3.14m and was 0.12m thick, with an uppermost level of 26.54m AOD.
