Post-Excavation Assessment

**Grasmere Avenue,
Farington,
South Ribble,
Lancashire**

Technical Report:

SA/2022/36

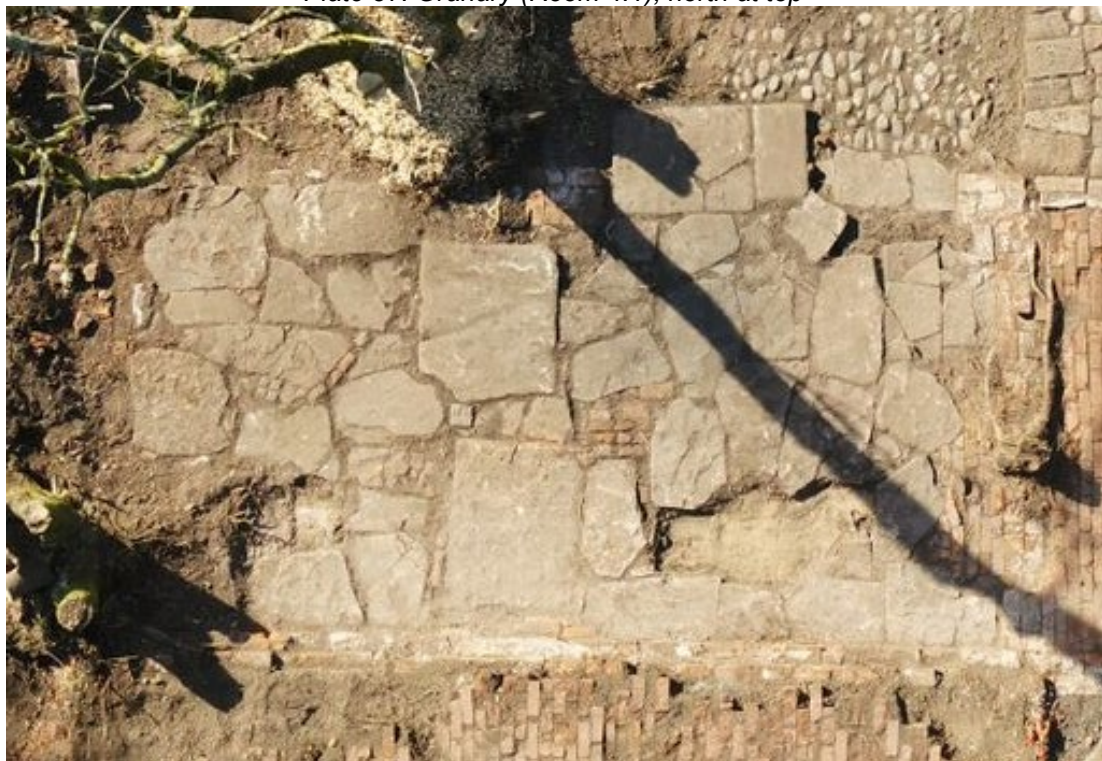
Plate 38: Stables (Room 4.2), west at top

6.29.2 The wall [052] was aligned east-west and formed the northern side of the stable block (Room 4.2). The wall [052] had a total length of 2.72m and was 0.23m wide. At its western end, the wall [052] was keyed into a brick column base [062], which formed the north-west corner of the open-fronted stable. The eastern end of the wall [052] was keyed into a north-south oriented wall [155].

6.29.3 Three rectangular construction cuts [359], [361] and [362] housed the remains of brick columns [058], [060] and [062] supporting the western side of the stable block (Plate 39). The construction cuts measured 0.63m x 0.53m and contained 0.37m x 0.50m brick columns. The fabric of the brickwork was consistent with the other structural remains assigned to this phase. Butting up to the brickwork within the construction cuts were backfill deposits [360], [376] and [377].

- 6.27 **Building 4: Room 4.1 & 4.2 (granary, stables)** (Figure 10 & 11; Plate 38)
- 6.27.1 The levelling layer [138] to the south of the causeway was truncated by a series of linear construction cuts [345], [352], [354], [359], [361] and [362]. Two associated linear construction cuts [348] and [350] truncated the backfill of the construction cut [142] of the drain described above.

- 6.30.2 A floor surface [059] of light grey sandstone flags had been laid within the stable block, located at the southern end of Building 4. This surface was uneven and comprised mainly of broken slabs. The floor surface [059] lay above the infilled construction trenches associated with the outer walls of the building, specifically fills [355], [360], [376] and [377]. The floor surface [059] covered a total area of 5.57m x 2.92m. The floor surface [059] lay at a height of 26.29m AOD. Two protruding flagstones extended slightly beyond the western side of Building 4, overlying an external floor surface [053], forming a threshold.

- 6.30.3 An area of 0.37m x 0.55m in the middle of the room was surfaced in brick [057], probably representing a repair. Elsewhere repairs were signified by the insertion of square, Staffordshire-blue, stable floor bricks (brick dimensions: 144mm x 144mm x 80mm).

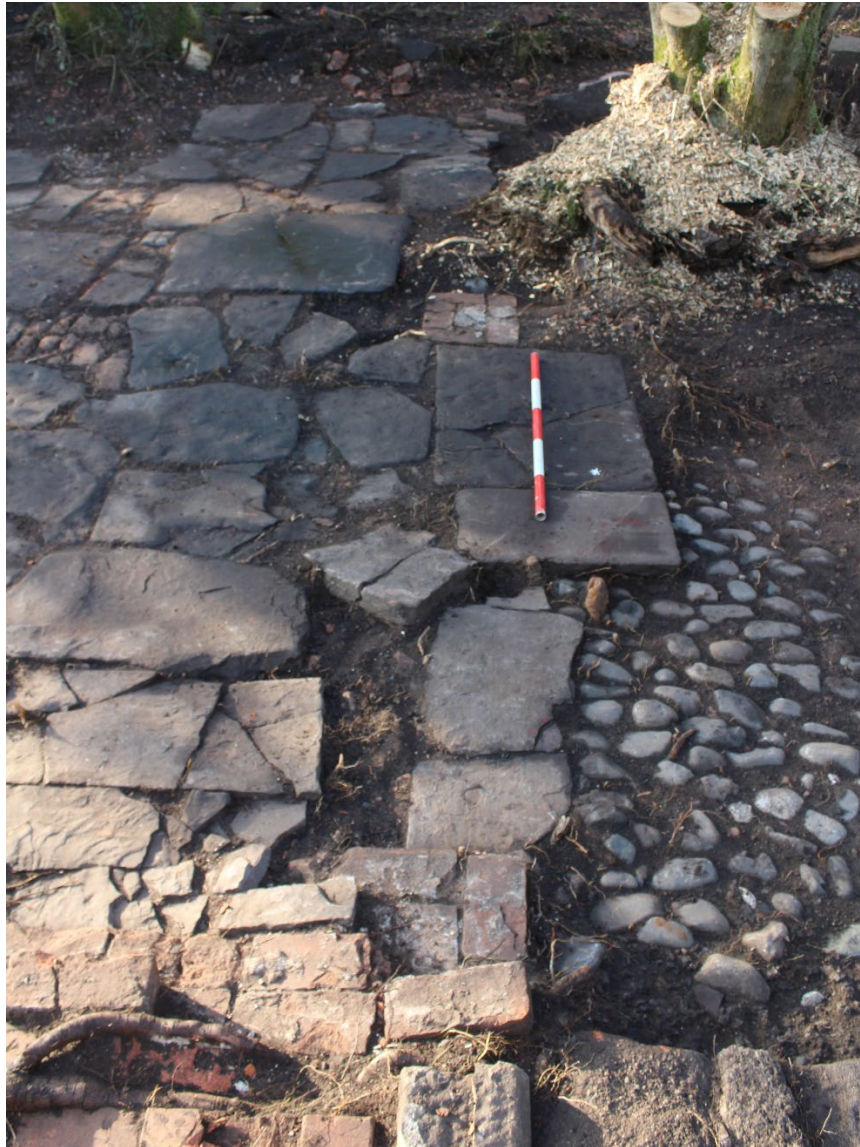
Plate 39: The western side of the stables showing brick column bases and threshold, looking south, scale: 1m

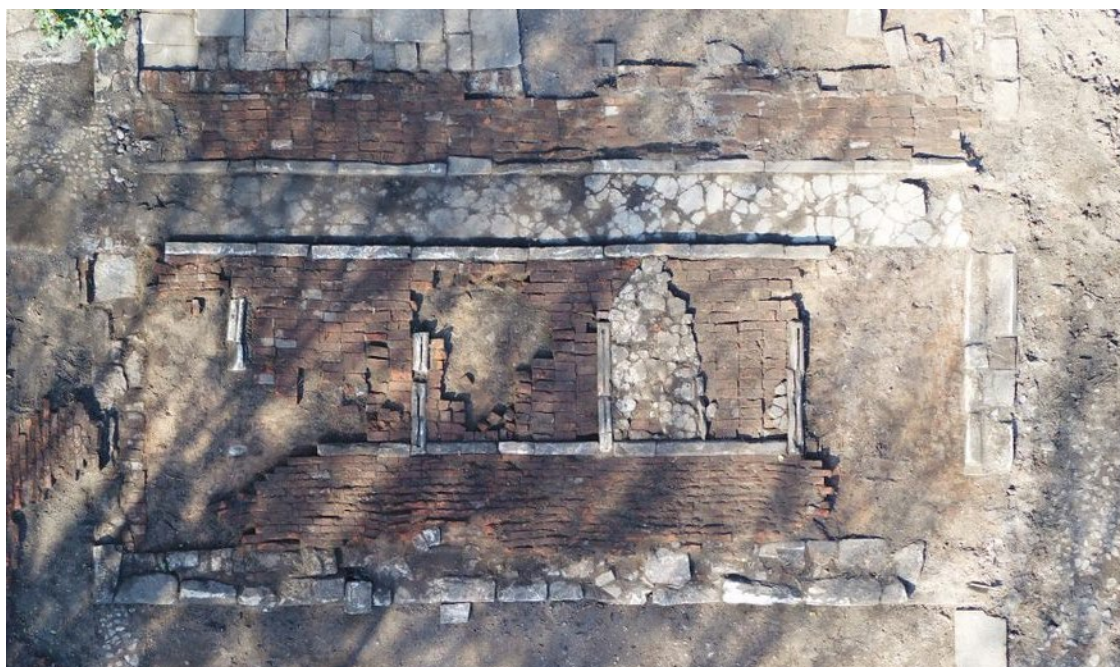
Plate 40: Building 1, cowhouse (Room 1.3), north at top

6.36 **Cowhouse (Room 1.3)** (Figure 12; Plate 40)

6.36.2 Stone stall divisions [035] within the cowhouse were formed from long chamfered stone blocks, measuring up to 900mm x 160mm x 160mm. Some of these exhibited a central groove or recess and were possibly reused window mullions. The recessed stones had evidently supported upright timber stalls. These subdivided part of the southern room into a maximum of four 1.80m-wide stalls (Plate 41).

6.36.3 Along the southern side of the building, to the south of the stalls was a narrow brick floor [033]. This surface was formed from handmade brick (brick sizes: 230mm x 110mm x 80mm), covering an area of 6.42m x 0.94m at a height of 26.65m AOD.

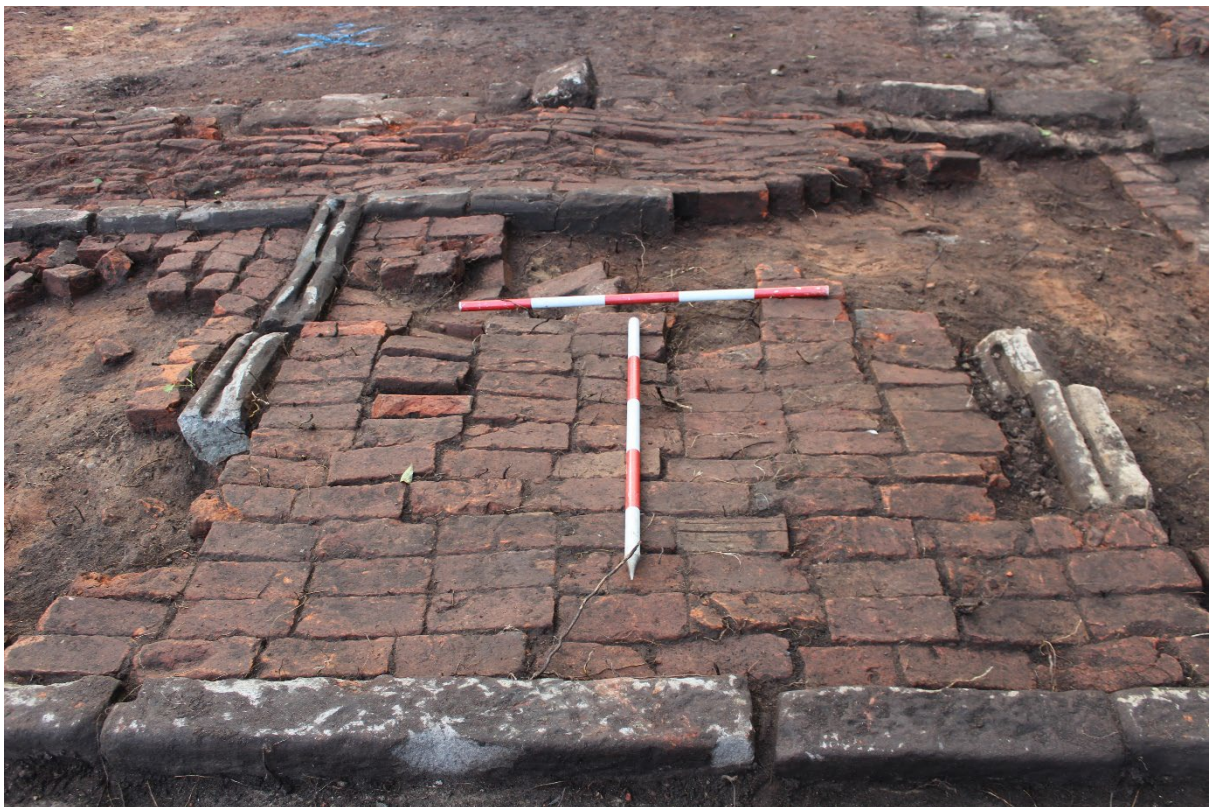
Plate 41: The westernmost stall in the cowhouse (Room 1.3), Building 1, looking south, scale: 1m horizontal, 1m vertical

6.36.4 Internally, the stalls were floored with handmade brick. This partially surviving surface [034] within the cowhouse covered an area of 7.05m x 1.00m and lay at a height of 26.61m AOD.

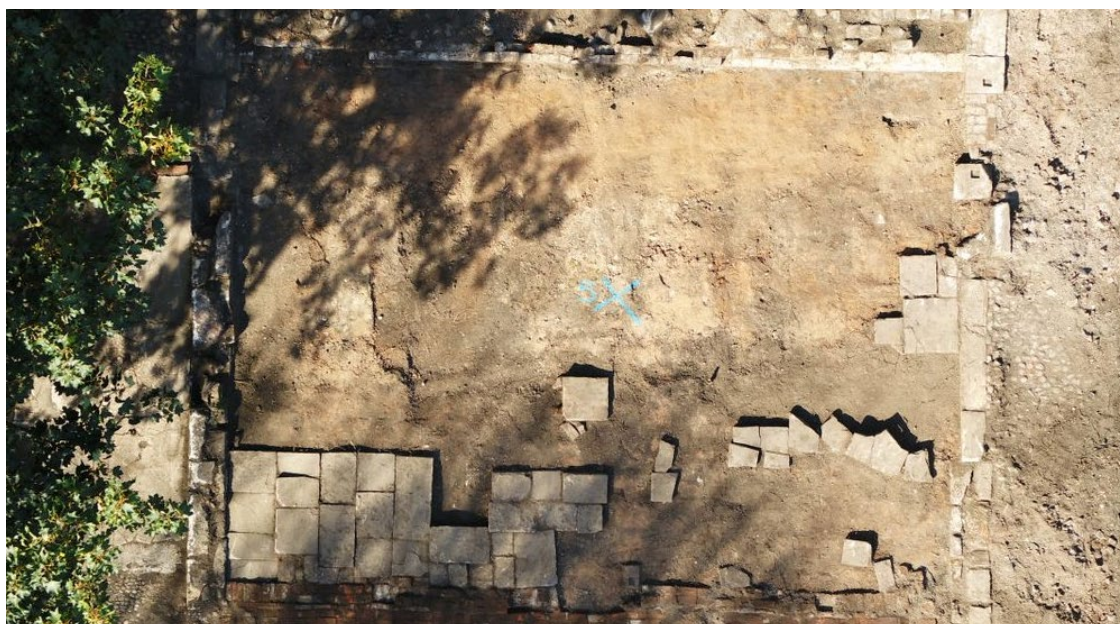
Plate 42: Building 1, barn (Room 1.2), north at top

6.37 **Barn (Room 1.2)** (Figure 12; Plate 42)

- 6.37.4 In the centre of the western wall of the barn, flags [438] had been laid over part of the external wall foundation [074] forming a 2.16m wide threshold. This suggested that a doorway had been made by knocking through the western wall of the barn.

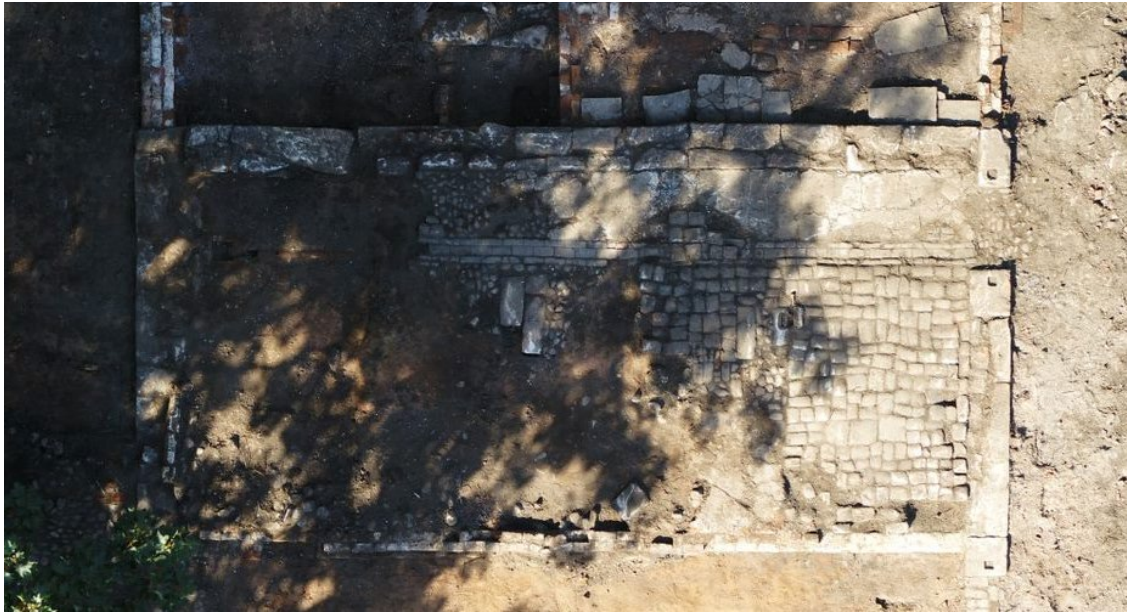
Plate 43: Building 1, stable (Room 1.1), north at top

- 6.38.4 In the south-western corner of the stables were the remains of a disturbed cobble surface [096] laid above layer [417]. The surface covered an area of 3.10m x 1.30m and was made up of cobbles measuring 70mm-180mm in diameter.

- 6.38.6 A cobble surface [093] was recorded along the northern side of the stable and had survived to a lesser extent to the south of an open drain [091]. It was exposed over an area of 2.17m x 1.84m although it was also visible in the north-west entranceway of the building, where it formed a cobbled threshold. As with the other surfaces in this room it had been laid above layer [417]. The cobble surface [093] was overlain for the most part by later concrete screed surface [094] taken as evidence of maintenance / repair. The cobble surface comprised small cobbles measuring <120mm in diameter though the majority used were 40mm-50mm in size. Several larger gritstone blocks [092] had been set within the southern part of the surface.

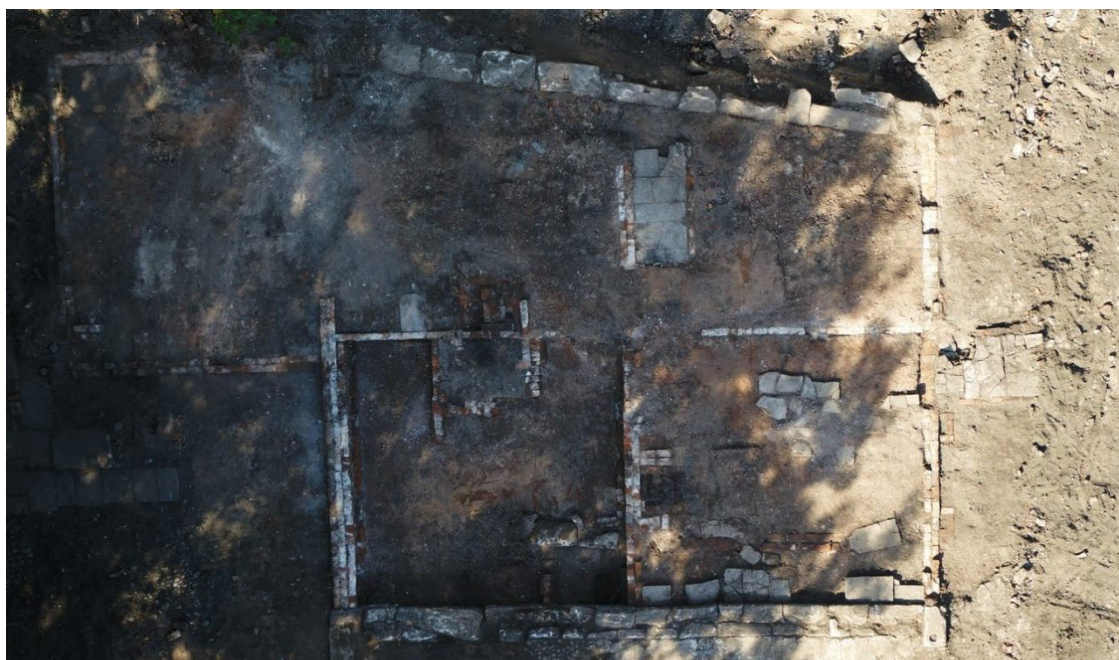
Plate 44: Building 3 the farmhouse and buttery, north at top

6.40 **Building 3: Rooms 3.1, 3.2, 3.3 (the farmhouse)** (Figure 11 & 12)

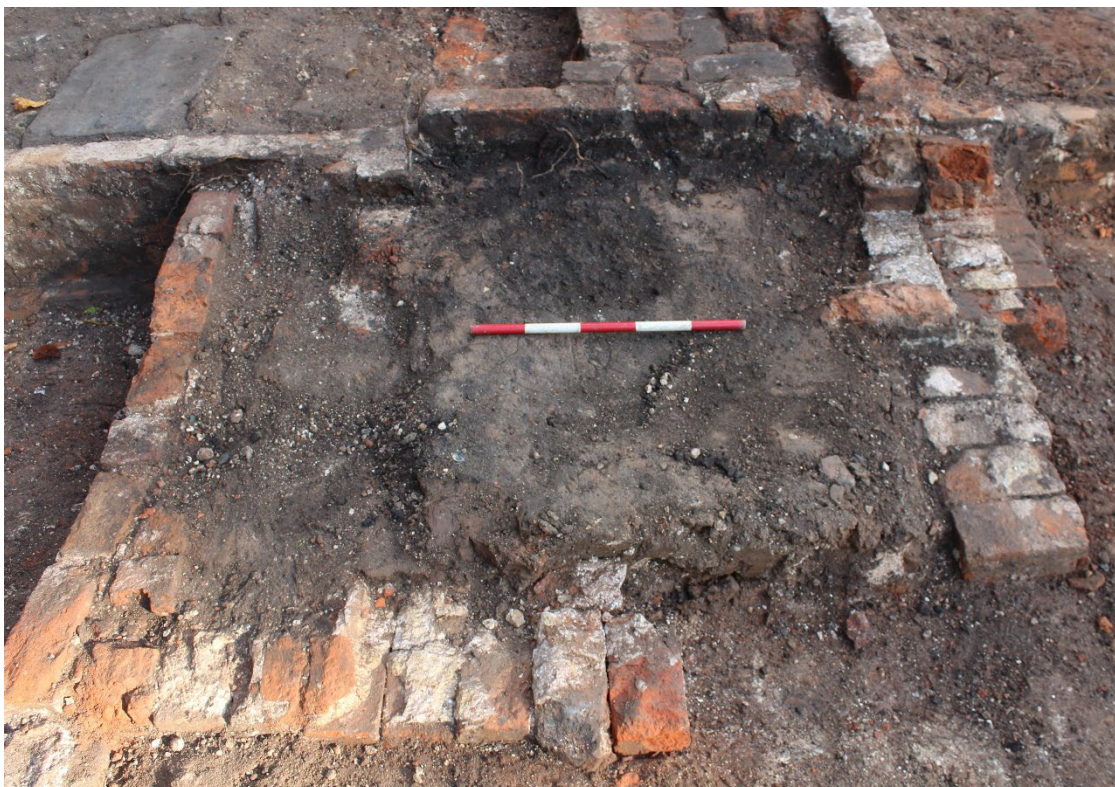
Plate 45: Fireplace [102] Building 3, Room 3.2, looking south, scale: 0.50m

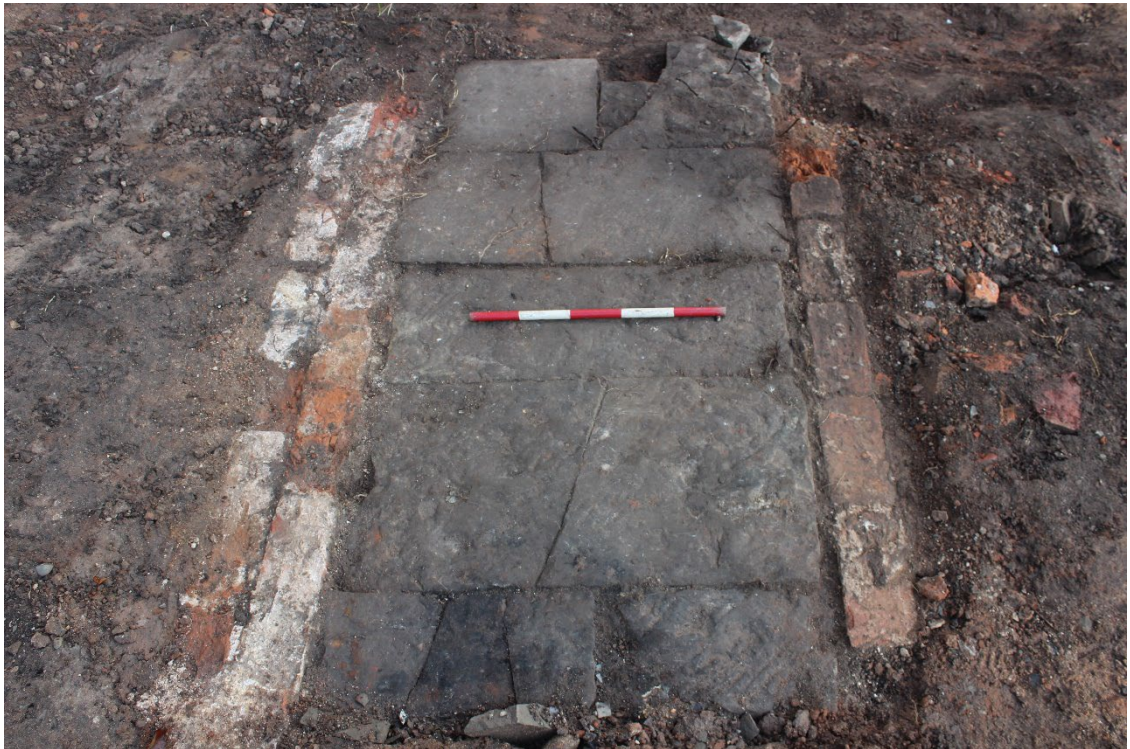
Plate 46: Stairwell structure [107]/[108], looking north, scale: 0.50m

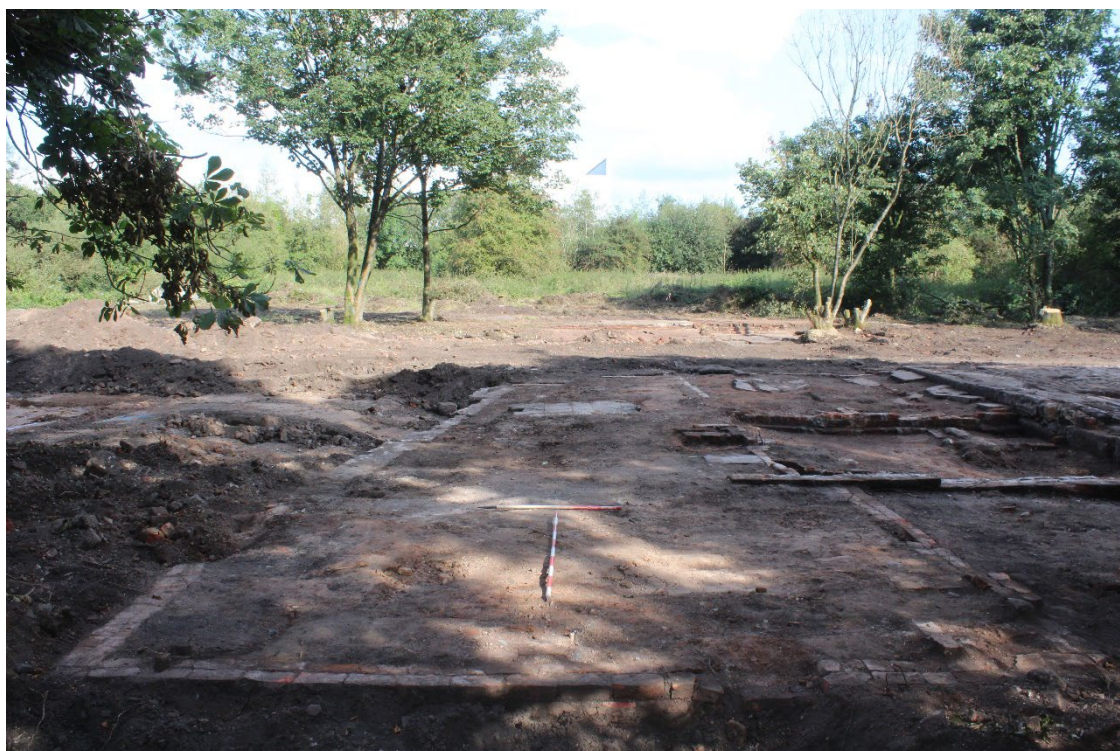
Plate 47: The buttery (Room 3.4), looking east, scale: 1m horizontal, 2m vertical

6.41 **Building 3: Room 3.4 (the buttery)** (Figure 12; Plate 47)

6.41.3 The western wall [111] of the buttery and was housed in a linear construction cut [411] extending 5.20m north-south. The foundation trench [411] was 0.45m wide. The wall [111] was identical in form and construction as the southern wall [112] of the buttery; it had a maximum length of 5.10m and was 0.24m wide. At its northern end it was keyed into the northern wall [427] of the buttery.

6.41.6 Constructed against the internal faces of the walls of the buttery were a series of additional trench-built foundations [430], [433] and [436], likely forming the bases of installations within the buttery. These walls [430], [433] and [436] were housed in linear construction cuts [429], [432] and [435]. The fabric of these walls [430], [433] and [436] was similar to the external walls of the buttery although they were not keyed in.

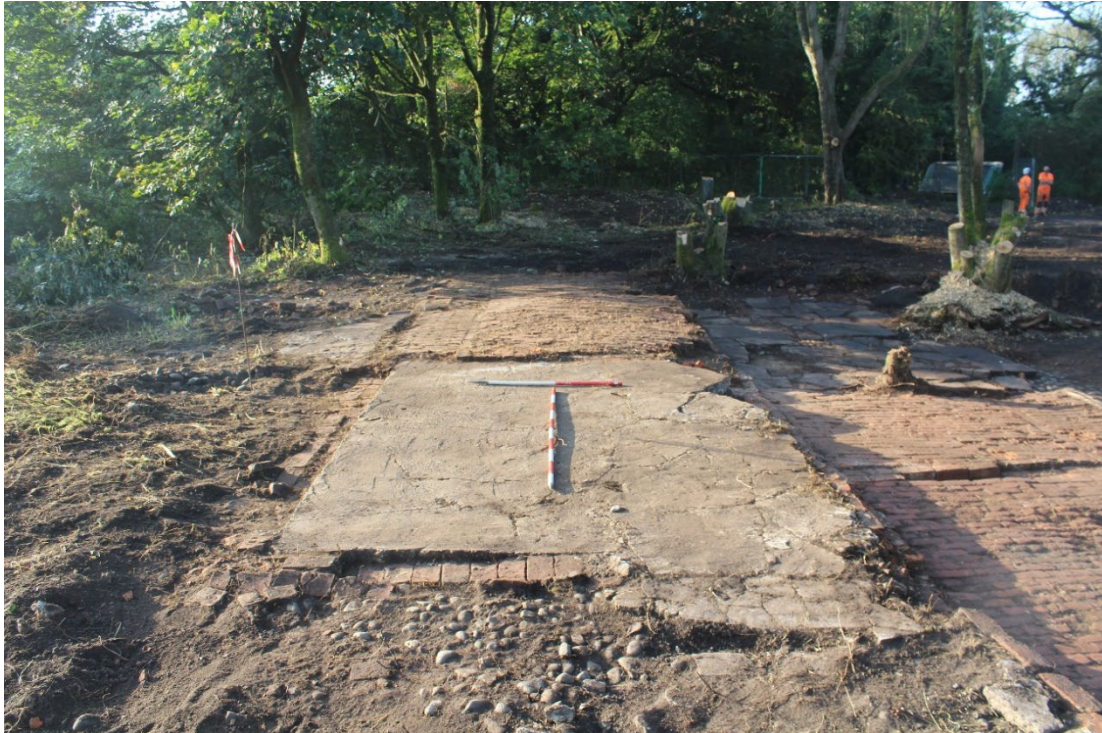
Plate 48: Calving pen (Room 5.1), looking south, scales: 1m horizontal, 2m vertical

6.44.2 **Calving pen (Room 5.1)** (Plate 48)

6.44.3 The calving pen (Room 5.1) was defined by three brick walls [054]/[368]/[371] housed in linear construction cuts [365]/[367]/[370]. These likely formed a lean-to extension against the eastern external wall [155] of Building 4.

6.44.4 The southern side of the room was delineated by an east-west-aligned construction cut [365] measuring 2.80m in length by 0.30m in width with vertical sides and a flat base. The construction cut [365] housed a wall [054], which was formed of red handmade bricks (brick sizes: 230mm x 120mm x 70mm) bonded with a hard, light, pinkish-white lime-based mortar. The wall [054] survived to a height of 26.76m AOD and measured 2.70m in length by 0.24m wide. Abutting the northern and southern faces of the wall [054] was a deposit of friable mid greyish-brown silty sand [373].

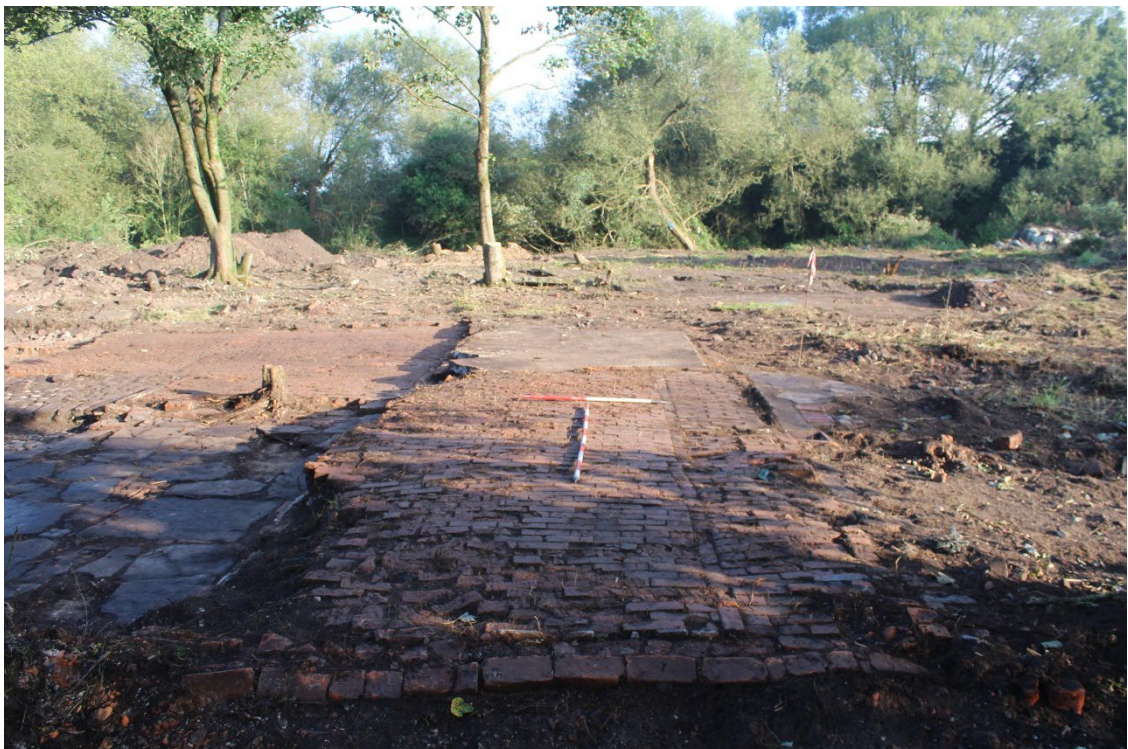
Plate 49: Loose box (Room 5.2), looking north, scales: 1m horizontal, 2m vertical

6.45 **Loose box (Room 5.2)**

- 6.45.1 A loose box located in the southern part of Building 5, was delineated by the eastern external wall [155] of Building 4 and two trench-built walls [054] and [061], which formed the northern and southern sides of this room, respectively.
- 6.45.2 The southern wall [061] was housed in a 0.34m-wide linear construction cut [363] with vertical sides and a flat base and was cut from a height of 26.66m AOD. The wall [061] had a length of 3.10m and was 0.22m wide. It was constructed from red handmade brick bonded with a hard pinkish-white lime-based mortar. A construction

6.45.5 A floor surface [056] comprising unfrosted bricks laid on bed at a maximum level of 26.82m AOD. The western portion of [056] was formed of the bricks were laid in rows with an east-west orientation. This part of the surface was bordered to the east by a single row of bricks laid on bed in a north-south orientation. To the east of this were shorter east-west oriented rows forming the remainder of the floor. The bricks used had a notably sharper arris and smoother surface than the handmade brick used in previous phases of construction; many were frost-fractured and damaged and were exposed at a shallow depth beneath the modern topsoil [341].

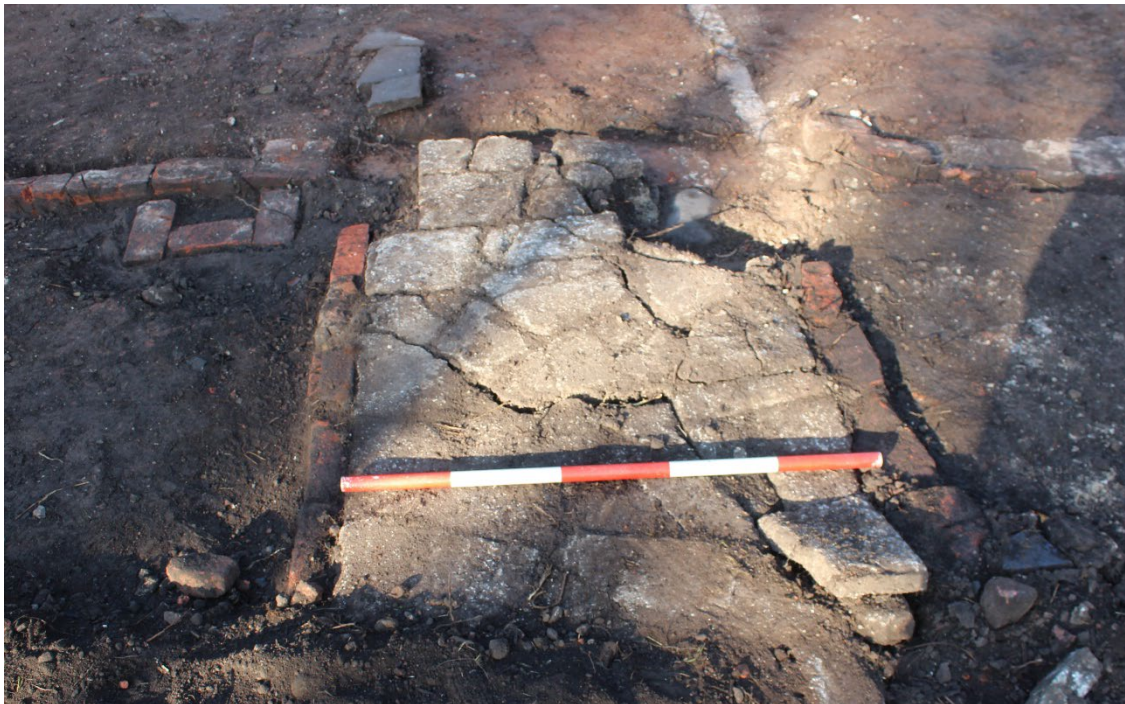
Plate 50: Porch (Room 3.5), looking west, scale: 1m horizontal

6.47.7 Porch (Room 3.5) (Plate 50)

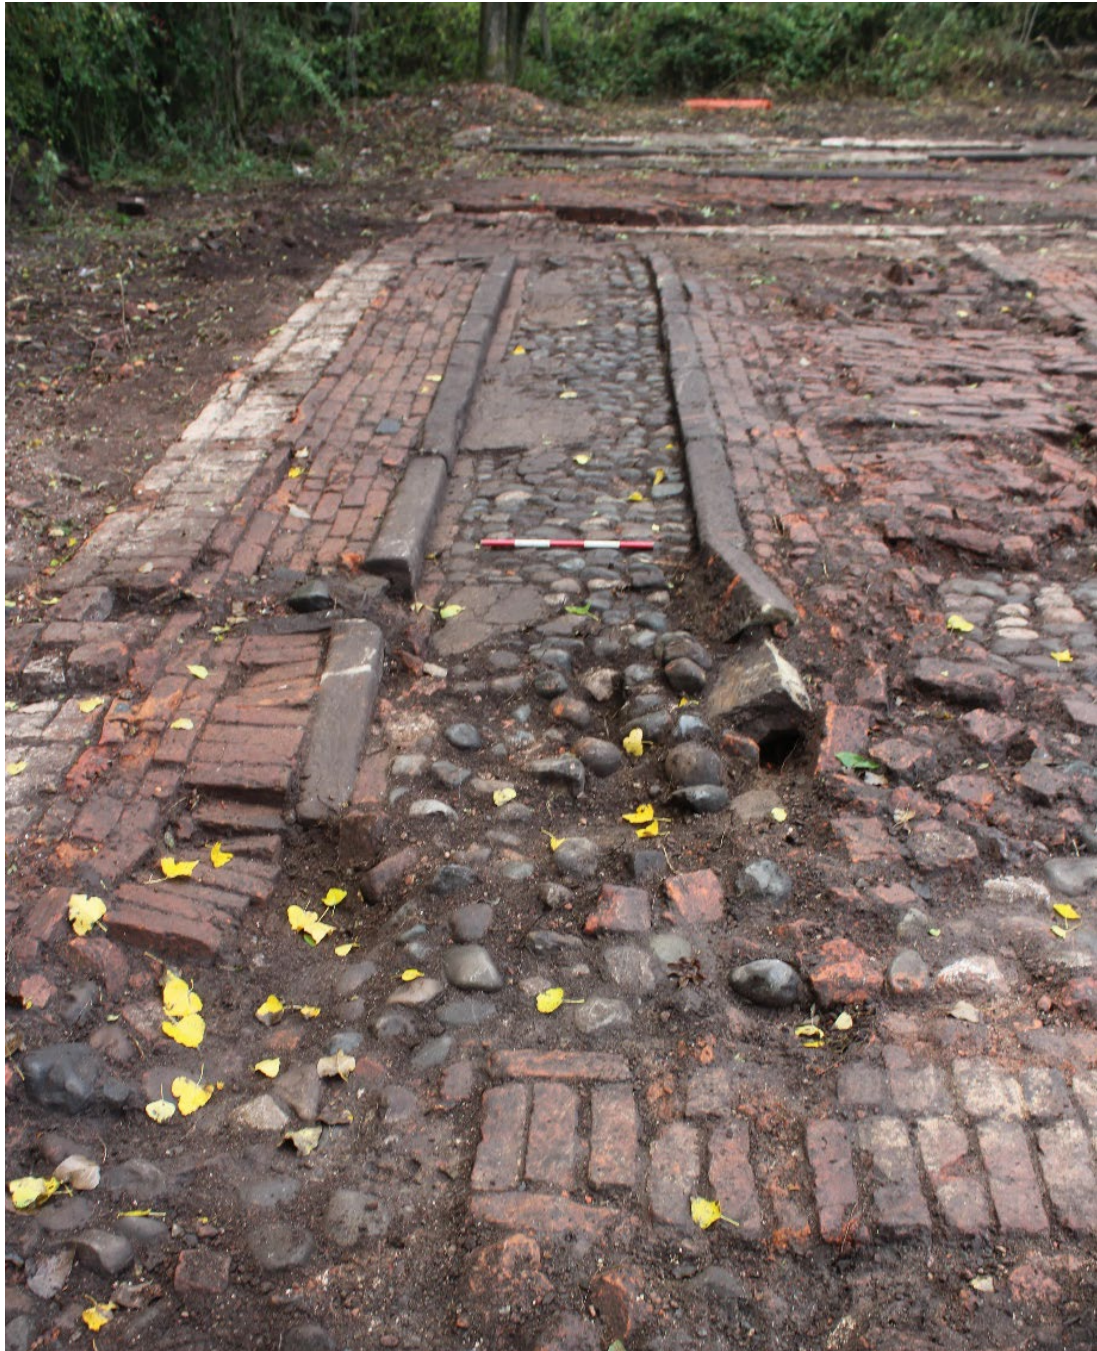
Plate 51: Sunken passage in the cowhouse (Building 6, Room 6.2), looking west, scale: 0.50m horizontal

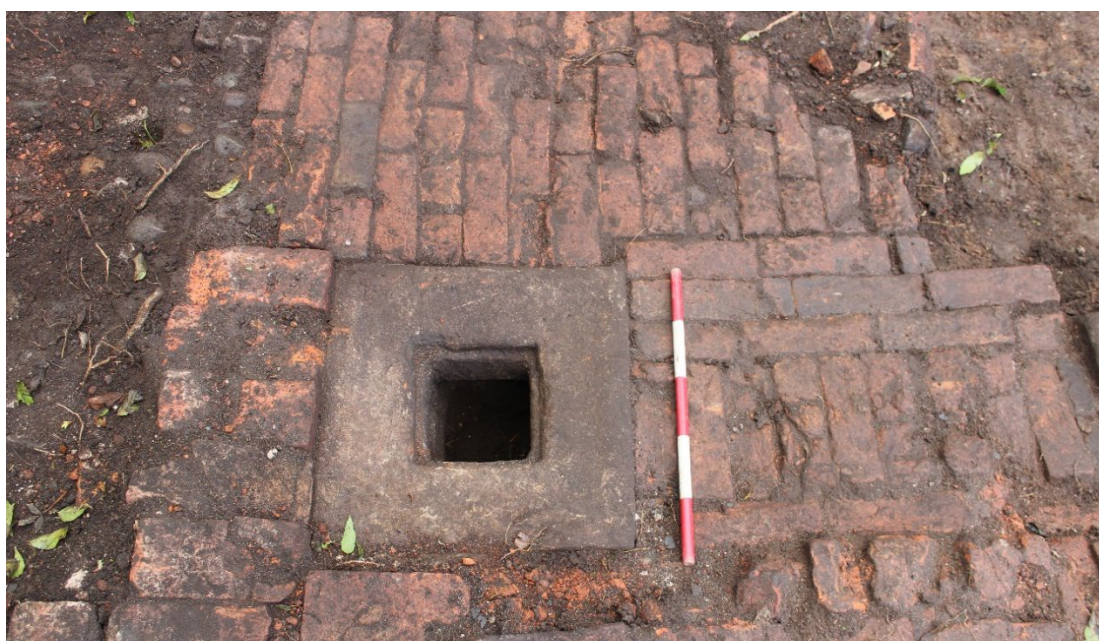
Plate 52: Brick floor [016] and associated drain, looking west, scale: 0.50m

- 6.50.2 The partial remains of a brick surface [016] survived in the southern half of the bull stable (Plate 52), covering an area of 1.25m x 1.90m, lying at a maximum height of 26.51m AOD. This surface [016] was formed of handmade brick laid on bed. A brick drain surmounted by a square capstone had been inserted in the south-east corner of the room against walls [001] and [014]. Remnants of stone edging [017], perhaps representing a continuation of [005] were recorded immediately north of surface [016].

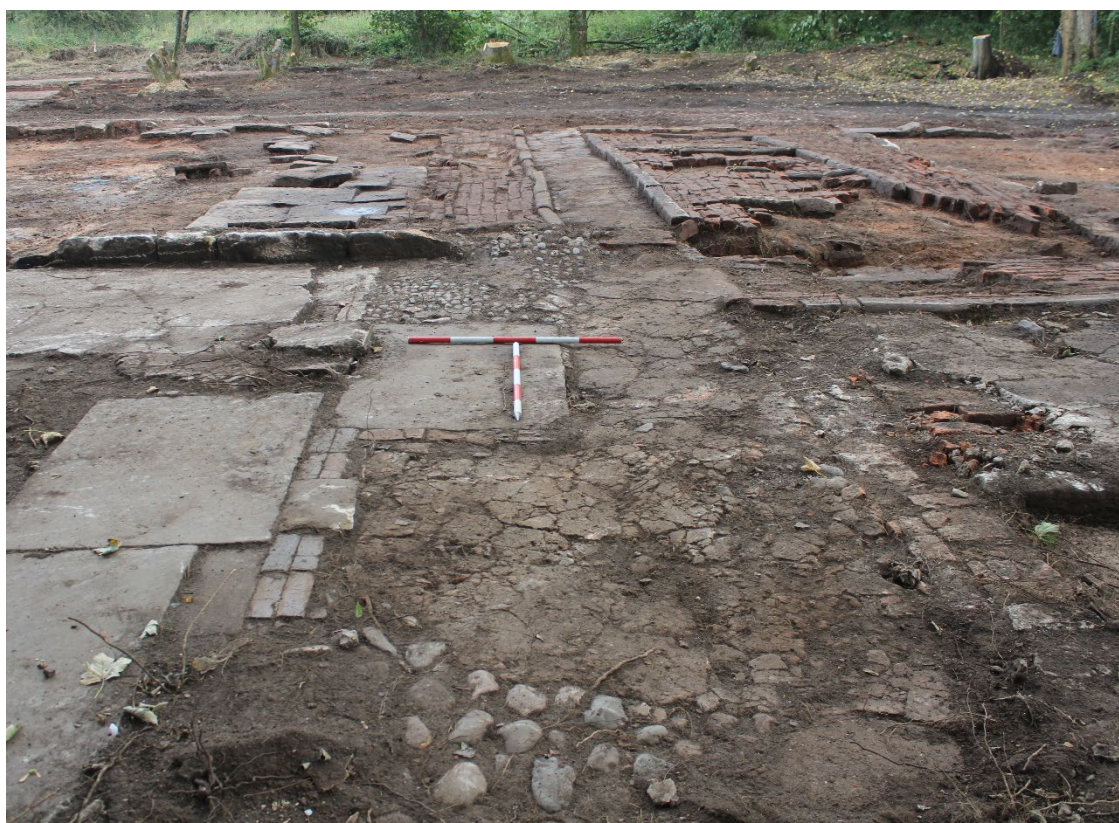
Plate 54: Building 7, looking east, scales: 1m vertical, 1m horizontal

6.62 **Building 7** (Figure 12 & 13)

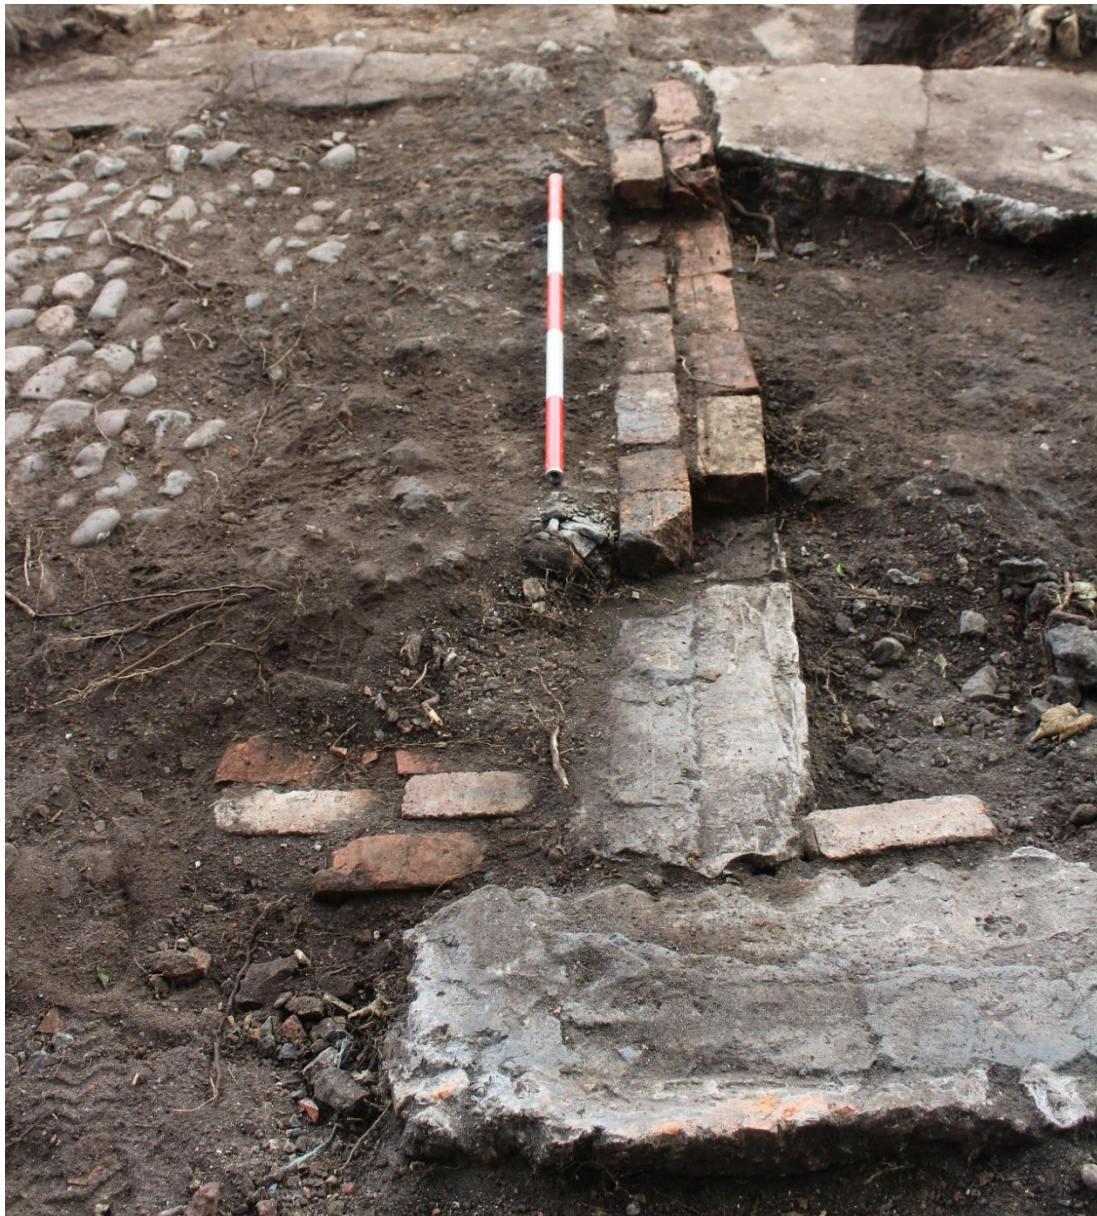
Plate 55: Wall [116], looking east, scale: 1m vertical

- 6.67.2 The east-west oriented wall [116] consisted of a concrete plinth foundation surmounted by three courses of red wire-cut bricks (brick sizes: 220mm x 105mm x 70mm) bonded with a bluish-grey cement. The dimensions of the masonry found were 2.60m x 0.25m. This had a maximum surviving height of 26.54m AOD.

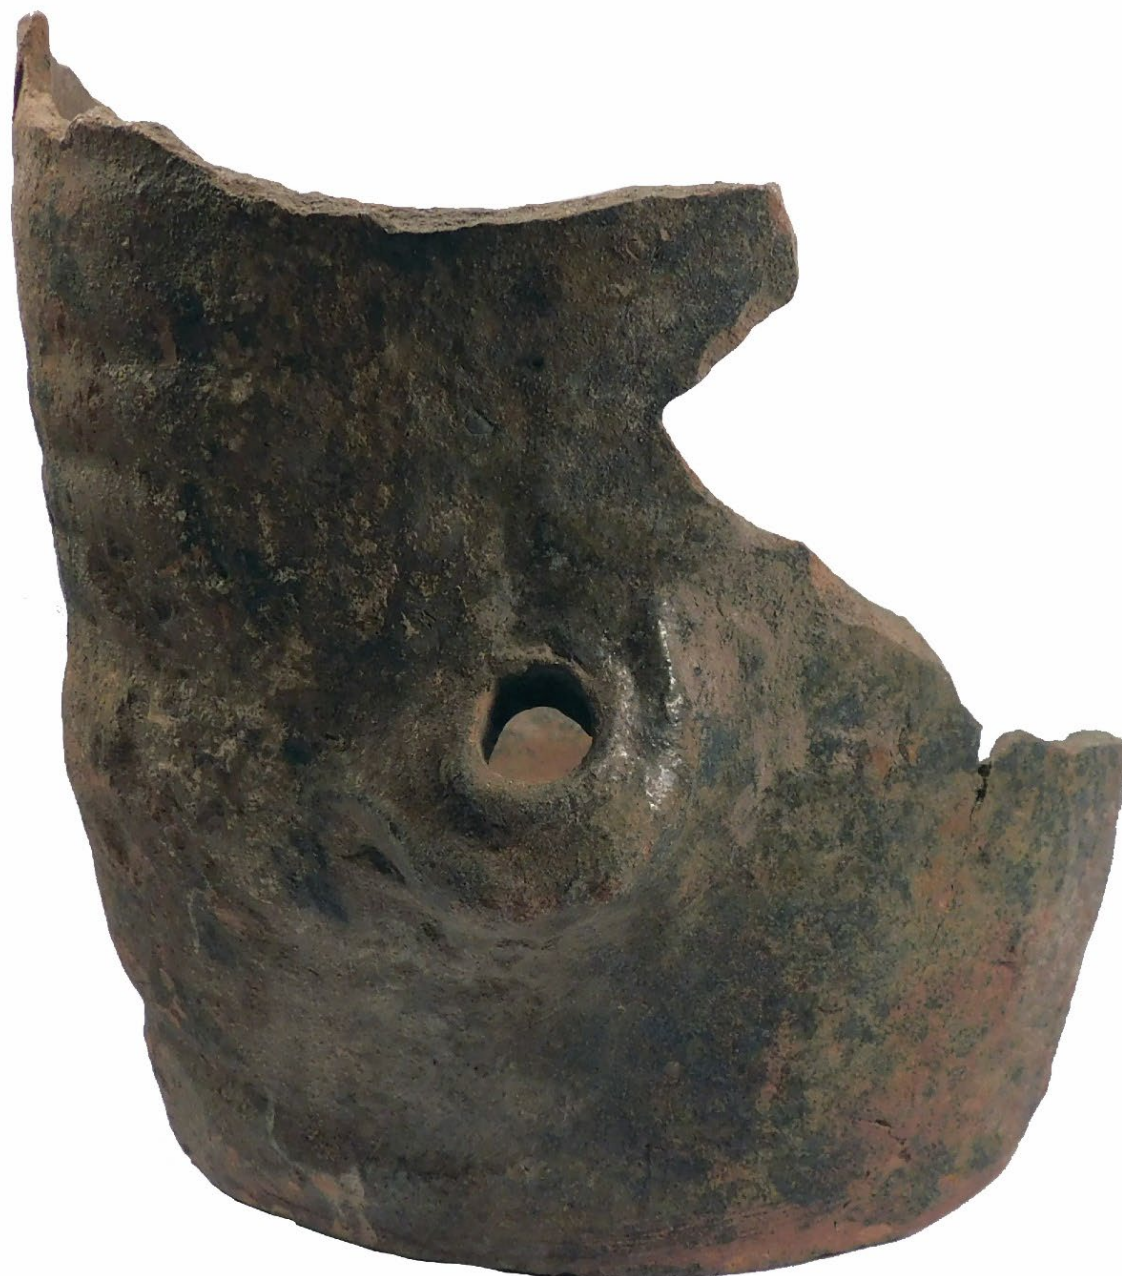
Plate A2.1: Partially reduced bunghole jar, scale: 5cm

The exception to this dating being the large bunghole jar fragment from recut moat fill [237] where the context dates to the mid to late 16th or early 17th century (Plate A2.1). This vessel, due to the large size of the sherd suggests primary deposition. Perhaps indicating that it was either being curated or part of a late surviving partially reduced tradition. The same can be said of a urinal (Plate A2.2), also from the recut moat, but from fill [260]. It should be noted that although bunghole jars were a recovered from Samlesbury, urinals were a noteworthy absence from the Samlesbury repertoire (Wood et al 2009).

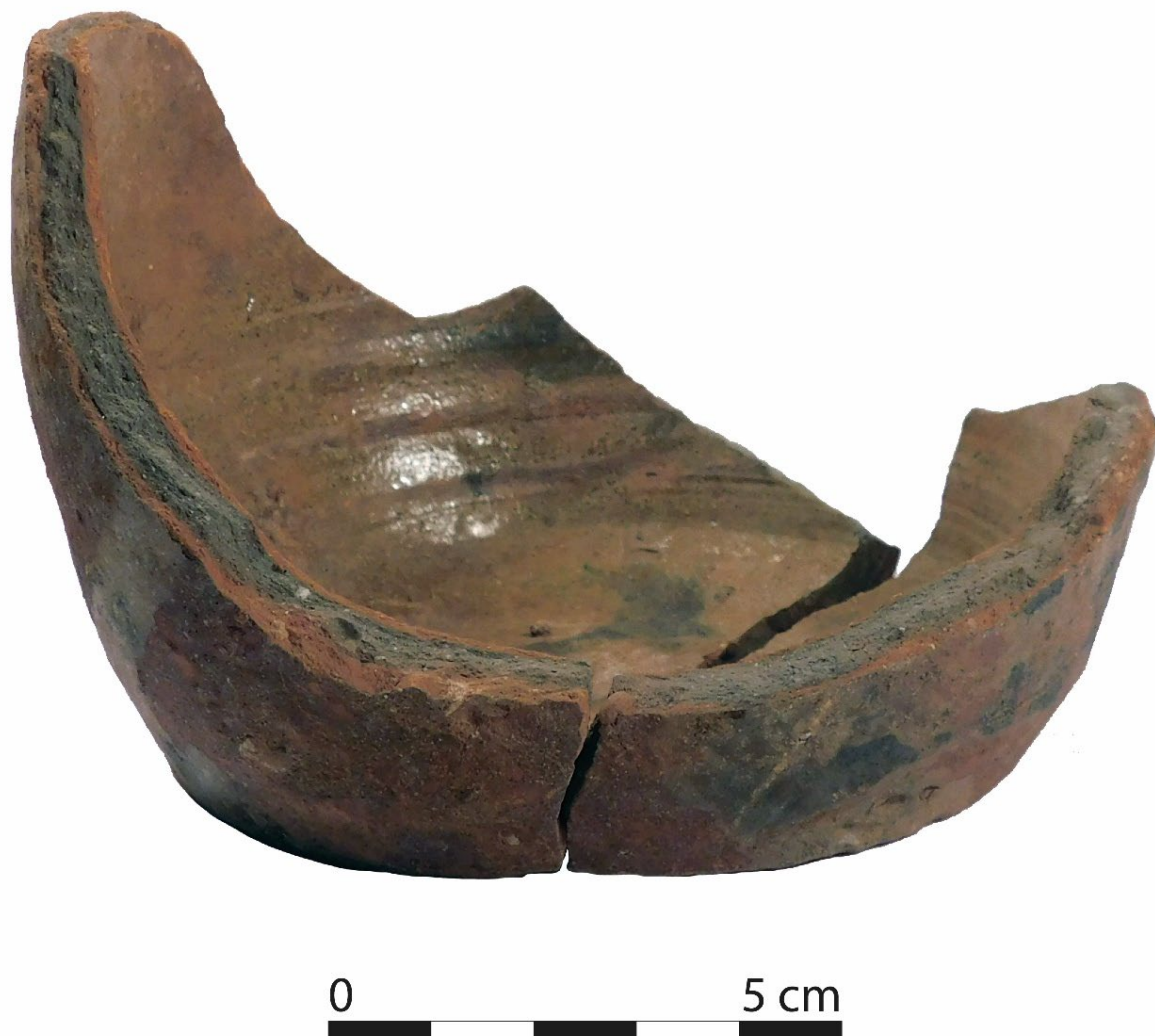
Plate A2.2: Partially reduced urinal, scale: 5cm

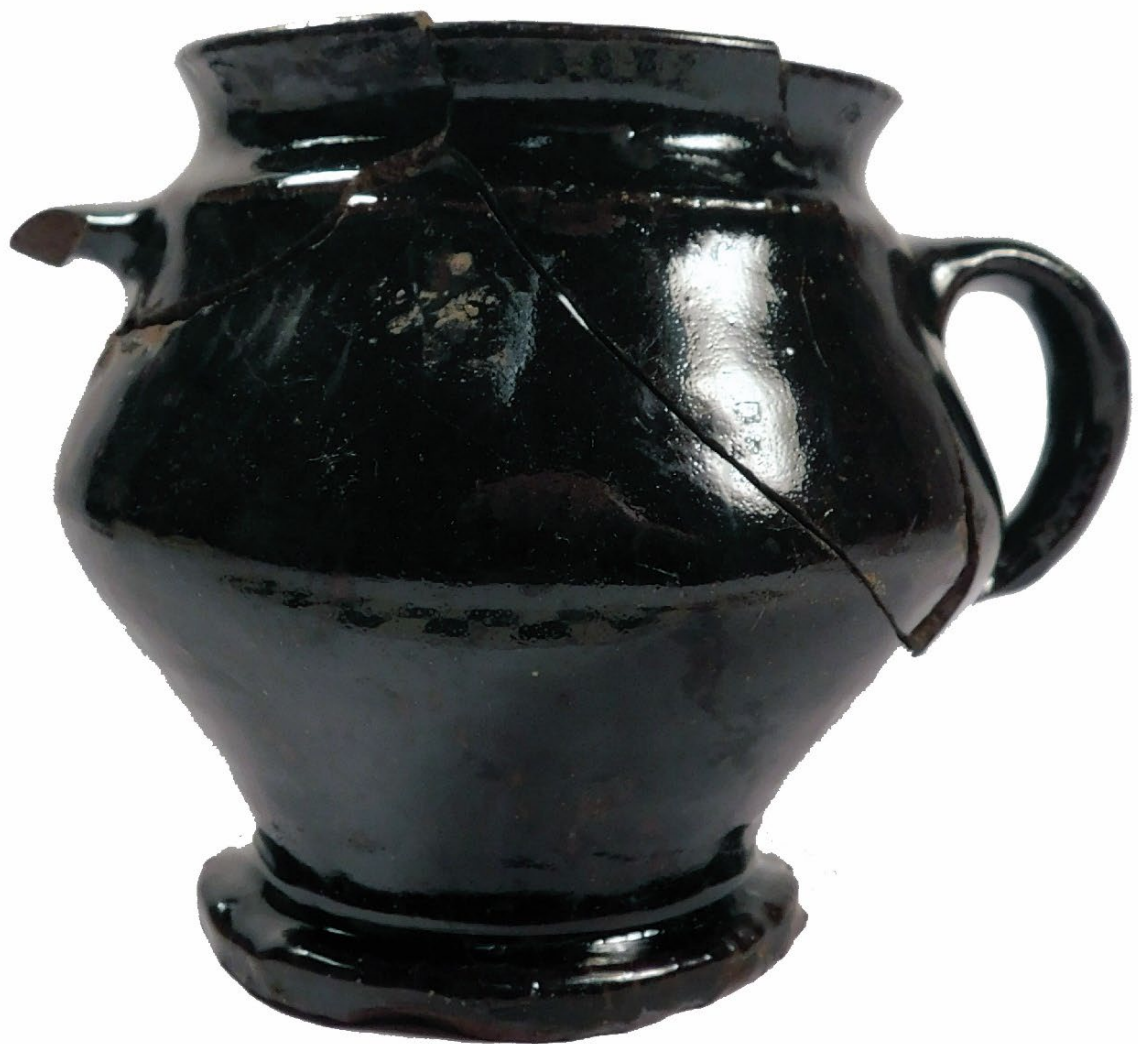
Plate A2.4: Rainford/Cistercian type two handled cup, scale: 5cm

Cup forms with comparators to vessels identified at excavated kiln sites in Rainford (Merseyside) and Wrenthorpe (West Yorkshire) have been identified in Moat recut fills [237 and 260] (Philpott 2015; Moorhouse and Roberts 1992) (Plate A2.4). A complete base from a waisted three handled chafing dish was recovered from causeway deposit [177] (Plate A2.5). A similar three handled yellow ware chafing dish, but with a pedestal base, was revealed at
