Post-Excavation Assessment

**Grasmere Avenue,
Farington,
South Ribble,
Lancashire**

Technical Report:

SA/2022/36

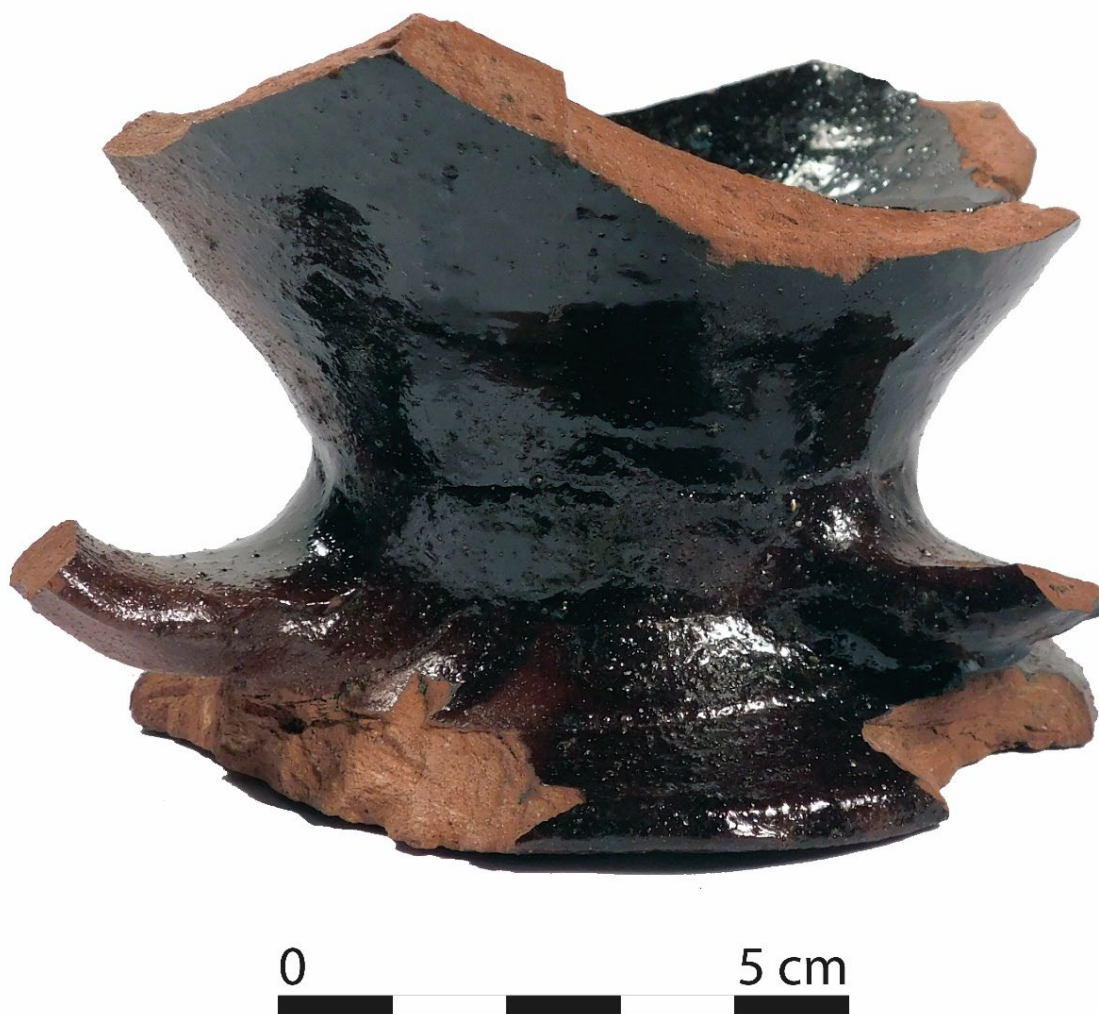
Plate A2.5: Chafing dish, scale: 5cm

Cup forms with comparators to vessels identified at excavated kiln sites in Rainford (Merseyside) and Wrenthorpe (West Yorkshire) have been identified in Moat recut fills [237 and 260] (Philpott 2015; Moorhouse and Roberts 1992) (Plate A2.4). A complete base from a waisted three handled chafing dish was recovered from causeway deposit [177] (Plate A2.5). A similar three handled yellow ware chafing dish, but with a pedestal base, was revealed at

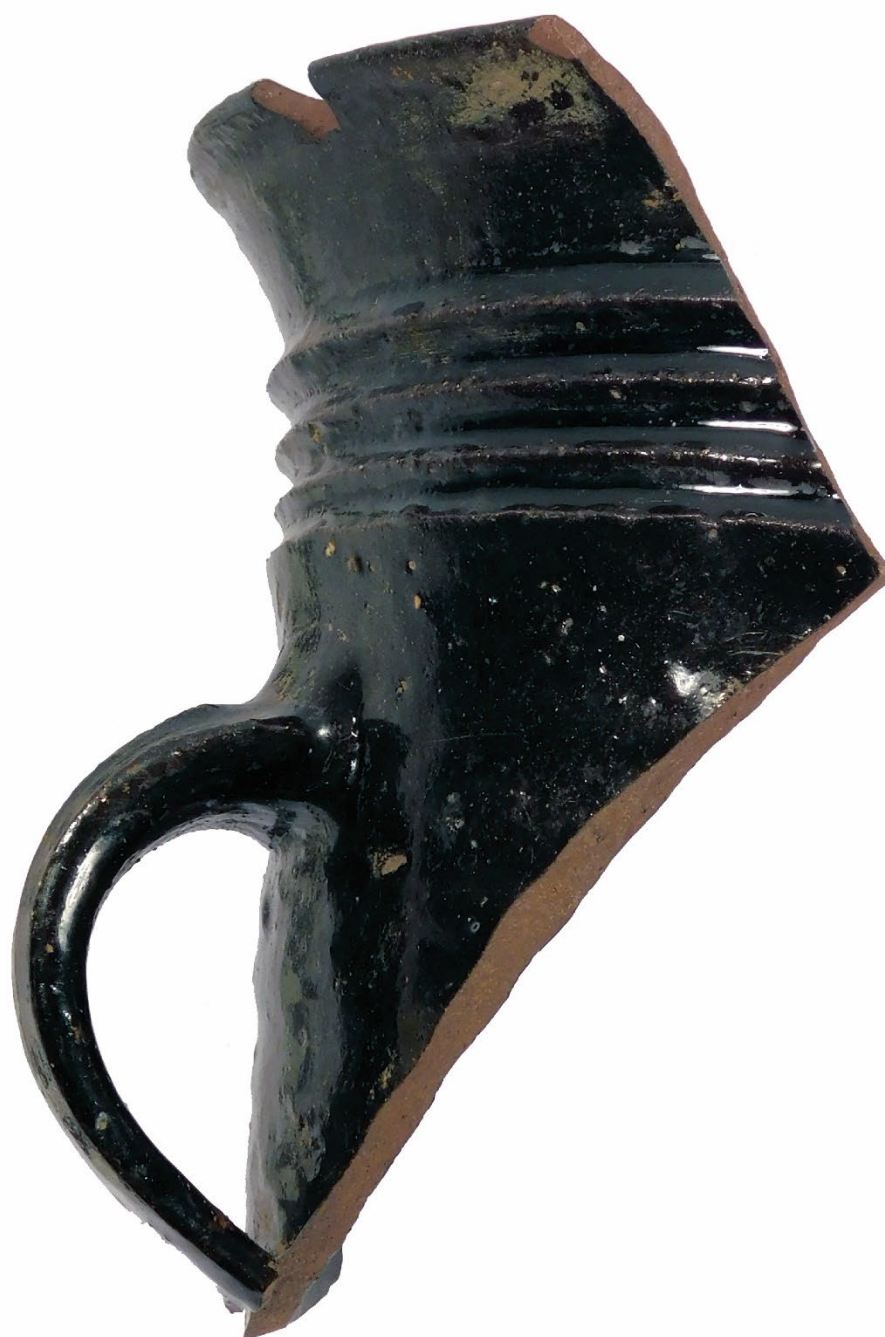
Plate A2.6: Large dark glazed fineware mug: 5cm

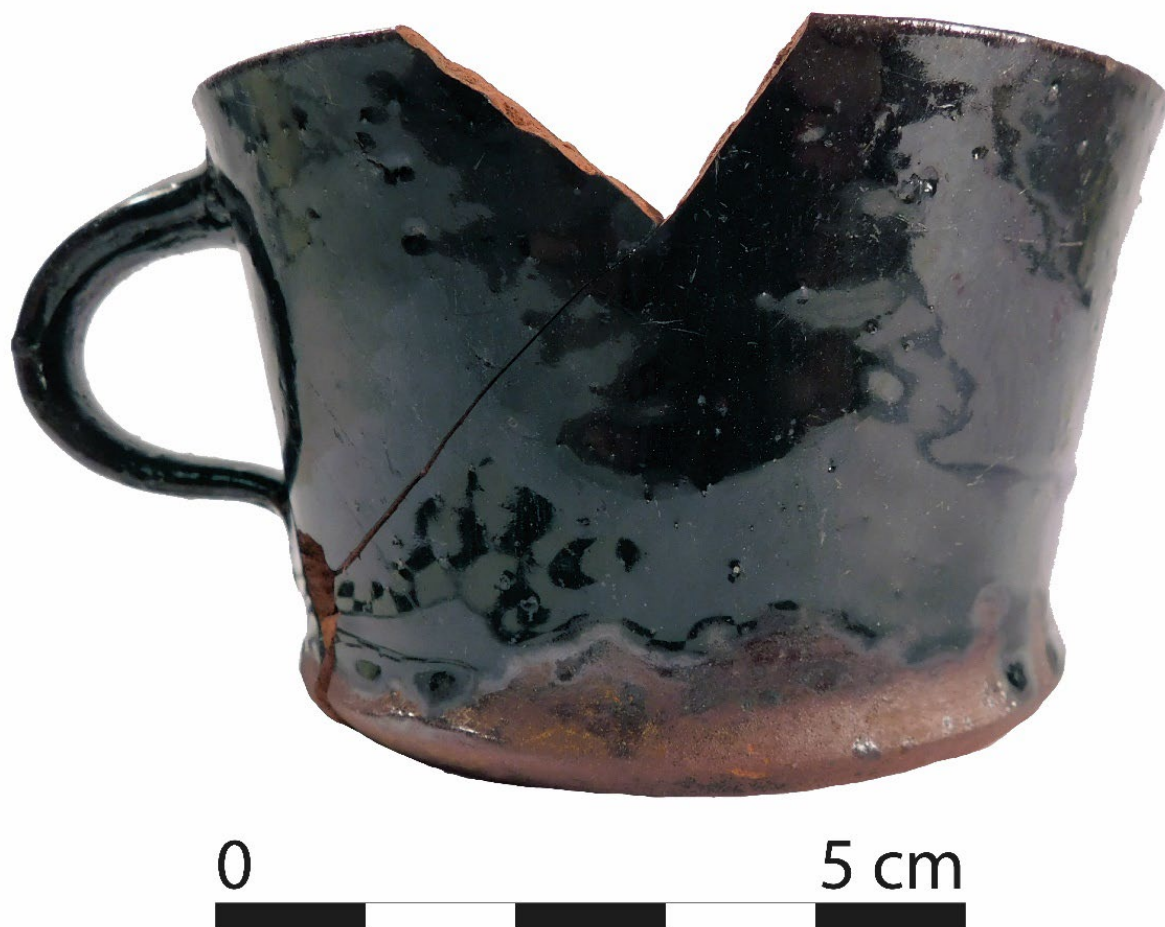
Plate A2.7: Dark glazed fineware cup

As well as the Rainford/Cistercian type ware a smaller amount of the later fabric type commonly referred to as Blackware was also found. Such vessels are a 17th-18th development of Rainford/Cistercian wares. Some 22 sherds weighing 853g were found during the excavations. Fabric and glazing being very similar to Rainford/Cistercian types, however the vessel forms are quite distinct. Vessels were retrieved from moat recut deposits [237 and 260] and evaluation moat deposit [703] and causeway deposits [180 and 217]. Like the Rainford/Cistercian wares there are several well preserved profiles analogous to vessels identified at other sites in the region, such as at Bury Castle (Plate A2.6) and Rainford and recorded as part of the Staffordshire Blackware type series (Philpott 2015, 85-7; Barker 1986; Tyson 1986; Plate A2.7).

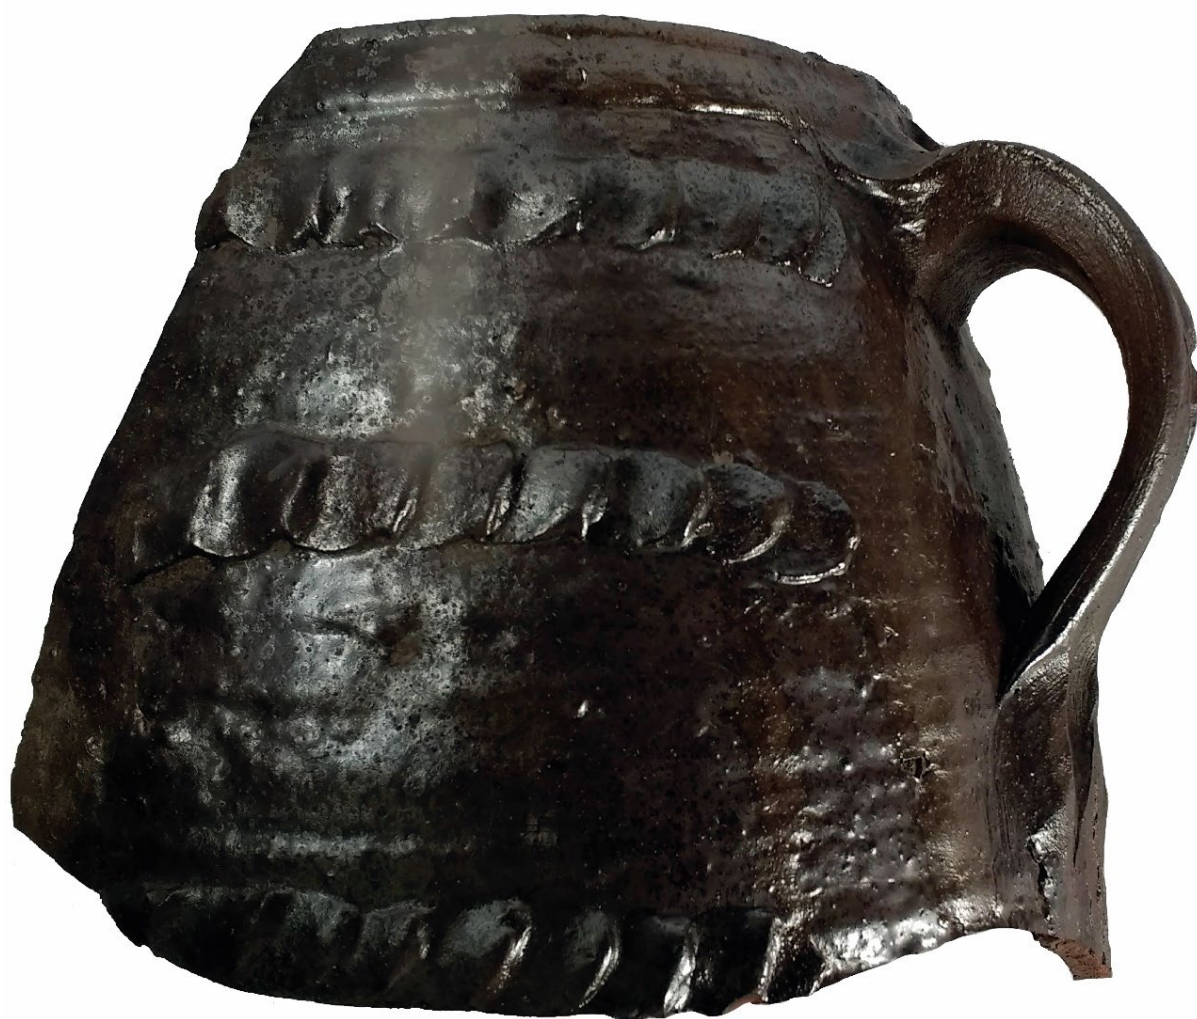
Plate A2.8: Midlands purple type cistern jar, scale: 5cm

At Farington, early moat fill [277] produced a large jar fragment with vertical loop handle, decorated with three horizontal applied thumbed strips (Plate A2.8) whilst the later recut moat fills [237 and 260] also included large fragments of a bung-hole jar, a possible chamber pot, bowl and jar rims. Also, of note from moat fill [260] was a an overfired decorated bodysherd from rounded hollow ware vessel with cross stamped applied medallion (Plate A2.9). Such cross stamps on 17th century vessels are thought to represent Catholic sympathies in a Protestant dominated country (National Museums Liverpool 2021).

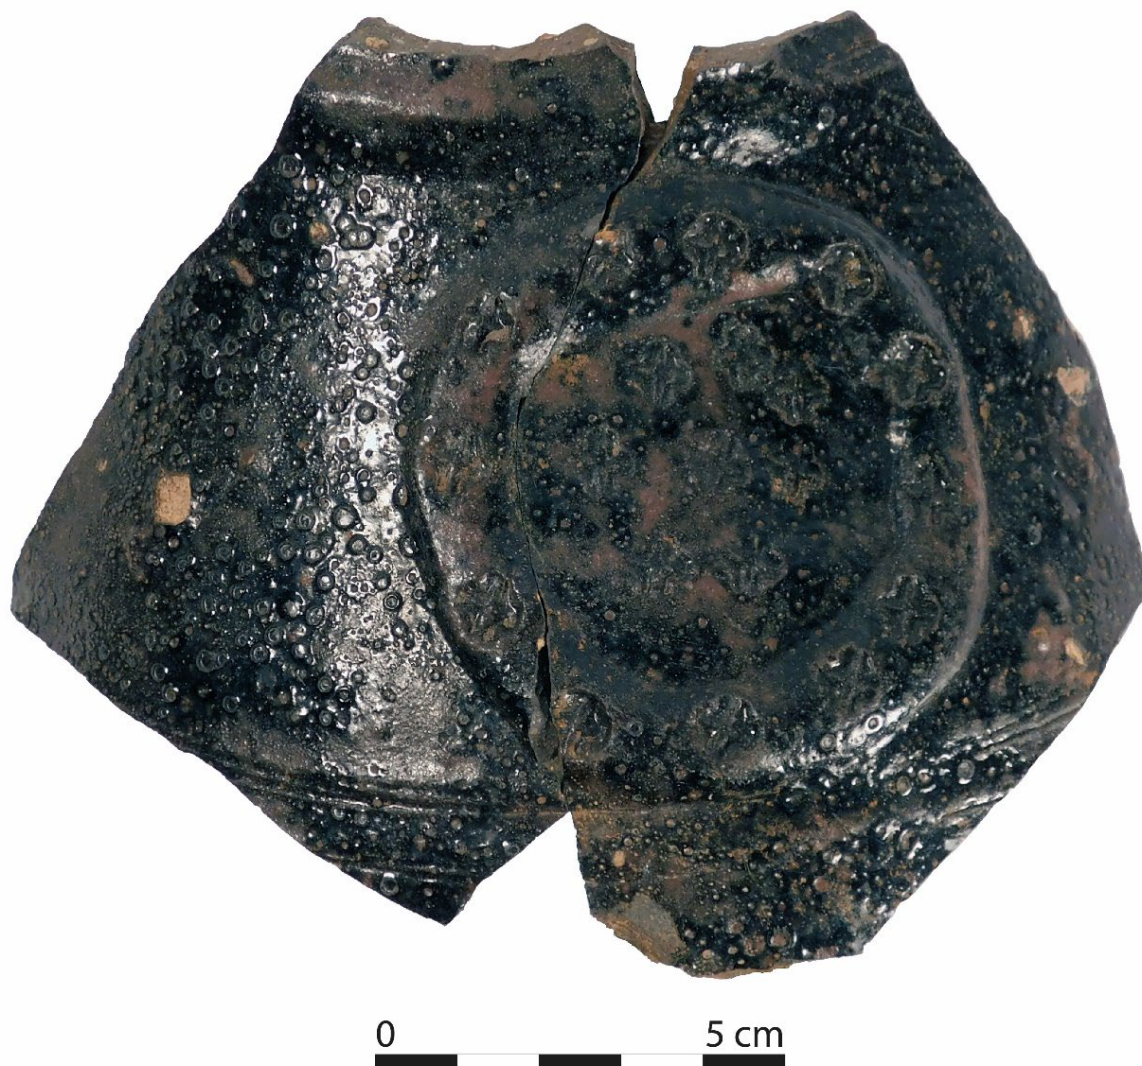
Plate A2.9: Midlands purple type waster medallion, scale: 5cm

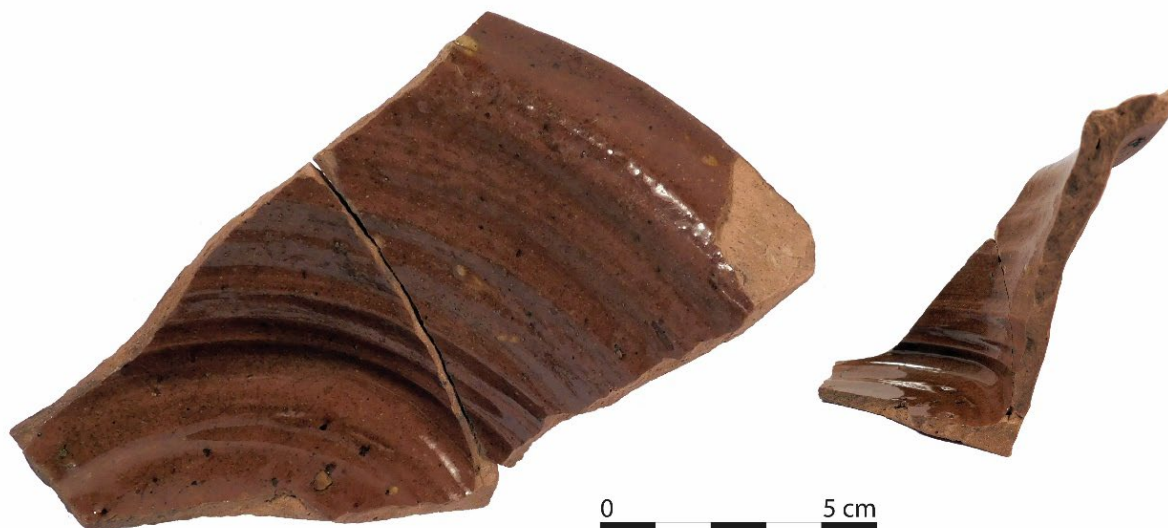
Plate A2.11: Self-coloured earthenware bowl, scale: 5cm

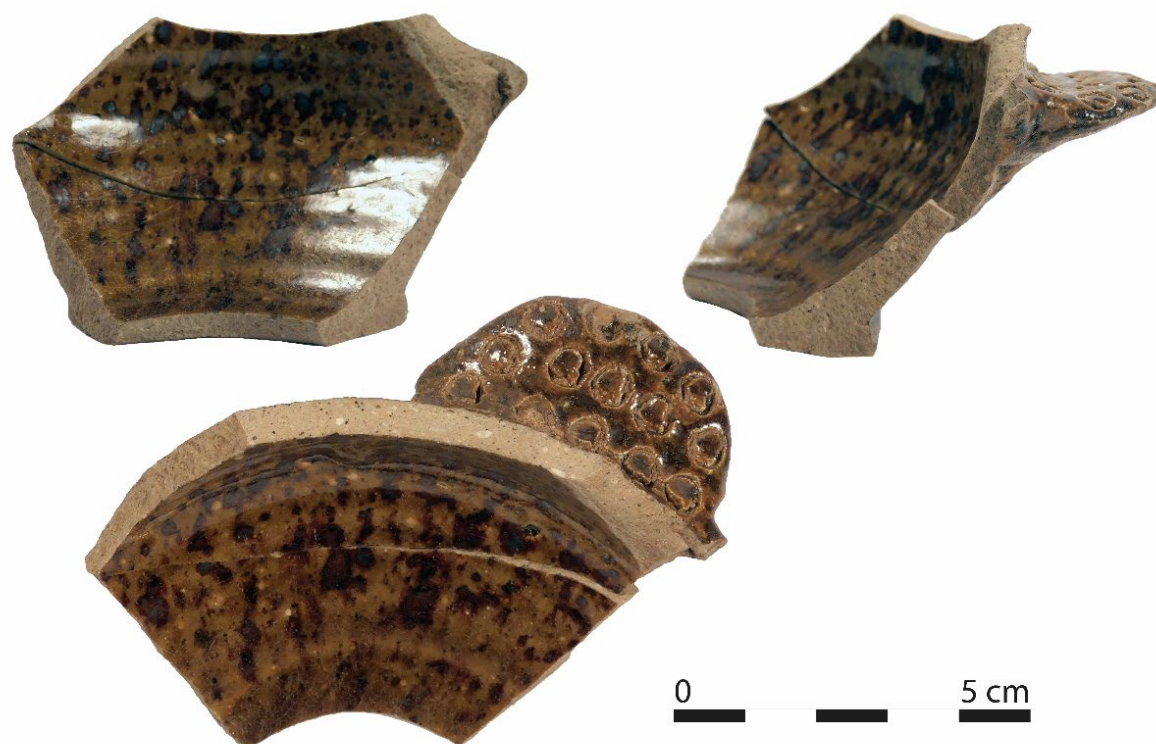
Plate A2.15: Mottled ware porringer, scale: 5cm

Few profiles were present, with the significant exception of a porringer or necked cup (Plate A2.15) with a horizontal side handle recovered from the upper fill of the moat [105] as

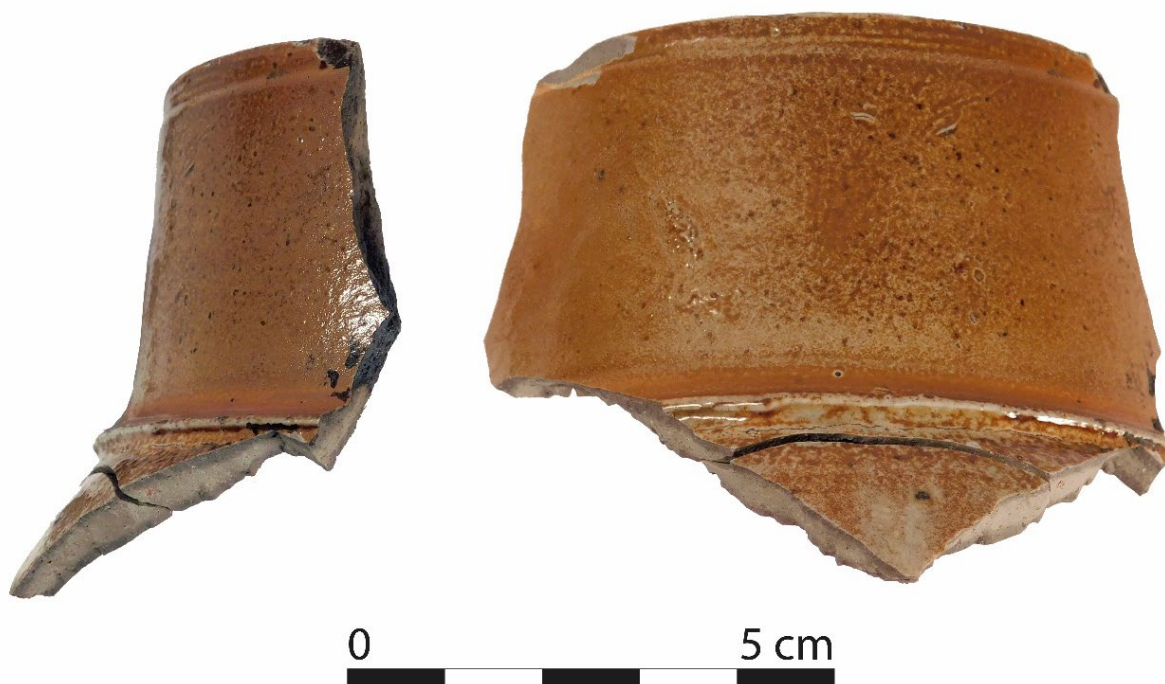
Plate A2.16: Raeren mug, scale: 5cm

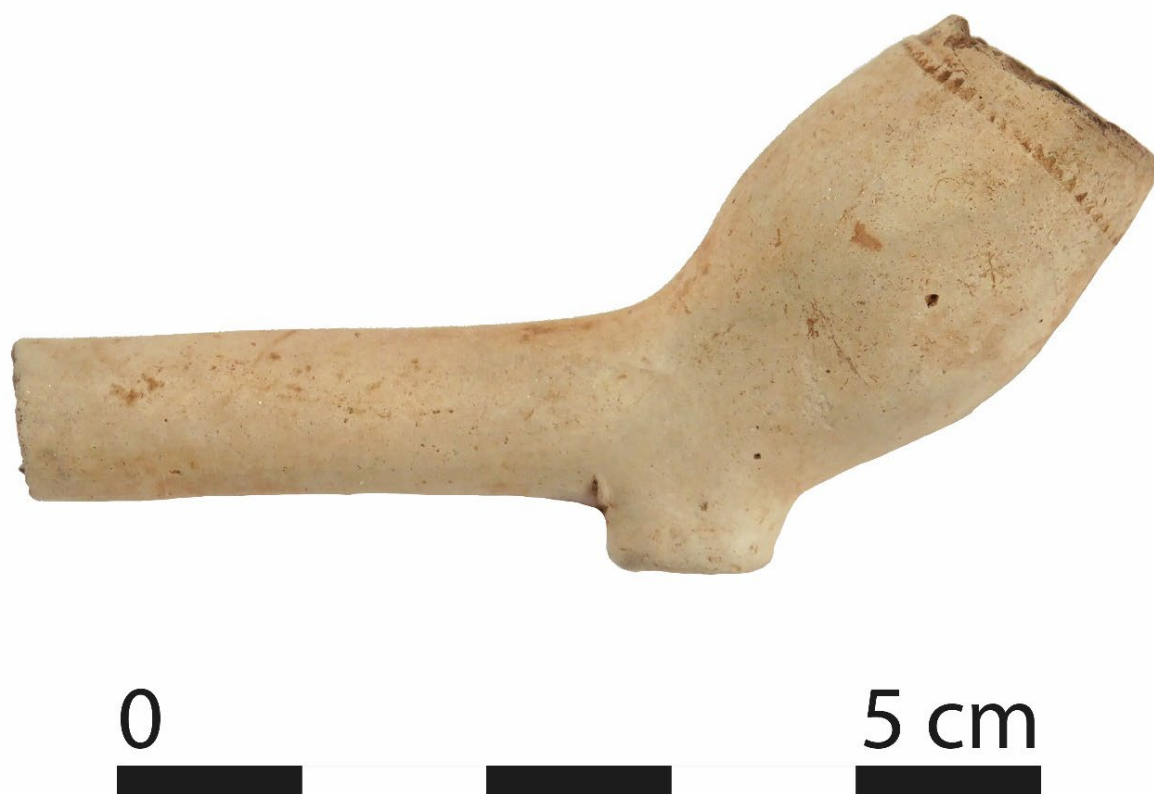
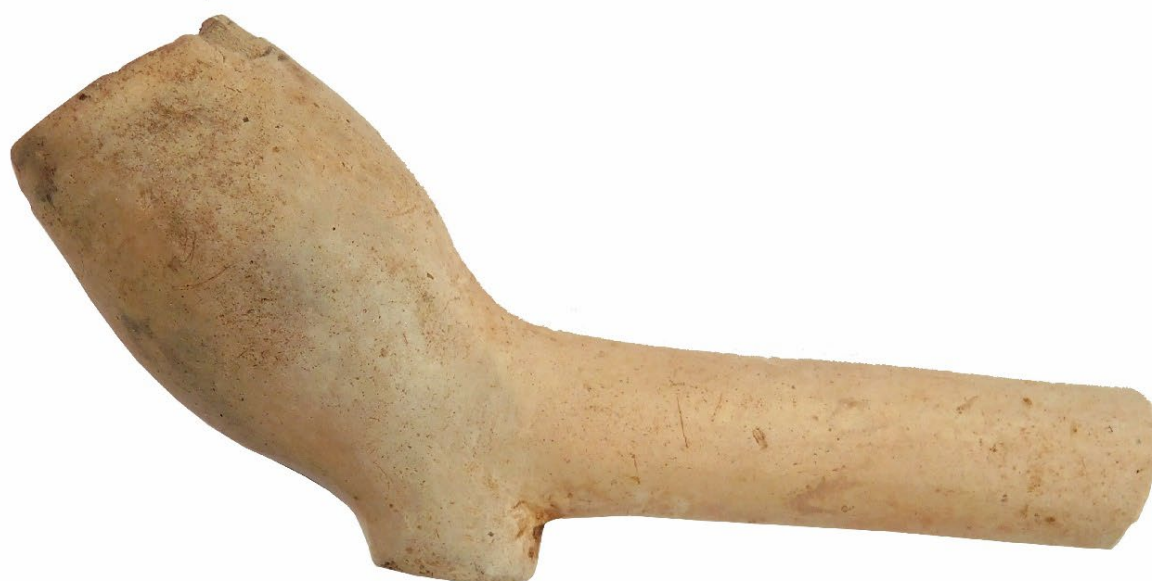
Plate A2.17: Clay tobacco pipe bowls, 1640-1660

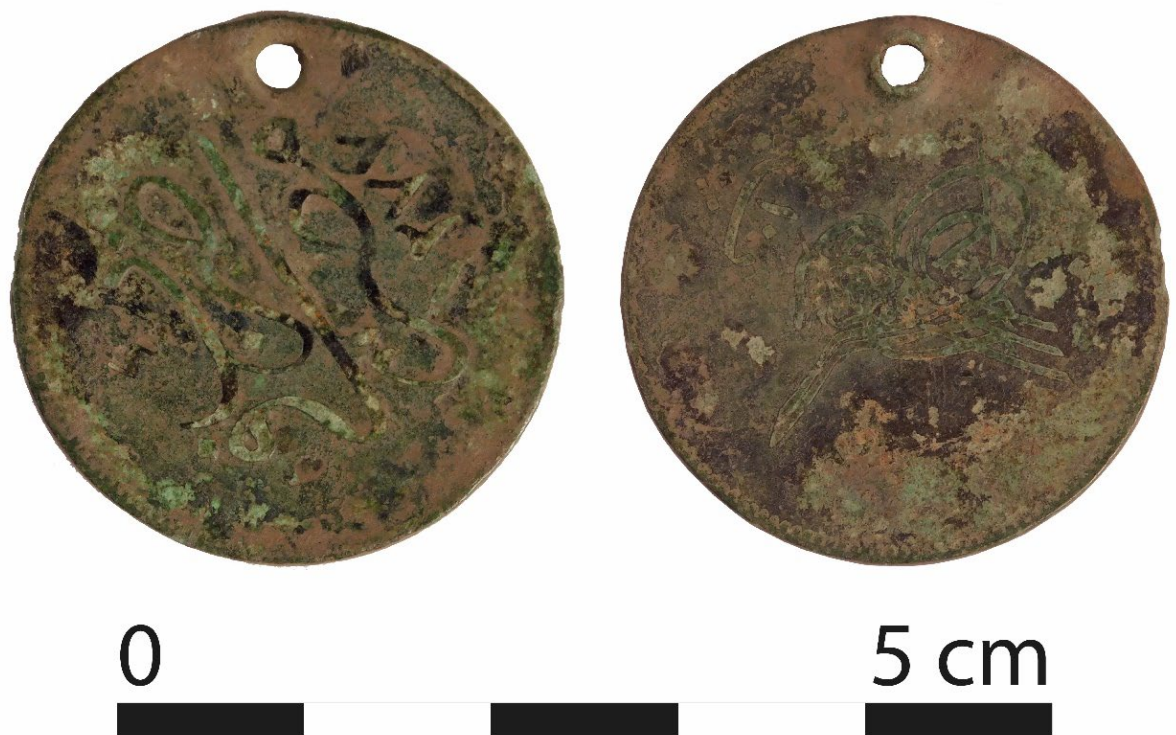
Plate A2.18: Ottoman coin obverse and reverse, scale 5cm

Ottoman 10 para coin (identification by Alex Payne)

The coin is dated 1860/1 (Hijri Islamic calendar 1277) from late Ottoman Egypt under Wali (a title somewhat like vassal or lord) Mohamed Sa'id Pasha, under Ottoman sultan Abdulaziz whose "Tughra" (name/signature) appears in calligraphic monogram on the obverse side to the date. Below the Tughra the value of the coin "10-papa" is given. The reverse side reads "8/Struck in Egypt/1277". A hole punched at its edge was presumably allowed the coin to be worn as a pendant, possibly for apotropaic purposes.

although unstratified was a 19th century Ottoman copper alloy 10 para coin (FN 129; Plate A2.18).

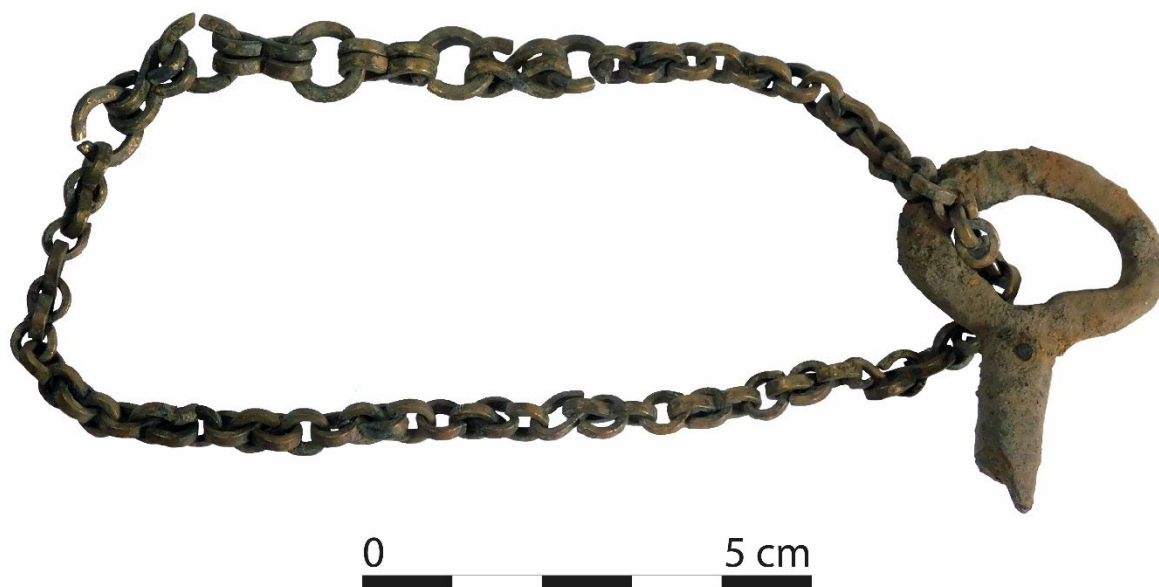
Plate A2.21: Key chain, scale: 5cm

Find 106 comprised a complete brass chain and part of key comprising bow and part of the shank. The chain comprises square sectioned wire formed into S-shaped links (Plate A2.21). Similar chains have been identified from Kirkstall Abbey and from London (Moorhouse and Wrathmell 1987; Egan 1998). X-ray fluorescence (XRF) analysis, gain carried out by the University of Salford School of Science, Engineering and Environment has enabled the material that the chain was fashioned from to be identified, which like the mail armour, was from brass.

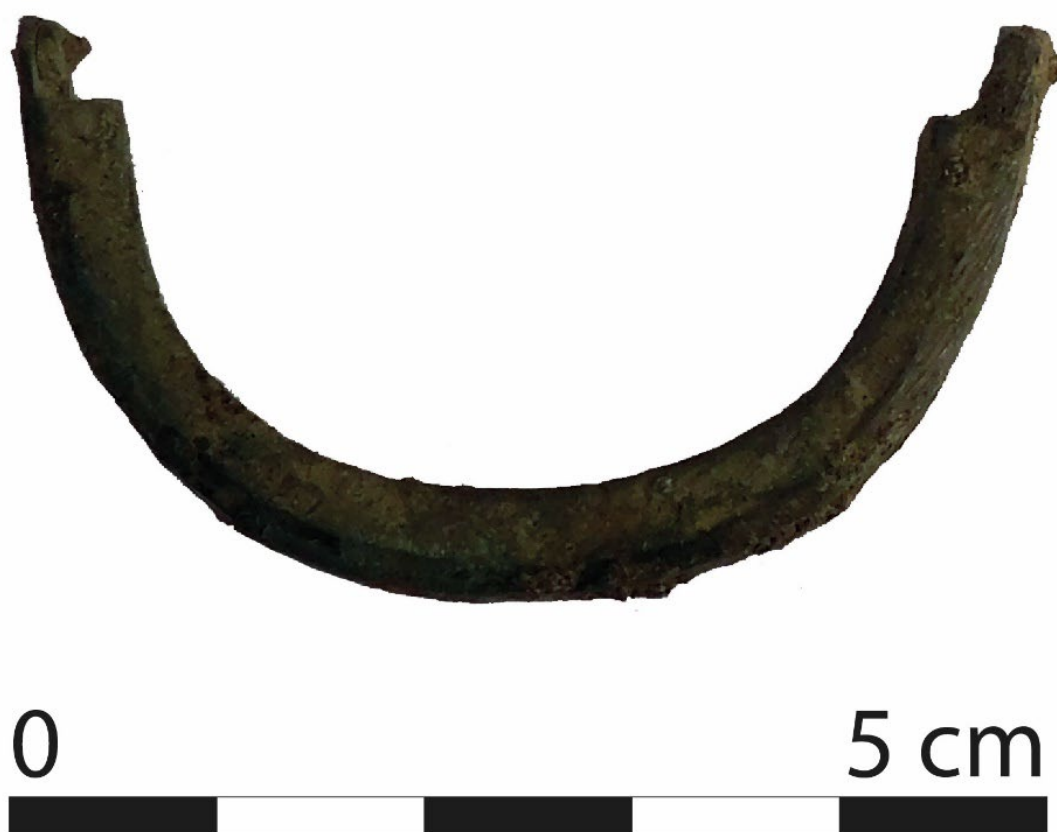
Plate A2.22: Possible sword chape, scale: 5cm

Two unusual finds were a copper alloy strip (FN 133), possibly repair for a cooking pot (Egan 1998) and an object composed of two crescentic pieces with a central spacer that may be a sword chape (FN 137; Plate A2.22). Rounded, as opposed to the more usual tapering style, sword or dagger chapes are recorded on the portable Antiquities Scheme, for instance a rounded form with a knob (GLO-9EA60E) from Gloucestershire, although this example is a closed form in the shape of a scallop shell. A form that appears to be closer in style to the Farington example can be seen in Pieter Bruegel the Elder's, 1568 painting *Three soldiers* (Plate A2.23; Oberthaler et al 2019).

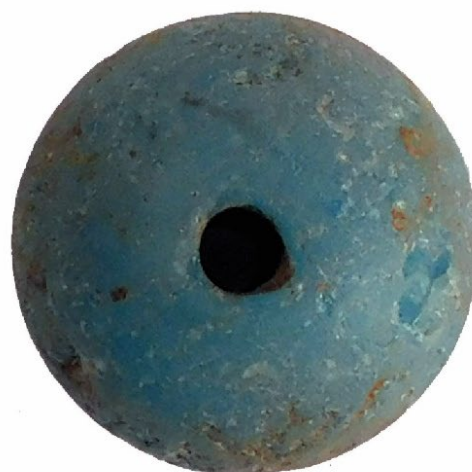
Plate A2.26: Glass bead, scale: 5cm

Some 45 fragments of glass weighing 800g were recovered from 10 stratified contexts. Glass from Farington can be sub-divided into three forms, comprising a single blue glass, bead (FN3), 11 vessel glass fragments and 33 fragments of window glass.

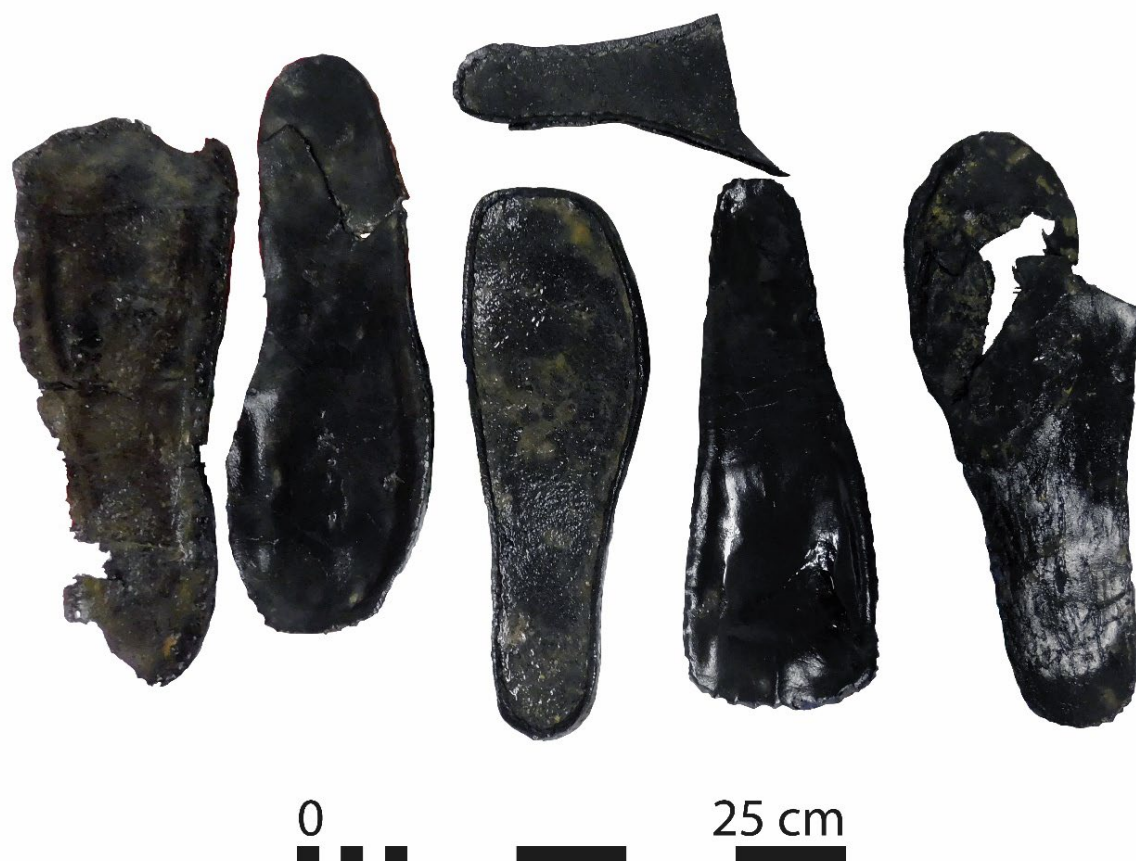
Plate A2.28: Leather shoe fragments, scale: 25cm

The earliest of the moat fills [277] produced some 50 fragments including seven soles (Plate A2.28). These were distinctive in shape and are characteristic of shoes dating to c 1500-1550 (Goubitz et al 2001). Moat recut fill [237] produced the largest collection of leather fragments, comprising some 83 pieces including 18 soles. Again, these appear to date to c 1500-1550. Stratigraphically above deposit [237], moat fill [260] yielded 26 pieces of leather within which

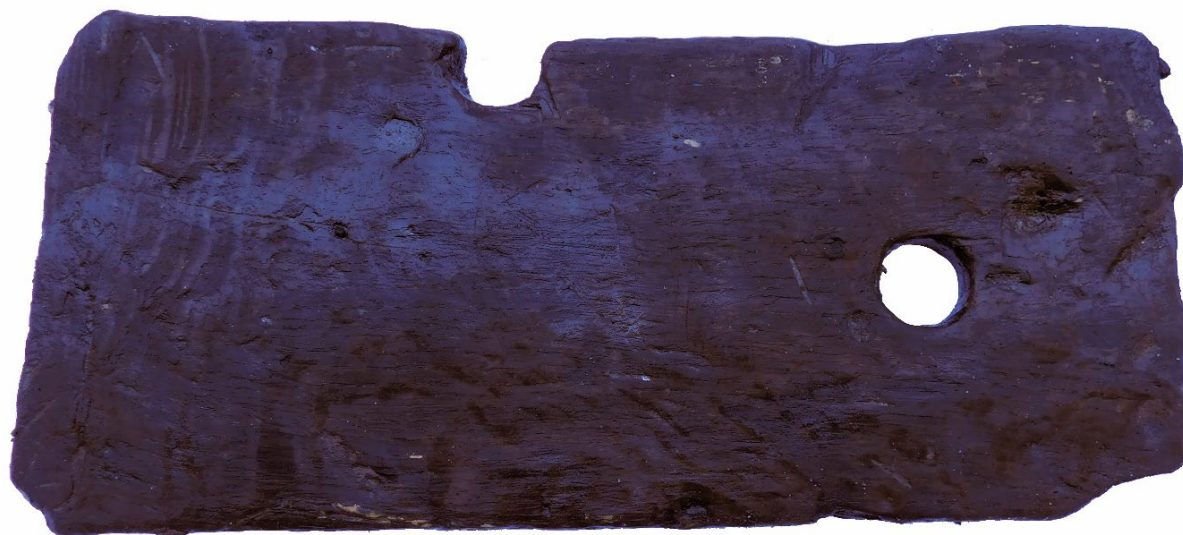
Plate A2.29: plank, scale: 25cm

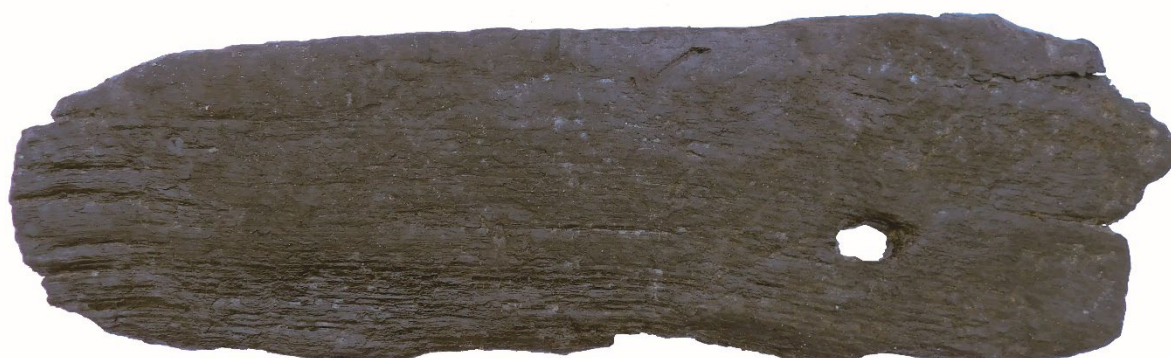
Plate A2.30: plank with possible keyhole, scale: 25cm

By far the most common worked wood objects were those that were likely to be tangentially split (see table x4 for quantification). Tangentially splitting usually encompasses splitting roundwood firstly in half, followed by splitting each half into two sections across the grain and so on (Morris 2000). In the main, these were likely to be plank off cuts, however, a few of these objects exhibited toolmarks or other indications of having being shaped or have holes created by boring tools. Of note were RF51 (Plate A2.29, FN51 (3) and 152 which both displayed bored holes, which were probably intended for trenails/pegs. Recorded find 50 may have had bored holed which had been further shaped into a possible keyhole (Plate A2.30, FN50 (3))

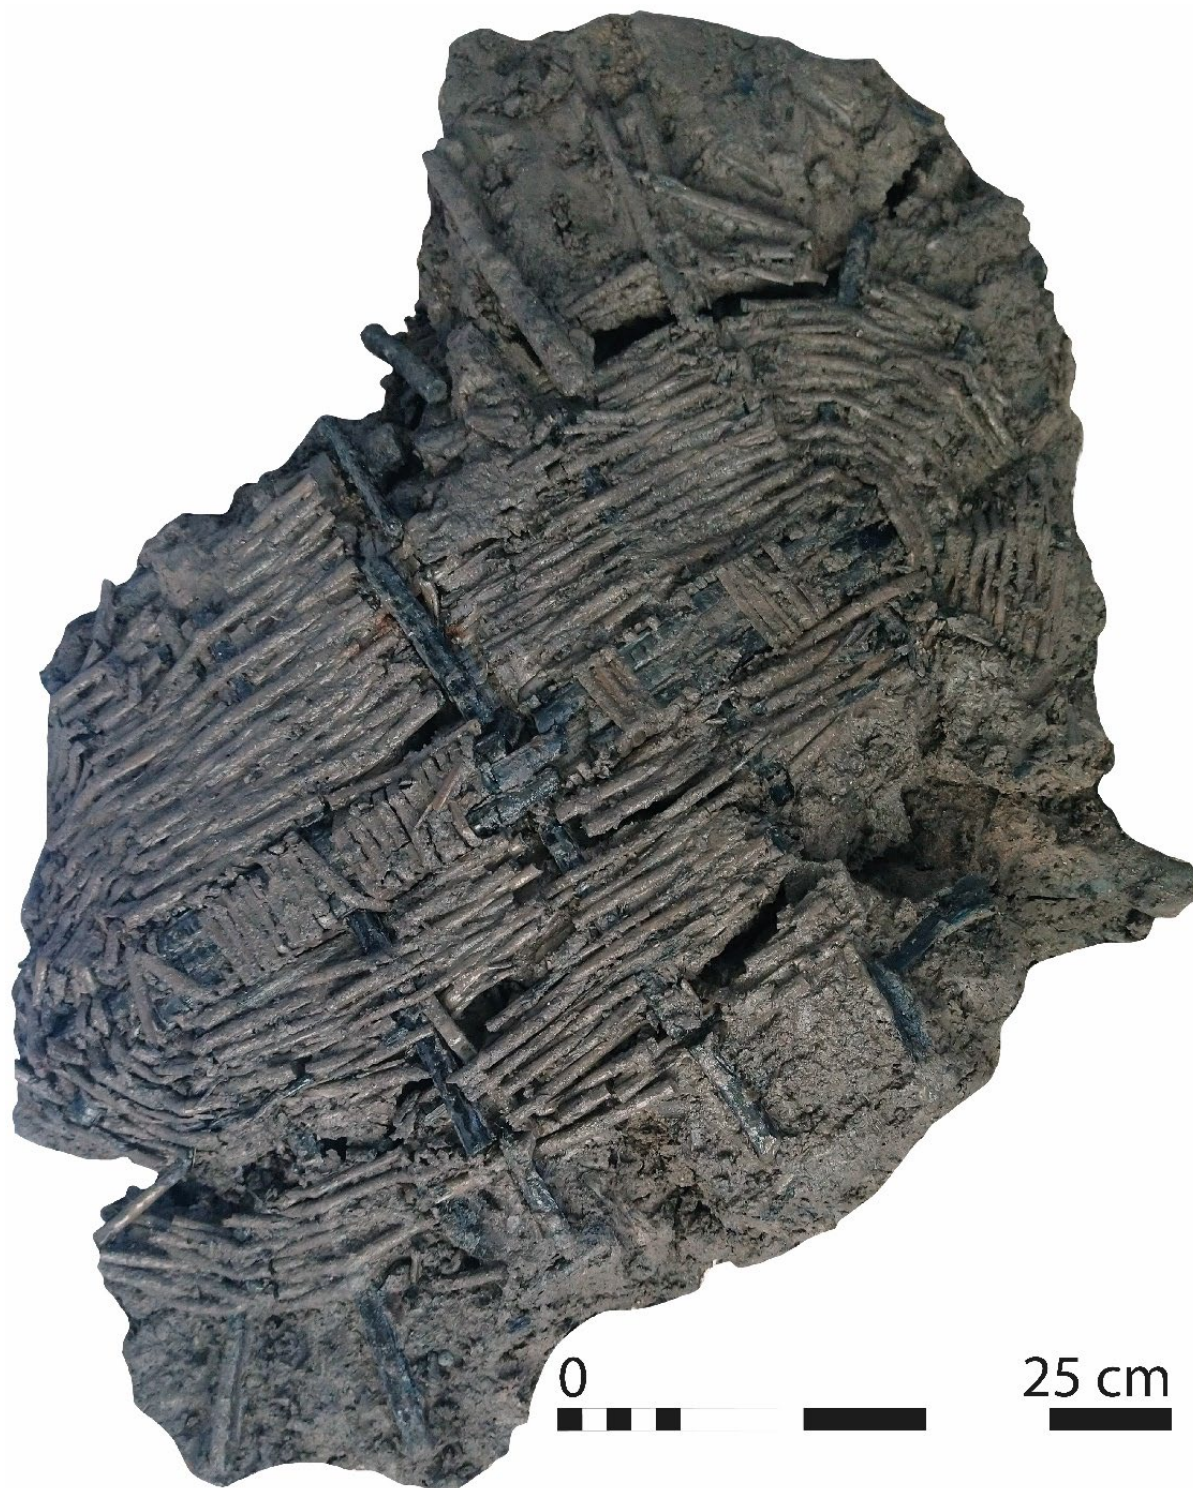
Plate A2.35: Oval basket, scale: 25cm

The fragmentary remains of an oval basketry container were recovered from moat fill [277] (Plate A2.35). The object was lifted whole and then hand cleaned. An oval base of similar construction is illustrated in Dorothy Wright's *Baskets and Basketry* (1959). Basket making

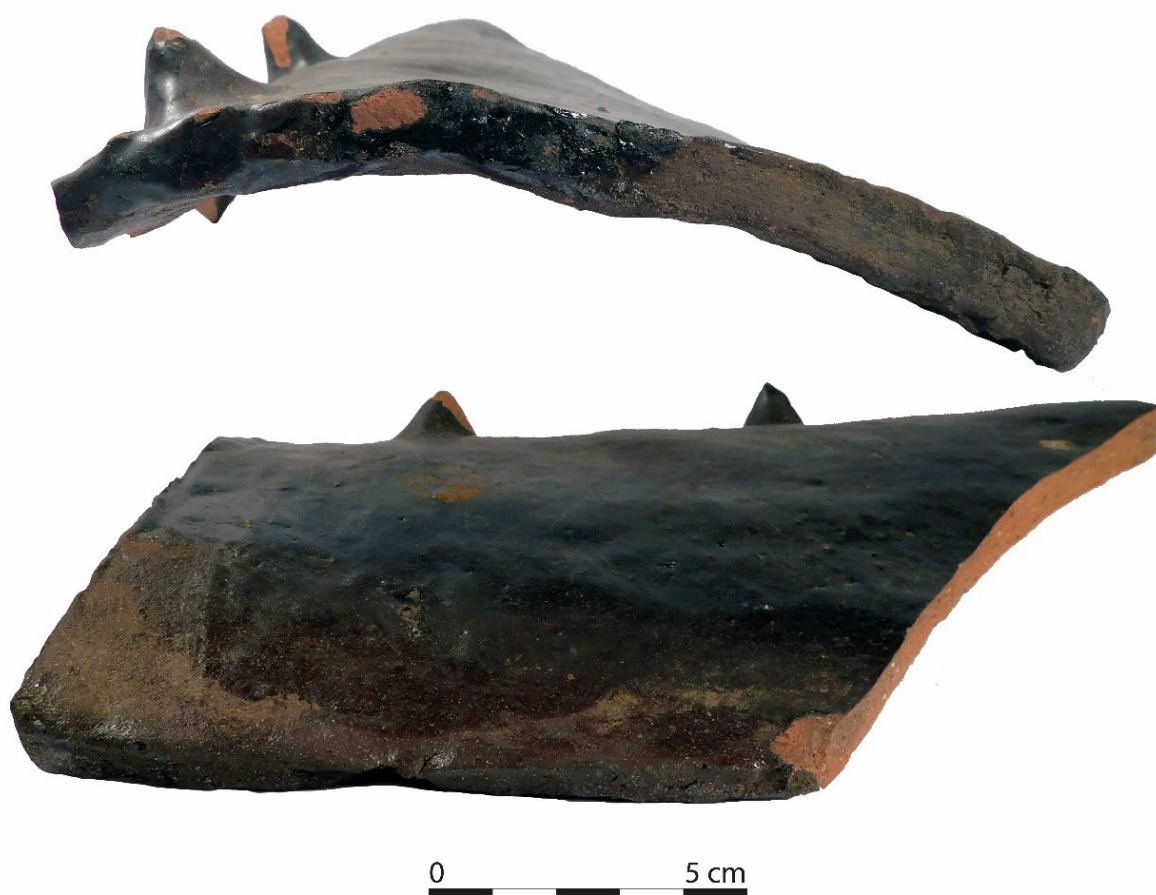
Plate A2.37: Spiked ridge tile, scale: 5cm

The majority of the roof tile was glazed, usually brownish-purple, with fabric ranging from rare pink to orange through to red and dark grey. The forms consisted of curve ridge tiles, sometimes exhibiting conical spikes, and to a lesser extent flat roof tile. However, it is possible that the flat examples are the terminal ends of the ridge tiles. No complete tiles were found, although occasional near complete examples measured 367mm wide (approximately 1 foot 2 $\frac{3}{4}$ inches) by 9-17mm thick (Plate A2.37).

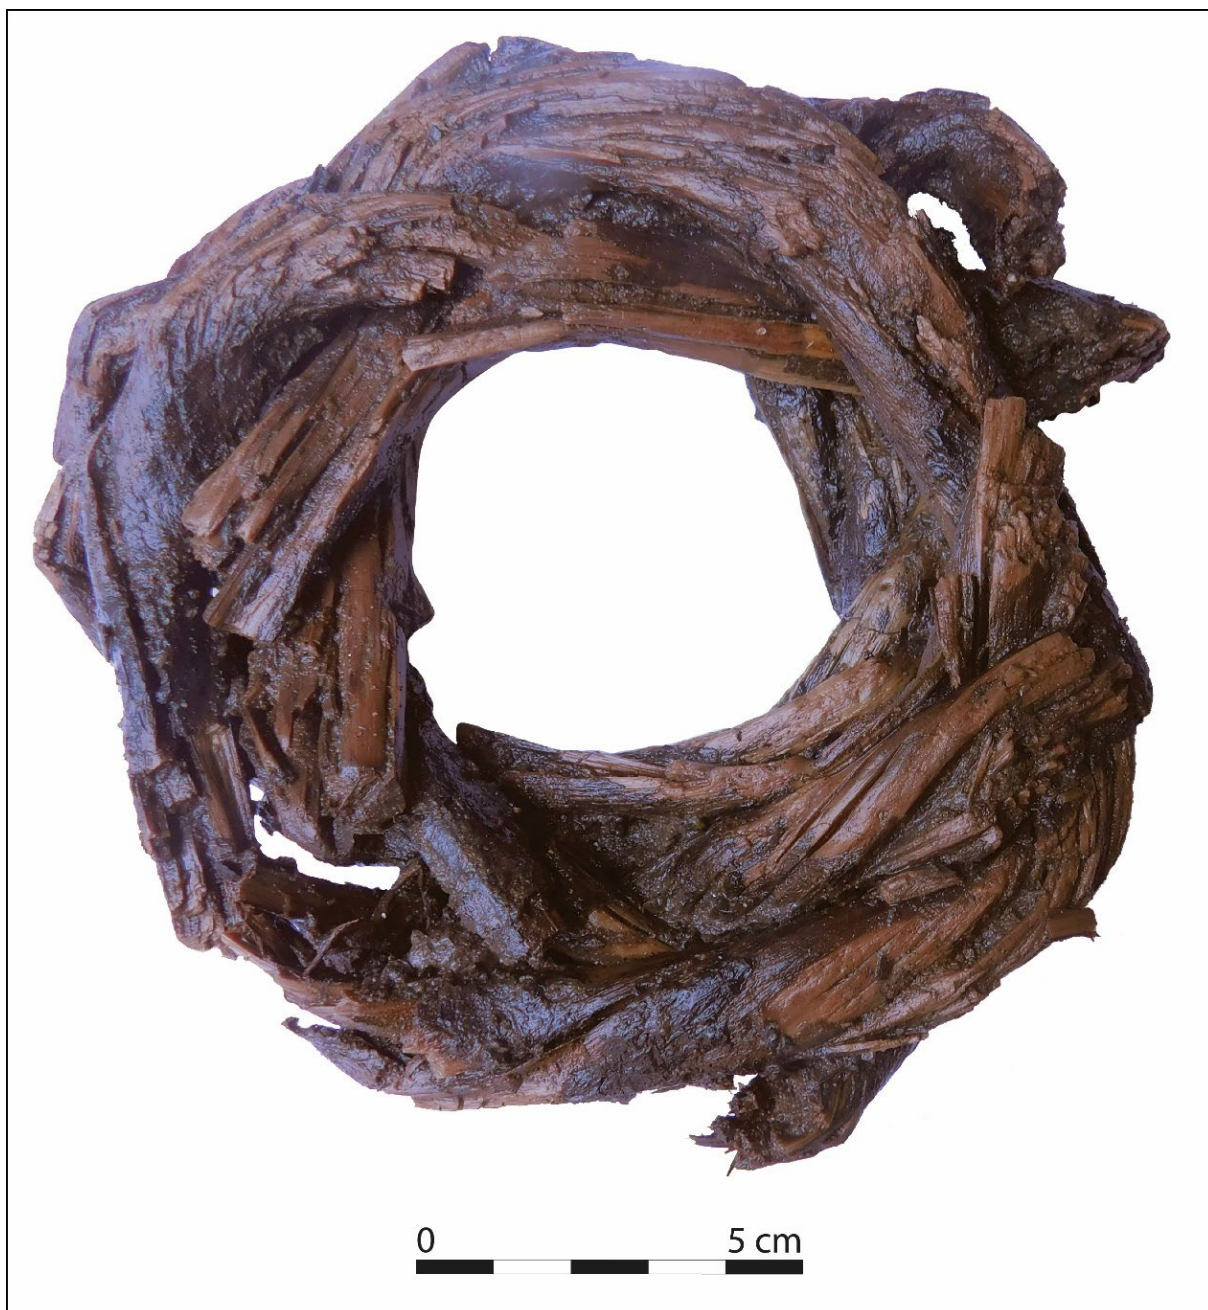
Plate A2.40: twisted fibrous material, scale: 5cm
