## HISTORIC BUILDING RECORDING

BRUFF FARM  
SOUTHFIELD ROAD  
NORTH KELSEY

SITE CODE: BFNK 13  
GRID REF: TA 0397 0049  
PLANNING: 127265  
ACCESSION NO: LCNCC 2013.135

SEPTEMBER 2013

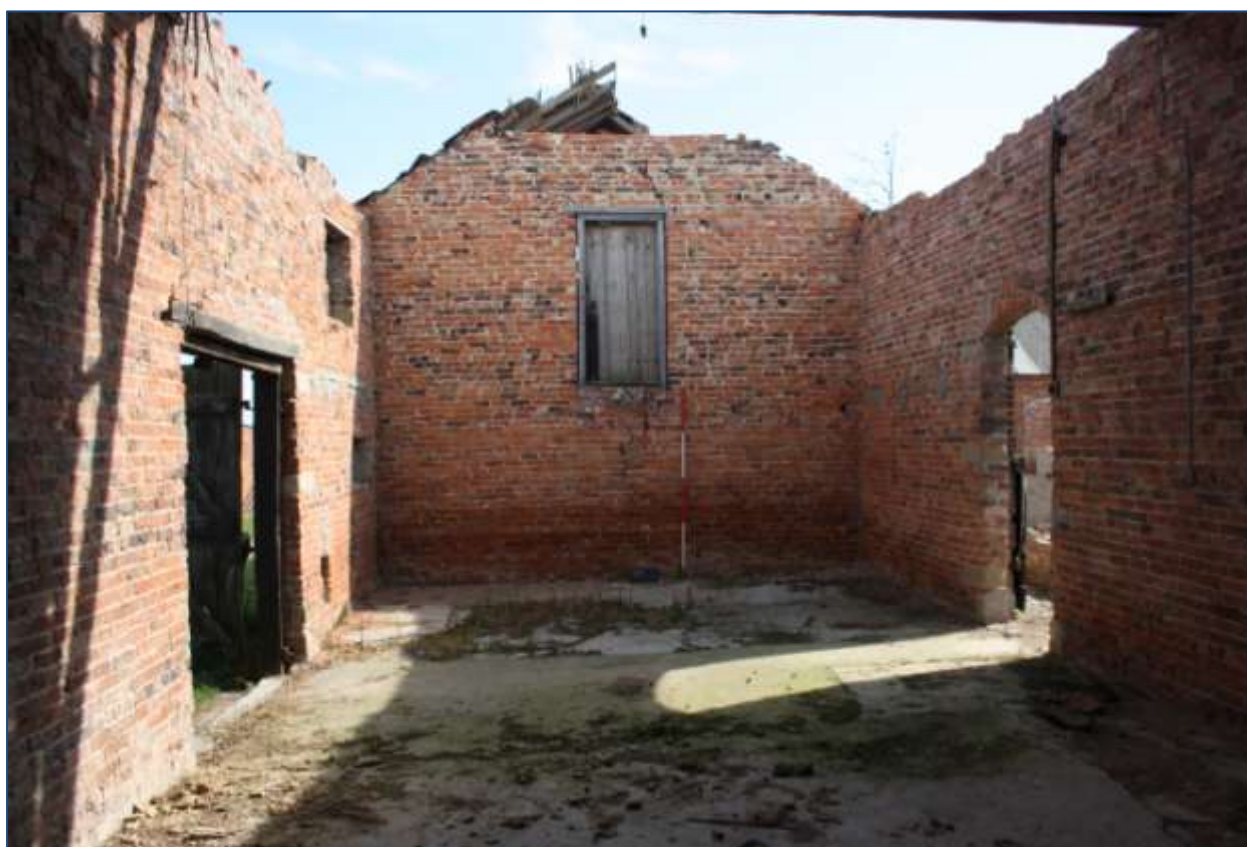
**Plate 7:** G1 interior looking north-east.

The inside of the building is rectangular in plan with a poured concrete floor, while some of the butt purlin King-Post construction roof survives. To the north-east a dividing gable is present and allows access to the adjoining granary at first floor level next door.

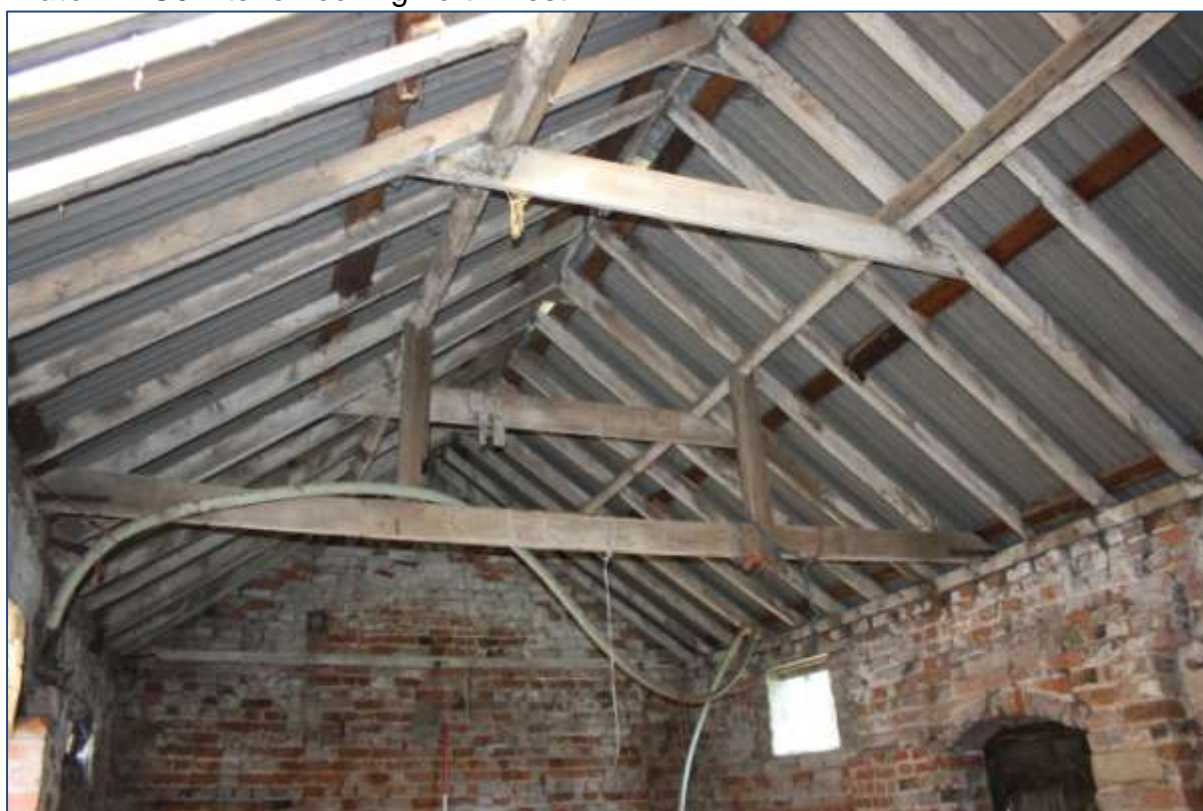
**Plate 15:** G5 Roof structure looking north-west.

The inside of the building is rectangular in plan and with a floor comprising of stable blocks. The roof structure consists of clasped purlins with supporting Queen posts. Within the north-east elevation, a large blocked single entrance with timber lintel is present.

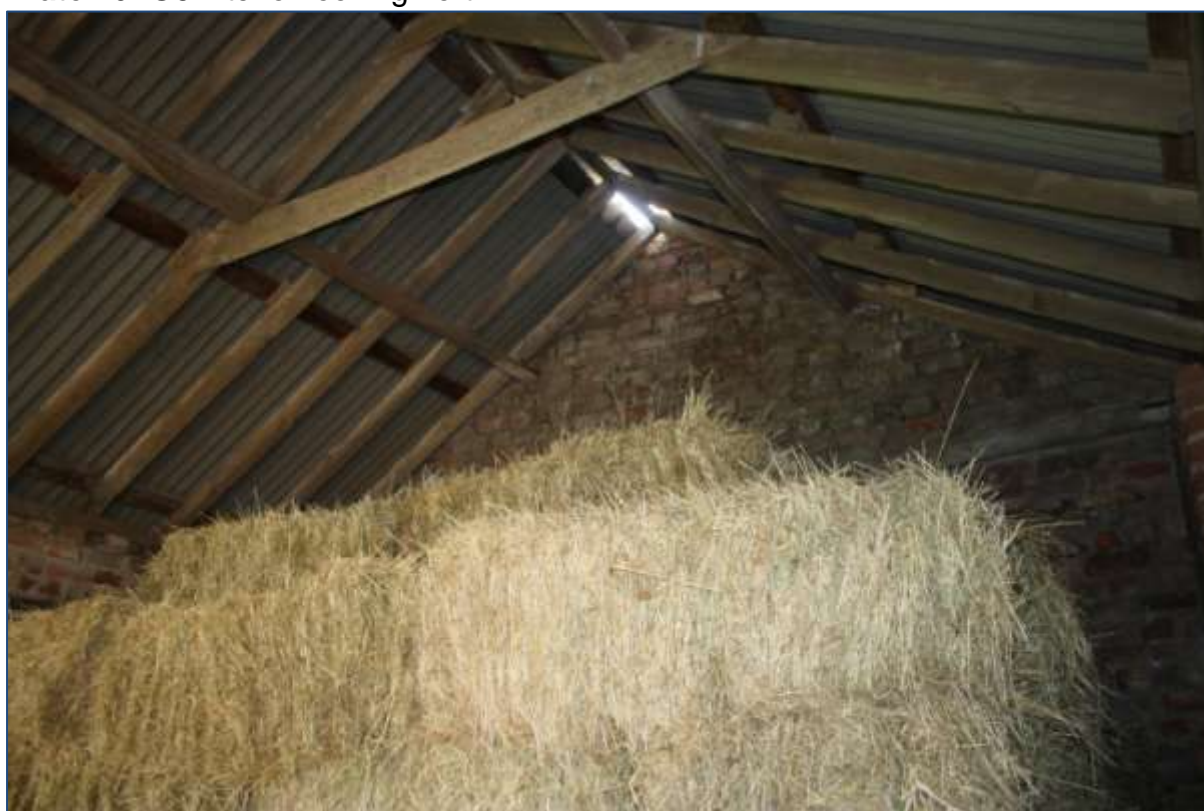
**Plate 17:** G6 roof structure looking south-east.

Inside the building is rectangular in plan with a poured concrete floor, whilst the roof is of clasped purlin construction.

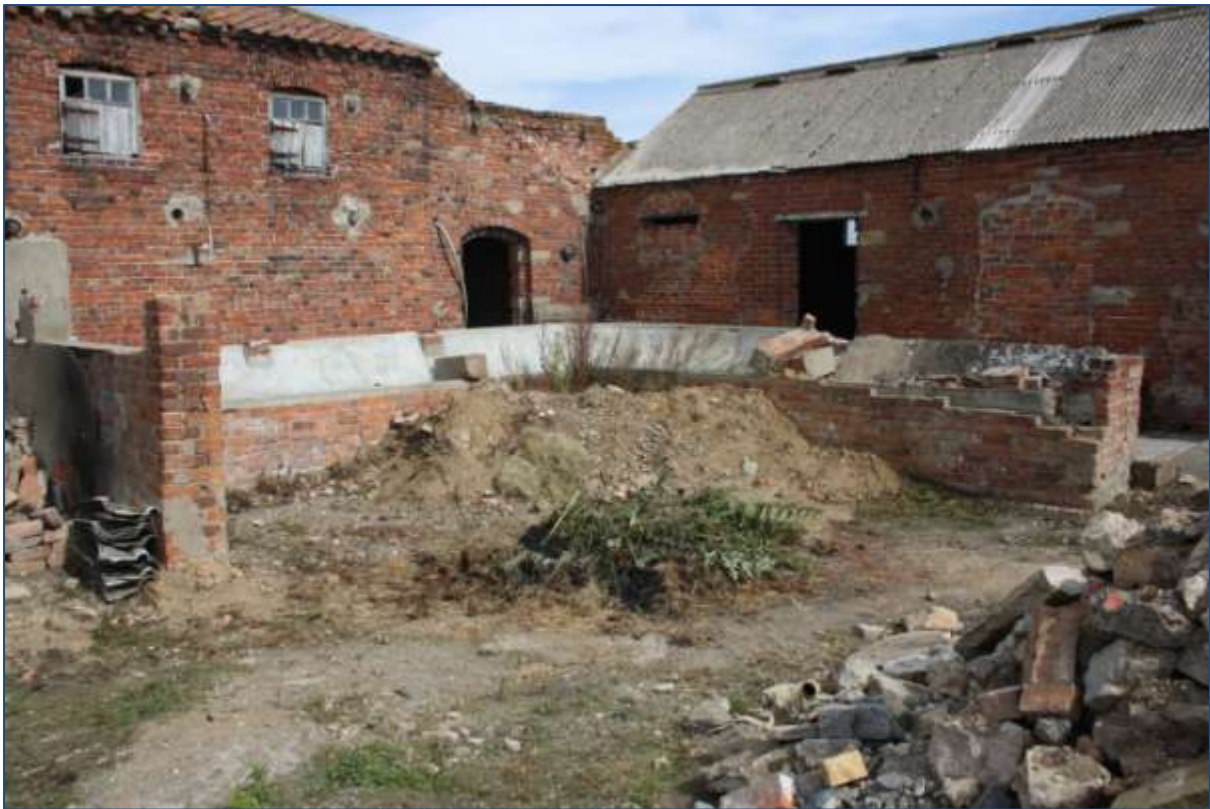
**Plate 22:** G5 blocked openings in south-west elevation looking north.

This building is entered via two opposing large single entrances in the north-east elevation and south-west elevations. Either side of the south-west entrance is a blocked up entranceway, both with a segmented arch above of brick headers and the interior of the openings show jambs of bull nose bricks. The current entrance in this elevation is plain in style and appears to be a more recent addition.

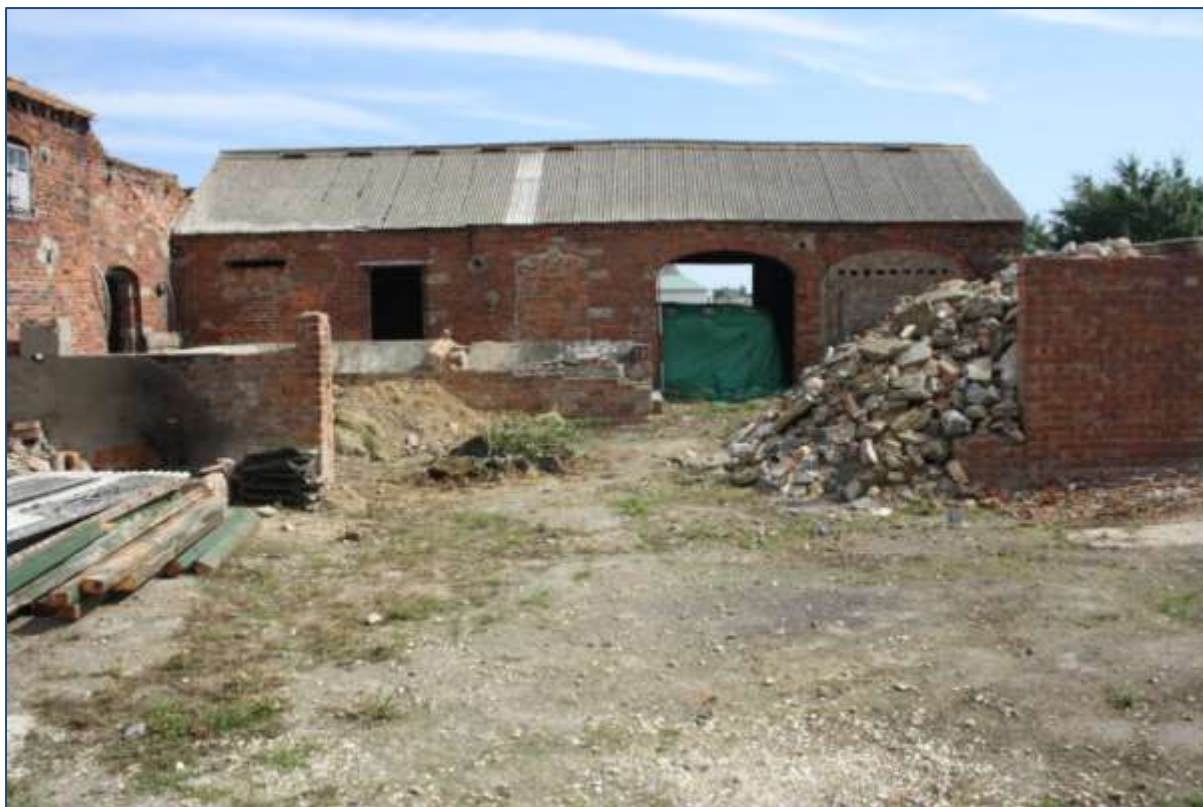
**Plate 24:** G5 and G6 showing blocked openings in south-west facing.

The cart store originally had access via two double-span entrances within the south-west elevation, both of which have jambs formed from bull nose brick, although one of these openings, that towards the south-east is now blocked up. A further double-span but slightly plainer entrance leads from the north-east elevation to the paddock beyond.

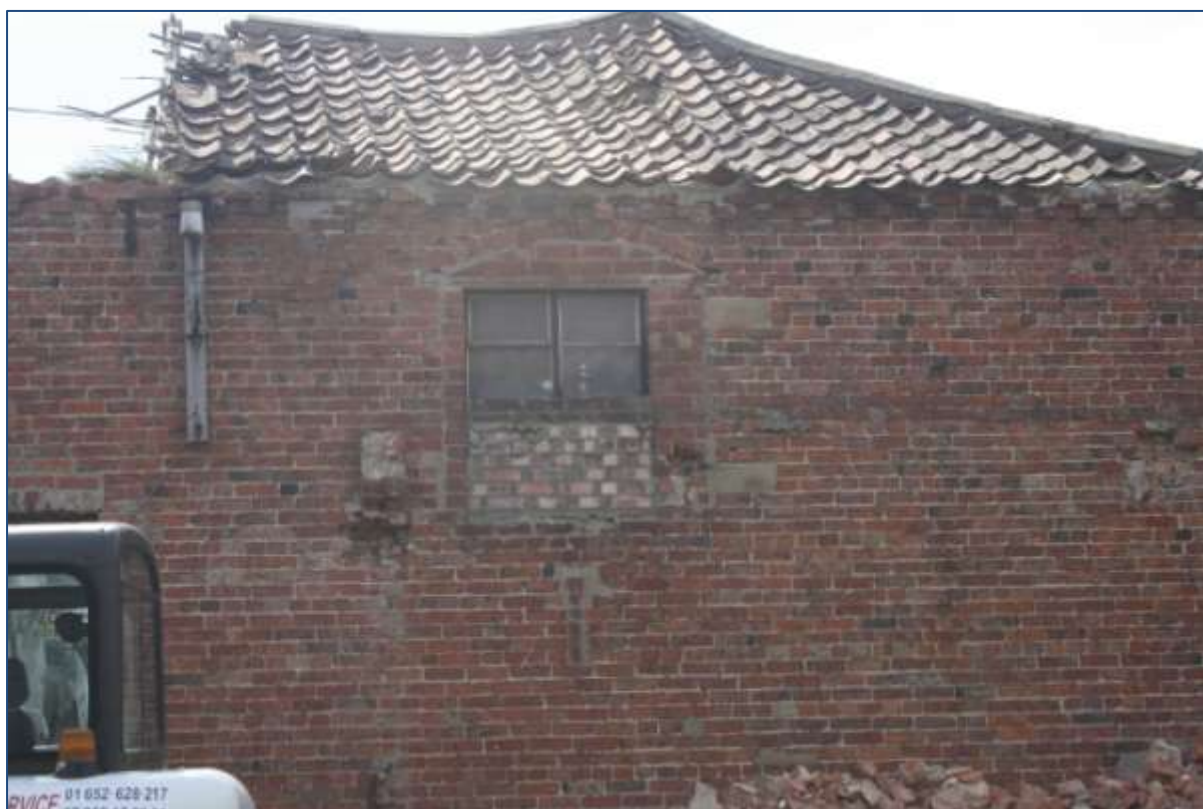
**Plate 27:** G1 Altered pitch-hole in north-west elevation looking south-east.

machinery. Above these openings is a small fixed case single light rectangular window below a fixed casement window of four lights just below eaves level. To the right of this window a further four light fixed casement window is present which has been 'let in' to an earlier pitch-hole, the latter displaying bull nose brick detailing and limestone jamb blocks, a feature mirrored throughout the other openings of this building. Features to note within the south-east elevation are the two ventilators of geometric design located at eaves level, both of which have been constructed to look similar to the two intact pitch-holes further to the north-east within the granary area.

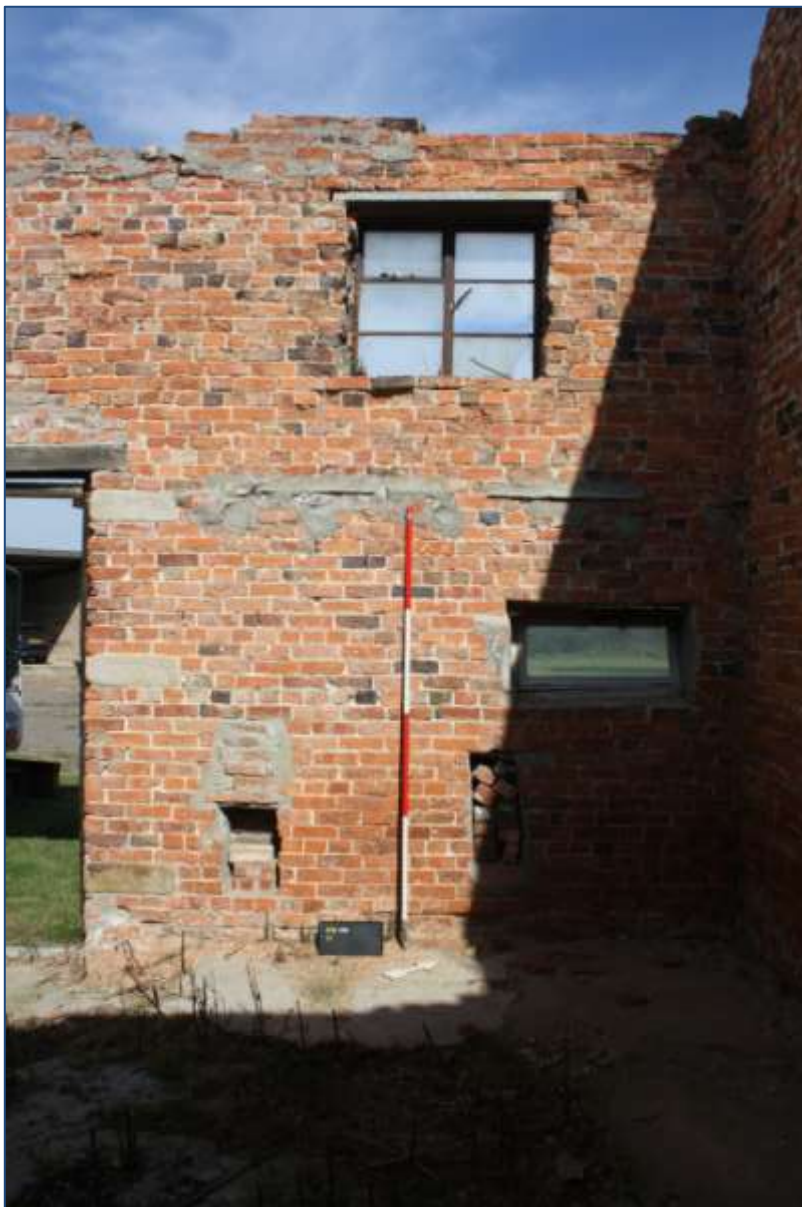
**Plate 29:** G1 possible alteration in north-west elevation to facilitate treashing machinery looking south-east.

Exterior openings comprise of a double-span entrance located within the north-west elevation, this lies opposite a large single-span entrance forming an asymmetrical building with unequal bays. At ground level, several openings are present and located to the north-east of the double-span entrance, possibly added after the buildings initial construction to aid the use of threshing or feed preparation

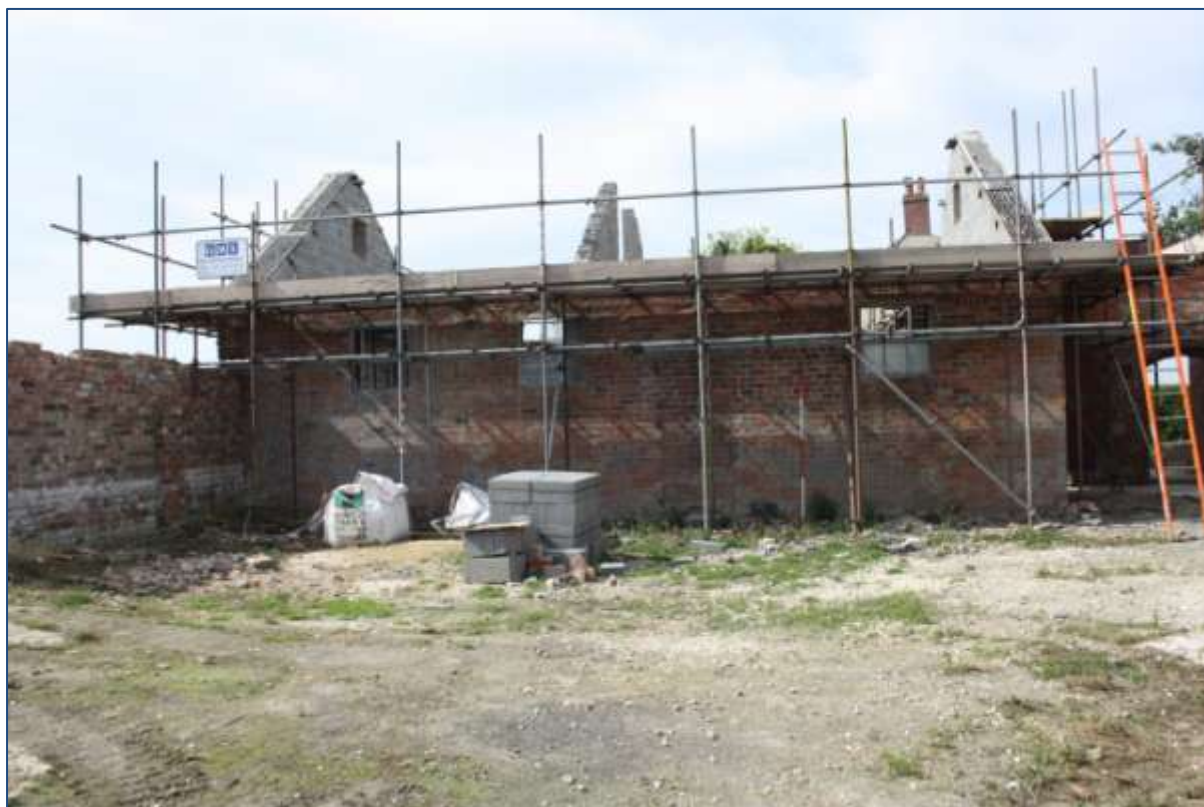
**Plate 31:** G9 north-east elevation looking south-west.

Set within the south-west elevation are three square blocked in window openings and which are mirrored throughout the north-east elevation by three fixed casement windows, two of which consist of six lights each, the third being partially blocked in. The south-east elevation has evidence of a double-span entrance now blocked in and a medium sized rectangular fixed casement window with a single light is positioned to the left of the entrance. At the apex of the gable, there is a small square pitch-hole opening. Set within the north-west gable there is a large single entrance with a small square pitch-hole above towards the apex.

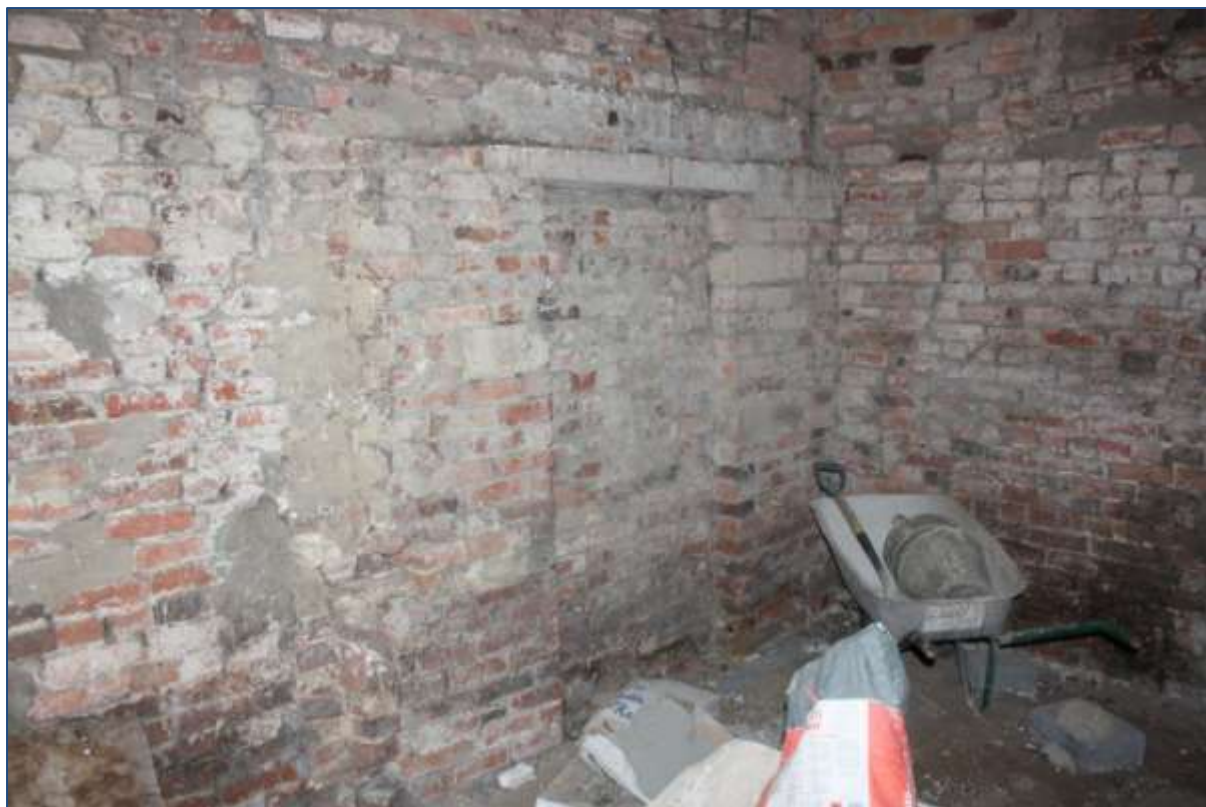
**Plate 32:** G8 blocked opening in north-west corner looking west.

This building is very similar in design to G3, except that at some point in its history it had access leading from the south-west into G12 and which is now blocked.

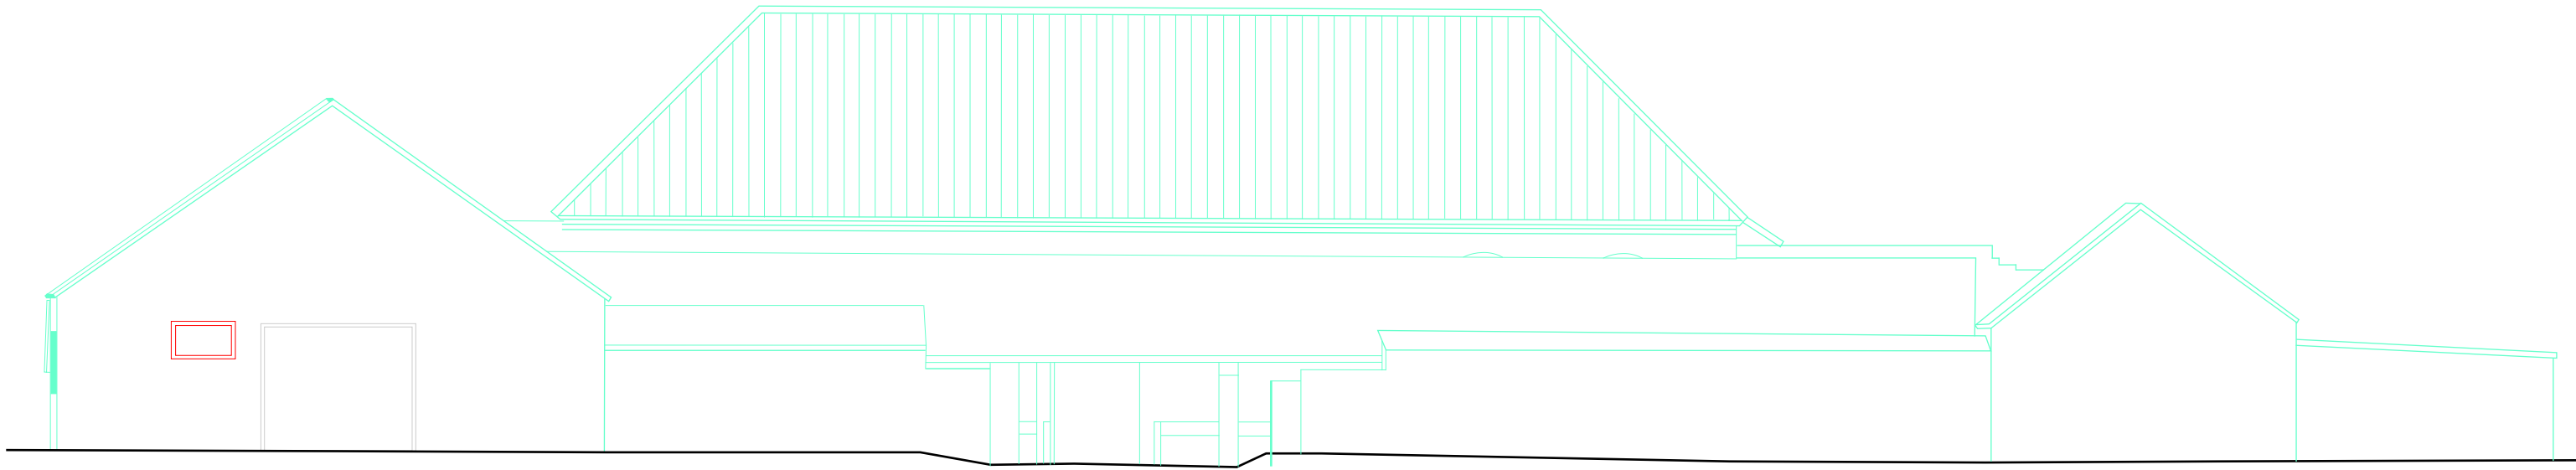
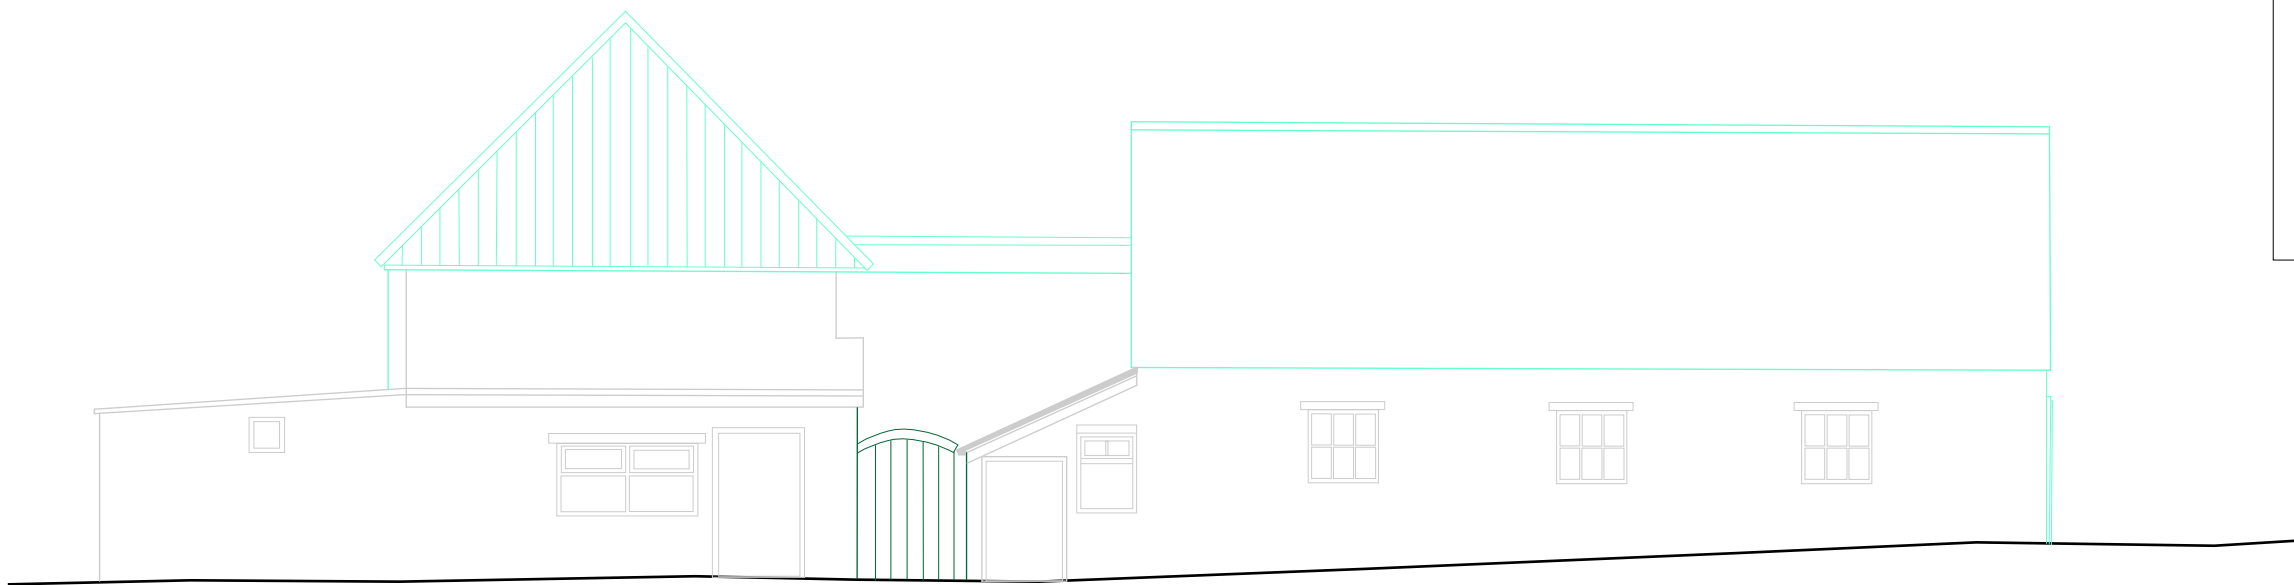
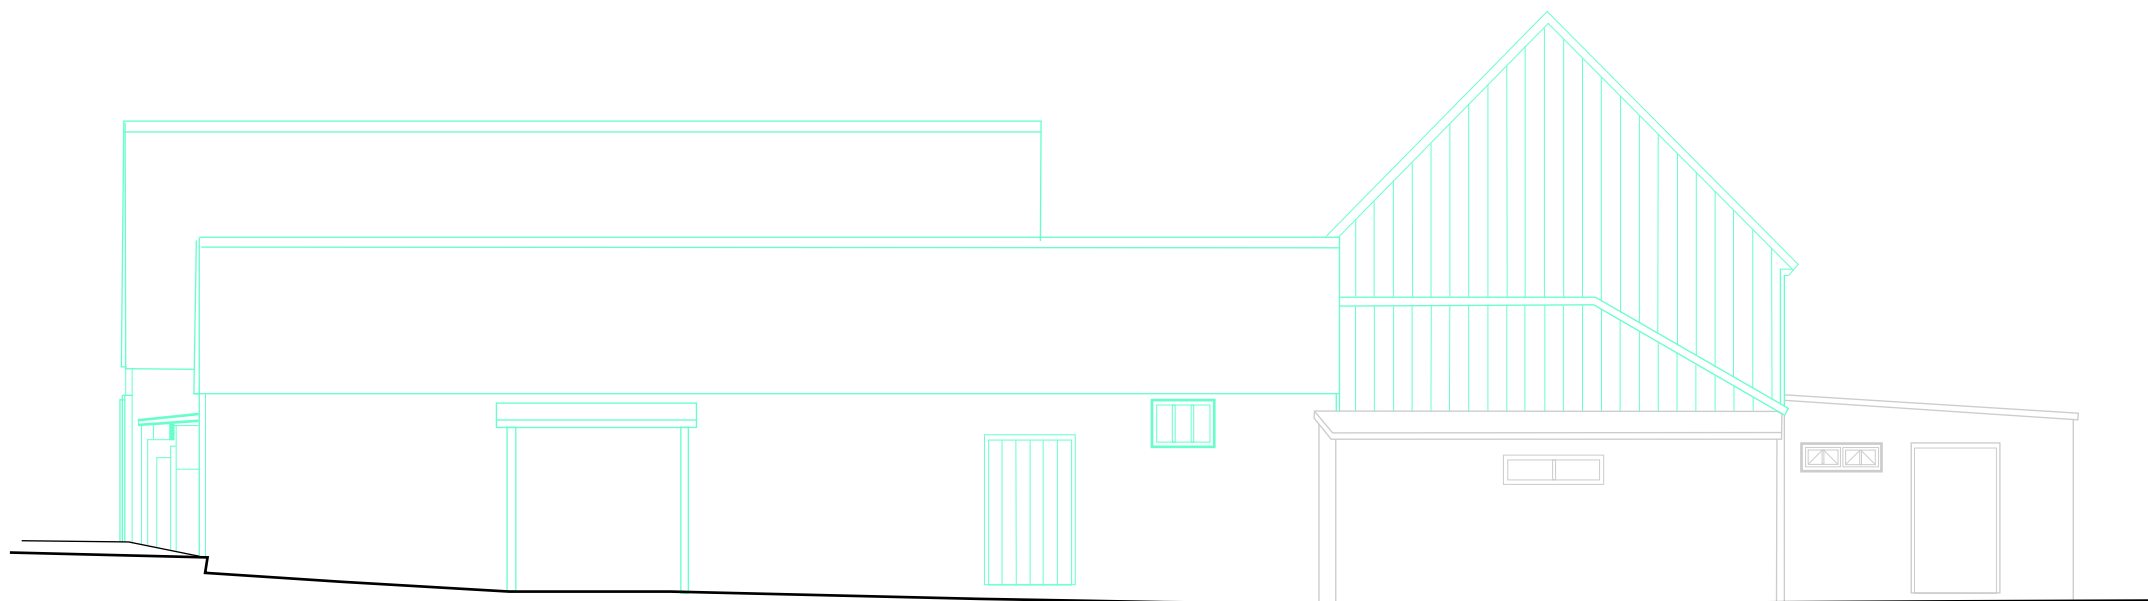
<span style="color: cyan;">■</span>	Mid 19th Century
<span style="color: darkgreen;">■</span>	Late 19th Century
<span style="color: red;">■</span>	20th Century
<span style="color: grey;">■</span>	Not Recorded

This group of buildings dates from the mid/late 19<sup>th</sup> century but with some alteration taking place throughout the early/mid 20<sup>th</sup> century.

This group of buildings was most likely constructed as a single unit along with the accompanying farmhouse, with G 3 and G 4 and Block 2 being added to Block 1 in a relatively short space of time. The addition of G 7, G 10, G 11, and G 12 were probably added sometime in the early 20<sup>th</sup> century, as they do not appear on the 2<sup>nd</sup> edition Ordnance Survey mapping of the site. One interesting aspect of these buildings is the rather late inclusion of a hand-threshing barn G 1, especially as this type of practice was being largely phased out and replaced by mechanical threshing from the mid 19<sup>th</sup> century.

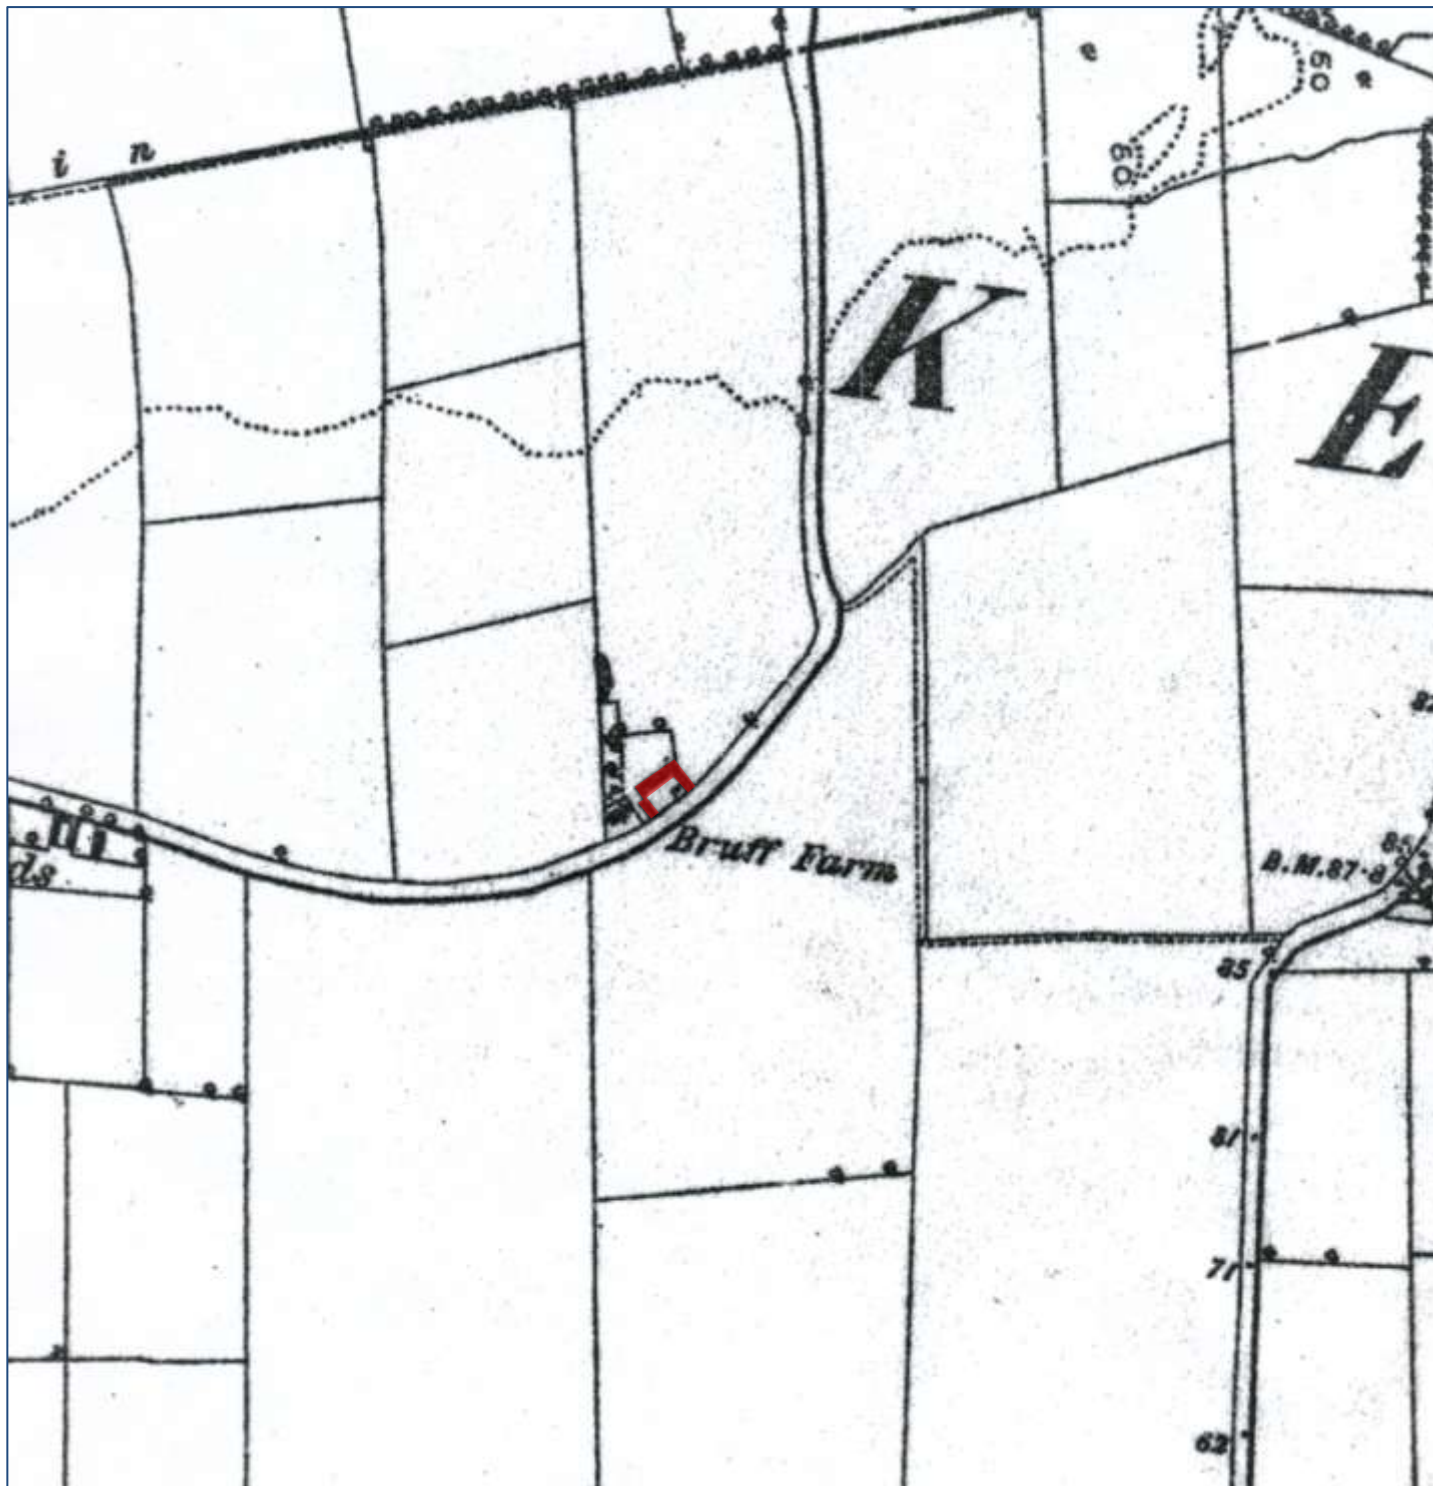
**Fig.10:** 1907 2<sup>nd</sup> edition Ordnance Survey 6"

The two Ordnance Survey maps clearly show the range of buildings forming the crew yard at Bruff Farm much as they stand today, although both the 1840 and 1866 maps show the area as undeveloped and as an open field (figs. 10-13).
