LEVEL 2 HISTORIC BUILDING SURVEY

QUINTINS ORCHARD FARM
PIPE LANE
PIPE RIDWARE
RUGELEY
WS15 3JL

NOVEMBER 2015

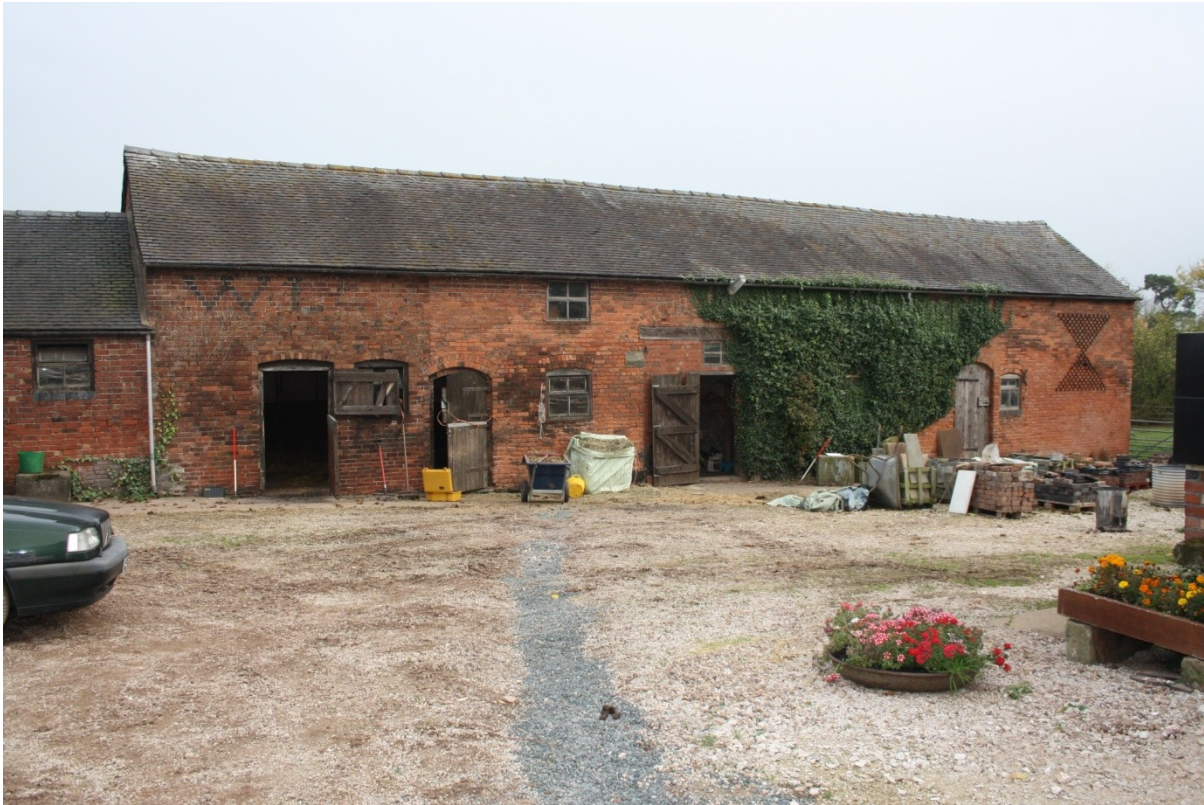
Plate 1: Front elevation NW.

Central to the NW elevation is a tall double-span entrance under a segmented brick arch with inset stone jambs. This has later been blocked up with brick and has a heavy timber lintel inserted below, along with a fixed casement window of 4 lights and a single-span entrance hung with a traditional planked door, this leads into the central threshing area of the barn (figs. 2, 6, 7, 8, plates 1, 24, 26)

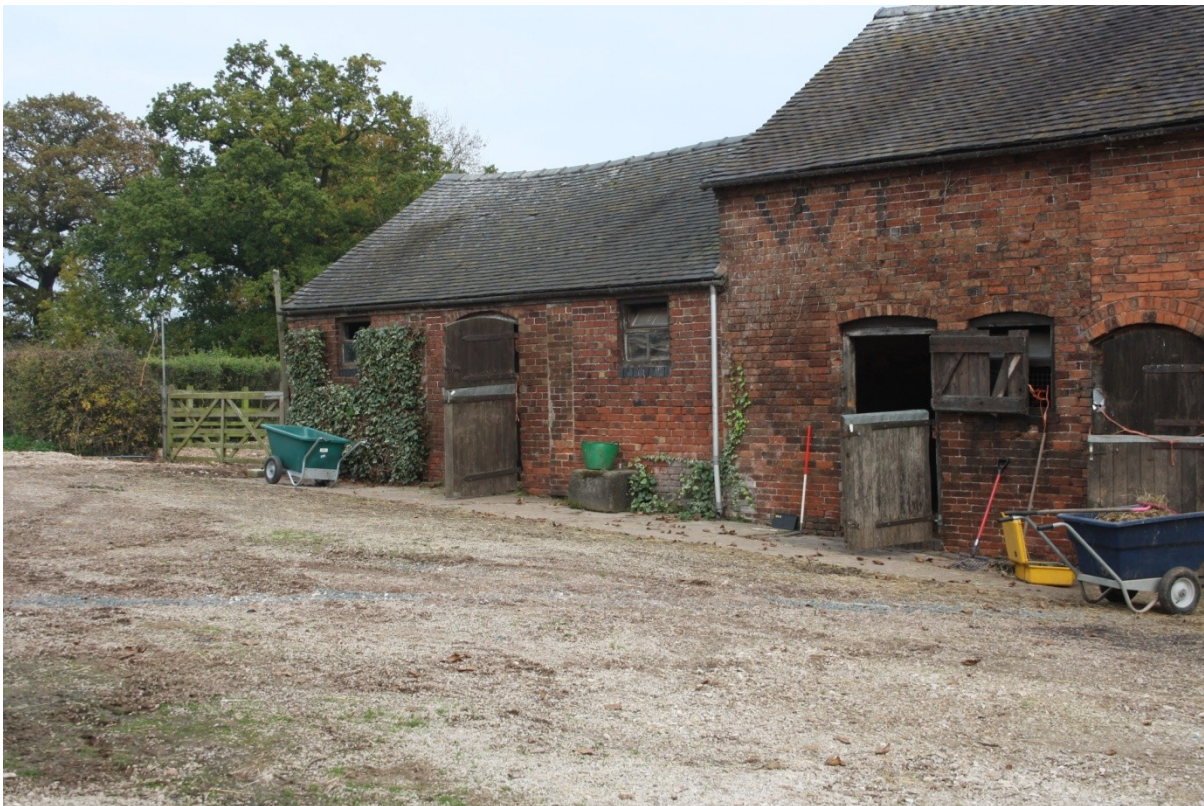
Plate 2: Front elevation NW.

The building is rectangular in plan north east to south west, built of (23x7.5x12cm) red brick with lime mortar in stretcher bond. The roof is gabled under grey clay tiles, the rainwater goods are in a traditional style cast in aluminium, there are ventilator holes in a diamond pattern in the NW, SE and SW elevations. Windows and doors are dispersed throughout the structure and explained in more detail below. There is also a single storey range of buildings attached to the north east and also along the south east elevation (1 Cart Store, 11 Stable and 7 Store, (figs. 2, 6, 7, 8, plates

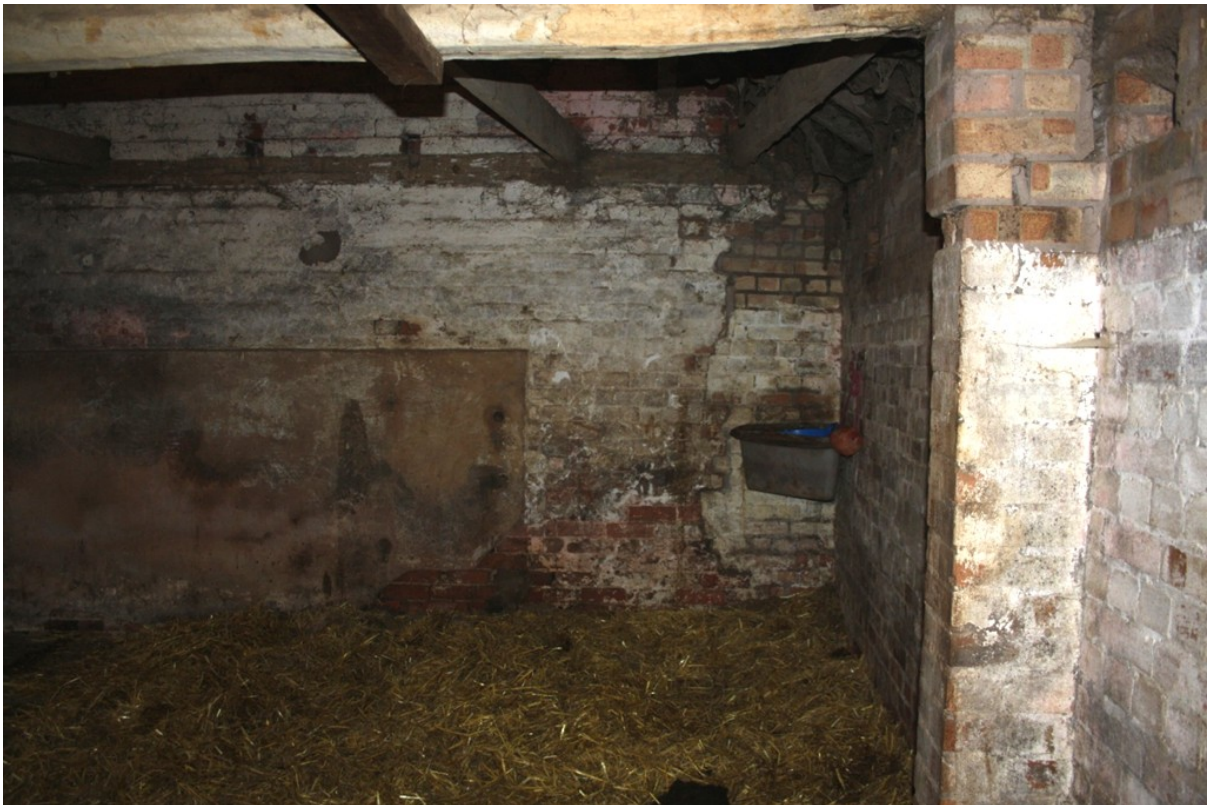
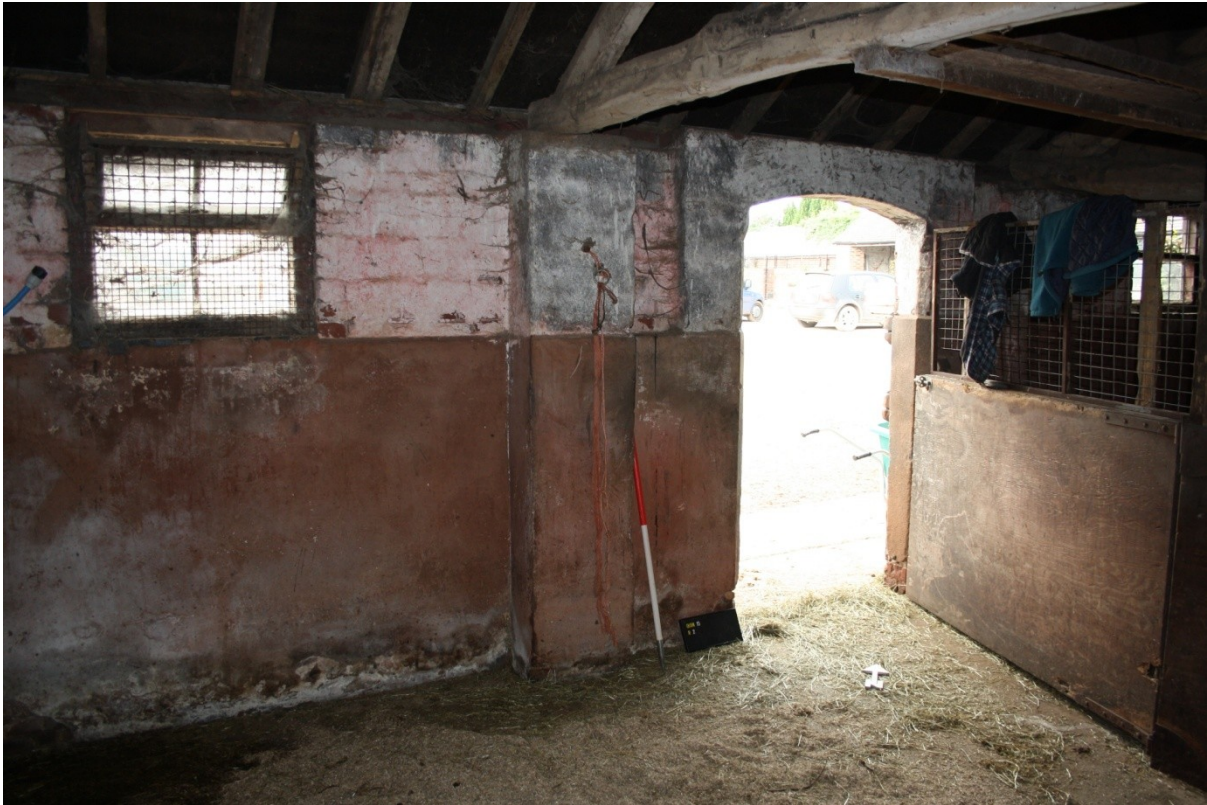
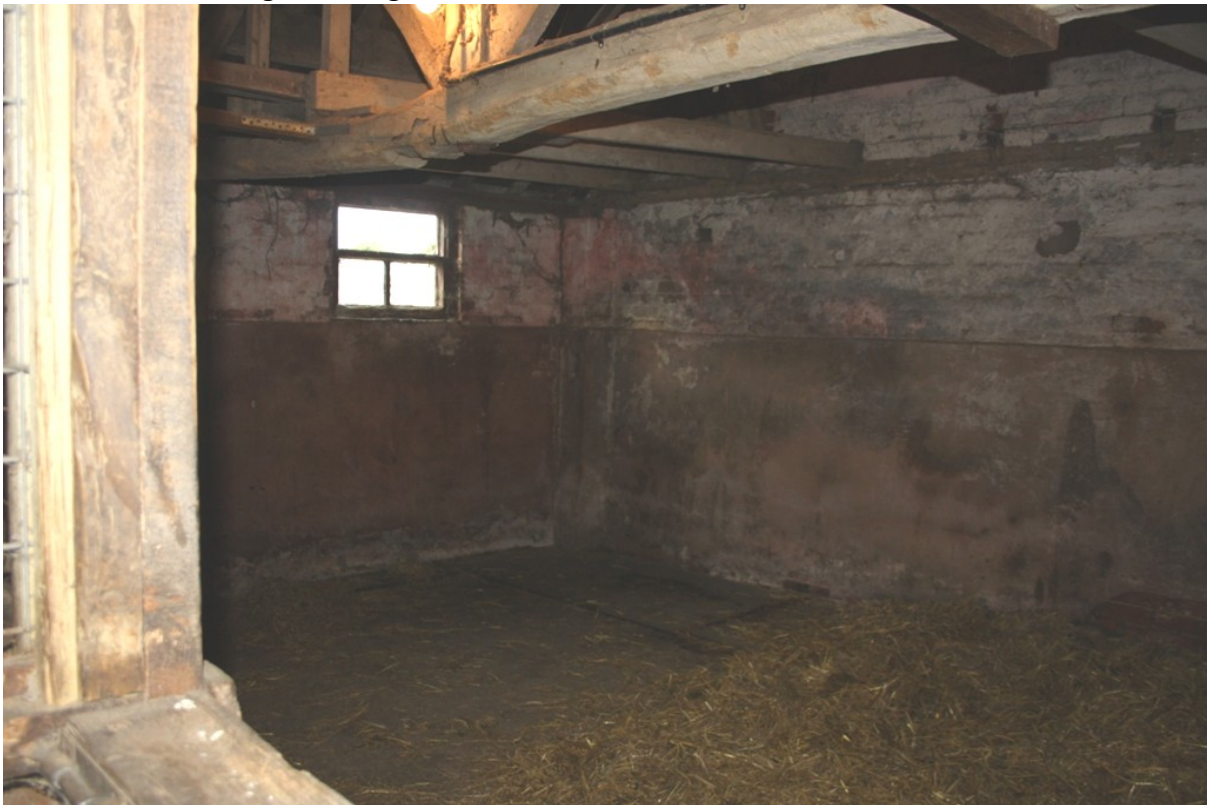
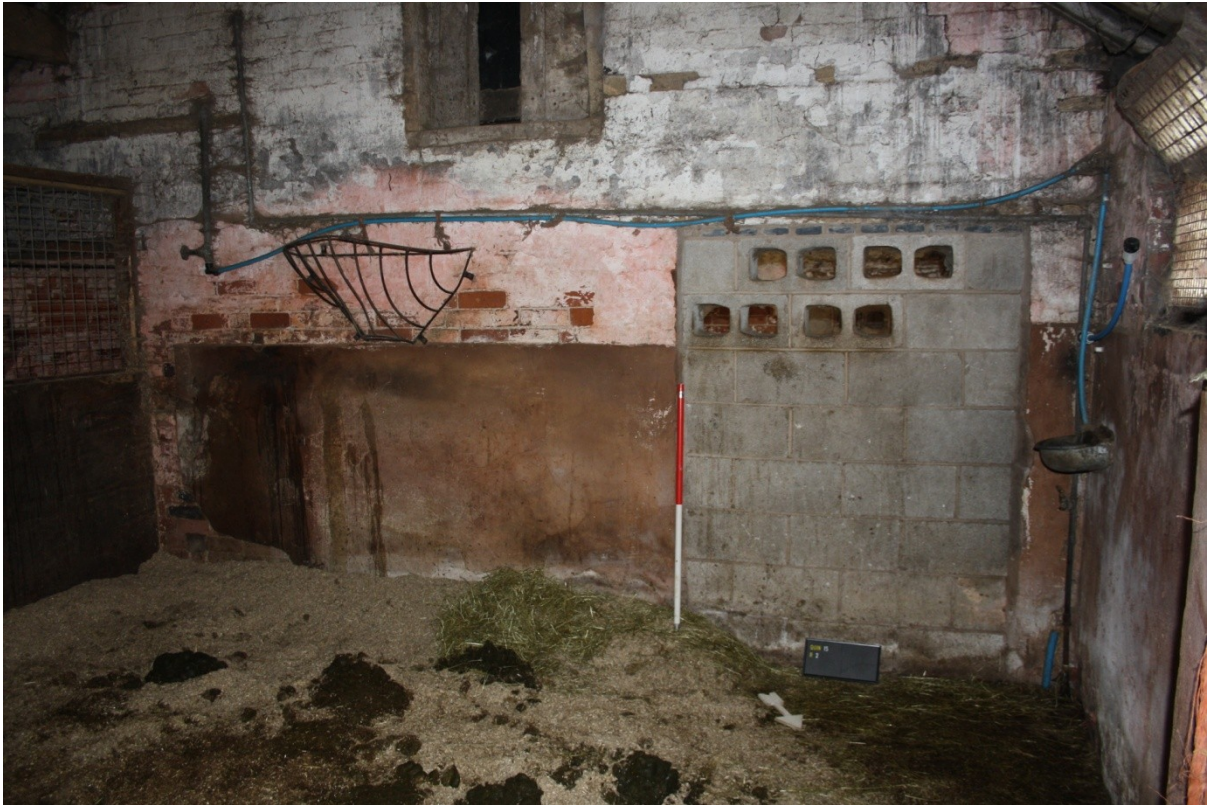
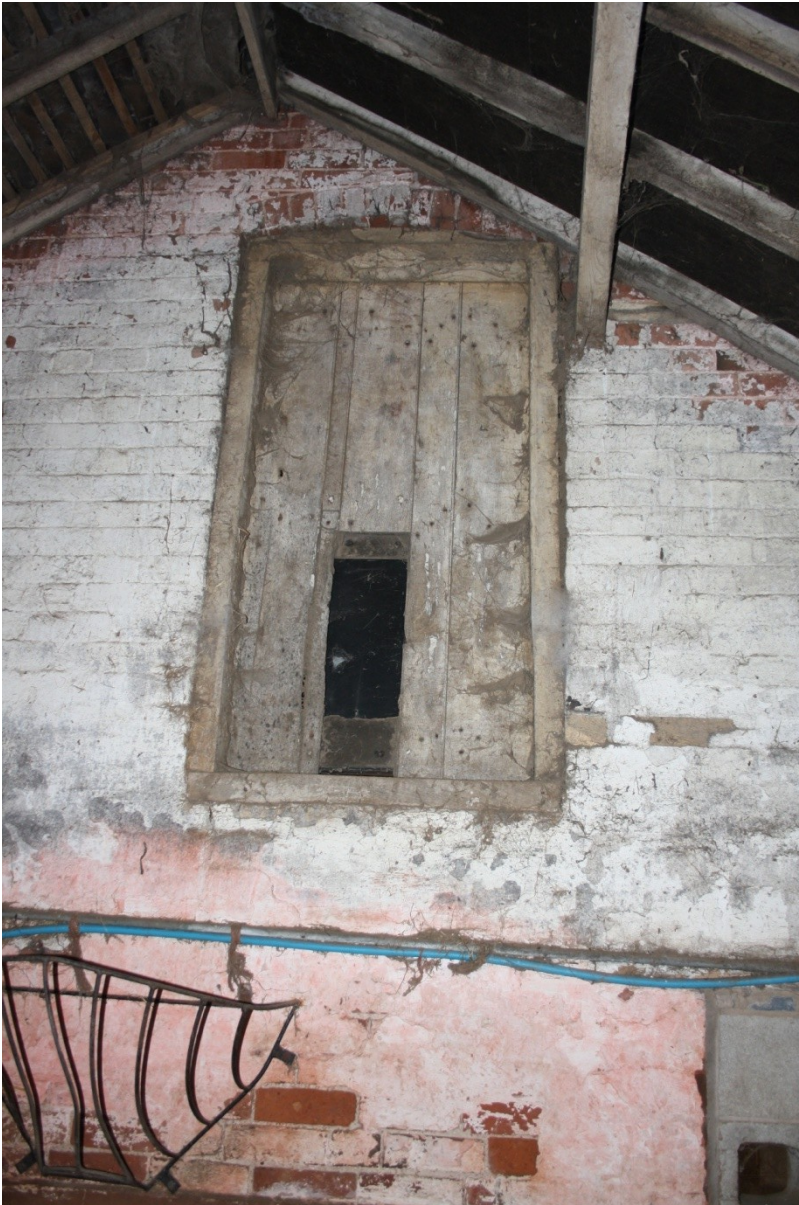
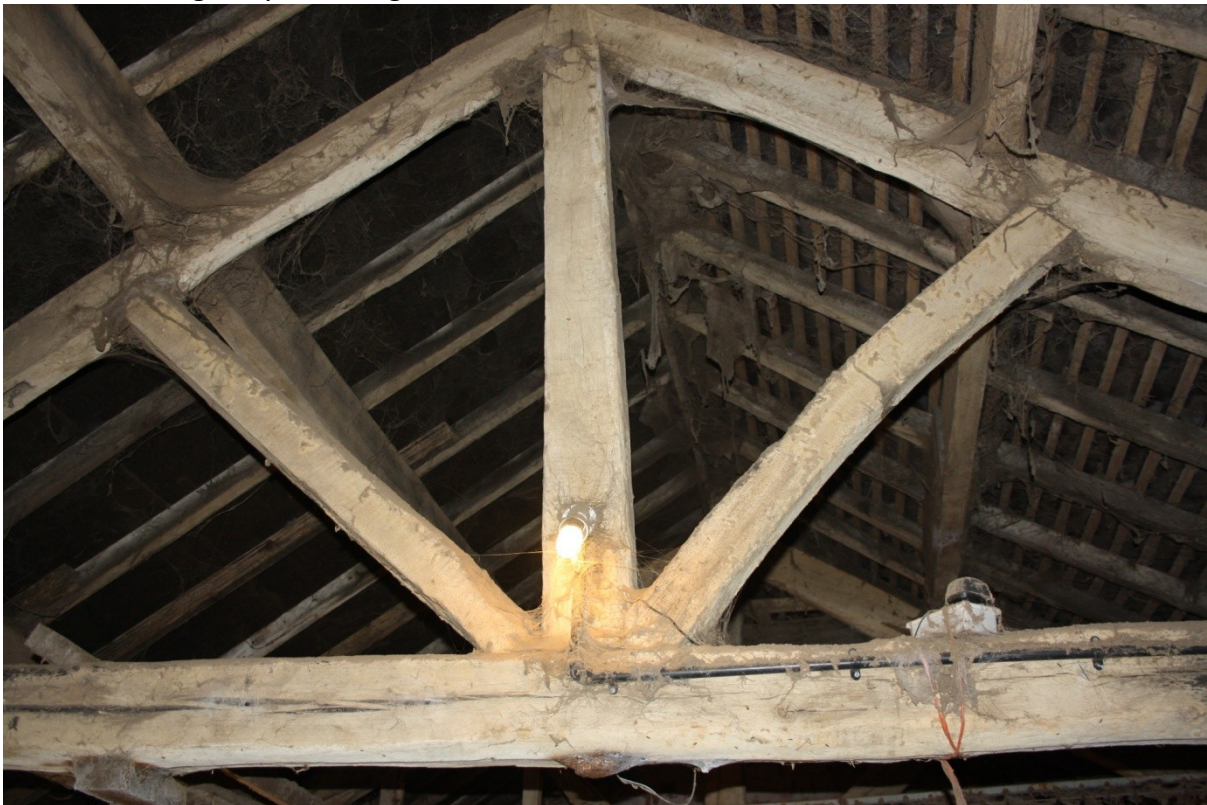
This part of the building complex is built off of the NE gable of the main structure at a later date. It is apparent on inspection that this elevation once comprised of three bays supported on brick piers, these are now bricked up. Set within this central bricked up area is a large single-span entrance, this is hung with a traditional planked stable door, while either side of this is a fixed casement window, each of 3 lights with a top opener and Staffordshire Blue brick sill.

The inside space is rectangular in plan with a poured concrete floor, with an exposed timber ceiling of king Post construction. The walls are a mixture of painted and unpainted red brick, whilst the interior space has been divided up with temporary ply boarding. At roof height within the NE gable is a single-span entrance with a traditional planked door which leads to storage bay (6).

Plate 8: Cow Housing 1 looking NE.

Plate 9: Cow Housing 1 looking N.

Plate 10: Cow Housing 1 looking N.

Plate 11: Cow Housing 1 looking SW

Plate 12: Cow Housing 1 looking SW.

Plate 38: Cow Housing 1 looking NE.

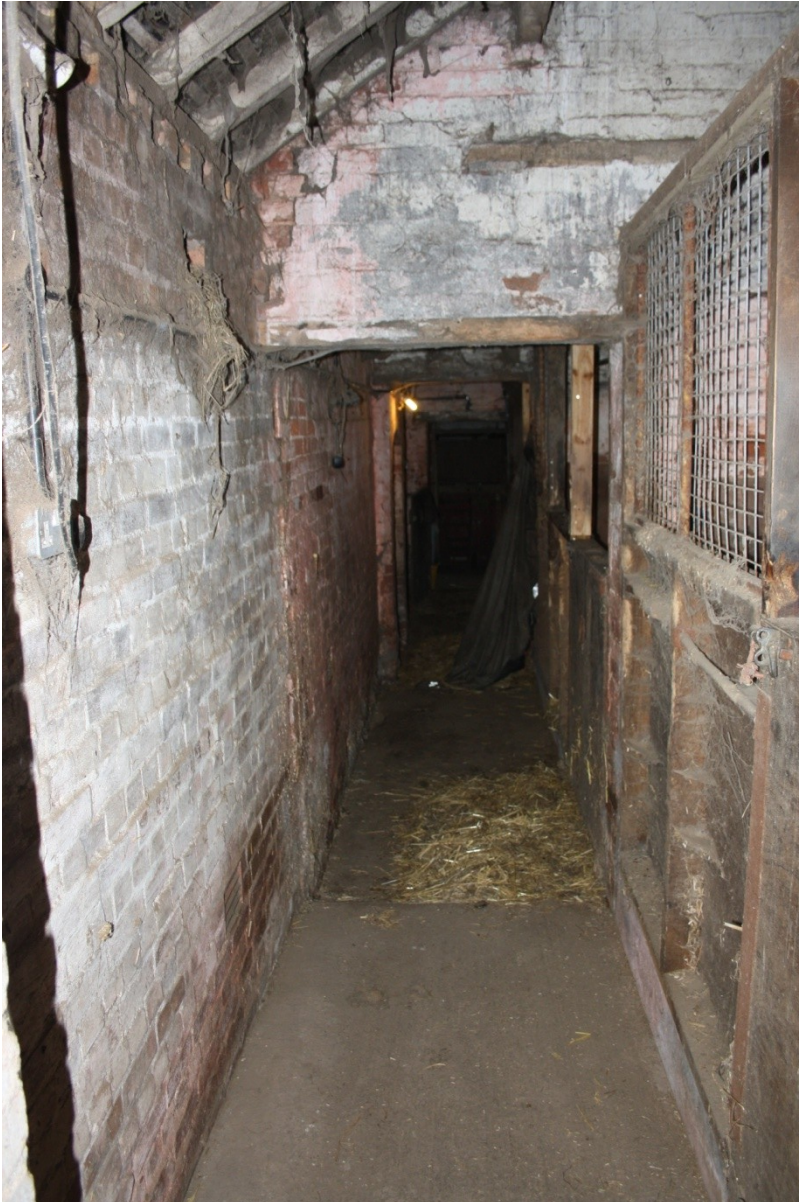
Plate 13: Corridor/feed passage ground floor looking SW.

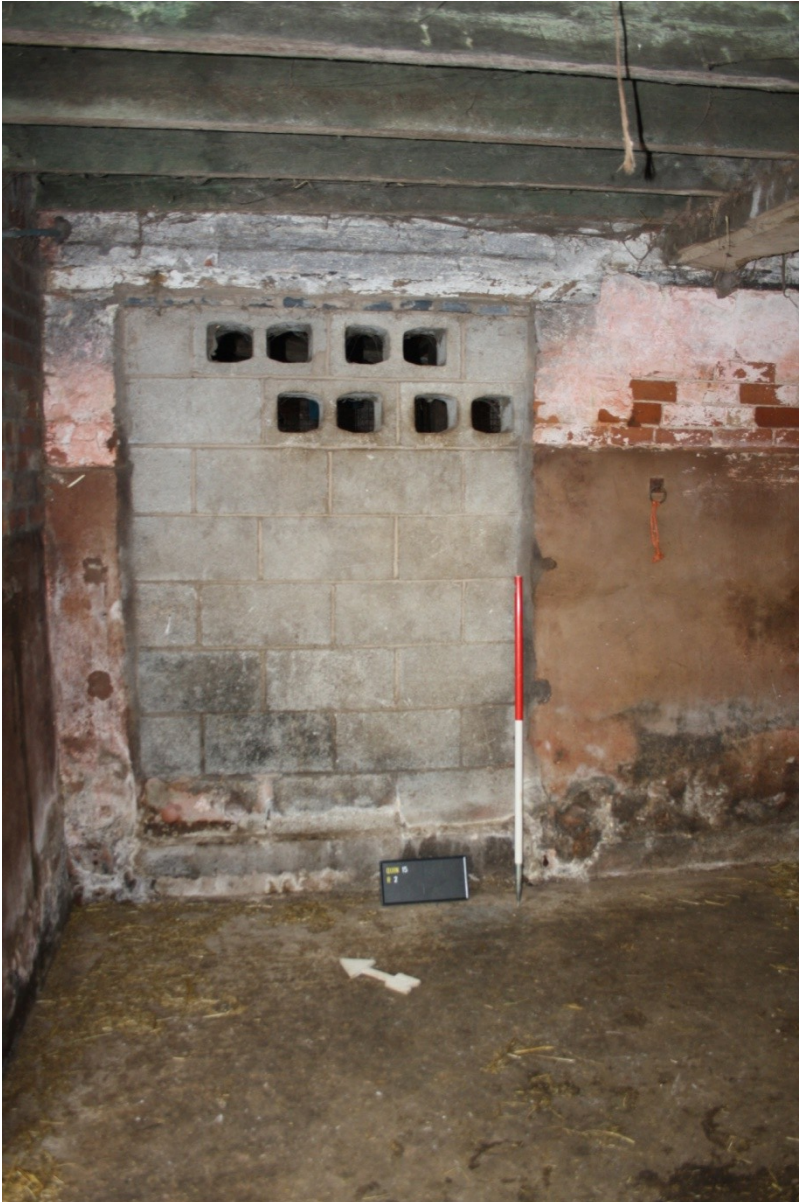
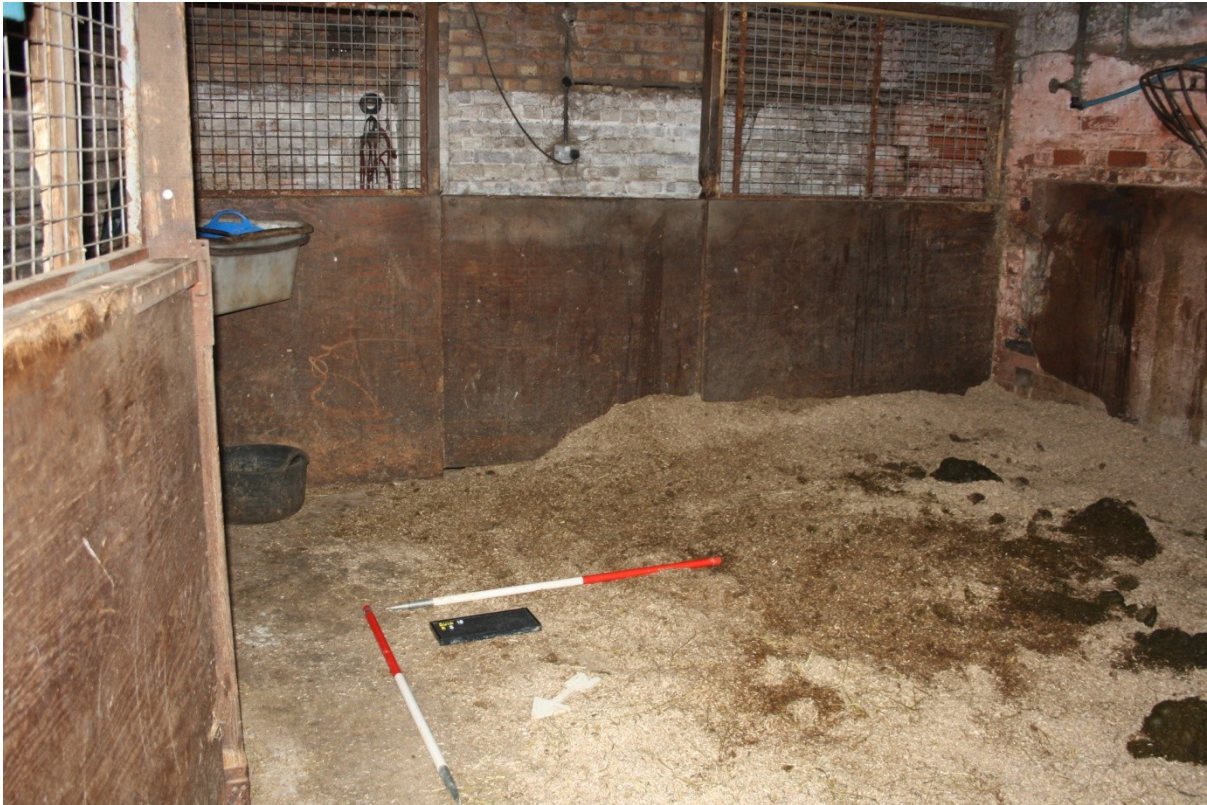
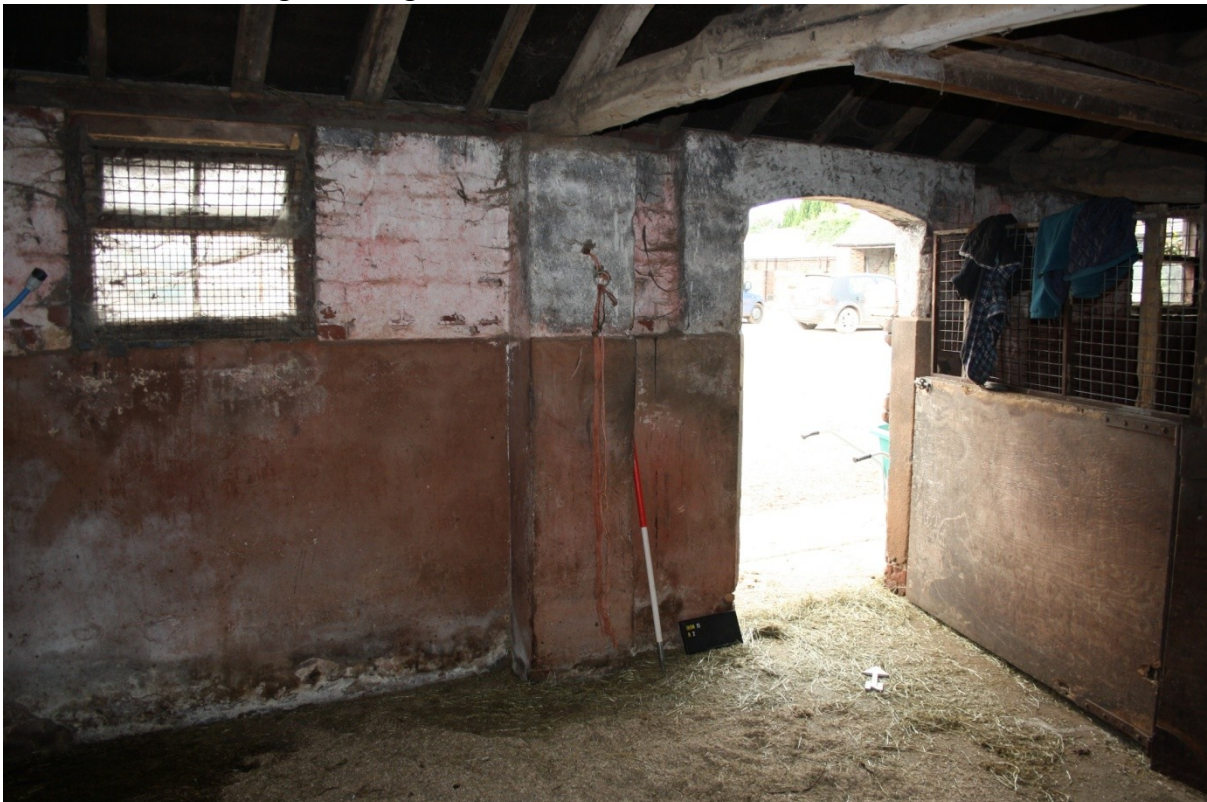
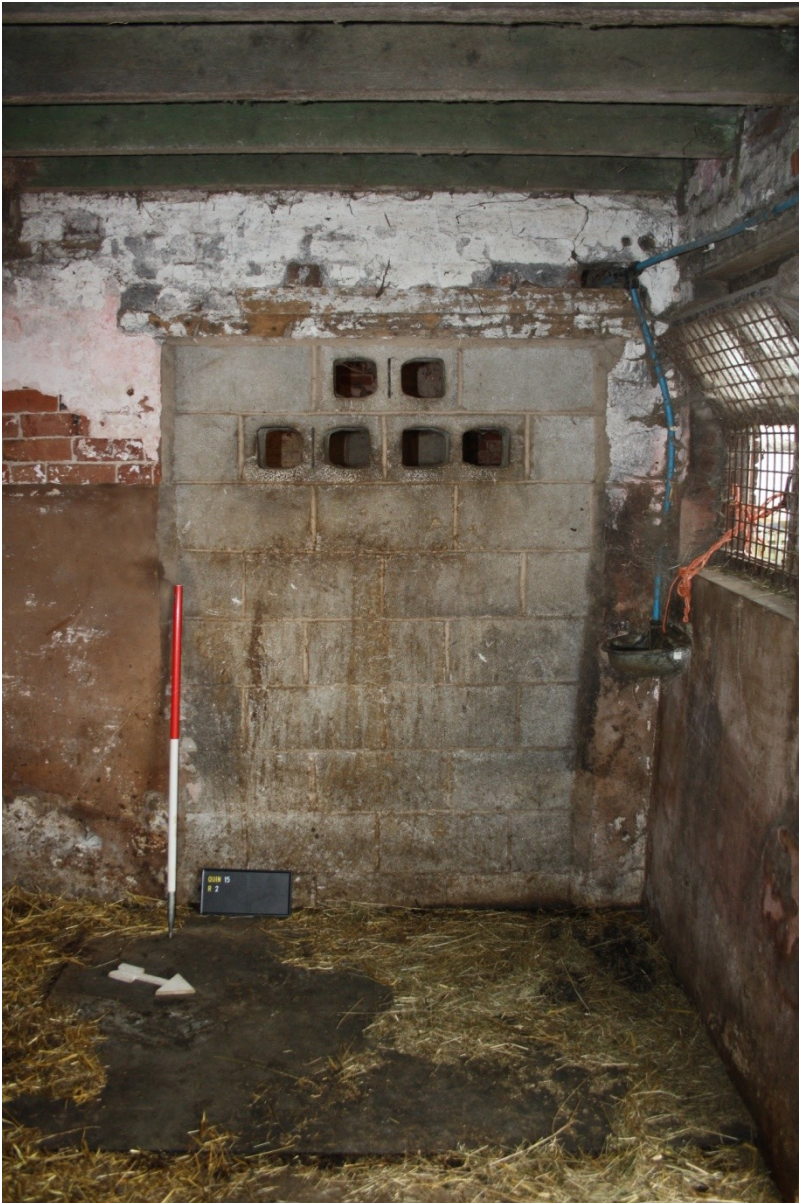
Accessed via a large single-span entrance in the NW elevation and hung with a traditional stable door. To the right of this at ground floor level is a fixed casement window comprising of 4 lights under a segmented brick arch. At first floor level, picked out in Staffordshire Blue bricks are the initials WL and may relate to the person who either built or commissioned the building.

The room inside is identical to Room 3, albeit for an exposed timber ceiling.

Plate 14: Cow Housing 2 looking NE.

Plate 15: Cow Housing 2 looking SE.

Plate 16: Cow Housing 2 looking NW.

Plate 17: Cow Housing 2 looking SW.

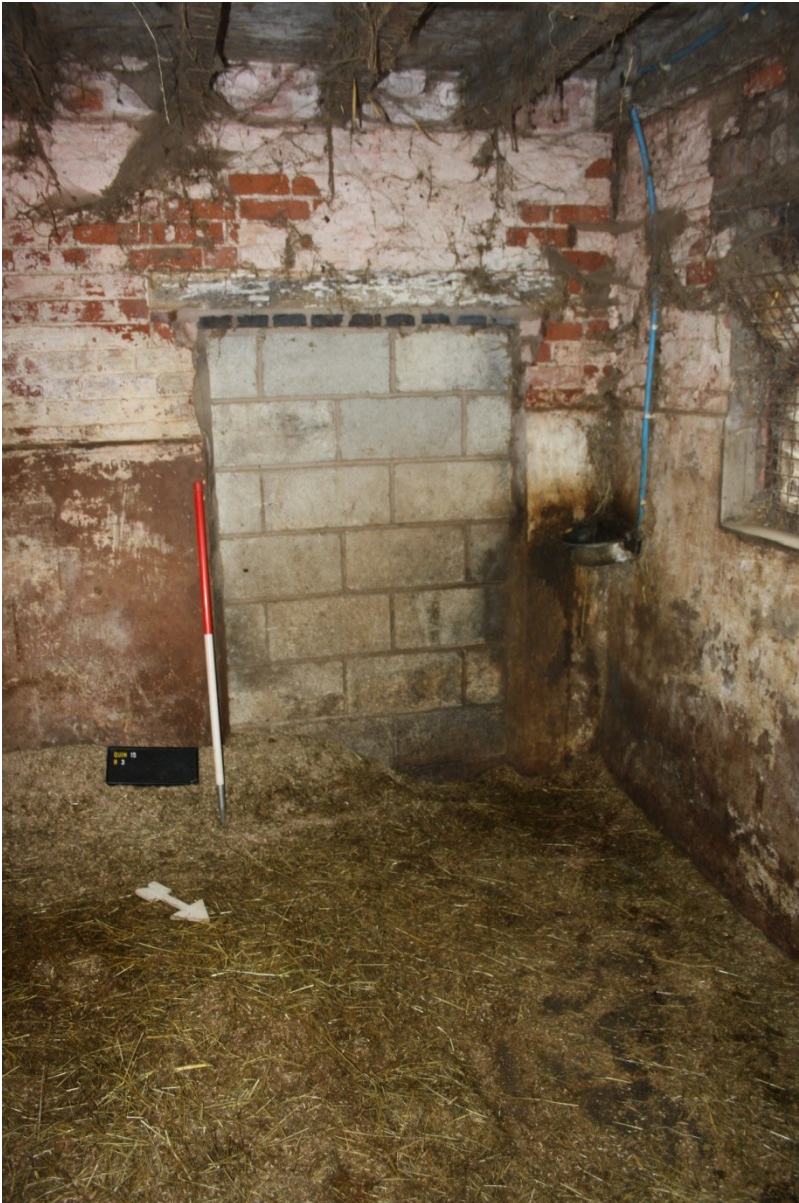
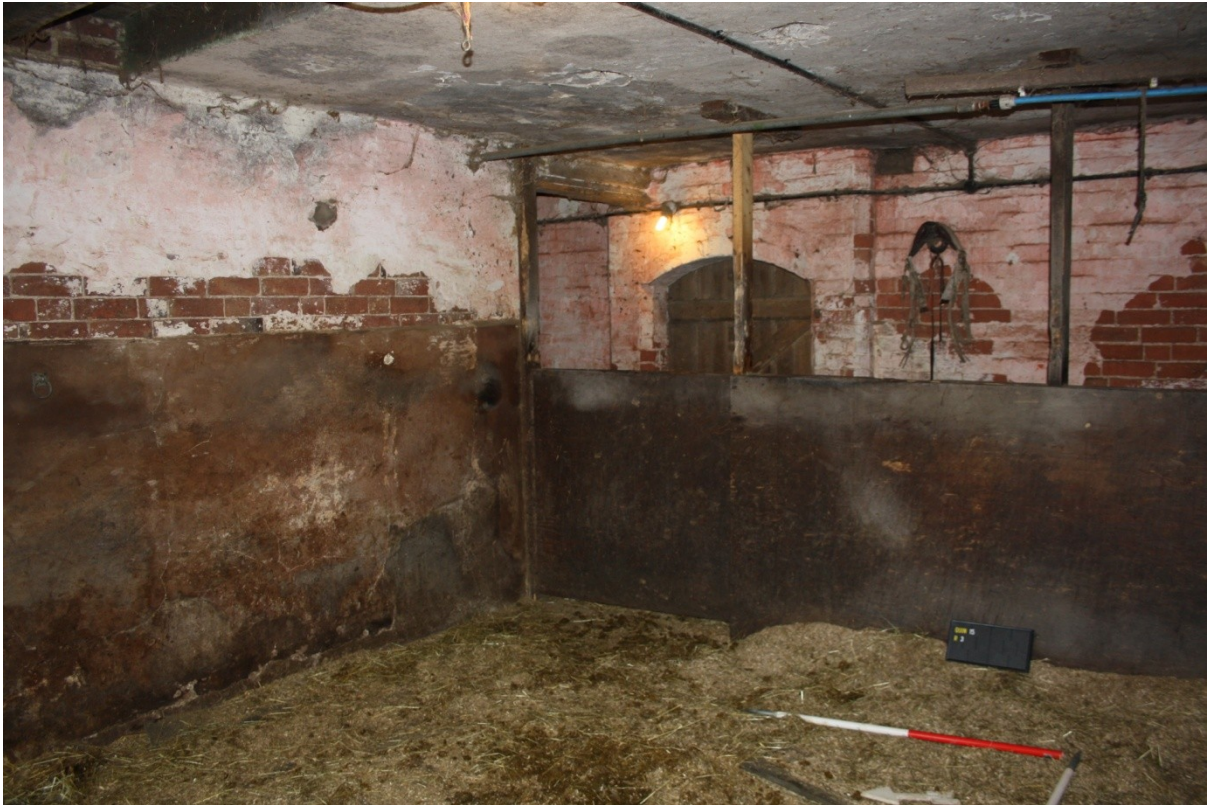
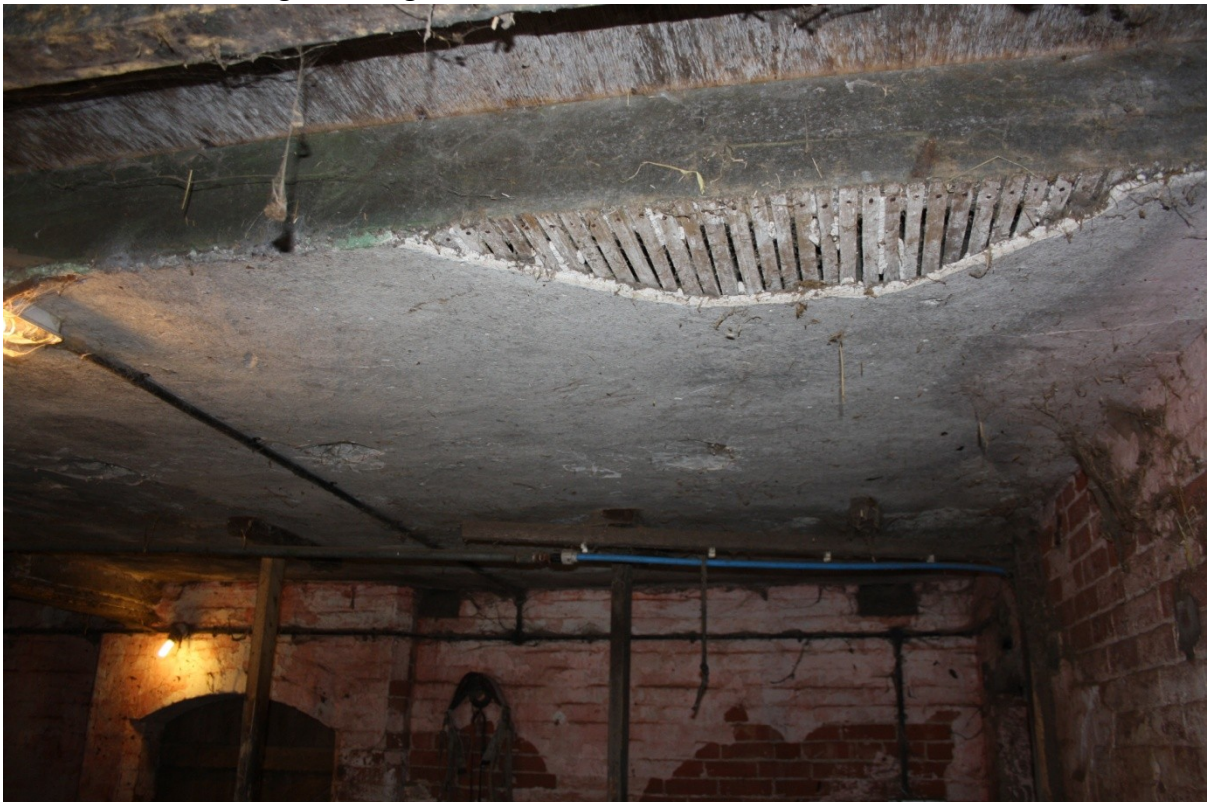
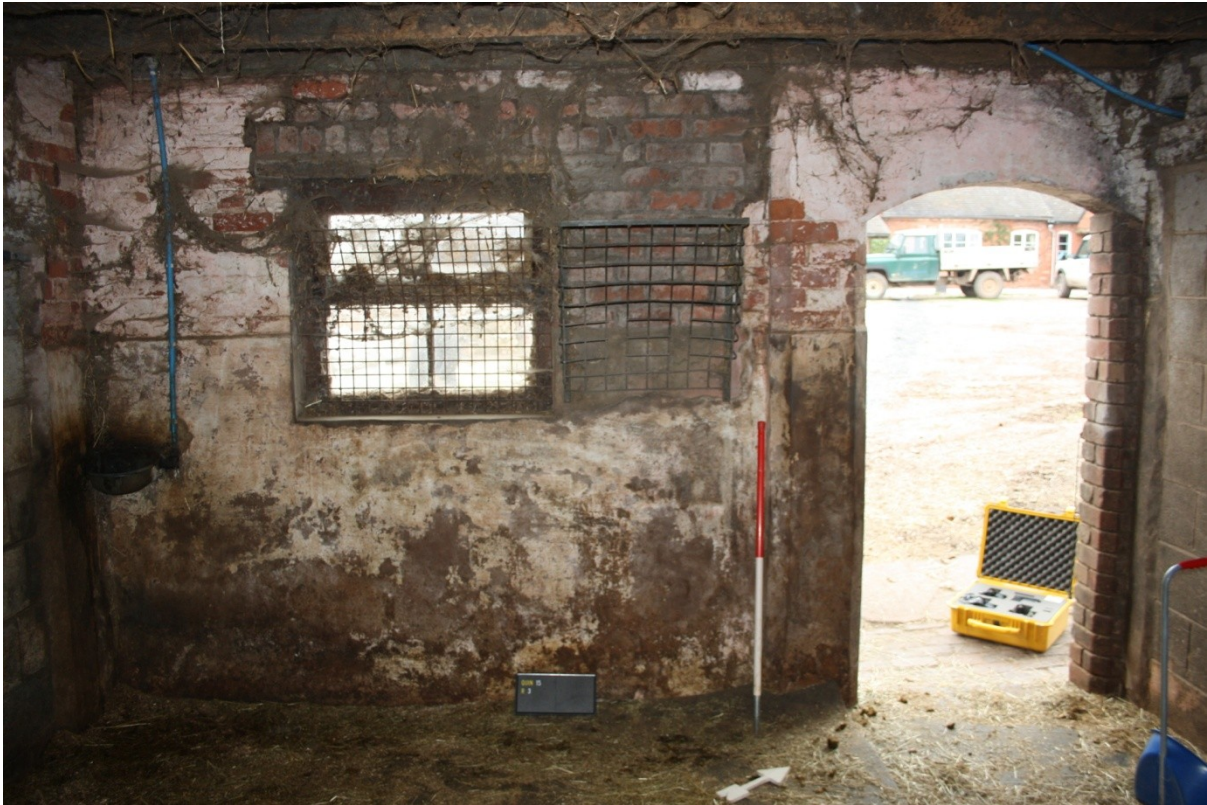
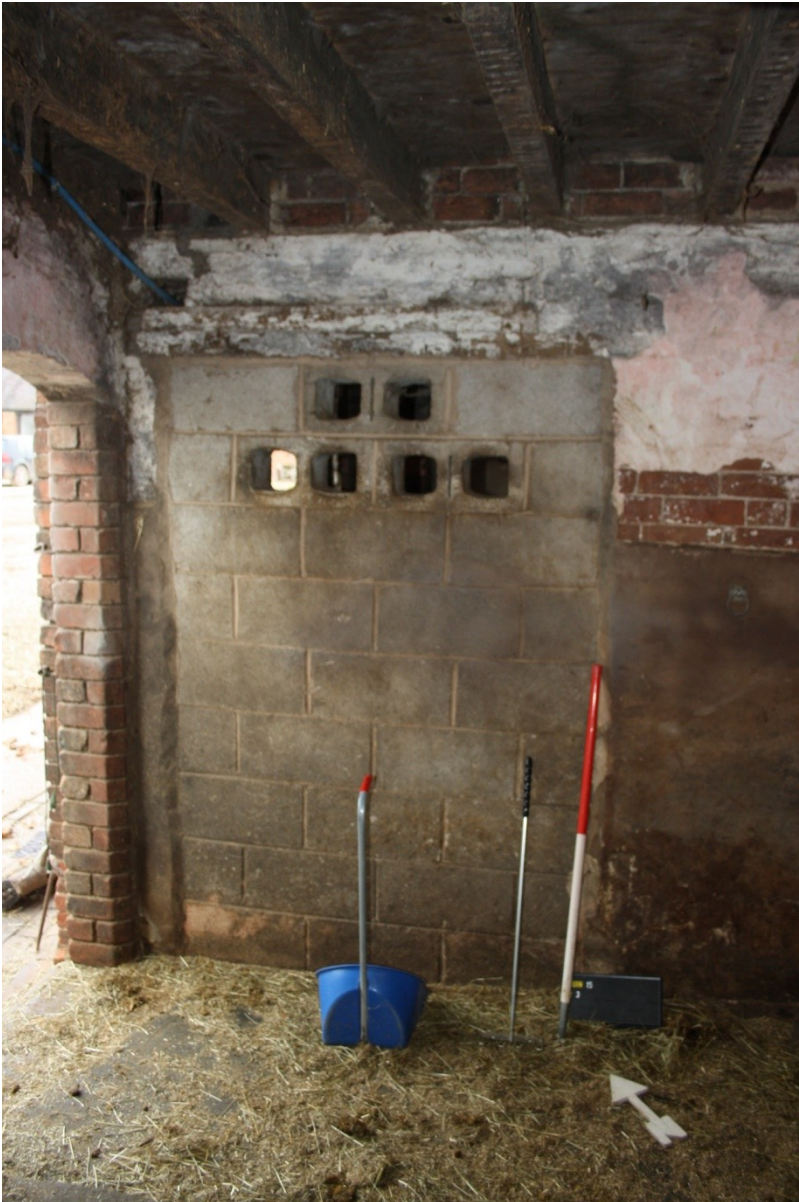
This room is accessed by a large single-span entrance, hung with a traditional style stable door under a segmented brick arch. To the right of this, at ground and first floor level is a fixed casement window, each of 4 lights, the bottom window having a top opener under a segmented brick arch, the top window being plain and at eaves level.

The room is rectangular in plan with a poured concrete floor and a lath and plaster ceiling, the walls are a mixture of painted and unpainted red brick and cement render. Some alteration is clearly evident inside, as you enter and to the immediate right and left are two blocked up entrances, these lead through to Cow House (2) and the Threshing Barn (4). These entrances would have once helped to form a feeding passage. To the south east is a corridor, this is formed with temporary boarding and would have originally also been a feeding passage.

Plate 18: Cow Housing 3 looking SW.

Plate 19: Cow Housing 3 looking E.

Plate 20: Cow Housing 3, plastered ceiling looking SE.

Plate 21: Cow Housing 3 looking NW.

Plate 23: Cow Housing 3 looking NE.

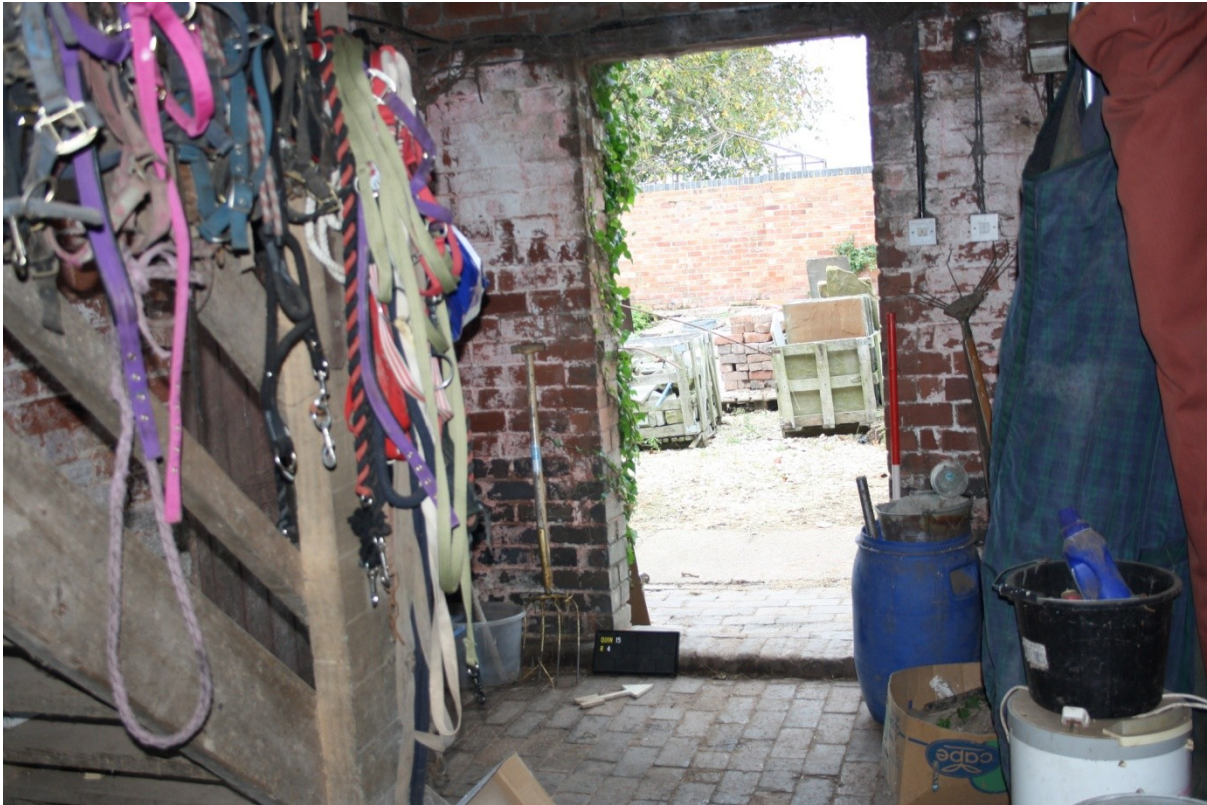
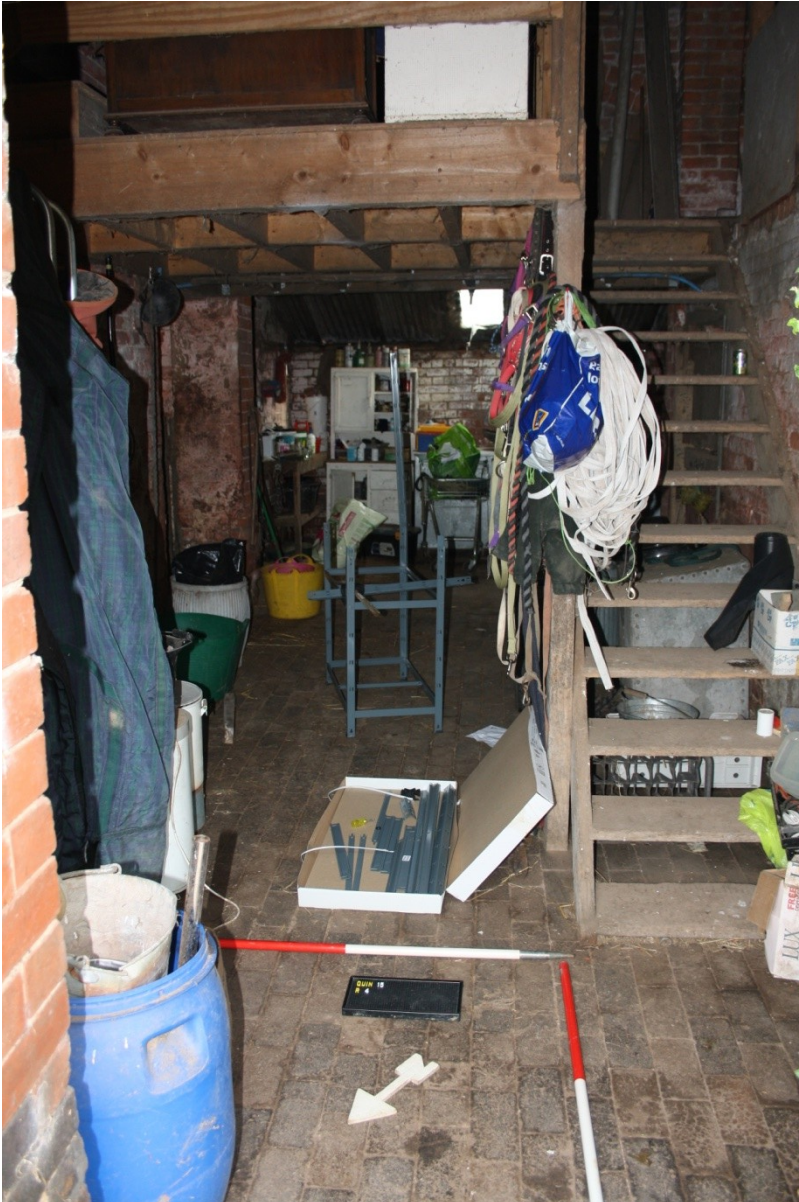
Inside this area is rectangular in plan, with a boarded timber ceiling and Staffordshire Blue brick floor, the walls are a mixture of painted and unpainted red brick. Leading from this area, to the right, there are two single-span entrances, both of these giving access to Cow Housing (8). To the immediate right is a timber staircase leading to the upper storey.

Plate 24: Threshing Barn 4 looking NW.

Plate 26: Threshing Barn 4 looking SE.

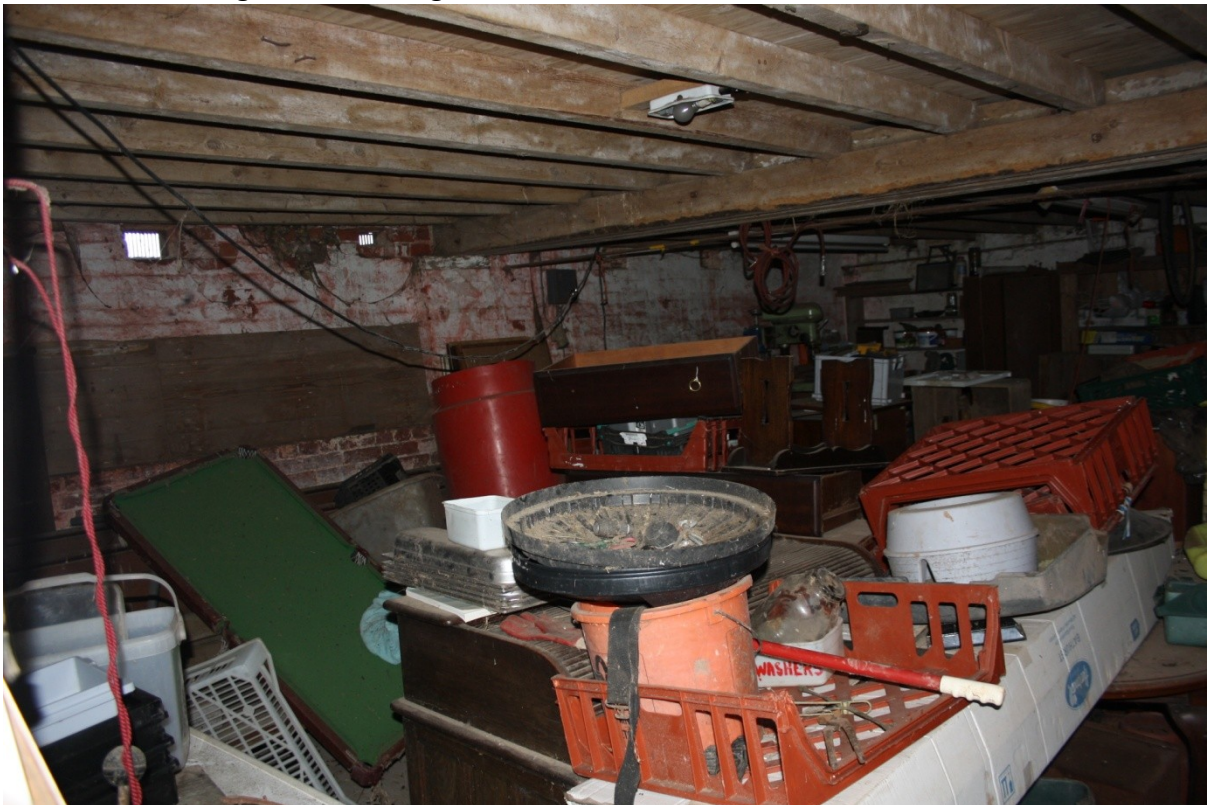
Plate 25: Cow Housing 8 looking SW.

Entrance to this is to the right of the central barn area, via a large single-span entrance hung with a traditional plank door within the NW elevation. To the right a fixed casement with 3 lights, 1 top opening and at 1st floor level a series of ventilators in a triangular pattern. (figs. 2, 6, 7, 8, plate 25).

The room is rectangular in plan, with a timber planked ceiling with exposed heavy timber joists and a red brick floor. Full recording of this building due to access being restricted and currently in use.

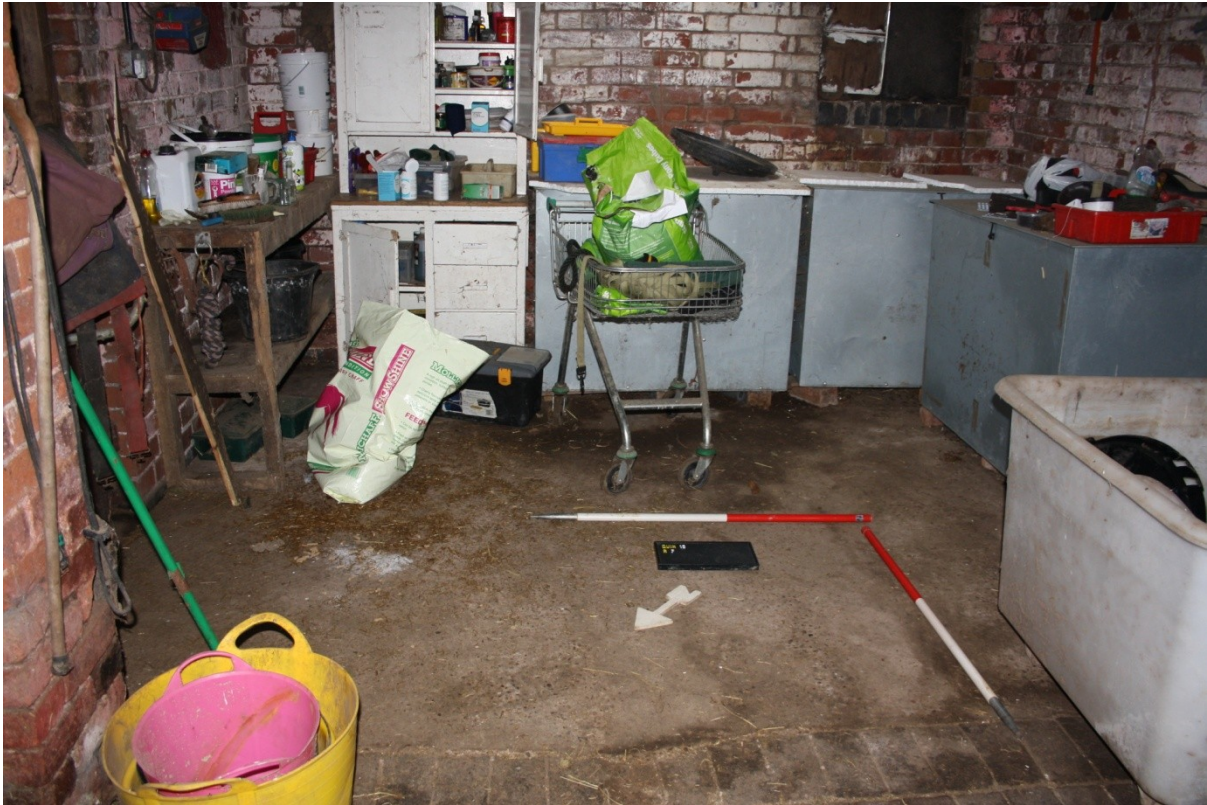
Plate 27: Store 7 looking SE.

This lean to has been built off of the SE elevation of the main building and obscures the SE double-span threshing entrance. Built of red brick in stretcher bond with a mixture of lime mortar and Portland cement. The roof is single pitch under asbestos corrugated sheeting, there is a single-span door with traditional planked door at both the SW and NE elevation, there are two fixed casement single light windows which both have Staffordshire Blue brick sills within the SE elevation.

Inside Store (7) is square in plan and with a poured concrete floor, the walls are of exposed red brickwork and there is an exposed timber ceiling comprising of simple rafters and sill plate.
