LEVEL 2 HISTORIC BUILDING SURVEY

QUINTINS ORCHARD FARM
PIPE LANE
PIPE RIDWARE
RUGELEY
WS15 3JL

NOVEMBER 2015

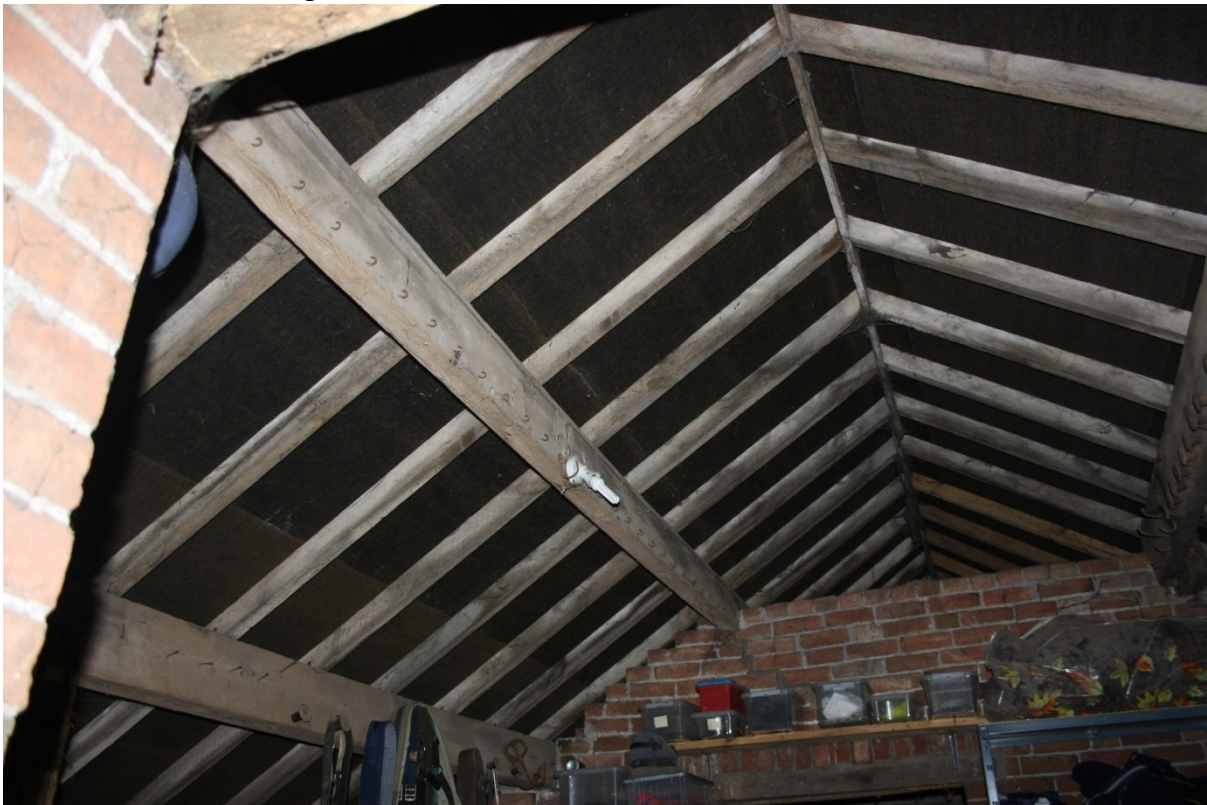
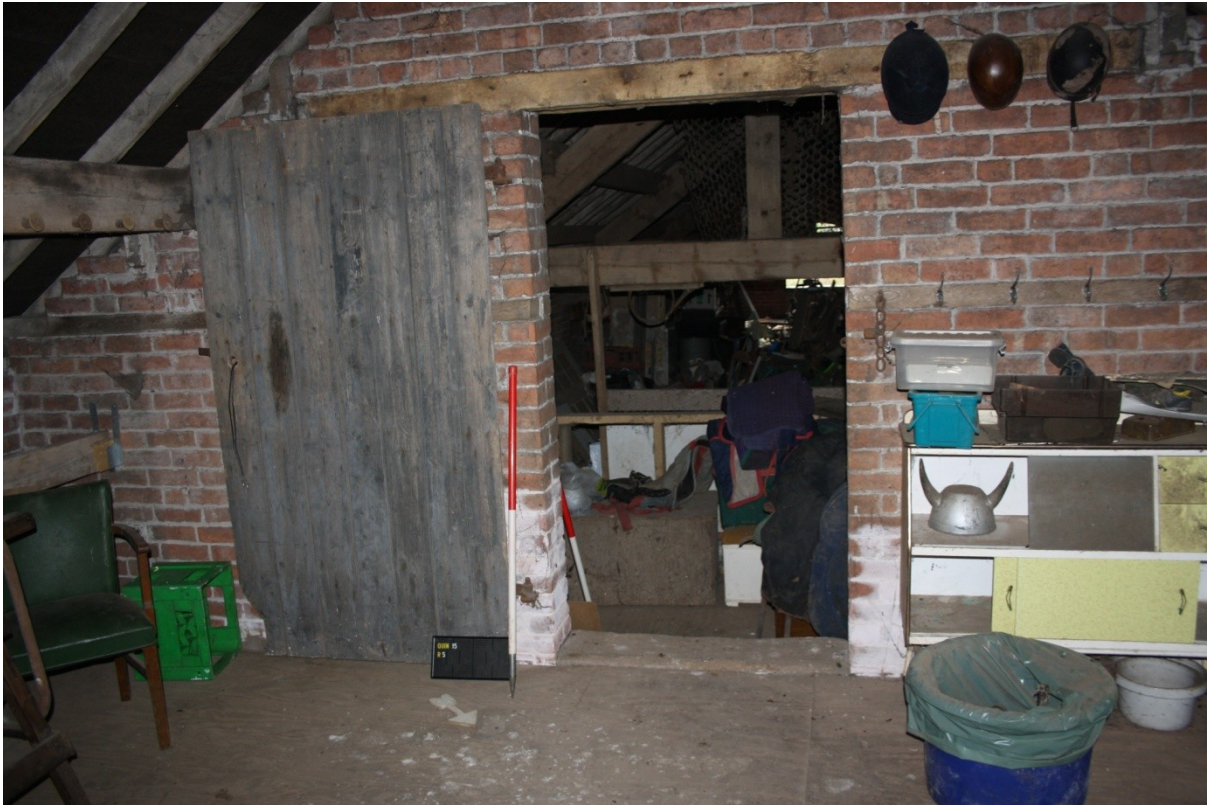
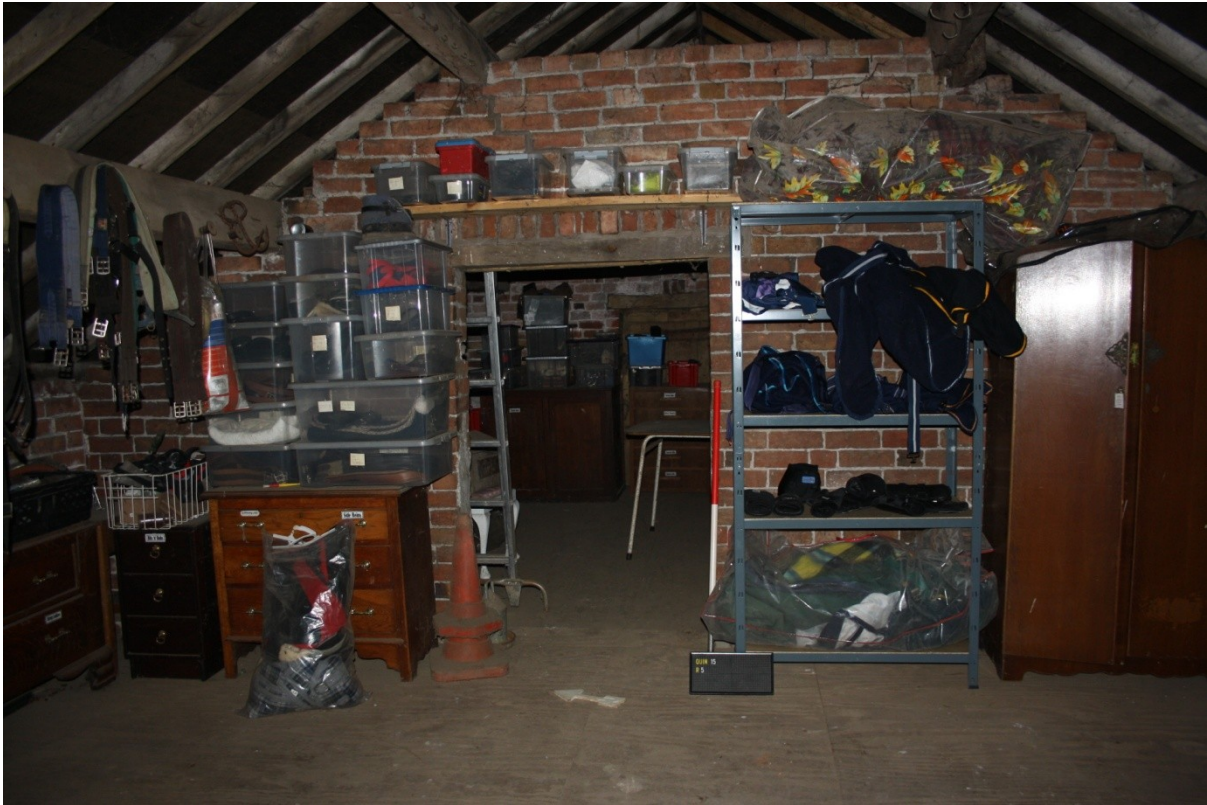
This area is rectangular in plan and leads to storage bay (6) through a single-span entrance which has a timber lintel above and hung with a traditional planked door.

Plate 28: Storage Bay 5 looking N.

Plate 29: Storage Bay 5 looking SE.

Plate 39: Storage Bay 5 looking NE.

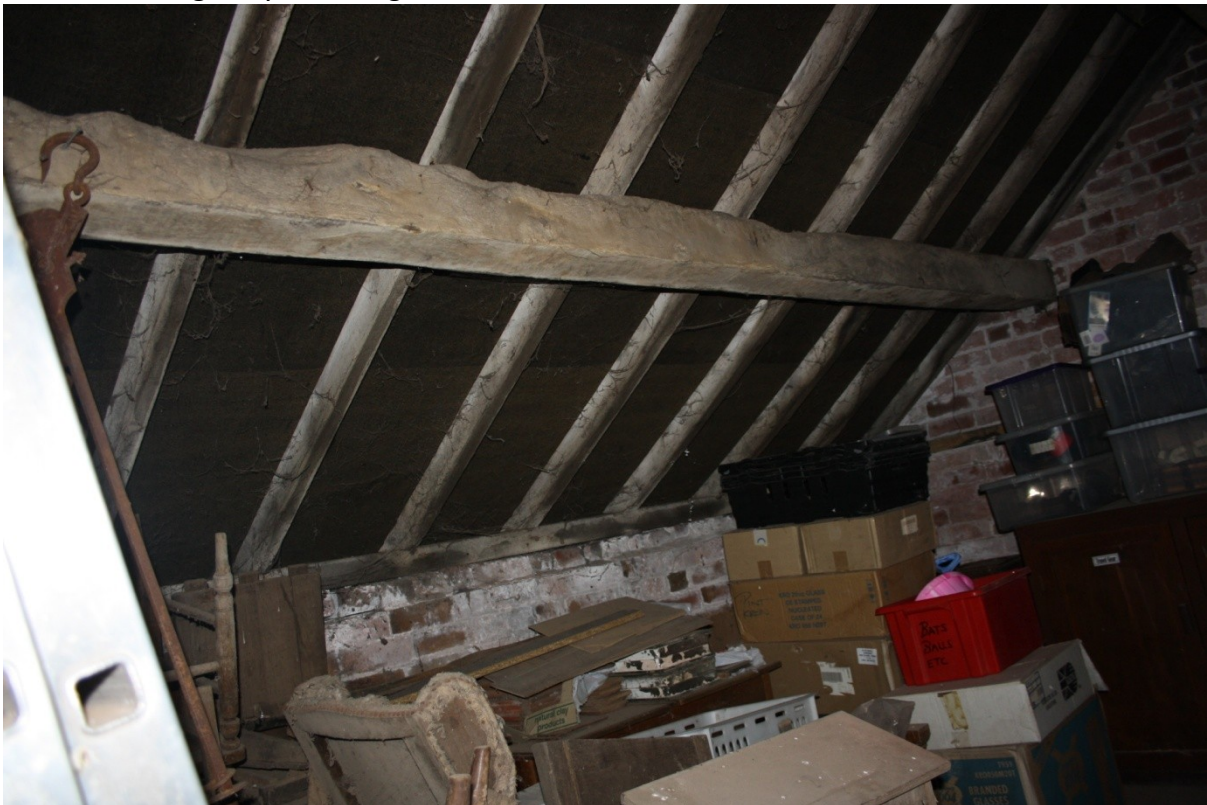
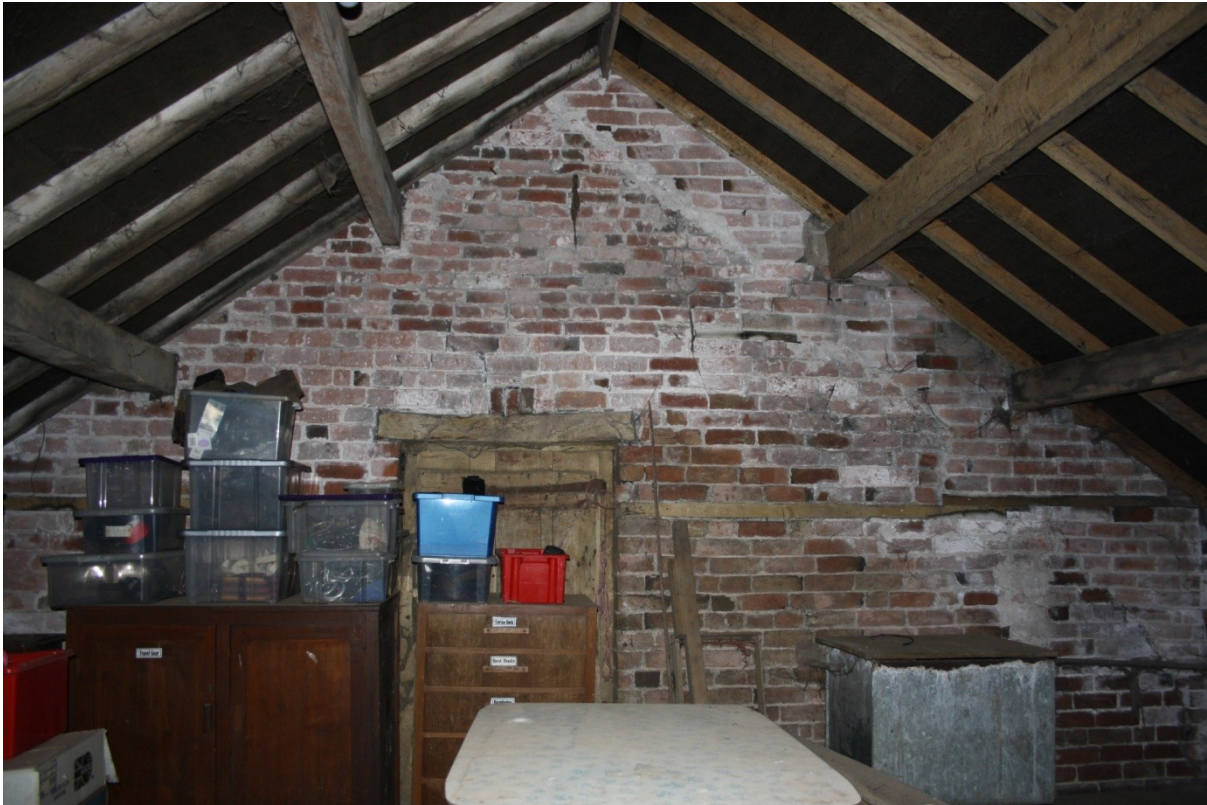
This room is identical to storage bay (5), except that it has a single-span entranceway in the NE gable of elm which is hung with a traditional planked door also in elm. This door would have originally giving access to the outside area, acting as a pitch hole.

Plate 31: Storage Bay 6 looking N.

Plate 32: Storage Bay 6 looking NE.

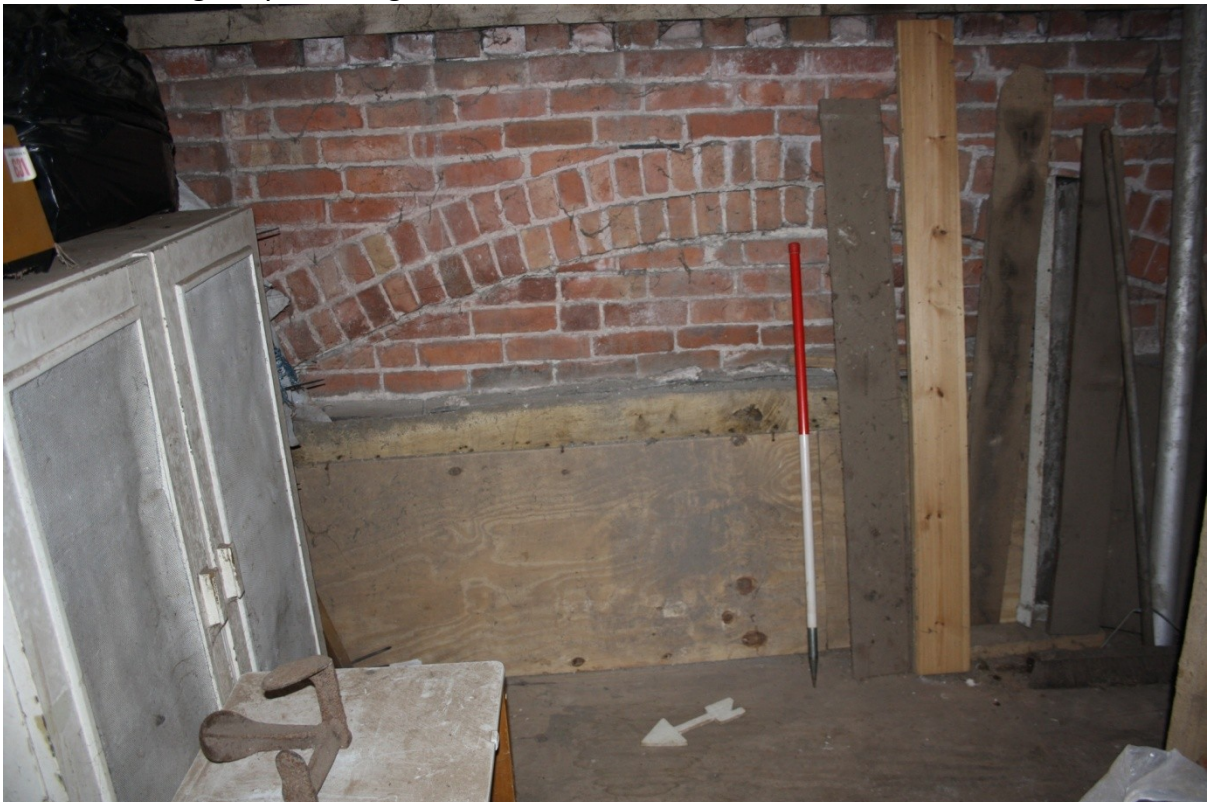
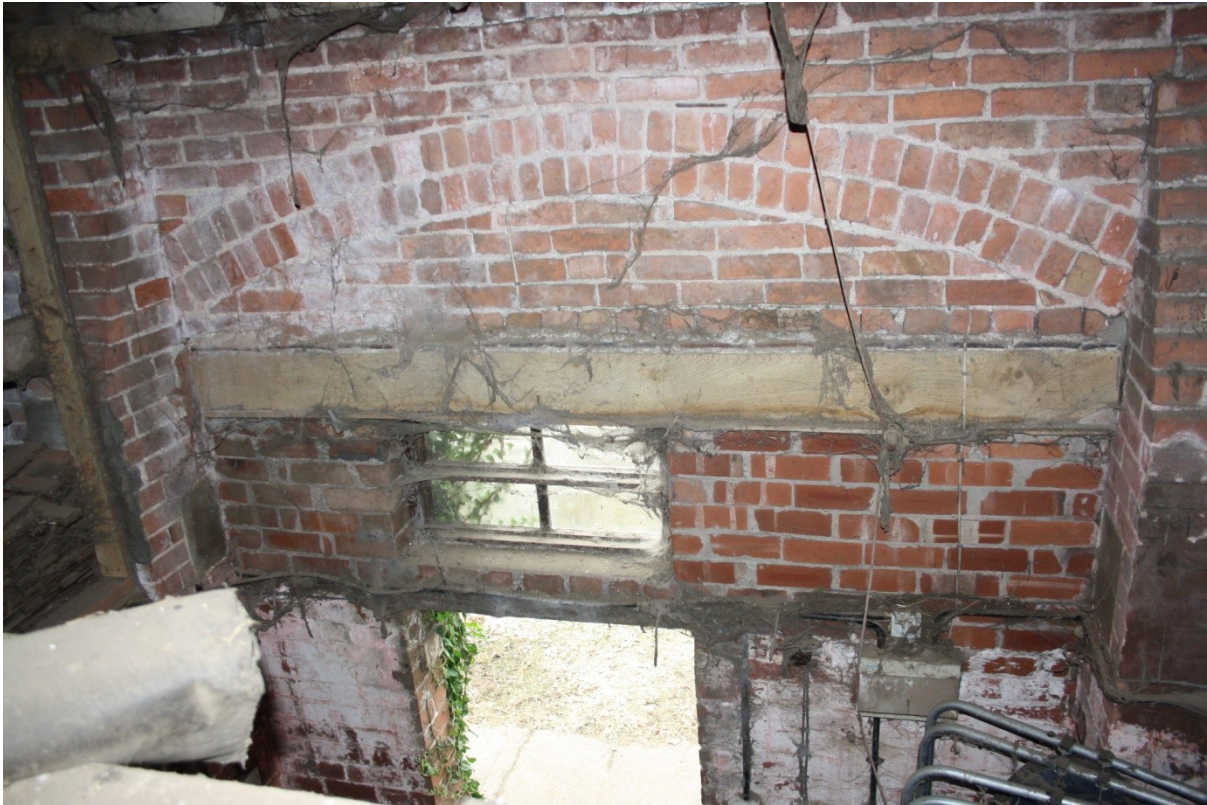
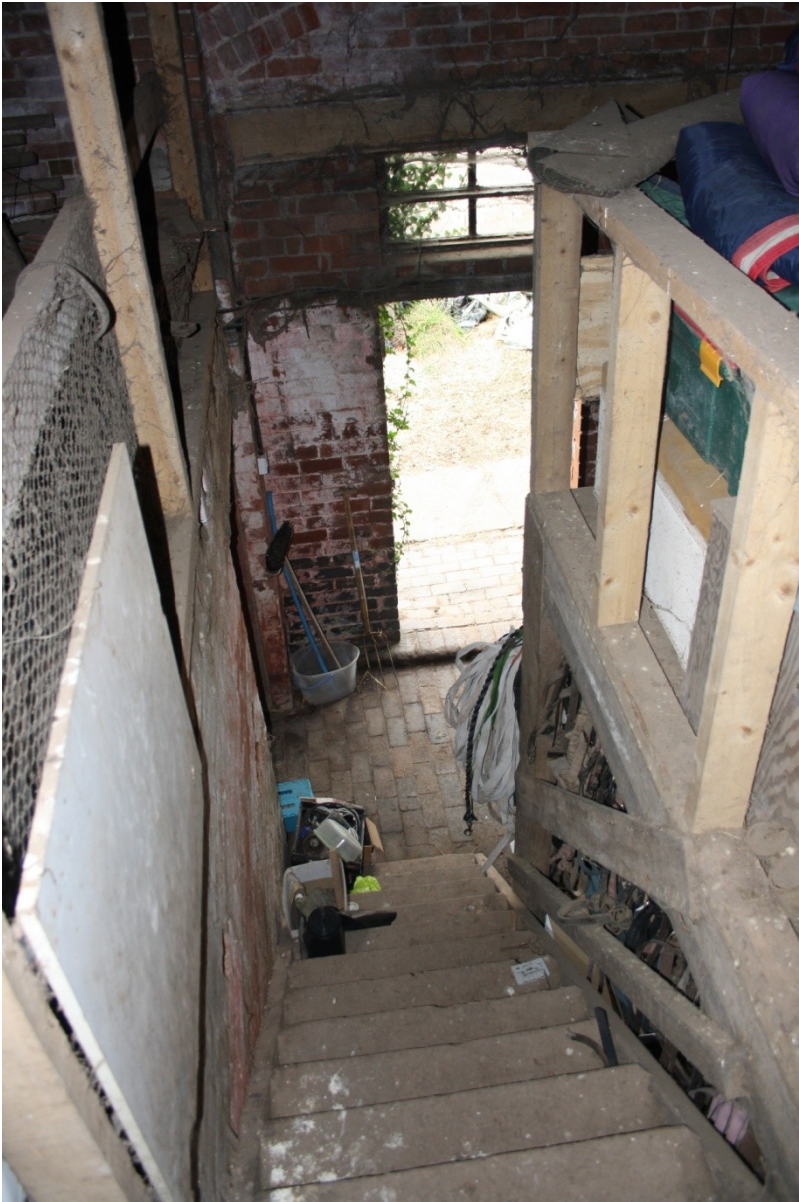
Rectangular in plan with exposed timber ceiling, timber boarded floor and unpainted red brick work. Timber stair leading down to (4).

Plate 33: Landing/access area 10 looking SE.

Plate 34: Landing/access area 10 looking NW.

Plate 41: Landing/access area 10 stairs looking NW.

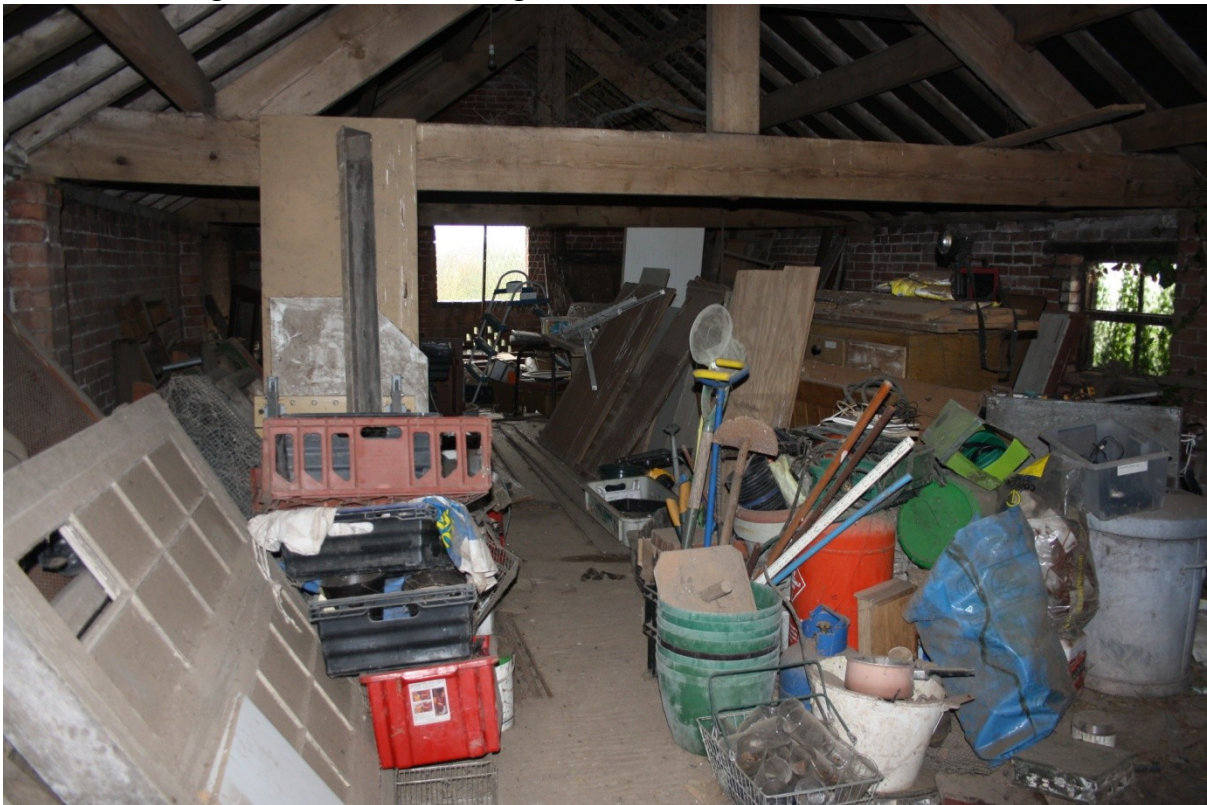
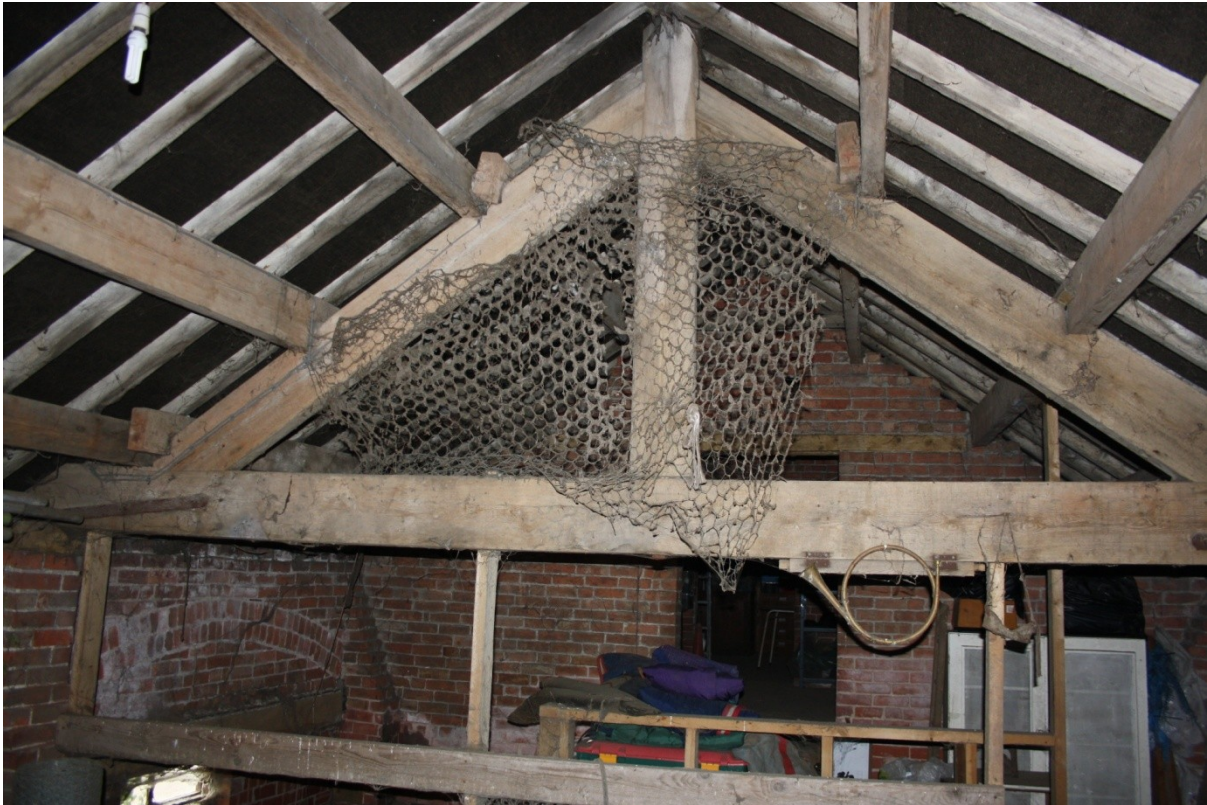
Rectangular in plan and leading off of area (10).

Plate 35: Storage Bay 9 looking W.

Plate 36: Storage Bay 9 looking NE.

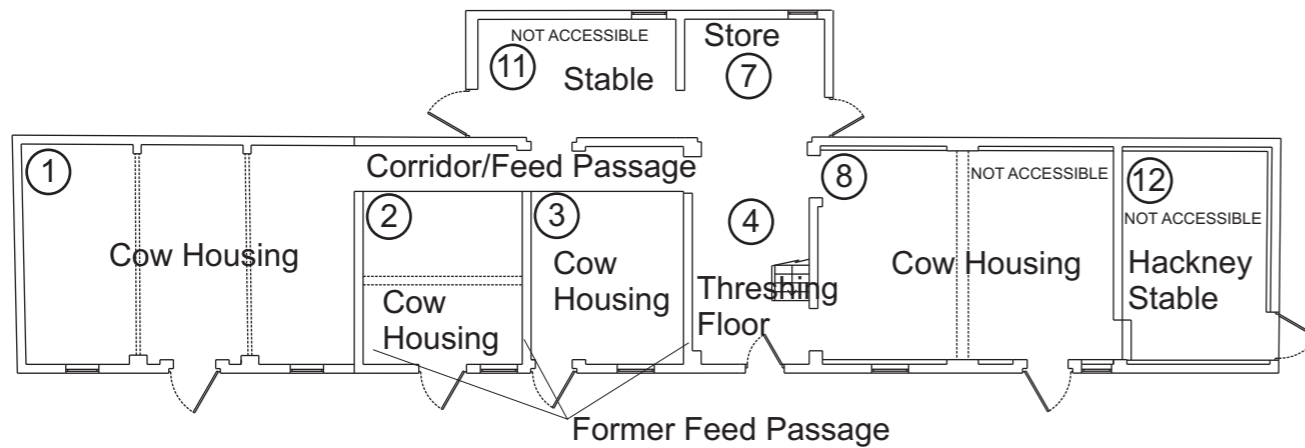
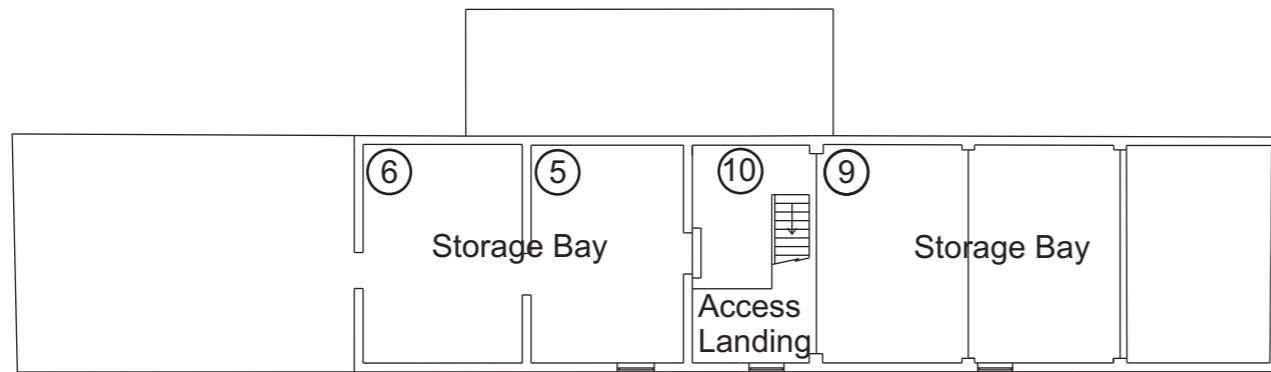
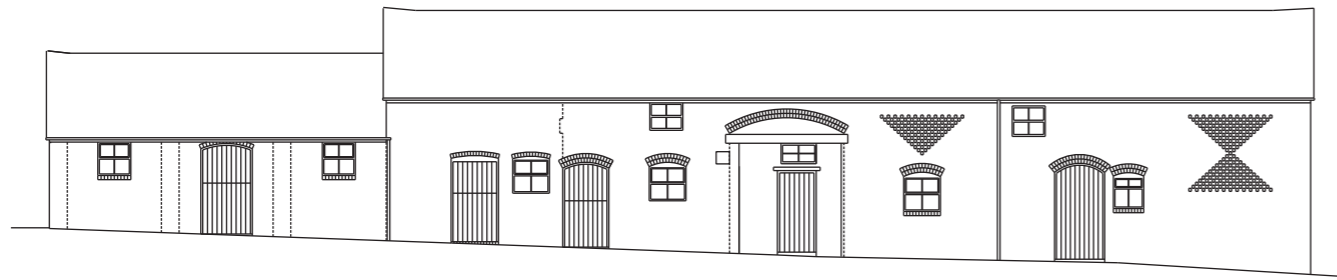
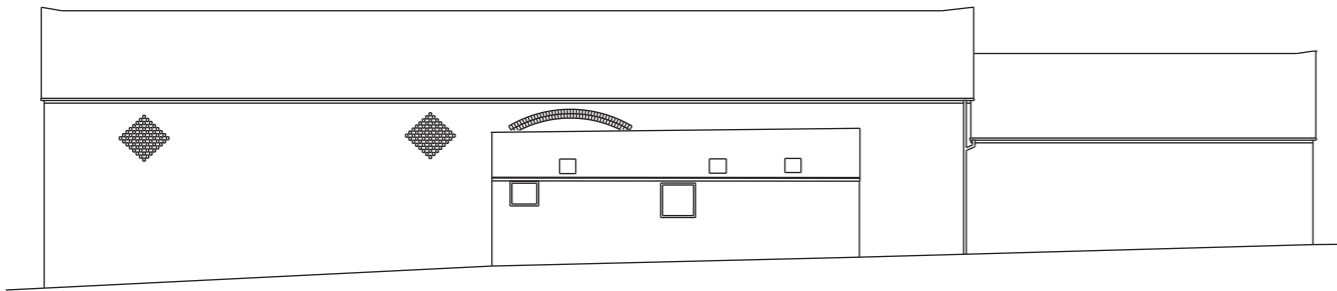
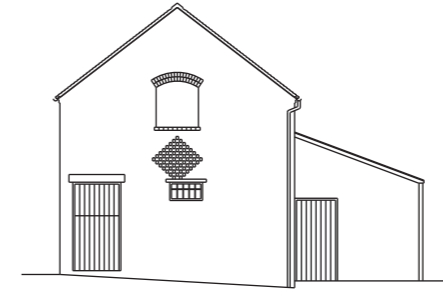
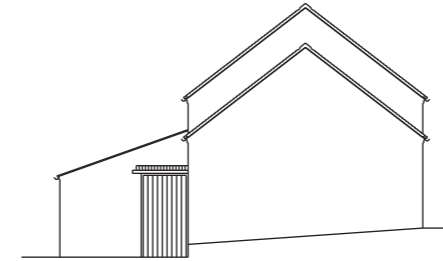
Drawing No: 423/6/15	
Project: Quintins Orchard Farm.	
Fig. 6: Plans and Elevations	
Scale: 1:200@A3	Site Code: QUIN 15
Drn SLW	Chk
Date 09/11/2015	
Midland Archaeological Services Old House 59 Church Street Digby Lincoln LN 4 3LZ Telephone: 01526 321 966 info@midarch.co.uk

The building is rectangular in plan north east to south west, built of (23x7.5x12cm) red brick with lime mortar in stretcher bond. The roof is gabled under grey clay tiles, the rainwater goods are in a traditional style cast in aluminium, there are ventilator holes in a diamond pattern in the NW, SE and SW elevations. Windows and doors are dispersed throughout the structure and explained in more detail below. There is also a single storey range of buildings attached to the north east and also along the south east elevation (1 Cart Store, 11 Stable and 7 Store, (figs. 2, 6, 7, 8, plates
