George House, George Street,
York, North Yorkshire

Archaeological Watching Brief Report

Site Codes: YGH 16

Development: Housing redevelopment

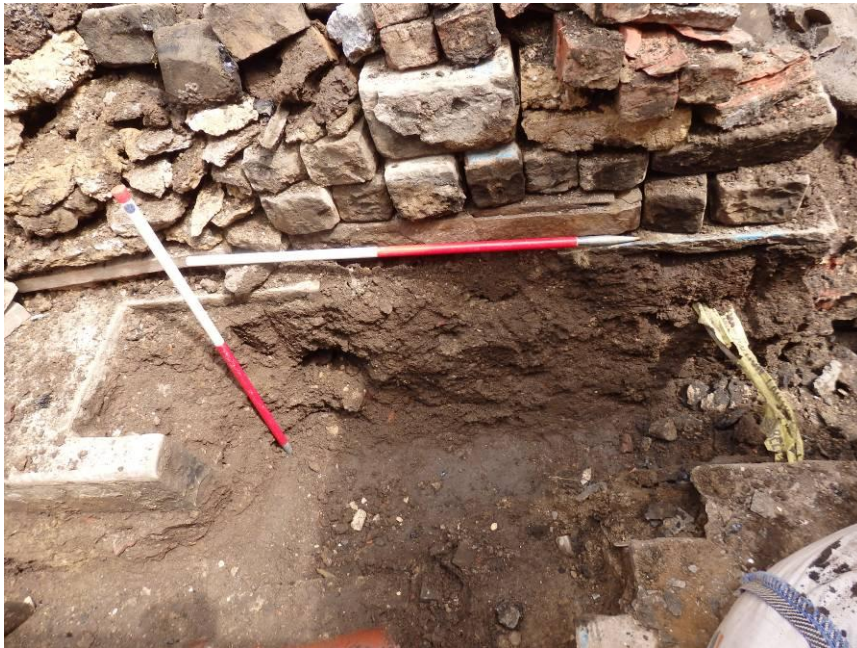
Figure 3: The main stratigraphy of the site, looking north

- 8.1 The service trench, which measured 0.5m in width and 0.7m in depth, was positioned alongside the south wall of George House. Hand excavated, for the length of about 5.5m, the service trench started at the southwest corner of the building, from the former manhole, running along the south wall up to the main entrance then turned at right angle into the building for the length of about 5m.
- 8.2 Within the court yard area the trench followed the former water main trench, and no further ground disturbance was made. The ground floor of the court yard consisted of large sandstone slabs, laid on top of a thin layer of sand. Overlaid upon the sand was a thick deposit consisting of a mixture of modern rubble and brown clay.

- 8.3 The same deposit was consistent throughout the whole length of the service trench.
- 8.4 No archaeological deposits or features were present within the limits of the service trench.

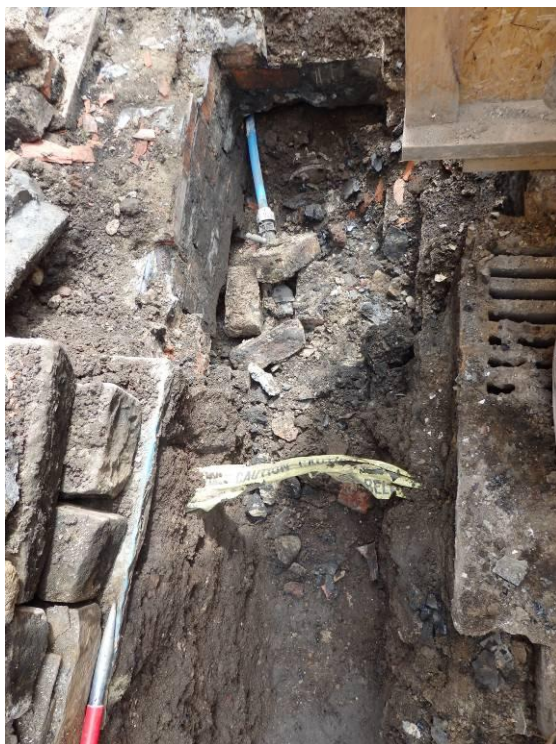
Figure 5: The former manhole, located at the southeast corner of George House

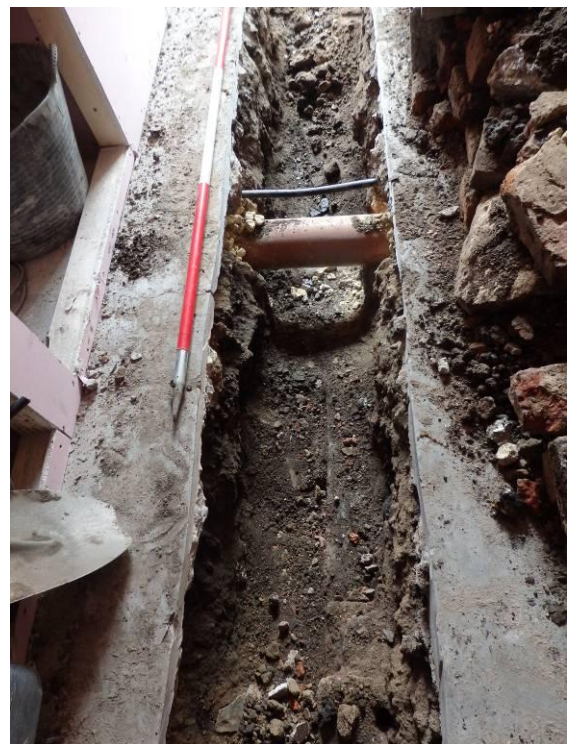
Figure 4: The rubble stratigraphy inside the building
