TRIAL TRENCHES EVALUATION

LS Archaeology

Hudson House

York

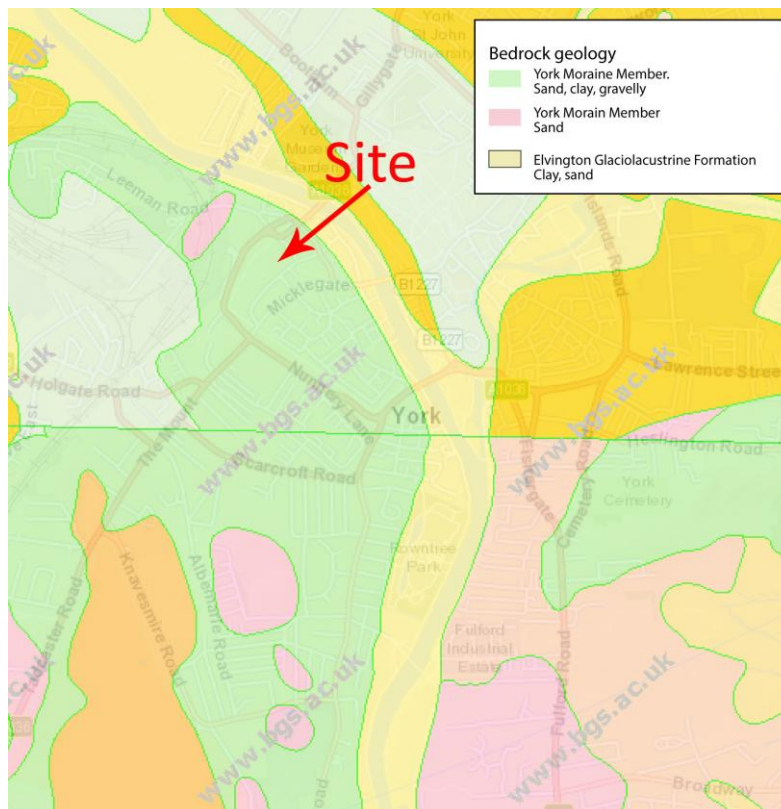
Figure 2 Geological Map of York (from the British Geological Survey Map).

These rocks were formed from rivers depositing mainly sand and gravel detrital material in channels to form river terrace deposits, with fine silt and clay from overbank floods forming floodplain estuarine and coastal plain deposits mapped as alluvium.

The superficial deposits around the site are characterized as the Vale Of York Formation - clay, Sandy, Gravel, formed up to 2 million years ago in the Quaternary Period, with the local environment previously dominated by ice age conditions (British Geology Survey).

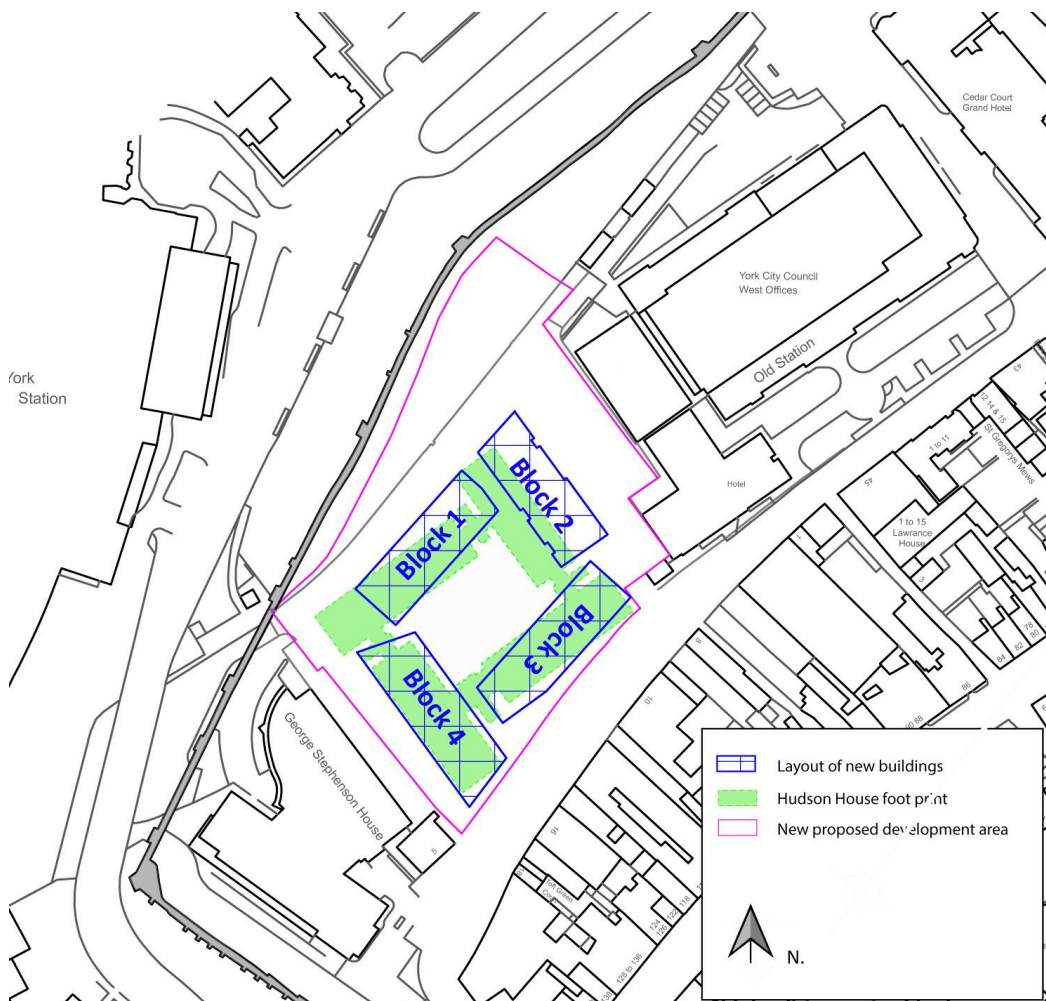
Figure 3: Plan of the new proposed development

The planned development is for the demolition of the existing Hudson House office blocks, to be replaced by four distinct blocks, three of which would accommodate apartments for residential use, and the fourth block will house offices.

In total the scheme will consist of 130 residential units, 37,000 sq. ft of office space and further 5,000sq.ft of commercial space (either restaurant/café or studio/office). In addition, new pedestrian routes will be created, providing easy flow between the City Wall entrance and Toft Green, through the site and its new landscaped ground.

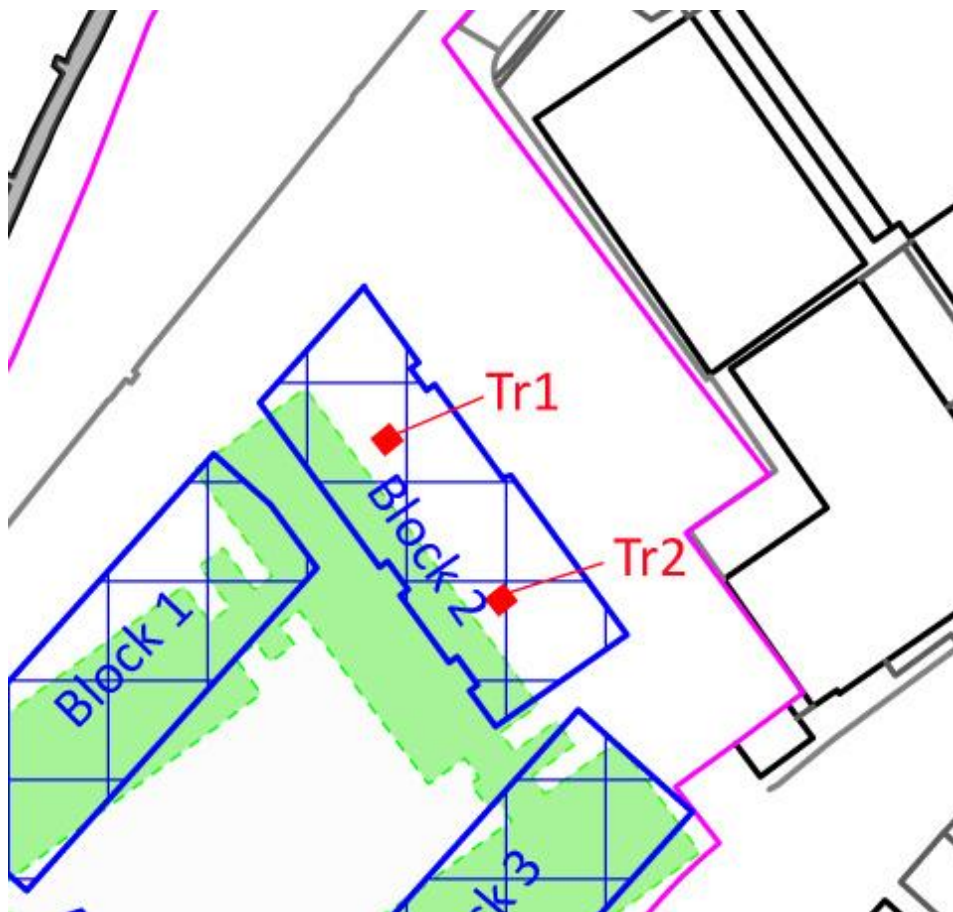
Figure 5: Location of the trial trenches

Two trenches measuring 2m by 2m were placed within the boundary of the proposed development (Figure 5) in order to investigate the potential archaeological deposits that may have survived the ground disturbance associated with the Old Railway York 1845.

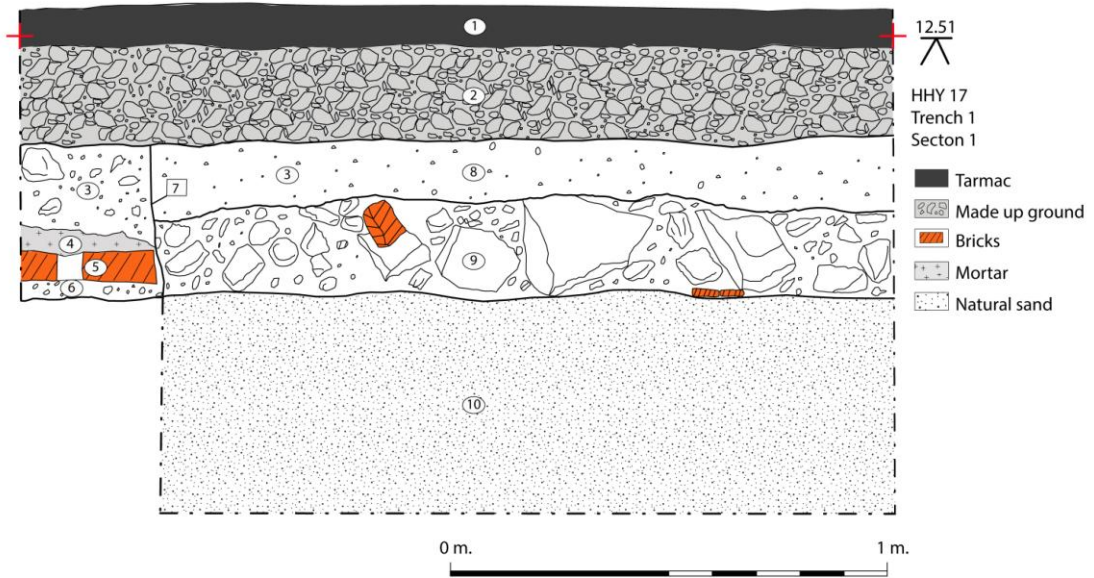
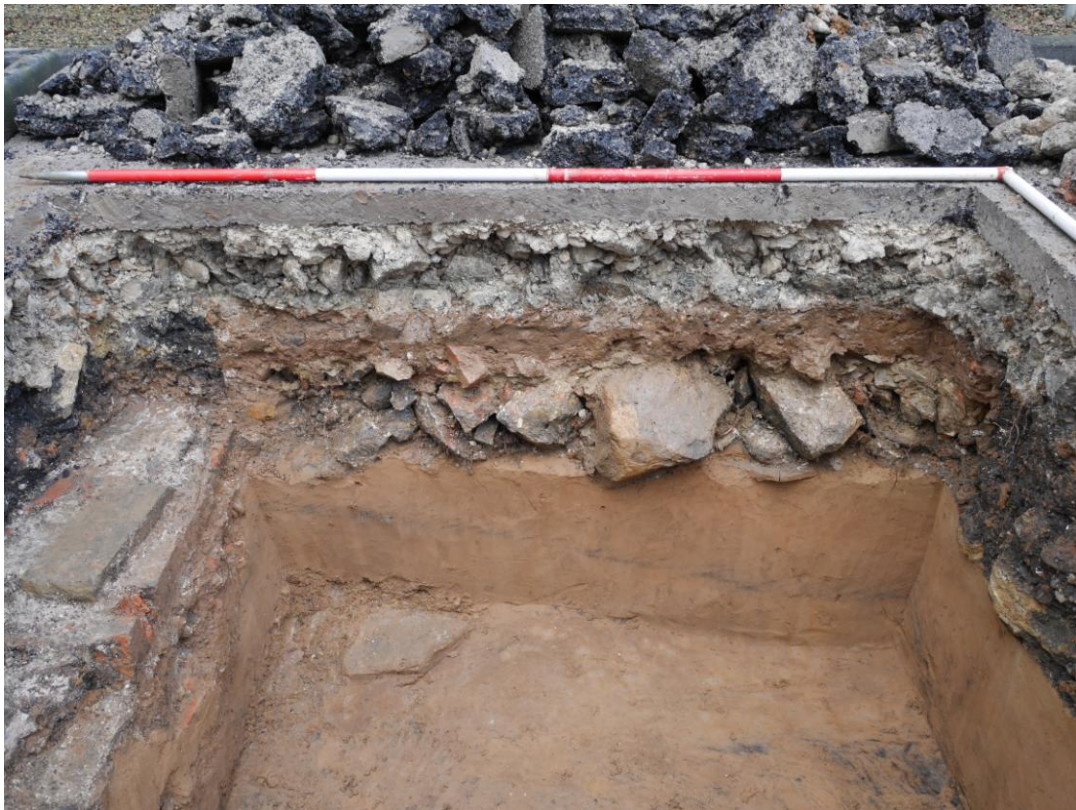
Figure 7: Section 1 facing northeast

Orientated on a northwest to southeast direction Trench 1 was excavated to an average depth of 1.15m. The removal of the tarmac layer (context 1) revealed the presence of a light grey sandy silty and gravel deposit (context 2) measuring in depth 0.3m, this layer functioned as the preparation layer for the deposition of the tarmac (Figure 7 - Figure 10).

Buried under context 2 was reddish brown clay and sand deposits (contexts 8 and 17) measuring in average 0.2m in depth. Sealed by both these deposits was a thick layer of a brown clay silt material (context 9) mixed with large angular stones, cobbles, gravel and fragmented ceramic building material (CBM) measuring 0.3m in depth. The natural sand deposit (context 10) was observed immediately beneath context 9.

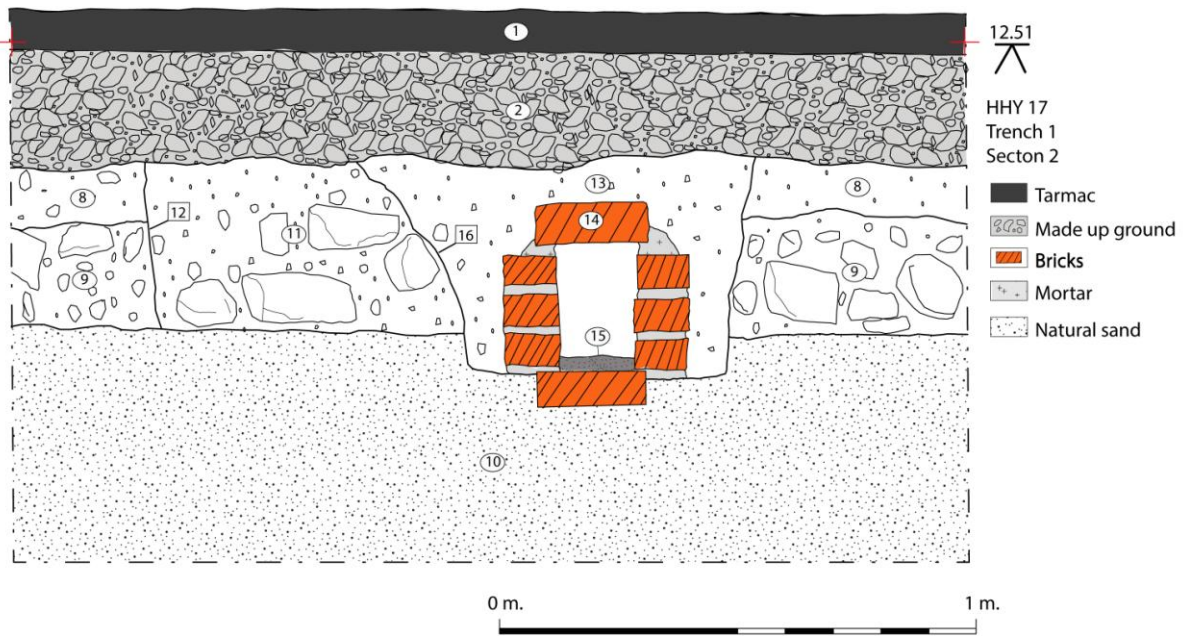
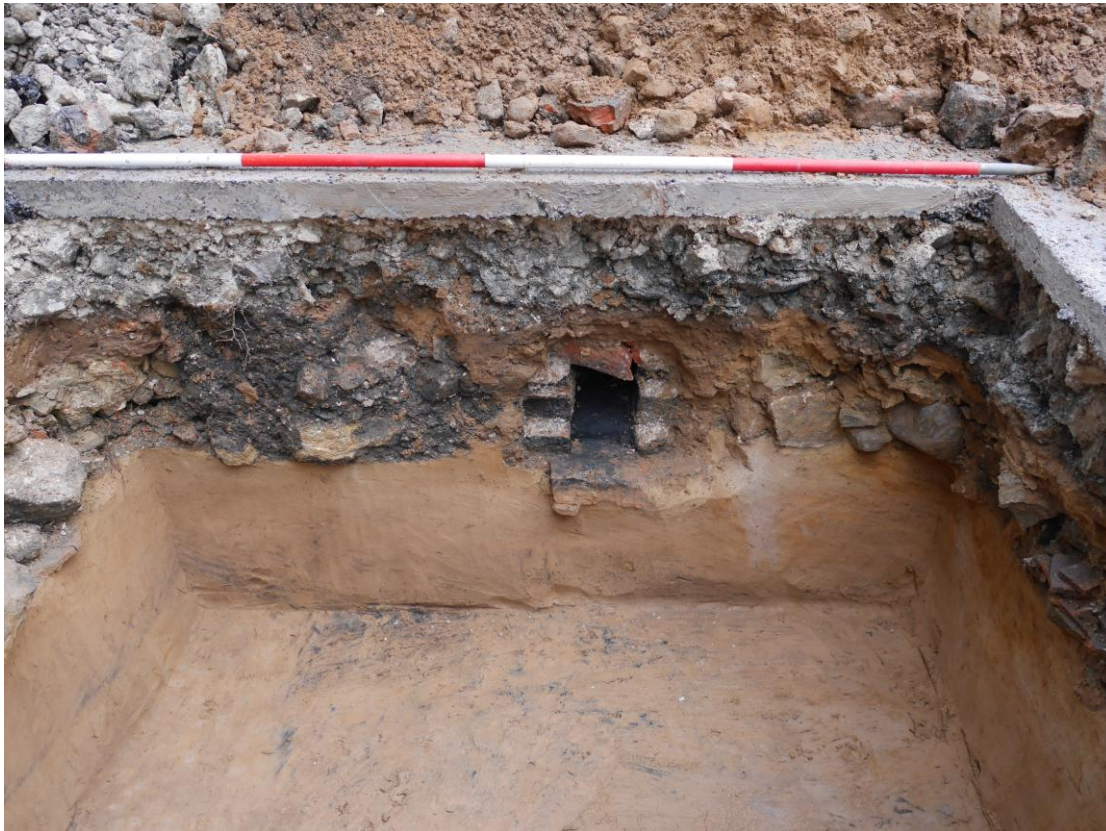
Figure 8: Section 2 facing southeast

Along section 2 it was visible that the drain foundation context 16 was cutting through an early feature (Context 11 and 12), interpreted as a possible large pit, measuring 0.65m in width and 0.37m in depth.

This pit was filled by a single deposit (context 11), made of a black gravelly sand and silt mixed with angular rocks gravel and occasional fragmented CBM. The fill context 11 appeared to be very similar in character to the fills (context 19 and 28) of the 20th century drains found in trench 2.

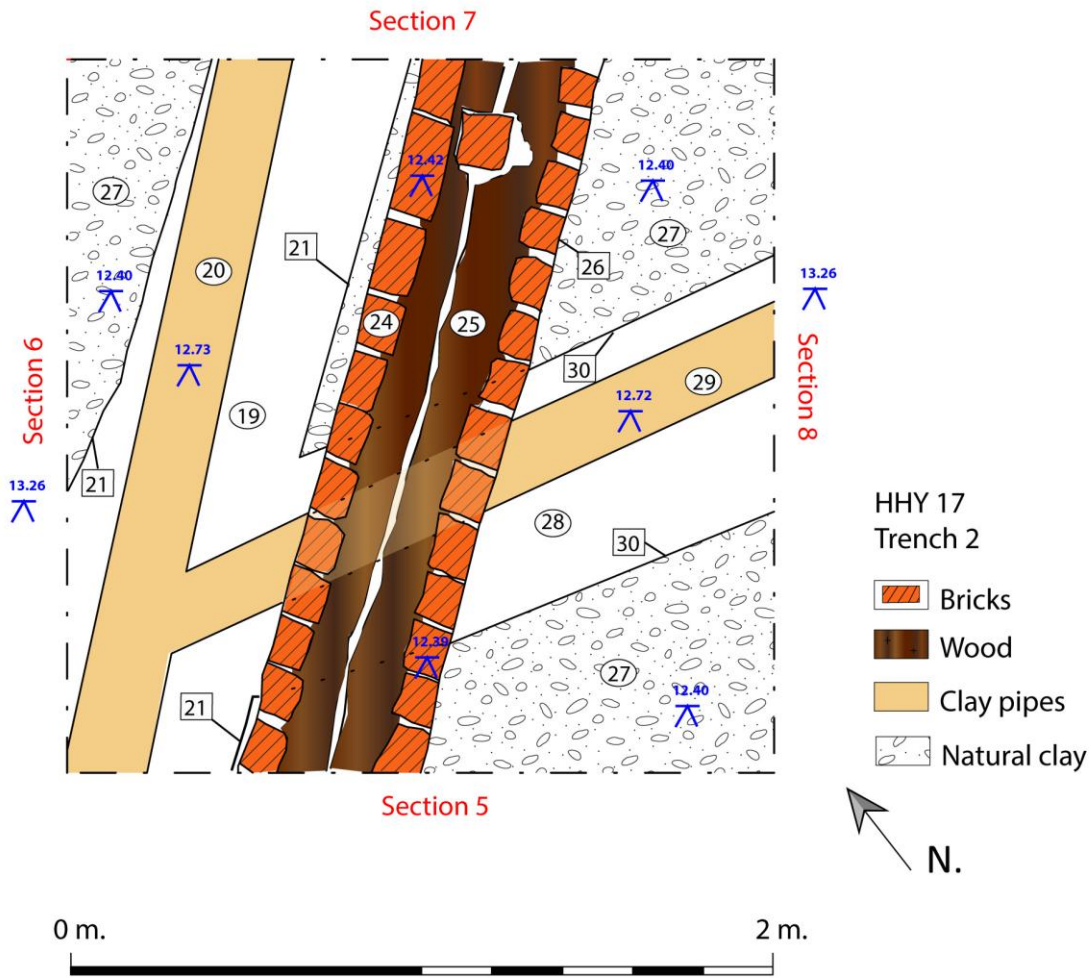
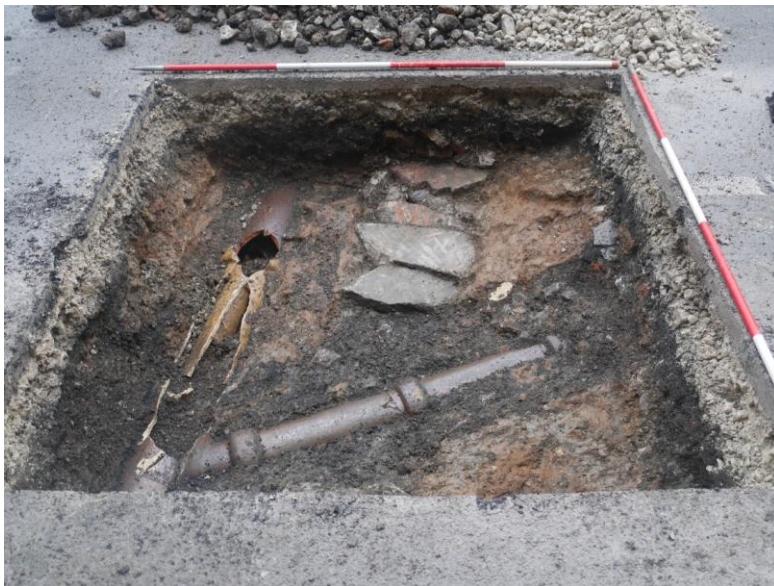
Figure 11: Plan of Trench 2

Trench 2, located towards the southeast end of the car park, orientated on an Northeast to Southwest direction, was excavated to an average depth of 0.85m where the removal of the tarmac and associated deposit (context 1 and 2) revealed the presence of three linear features (context 21, 26 and 30).

Three linear features were recorded within the limits of trench 2. Two of these linear features consisted of a 20th century clay drainpipes (context 20 and 29) each respectively measuring 0.25m and 0.21m in diameter.

Drain 20 (cut context 21) runs on a north-northeast to south-southwest direction, parallel to an early brick built drain/flue type feature (contexts 24, 25 and cut context 26).

Drain 29 (cut context 30) runs on an east to west alignment and at its western end join drain 20, and on doing so it cuts through the early drain/flue structure 24, removing most of its upper part (Figure 11, Plate 5, Plate 8).

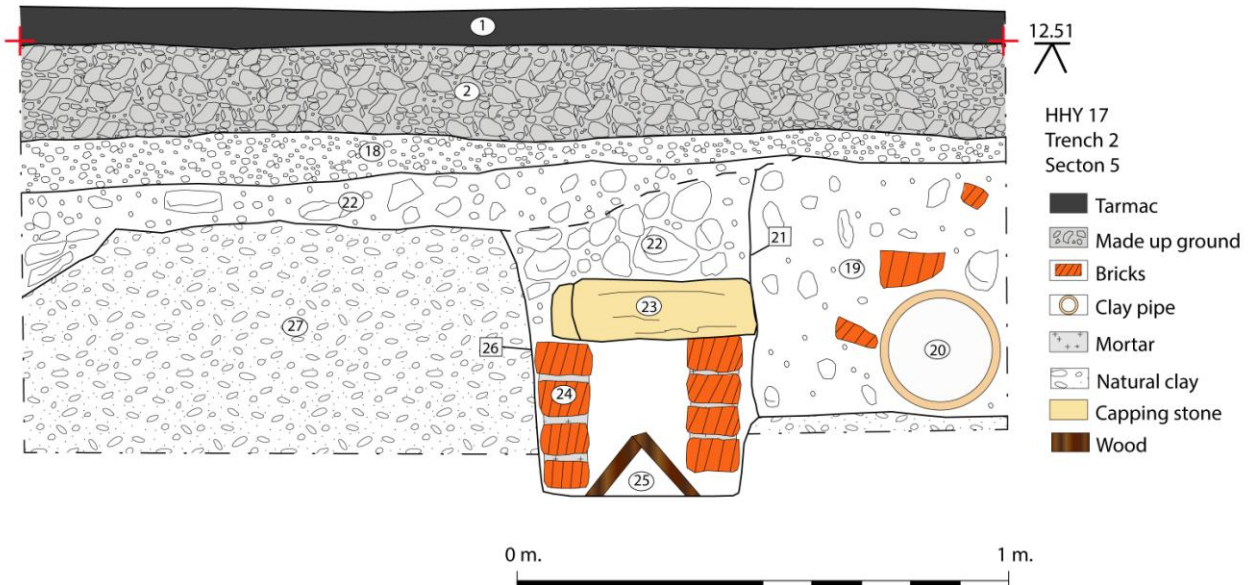
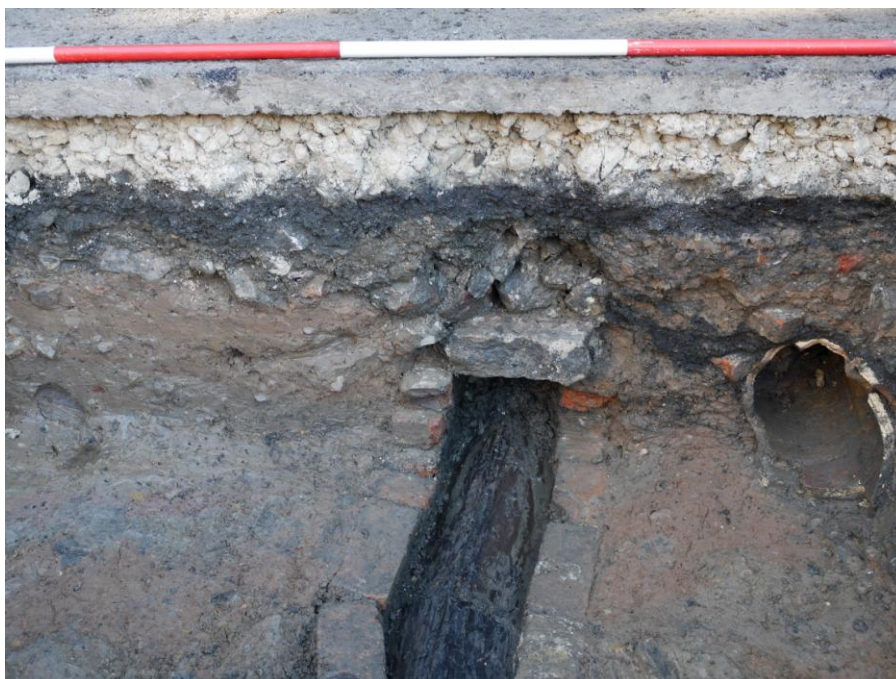
Figure 12: Section 5 facing northeast

Buried under context 2 was a black sandy gravel deposits (contexts 18) measuring in average 0.1m in depth, most likely to be associated with the former railway occupation. Sealed by these deposit was a thick layer of a brown clay silt material (context 22) mixed with large angular stones, cobbles, gravel and fragmented ceramic building material (CBM) measuring 0.3m in depth, and very similar to context 9 recorded in trench 1. The natural in trench 2 consisted of a clay deposit (context 27) observed immediately beneath context 22.

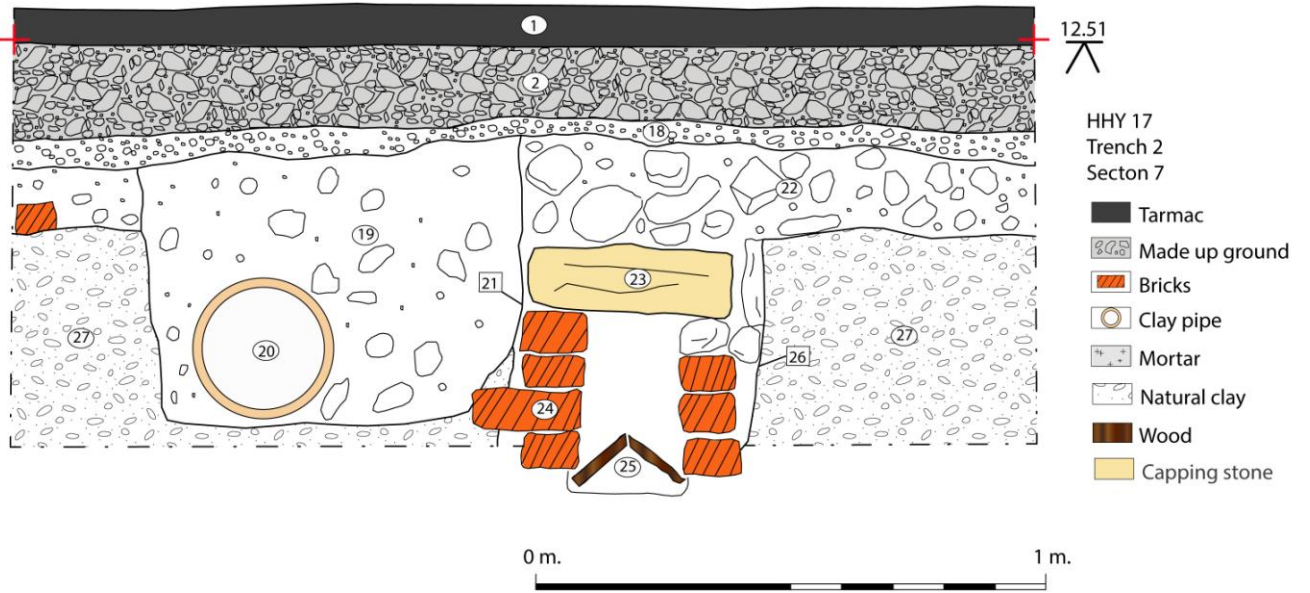
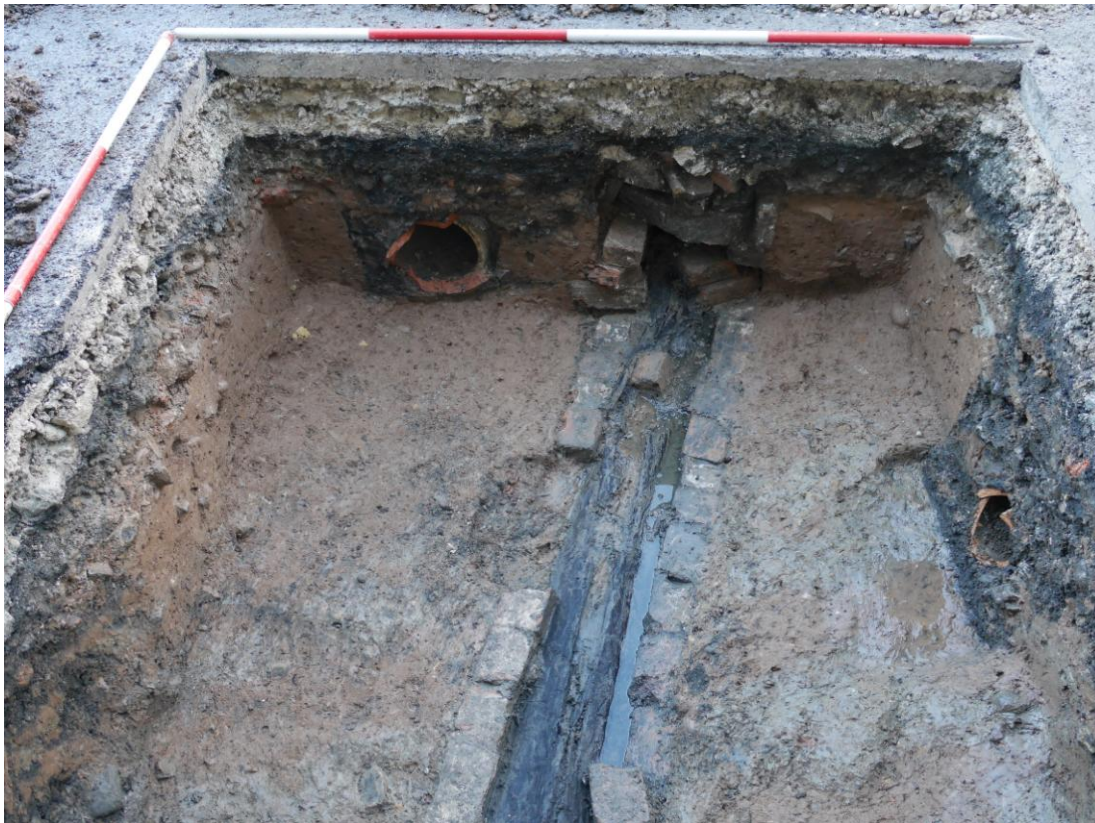
Figure 14: Section 7 facing southwest

The cut (context 26) for the drain context 24 has vertical edges, a flat base and measures 0.48m in width and 0.5m in depth. The drain edges (context 24) are made with four layers of bricks (each brick measures 0.23m long, 0.11m wide and 0.07m deep).

The drain capping (context 23) consisted of a series of sandstone slabs measuring in average 0.45m long, 0.3m wide and 0.1m thick. At the base of the drain, there were a set of wooden planks measuring circa 0.14m in width and 0.02m deep, laid at 45 degrees (Figure 14).
