**LS** Archaeology

## 18 Fenwick's Lane, Fulford, York Archaeological Watching Brief Report

**December 2017**

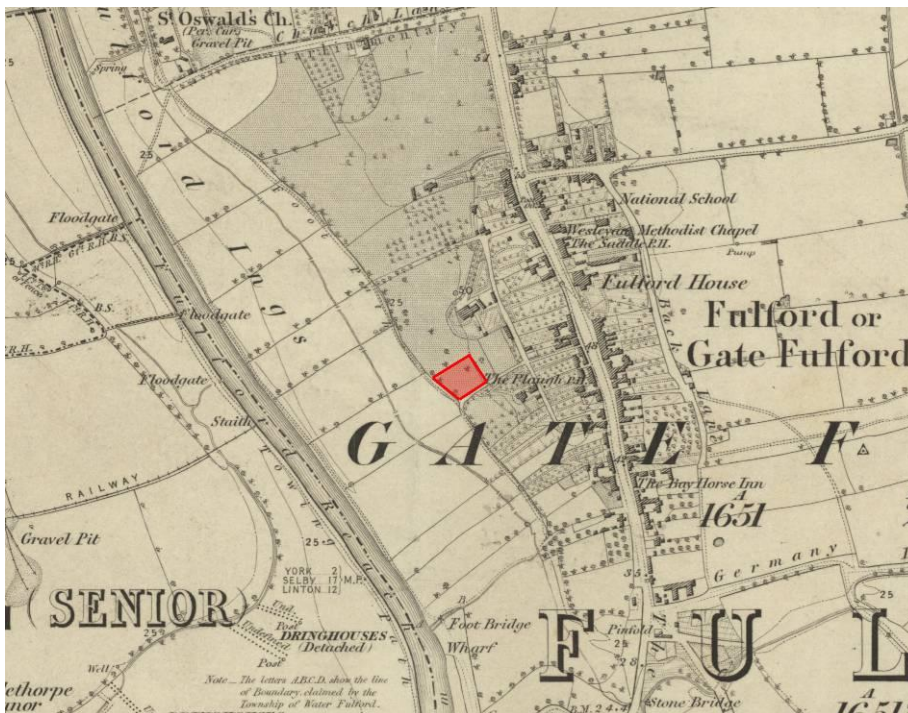
Figure 3: 1854 Ordnance Survey Map

The 1845 1st Edition Ordnance Survey Map of the area shows that the development site is at that time under open fields dotted with trees. Medd's Lane bounds the south of the site.

The presence of a lane heading towards Fulford Ings and the flood plains suggests there was a relatively important reason for movement, back and forth in this direction. Medd's (Medd's being a common Yorkshire surname -earliest origins 1550) lane bisects Fenwick's lanes heading towards Fulford Main Street. The western part of Medd's lane is now known as Fenwick's Lane.

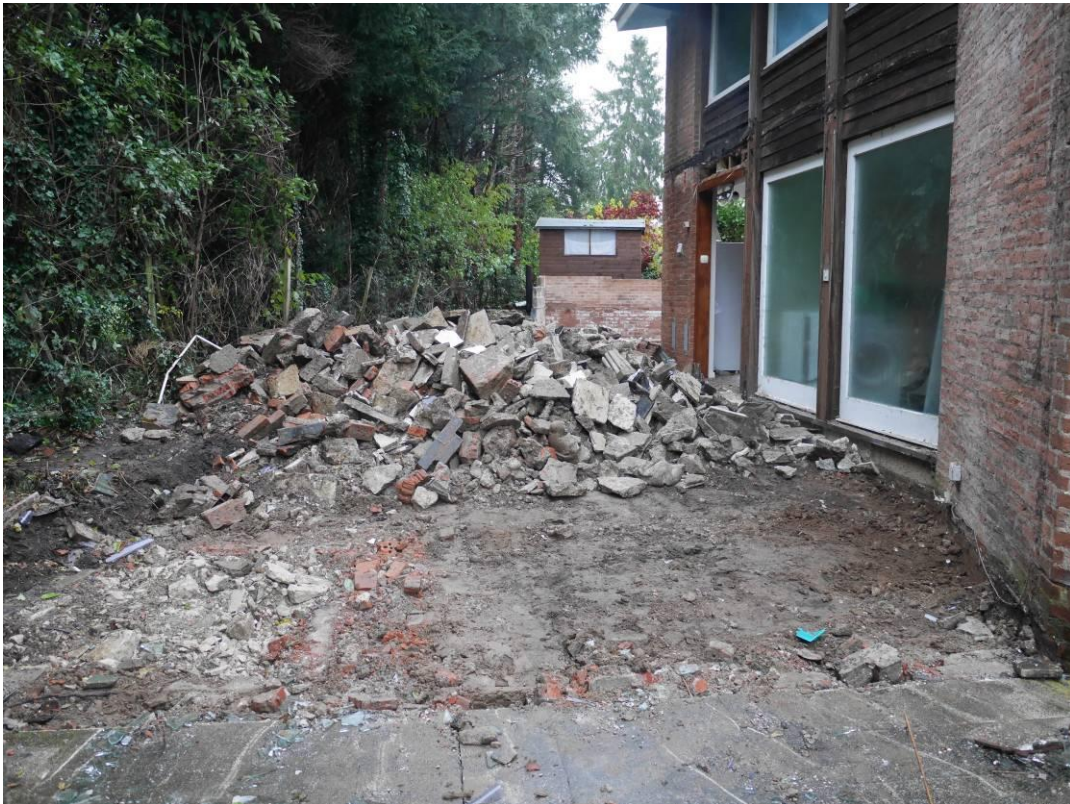
The ground was reduced by 0.30m as was required for the construction of the new extension. After removal of the concrete floor and make up ground, along the southwest corner, garden soil was still visible.

Photograph 1: Remains of the concrete ground floor. Facing northeast

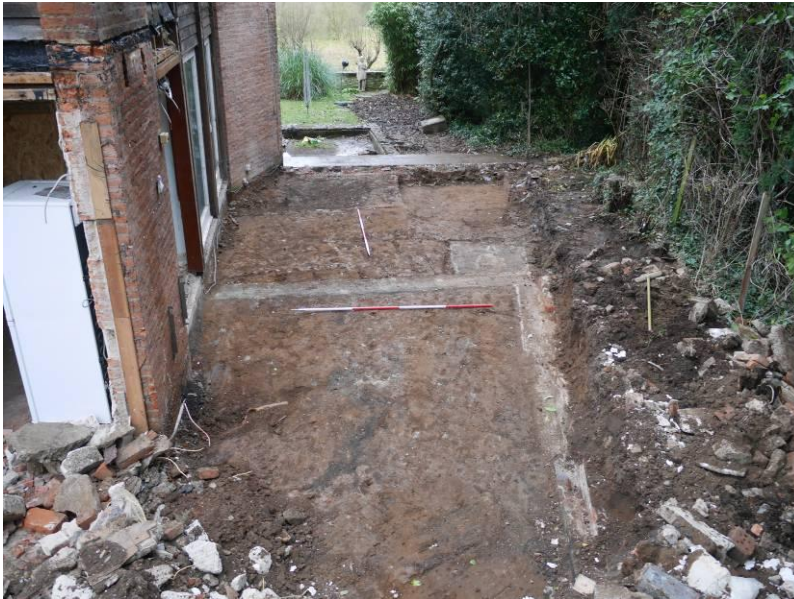
Photograph 2: View of the site after removal of the concrete ground surface, facing southwest

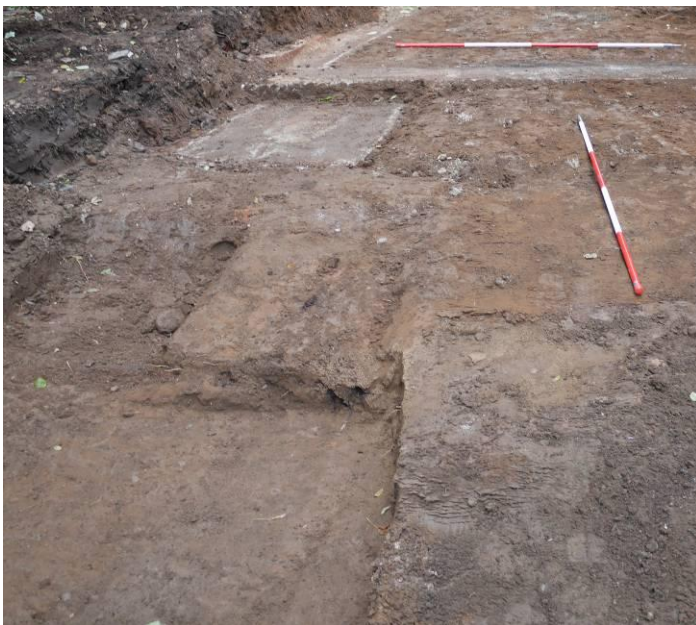
Some structures were encountered during the ground levelling: two small rectangular concrete pads, which functioned as the footings for larger concrete garden statues, and a rectangular soak away brick feature and related drains all located towards the southwest end of the site (structures 4, 5 and 6) .

Photograph 3: Remains of the soak away trench and concrete pad for the former garden concrete statues
