Old Post Office, Askham Richard

Report on an Archaeological Watching Brief

Date of Issue	July 2019		
Site Dates	16th-17th April 2019		
Client	Mr. B. Pickering

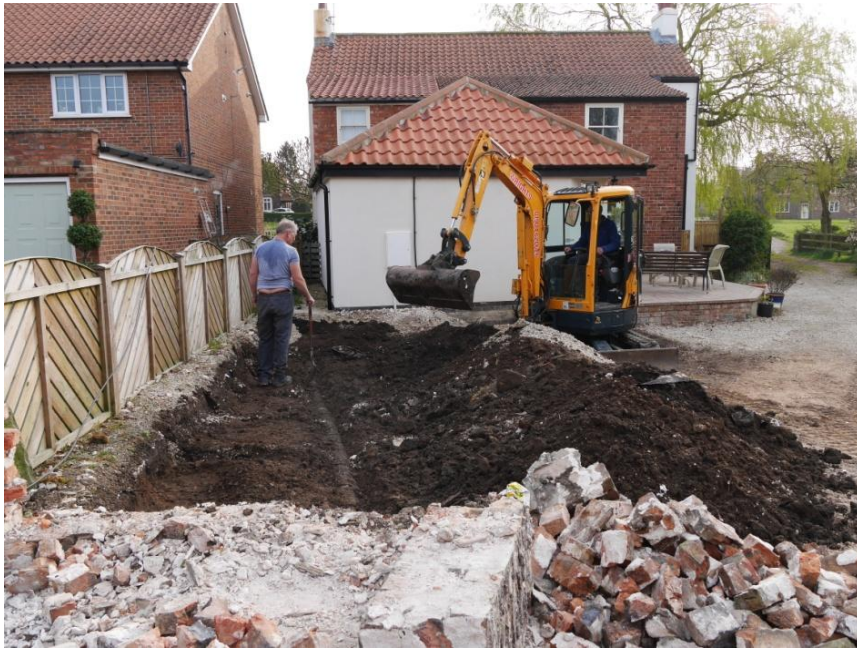
Figure 2: Image showing the excavation of the foundation for the new extension. Looking east

A back-acting mini digger fitted with a toothless bucket was used to strip during groundworks. The machine stripped in shallow spits to enable archaeological deposits to be observed (Figure 2). The watching brief revealed a north west -southeast aligned ditch and the contractor and all sub-contractors facilitated the archaeological recording of this feature.

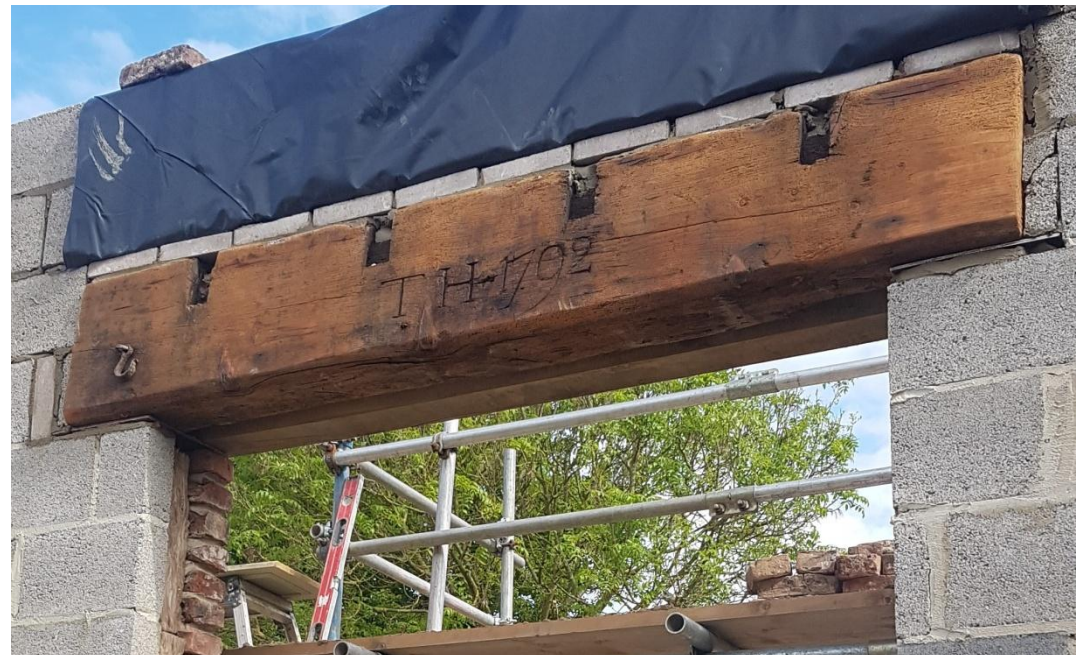
Figure 3: Original beam retained, by the owner, from the demolished 18th century outbuilding. Presently, repositioned as a window lintel, in the new build. Inscribed TH 1792- Thomas Hudson, Farmer residing at the plot during the late 18th to early 19th century.

The brick foundations of the 18th-19th century outbuilding were recorded. This building was demolished prior to the watching brief and is therefore not recorded in this document. The actual use of this building is unknown however it was noted by the owner that on one of the beams, the date '1792' was inscribed. This may indicate that this outbuilding was constructed in the late 18th century.

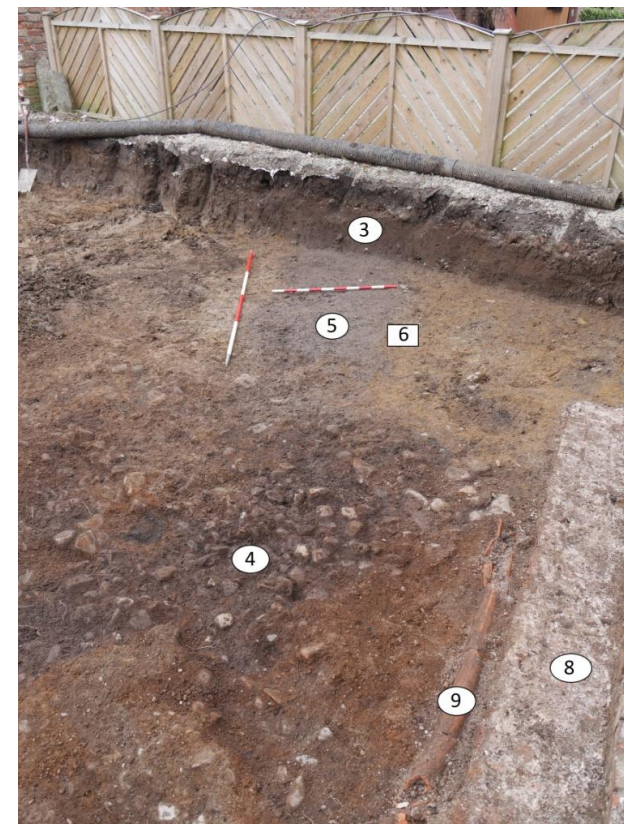
Figure 7: Post cleaning image of Contexts (3), (4), (5) and Features [6], [8] and [9]

The area impacted by the foundations of the new extensions consisted of approximately 50² m. Layers (1), (2) and (3) were removed using a mechanical excavator fitted with a tooth-less bucket. These made up ground (1) and garden layers (2) and (3) that were 0.80m, in depth sealed archaeological deposits, the base of the earliest archaeological feature (6) was 1.25m below ground level (Figure 7).

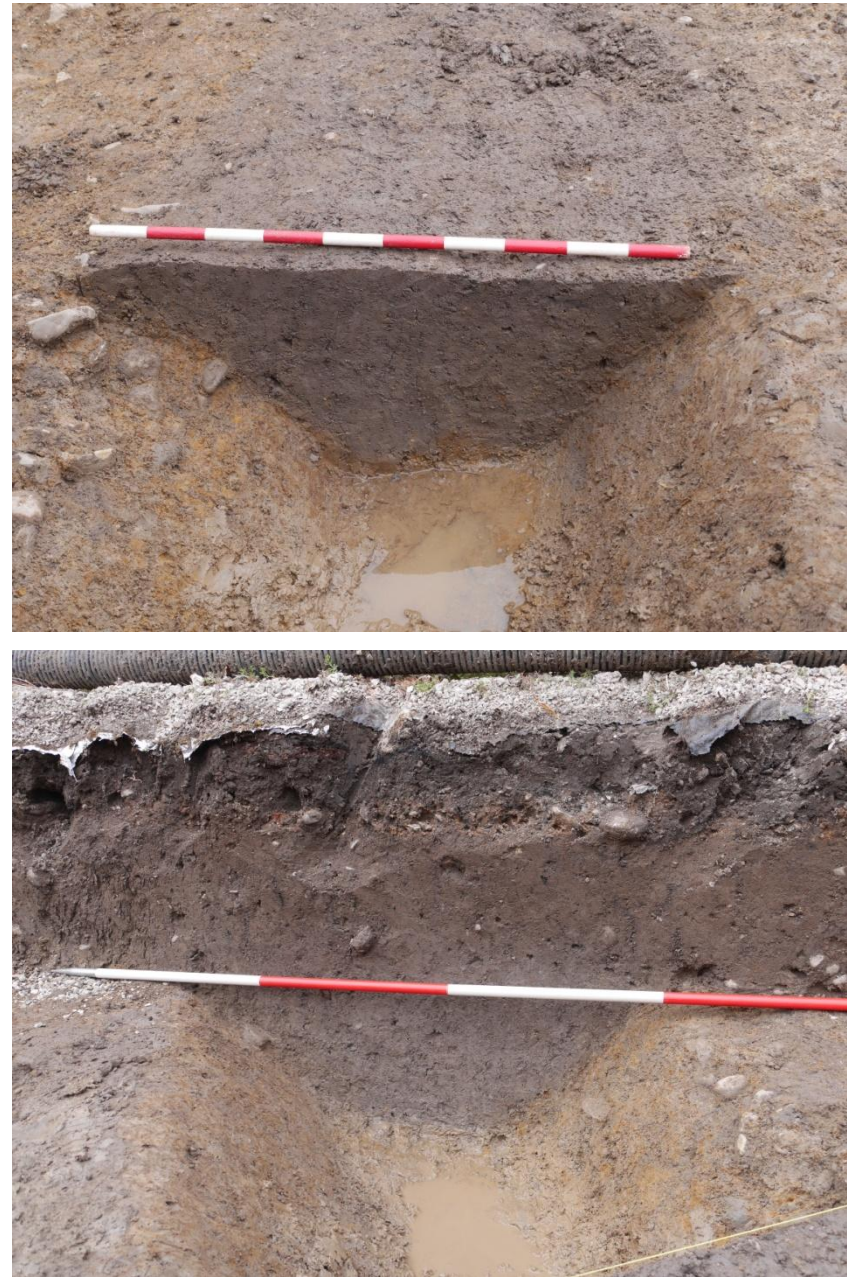
Figure 9: Feature [6] section photographs

Context (4) consisted of a layer of cobbles and rubble bonded with a very dark greyish brown silty clay material. This context measured 0.25m in depth and was observed covering most of the southern half of the development site, and was identified as a layer of rubble and cobbles; made up ground associated with the construction of the 18th -19th century outbuilding as the clay drain pie [9] is situated within (4) and (4) abuts the brick foundation wall [8] (Figure 6). Sealed under Context (3) and partly Context (4), was the remains of a linear feature [6] orientated northwest to southeast. This feature had a large U shaped profile with a concave base and measured 1.05m in width and 0.45m in depth. It was exposed to 1.80m. This linear was filled with a homogenous dark grey sandy clay silt. No archaeological remains were found during the excavation of this feature (Figures 8 and 9).
