4 St. Martin's Lane, York

Archaeological Watching Brief Report

This report outlines the results of an archaeological watching brief carried out, at 4 St. Martin's Lane, during February 2020.

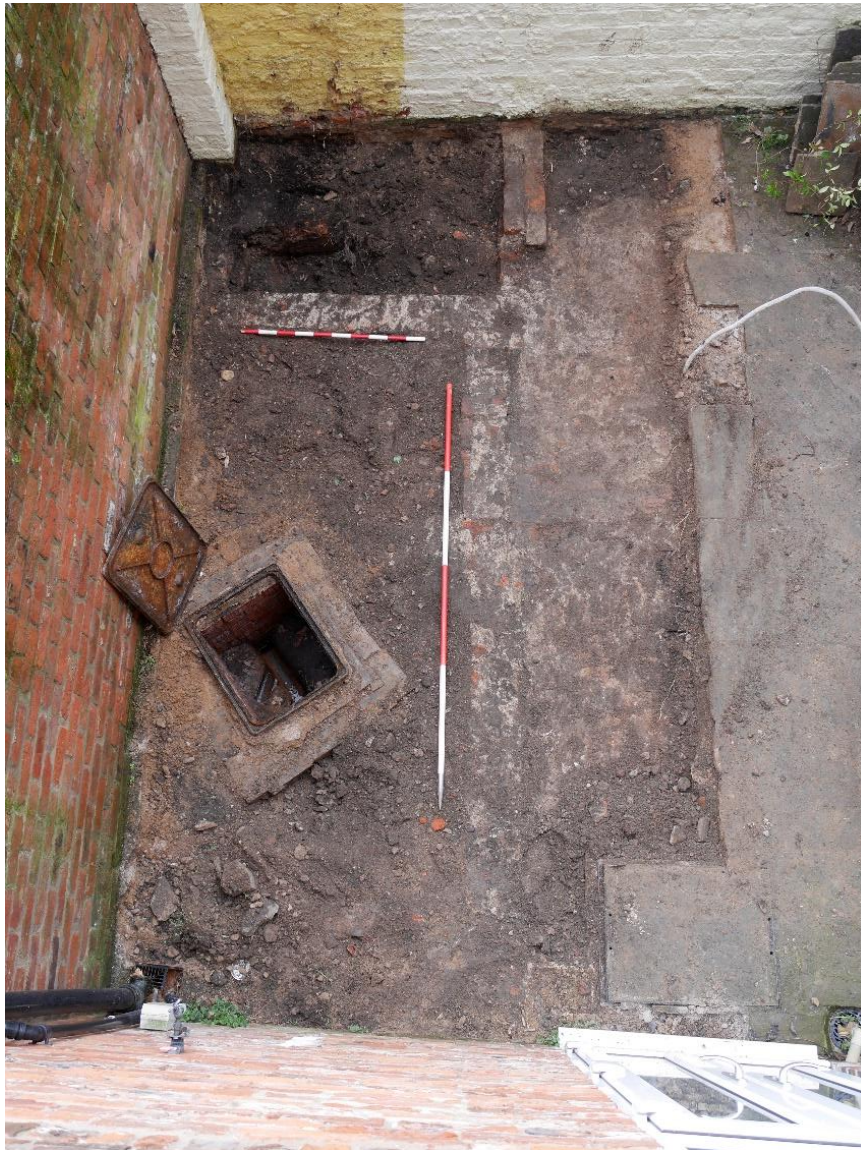
Figure 7: View of the site after the removal of the floor sandstone slab.

The archaeological watching brief, monitored the groundworks associated with the rear extension at 4 St. Martin's Lane, York. The impacted space was 12.00m² (Figure 7) measuring 2.5m in width and 5.0m in length. The ground was reduced to 0.45m below ground level.

The ground reduction, due to limited space, was undertaken by hand. Sandstone slabs were lifted then the area was hand dug and cleaned to reveal the first archaeological horizon, 0.15m bgl, which comprised of two 19th century foundation walls which once served as a garden shed.

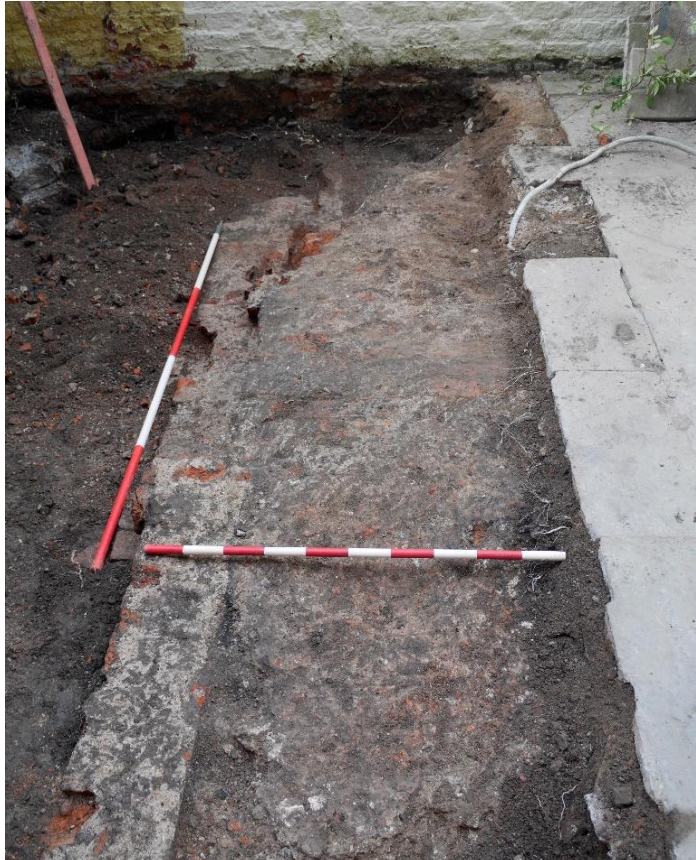
Figure 9: Wall (8) and cellar roof (9).

The removal of the made-up ground (Context 5) also revealed the presence of a north south aligned brick wall (Context 8) and the roof of a barrel vaulted cellar (Context 9) (Figure 9).

The brick wall (Context 8) was the western back wall of a large cellar. This feature, built in an English Bond, measured 4.90m in length, 2.30m high and 0.25m wide, and was bonded by a strong grey sandy mortar.

The cellar, which was exposed directly underneath the clients property, measures 6.10m in length, 4.90 width and has a vertical plane of 2.30m. This interconnecting brick single nave, semi circular, barrel vaulted cellar (Context 9) roof was supported by two sidewalls, with frogless red bricks with a sandy grey mortar laid in a stretcher bond and constructed to a height of 1.50m (Figures 10-11). There was a single alcove with a lunette vault set into the western wall. Running on an east to west direction this cellar extended beyond the eastern boundary of the property.

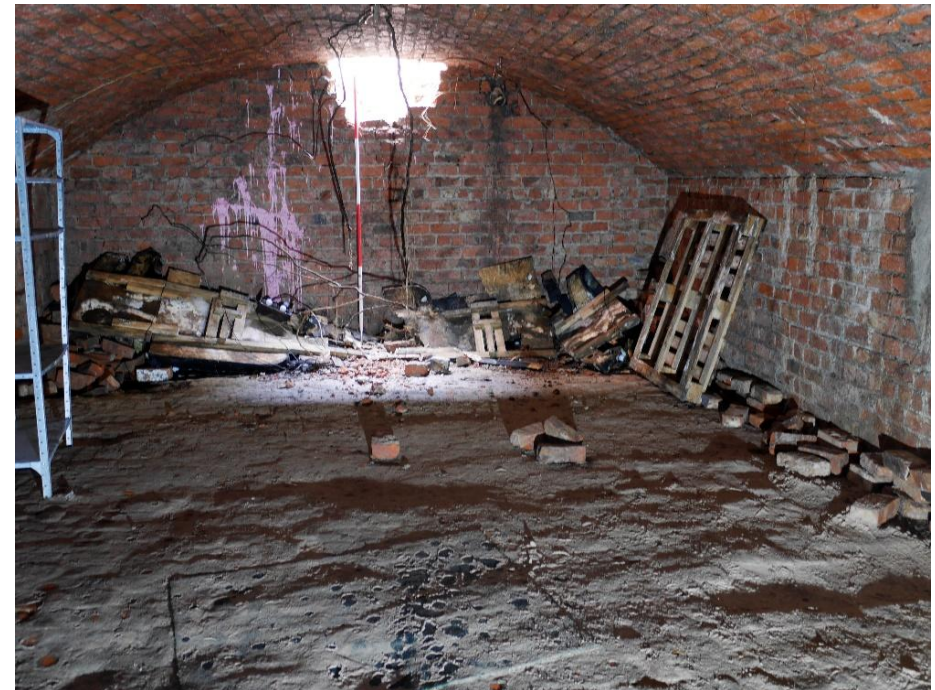
Figure 10: Internal view of the single nave barrel vaulted cellar.

Surprisingly, underneath the rear yard, was an intact single nave barrel vaulted cellar.

The 19th century cellar extends beyond the eastern boundary of 4 St. Martin's Lane, and appears to be part of a complex of cellars which run underneath properties 1, 2, 3 and 4.

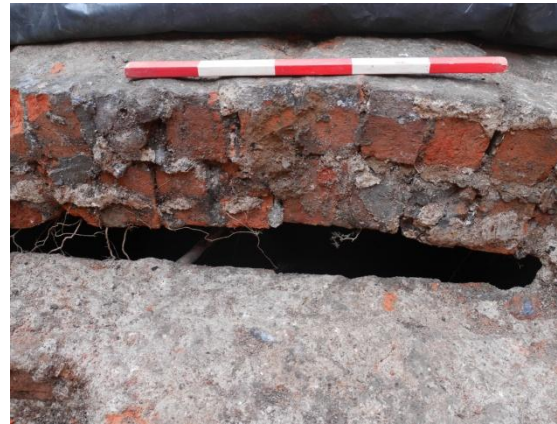
Figure 12: Exposed barrel vaulted cellar roof at garden height.

The ceiling of the barrel-vaulted cellar was exposed and hand excavation along its western edge, revealed the curved angle, of its barrel vaulted roof.

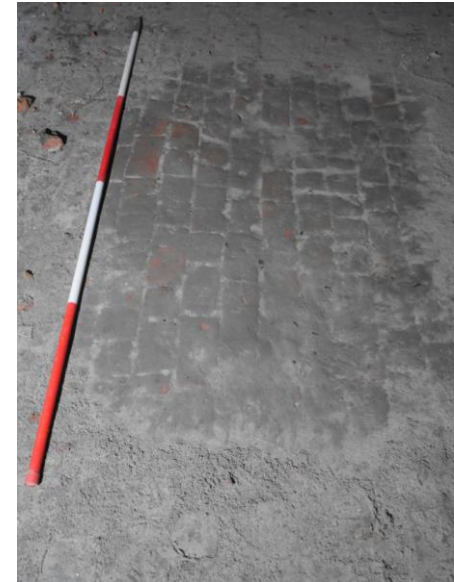
Figure 11: Heavily worn brick flooring inside the single nave barrel vaulted cellar

The cellar floor consisted of heavily worn bricks laid in a running bond. All bricks used for the construction of the cellar measured 0.225m in length, 0.10m in width, 0.08m in height (Figure 12).
