Brecks Farm, Wigginton, York

Archaeological Watching Brief Report

| Site | Brecks Farm, Wigginton road, York, YO32 2RH | |
| Site Code | BFW19 | |

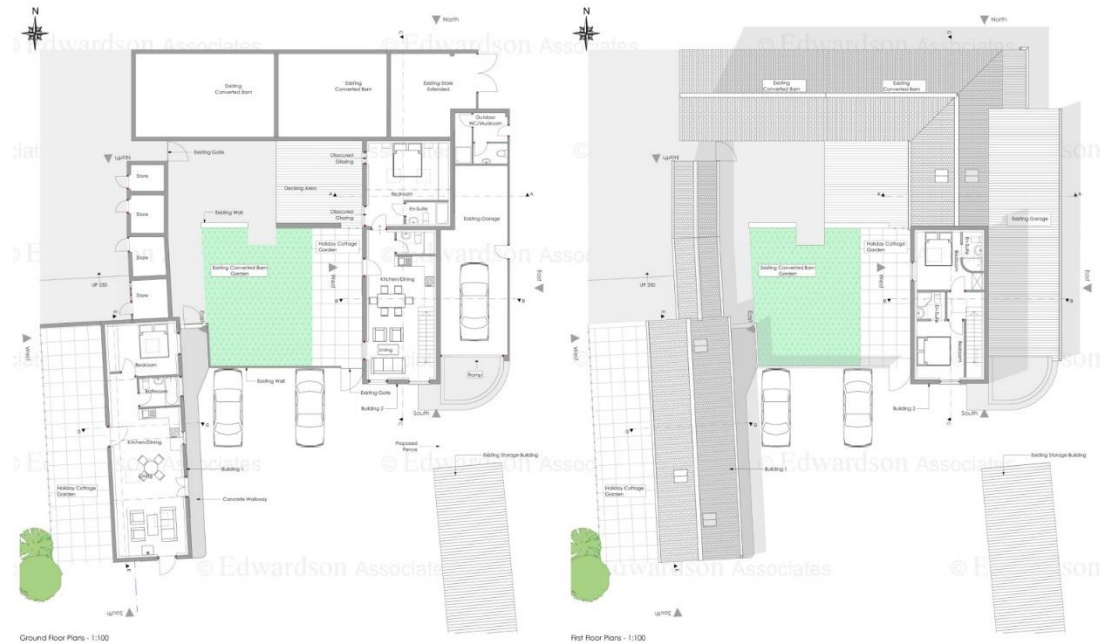
Figure 3: Plan of the Development, Courtesy of Edwardson Associates.

Three agricultural buildings (Combination Barn, Cow House, and Loosebox) are to be converted into two holiday homes, whereas other temporary farm buildings (Storage Buildings 1 and 2) are to be demolished for the construction of two new holiday cottages. An access road and ground source heat pump system will be installed (Fig. 3).

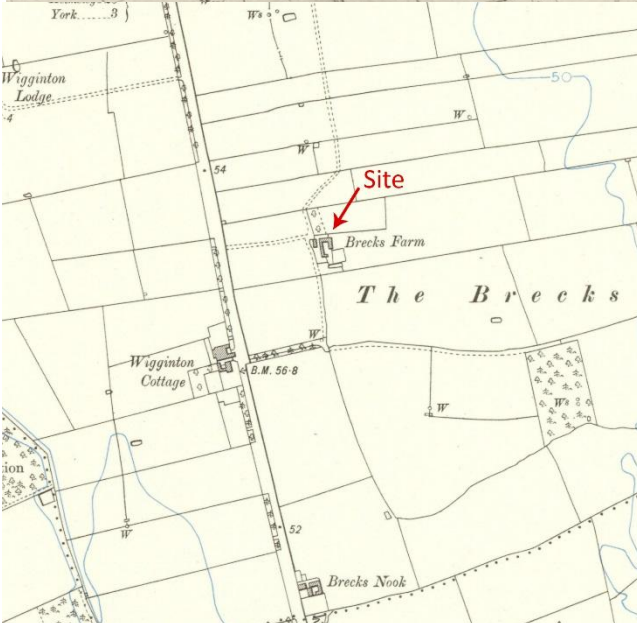
Figure 4: Brecks Farm as depicted in the Ordnance Survey Maps 1854 (top) and 1907 (bottom).

Brecks Farm is located within an area of enclosed fields that slope gently to the east, draining into Westfield Beck. Land known as 'The Brecks' in 1854 (Fig. 4), included Brecks Farm and Brecks Nook. The map depicts the farmstead Brecks Farm as consisting of two buildings, one square suggestive of the farmhouse and another L-shaped, suggesting multiple adjoining buildings constructed in a loose courtyard.

Deciduous trees, a sizeable pond and trackways are indicated. The trackways extend from the farm to the east to join the York-Helmsley road and to the north leading to Wigginton. To the south of the farm is a brook/beck which flows south-east where it merges with the River Foss.

The later ordnance survey map from 1907 show a full courtyard farmstead with some changes to the buildings such as the addition of the Cow House (Fig. 4).

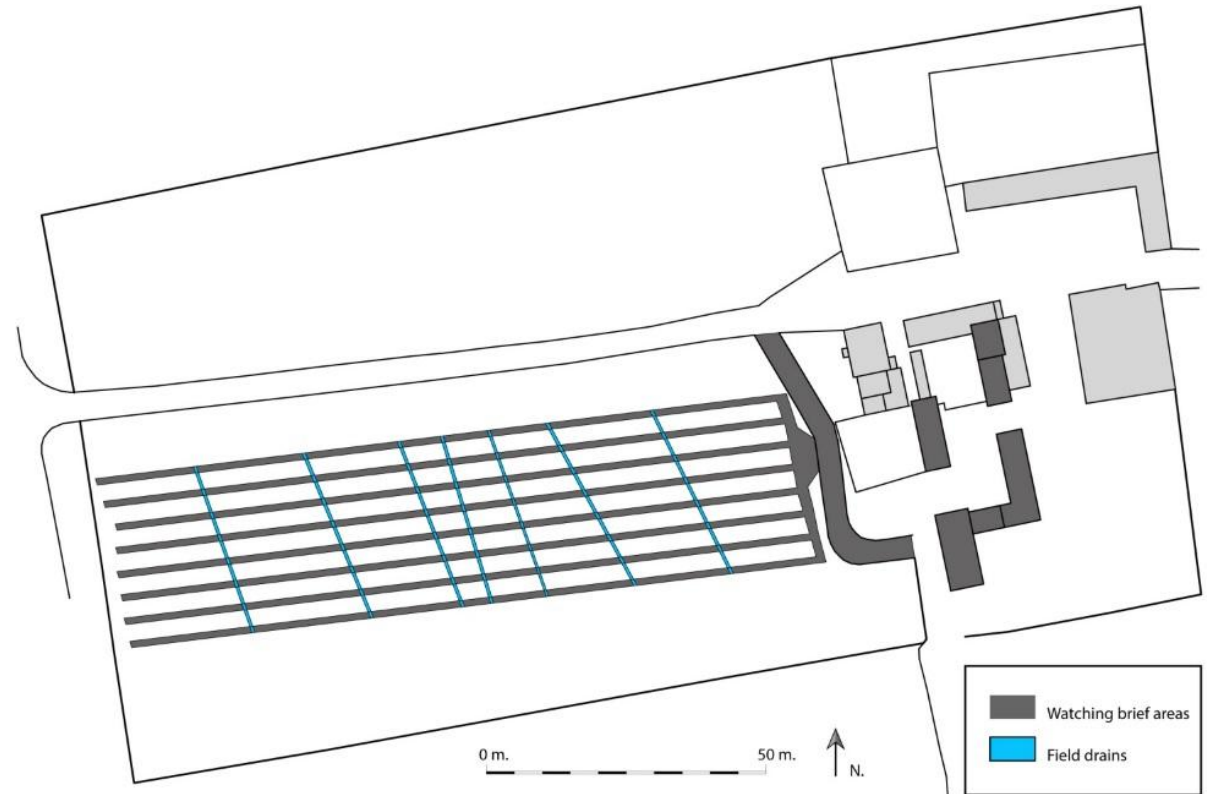
Figure 5: Plan of the site and the watching brief areas as indicated in grey.

The watching brief covered the following (Fig.5):

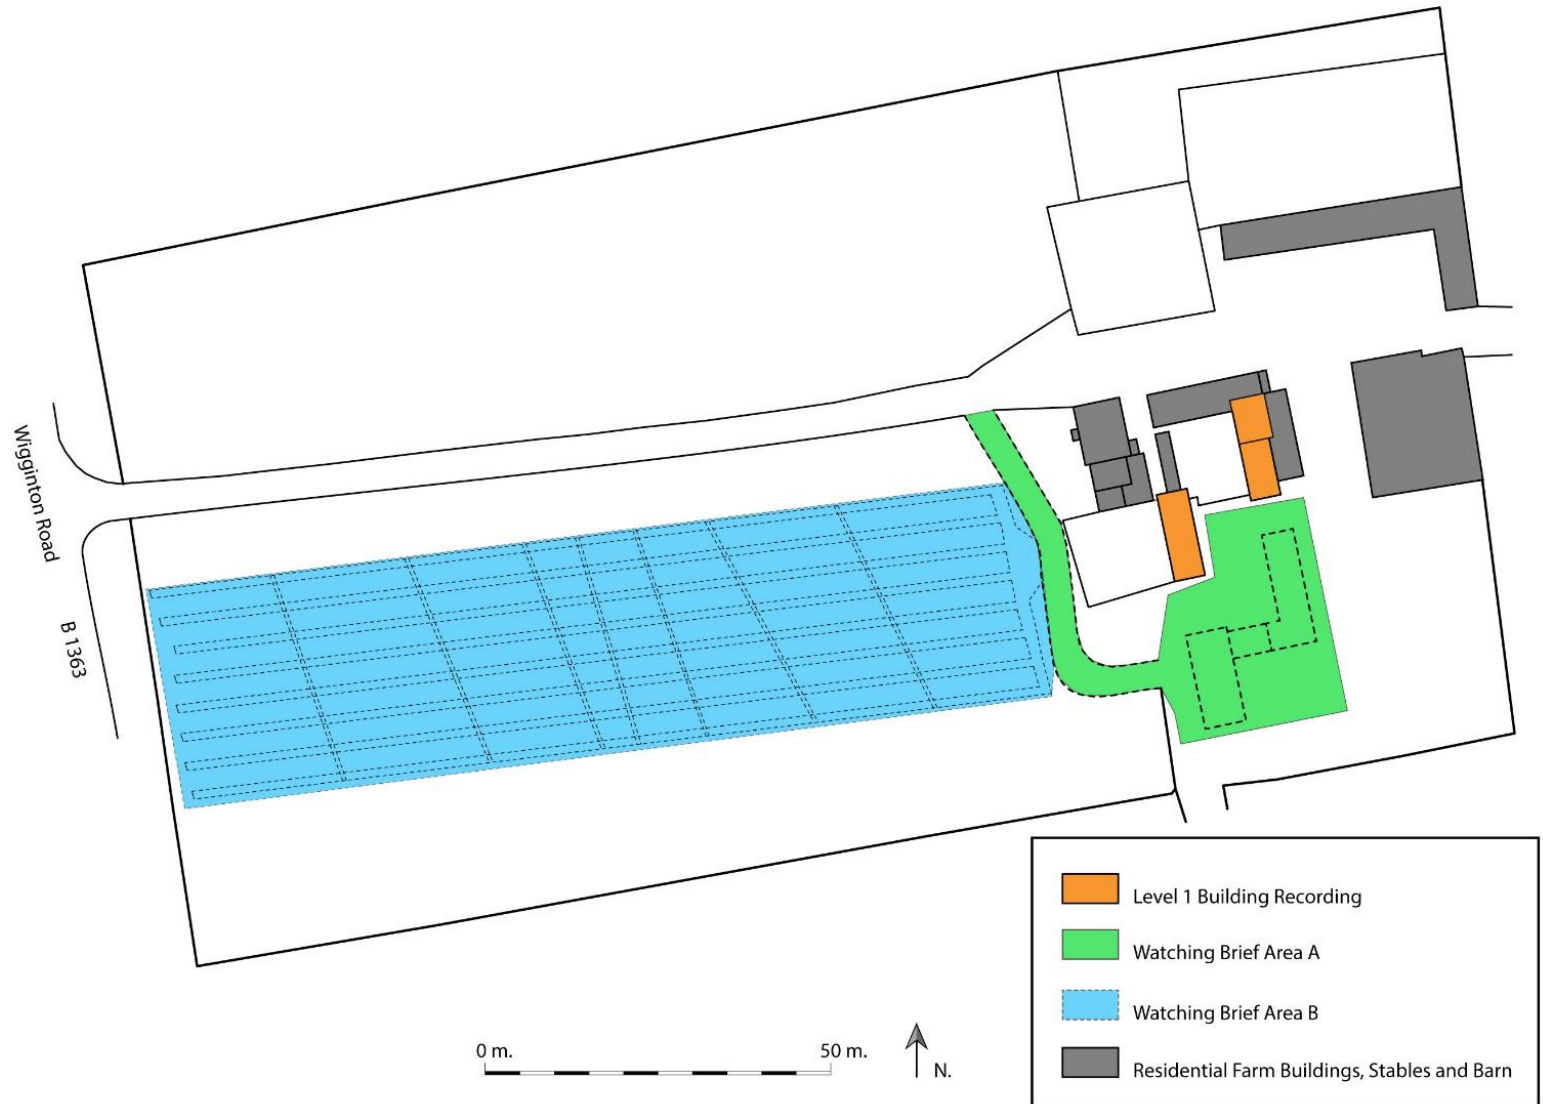
Figure 6: Site plan indicating the location of the three phases of the monitoring.

The results are organised as following (Fig.6):

- Level 1 Buildings Recording:
Combination Barn, Loosebox and Cow Shed.
- Watching brief A:
the Farmyard
- Watching brief B:
trenching for the Ground Source Heat Pump

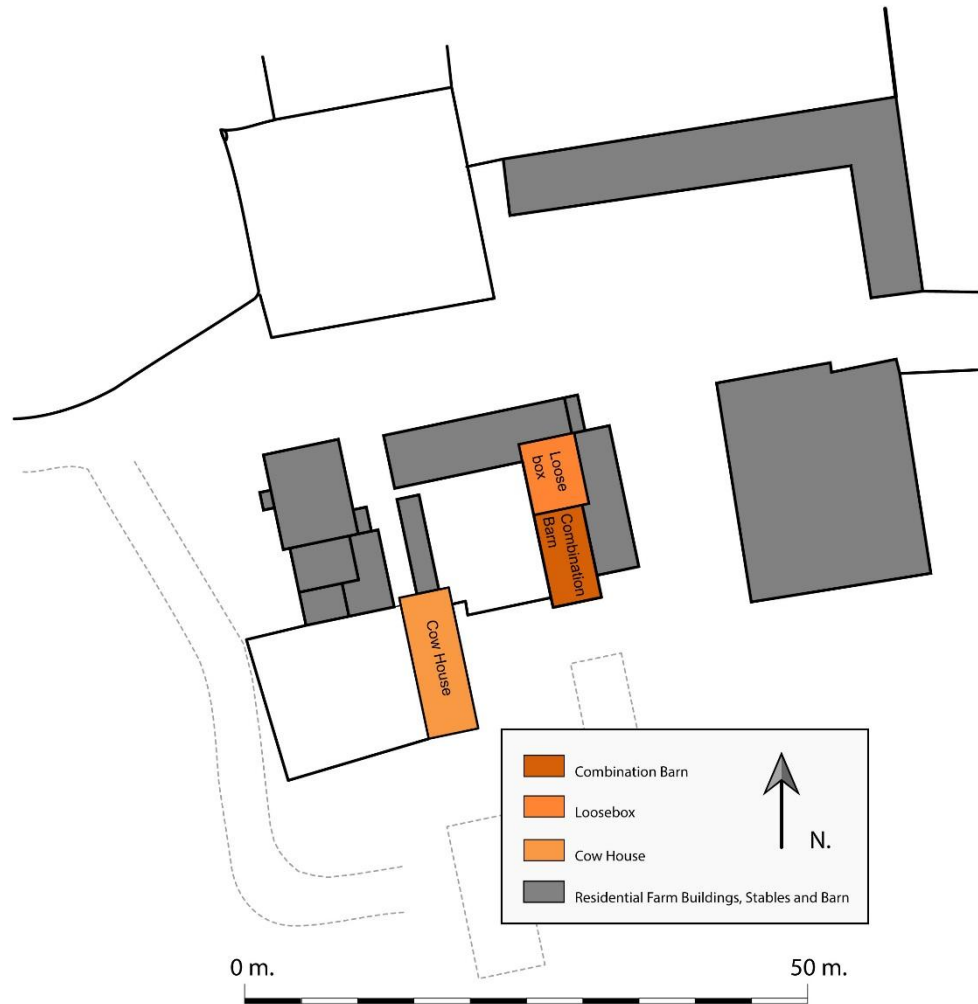
Figure 8: Plan Indicating the Locations of the Recorded Buildings (In Orange).

Three buildings were lightly recorded during the archaeological watching brief (Figs.7 & 8). These comprise of a Combination Barn, Loosebox, and Cow House. These buildings have been utilised for different purposes and since 1988, have been known by the current owners as stables, parlours, a piggery, a calving barn and mill- illuminating the changeable functional narrative of these farm structures.

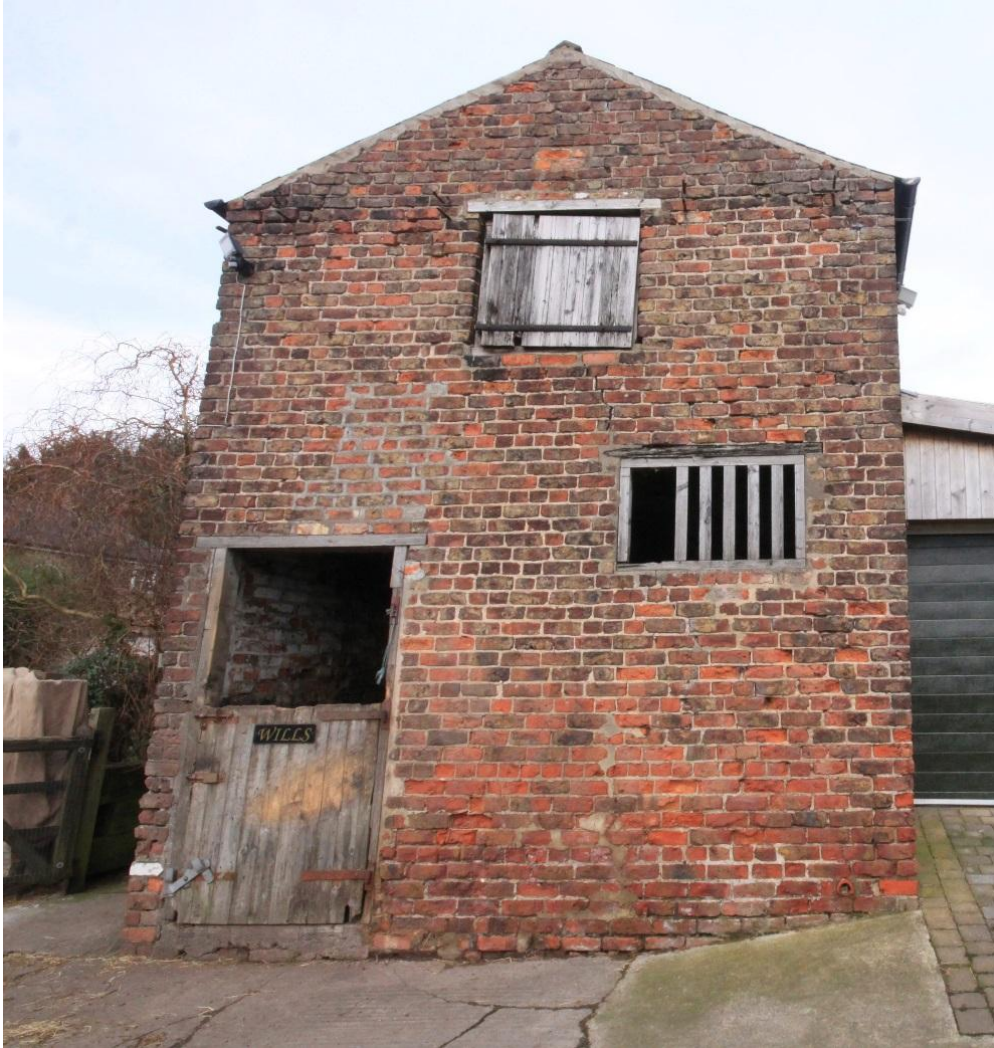
Figure 9: South Facing Elevation of the Combination Barn.

A brick internal wall (Context (3)) separates the downstairs room into two, known as a stable to the southern aspect and a store to the north. There is no internal access between these rooms. Access to the stable is from the south facing elevation doorway, constructed of a wood frame with wood lintel and a planked traditional stable door with cast iron fixtures. The flooring within the stable is brick. The brick floor, Context (5) is partially abutted by the later concrete drain Context (4) (Figs. 11 & 12). A second storey is constructed with wood plank flooring and a wooden staircase served access from the store to the upper floor.

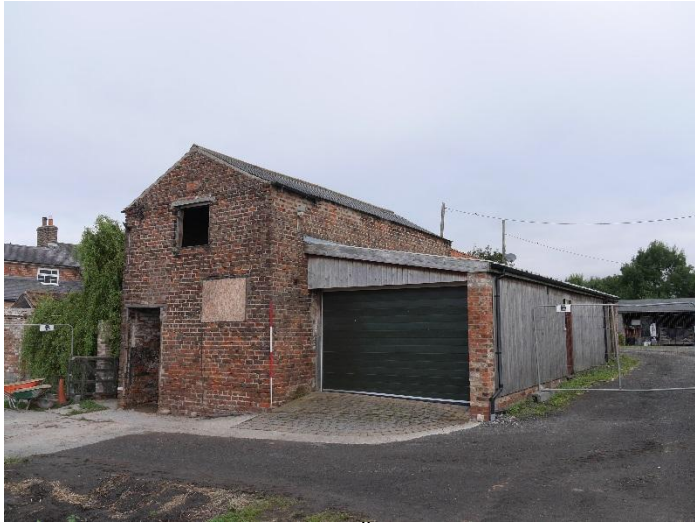
Figure 11: Combination Barn and 20th Century Garage Addition.

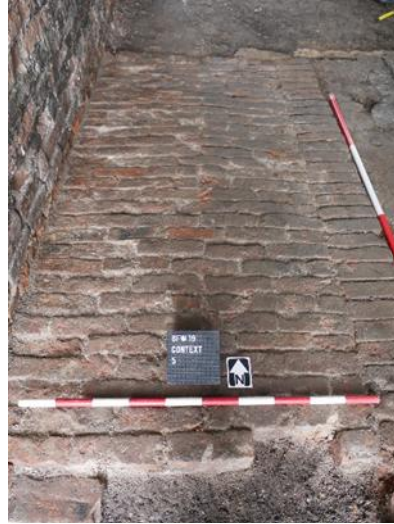
Figure 11: Original Brick Flooring Context (5), sealed under C20th century concrete surface, Context (1) and made-up ground Context (2).

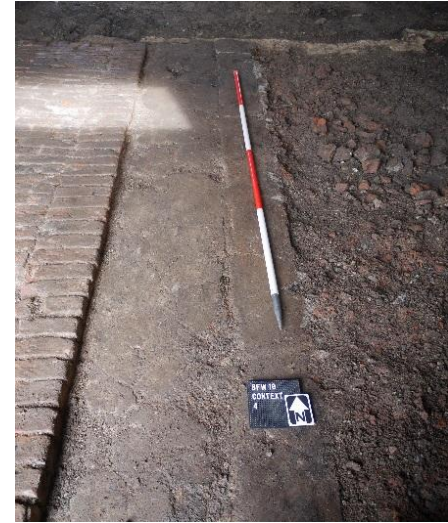
Figure 12: C20th century concrete drain Context (4) abutting original flooring Context (5).

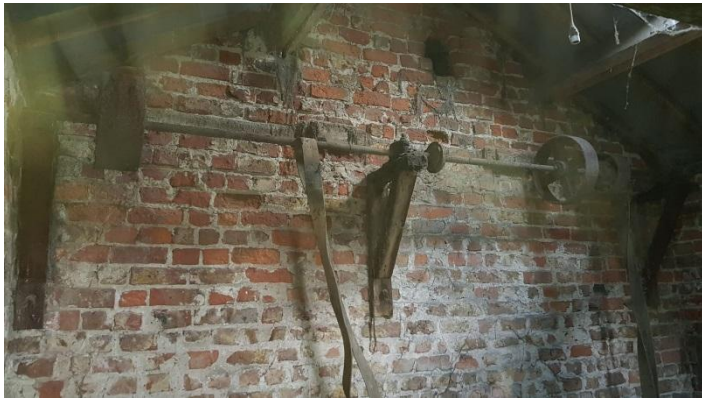
Fixed on the upper floor's north facing elevation internal wall by sturdy wood and metal brackets, was a cast iron drive shaft with flywheels and attached pulleys (Figs. 13 & 14). The upper floor room was open and ventilation was in the form of a square opening situated on the upper south facing elevation. The shutter is constructed of wood planks with cast iron hinges, set in a wooden frame with wood lintel. At the lower level on the south facing elevation, the window has wooden vertical slots set within a wood frame with a wooden lintel. A concrete feeding trough had been added to the stable area in 1991 (Fig.15).

Figure 10: Cast Iron Drive Shaft with Flywheels and Attached Pulleys.

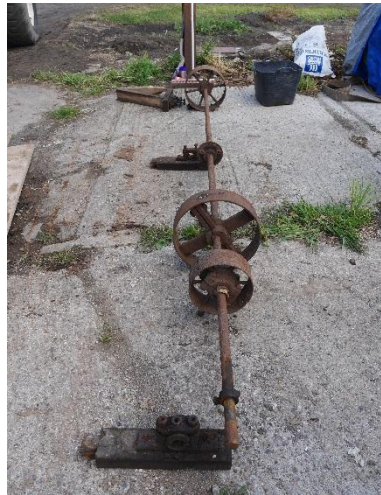
Figure 14: Cast Iron Drive Shaft.

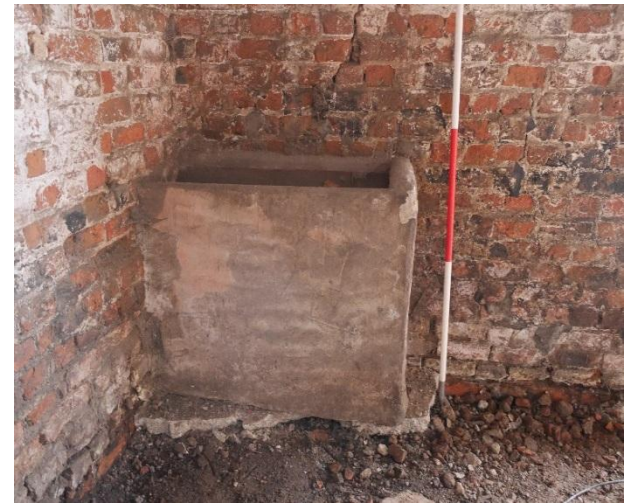
Figure 15: 1991 (inscribed on the side) Concrete Trough.

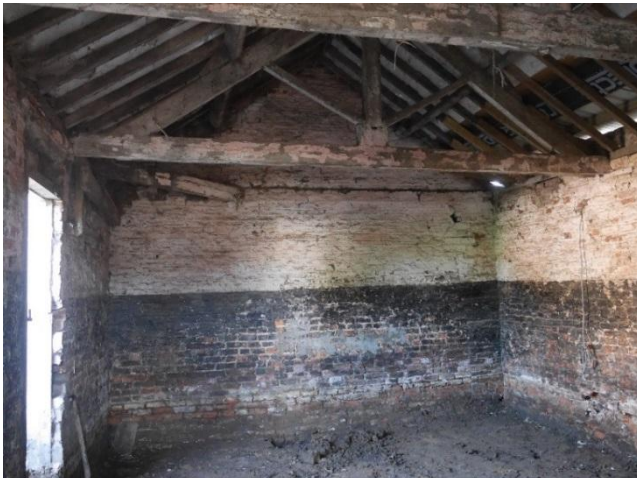
Figure 12: Details of the King Post Roof Construction Typical of All Three Buildings.

The roof is pitched under traditional clay pantiles of King Post construction with trenched purlins and vertical rafters (Fig.16). The tiles have been recently replaced or re-laid as roof insulation sheeting was observed between the pantiles and rafters.

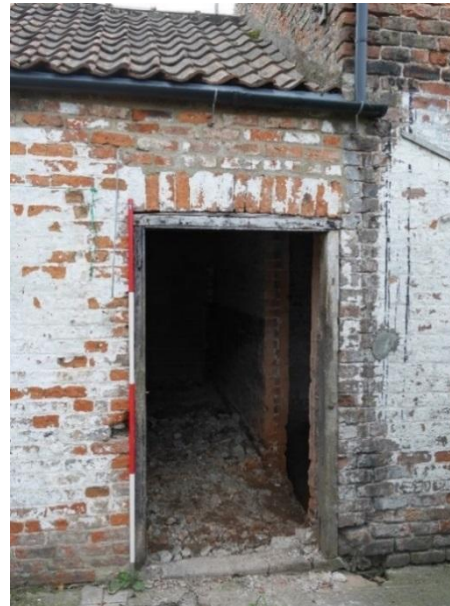
Figure 13: Loosebox West Facing Elevation Entrance. The door frame on the west facing elevation is constructed of timber with a single row brick lintel (Fig.17).

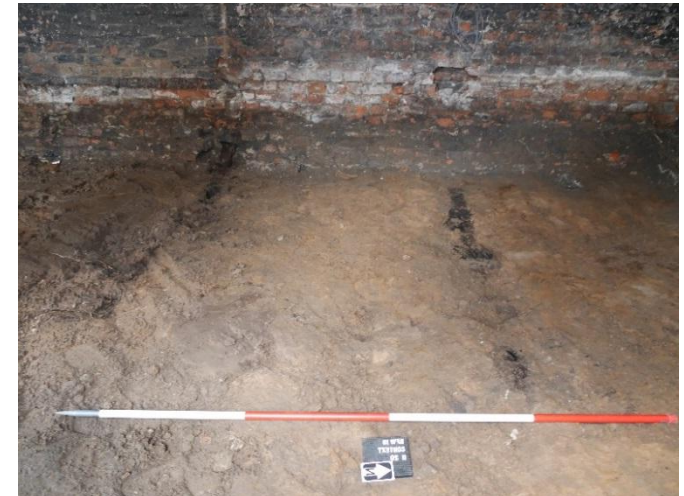
Figure 14: Natural Sandy Flooring inside the Loosebox with Wood Staining from the Original Stalls.

Wood stains indicating the location of wooden stalls (Fig.18). A feature of Looseboxes, natural flooring would build up with manure over time. The importance of keeping livestock warm determined this function/design.

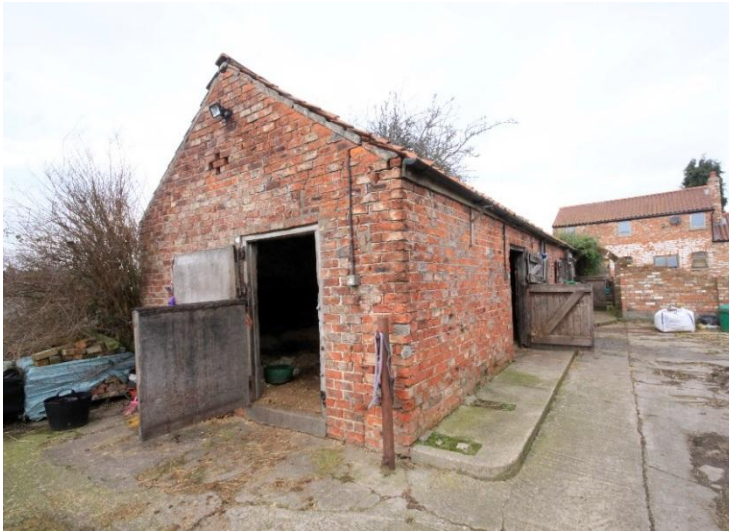
Oblong in plan and measuring 12m in length by 4.5m in width, the single storey double brick walled Cow House is built of red brick bonded by grey mortar (Fig.19). The brick is mostly laid in running bond, although this is not consistent.

Figure 15: South and east facing elevations of the Cow House.

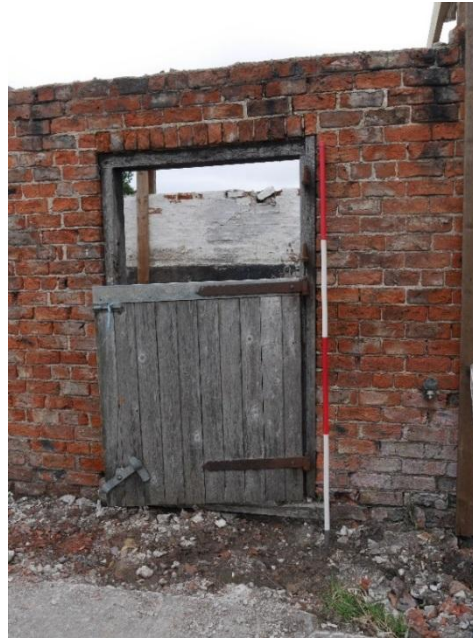
Figure 16: East facing elevation traditional wood plank stable door details.

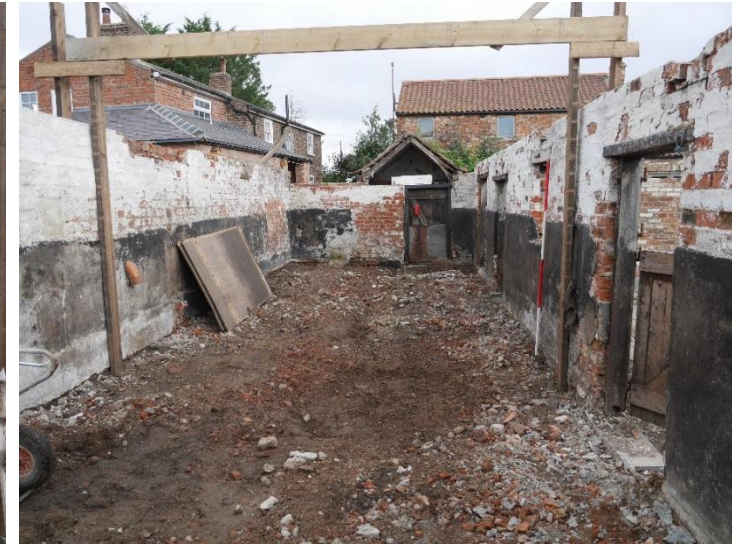
Figure 17: Internal aspect of the Cow House after the removal of the roof and concrete flooring.

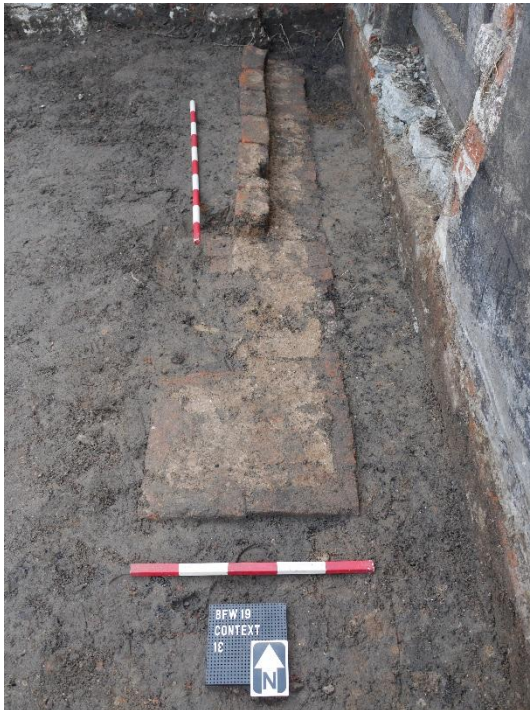
Figure 18: Linear drain Contexts (13) and (14).

A partially complete linear brick structure running parallel to the east facing elevation (Fig.22). Constructed to double brick width, bound with mortar and edged with soldier course. Light brownish grey sandy coarse mortar.

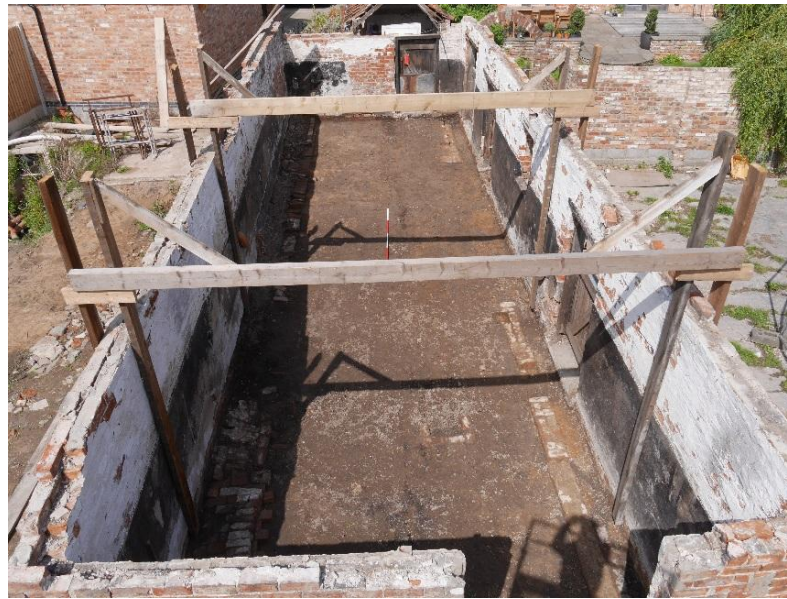
Figure 19: Internal view of Cow House looking north.

Elevated view of the internal floor level of the Cow House showing the linear drain to the right of the photograph and the brick floor/trough to the left (Fig.23).

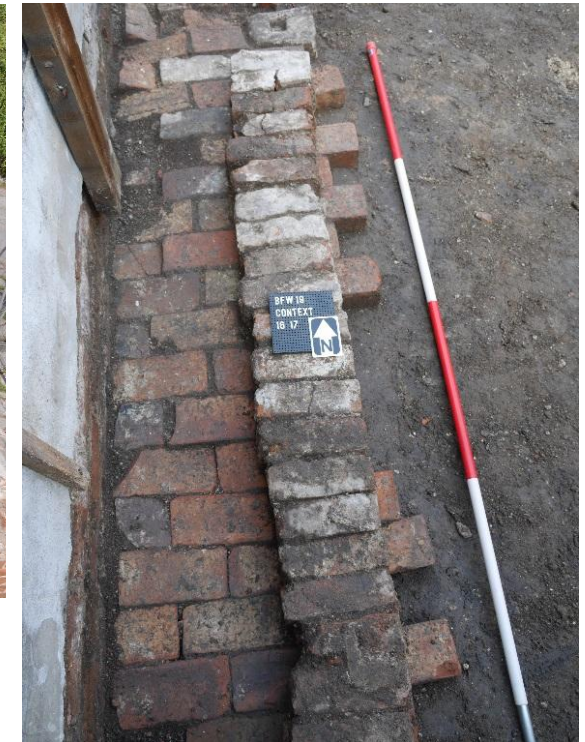
Figure 20: Brick floor/trough Contexts (16), (17) and (19).

Linear feature constructed of a single layer of bricks laid in running bond (Fig.24). Appears to form a type of flooring or base of a structure. A single soldier row of bricks has been laid on top of the base. Feature incomplete and partial in places.

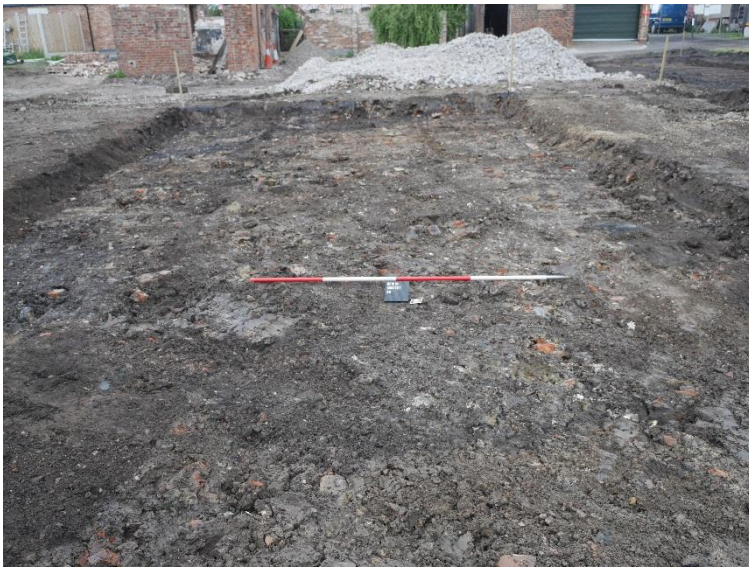
The temporary storage buildings 1 and 2 were demolished prior to the commencement of groundworks in the farmyard area. A poured concrete surface, Context (23) with gravel and mortar inclusions and a depth of 0.2m, covered most of the farm yard area, including the internal flooring of both Storage Buildings 1 and 2. Concrete surface (23) sealed Contexts (24) and (26), both being a very dark greyish brown sandy clay material mixed with round stones, fragments of CBM, and grey mortar. Contexts (24) and (26) included sherds of C20th pottery and glass and extended to a depth of approximately 0.5m. The ground reduction in the farmyard ceased at this level, aside from the excavation of the foundation trenches for two new buildings. These two new building foundations were positioned roughly in line with the old foundations belonging to the two storage buildings.

Figure 21: Post stripping in the Farmyard, Contexts (24) and (26).

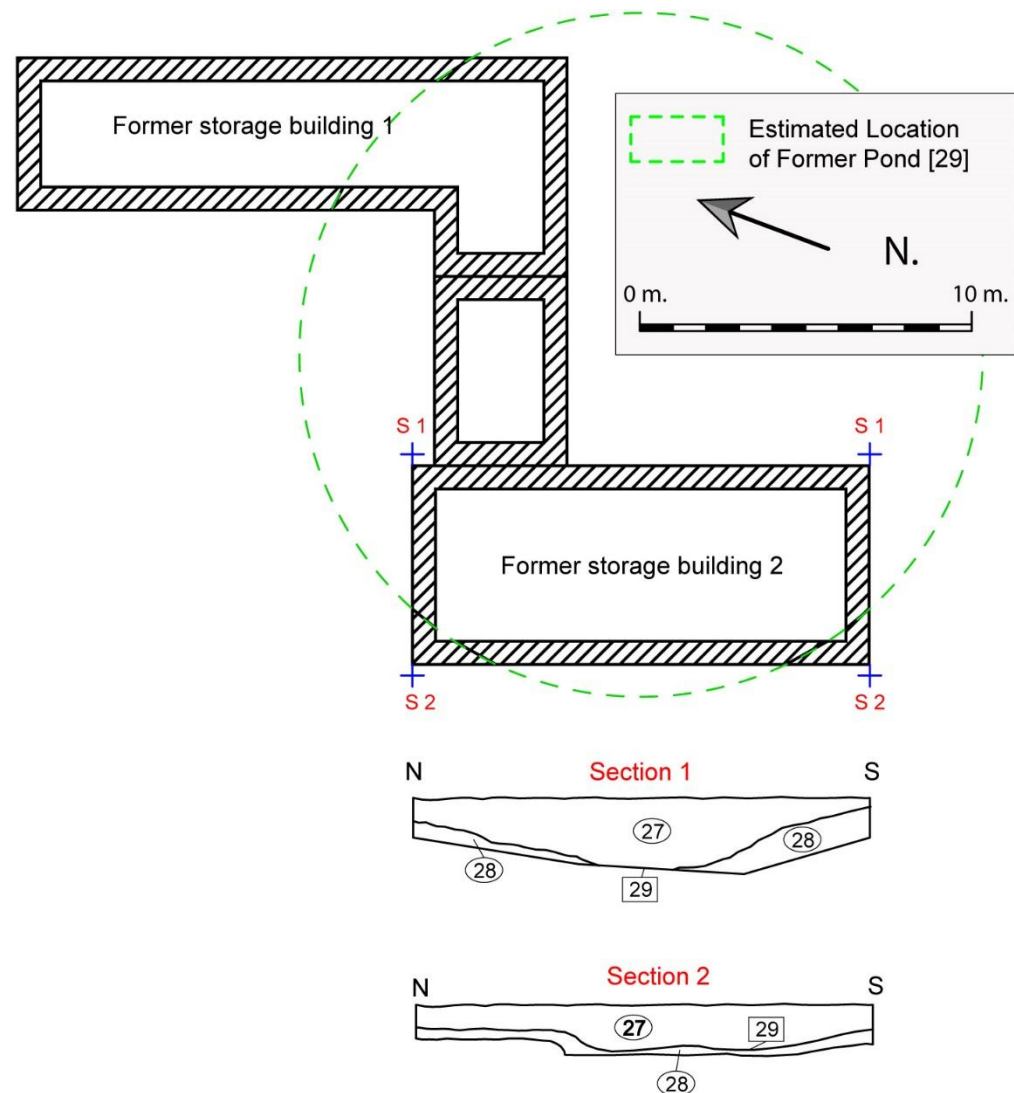
The cut for the pond, Feature [29] (Figs.32 & 33) was the only archaeological feature observed during Watching Brief A and is likely to date to the 19th century; ponds were visible, within the vicinity of the farmstead on the Ordnance Survey Map of 1854.

Figure 23: Section details of pond Feature [29]

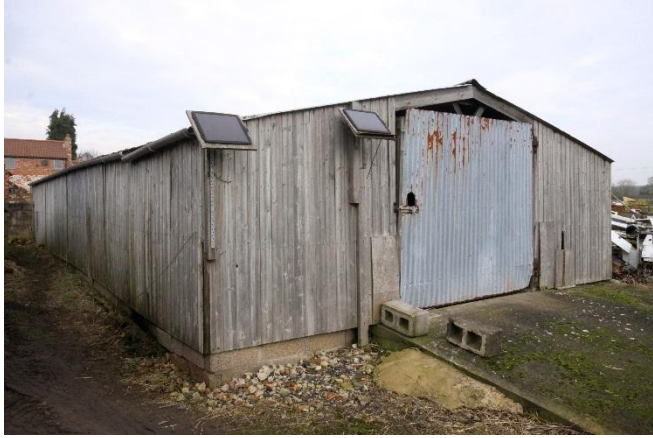
Figure 24: Storage Building 1 looking north-east.

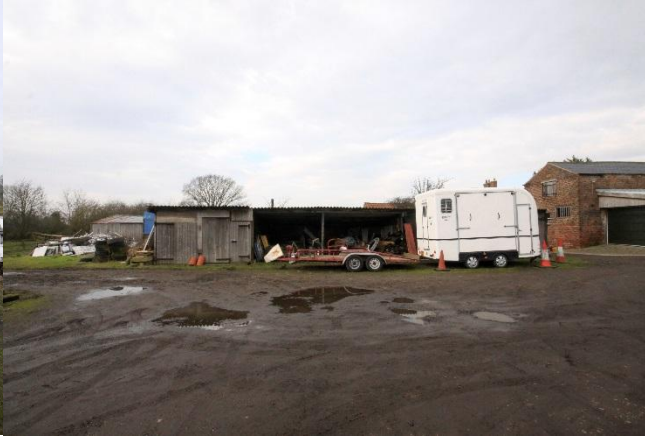
Figure 25: Storage Building 2 looking west.

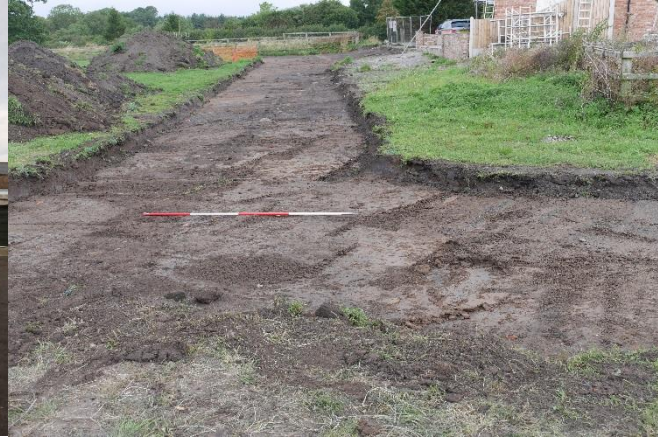
The access road required the stripping of topsoil to a depth of 0.3m, revealing very dark brown sandy clay loam, Context (21) sealing very dark greyish brown sandy clay, Context (22) and no further deposits (Fig.30).

Figure 26: Access Road after stripping looking north-west.

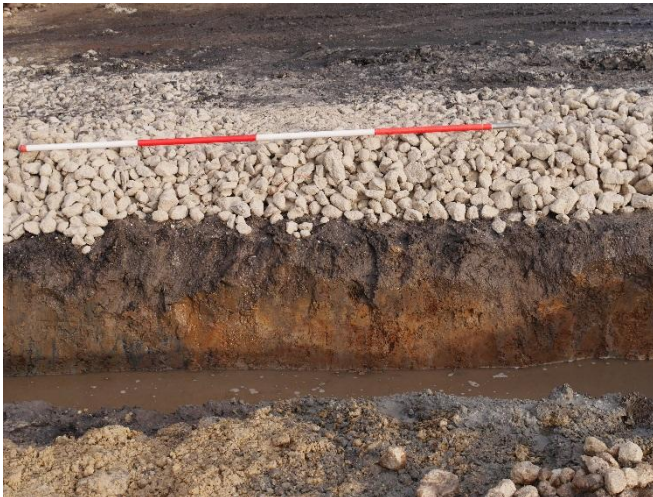
The cut of Feature [29] was concave and cut into the natural. Its primary fill was Context (28); a dark brown clay and loam (Fig.27). Foundation trenches excavated within the footprint of Storage Building 2 revealed Context (25) sealed below Contexts (23), Contexts (24), and (26). Context (25) extending to a depth of 0.15m (Fig. 31) was a dark brown sandy clay loam, mixed with small occasional round stones and tree roots. It was identified as subsoil.

Figure 27: South facing section Contexts (25) and (28).

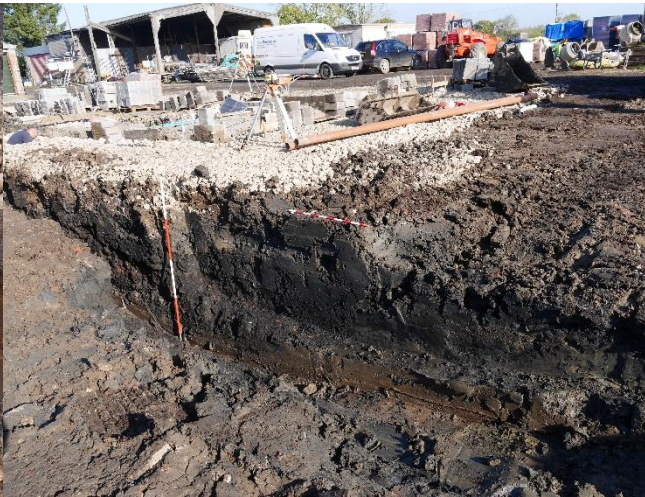
Figure 28: West facing section Contexts (27), (28) Feature [29].

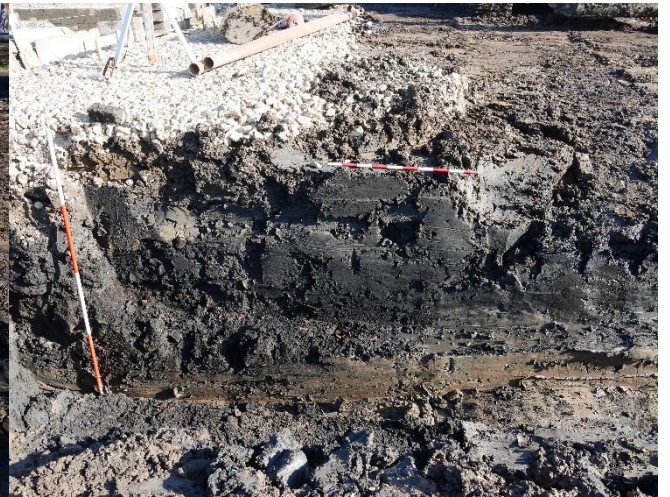
Figure 29: West facing section Contexts (27), (28) Feature [29].

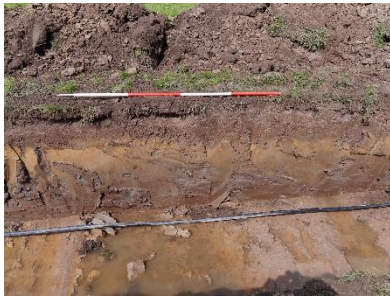
Figure 31: Sterile stratigraphy within trenches.

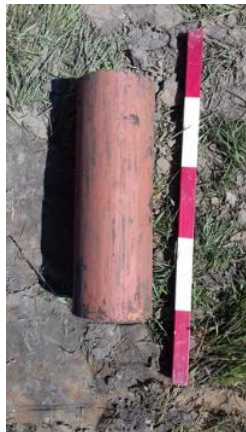
Figure 32: Clay field drain sample.

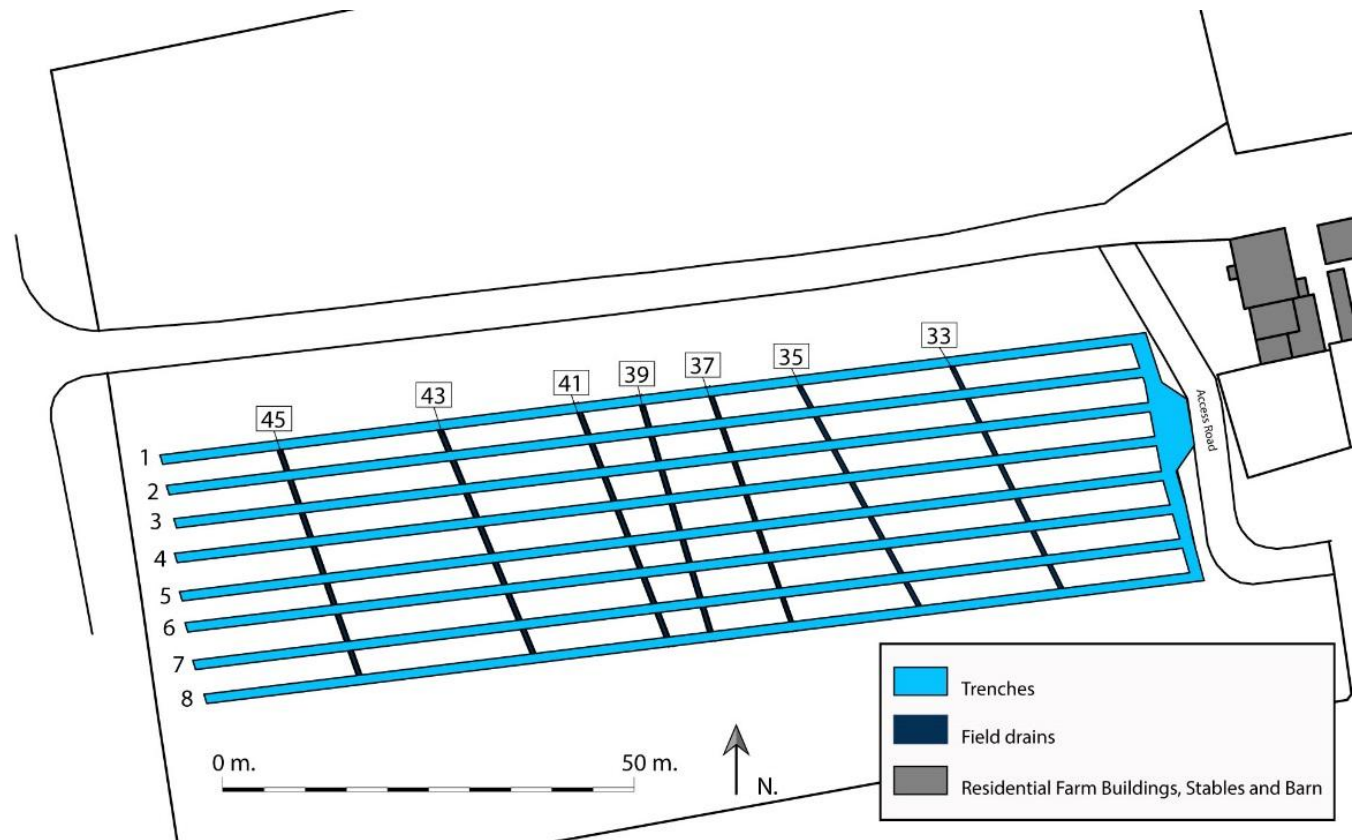
The Ground Source Heat Pump system required the excavation of eight 1.2m by 115m trenches spaced at approximately 5m intervals (Fig.34). The trenches were aligned east/west and extended to a depth of 1.2m. No archaeological deposits were encountered during these groundworks (Fig.35). Features observed were the cuts and fills of north/south aligned 20th century field drains (Fig.36), (Features [33], [35], [37], [39], [41], [43] and [45]) (Figs. 37-44).

Figure 30: Plan of the Ground Source Heat Pump and Field Drains.

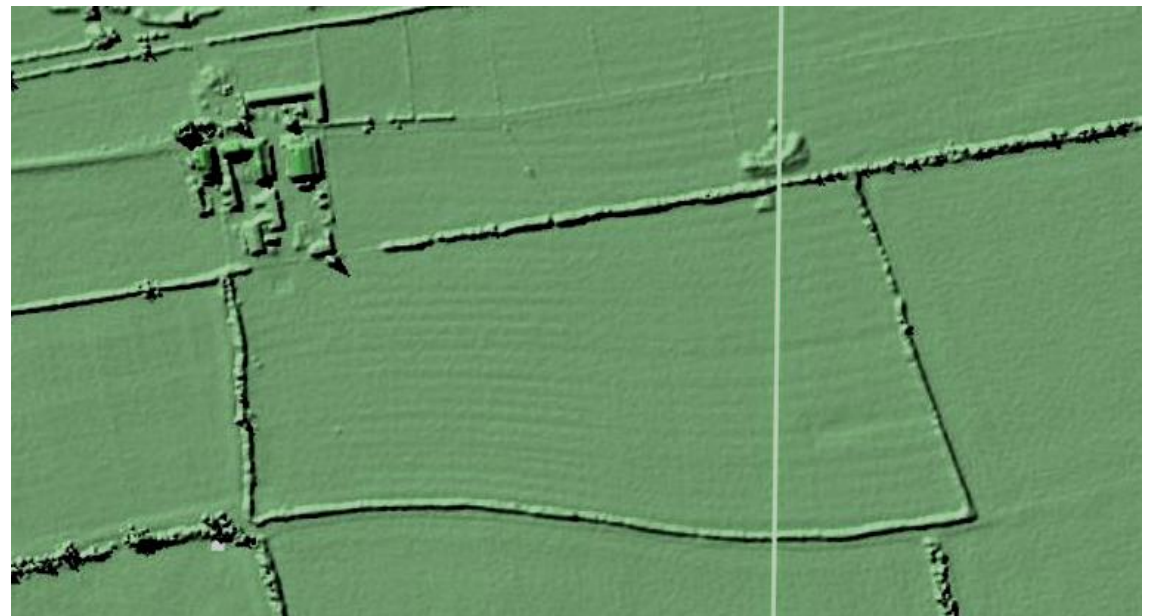
Figure 41: Lidar image of Brecks Farm (top left) inserted into the medieval ridge and furrows (lindarfindar.com).

No evidence was observed of deposits dating from the medieval period. The evidence encountered would suggest that Brecks Farm is likely to have been constructed on land under a planned regular enclosure, rather than being a farmstead with medieval origins.

Broad, 's' curving furrows, which are associated with the medieval period and later, are located to the immediate south and east of the farmstead. This suggests that the land was being farmed during earlier periods. Lidar imagery (Fig. 41) shows Brecks Farm cut/inserted into this earlier agricultural landscape, rather than the landscape being developed around an earlier farmstead.
