Hudson House, York

Report on an Archaeological Investigation

Part 1: Results and Discussion

Site	Hudson House, Toft Green, York YO1 6JT
Site Code	HHY18
County	North Yorkshire
NGR	SE 59739 51628
Planning Application Reference No.	17/00576/FULM
Development	Erection of 4 buildings comprising of 127 flats (C3), office (B1) use, and office or restaurant (B1 or A3) uses, following the demolition of existing office buildings
Images and text	LS Archaeology
Month of Issue	March 2020
Site Dates	Trial Trenches: 28/01/17-30/01/17 Strip Map and Record: 05/02/18-05/03/18 Watching Brief: 01/07/18-30/11/18
Client	Palace Capital Developments Ltd

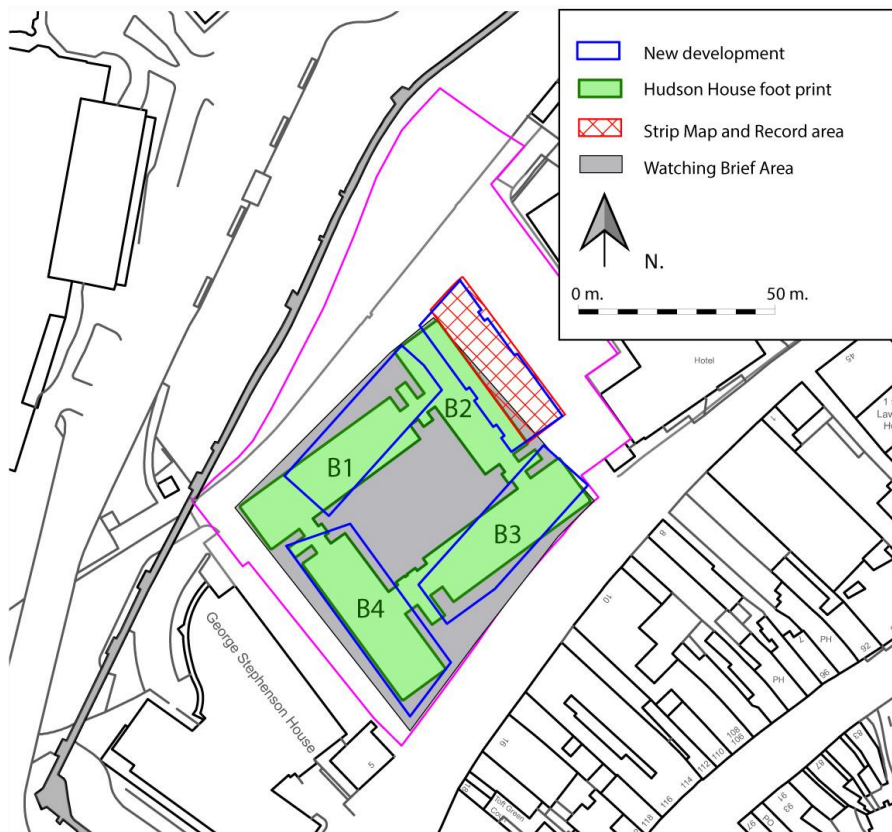
Figure 3: Plan of archaeological monitoring

The condition requested that further archaeological investigations took place via two distinct methods. The first was to strip, map and record the car park area (Area A). Then an archaeological watching brief was assigned to groundworks within the footprint of Hudson House (Area B) (Figure 3).

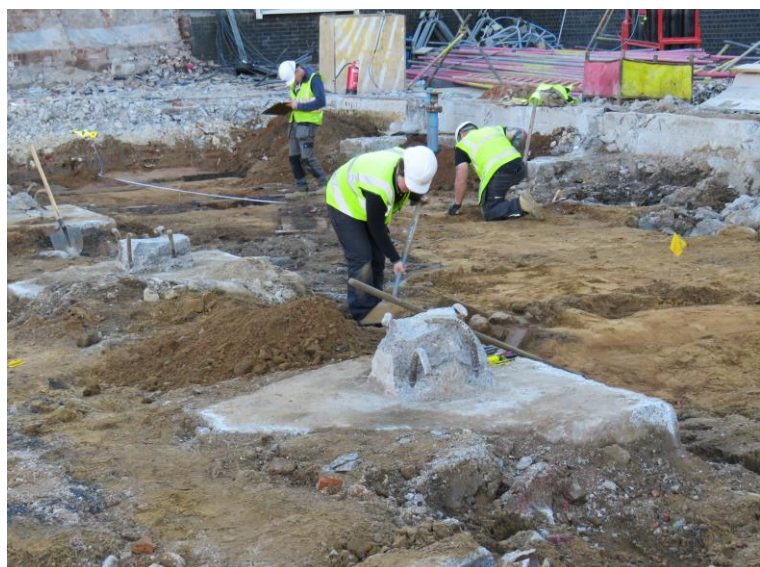
Figure 4: Archaeologists recording archaeology amongst pile cuts

The number of archaeologists required on site would fluctuate depending on the quantity of deposits to be recorded (Figure 4).

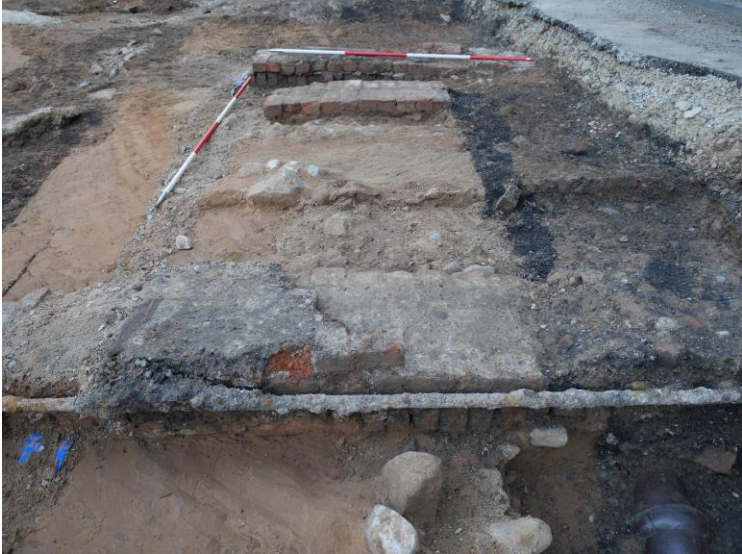
<p>Figure 12: Platform Foundation wall [104] with attached metal water pipe, (107) with [108] and [111] all truncated by utility trench [41] facing SE</p> <p>40.41m of the 1841 departure platform footings were observed in both Area A (Structures [74], [83], (107), [108] and [111]) and Area B (Structures [201], [202], [203] and [326]), measuring a maximum 4.90m width and 1.87m minimum width at its terminus [326].</p> <p>In both areas the structures were sealed below made-up ground contexts (2) and (3) and had been heavily truncated by later utilities associated with the post 1841 phase of the Old Railway.</p>	<p>Within Area A, three brick structures [104], [108] and [111] ran parallel to each other and were aligned roughly NE/SW. [104] (Figure 13 foreground) was 3.13m long NE/SW, 0.61m wide and survived to a height of 0.59m (3 courses). The bottom course was laid in frogless red bricks, header bond, and stretcher on edge. The top two courses were laid in frogless red bricks, and stretcher bond with mortar visible across the exposed upper layer.</p> <p>The southern extent had been truncated by trench [41] for drainage pipe [20], and a modern water pipe truncated the northern extent. A metal water pipe (107) was attached to the western edge of the structure and was not disturbed by the service trenches.</p> <p>[108] (Figure 13 centre) was a single layer of frogless, red bricks that were 1.22m long, 0.46m wide and 0.11m high, laid directly on the natural clay, sand and cobbles, and running NE/SW. Laid in a standard Header Bond, the southern extent had been truncated by trench [41], a utility trench laid underneath the metal water pipe (107). Trench [41] was cut during the later 20th century phase of the York Old Railway.</p> <p>The construction of [111] (Figure 13 background) was similar to [104] but was 2.44m long NE/SW, 0.66m wide and 0.29m (3 courses) high.</p>

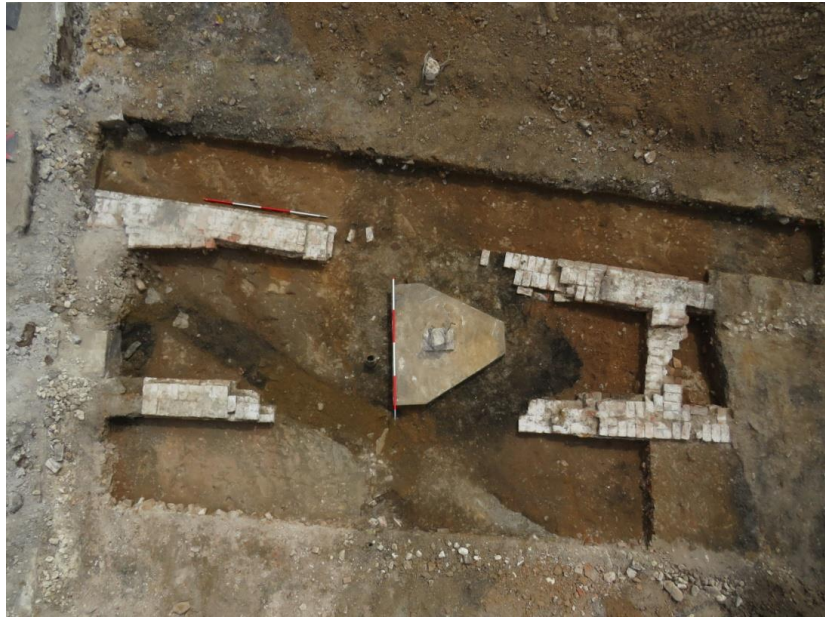
<p data-bbox="427 874 1218 938">Figure 13: Departure platform structures [201], [202] and [203] in Area B with pile [571] truncating its center</p>	<p data-bbox="1279 256 2083 408">The construction technique employed a mix of bonds, including Stretcher Bond on the facing edge of the easternmost footing [201] and English Bond on the facing edge of the westernmost footing [202].</p> <p data-bbox="1279 464 2092 536">The frogless red bricks of the structures were bonded with grey lime mortar.</p> <p data-bbox="1279 584 2069 655">The central extent of the platform footings had been truncated by pile [571] (Figure 13).</p> <p data-bbox="1279 711 2092 823">The southernmost 'H'-shaped portion of the platform footings [203] showing English Bond facing edge with metal pipe (107) work still attached. This metal pipe would have carried water (Figure 7).</p> <p data-bbox="1279 879 2080 991">The same metal water pipe (107) was initially observed in a section [104] of the departure platform uncovered during excavations in Area A (Figure 14).</p>

<p data-bbox="501 1260 1115 1324">Figure 50: Pile Cap [571] cutting Departure Platform [201], [202] and [203], facing SW</p>	<p data-bbox="1272 801 2047 916">The caps were sub-triangular and approximately 0.34m of the cap would protrude above the level that contained features associated with the 1841 railway (Figure 50).</p> <p data-bbox="1272 960 2047 1075">The caps were generally 1.80m in length from vertex to base and were reinforced with rebar, which protruded from the cap centre (Figure 51).</p> <p data-bbox="1272 1120 2047 1190">The foundation ring beams and lift shaft [394] were present on site below the 1841 archaeological level.</p>

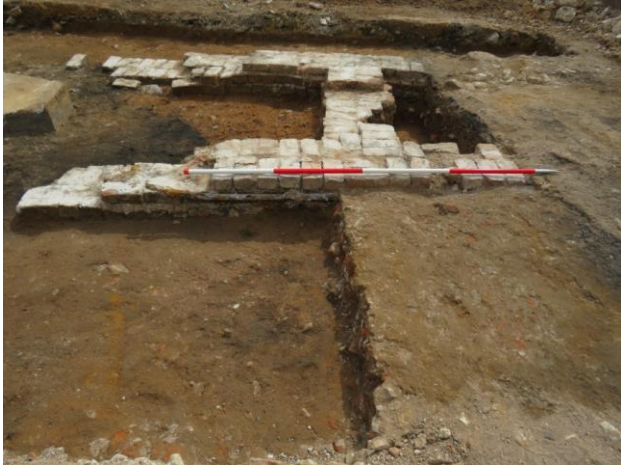
<p>Figure 14: 'H'-shaped section of Departure Platform foundations Structure [203] with metal water pipe (107) facing SE</p>	<p>The terminus [326] of the Departure Platform was observed 19.71m approximately to the south-west of the 'H'-shaped section [203] (Figure 15).</p> <p>One course of red frogless brick was exposed and was bound with grey mortar.</p> <p>Structure [326] measured 1.90m in length, 2.30m in width and had an exposed height of 0.08m (Figure 16).</p> <p>This layer of bricks had one row of stack bond soldiers topped with stack bond headers, partially along the interior elevations and exterior.</p>

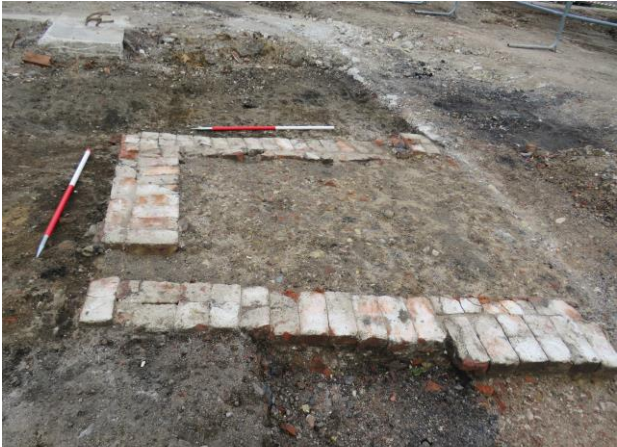
<p>Figure 15: Departure Platform Terminus Structure [326] facing SE</p>	<p>The bricks appear to have been utilised to create a non-standard shape that tapers at its end, with the bricks positioned as appropriately as possible.</p>

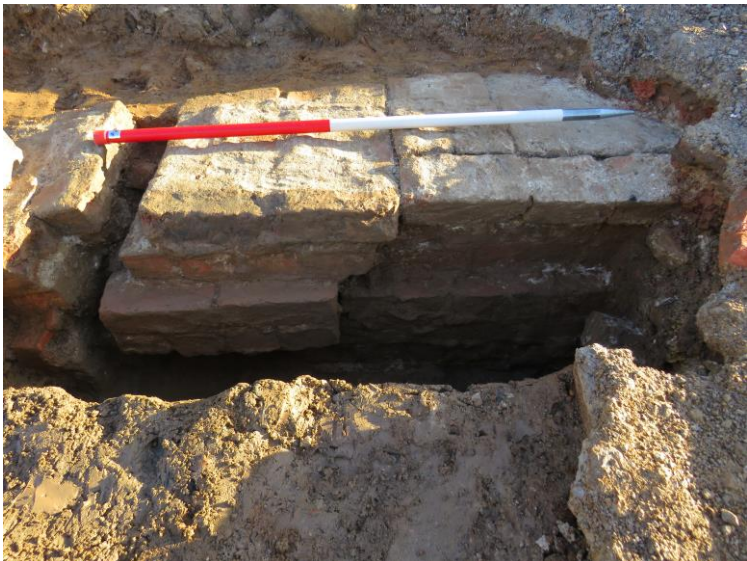
<p data-bbox="445 842 904 871">Figure 16: facing section of [491] facing SE</p>	<p>The partially complete wall foundations of the external elevations of the 1841 stable block [484], [491] and [547] extended for approximately 19.25m aligned NW/SE parallel to [497] following the retaining wall's slight curved angle. There was evidence that the stable foundations were comprised of a mortar base, as seen in wall structure [491]. The wall was constructed of frogless red bricks laid in English bond, 6 courses of bricks were observed (Figure 17).</p> <p>The mortar sampled from [547] was visually homogenous to other structures from 1841 across site. <i>'It comprised of a combination of 1 part feebly hydraulic lime, although this hydraulic nature could have been created by the finer ash content, to 1.5-2 parts of silica sand, unburnt lime and waste ash'</i> (Womersley, 2020).</p> <p>Partial foundation walls [550] and [560] consisted of an English bond, frogless red brick and mortar wall that extended NW, perpendicular to retaining wall [497]. Structures [550] and [560] had been truncated by pile [487].</p> <p>Partial foundation wall [535] extended NW for 4.60m, at a right angle to wall [497], and was laid in English bond in frogless red bricks and grey mortar. Wall [535] was truncated at its north end by a concrete deposit associated with Hudson House [521]. Wall [535] functioned as an internal partition wall separating two spaces within the Railway Stables, as indicated on the 1852 OS Map (Figure 74).</p>

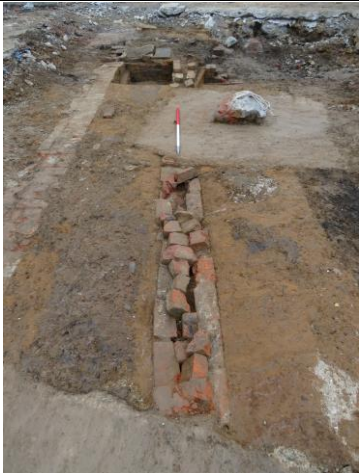
<p data-bbox="539 740 1061 804">Figure 18: Drain [475] cut by pile [485] with wall [484] running parallel to the left facing NE</p>	<p data-bbox="1279 300 2085 576">Aligned with the Railway Stable front elevation walls, was a narrow drain [475] (Figure 19). It was constructed of frogless red brick walls, bound with grey mortar, with a grey slate base and grey, soft clay-sand, internal fill (474). A metal pipe (476) ran parallel to the drain [475] for approximately 1.00m, then disappeared beneath [475]. Drain [475] was truncated by concrete pile [485] but continued to the NE, surviving for 4.40m.</p> <p data-bbox="1279 632 2085 826">External drain [475] would collect downpipe water runoff from the Railway Stables roof guttering, the water running south-west into larger drain [481] (Figure 20). [481] intersects with wall [484] and drain [475] flowed into it. The internal faces of the bricks in drain [481] are stained black similar to [538].</p>

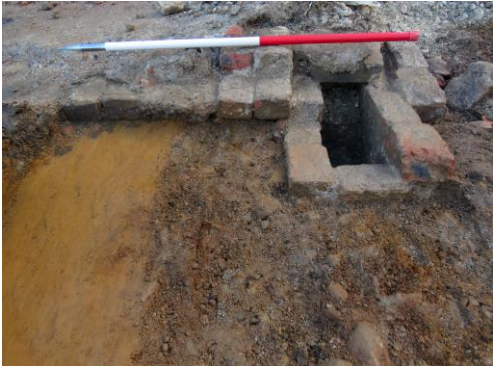
<p data-bbox="501 1240 1016 1303">Figure 20: Surface Water Drain/Sink Gully [517] facing SE</p>	<p data-bbox="1279 879 2085 1031">Surface water drain/sink gully [517] (Figure 21) are constructed with the standard frogless red bricks, bound with grey mortar, and had a black, oily industrial sediment fill (531).</p>

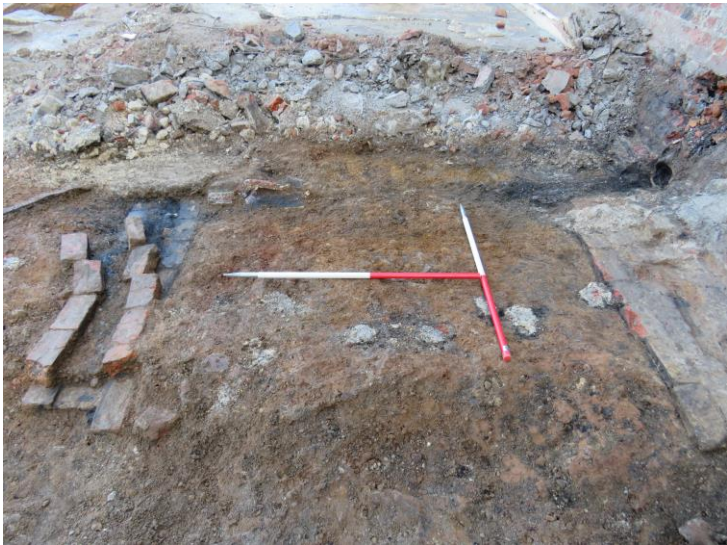
<p>Figure 21: Rectangular brick structure [514] and adjacent Weep Hole [582] to the left with drain [516] to the right, facing NE</p>	<p>A rectangular brick structure [514] is positioned parallel and adjoining to wall [497]. Mortar is visible at the top of the exposed bricks, suggesting there were once more courses. This may have been constructed to support a fire/small furnace for a blacksmith. It is located within the stable area underneath possible flue scarring (505) and (506).</p> <p>Weep hole [582] protrudes from retaining wall [497] and consisted of the fragmented end of a 0.01m in diameter ceramic pipe. This pipe discharged into a drain/open gutter (visible through staining) that was linked to drain [516].</p> <p>Drain [516] was aligned NE/SW, and had been badly disturbed, surviving to a length of 1.56m. It contained oily, black sediment (531) and was similar to fill (515) of drain [516], which was located approximately 2.00m to the north-west.</p>

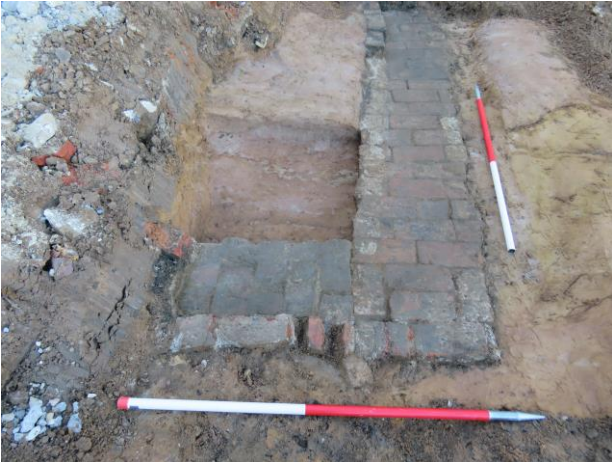
<p data-bbox="472 695 869 722">Figure 22: Brick Wall [442] facing SW</p>	<p data-bbox="1279 252 2089 363">Structure [442] was 'L'-shaped, constructed of frogless red brick and grey mortar. It was possibly a wall or a pathway/walkway (Figure 23).</p> <p data-bbox="1279 408 2051 560">The bricks are arranged in a stretcher bond with a soldier edging. The wall's western edge is uneven and was truncated or possibly removed later. The eastern return of the 'L' appears to butt the north/south part of the structure, as the bricks are not tied in.</p> <p data-bbox="1279 604 2078 756">Given the location of this wall [442] as seen on the 1852 OS Map, it is likely that this was either a tapering wall of uncertain height constructed to create an enclosed area, or the foundations of a narrow external walkway.</p>

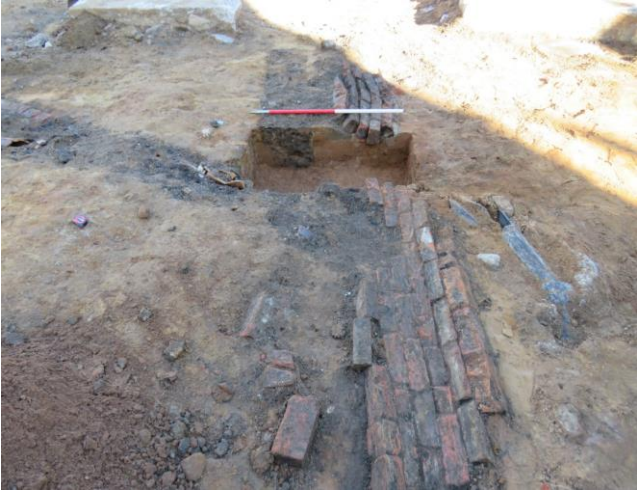
<p data-bbox="472 1302 949 1329">Figure 23: Brick Culvert Base [441] facing NE</p>	<p data-bbox="1279 804 2069 916">A 4.94m length of the base of a culvert/drain [441] aligned NE/SW was situated towards the western edge of the Railway Stables (Figure 24).</p> <p data-bbox="1279 967 2074 1078">The culvert was 0.56m in width and had a depth of 0.18m. Red frogless bricks were placed directly onto natural silty-clay sand in a rowlock, running bond arrangement, with bull header prominent.</p> <p data-bbox="1279 1129 2085 1329">A defined, curved cut [439] for gutter [441] was observed in section and a fine black/grey clinker and mortar fill (440) was packed into gaps at the structure's edges and between bricks. The NE portion of the [441] had evidence of ground shifting compared to the SW portion, which was still intact.</p>

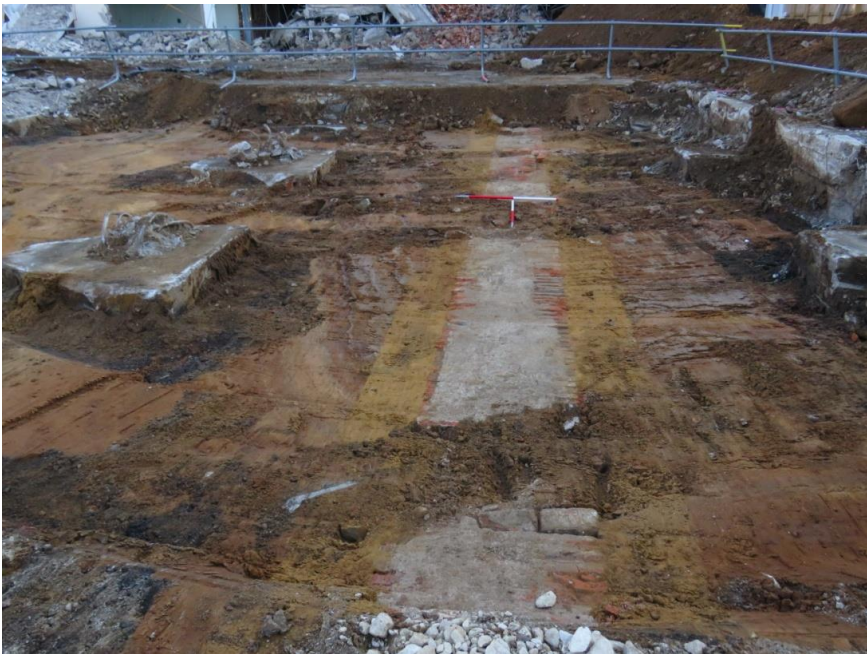
<p>Figure 24: Foundation wall [393] of the Merchandise Station. Vertical cut [426] into natural dark brown sandy clay [561] with sandy yellow back fill (425), facing SE</p>	<p>Foundation walls associated with the rear elevation [433], [436], [489], [490], [519] of the Merchandise Station and one central partition wall and adjoining front elevation [393] were present.</p> <p>The internal wall and adjoining front elevation [393] were seen cut [426] into the dark brown sandy-clay natural [561], with striking yellowish sand backfill (425). This feature was a 3.90m long, NW/SE orientated, 1.70m wide, brick-built foundation wall [393] (Figure 25).</p> <p>[393] was a central internal wall, located within the Merchandise Station and situated between two turntables, with turntable [398] located approximately 3.50m to its east.</p> <p>Sondages [416] and [422] were excavated to investigate foundation wall [393].</p>

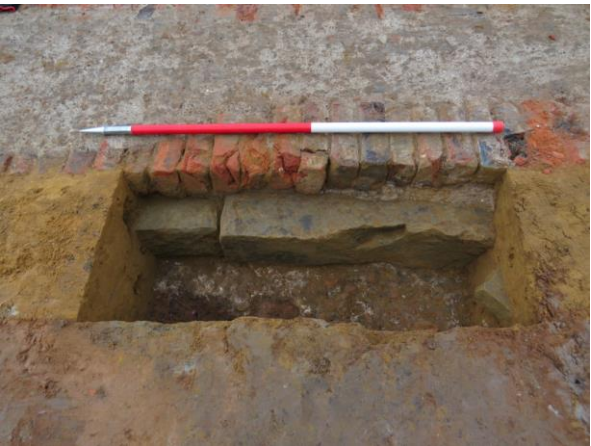
<p>Figure 25: Sondage [416] exposing foundation layers (414) and [412], facing NE</p>	<p>The substantial size and height of the Merchandise Station and the instability of the natural determined that it was necessary to consolidate the ground beneath wall [393] to provide a solid base.</p> <p>Including fragmented brick rubble/mortar ground consolidation deposit (414), and flagstone leveling layer (412), the structure was 1.14m deep.</p> <p>Figures 18 and 19 show the fragmented brick rubble and mortar consolidation deposit (414), and coarse grain sandstone flagstone leveling layer (412). The flagstones were up to 1.31m in length, 0.98m in width and 0.19m in depth.</p>
<p>Foundation Wall [416]</p> <p>Plans 9-12</p>

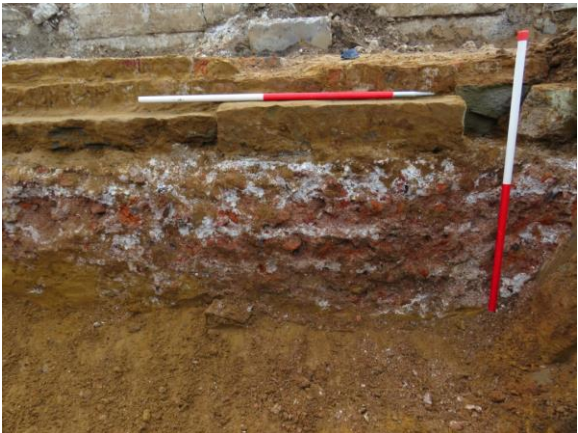
<p>Figure 26: Brick and mortar ground consolidation deposit (414) of approximate depth of 0.65m, facing NE</p>	<p>The red bricks to the edge of wall [393] above [412] were laid in Header Bond, stretched to the base. A layer of greyish white mortar concealed the central extent of the wall.</p> <p>The vertical construction cut [426] for [393] (Figure 26) was approximately 2.30m wide and was backfilled with soft, yellow sand (425).</p> <p>The north-western extent of the wall was truncated by trench [419], which contained a black metal service pipe (417).</p> <p>The central extent of the wall was truncated by trench [422], which also contained a black metal service pipe (420) (Figure 28).</p>

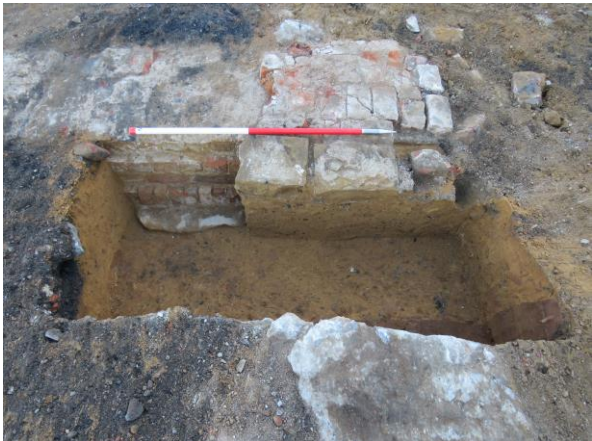
<p>Figure 30: Merchandise Station Foundation Wall [433], facing SE</p>
<p>Foundation Walls [393], [433], [436] and [490].</p> <p>Plans 9-12</p>	  <p>Figure 31: Pre-Excavation of Foundation Wall [436] and adjacent post 1841 inspection chamber [434], facing SE</p>

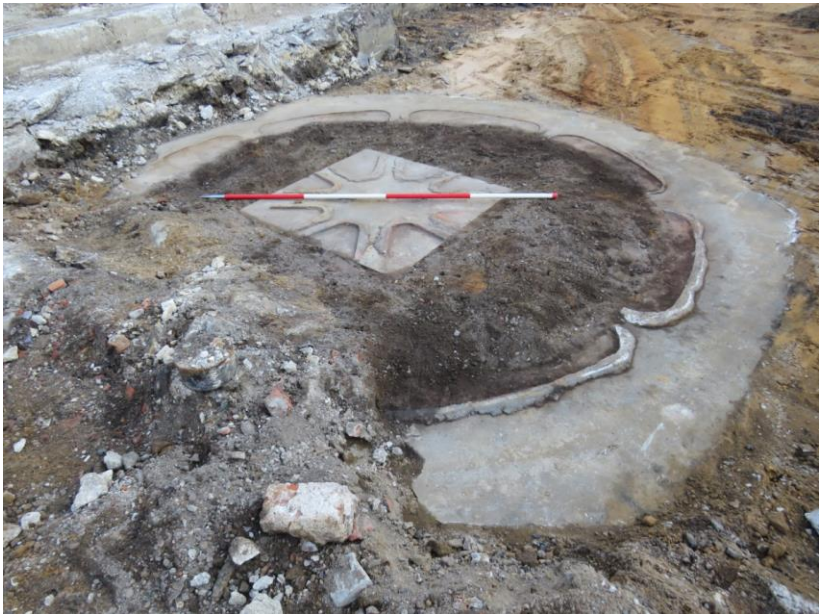
<p>Figure 35: Turntable Base [397] and [398] facing SW</p>	<p>The area between the outer arc and the sub-square block was filled with a loose, black clinker material (413). Turntable [397] was cut to the north by service trench [580].</p> <p>The central sub-square block [398] (Figure 37) was lifted by machine after archaeological recording. The lifted block sat at a height of 0.60m; 0.20m consisting of the fine concrete shuttered surround to top with tamped or float finish with spider casting. The lower 0.40m is rough cast <i>in situ</i> concrete.</p>
<p>Turntable Base [397] and [398]</p> <p>Plans 11-12</p>	<p>Located to the southwest of turntable base [376] and [377] was a near complete, formed concrete turntable base. The outer arc [397] surrounded the central sub-square block [398] (Figure 36).</p> <p>[397] was 2.94m in length, 1.18m in width, while [398] was 1.22m in length and 1.18m in width. The overall diameter of the turntable was 4.18m.</p>

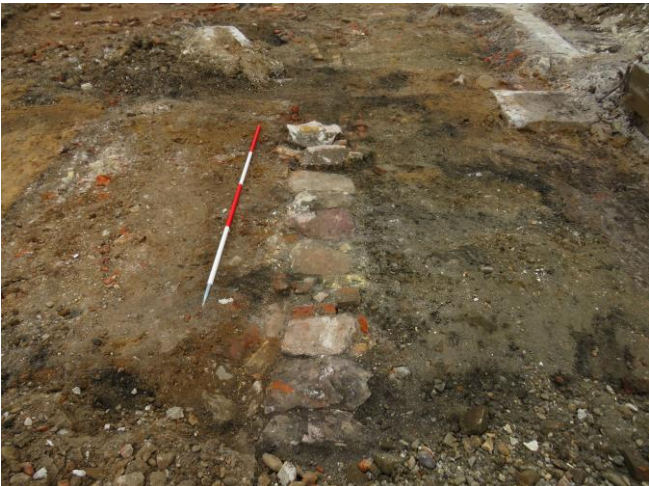
<p data-bbox="506 762 1133 826">Figure 37: Pre-Excavation Image of Box Drain [188], facing SW</p>	<p>A railway requires substantial and effective drainage to ensure the tracks remain functional. This was evident in the large quantity (total 35) of well-constructed box drains found in all areas of the site:</p> <p>[6], [11], [49], [53], [77], [89], [129], [150], [156], [159], [161], [169], [188], [233], [237], [261], [269], [288], [311], [321], [324], [325], [330], [347], [350], [355], [368], [372], [475], [481], [499], [516], [538], [541], [556].</p> <p>The vast majority of box drains were aligned SW/NE with water being directed close to the lines, down the slope and out of the City Wall Arches, towards a larger drainage system that discharged into the River Ouse via Holbeck Beck.</p>

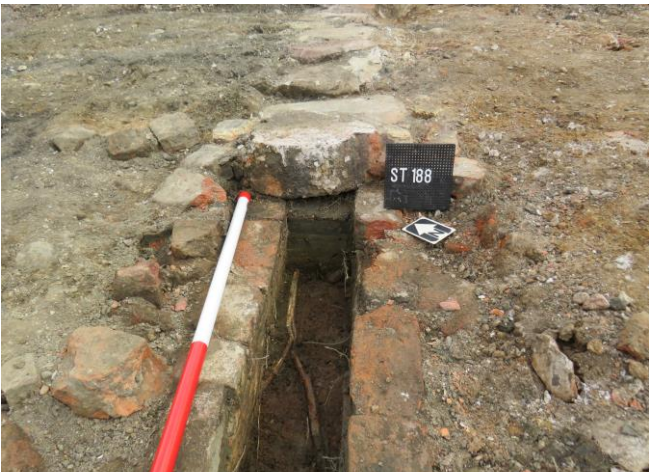
<p data-bbox="506 1329 1104 1361">Figure 38: Post Excavation of Box Drain [188], facing NE</p>	<p>Box Drains were:</p> <ul style="list-style-type: none"> • Aligned west-east, close to rail tracks and the Departure Platform • Next to the external turntable associated with the Merchandise Station • Perpendicular to the retaining wall • Located internally and externally to the stables <p>The characteristics of the drains were primarily the same: a base, sides constructed of brick, and with a stone slab or brick cap as seen in Box Drain [188] (Figures 38-39).</p>

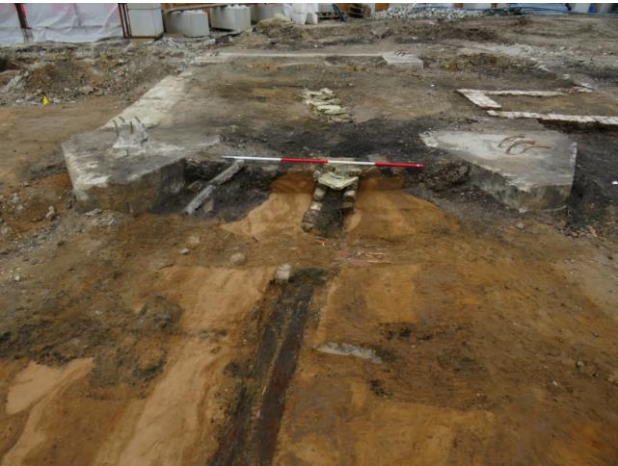
<p data-bbox="495 759 1070 786">Figure 39: NW/SE aligned wood lined Box Drain [324]</p>	<p>Variations in the box drains included:</p> <ul data-bbox="1328 347 1848 592" style="list-style-type: none"> • drains with wood lined bases • box drain alignment (NE/SW or NW/SE) • parallel groupings of box drains • sediment consistency and colour • graffiti • preservation <p>An 8.00m section of a box drain with a wood lined base [324] (Figure 40) in varying degrees of completeness narrowly missed the cuts required for Hudson House concrete and rebar piles [306] and [309]. Box Drain [324] was later cut by service trenches [563], [565], and [566].</p>

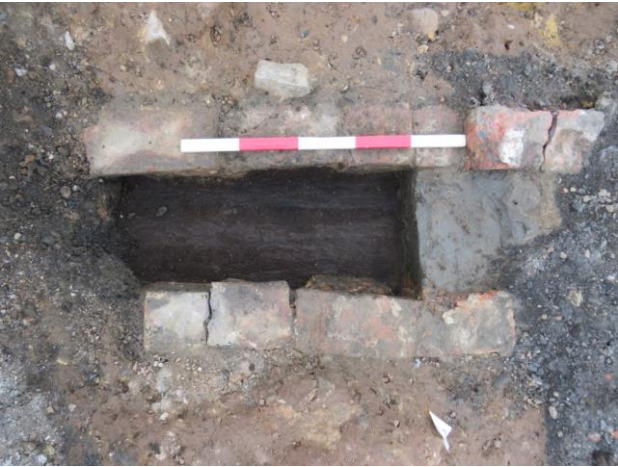
<p data-bbox="495 1302 1070 1329">Figure 40: NE/SW aligned wood lined Box Drain [325]</p>	<p>Box Drain [324] was unusually aligned NW/SE; only four NW/SE aligned box drains [269], [324], [481] and [538] were present on site. [324] was 0.45m wide and approximately 0.40m in height, constructed of three courses of red frogless bricks in running bond and capped with stone.</p> <p>Box drain [324] contained dark brown/black pliable silty-clay sediment (336) on top of its wooden base (337).</p> <p>Six wood lined base box drains were observed on site [129], [233], [321], [324], [325] (Figure 41) and [350]. The wood used to line [129] was assessed as oak (Carrott, Barker and England, 2020).</p>

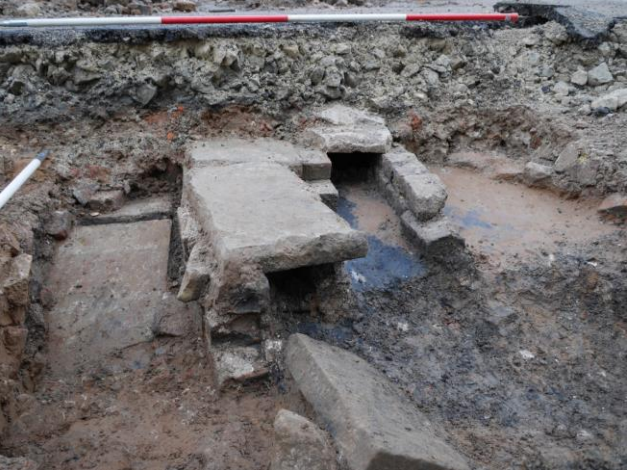
<p data-bbox="495 794 1122 858">Figure 41: Box Drains from left to right [77], [53] and [49], facing E</p>	<p data-bbox="1276 347 2074 419">Examples of parallel drains were observed on three occasions: box drains [49], [53] and [77]; [161] and [162]; [368] and [372].</p> <p data-bbox="1276 475 2098 587">Three brick-built and stone capped structured box drains listed from left to right, [77], [53] and [49] (Figure 42) were encountered underneath made-up ground contexts (2) and (3) within Trench 33.</p> <p data-bbox="1276 639 2074 834">Aligned NE/SW, box drain [49] survived to the longest length of 7.54m. Between 0.28m-0.43m in width and up to 0.35m in depth, all three box drains [49], [53] and [77] appeared to be constructed in a similar manner; with red bricks laid in Stretcher Bond and capped with limestone slabs.</p>

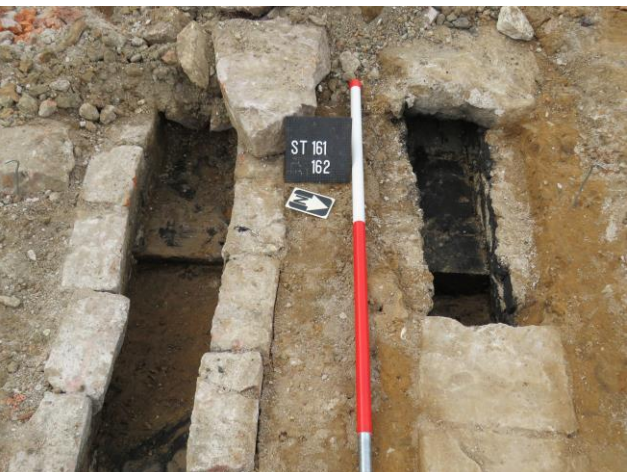
<p data-bbox="495 1361 1003 1393">Figure 42: Box Drains [161] and [162], facing W</p>	<p data-bbox="1276 879 2098 1031">Box drains [161] and [162] were similarly constructed (Figure 35) with identical black clay-silt sediments (160) and (192). Both drain sediments had evidence of lamination which may indicate different periods of heavy water activity.</p> <p data-bbox="1276 1075 2074 1230">[161/185] and [162] measured 1.76m and 2.17m in length, 0.43m and 0.45m in width and <0.20m and 0.24m in depth, respectively (Figure 43). They were constructed of red frogless bricks in a running bond, both capped with angular limestone flags.</p> <p data-bbox="1276 1275 2098 1386">Box drain [161] survived [185] beyond the cut for pile [567]. Alternatively, box drain [162] does not survive beyond the same pile cut.</p>

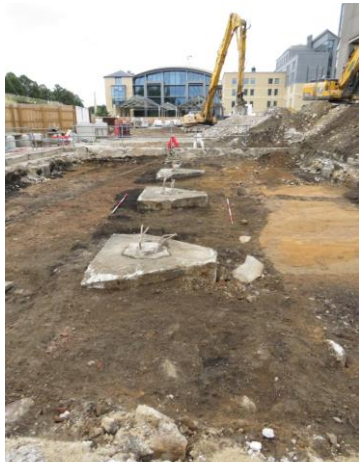
<p data-bbox="624 689 981 753">Figure 49: Pile Caps [297], [300] and [303], facing NE</p>	<p data-bbox="1272 248 2047 402">Hudson House consisted of four multi-storey blocks laid out in a pinwheel, centered on a courtyard. The blocks ranged from four to six storeys, and therefore required substantial piled foundations.</p> <p data-bbox="1272 450 2047 520">Deep piling was required and 48 pile caps were observed during the demolition and stripping of the site:</p> <p data-bbox="1272 561 2047 759">[189], [247], [274], [275], [276], [277], [278], [279], [280], [281], [297], [300], [303], [306], [309], [446], [452], [457], [460], [463], [485], [487], [492], [493], [494], [495], [507], [508], [532], [533], [534], [542], [544], [545], [546], [562], [576], [568], [569], [570], [571], [572], [573], [574], [575], [576], [577] and [578].</p>

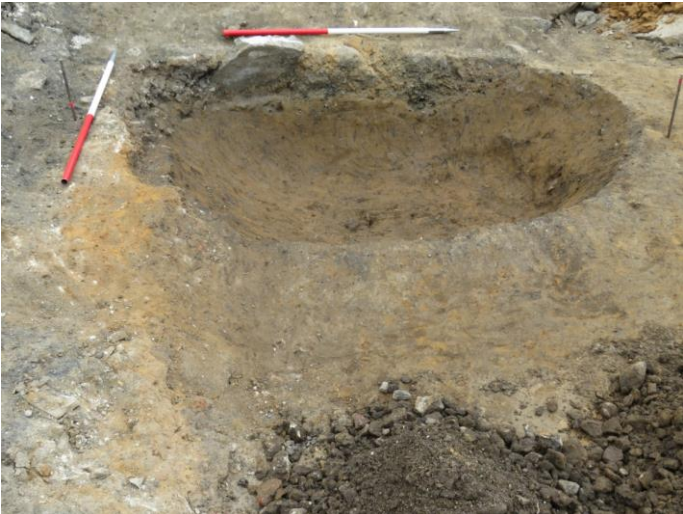
<p>Figure 52: Cut of Pit [251] facing SE.</p> <p>The primary fill (252) of pit [251] contained ceramic building material in the form of Roman Imbrex, Roman brick, Tegula, Tessera Stone floor tiles; three small sherds of colourless and blue/green glass (of unknown function), 2 sherds of pale blue/green glass (Roman window); a natural till flint (associated with glacial moraine); a medium sized group of pottery including late 4th-early 5th century sherds from Dressel 20 type amphorae, a mortarium (with a reeded rim), grey ware, Crambeck grey ware, calcite-gritted ware, Black Burnished ware 1, sherds from colour-coated beakers, 7 sherds of 1st to 3rd residual Samian ware; 396 animal bone fragments including young pig, cattle, sheep and chicken; iron nails; a bone or antler object (possible inlay); stone tesserae; fired clay tesserae; jet offcuts; smith slag, slagged lining; fired clay; and cinder.</p>	<p>Sealing the primary fill (252) of pit [251] was secondary fill (250). The fill comprised of black clayey-silt with abundant inclusions of cobbles, limestone, and ceramic building material. The fill was amorphous- possibly due to build up over time. Oyster shell was visible in the fill but was too fragile to recover completely. The fill appears to have built with material apparently being deposited from the NE edge of the feature.</p> <p>Fill (250) contained ceramic building material in the form of Roman Box flue, Imbrex, Roman brick, Tegula, Tessera, Roman Stone floor tiles, Tessera, lime based mortar and Opus Signinum; a colourless glass rim sherd (from a 2nd-4th century cup or bowl); a large mixed group of mostly late Roman pottery (late 4th-early 5th) including sherds from Dressel 20 amphora, Crambeck mortaria, colour-coated beakers, a colour-coated bead and flange bowl, a Crambeck red ware paint-decorated bowl, a sherd of Derbyshire ware, calcite-gritted Huntcliff jars, grey ware, Crambeck grey ware (including a straight sided bead and flange bowl), an unusual mortarium with a grooved bead, 11 sherds of 1st to 3rd century residual Samian ware; 976 fragments of animal bone including cattle, chicken, sheep, horn cores, deer antler, horse, dog, bird and bone from young pigs (most prevalent); iron nails; stone tesserae; and jet offcuts.</p>

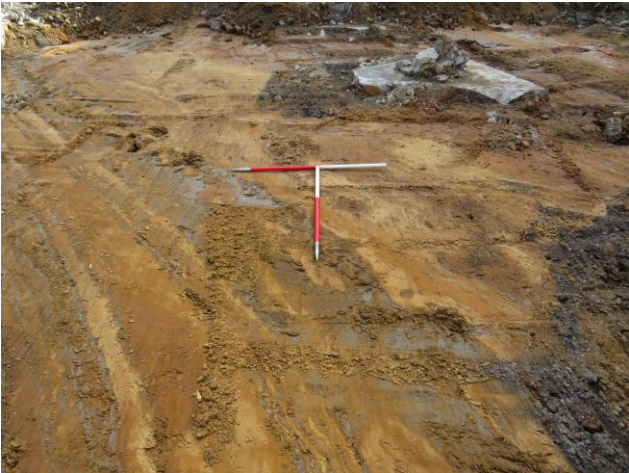
<p>Figure 53: Alluvial Deposit [292] in plan facing SE</p>	<p>3D model: https://sketchfab.com/3d-models/hudson-house-periglacial-deposits-67e69a7e433347249292fa9993739567</p> <p>(257) and (292) were natural alluvial deposits of layered sand and clay particles. Pure sand layers were interspersed with silt and clay layers (Figures 54-55).</p> <p>A sampling programme was undertaken: 8 auger samples (320) and 5 monolith samples (319) were extracted.</p> <p>Evidence of low energy turbulence or 'fluvial rollers' were present in some layers. There was no evidence of peat or organic matter in the auguring samples extracted from the base of the sondage. Only a gravel layer was present and this became impenetrable at a minimum depth of 0.10m and a maximum depth of 1.55m from the base of the sondage and pit [251] (Figures 56-58).</p> <p>The sand, clay and silt layers sloped downwards towards the south-west at a maximum angle of 10 degrees, suggesting that the slope could be due to subsidence into an unknown void/pre-existing surface (Carrott, Barker and England, 2020).</p> <p>Deposit (257) and (292) were cut by a Romano-British pit [251] and amorphous deposits (267), (268), and (270); 19th century drainage [269]; post 1841 railway utilities [248]; piling [266] and utilities [254] for Hudson House.</p>

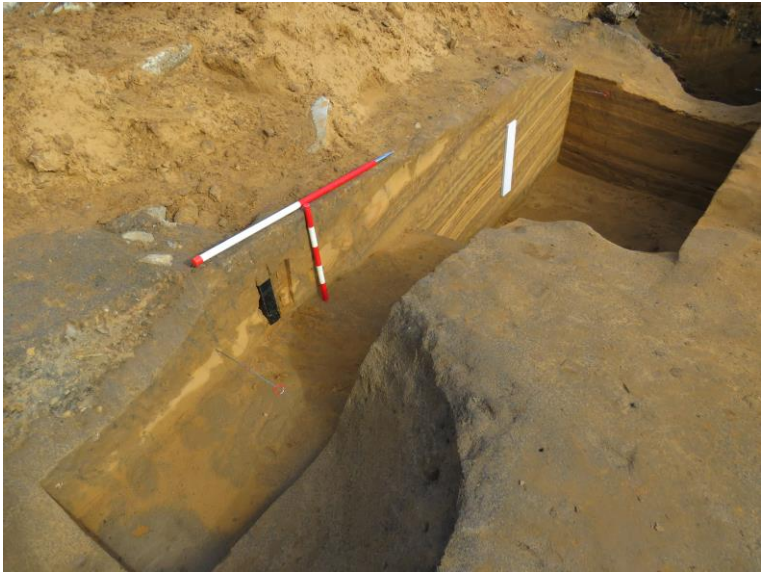
<p data-bbox="456 823 1227 890">Figure 58: Monolith sampling the sondage through the alluvial deposit [257] and [292]</p>	<p data-bbox="1256 264 1877 288">A summary of assessment of the monolith samples:</p> <p data-bbox="1256 344 2047 624"><i>“Investigation of the column samples through the undated alluvial deposits, Contexts 257 and 292, provided little additional information. Interpretatively valuable microfossils (e.g. diatoms which could provide information regarding deposition or pollen which could indicate habitats in the local environment and wider landscape) were entirely absent from the subsamples examined; only occasional fragments of fungal hyphae were noted.</i></p> <p data-bbox="1256 679 2033 831"><i>Two principal mineral components were consistently recorded, a light yellow/yellow-brown (occasionally light/mid brown or grey-brown) fine sand and a light/mid to mid grey-brown fine sandy silt/silty fine sand”.</i></p> <p data-bbox="1256 887 1688 911">(Carrott, Barker and England, 2020).</p>

<p data-bbox="450 999 1234 1102">Monolith sampling (319) was extracted from alluvial deposit [292] and [257] for further environmental assessment (Figures 56 and 59).</p> <p data-bbox="450 1166 1234 1270">These isolated silty-sand alluvial deposits and late Romano-British deposits were unusual for the site and were specifically confined to the far north-western extent of the site.</p>	<p data-bbox="1256 967 1995 1070">These silty sands were interpreted as flood deposits from the River Ouse, formed during the late Romano-British period, or earlier.</p> <p data-bbox="1256 1134 2047 1286">An attempt at ground consolidation was observed through the presence of amorphous black deposits (267), (268) and (270), as well as a large pit [251]. All of these were situated at the northern extent of the alluvial sand deposits.</p>

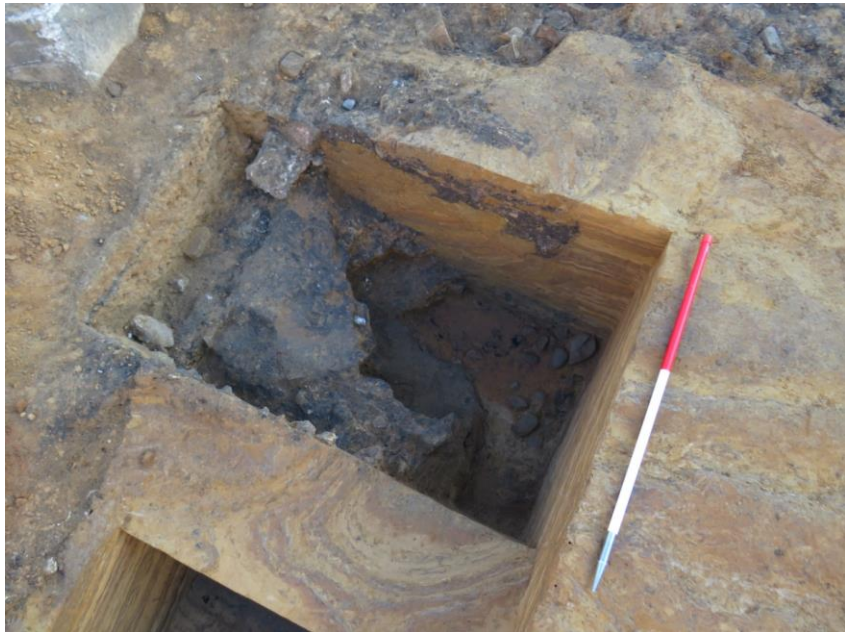
<p>Figure 59: Dump deposits (267) and (268)</p> <p>3D model: https://sketchfab.com/3d-models/hudson-house-periglacial-deposits-67e69a7e433347249292fa9993739567</p> <p>Amorphous, sticky, silt-clay, dense black deposits (267), (268) and (270) were observed to be embedded and sealed within alluvial deposit (257/292).</p>	<p>Deposits (267) and (268) were finds rich, therefore due to the impacted and dense nature of the fill, both (aside from the retained sample) were coarse wet sieved to aid retrieval (Figure 60).</p> <p>Contexts (267) and (268) were excavated to a length of 1.10m NE/SW and varied in width and depth, from 0.42m-1.10m and between 0.13m-0.24m, respectively.</p> <p>The deposits sloped down towards the south-east, suggestive of dumped materials at the edge of a wetland/flood land.</p> <p>Below and to the front of contexts (267) and (268) was the sub rectangular cut of a posthole feature [271]. This was 0.30m in length, 0.16m in width and 0.20m in depth.</p> <p>Dumped deposit (267) abuts the posthole [271] at the base of the sondage. This posthole extended to an equal distance into the sand layers as the dumped deposits did, suggesting a barrier/shoring may have been positioned along this wetland/flood land.</p> <p>The fine bands of silty-sand seen in alluvial (257/292) change- they become more disturbed and appear to end at a vertical angle.</p>

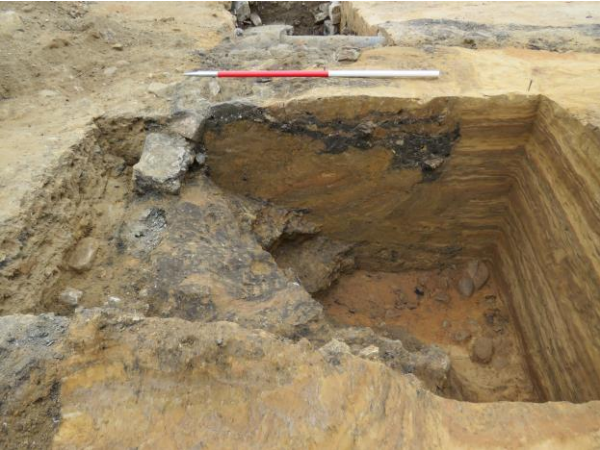
<p data-bbox="517 751 1115 778">Figure 60: Dumped deposit (267) and (268), facing NE</p>	<p data-bbox="1263 266 2049 419">These bands also display a different energy: <i>“swirled’ appearance as if disturbed by a subsequent higher energy inwash or deposited in a backwash against an obstacle not previously or subsequently present”</i> (Figure 61).</p> <p data-bbox="1263 472 1688 499">(Carrott, Barker and England, 2020).</p> <p data-bbox="1263 552 2029 831">A truncated pit/dump feature [259] with fill context (258) was observed in section (Figure 62), sealed underneath alluvial sands (257/292). It had an approximate width of 0.79m and was comparably shallow in depth 0.19m. The deposit was generally amorphous but showed sloping to the south-west. Fill (258) comprised of a sticky silt-clay with small to medium sized stone inclusions.</p>

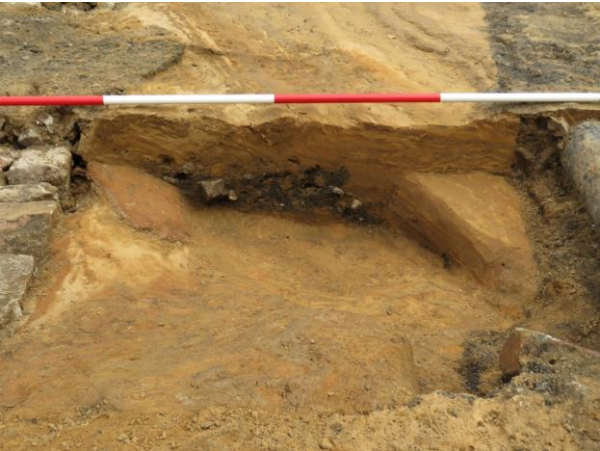
<p data-bbox="517 1289 1115 1316">Figure 61: Feature [259] in section, facing SW</p>	<p data-bbox="1263 884 2018 1082">As noted in the other deposits (267) and (268), the finds within these were mixed; including ceramic building material, fragmented animal bone, and a small group of 3rd to 4th century sherds which included grey ware and a body sherd from a large Soller type mortarium.</p> <p data-bbox="1263 1134 2049 1332">Originally thought to be a pit, further excavation revealed that this deposit was more likely to have been washed into a natural depression within the alluvial deposit (257/292). The shape of this deposit follows the general contours of the silt and sand layers seen in alluvial deposit (257/292).</p>

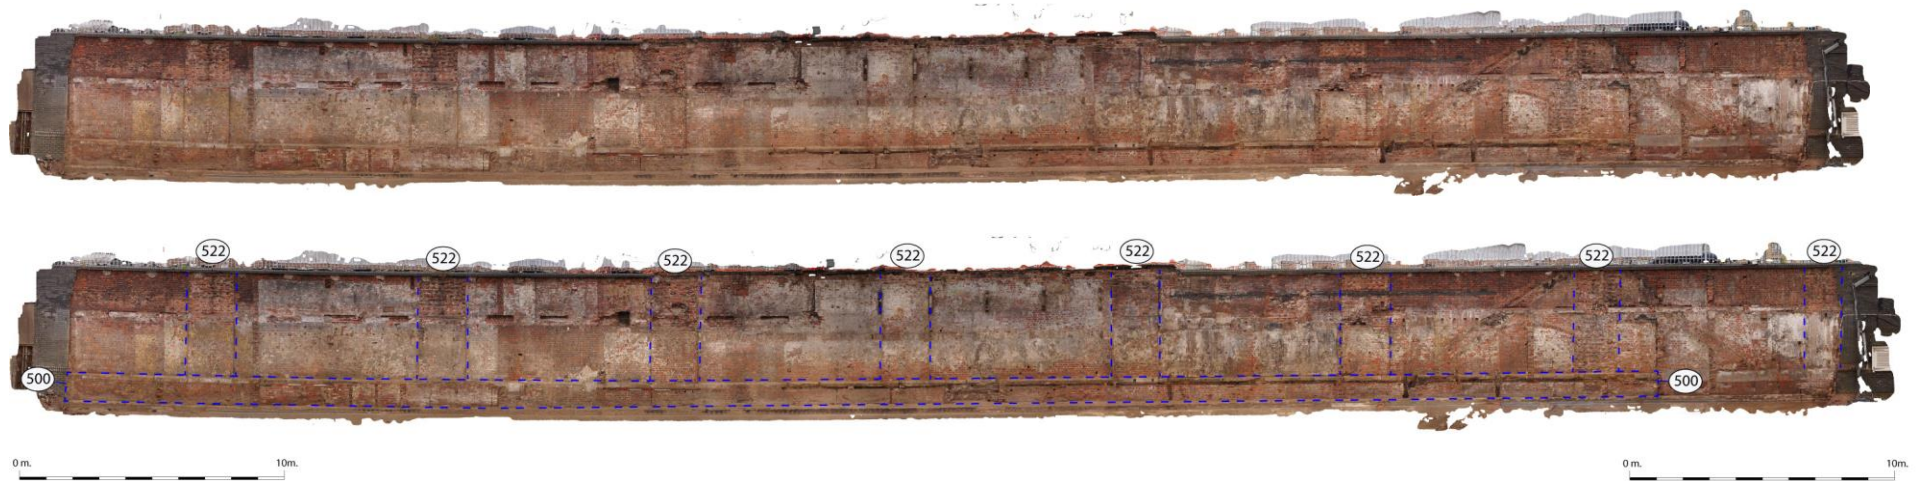
Phase 1 describes the retaining wall at the first stage of completion c.1841.

Earth retaining wall [497], constructed by applying gravity methods, is orientated NE/SW and extends in a curvilinear fashion from the SW at Toft Green Chambers (Monument ID: MYO714) to the NE Main Gates and Wickets (Monument ID: MYO711) of the North Eastern Railway Company Offices (Figure 63).

Wall (Feature [497]) total length is approximately 250m. Of this, 90.00m was exposed within the site of Hudson House, and is constructed of red bricks laid in English Bond style bound with grey mortar. Feature [497] has a wall base plinth (500), enabling the weight of the structure to be distributed more evenly through the ground.

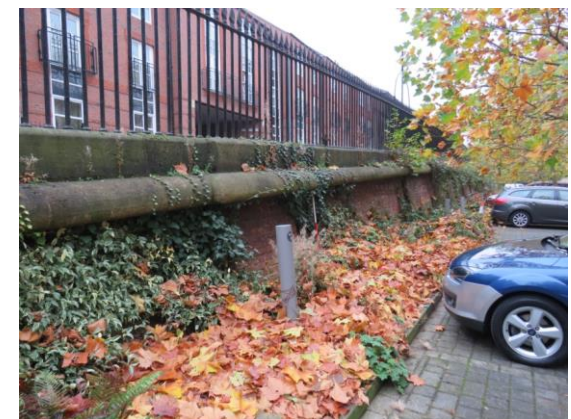
Figure 62: View of the retaining wall with decorative ashlar plinth and turned iron railings

A wall base plinth (500) of the same brick construction as the rest of the wall (including a decorative trim and consisting of one course of bevelled sandstone), is situated at approximately 1.10m from the ground level. The decorative trim comprised of coarse-grained yellow bevelled sandstone ashlar blocks, which slightly protrude (Figure 64-65).

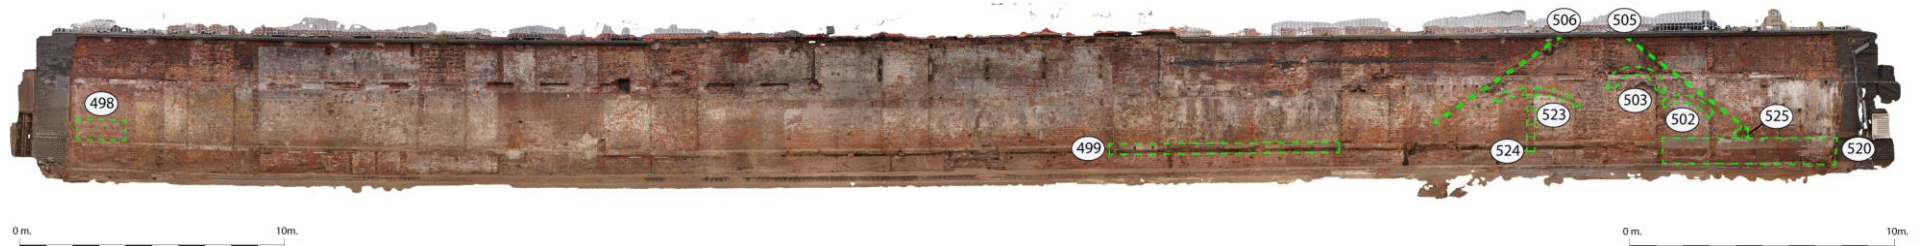
Phase 2 includes post 1842 additional changes to [497] associated with the York Old Railway Station and its use after 1877 as a carriage storage yard.

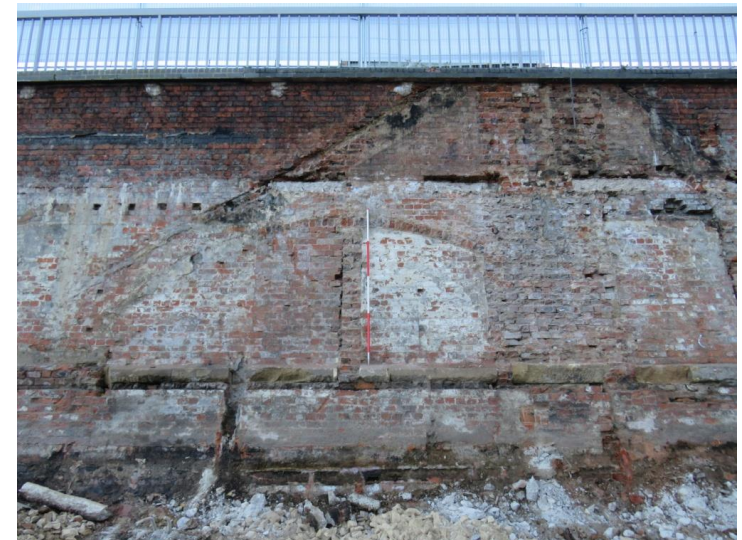
Figure 65: Wide span semi-circular brick arch (523) and flue scarring (505) and (506)

Arches (503) and (523) are located abutting the scarring produced by the removal of the wing wall buttress (522). Archway (523) incorporates a red brick and grey mortar column (524) rising from the level of the wall base plinth (500) to the central point of the rise (523). This column (524) had makeshift stone plinths at its top and base; the plinths were rough stone and not cut to exact sizes.

(506) is a thin, diagonally angled fill of sandstone and brick which is very similar to (505). The sandstone fill is coarse-grained yellow sandstone and the brick is red ceramic. (506) does not extend from a lintel base. Both diagonal (505) and (506) extend to Toft Green street level. The function of these two contexts is uncertain; it could indicate some type of stair access, or may be structural support for a flue system (Figure 66).

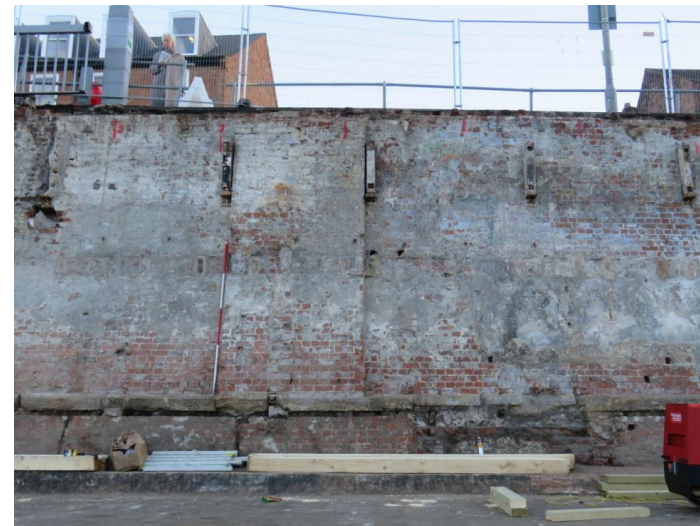
Figures 66: From left to right:
Curvature of retaining wall [497]
with later 20th century

Structural impact of these works on wall [497] was evident in the form of five cast iron shoes (512) which would have supported the walkway into Hudson House (Figures 67).

At the base of [497] was a grey concrete drainage channel (511) which was set *in situ*, with the drainage channel gauged out of the concrete from (Figures 67). The concrete had been smoothed upwards to create a seal between [497] and (511).

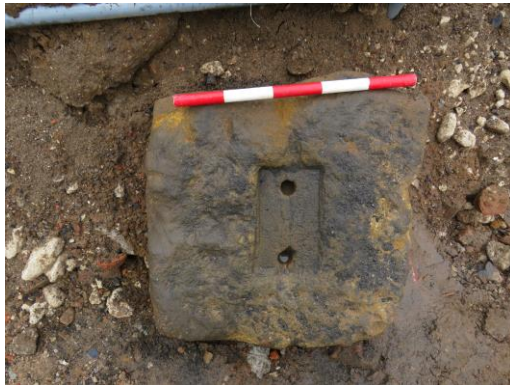
Figure 67: Railway sleeper block. The rail chair would be affixed with timber trenails

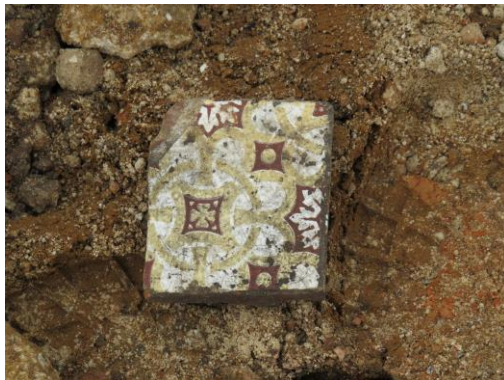
Figure 68: Tile possibly indicative of interior design theme of the original Old Railway Station

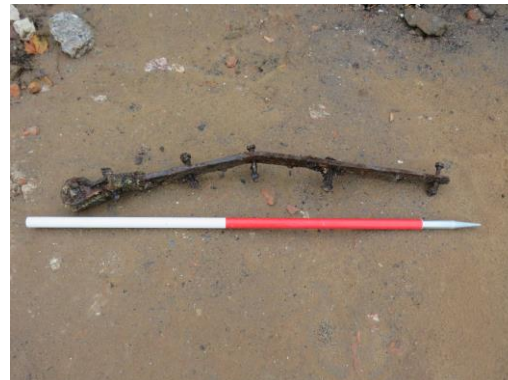
Figure 69: Wrought Iron single leaf hinge with a rolled end and four fixtures with attached hexagonal bolts (Appendix 3)

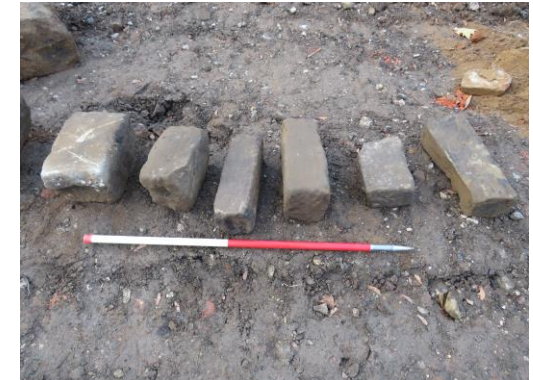
Figure 70: Railway kerbstones
