Hudson House, York

Report on an Archaeological Investigation

Part 1: Results and Discussion

Site	Hudson House, Toft Green, York YO1 6JT
Site Code	HHY18
County	North Yorkshire
NGR	SE 59739 51628
Planning Application Reference No.	17/00576/FULM
Development	Erection of 4 buildings comprising of 127 flats (C3), office (B1) use, and office or restaurant (B1 or A3) uses, following the demolition of existing office buildings
Images and text	LS Archaeology
Month of Issue	March 2020
Site Dates	Trial Trenches: 28/01/17-30/01/17 Strip Map and Record: 05/02/18-05/03/18 Watching Brief: 01/07/18-30/11/18
Client	Palace Capital Developments Ltd

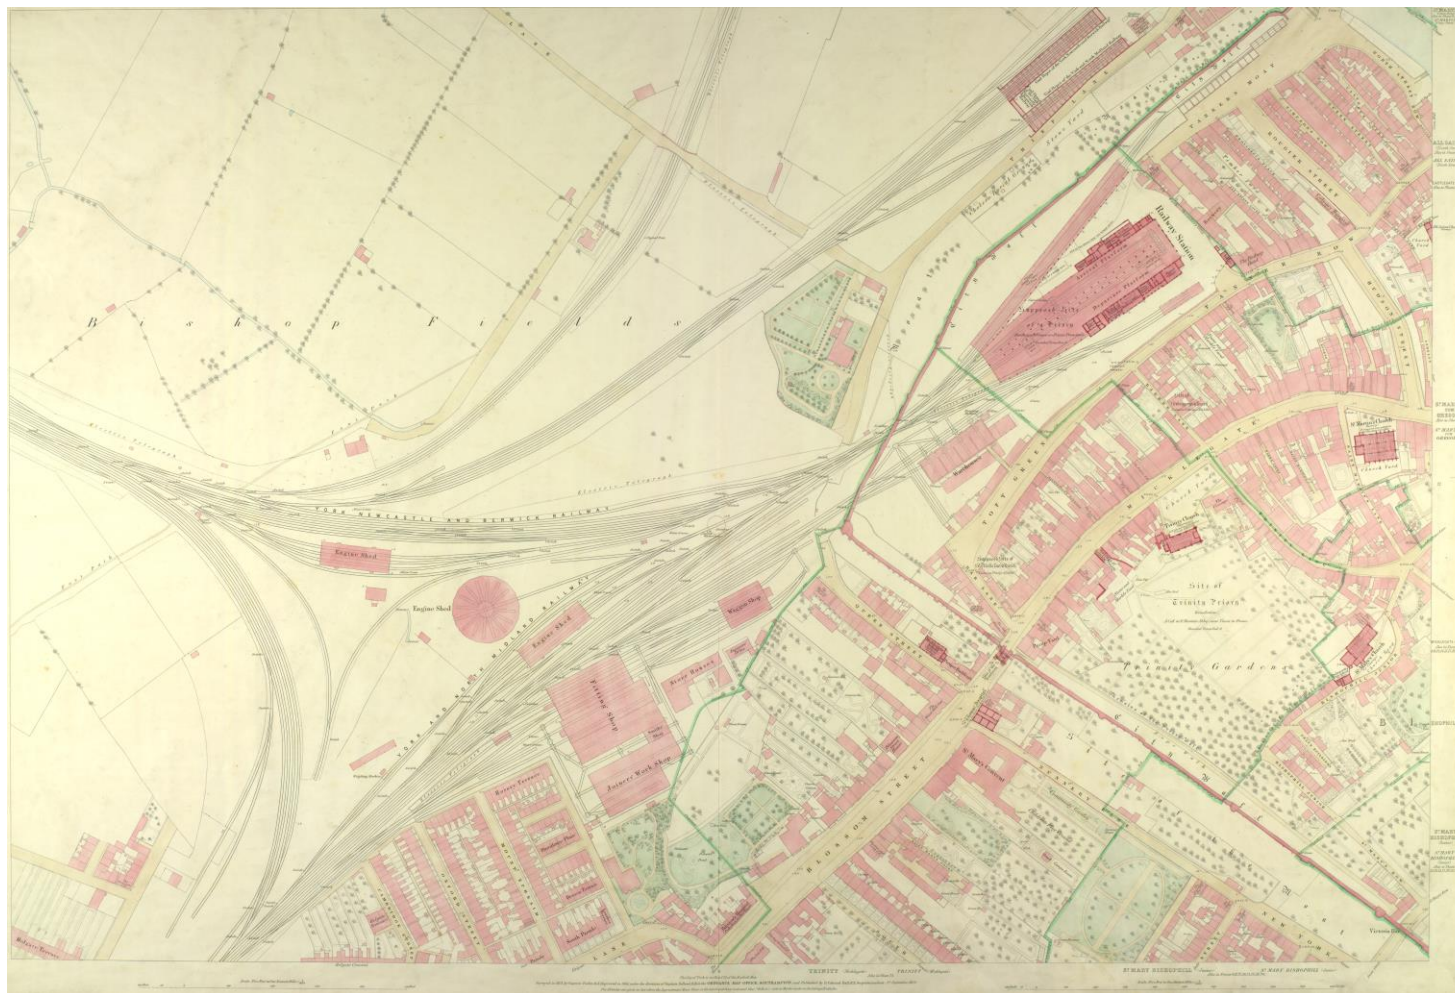
Figure 71: 1856 Ordnance Survey Map showing the extent of the 1841 York Old Railway

Historical and cartographic evidence identified that the development site was located within the bounds of the 1841 York Old Railway Station. Features revealed on site included the departure platform, the Railway Stables, Merchandise Station, turntables, and numerous box drains.

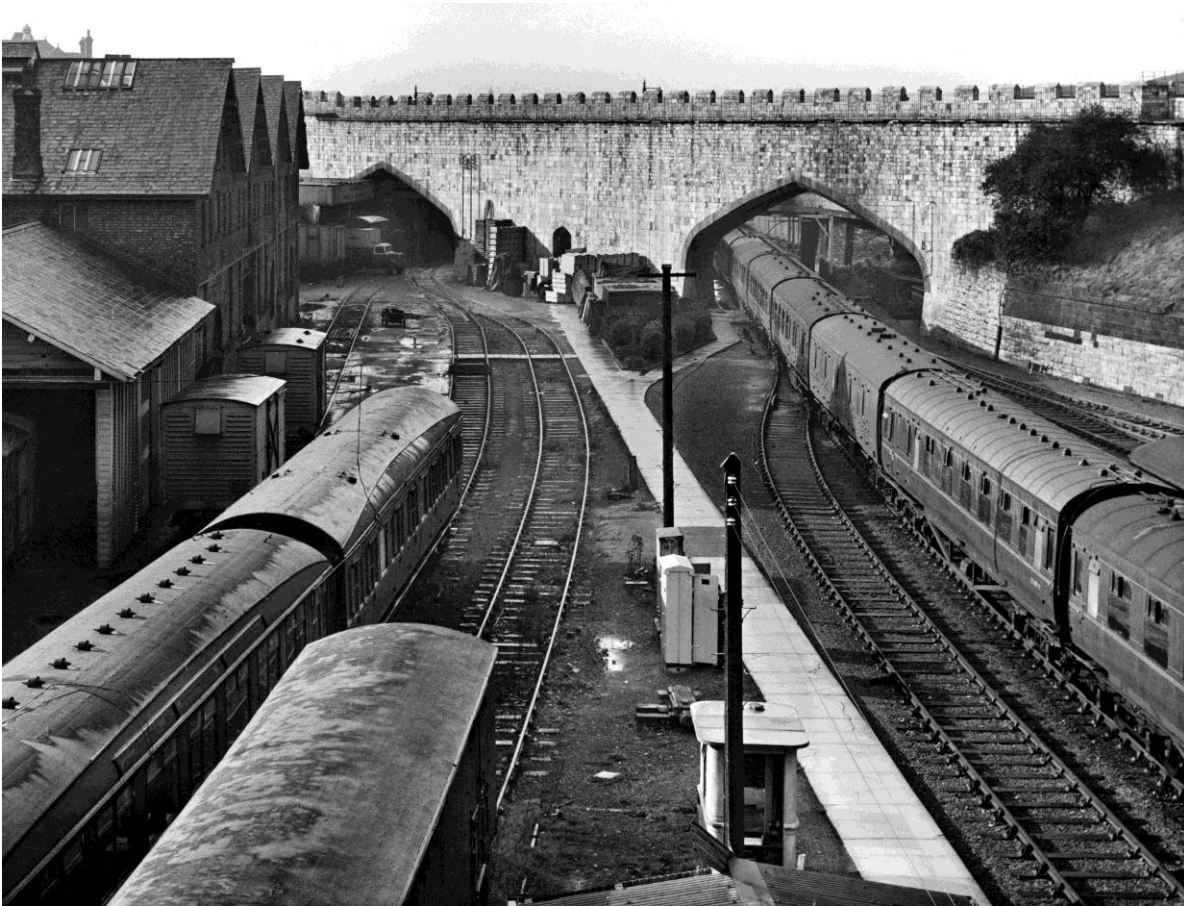
Figure 72: OP01486 General View showing cuttings to city walls © Crown copyright. Historic England Archive

The York Old Railway consisted of extensive infrastructure within the city walls and out with them (Figure 72).

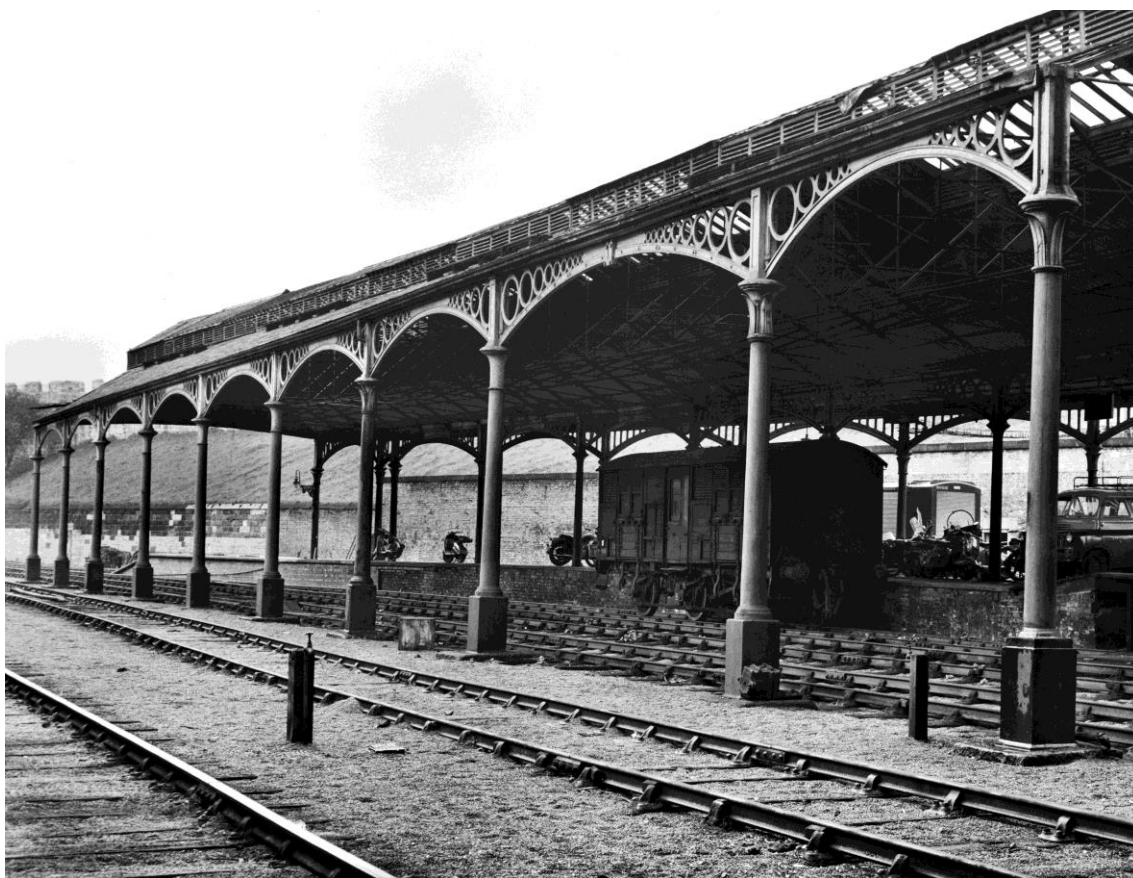
Figure 74:OP01486 General View showing arrival platform, roofing and ironwork © Crown copyright. Historic England Archive

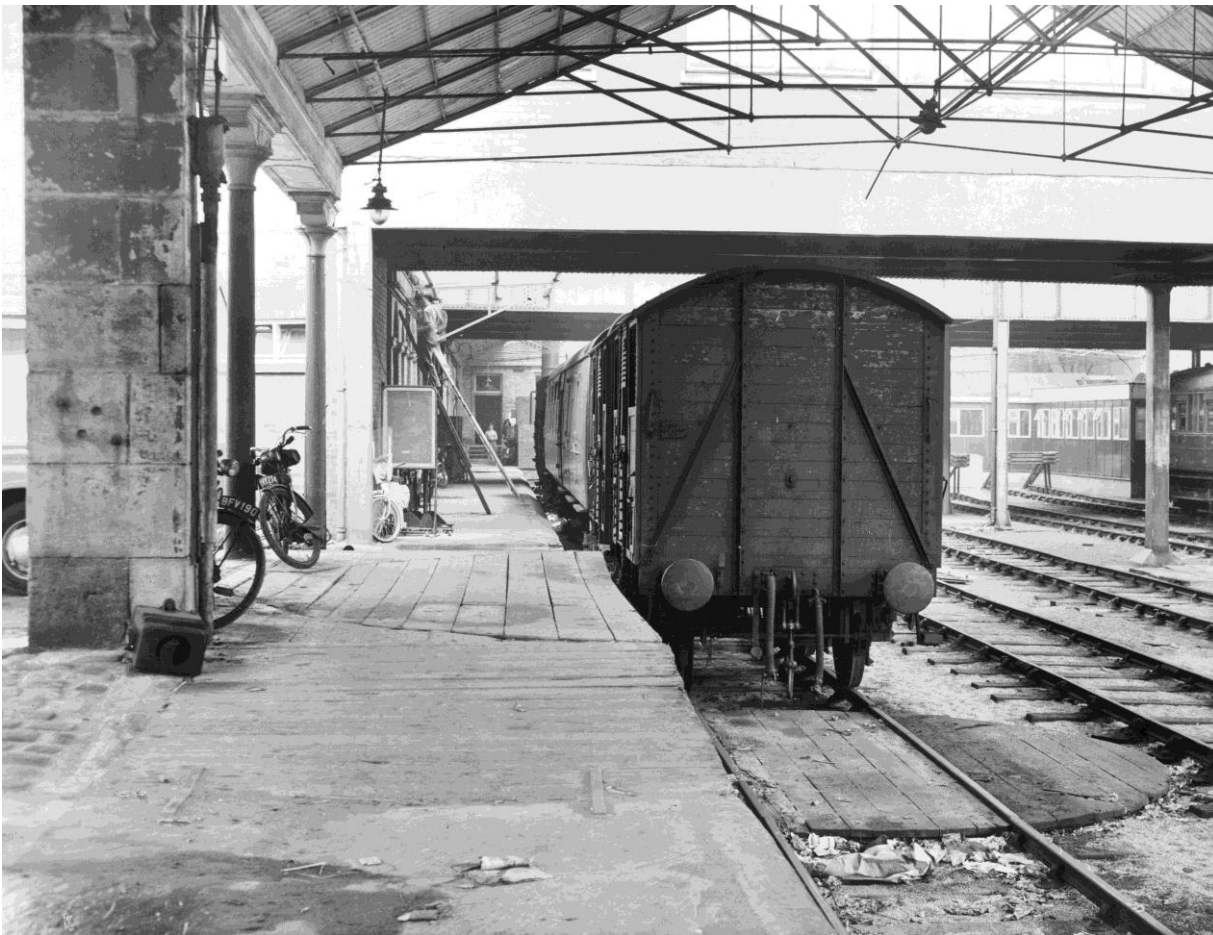
Figure 75: General View of wooden turntable and cutaway platform © Crown copyright. Historic England Archive

In total 38.63m of the departure platform foundations survived albeit truncated at two points by later piling and groundworks associated with the construction of Hudson House. The foundations to this structure would have supported raised walls and pedestrian surface as captured in Figure 75.

The Merchandise Station turntables and their size were 14 feet in diameter. An *in situ* cast concrete base, with internal and external spider casting, was all that remained. Positioned on top would originally have been a bridge unit which would have supported one to five plank open freight wagons or vans, measuring between 9 feet 6 inch wheel bases to 10 feet. The bridge unit would rotate on the central bearing, which was seated on a pedestal. Small wheels attached to the bridge unit would run on a track. Due to the small size and weight of these early wagons and vans, the turntable could be moved laterally by either hand or by horse on a trod path. Figure 76 indicates the relative size of these early turntables.
