Sutton Bank Car Park

Report on an Archaeological Watching Brief 2019

Site	Sutton Bank National Park Centre, Thirsk, YO7 2EX	
Site Code	SBC19	
County	North Yorkshire	
Location	National Grid Reference	SE 51592 83057
	Easting and Northing	X 451592 Y483057
	Latitude Longitude	54.240616 -1.2098747
Planning Reference		
Development	Sutton Bank Visitors Centre Car Park Extension and Modifications	
Text and Images Watching Brief	D. Signorelli L. Signorelli L. Signorelli	
Date of Issue	July 2019	
Project by

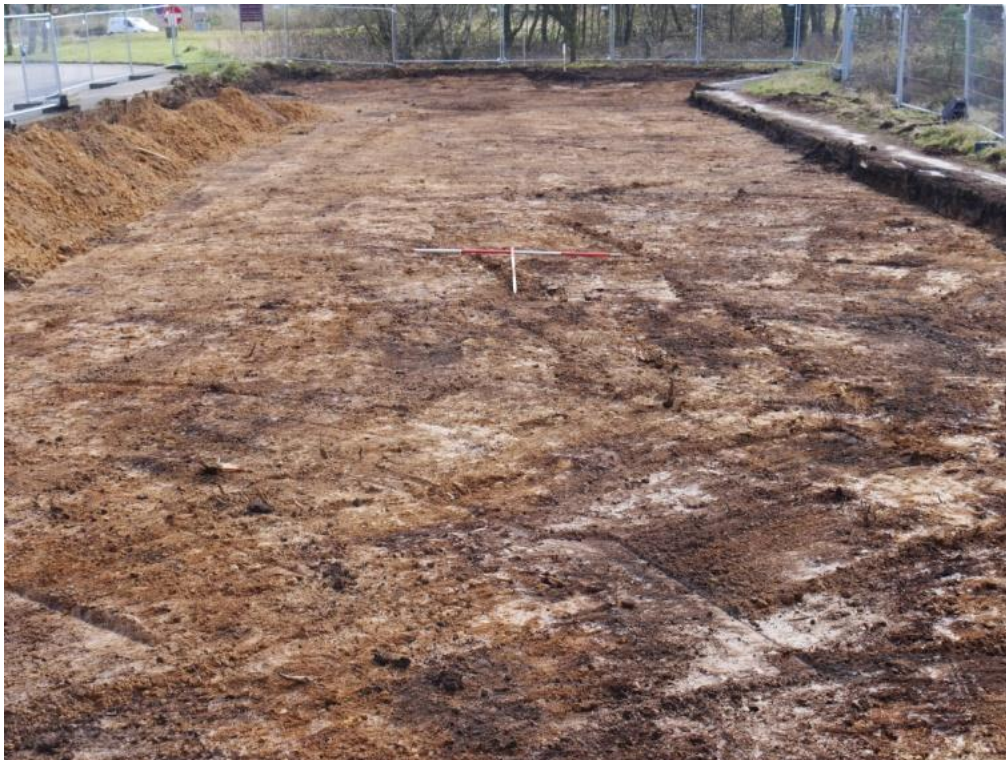
Figure 3: Car Park 1 post machine stripping

The stratigraphy of this area consisted of a vegetation layer (Context (1)) sealing the very dark brown clay silt topsoil (Context (2)) (Figure 3).

Context (2) overlay the subsoil which was dark reddish-brown clay silt mixed with 50% angular limestone fragments and gravel (Context (3)).

Below Context (3), lay the natural, Context (4). This comprised of strong brown clay sandy silt with limestone fragments and gravel.

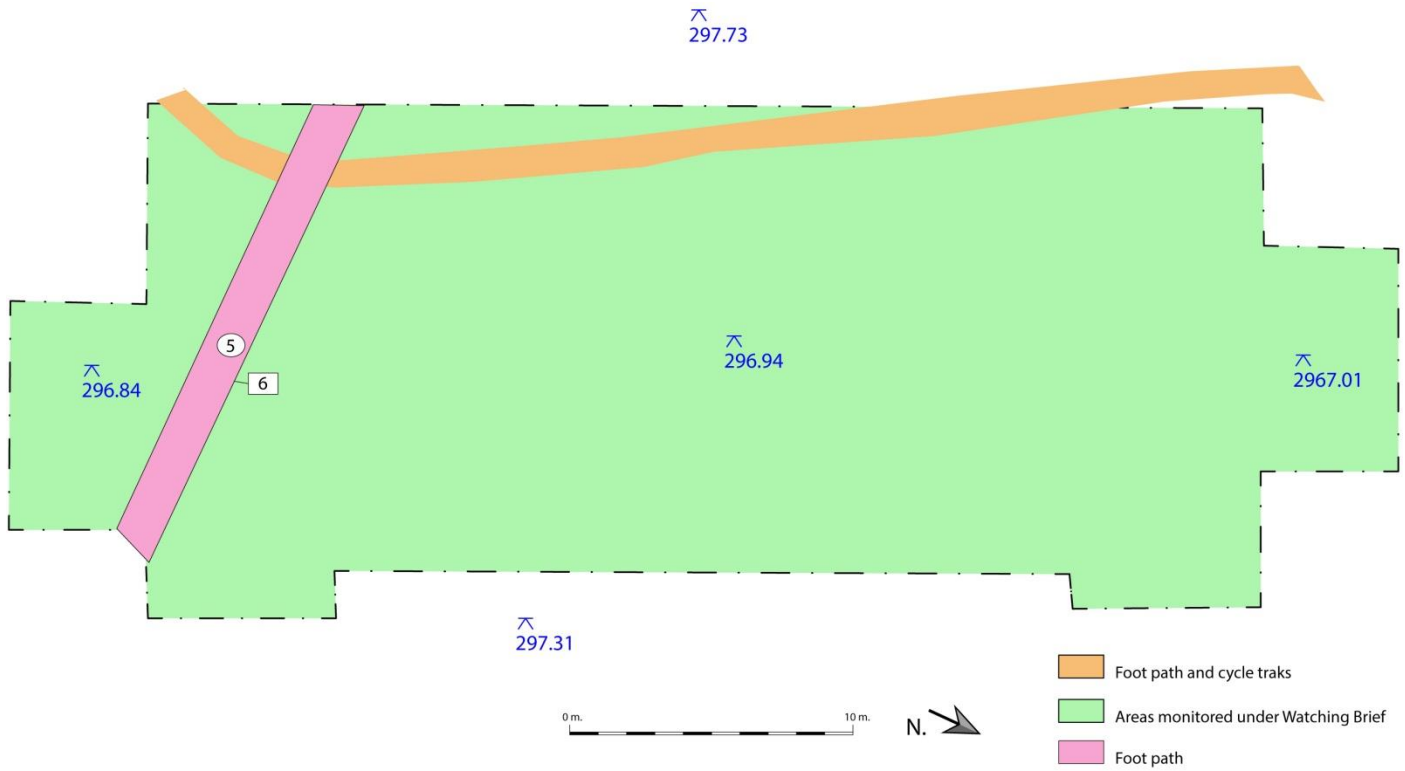
Figure 4: Car Park 1 area plan

Car Park 1 is located to the south entrance of the former car park, and measured 48.00m in length and 18.00m in width, covering an area of 74.45 square meters (Figure 4).

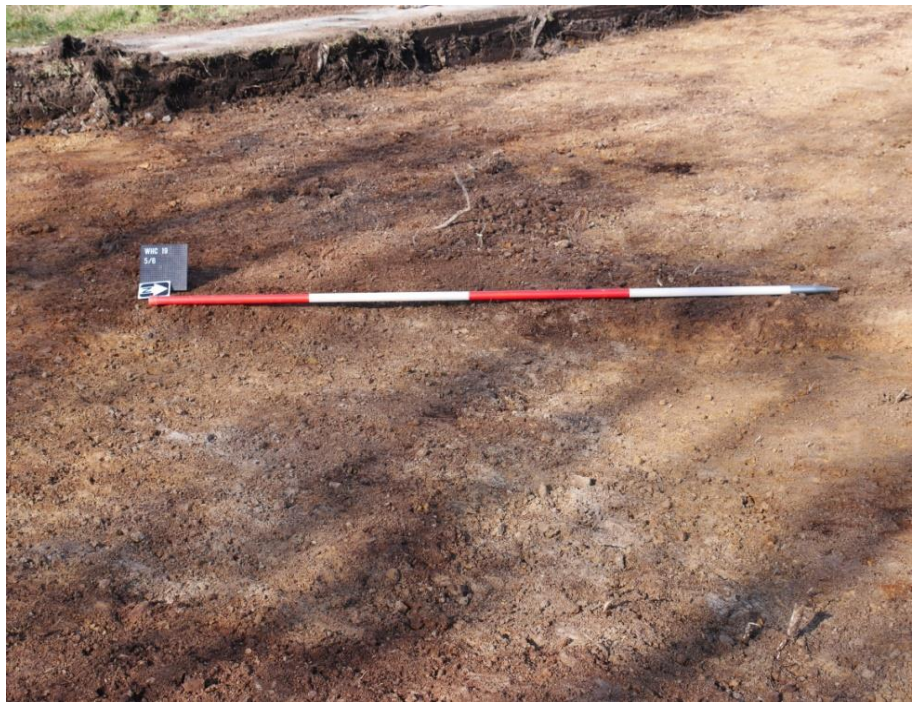
Figure 5: Car Park 1 Feature [6]

The feature identified within this area was the remains of a former footpath located at the southern end of the site, crossing it on an east to west direction (Figure 5).

The cut for this linear Feature [6], measuring 1.80m in width, 19m in length and no deeper than 0.02m had a flat base, and was filled with a strong brown clay sandy silt material (Context (5)).

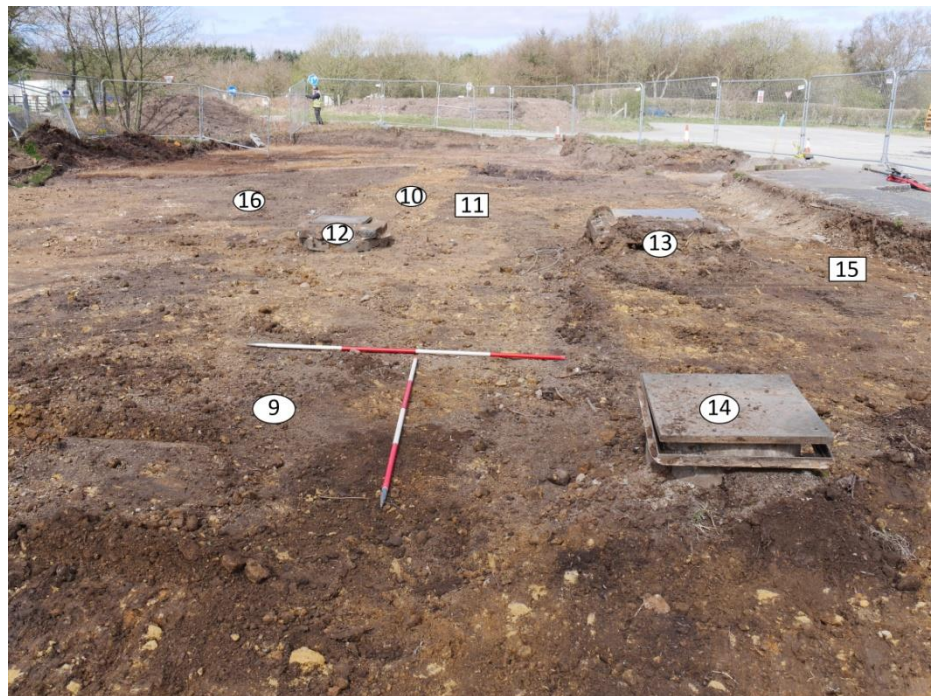
Figure 7: Car Park 2 features related to water and sewage systems

The features observed were identified as the water and sewage services for the visitors centre (Figure 7).

These features are located in the middle of the site and consist of an overflow brick chamber, (Context (12)) linked to a soak away trench filled by a yellowish-brown limestone fragments and gravel Context (10). (Context (10)) fills a cut that runs for 18.00m North West and measures 1.30m Feature [11].

The over flow chamber (Context (12)) is linked to a brick made pump chamber/septic tank (Feature [13]), to the south of this chamber there is another manhole that links to a large sump station (Feature [14]).

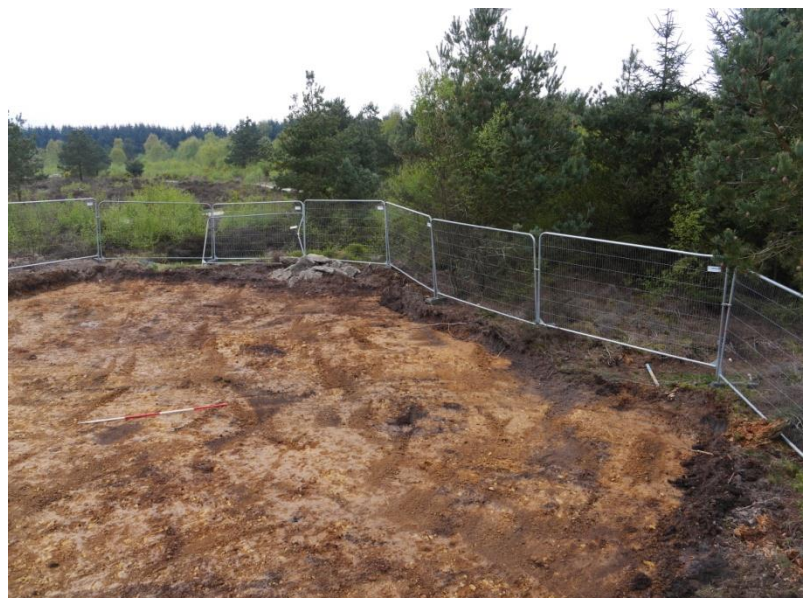
Figure 9: Car Park 3 post machine stripping

No features were identified within this monitored area (Figure 9).
