Prospect Farm, Murton Way, Murton, York

Report on a Level 2 Buildings Recording

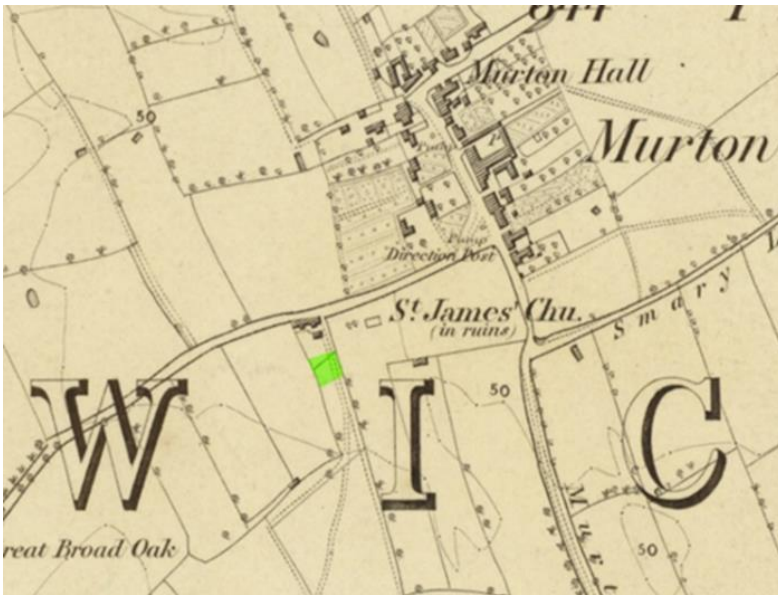
Image 7: 1853 Ordnance Survey 6-inch first edition Map of Yorkshire (site in green with the Rubbing House identified by the arrow).

The 1853 Ordnance Survey Map indicates a trackway off Murton Way, passing the eastern boundary of the plot, heading south towards enclosed fields, whereby the track changes to a right of way which leads to Grimston Lodge.

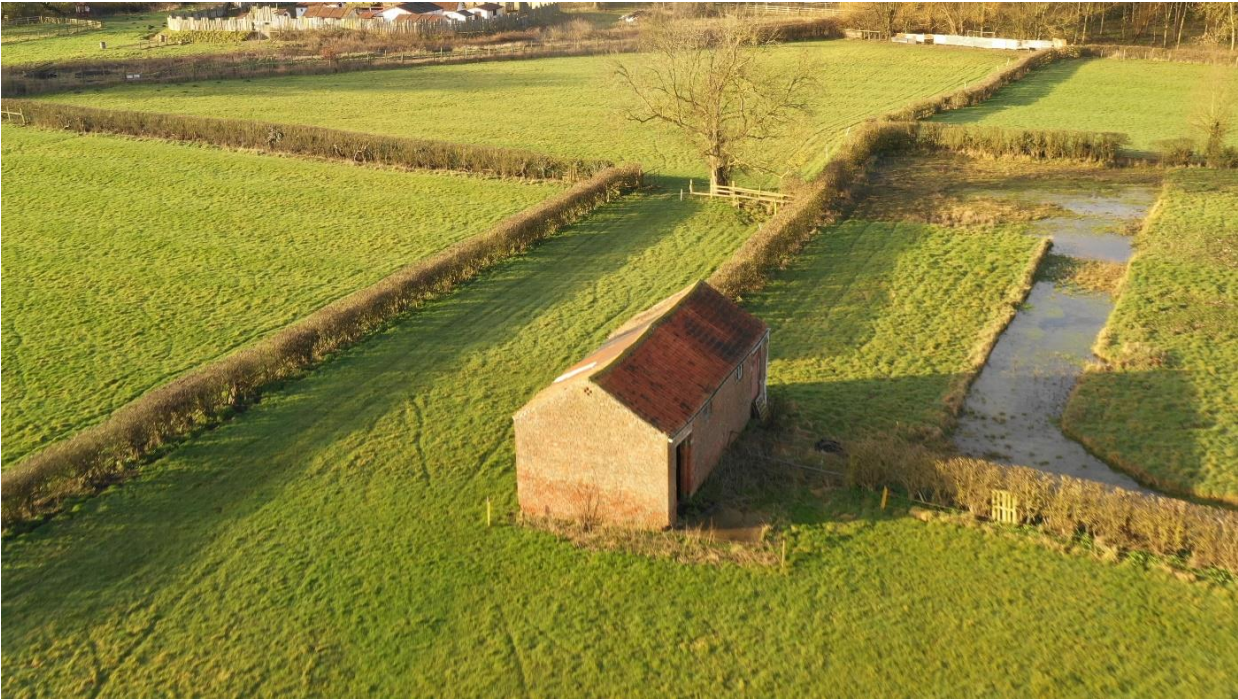
Image 8: The Rubbing House situated within a ridge and furrow landscape.

During the 19th century, Murton was associated with horse training/racing. In 1820, Robert Ridsdale (1783-1857), a wealthy English horse breeder, resided in the village and was the owner of the 320-acre Murton stud farm which included stabling, loose boxes, blacksmiths shop, shoeing shed, saddle rooms, coach house, granaries, barns, and staff accommodation.

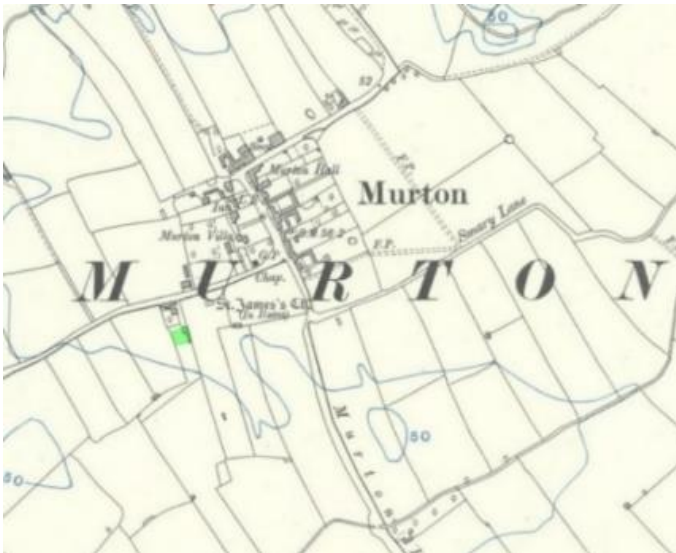
Image 9: 1910 Ordnance Survey 6-inch to the mile Yorkshire CLXXIV.NE (site in green).

Cartographic evidence of this change in use is seen in the 1910 Ordnance Survey Map of Yorkshire ([Image 7](#)). By 1910, a structure is depicted on the eastern boundary of the plot. It is L-shaped and comprises the Combination Barn (**100**) and Multi Bay Shelter Shed (**200**).

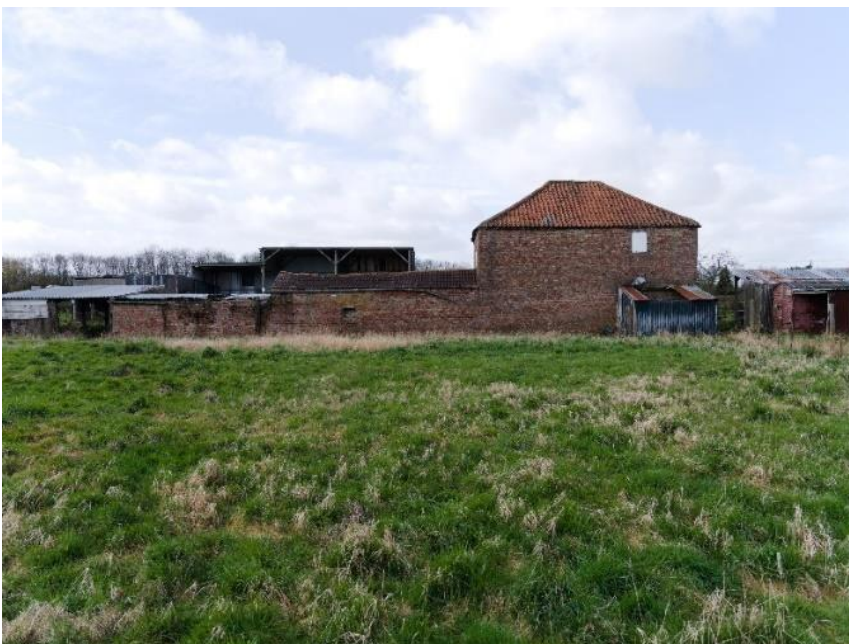
Image 10: The west facing elevation of the Combination Barn and Multi Bay Shelter Shed.

The brickwork bond used to construct the Shelter Shed (200) and the Combination Barn (100) is continuous with no evidence of scarring due annexing. This would suggest that both buildings were constructed at the same time, specifically designed to be integrated (Image 9).

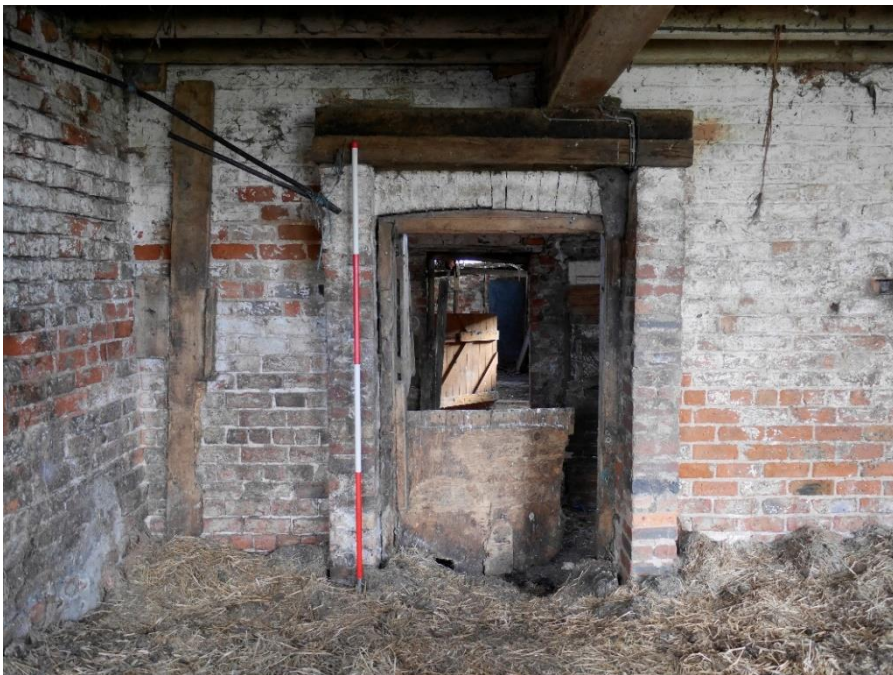
Image 11: Inside the Cart shed looking south through the single storey barn towards the doorway linking the Combination Barn to the Multi Bay Shelter Shed.

Combination Barns were common and enabled the building to have several functions. The ground floor of the Combination Barn (100) comprises a three-bay cart shed (138) with an overhead granary (139) and a single-story barn. The Multi Bay Shelter Shed (124) is linked to the Combination Barn via a south facing doorway. Originally the Shelter Shed was open to its eastern elevation, enabling direct access to the internal yard, around which the loose courtyard has formed.

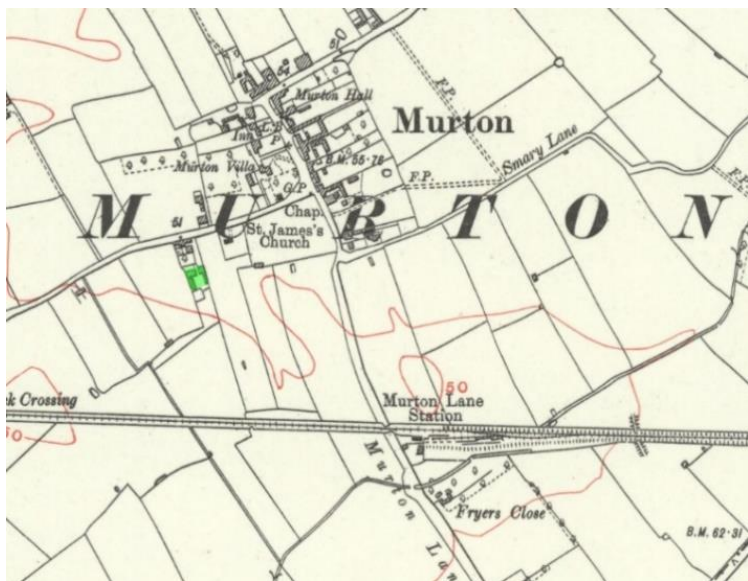
Image 12: 1931 Ordnance Survey 6-inch to the mile Yorkshire CLXXIV.NE (site in green).

By 1931, two additional structures are present (Image 10). Located along the western boundary, the structures have oblong forms. They align with the existing buildings to form a loose courtyard (603) accessible via the trackway leading from Murton Way towards the enclosed fields to the south. The building facing south onto the loose courtyard is the Milking Parlour (300); the other narrower structure was identified as a pole barn (Image 11). The pole barn that currently stands would appear to be a newer replacement (600).

The most significant change to the village, as indicated on the 1931 map, was the addition of the 1913 Derwent Valley Light Railway, indicated to the south with Murton Station located off Murton Lane. This railway was later closed, in sections, between 1965 and 1979. A railway sleeper was reused as a lintel repair (125) in the cart house and for supporting frameworks of other temporary farm buildings. Salvaged internal and external doors have been widely utilised as internal cladding in the single storey barn (128) and to create walls in some temporary structures (601 and 602). Google maps history suggests the farm was active until 2012, with animals being kept at the site and buildings being utilised.

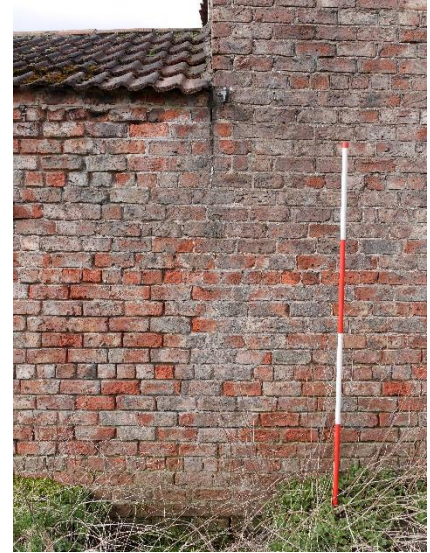
Image 13: East elevation of the Combination Barn and Shelter Shed with scarring due to an increase in height.

The shelter shed (200) underwent significant 20th century adaptations (203, 204 and 205) which would have altered how the building was used. The east facing elevation that connects the Combination Barn to the Shelter Shed was raised by six courses of bricks (203), suggesting that the internal head space was increased and any existing roof replaced (Image 13). The south and west facing elevations fronting the yard were enclosed (204) and a window was inserted into the east facing elevation (205).

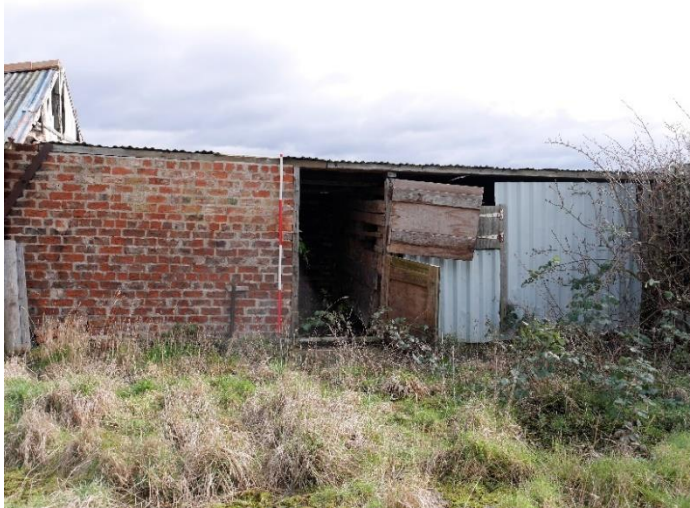
Image 15: West facing elevation of the Loose Box.

A Loose box (400) was annexed to the south facing elevation of the Shelter Shed (200). It was later partitioned (404) to create two internal rooms with the west elevations comprising makeshift doorways and walls (Image 13). In the midcentury, the Milking Parlour (300) was updated with milking stalls (318) and associated apparatus. Internal partitions (320-321) created a small office (325) and subsequently an additional door (326) was inserted into the south facing elevation (301) to accommodate this change in use.

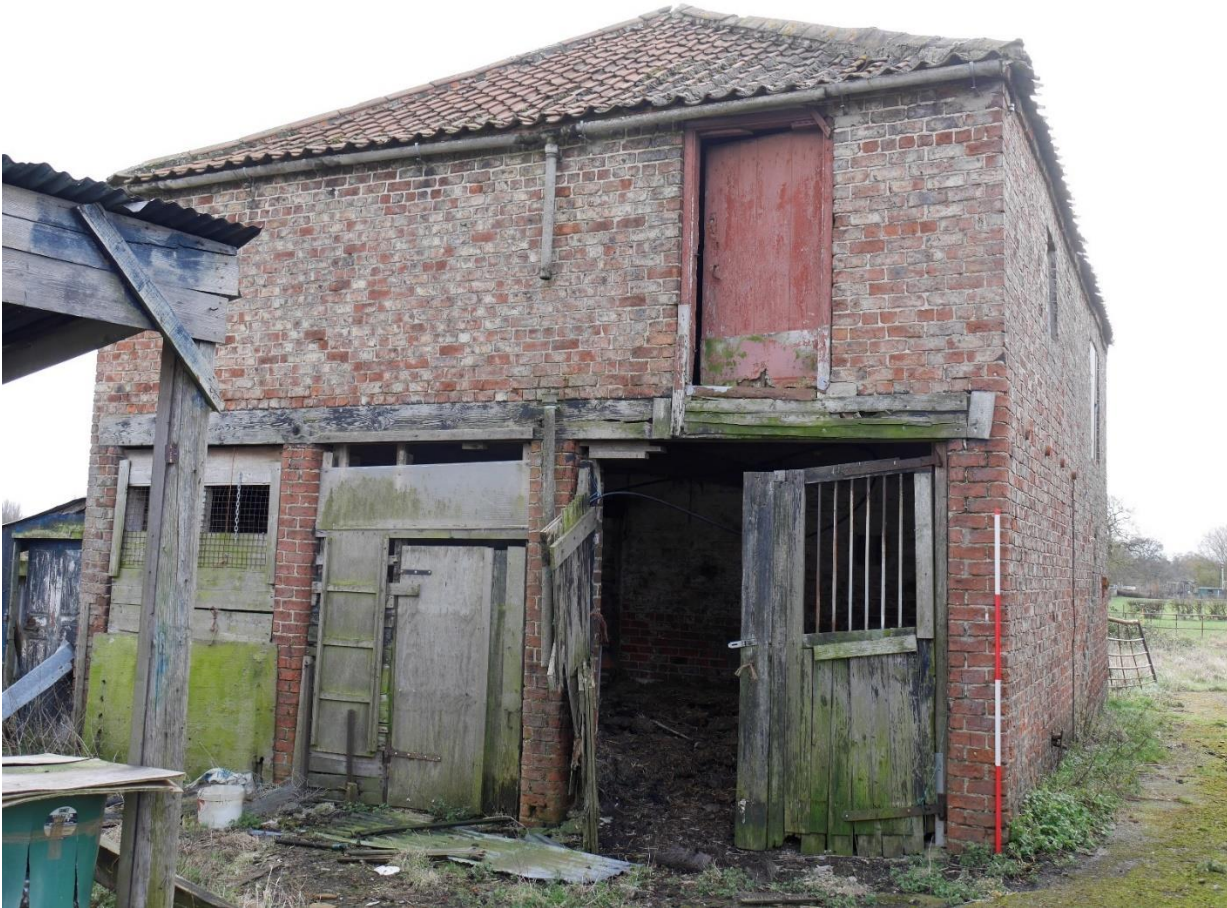
Image 26: North facing elevation of the Combination Barn.

The Combination Barn (**100**) is constructed from red machine-made bricks. These are laid in a five-course common bond and bound with a grey gritty mortar. The barn is 10.20 m in length and 7.90 m in width.

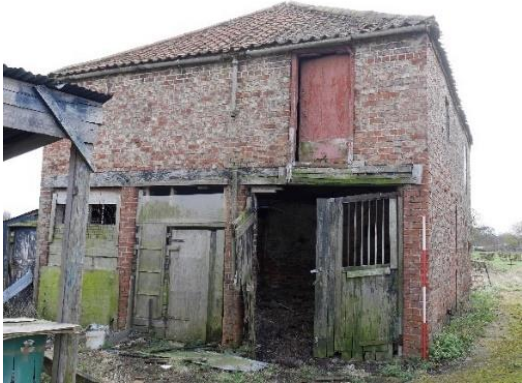
101 South Elevation	Southern elevation of (100). Constructed out of red brick laid in five course common bond bound with grey mortar. C19th PDR 2

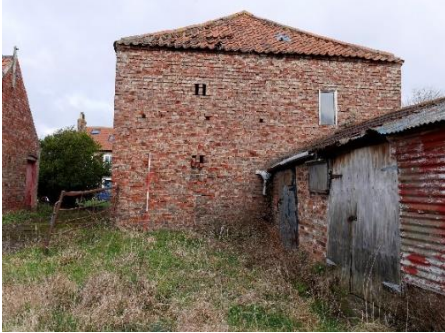
102 Slit Ventilators	Pair of slit ventilators in the southern Elevation of (100). C19th PDR 3

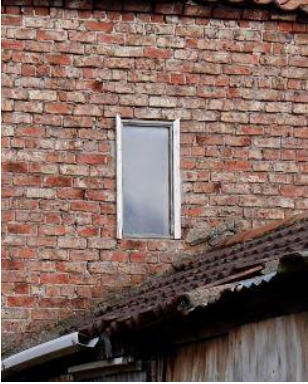
105 West Elevation of (100)	Western elevation of (100). Constructed out of red brick laid in five course common bond. C19th PDR 5

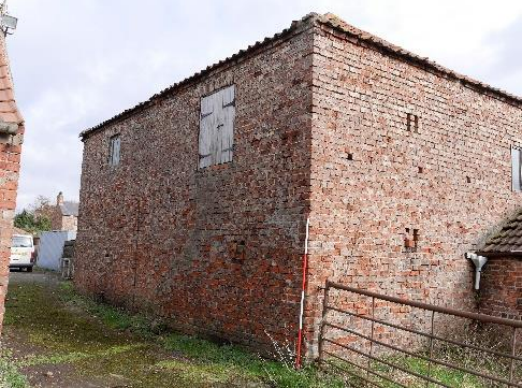
106 Slit Ventilators	Pair of slit ventilators in the western elevation of (100). C19th PDR 6

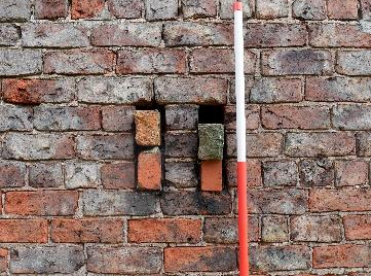
107 High Pitching Door	A high pitching double door constructed out of wooden planks with iron T hinges in the western elevation of (100). Doors replaced C20th. C19th PDR 7

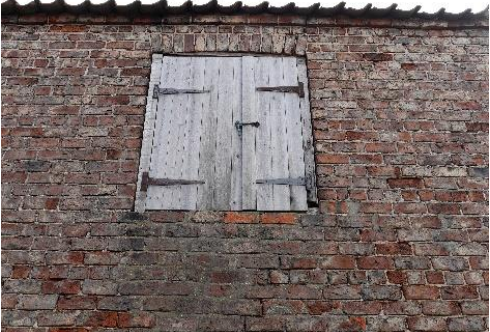
Context Number Name Associated contexts	Description and PDR (Photograph Direction Reference No.)	Photograph
108 Window	A fixed glazed double pane window set in a wood frame with a single soldier brick lintel in the western elevation of (100). C19th PDR 8

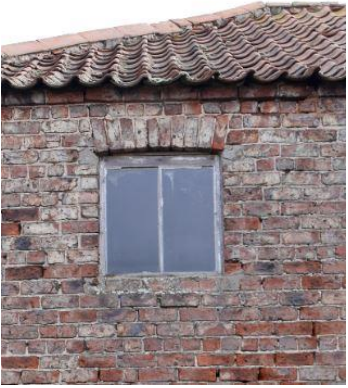
109 Fittings for Gatepost	Two bricks removed to enable fixtures for a gate post to be inserted in the western elevation of (100). C19th PDR 9

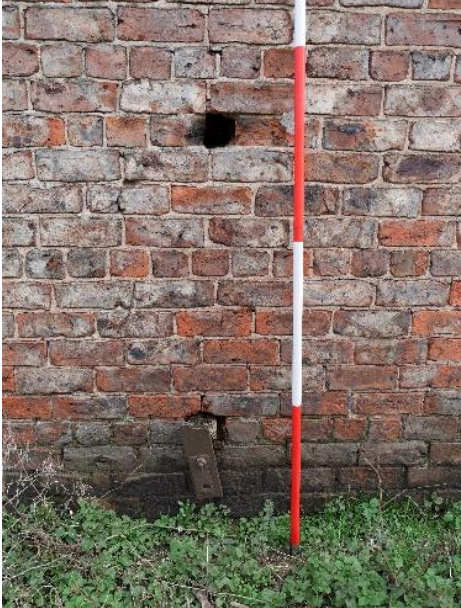
110 Ventilation Holes	Four parallel round ventilation holes formed out of a cylindrical ceramic pipe set into the western elevation of (100). C20th PDR 8

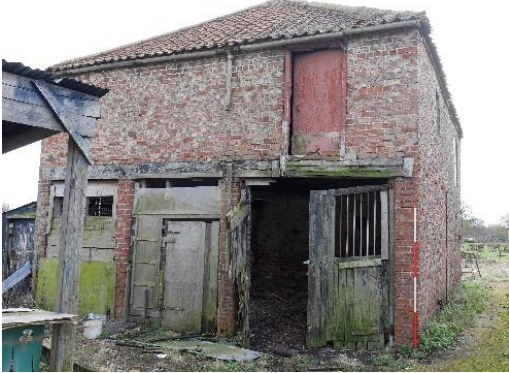
112 Two Bullnose Piers	Both piers constructed with red bricks laid in running bond. Bullnose bricks used at the edges of the piers of the northern elevation of (100). C19th PDR 10

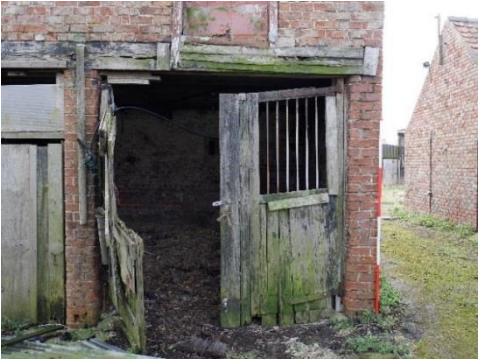
113 Wooden Lintel	A wooden beam lintel positioned on top of the bullnose piers extending the width of the northern elevation of (100). C19th PDR 10

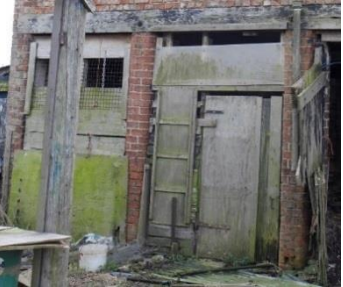
117 East Elevation of (100)	Eastern elevation of (100). Constructed out of red brick laid in five course common bond. C19th PDR 11

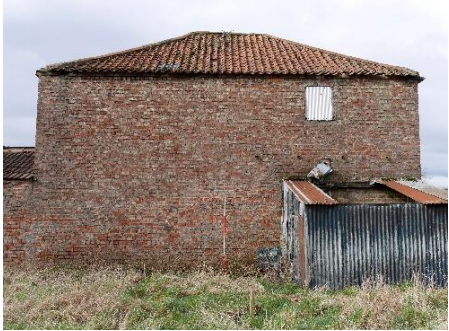
118 Window	A window in the overhead granary of (100). Wooden frame with a single soldier brick lintel. C19th PDR 11

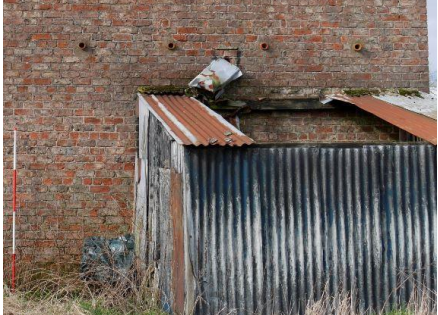
Context Number Name Associated contexts	Description and PDR (Photograph Direction Reference No.)	Photograph
120 Chute Hole	A round hole chiselled out of the existing brickwork to enable a plastic pipe to be positioned to send grain from the overhead granary to the temporary annexe (138). C20th PDR 12

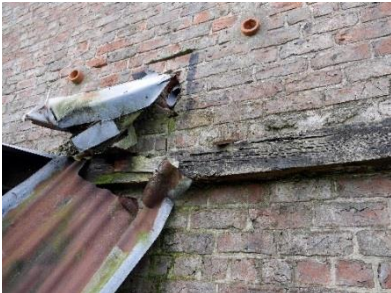
121 Boundary Wall	A farmyard boundary wall as a continuation from the eastern elevation of the combination barn. The wall extended for an approximate height of 2 m and was laid in red brick five course common bond. C19th PDR 13

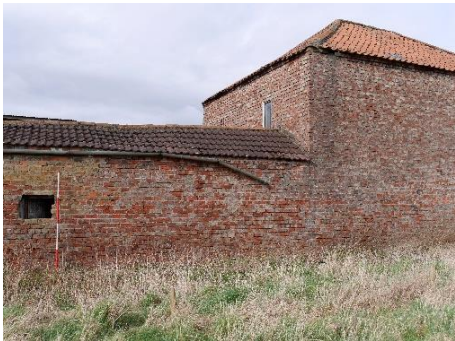
122 Hipped Roof	A hipped roof constructed out of natural red clay pantiles with angular clay hipped pantile ridging supported by two king post trusses (123). C19th PDR 11

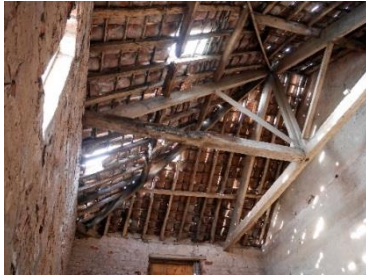
124 Single Story Barn	A single-story barn located within the southern and eastern elevations of the combination barn. Extends full height. C19th PDR 15

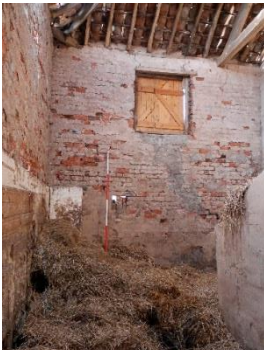
Context Number Name Associated contexts	Description and PDR (Photograph Direction Reference No.)	Photograph
125 Internal Doorway	An internal doorway connecting the cart shed to the single storey barn. Framed in wood with the original batten and plank wood stable door with cast iron T hinges, handle and locks. The internal door's function is different when viewed from the cart shed. It has been framed with two brick-built pillars that support an upper floor beam. The doorway has a single soldier brick lintel. The original beam has been replaced at a later date with two reused railway sleepers.

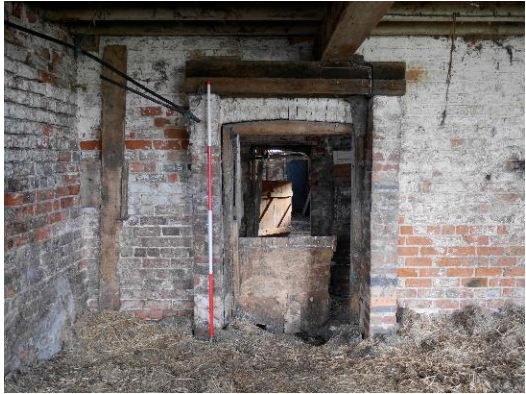
C19th PDR 16	
126 Ladder Storage	Area within the single storey barn allocated to the storage of a collection of wooden hay loft ladders, some extending over 4 m in length.

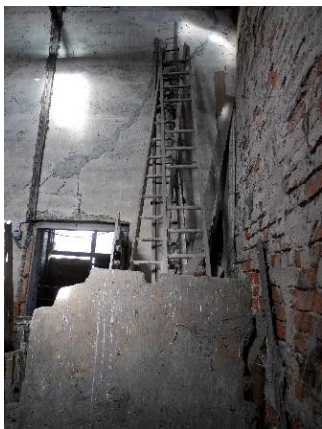
C19th?-20th PDR 17	
127 Internal Roofed Stall	A roofed stall constructed within the single-story barn. Built from red brick in running bond with a wood plank lintel and reused internal wood doors as roofing cover.

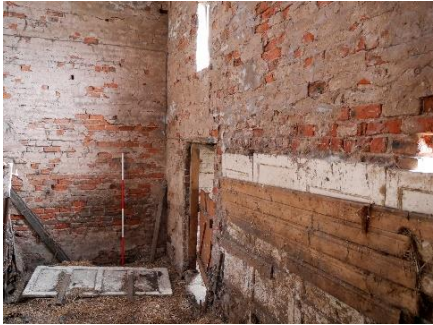
129 Floor	The floor is made of compressed layers of hay on earth. C19th PDR 19

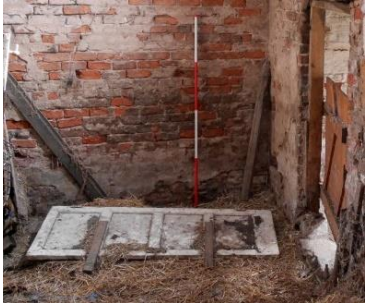
130 Walls	The interior walls of the single storey barn have been plastered. There appears to be two phases of plastering: one after the construction of the barn and one later during the construction of the roofed stall (127) on the northern and eastern elevations only. C19th-C20th PDR 20

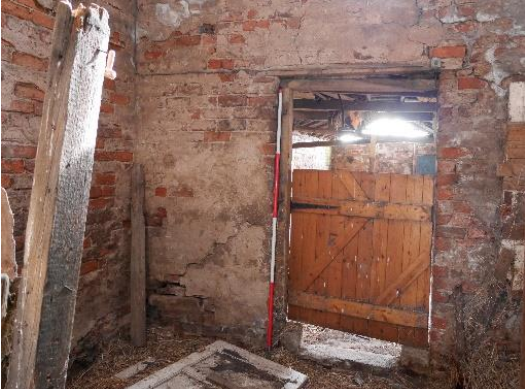
Context Number Name Associated contexts	Description and PDR (Photograph Direction Reference No.)	Photograph
132 Ceiling	The ceiling in the cart shed is comprised of two strutting beams positioned on top of the bullnose piers and internal wall. The floor of the overhead granary and ceiling of the cart shed comprise of wooden plank flooring and supporting joists. C19th PDR 22

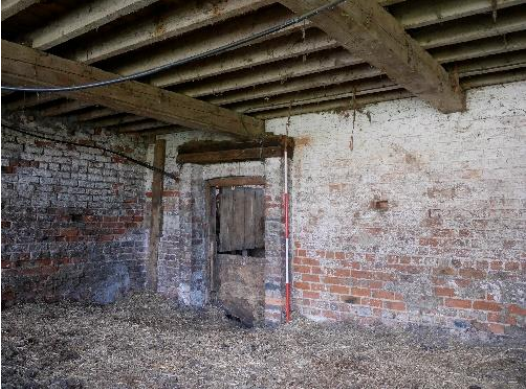
133 Floor	Poured concrete floor with brush texturing inside the cart shed. Covered with layers of compressed hay. C19th PDR 23

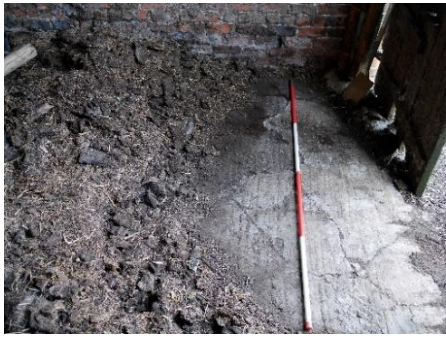
134 Walls	The internal walls of the cart shed comprise of red brick laid in five course running common bond. South elevation has one pair of slit ventilators. C19th PDR 22

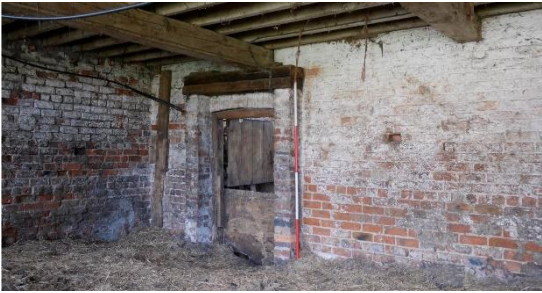
135 Walls	The internal walls of the overhead granary comprise of red brick that has lime mortar plaster on the north, east and western elevations. The internal partition wall is not plastered. C19th PDR 24

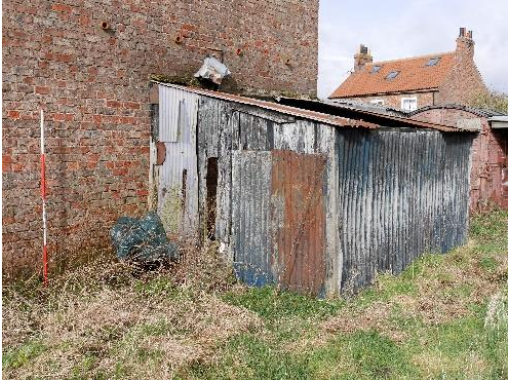
138 Three Bay Cart shed	The north-facing ground floor room of the Combination Barn constructed as a Three Bay Cart Shed. C19th PDR 1

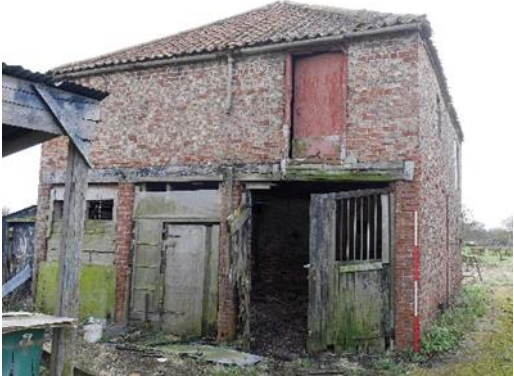
139 Overhead Granary	The first-floor room above the Three Bay Cart Shed designed to function as an overhead granary. C19th PDR 24

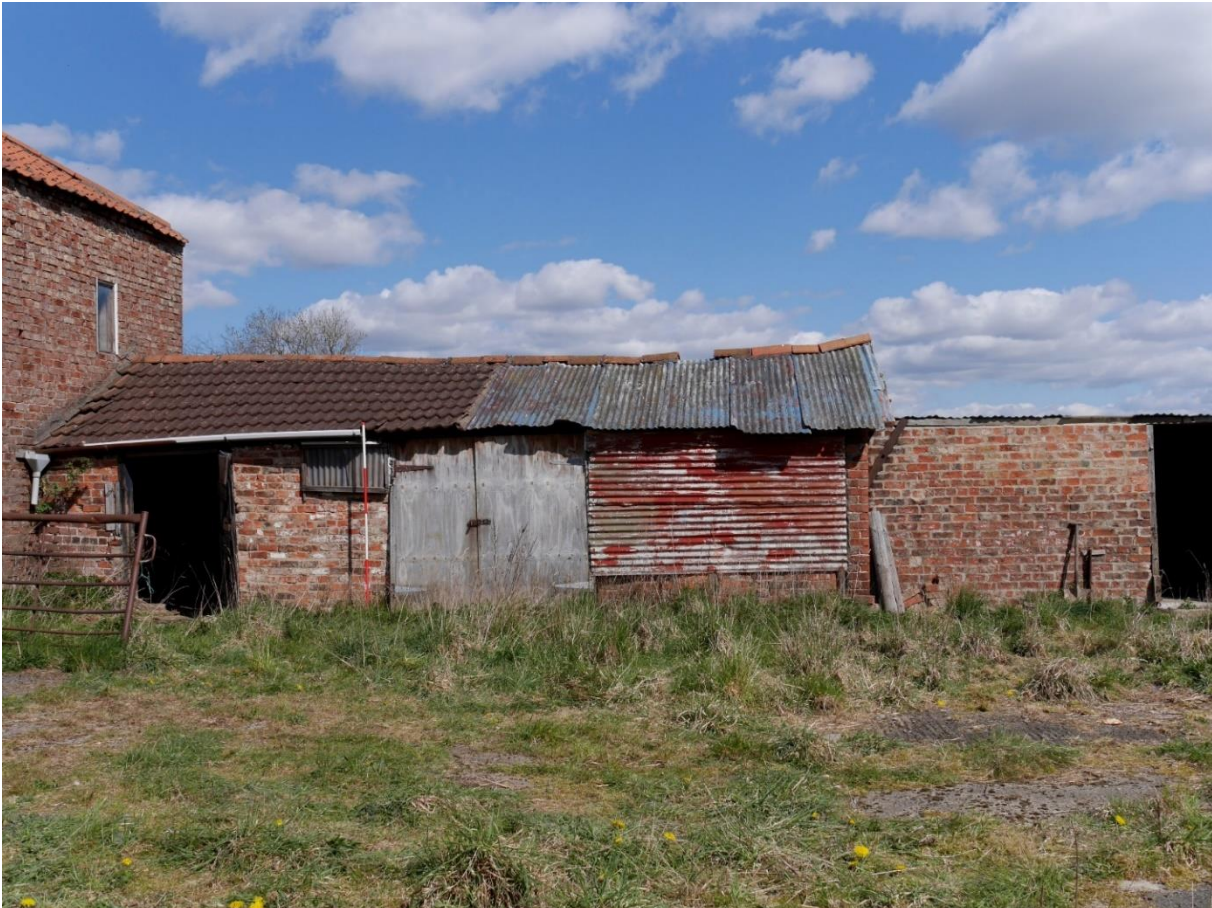
Image 27: Northwest facing elevation of the Multi Bay Shelter Shed.

The Multi Bay Shelter Shed (**200**) is built from red machine-made bricks laid in five-course common bond bound with a grey gritty mortar. It is contemporary with, and the same construction as, the Victorian Combination Barn (**100**). It is 10.00 m in length and 7.90 m in width.

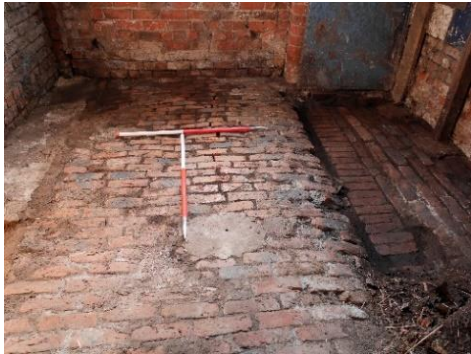
Context Number Name Associated contexts	Description and PDR (Photograph Direction Reference No.)	Photograph
203 Boundary Wall Height Extension	The eastern elevation boundary wall was extended by a height of 0.60m. The extension was constructed from red brick laid in 3 course common bond. C20th PDR 30	 
204 Enclosing of the Western and Southern Elevations	The enclosing walls are constructed out of red brick laid in an ad hoc 5 and 6 course running bond. Reaching a height of approximately 2.00m, it sealed the Multi Bay Shelter Shed at its southern and western elevations. The southern elevation enclosing wall was constructed adjoining the earlier existing bullnose piers. C20th PDR 31	 
205 Insertion of a Window to the Eastern Elevation	A small square window set in a wooden frame with a wooden Z brace shutter with metal T hinges. C20th PDR 32	 
206 Feeding Trough	Constructed from red brick laid in running bond with a wooden frame and flat surface. Internally holds a smoothed concrete concaved trough. C20th PDR 33

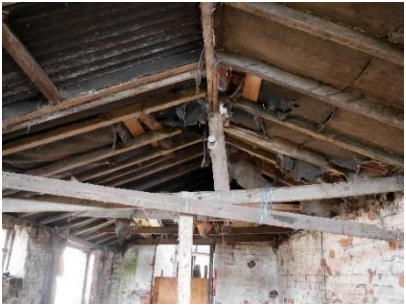
211 Roof	An unequal pitched roof constructed out of a ridge beam with common rafters supported with purlins. C20th PDR 36

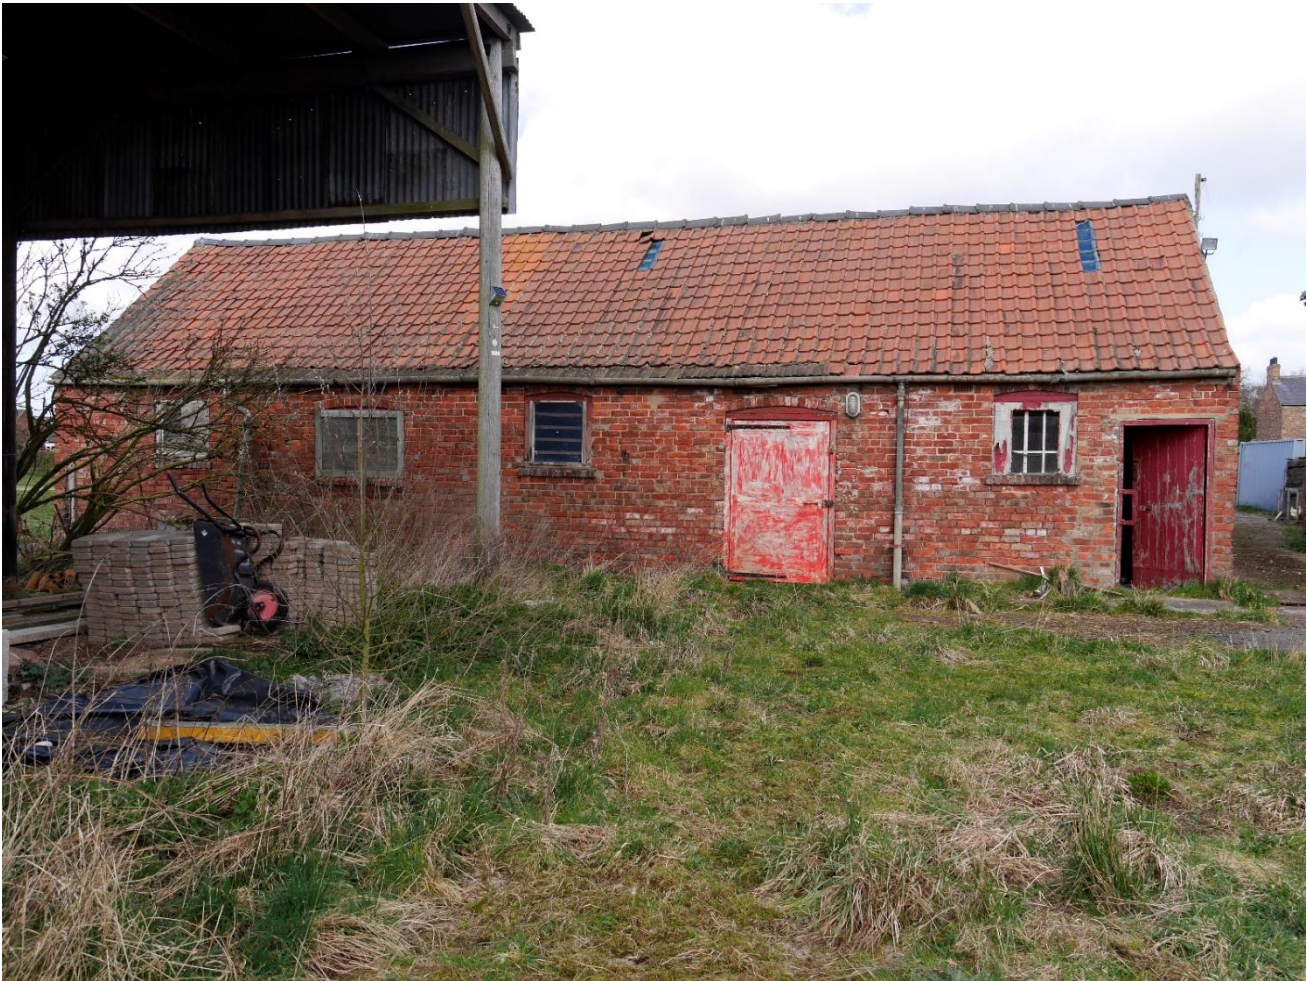
Image 28: South facing elevation of the Milking Parlour.

The Milking Parlour (**300**) is built from red machine-made bricks laid in inconsistent running bond under a gabled pitched roof (**312**). It is 15.80 m in length and 6.30 m in width.

Built during the interwar period, sometime prior to 1931, the milking parlour was originally one large open space with a concrete floor (**317**). Three large doors are situated to the south, west and east elevations (**302**, **307** and **311**). The south facing door (**302**) opens straight into the collecting yard (**603**) from which the cows would, after rounding, be able to access the Milking Parlour, then leave from the west facing door (**307**) straight back into the enclosed field.

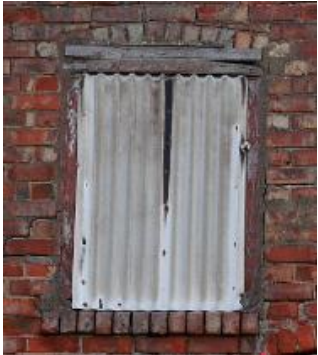
Context Number Name Associated contexts	Description and PDR (Photograph Direction Reference No.)	Photograph
308 Window	Set in a wooden frame with a single soldier course slightly arched lintel. Window is glazed sat above a beveled header row brick windowsill. Positioned central to the western gable and at a more elevated height to (303) and (304). Post-1910 pre-1931 PDR 40

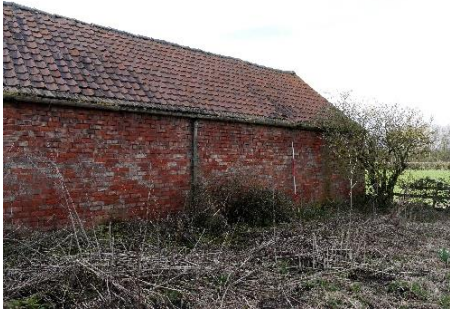
309 North Elevation	Northern elevation of (300), constructed out red brick laid in an inconsistent bond; mostly in running bond. Post-1910 pre-1931 PDR 41

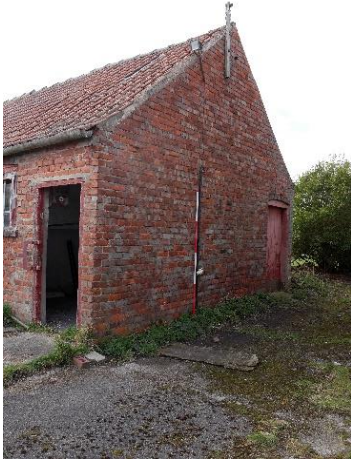
310 East Elevation	Eastern elevation of (300), constructed out red brick laid in an inconsistent bond; mostly in running bond. Post -1910 pre-1931 PDR 42

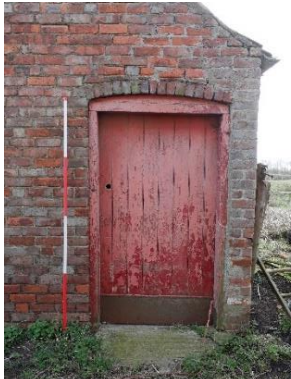
311 External Door	Set in a wooden frame with a single soldier course slightly arched lintel. Original double Z-braced wood plank door with iron T hinges with a later addition internal bolt lock. Same as (302) and (307). Post-1910 pre-1931 PDR 43

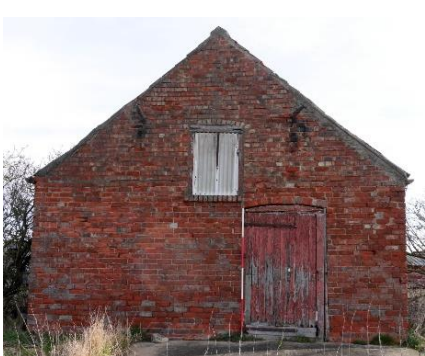
Context Number Name Associated contexts	Description and PDR (Photograph Direction Reference No.)	Photograph
312 Gabled Pitched Roof	Gabled pitched roof constructed out of red clay Gaelic tiles with a capped angled ridge. Supported by four king post trusses (314). Post-1910 pre-1931 PDR 40

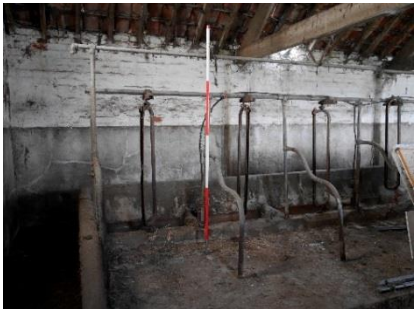
313 Walls	The internal walls of the Milking Parlour have been painted with a whitewash; therefore the bond was unable to be ascertained. Post-1910 pre-1931 PDR 44

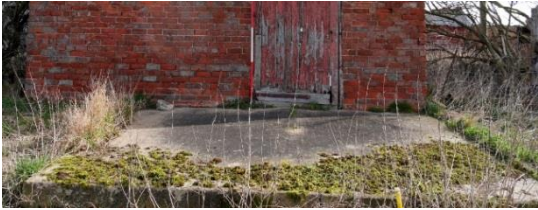
314 Concrete	Concrete areas located outside. Post-1910 pre-1931 PDR 40

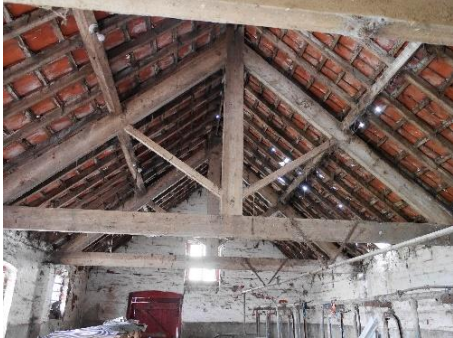
315 Four King Post Trusses	Four king post trusses equally spaced and supported by pairs of bullnose pilasters. Post -910 pre-1931 PDR 45

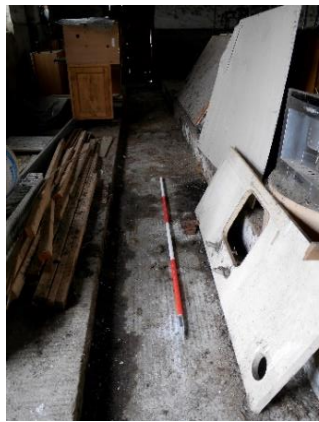
Context Number Name Associated contexts	Description and PDR (Photograph Direction Reference No.)	Photograph
317 Floor	Poured concrete floor with brush texturing. Post-1910 pre-1931 PDR 47

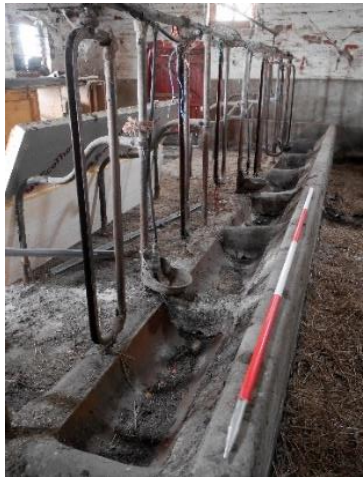
318 Milking Parlour / Cow Stalls	1930-1940 milking stalls and equipment. Positioned centrally to the Milking Parlour with 10 stalls spaced at 1.10 m intervals. Post 1931 PDR 48

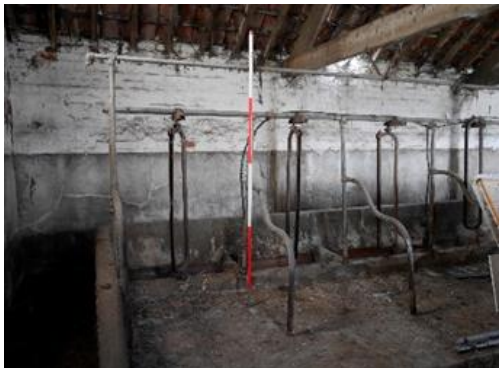
319 Internal Wall Concrete Plastering	The internal walls of the milking parlour were plastered with a smoothed layer of concrete up to a height of 1.40 m. This plaster is only present in the defined milking area alongside the installed equipment (318). Post 1931 PDR 44

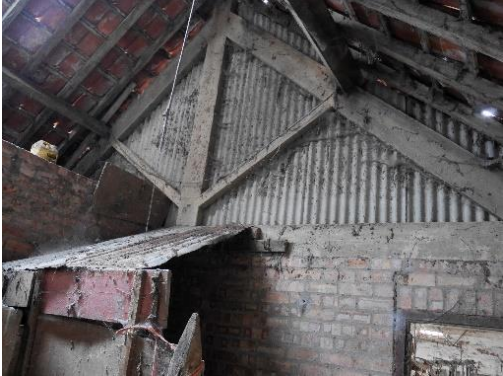
Context Number Name Associated contexts	Description and PDR (Photograph Direction Reference No.)	Photograph
320 Internal Partition Wall	<p>A single partition wall extending the width of the Milking Parlour from the southern to northern elevation. Partitioning the open milking parlour into a milking area with a smaller mixed use and office zone. Constructed from red bricks in an ad hoc running bond adjoining a joist. Concrete plastering evident the same as (319). Corrugated panels of unknown material, possible asbestos, sit atop the partition wall creating a seal across the king post truss.</p> <p>Post 1931 PDR 49</p>

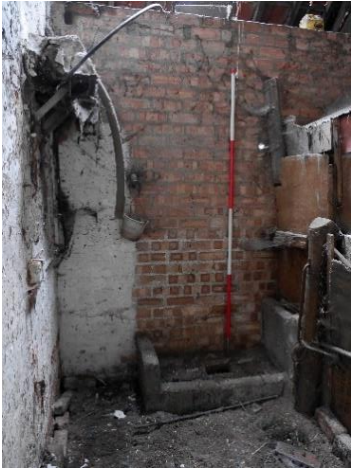
321 Internal Partition Wall	<p>Partition wall perpendicular to internal wall (320) extending to the eastern elevation. Same construction as (320), albeit constructed to a slightly higher elevation.</p> <p>Post 1931 PDR 50</p>

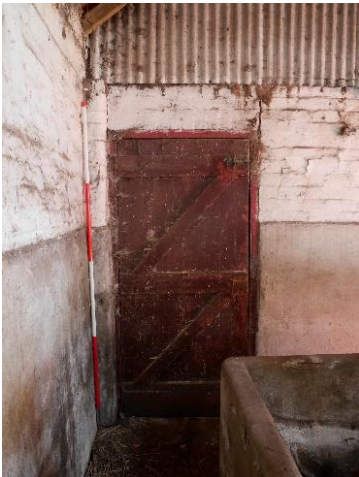
322 Internal Door	<p>Set in a wooden frame with a single soldier course lintel. A double z braced wood plank door with metal T hinges with a later addition internal bolt lock.</p> <p>Post 1931 PDR 51</p>

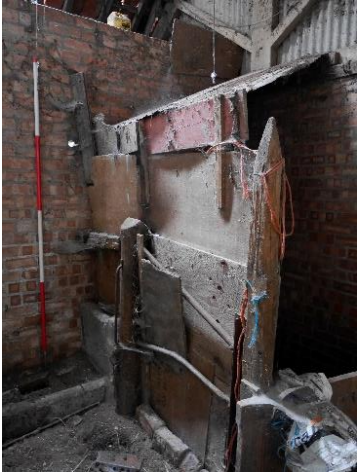
Context Number Name Associated contexts	Description and PDR (Photograph Direction Reference No.)	Photograph
323 Internal Roofed Stall	Wooden stall constructed out of offcut timber sheets and planks with a corrugated iron roof. Concrete feeding troughs are located adjacent to this stall. Post 1931 PDR 52

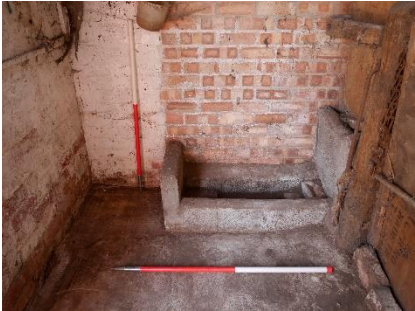
324 Troughs	Breeze block constructed with an internal concrete render. Sealed with concrete at its base to form a seal after the trough was positioned in the pre-existing concrete flooring. Post 1931 PDR 53

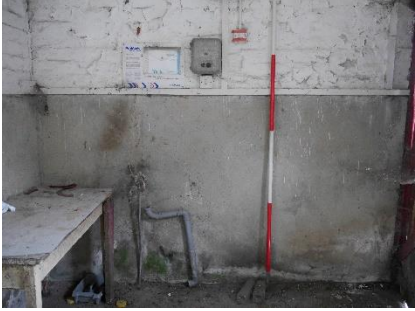
325 Dairy/Office	A small room created from two internal partitions (320) and (321) with an enclosed ceiling. Concrete plaster on the internal walls same as (319). Post 1931 PDR 54

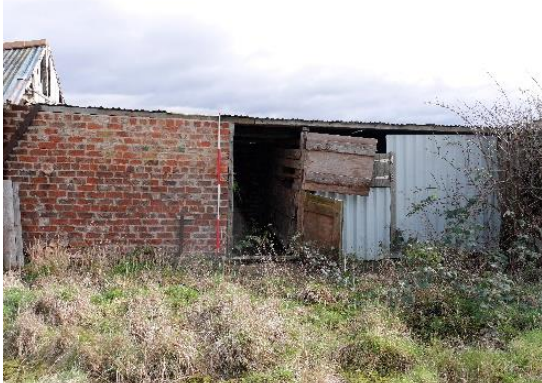
Context Number Name Associated contexts	Description and PDR (Photograph Direction Reference No.)	Photograph
400 Loose Box 1 Contexts 400-409	A small, single storey, windowless loosebox, annexed to the enclosed Multi Bay Shelter Shed, 7.90 x 3.50 m. Initially constructed as one and later partitioned to create two smaller spaces. The northern half being 4.20 m x 3.50 m with the southern room 3.70 m x 3.50 m. Post 1931 PDR 56

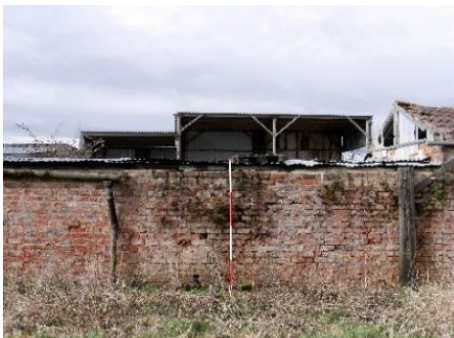
401 West Elevation	Constructed out of red bricks laid in ad hoc 5 and 6 course running bond with openings for the external doors (408) and (409). Post 1931 PDR 56	
402 East Elevation	Abutting boundary wall (121), constructed out of red bricks, laid in an ad hoc 5 and 6 course running bond. Post 1931 PDR 57

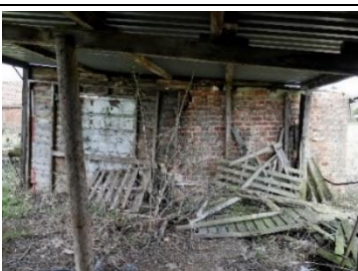
403 South Elevation	Constructed out of red bricks laid in ad hoc 5 and 6 course running bond. Post 1931 PDR 58

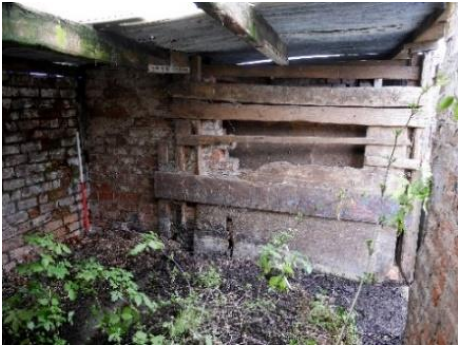
Context Number Name Associated contexts	Description and PDR (Photograph Direction Reference No.)	Photograph
404 Partition Wall	Constructed out of red bricks laid in ad hoc 5 and 6 course running bond. Extending from the east elevation to the west elevation. Post 1931 PDR 59

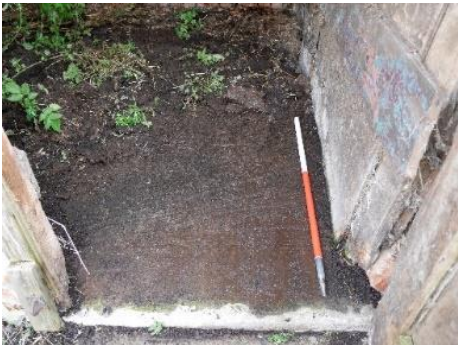
405 Floor	Poured concrete floor with brushed texture. Post 1931 PDR 60

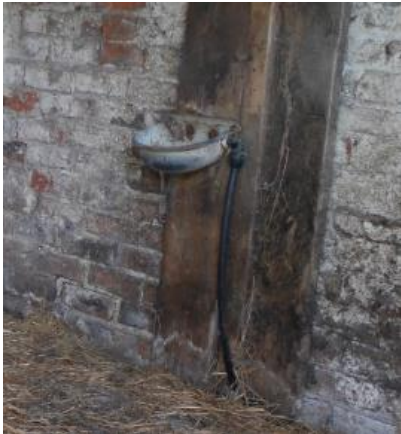
406 Drinking Trough	A small metal drinking trough fixed onto the southern elevation. Post 1931 PDR 61

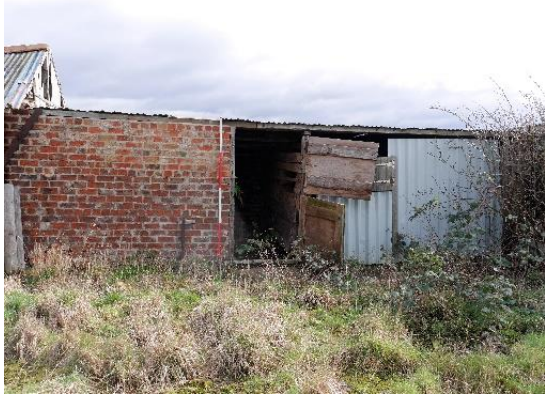
409 External Door	Set in a wooden frame. A ledged stable door constructed out of wooden planks and timber sheets fixed with metal T hinges. Post 1931 PDR 62

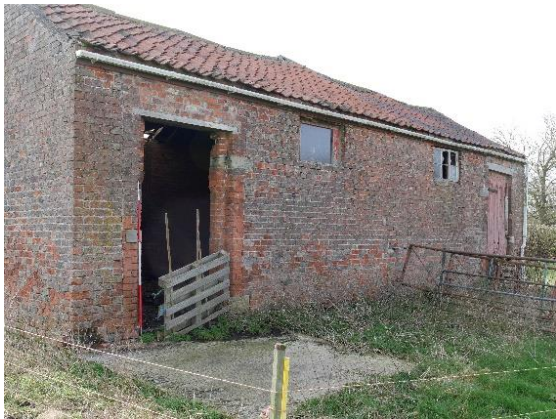
<p>North northwest facing elevation</p>

Context Number Name Associated contexts	Description and PDR (Photograph Direction Reference No.)	Photograph
500 Rubbing House	A single-story brick structure under a gabled pitched roof with natural red clay pantiles and capped angle ridge supported by two king post trusses. The building is divided into two identical rooms. Both rooms at the southern elevation have large arched windows, both now containing brick infill. To the northern elevation are two smaller rectangular windows set at a raised height. The rooms have external doorways extending to >2.50 m in height with ashlar decorative blocks set with splayed jamb bricks. Two large cast iron

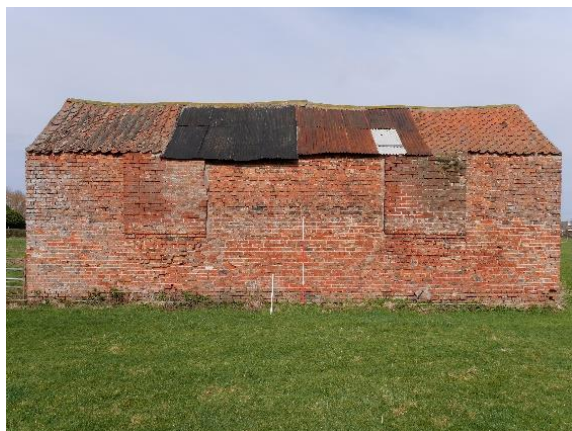
South southeast facing elevation

hinges are set into ashlar blocks on which the door would be hung. One doorway still has the original wooden plank door hung with cast iron T hinges. Some later repairs to the doorway are evident. Internal floor comprised of red bricks laid in running bond. Each room contains four brick-built stands supporting ashlar troughs. Troughs are located at each corner of the room and some still have evidence of metal bar fixtures.

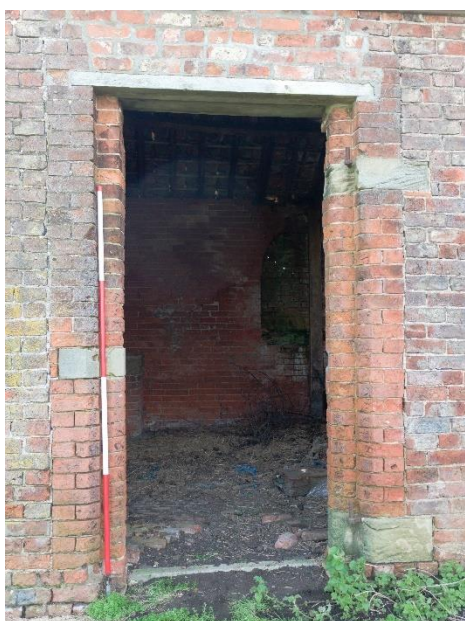
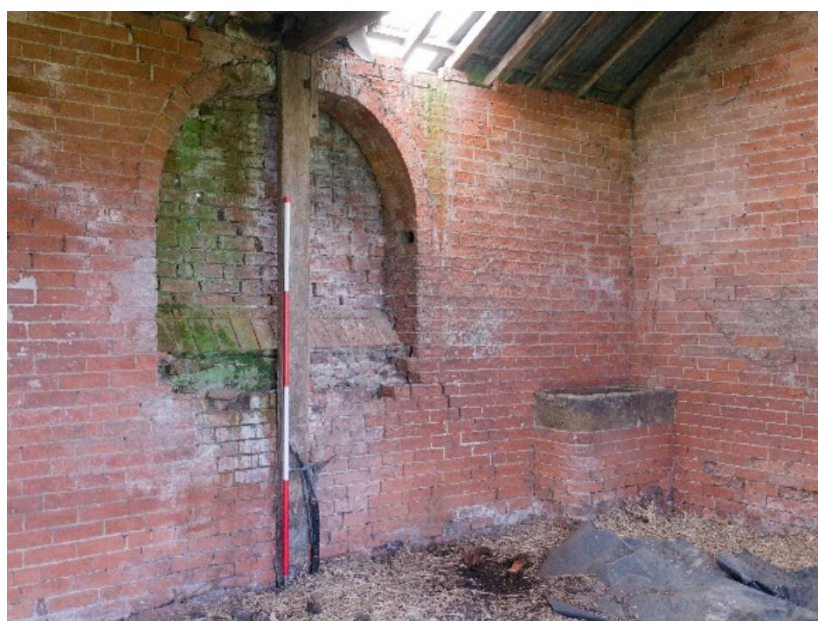
Clockwise from left: One of the two identical external doorways with splayed jambs, brick infilled arched window, brick trough? With mounted ashlar basin, kingpost truss. Additional images of the Rubbing House have been incorporated into a short film that can be seen via this link: <https://www.instagram.com/p/CMzQA4-gyAf/>

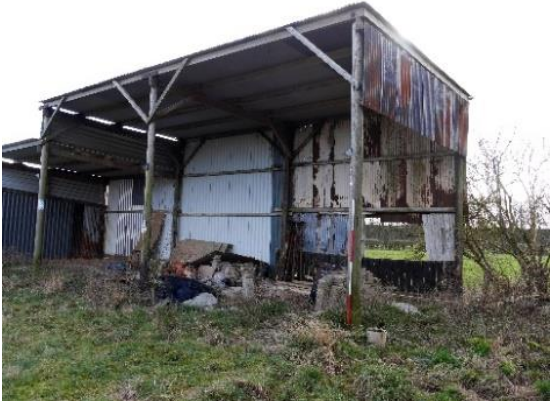
601 Pole Barn 2	Enclosed nonstandard pole barn constructed out of timber and corrugated iron sheets. C20th PDR 66

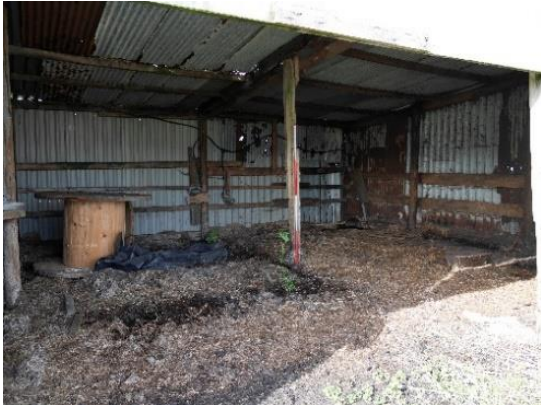
602 Pole Barn 3	Open non-standardised pole barn constructed out of reused timber offcuts, panel doors, telegraph poles, corrugated iron sheets and railway sleepers. C20th PDR 67
