Prospect Farm, Murton Way, Murton, York

Report on a Level 2 Buildings Recording

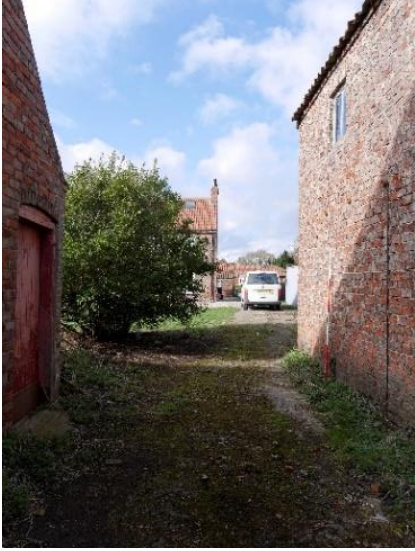
Context Number Name Associated contexts	Description and PDR (Photograph Direction Reference No.)	Photograph
603 Central Courtyard/ Collecting Yard	Located to the south of the combination barn and the milking parlour, mostly concrete. C19th PDR 68	 
604 Access Road	A gravel and earth access road leading off Murton Way into the farmyard. C19th PDR 69
