**Overdale, Le Carrefour a Cendre,
St Peter, Jersey**

Historic Building Survey

HISTORIC BUILDING REPORT

OCTOBER 2008

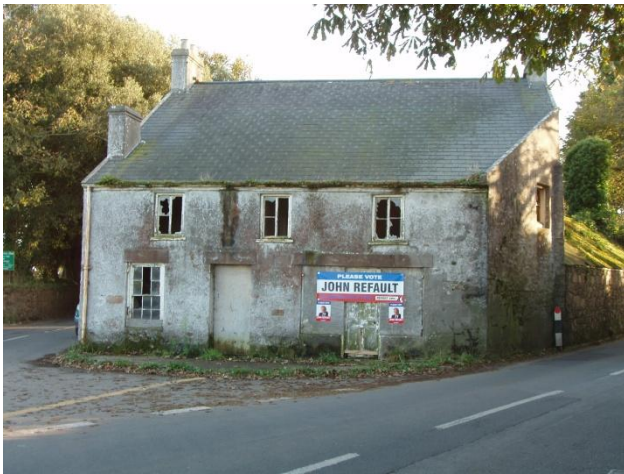
Plate 1. North facing facade, Overdale, Le Carrefour a Cendre.

1.2.2 Overdale is a two storey detached property, with associated outbuildings (Plates 1 & 2). The cottage is situated to the northern end of a neglected garden area. The property has undergone several phases of development, resulting in an irregular shaped build with the form dictated by the outline of the roads to the east and west of the structure. The main build takes a pentagonal form, with a line of single storey outbuildings including kitchen, utility/wash room and toilet added to the west flank, following the route of La Grande Route Des Augerez. A ruined detached brick build is located to the south of the property (Plates 3-5). The land associated with the site is defined by a partially demolished random coursed granite wall standing to height of around 1.7m.

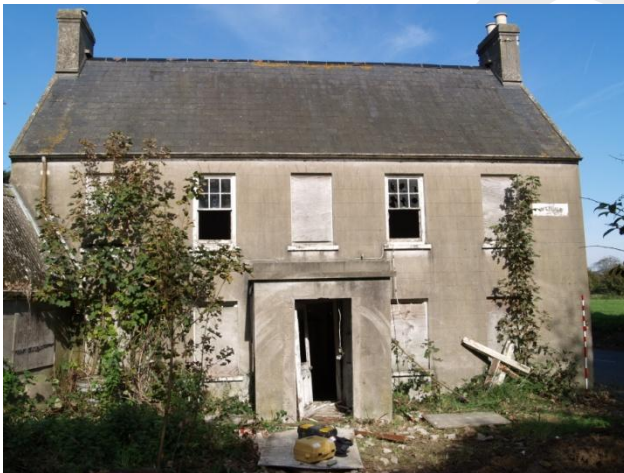
Plate 2. South facing elevation, Overdale, Le Carrefour a Cendre.

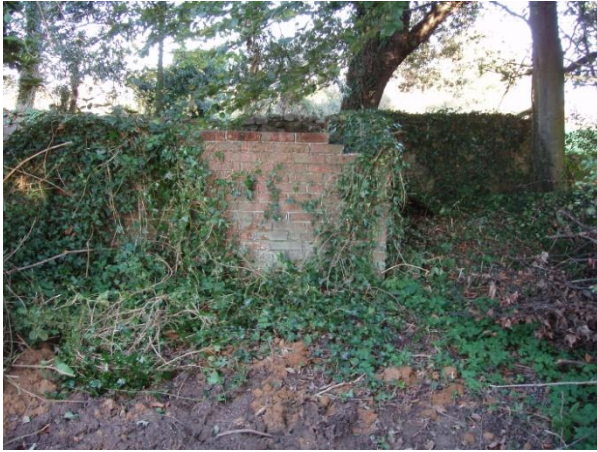
Plate 4. West facing outer wall of outbuilding 'c'.

- 4.1.9 Outbuildings 'a', 'b' and 'c' are constructed using a basic single leaf stretcher bond to enclose three small areas between the granite facade of Rooms 8 and 9 and the outer boundary wall of the property. All three exhibit a level concrete base.

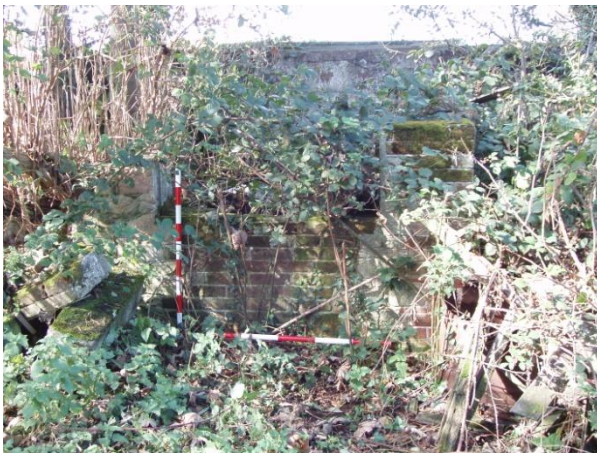
Plate 5. East facing wall of outbuilding 'd'.
(Scales: Vertical 1m. Horizontal 1m)

- 4.1.10 Outbuilding 'd' comprises a single leaf, red brick stretcher bond construction incorporating reused granite building material. The building is keyed into the granite boundary wall to the west. 17 courses remain to height of 1.3m, standing on a level concrete base.

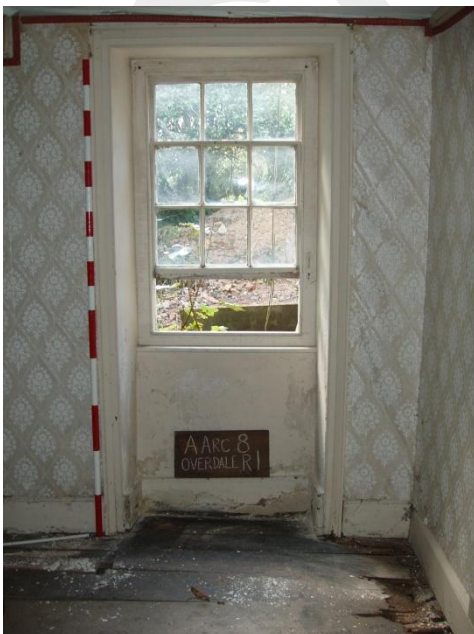
Plate 6. Recessed sash window, Room 1.
(2m Scale).

3.1.3 The rear of the property has nine 19th century plain wood framed sash windows, with the upper and lower sash segmented into six panes. With the exception of Room 3, all windows are set into an internal recess to floor level (Plate 6-7). The recess is finished with a moulded wooden surround in Room 1 and a plain wooden surround in Rooms 10 and 11. The two windows in Room 3 would appear to have originally mirrored the style of those in Room 1, but have since had the recess partially filled in creating two deep set window sills/seats. The moulded surround remains in situ, but has been trimmed to compliment the altered design.

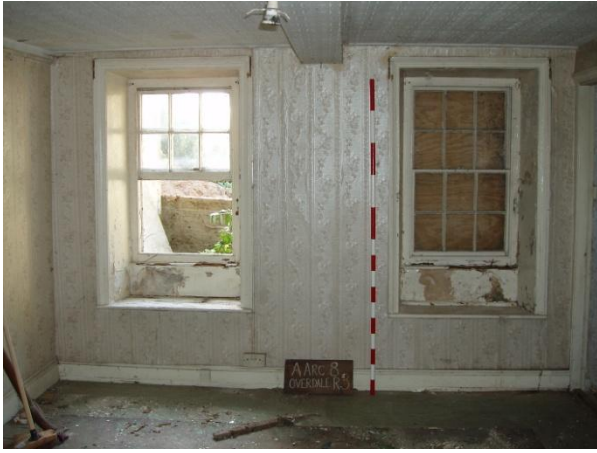
Plate 7. Recessed sash window with deep sill/seat, Room 3 (2m Scale)

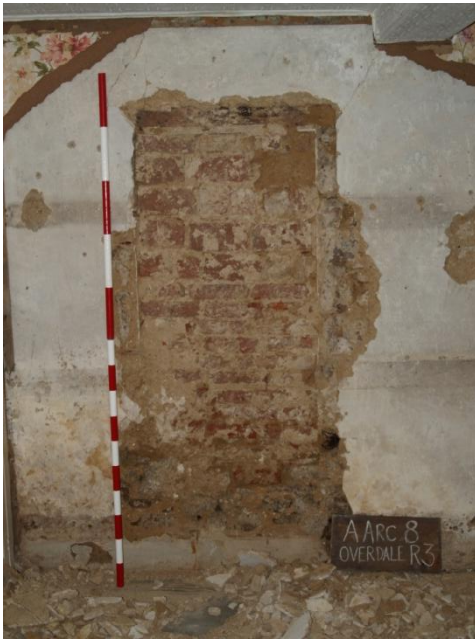
- 3.1.4 Five bricked up windows were identified during the course of the survey (Plate 8). Three located at ground floor level in Rooms 2a, 3 and 4 (Figure 2) and two in the upper storey, in Rooms 12 & 13 (Figure 3). Windows identified in rooms 2a, 3 and 4 are associated with the earliest phase of the building, having been bricked up during the construction of the 19th/20th century extension. The bricked up window in Room 5 is set into the east flank of the extension.

Plate 8. Bricked up window, rear wall of Room 3 (2m Scale)

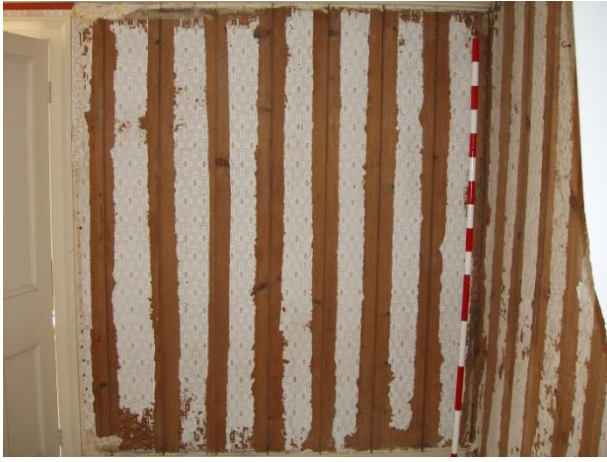
Plate 10. Jersey Panelling, Room 1(2m Scale).

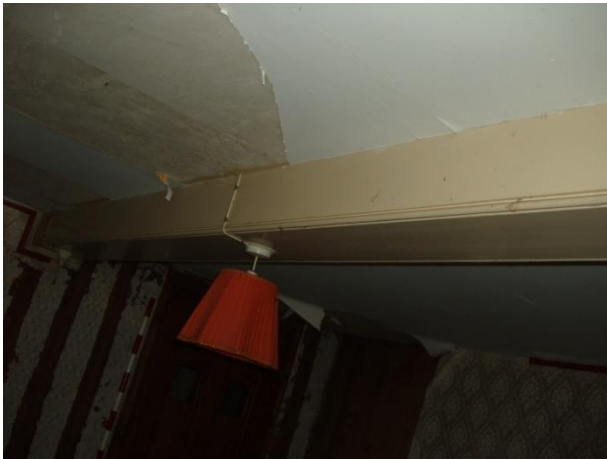
- 4.1.5 Rooms 1 (extending through Room 4), 3, 10 and 12 exhibit a single support beam of Elm or Oak encased in pine, bracing the width of main building (Plate 11). A reused beam can also be seen Room 5. An exposed section of one of the beams as visible in Room 4 would indicate a late 18th/early 19th date, corresponding with the earliest documented date for the property.

Plate 11. Central Beam. Room 1.

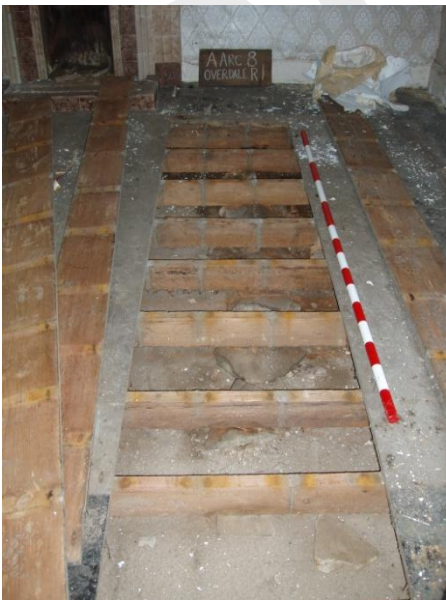
- 4.1.6 The floor boards and joists on both ground and upper levels comprise thin sawn pine timber and are a 19th/20th addition to the house (Plate 12). These are apparent in rooms 1-4 (Ground Floor) and 10-15 (Upper Storey). Ground floor joists are levelled on mixed stacks of granite rubble, brick and broken tile standing to height of approximately 150mm above current ground level. The ground floor surface in Rooms 5 and 6 comprises a level concrete base. In addition, Room 5 has a linear hard wearing area of red brick forming a track between the front door and the doorway between Rooms 4 and 5.

Plate 12. Floor boards and joists, Room 1.
(2m Scale)

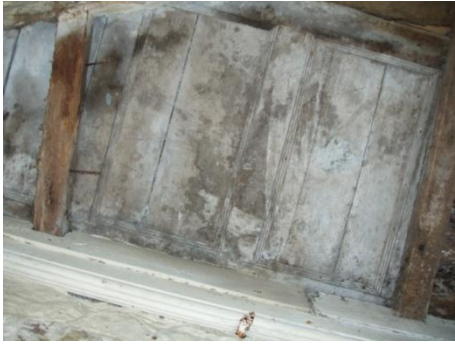
- 4.1.7 Room 7, extending from the west flank of the main building comprises a granite store room created by enclosing the original outer wall of the property and the granite boundary wall following La Grande Route Des Augerez. The ceiling comprises reused moulded wooden boards supported on horizontal beams. The form and style of the boards suggests that they are of 18th century origin and have clearly been reclaimed (Plate 13). The floor surface comprises a level concrete base.

Plate 13. Reclaimed boards, Room 7.
