Results of an Archaeological Evaluation  
of 12 to 14 Hilgrove Street & 12 Halkett Street, St Helier, Jersey

Absolute Archaeology

Trump Holding Ltd

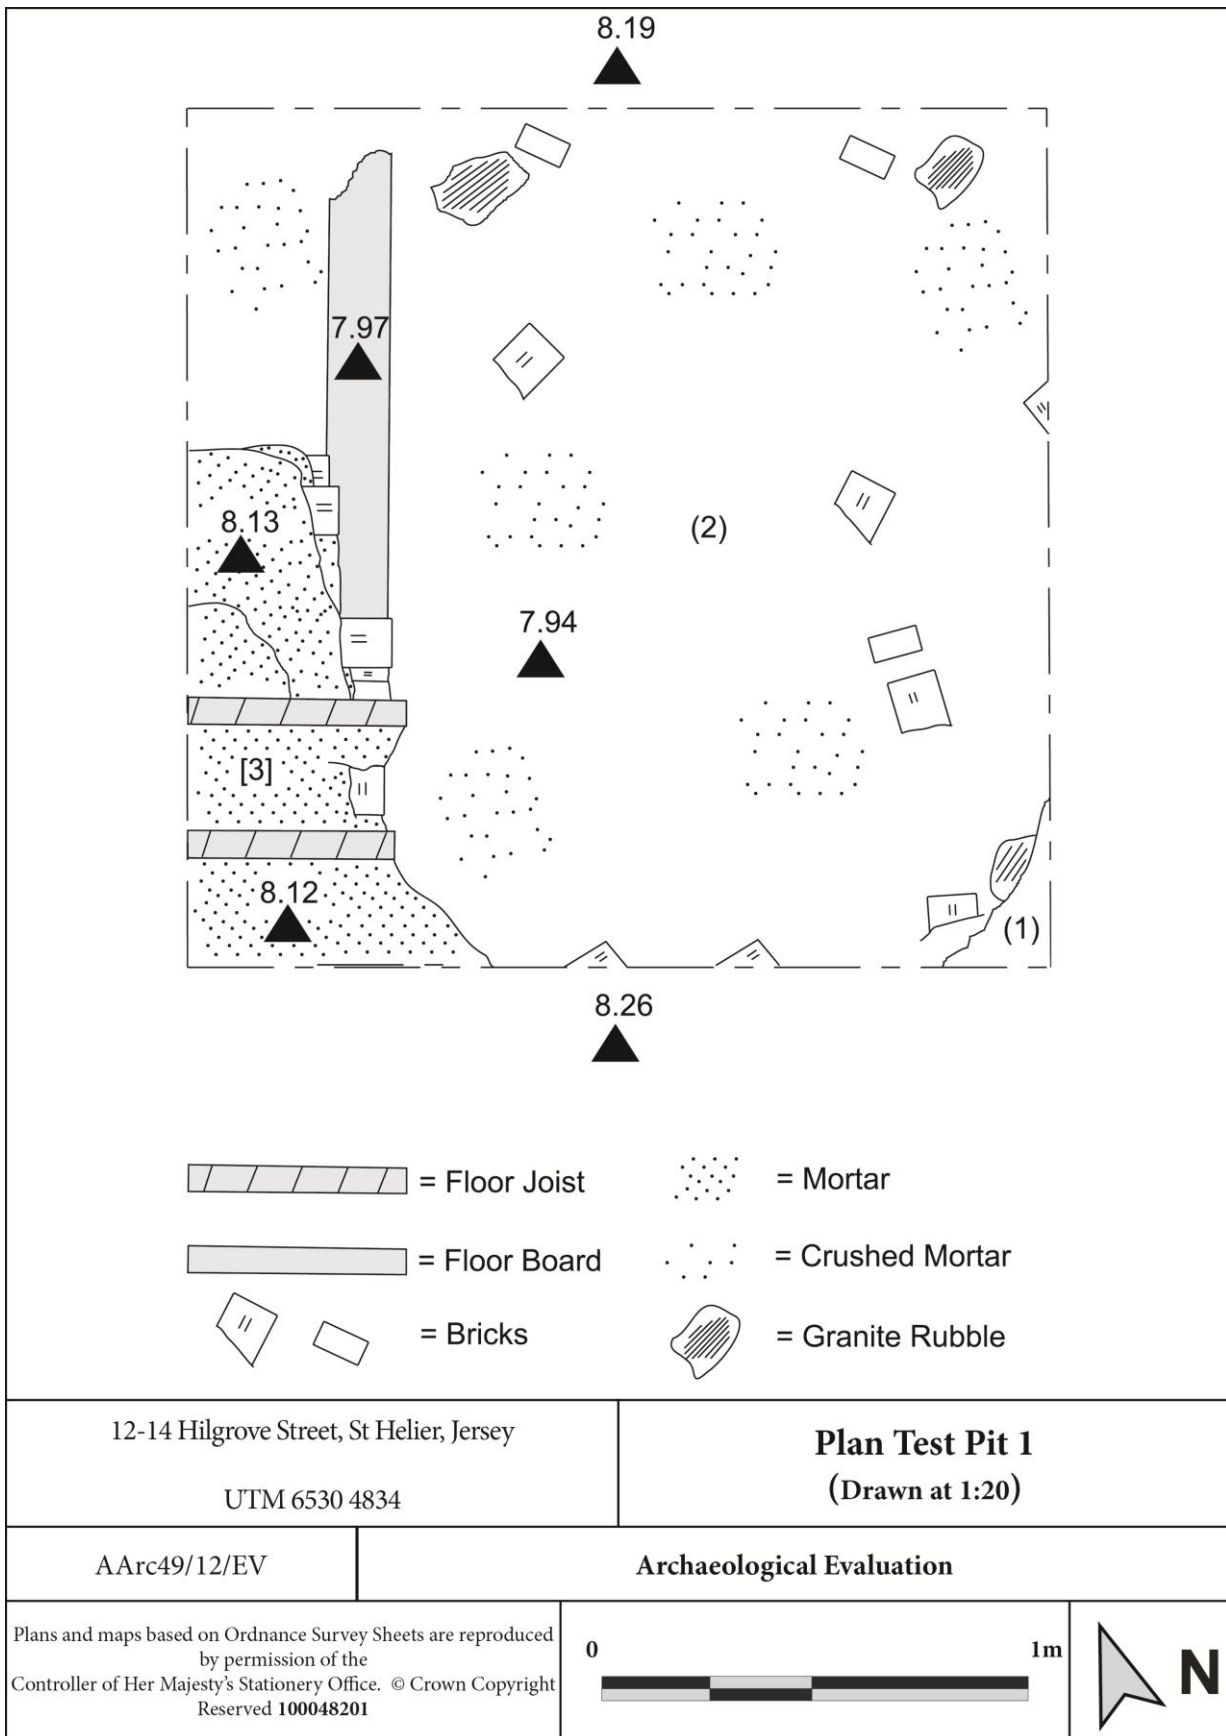
Figure 8: Plan of Test Pit 1

Test Pit 1 (see Figure 8) was excavated in the area of the recently demolished number 12 Halkett Street. The modern hardcore material was removed to a depth of 50mm, to reveal a large area of modern demolition material (2). The demolition material was seen to compact a brick pier [4] structure, which appeared in plan to be supporting east-west orientated floor joists, [3]. It was clear, after the removal of 350mm of context (2), that this represented the demolition material belonging to the recently removed number 12 Halkett Street. It was later confirmed that the material was used to backfill the basement, which was identified during the demolition of the standing building (pers. comm. Mr S Batty, ground worker). Brick pier [4] would appear to be a structural feature supporting joists [3], which represented the remains of the street level floor surface of number 12 Halkett Street.

The existence of a basement, belonging to the structure was not communicated to Absolute Archaeology at the time of agreeing the Test Pit Locations. As a result, no further excavation was undertaken in this area of the site, since the excavation of the basement in the early 19<sup>th</sup> century, would have destroyed all earlier archaeological remains.

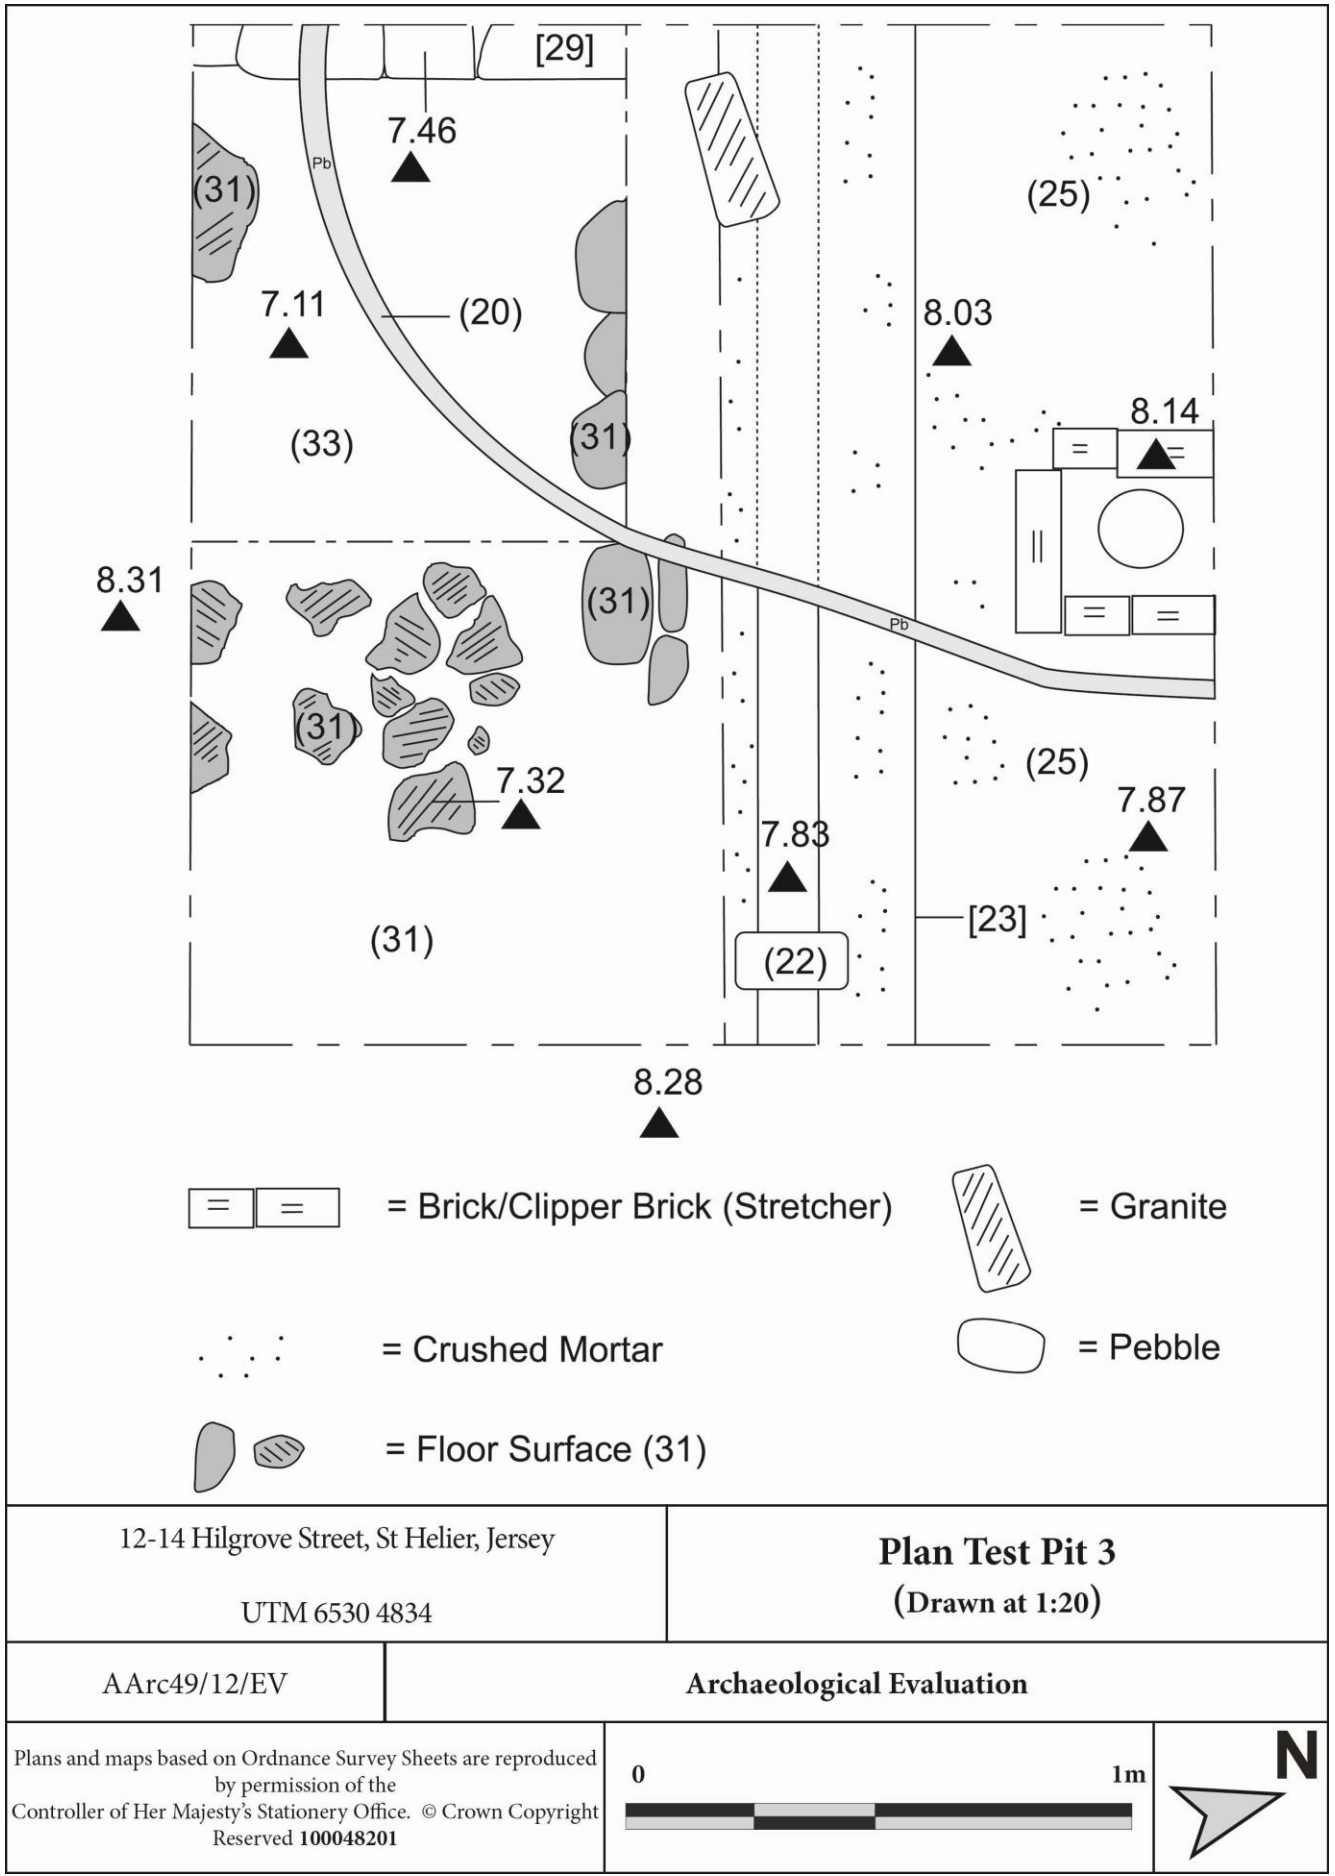
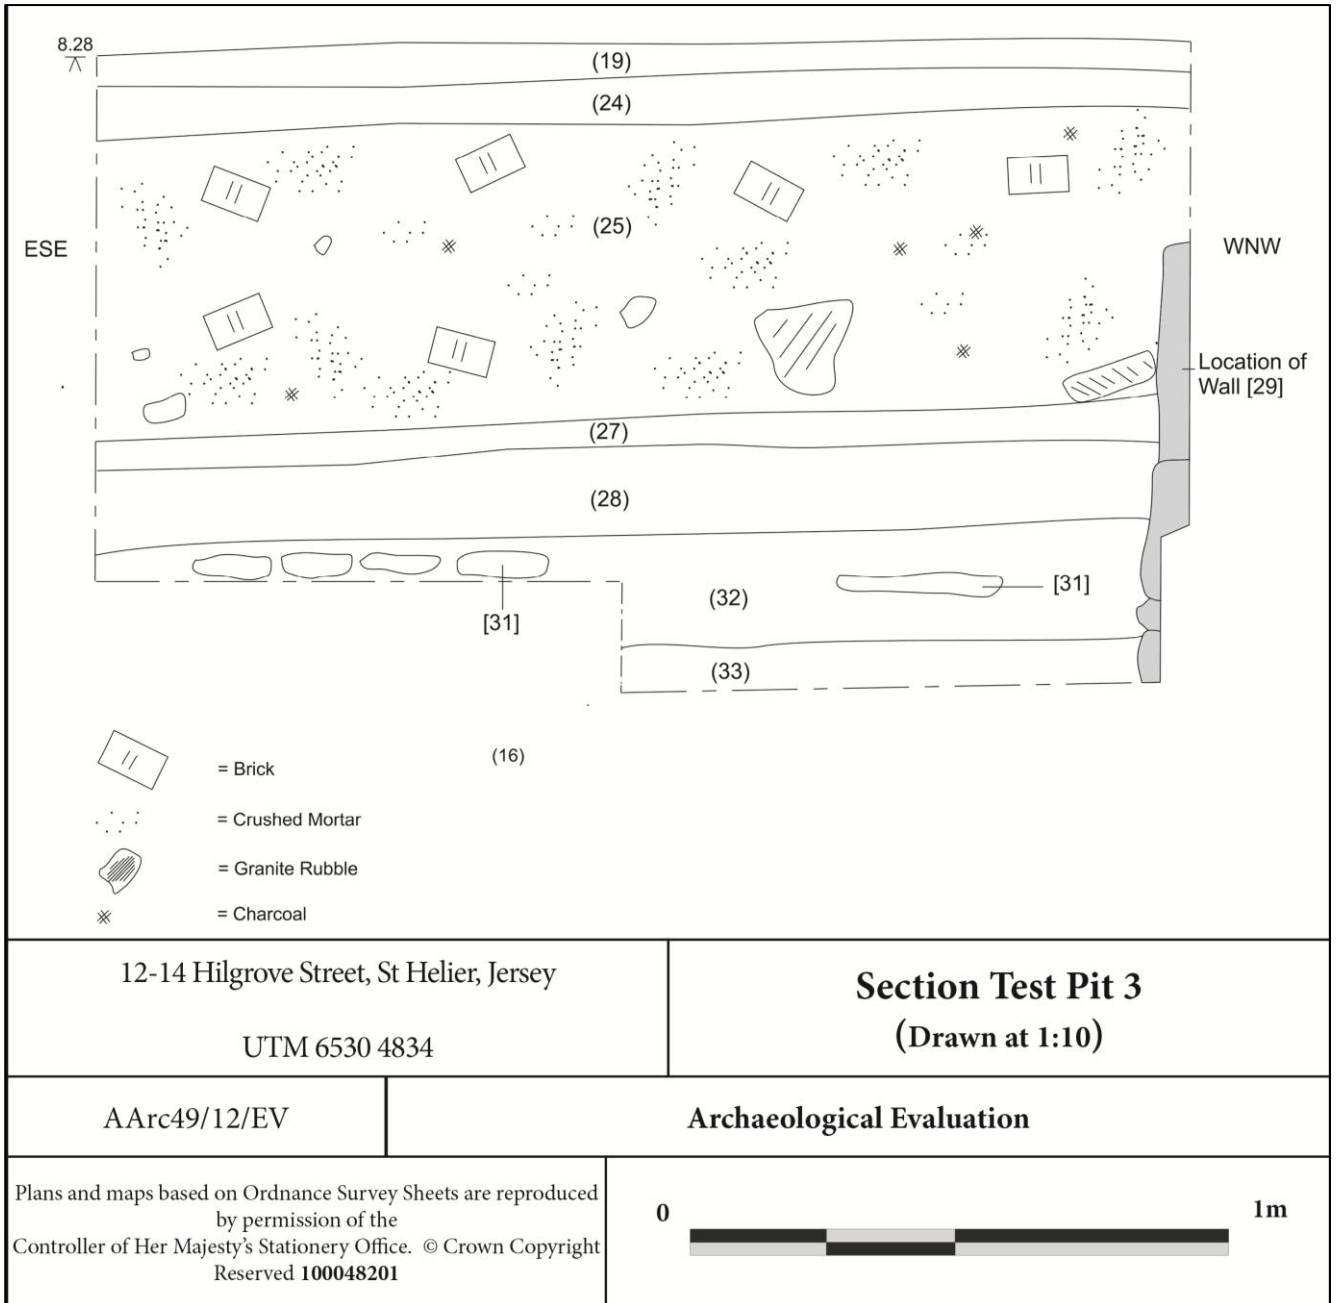
Figure 10: Plan of Test Pit 3

Test Pit 3 (see Figure 10 and Figure 13) was excavated in the area of the yard belonging to number 14 Hilgrove Street. Once again, modern services occupied the northern side of the excavation, restricting the investigation in this area. The modern concrete covering was seen to seal an earlier yard surface, comprising square cut modern flags [24], which in turn sealed a makeup layer (25), comprising broken red brick and tile, along with general domestic waste, in the form of 19<sup>th</sup> century ceramic sherds. Makeup material (25) was seen to overlay a sequence of layers abutting the ESE elevation of SSW-NNW orientated wall [29]. Directly beneath, and stratigraphically sealed by layer (25), was a dark greyish brown, silty humus layer (27), measured to a depth of 80mm. Layer (27) was seen throughout the NNE facing section of Test Pit 3, sloping to the ESE and sealing a blown sand deposit (28). Beneath deposit (28) is a yard surface [31], comprising small irregular limestone flags (measuring c. 150mm (l) x 100mm (w) x 60mm (d)) with large rounded cobbles (measuring 180mm (l) x 120mm (w) x 110mm (d)), compacted by a sand matrix (32). The surface was seen throughout the base of Test Pit 3.

The outside elevation of wall [29] was recorded in the ESE facing section of Test Pit 3. The structure comprised granite rubble masonry, roughly dressed on the outer and upper faces, laid in random coursed rows of uneven height. The upper courses are largely obscured by a thick light reddish brown render. The foundation courses (revealed in section) are identifiable, as they protrude 70mm from the upper courses and are not rendered.

The wall appears to have been truncated during the redevelopment of Hilgrove Street, in the early 19<sup>th</sup> century. The stratigraphy in Test Pit 3 suggests that prior to this, layer (27) represented the pre 19<sup>th</sup> century ground level, with makeup material (25) brought in to level

the site to the current street height, in line with the regeneration of Hilgrove Street and Halkett Street, in the period between 1800 and 1834. The result being that the upper coursing of wall [29] survives to just 400mm below the current ground level (7.88m aOD).

The survival of layers representing outdoor surfaces, abutting the ESE elevation of wall [29] indicates that the structure continues to the west of Test Pit 3. The level of the yard surface [31], at 960mm below current ground level (7.32m aOD) indicates that the associated building belongs to a pre 19<sup>th</sup> century phase of activity on the site. Cartographic resources indicate evidence of a building on the Project Site since the 17<sup>th</sup> century; however no artefacts of this date were recovered from Test Pit 3. Due to the proximity of the building to the natural course of Le Grand Douet, it is suggested here that wall [29] may belong to a mill, or similar building requiring a site close to a water source, for industrial/utilitarian purposes. The potential for a mill on the Project Site was previously raised by the Société Jersiaise (as commented in the *Brief for an Archaeological Evaluation 12 to 14 Hilgrove Street*). This may account for the lack of domestic waste/artefacts at this level. In support of this, a map of the Project Site surveyed in 1800 illustrates potential alterations to the natural course of Le Grand Douet. The flow, which is shown to be following the natural topography in earlier maps, appears to be redirecting around a large building on the Project Site.

The evidence suggests that the yard area went through a period of change, in which blown sand was allowed to accumulate and a humic layer built up, suggesting organic growth of perhaps windblown grasses or grains in the area, creating a turfline. The only find retrieved from this sequence, was an 18<sup>th</sup> century sherd of creamware from the blown sand layer (28).

Despite the lack of material finds associated with the early layers, the good preservation and cementation of the render indicates a post-medieval date. Taking into account that the yard surface associated with wall [29] is sealed beneath a blown sand and organic layer, it is suggested here that a conservative date for the building is 17<sup>th</sup> century, based on the available evidence. This would allow for the change in use of the yard area, in the 18<sup>th</sup> century and the eventual demolition of the then existing structure, in conjunction with the early 19<sup>th</sup> century urban regeneration. However, this is speculative at present and further investigation may reveal evidence of an earlier date.

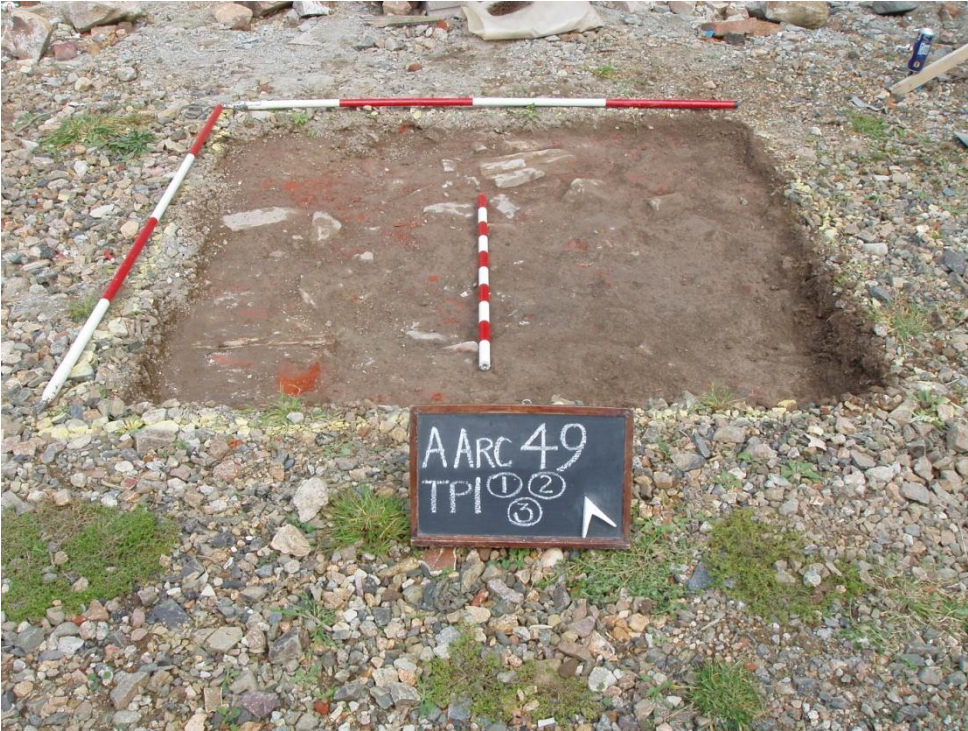
Photograph 1: NNE Facing View of Test Pit 1 (Scales 2 x 2m & 1 x 1m)

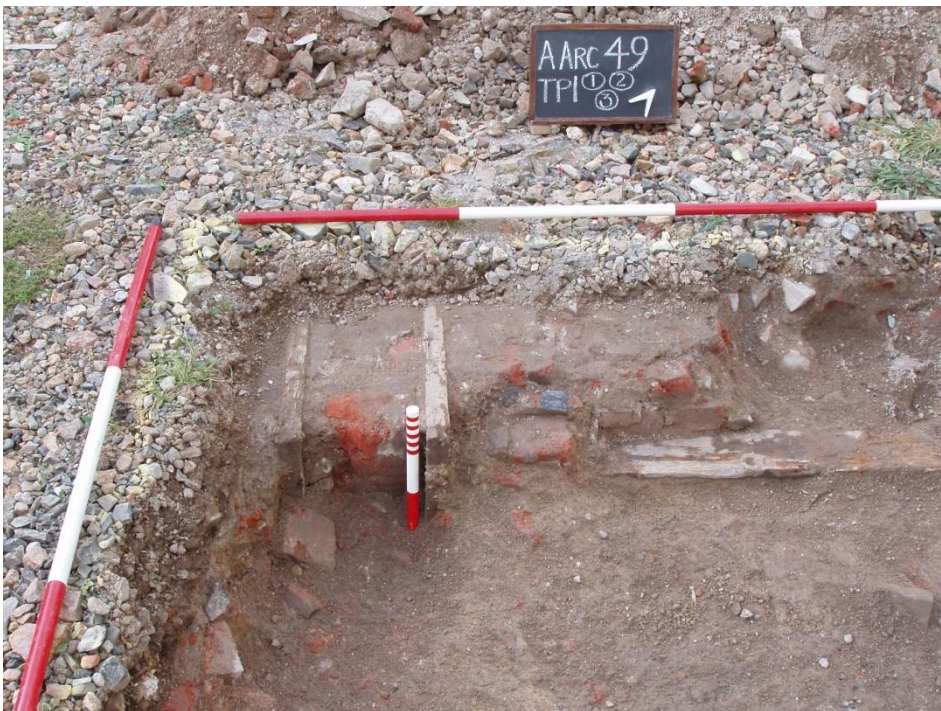
Photograph 2: Test Pit 1 Showing Floor Joists and Brick Pier [3] (Scales 2 x 2m & 1 x 300mm)

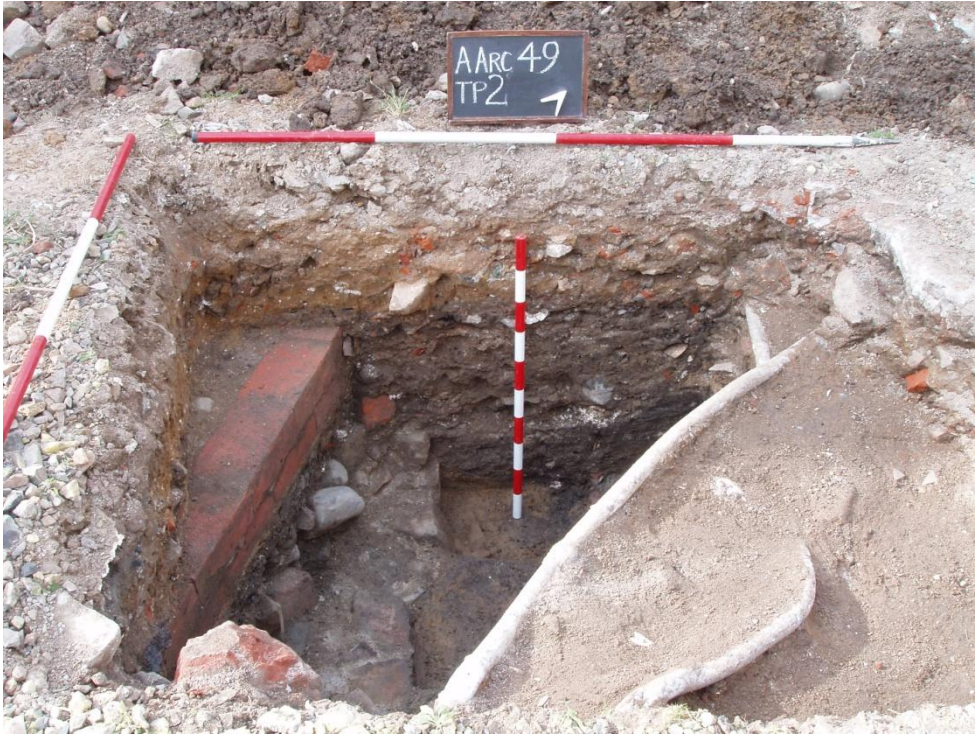
**Photograph 3: SSE Facing Section of Test Pit 2 (Scales 2 x 2m & 1 x 1m)**

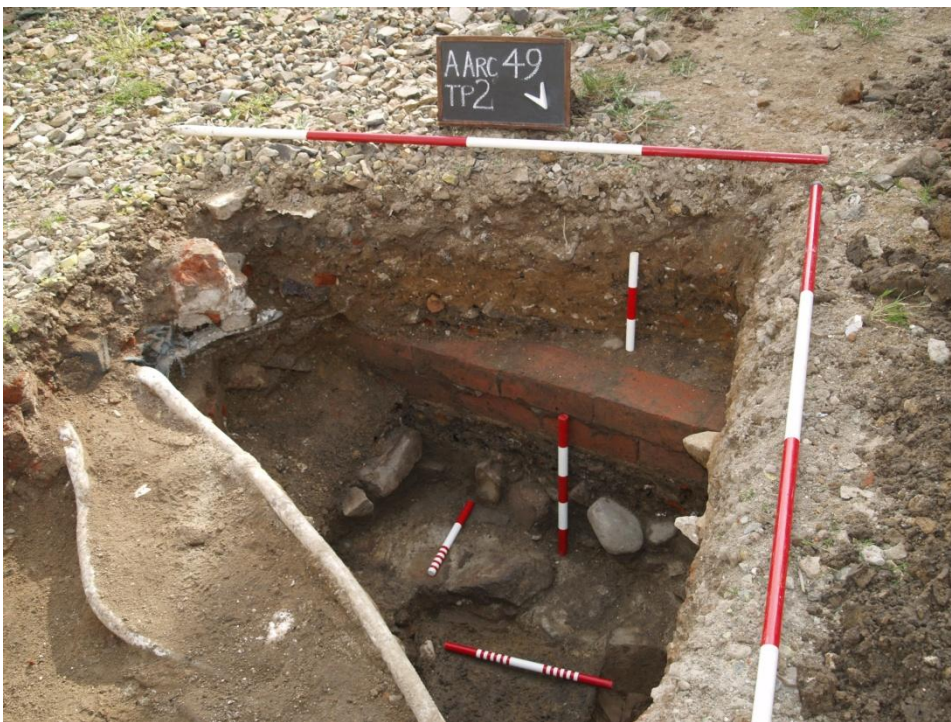
The lower two courses of a granite wall were revealed at the base of Test Pit 2. The feature was orientated WNW-ESE, and observed at 1.02m below current ground level (7.18m aOD). It is suggested that the upper stratigraphy may have been truncated by either service trench [7] or rubbish pit cut [12]. The wall, which was partially visible in plan, comprised granite rubble masonry, roughly dressed on the outer and upper faces, laid in coursed rows of even height. The granite blocks are irregular in shape, measuring 160mm (h) x <170mm (w) x <180mm (l). A rubble core was visible, indicating a parallel row of granite blocks (double skin wall), sealed beneath the north facing section. Fragments of lime render (c. 15mm), identified in fill (11), may represent a residual deposit from the demolished wall. The partially sealed width of the wall measured 380mm in plan, suggesting a total width of c. >550mm. A sondage excavated against the NNE facing elevation of the wall, revealed the base of the structure at 1.21m below the current ground level (6.99m aOD). No construction cut for wall [14] was visible in section, due to the disturbance from rubbish pit cut [12]. However, the lower course of the structure could be seen to be compacted by the soft, silty sand material

Although no dating evidence was retrieved from the stratigraphy of wall [14], it is proposed that the structure belongs to a pre 19<sup>th</sup> century phase of activity, and may even relate to the 17<sup>th</sup> century building, recorded in early cartographic resources (Driscoll *et al.* 2011).

**Photograph 4: SSW Facing View of Test Pit 2 Showing Wall [14] at Base of Trench (2 x 2m, 2 x 500mm, 2 x 300mm)**

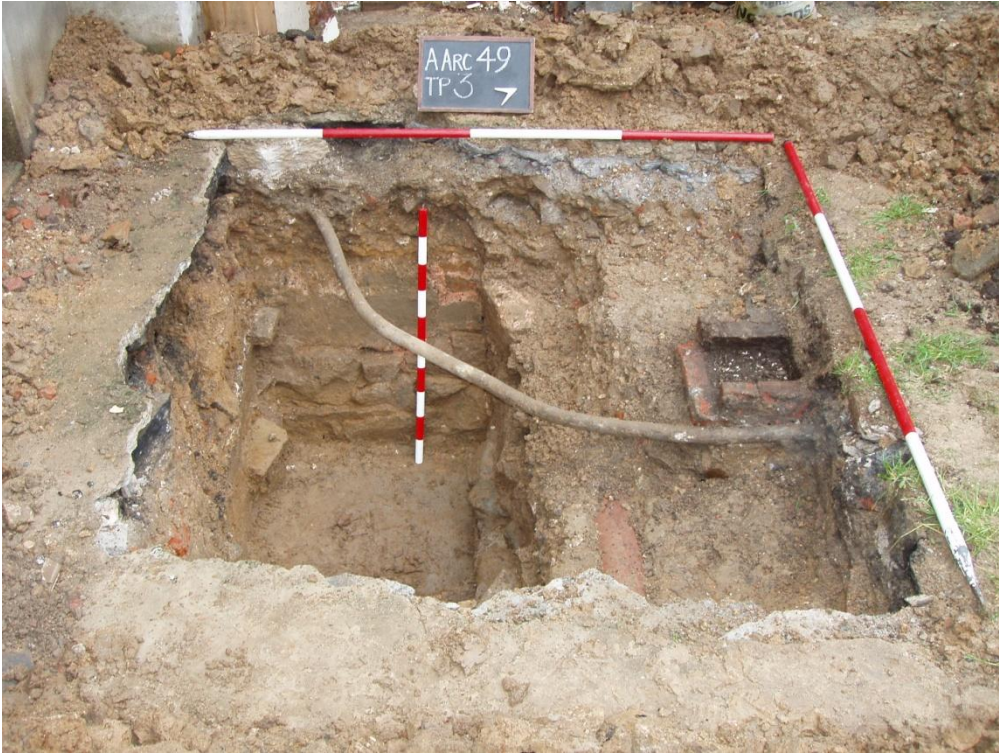
**Photograph 5: ESE Facing Section of Test Pit 3 (Scales 2 x 2m & 1 x 1m)**

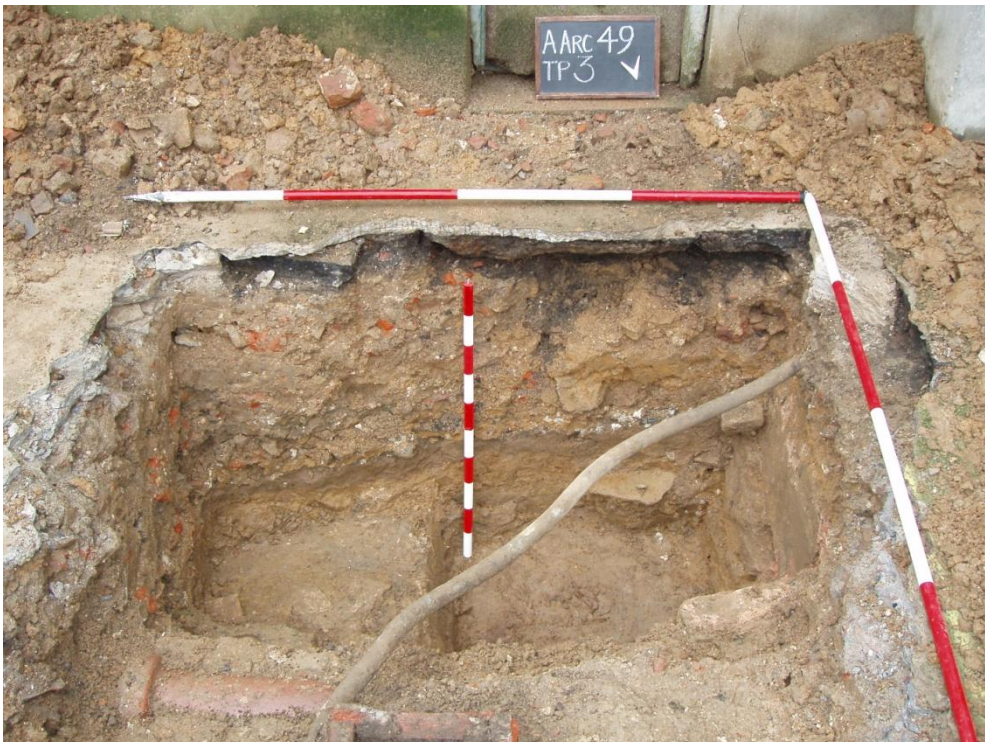
**Photograph 6: ENE Facing Section of Test Pit 3 (Scales 2 x 2m & 1 x 1m)**

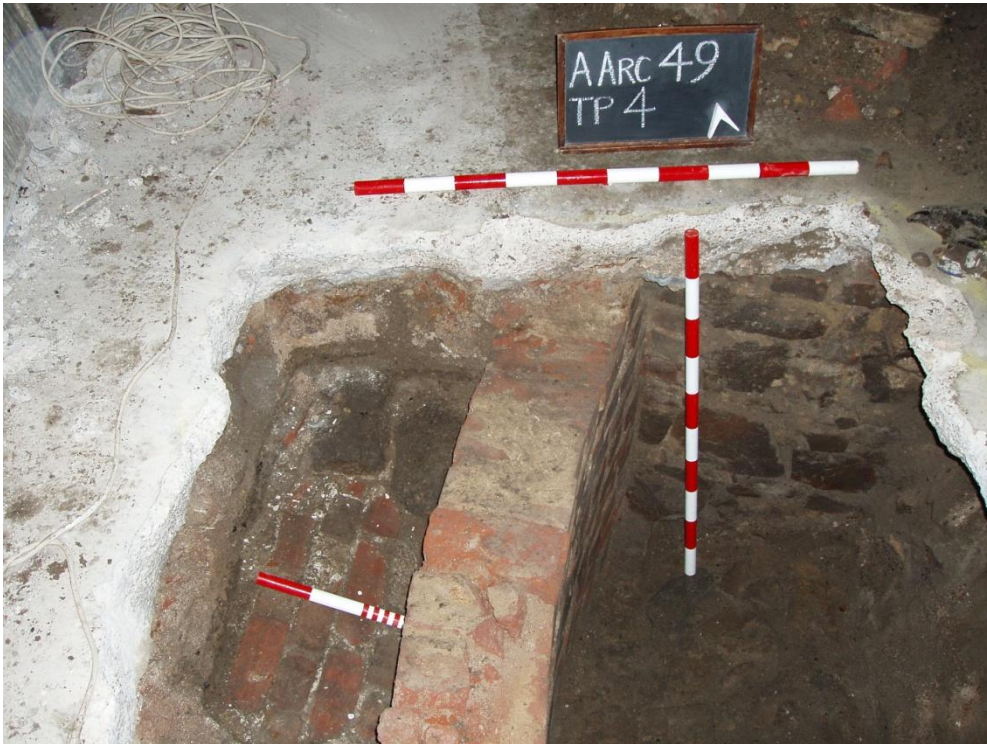
Site, at the time of the investigation. The 19<sup>th</sup> century brick lined culvert, built to channel the flow of Le Grand Douet beneath number 12 Hilgrove Street, was identified directly beneath the reinforced concrete floor of the property. The structure [39] comprising a single skin, header bond brick wall, curved SW-NE through the excavated area. The wall appeared to be supporting the brick culvert, which was seen to arch into the ESE facing section. The structure is sealed by a friable mid brown white lime mortar (wall) and a thick brownish white, well cemented lime mortar (arch). Three granite blocks seal the brick arch to the NE of the structure [37], which may represent a rough surface. To the ESE of the culvert, 300mm of demolition material (35), sealed 600mm of dark brownish grey loose sand (36). Modern discarded polythene film was identified throughout, confirming that both contexts had been deposited in the 20<sup>th</sup> century. Once removed, a well preserved sequence of archaeology was revealed.

**Photograph 7: SSW Facing Section of Test Pit 4 Showing 19<sup>th</sup> century Culvert with wall [42] (Scales 2 x 1m & 1 x 300mm)**

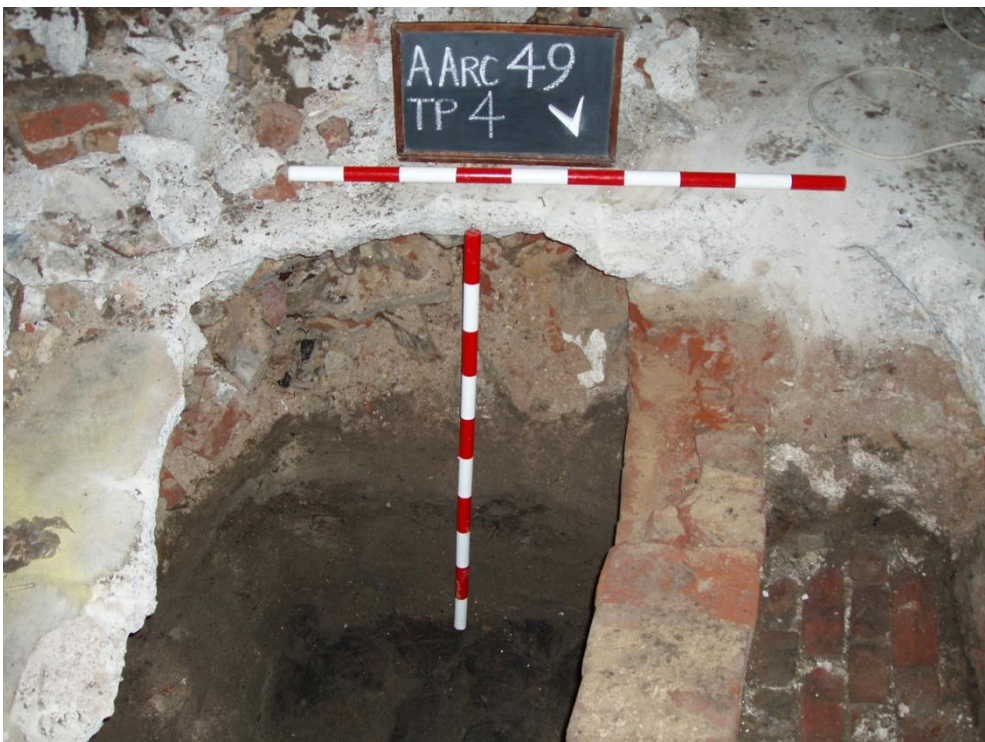
Contexts (35) and (36) had been masking the 11 courses of visible brickwork belonging to the outer wall of culvert [39]. At the base of Test Pit 4, a rough stone floor surface [41] was identified, abutting a granite wall [42], visible against the SSW facing section (recorded at 7.14m aOD, 1.02m below current ground level). The construction cut [40], for the culvert could be seen to truncate both floor [41] and wall [42] to the WNW. Stone floor [41] comprised irregular stone slabs, measuring <150mm (w) x 220mm (l) x 50mm (d), arranged to form an even surface. The floor was seen to abut wall [42] against the SSW elevation. The irregular coursed granite wall, is orientated roughly WNW-ESE, and survives to a truncated height of 900mm. A single course of brickwork has been added to the top of the wall to make it up to the height of the modern floor concrete.

**Photograph 8: NNE Facing Section of Test Pit 4 Showing 20<sup>th</sup> Make Up (36) & Fill (37) (Scales 2 x 1m)**
