Results of an Archaeological Watching Brief & Building Recording ~
Archirondel Cottage, La Route De La Cote, St Martin, JE3 6DY

Absolute Archaeology LLP

On behalf of Mr K Martin

Date of Preparation: 26th May 2015

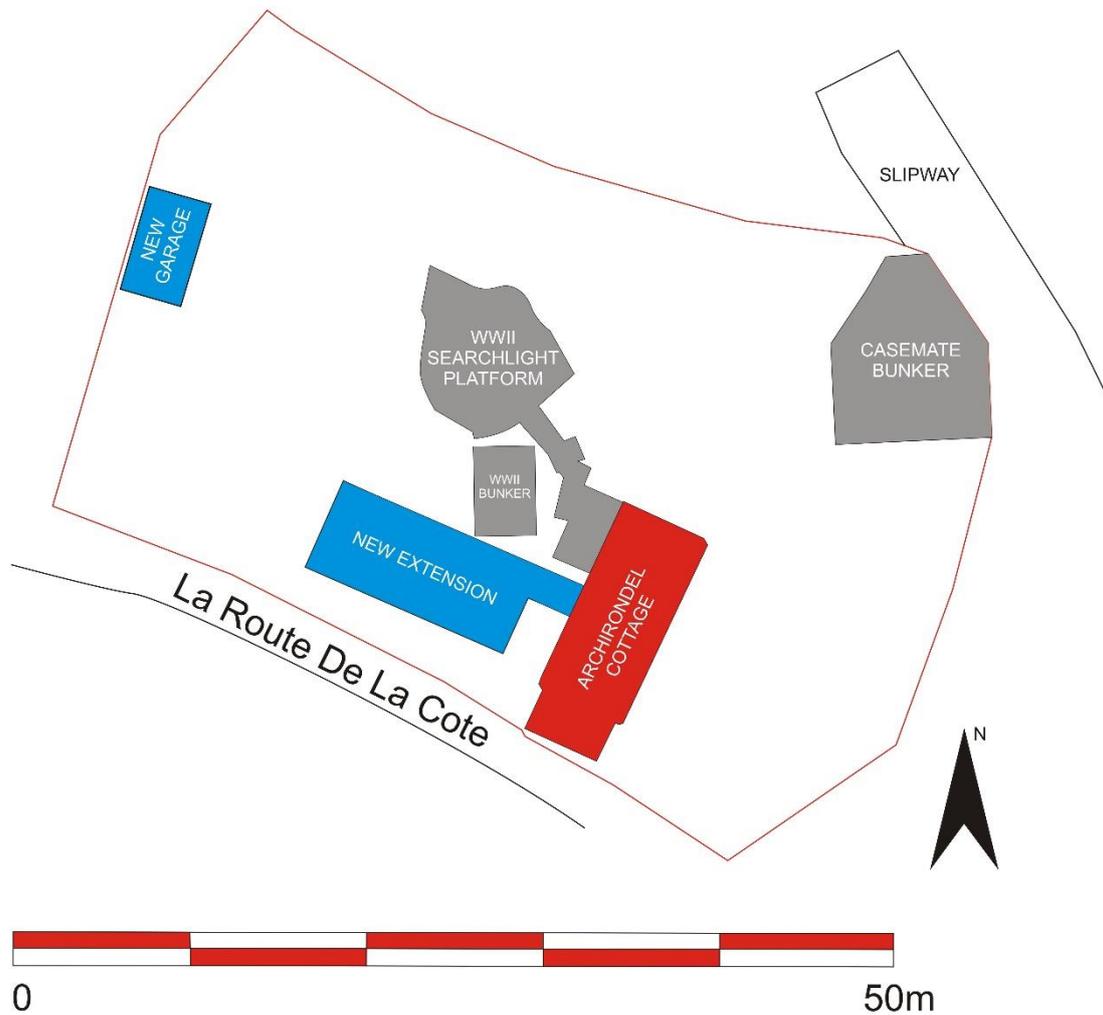
Figure 3 Site plan showing main features. Areas of excavation shown in blue.

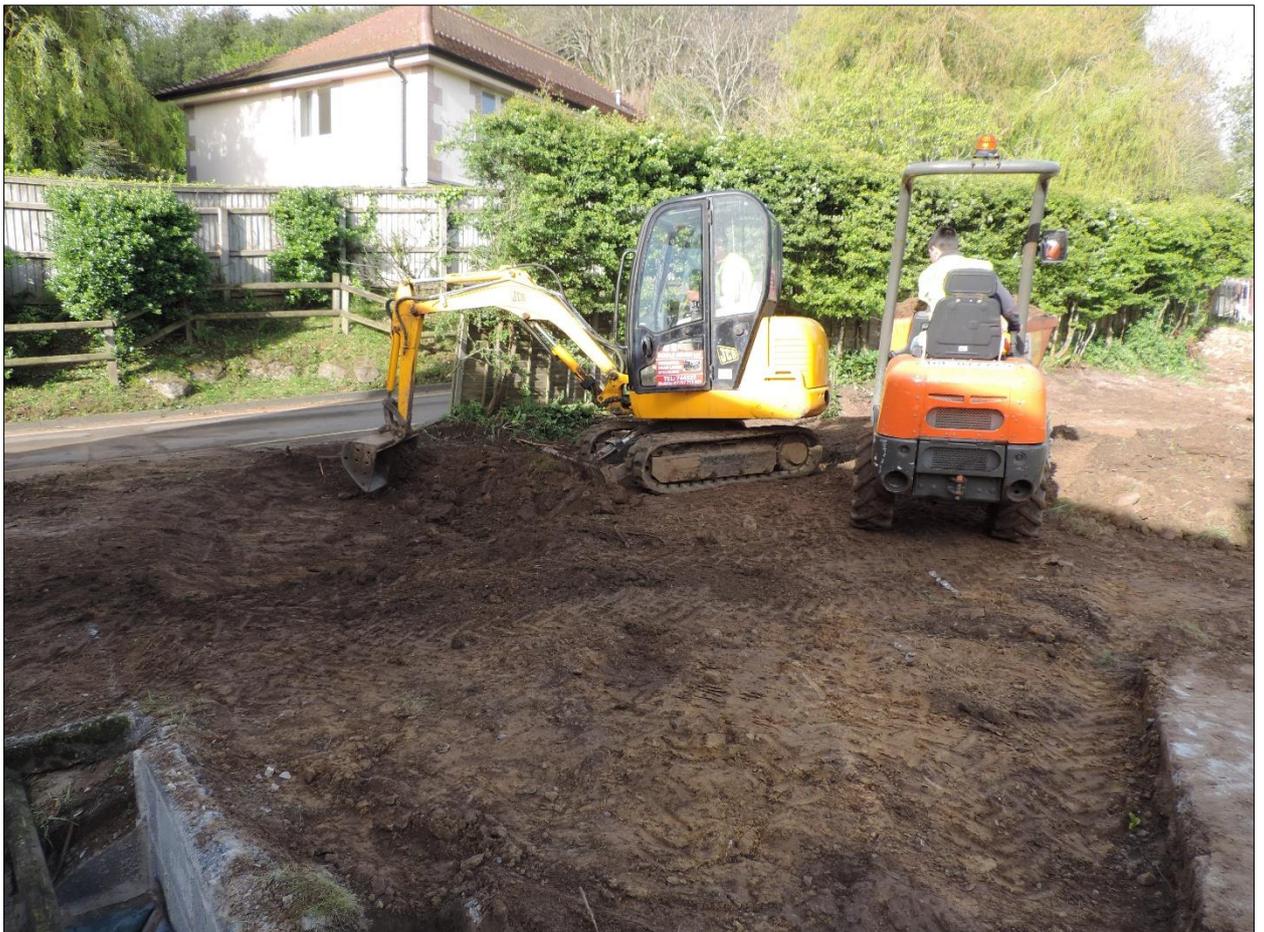
The mechanical excavation of the footprint of the new build revealed a topsoil/ turfline deposited in the modern period (1), sealing the reinforced concrete roof slab of the WWII bunker [2], which is preserved to the SE of the site and a modern period soakaway [4] to the SW. Both features were cut into made ground (3) which consisted of poorly mixed topsoil and sandy clay. The made ground was seen to seal a truncated compacted silty deposit (7), which was noted across the Project Site, at a depth of between 9.60m aJD – 11.55m aJD (400mm – 750mm below the current ground level).

Photo 1 SW facing view of Project Site during excavation

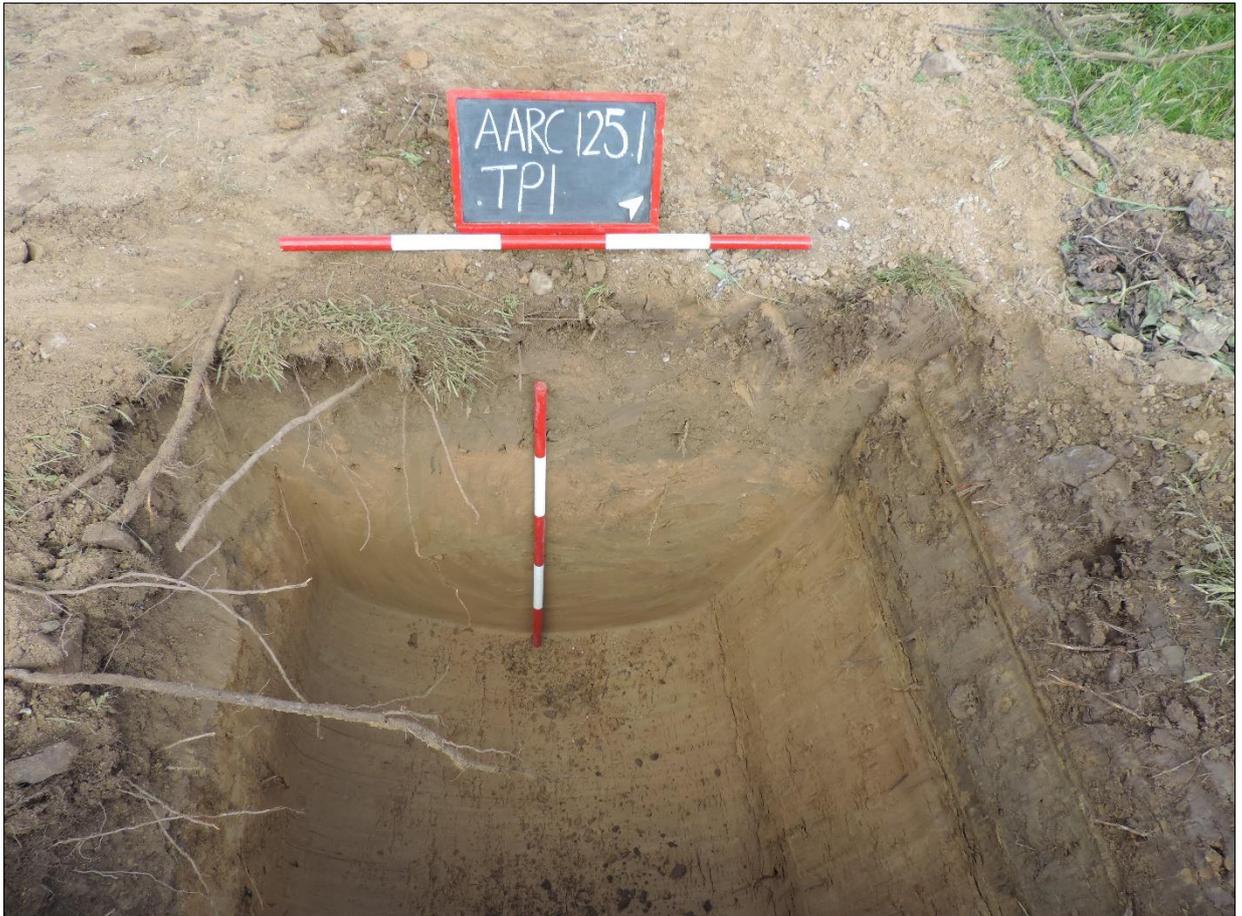
Test Pit 1 was located to the NW corner of the footprint of the main new build. Excavation revealed a topsoil/turfline (100), deposited in the modern period, sealing made ground comprising soft humic topsoil, poorly mixed with soft sandy clay (101). The material was loosely compacted and represents Post Medieval ground disturbance, most likely contemporary with the WWII redevelopment of the Project Site. The made ground was seen to seal a truncated compacted silty deposit, with low clay content (102).

Photo 2 SSE facing section of Test Pt 1 (Scales 2 x 1m)

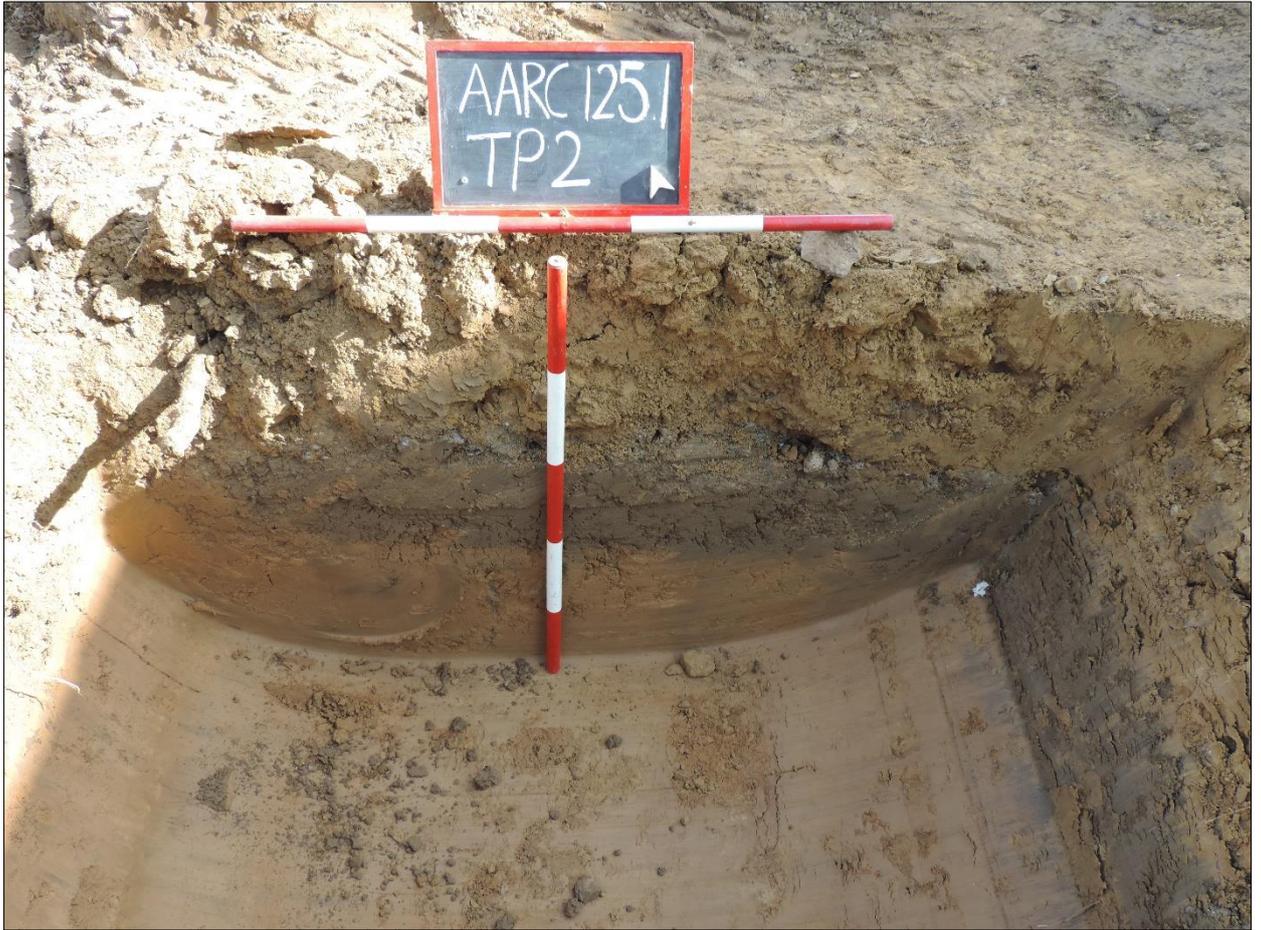
Test Pit 2 was located to the NE corner of the footprint of the new build. Excavation revealed 300mm of made ground (200), comprising soft sandy clay mixed with modern plastic sheeting. This deposit was seen to seal a soft sandy clay (201) with crushed concrete throughout, which was seen to overlay a truncated compacted silty deposit with a low clay content (202).

Photo 3 SSW facing section of Test Pit 2 (Scales 2 x 1m)

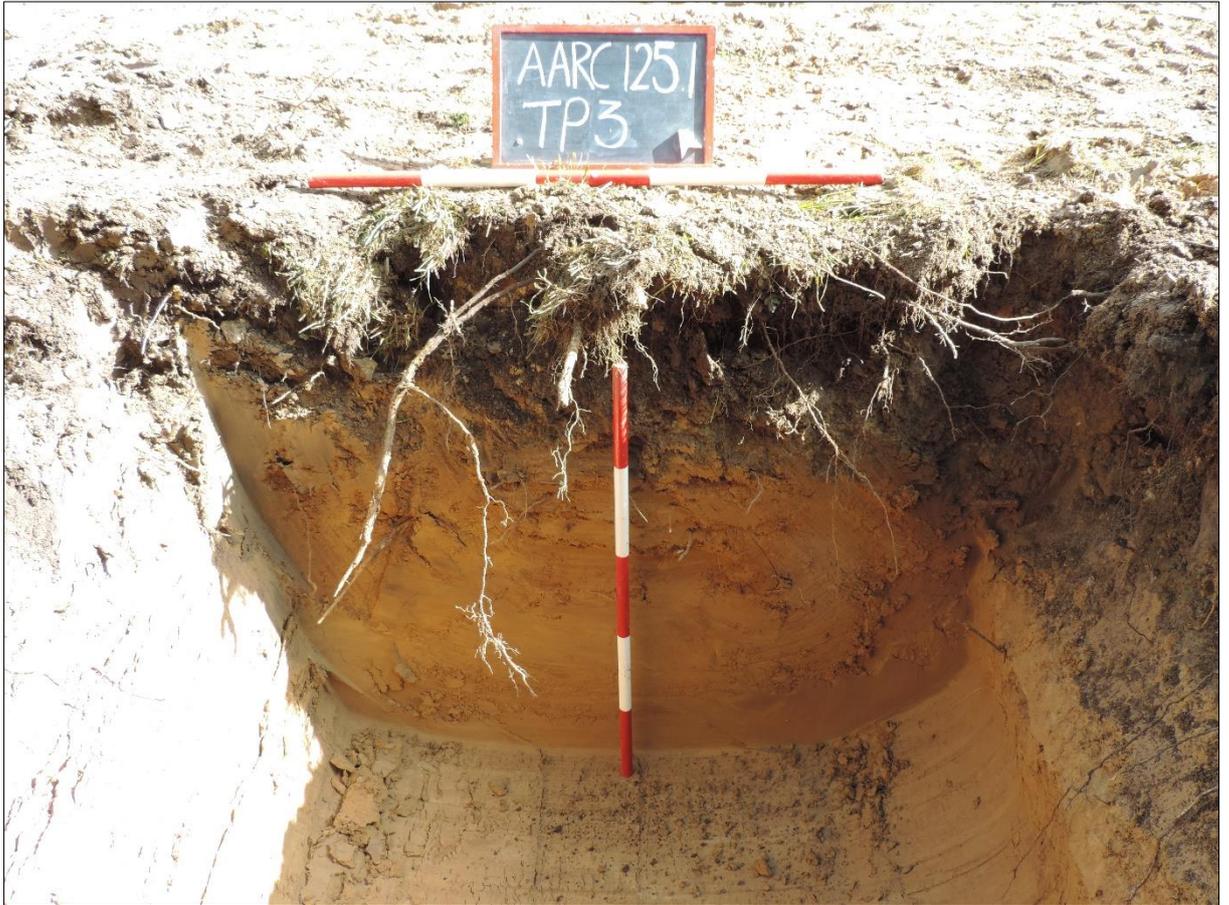
Test Pit 3 was located to the SE corner of the footprint of the new build. Excavation revealed 400mm of loosely compacted made ground (300), sealing truncated compacted silt with a low clay content (301).

Photo 4 SSW facing section Test Pit 3 (Scales 2 x 1m)

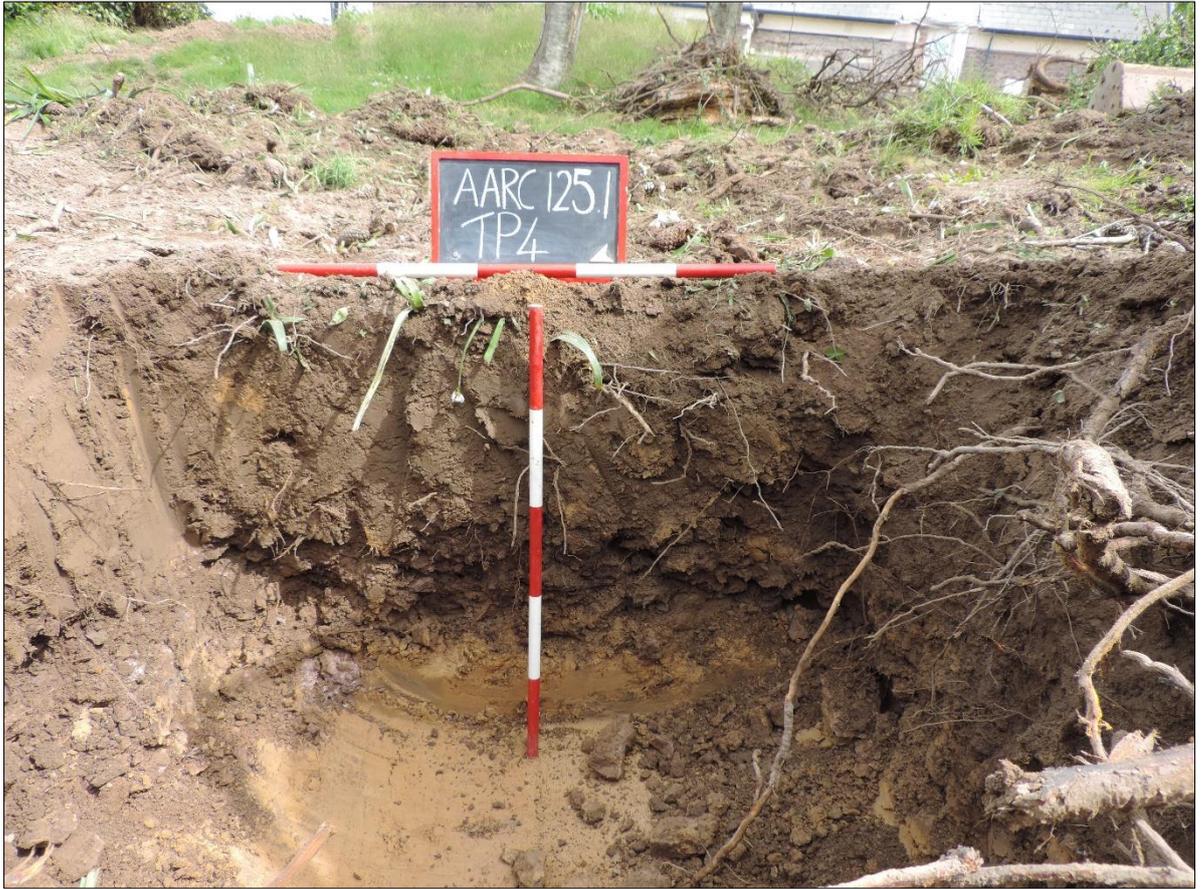
Test Pit 4 was located to the NE corner of the Project Site, in the area of the new garage building. Excavation revealed topsoil turfline (400), sealing made ground comprising redeposited topsoil with irregular angular stone inclusions (average size 200mm (l) x 150mm (w) x 100mm (d)). The deposit was seen to overlay a truncated compacted silt deposit with a low clay content.

Photo 5 West facing section of Test Pit 4 (Sales 2 x 1m)

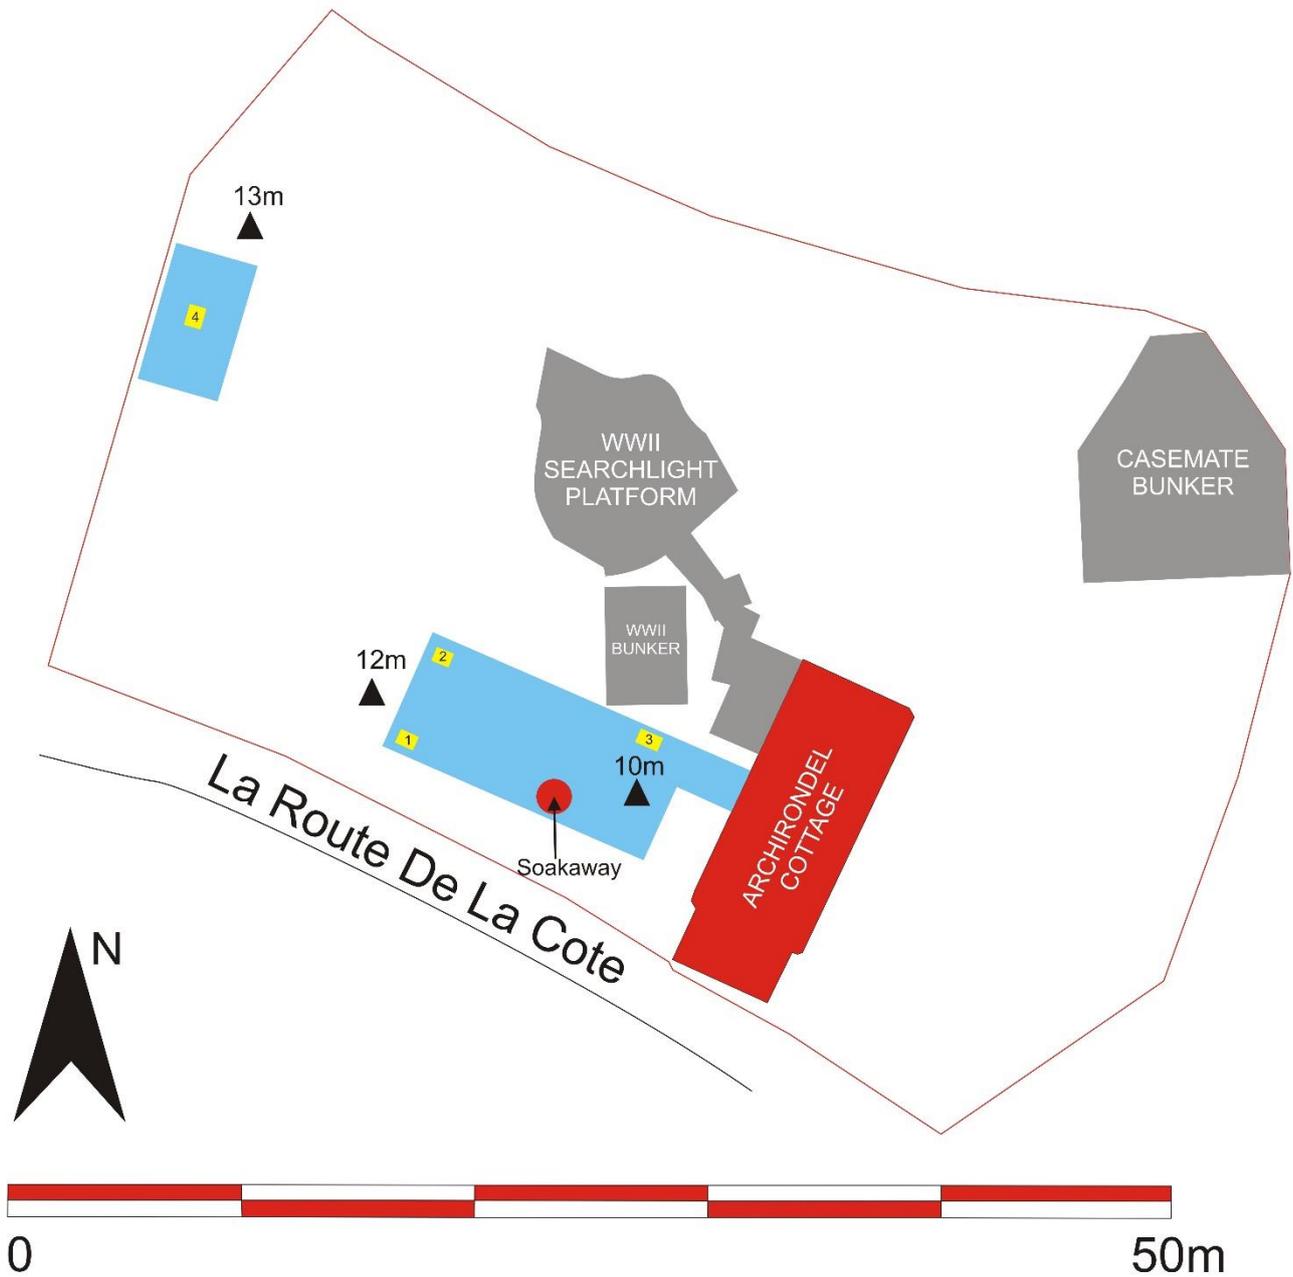
Figure 4 Test Pit & Soakaway locations (yellow)

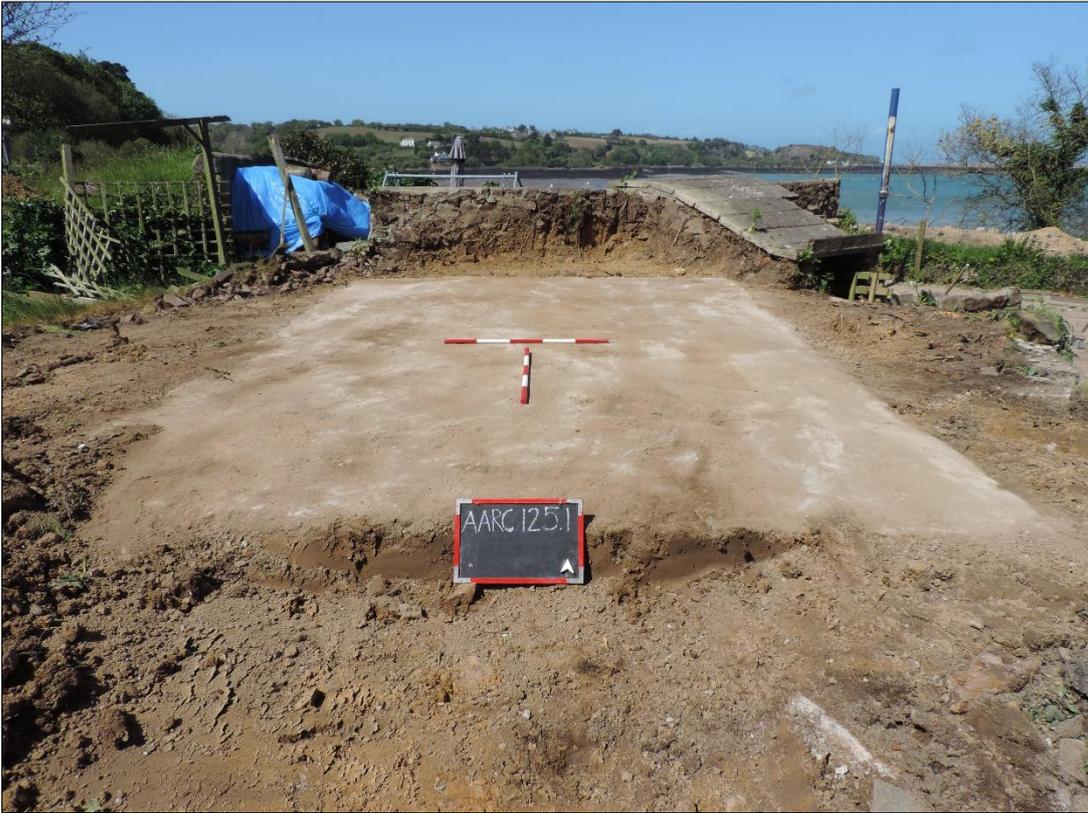
The groundwork to establish the foundation of the new extension to Archirondel Cottage did not have a negative impact on the WWII bunker [2], which is located close to the NE portion of the area of excavation. However the reinforced concrete slab that forms the roof was exposed during the groundwork, to improve visibility and to ensure that it was not accidentally damaged.

The feature [2] comprised a single cast concrete slab, measuring 5.1m (l) x 3.48m (w) x 440mm (d). The top of the slab has a smooth finish, whilst the base and sides are rough, having most likely been cast in situ.

Photo 6 North facing view of bunker roof slab (Scales 2 x 1m)

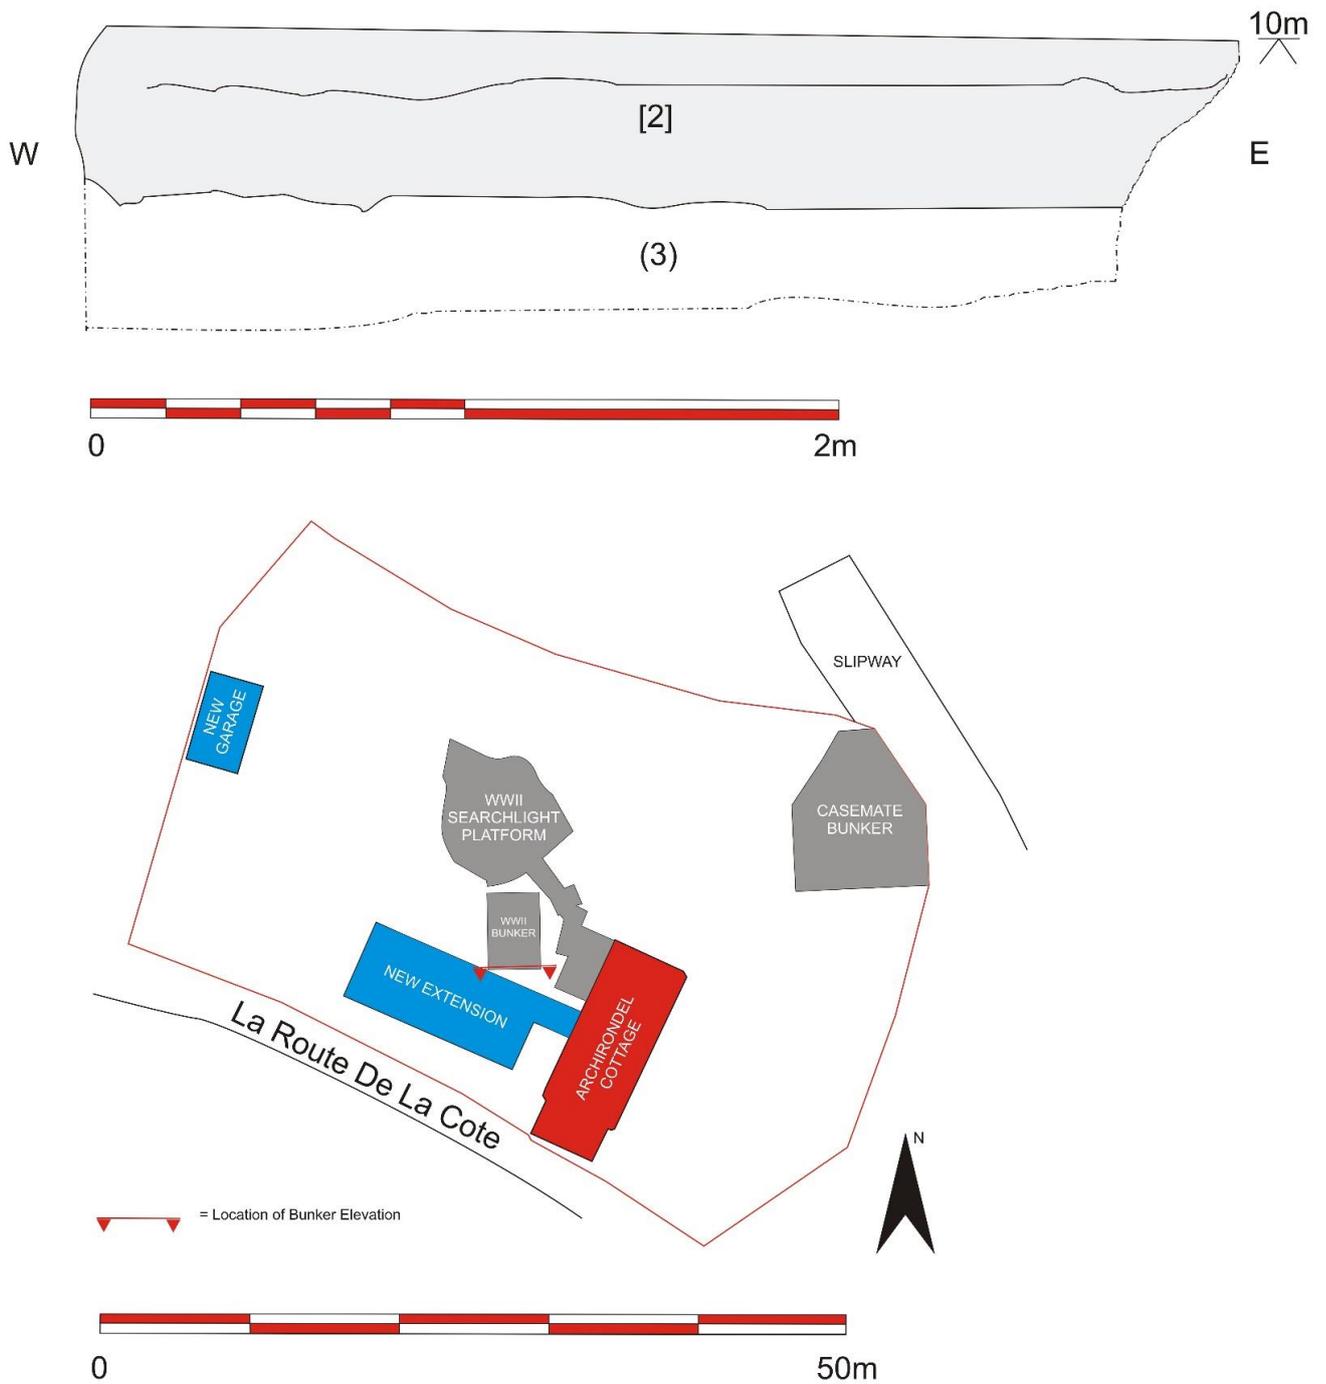
Figure 5 Elevation of bunker roof slab with location plan

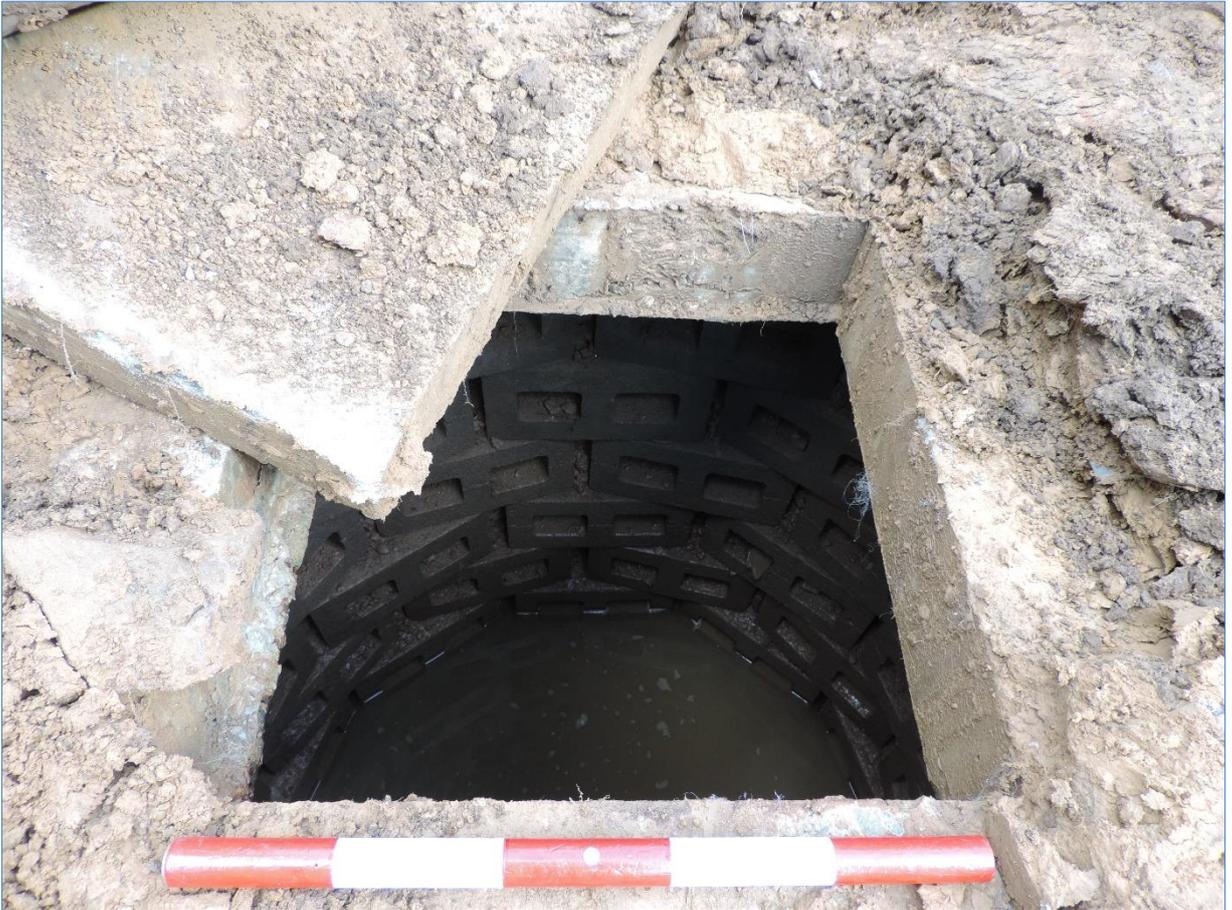
A modern soakaway was discovered to the SW of the Project Site, which was preserved in situ, as it was apparently still functioning. Discovery of the feature [5] halted work in this area of the site, in order not to destabilise the brickwork. The tank was covered by a single square

cast concrete slab and is thought to have been inserted during 20th century road works, carried out by the States' highways authority.

Photo 8 WNW facing view of modern soakaway (Scale 500mm)
