SCARBOROUGH ARCHAEOLOGICAL AND  
HISTORICAL SOCIETY

WATCHING BRIEF REPORT

# WOOD END THE CRESCENT SCARBOROUGH

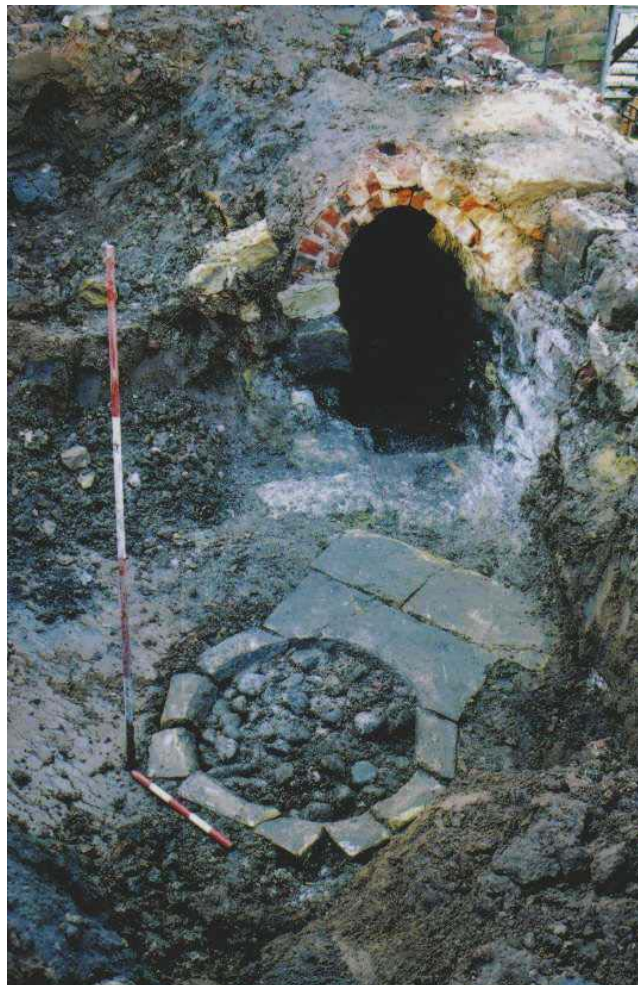
The base of the ice house and tunnel un-covered  
during the excavation work

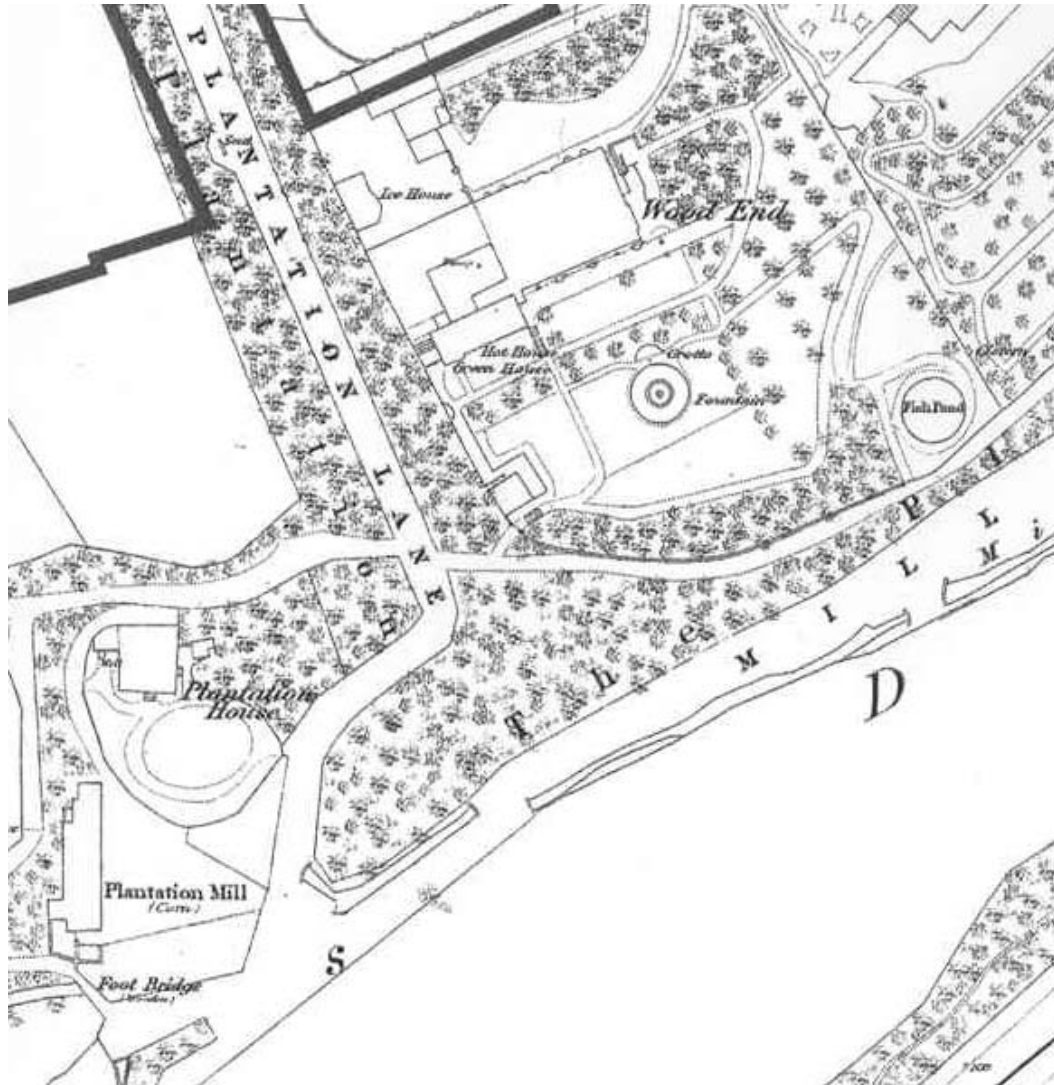
ANNEX 4

Extract from Ordnance Survey 1852 Scale 1:1,056

The ice house is clearly shown against the boundary with Plantation Hill  
The pump within the then inner courtyard marks the position of the well F2001

The first map to show Wood End in any detail is the 1852 Ordnance Survey plan of Scarborough at a scale of 1:1056 (5' to a mile) (Annex 4). This shows what is referred to in the Conservation Plan as the rear service yard occupying the space between what was to become the vivarium and the north boundary wall to the site (the retaining wall to 15 The Crescent). The service yard was bounded to the east and west by walls which as part of this monitoring were given the context number F1003. The east wall already had its characteristic 'dog leg' which existed to the present day. The garden was occupied by a number of small structures or dividing walls – the map is not clear on this point – but critically in the south west corner an Ice House is

shown. The above ground dimensions of this from the map were approximately 7metres by 4.5metres

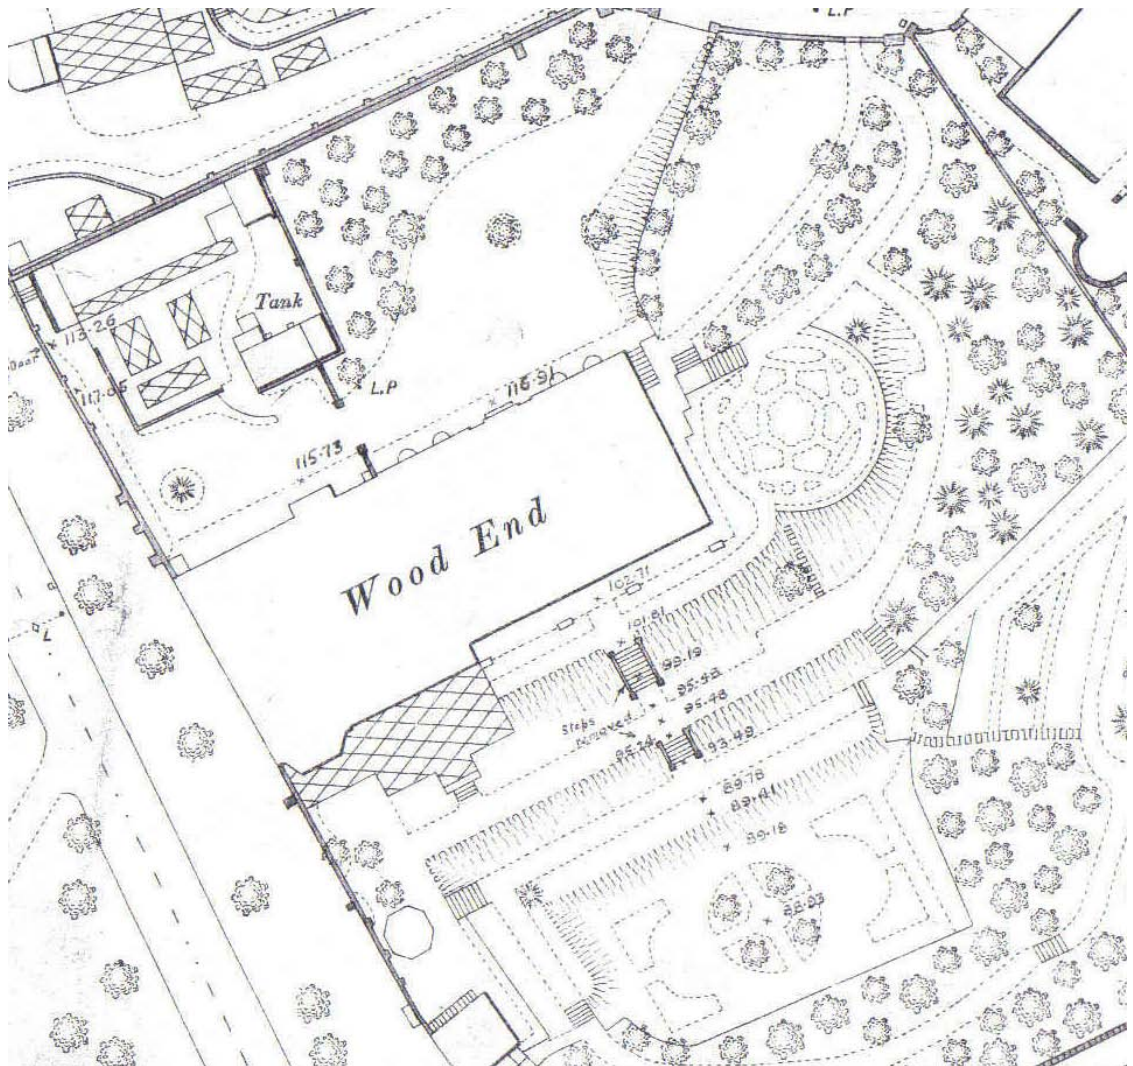
ANNEX 5

Extract from Ordnance Survey 1892 Scale 1:500

The ice house has gone and the rear service yard split into two the northern part surrounded by a wall and containing greenhouses, outbuildings and tanks

By the time of the publication of the 1892 Ordnance Survey plan at a scale of 1:500 (Annex 5) the ice house had gone. The garden had been divided into two with a cross wall to the south of one of the structures referred to above. The southern part of the garden (about a third) was presumably a kitchen garden judging by the layout on the map with a passage to the entrance gate in the west wall approached by steps. The new internal walls enclosed an area occupied by green houses (four) sheds and a tank.

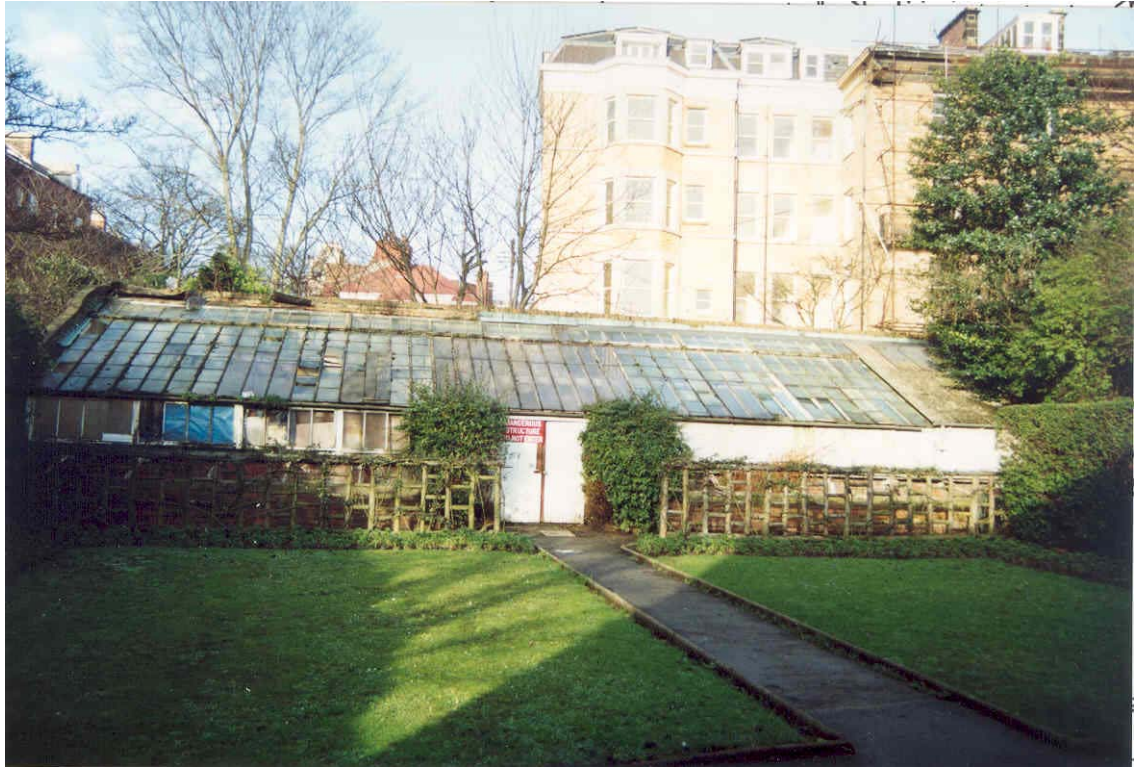
## ANNEX 7

The rear garden in 1994 just prior to the demolition of the large lean-to greenhouse against the north retaining wall – this green house shown on the 1929, and 1939, 1:2500 scale OS maps and the 1965, 1:1250 scale map

This form was still extant on the 1912 Ordnance Survey plan at a scale of 1:2500 although one greenhouse had gone, but by the time of the 1929 plan at the same scale the sheds, greenhouses and dividing walls had been swept away to be replaced by one large lean to greenhouse sited along the north boundary wall a situation which continued on the 1939, 1:2500 scale map (Annex 6) and the 1965, 1:1250 scale map and indeed until the greenhouse was demolished in 1994 (Annex 7).

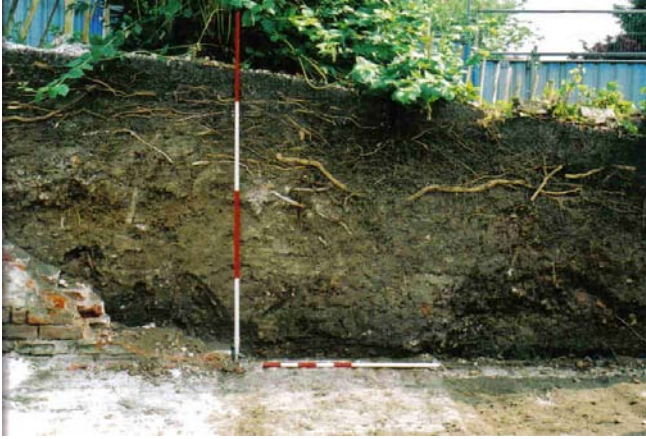
PHOTOGRAPH 1 SHOWING SECTION EXPOSED AFTER REMOVAL OF WALL F1003. SCALES 2m & 1m

The ground level to the east of the north/south garden wall was up to 2 metres higher than the level within the service garden or yard. Hand removal of the wall revealed this differential in section allowing it to be examined and its battering back to be monitored. The section was given the context number 1000 The monitoring of the demolition of this wall F1003 showed an extensive root system consistent with a deep fill of garden soil – Photograph 1 see also Films II 25 & 26., II 27 and VI 20a.

The conclusion was made that this area had been filled with good garden soil for a planting area. Finds in this soil were late 19<sup>th</sup> century and 20<sup>th</sup> century blue and white Staffordshire pottery, Copeland Spode, some early Leeds ware, Sponge ware, clay pipes, and kitchen ware. These finds were spread over the whole area of 1001 across the garden.

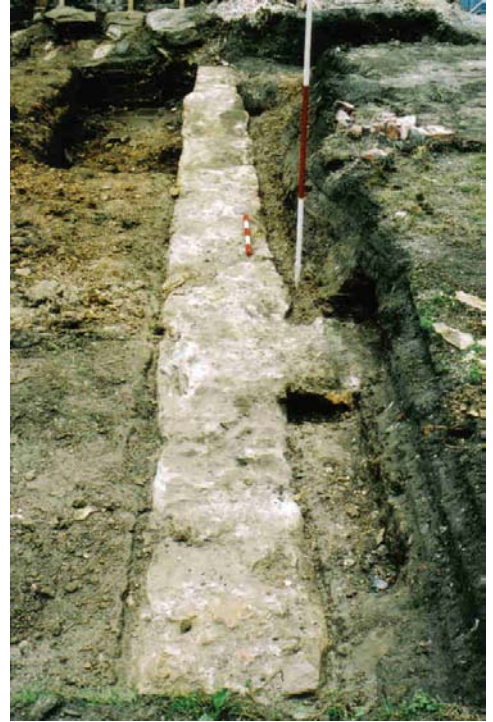
PHOTOGRAPH 2 WALL F1004  
LOOKING WEST  
SCALES 2m & 500mm

F1004, a heavily constructed stone wall, ran across the site from west to east - Photograph 2 – also see Film IV 23. This is probably from the first build of 1835. A sondage - Film IV 24, was cut at the southern side of this wall. It was found to be sitting on a heavy orangey clay but with brick particles, stones and pebbles which were thought to be site debris from the building of the house. There were some small pieces of bone, chalk and charcoal. On further excavation from the west the wall had a gusset of red bricks which were contemporary with the wall F1003 ie mid 19<sup>th</sup> century, - Film V 32. The clay at the bottom was very heavy and dense in consistency and natural. For 7 metres from the west wall, the wall F1004 consisted of three courses in height 800mm high then it dropped to two courses. The average size of the blocks was 500x300mm, roughly hewn and two stones wide. See Photograph 3 and film XVIII 35 for the cleaned face of this wall, showing the clay base and the coarse pinky, red base of brick dust over black clay on which some of the wall was built.

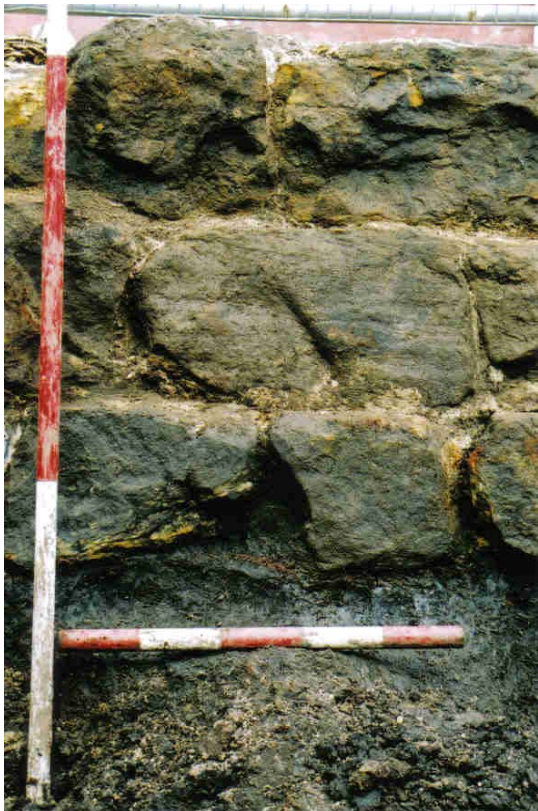
PHOTOGRAPH 3 DETAIL OF BLOCKS IN WALL F1004 SCALES 1m & 500mm

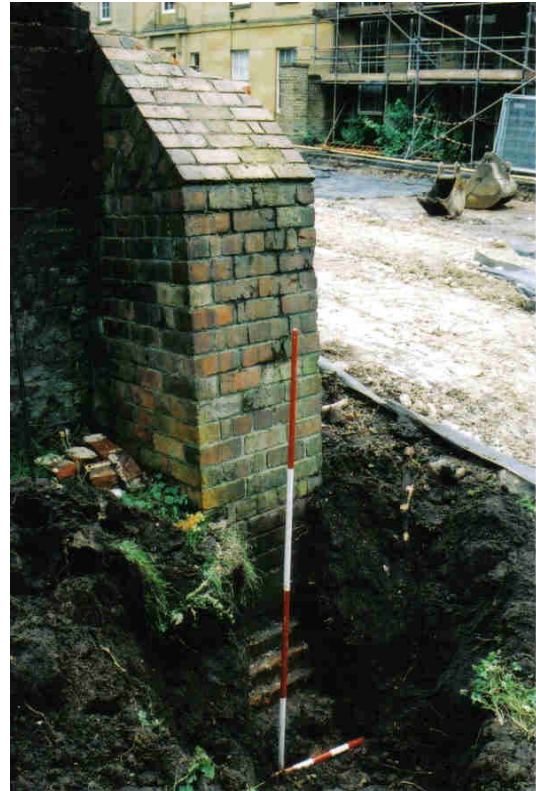
PHOTOGRAPH 4  
DETAIL OF BUTRESS F1022  
SCALES 2m 7 500mm

To the northern end of Plantation Hill wall is a large buttress which was built in 1891 (G. Oliver of Carlisle architects) the conclusion being that this boundary wall was giving problems even then. The structure has a stepped out brick base set into rough concrete on a very hefty orange brown dense clay bottom – Photograph 4. F1022. The piling residue along the eastern and northern boundaries were 10.5 metres deep and revealed grey brown natural clay with no inclusions. The change occurred 3.5 metres down (Film X 12).

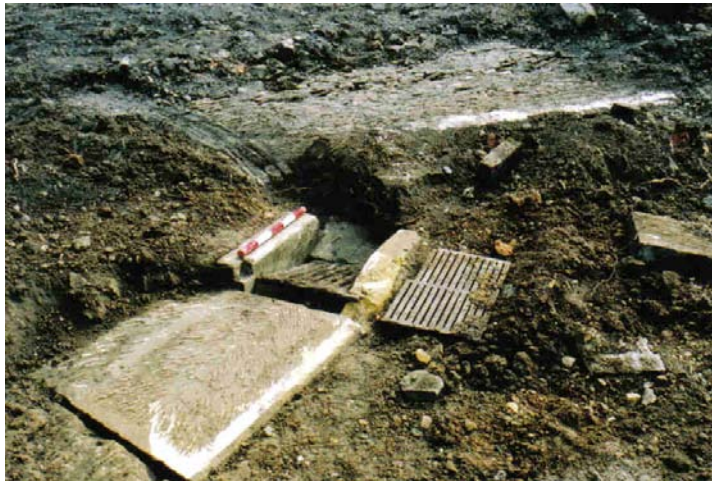
PHOTOGRAPH 5 CULVERT DRAIN F1012  
SCALE 500mm

On the eastern boundary a culvert drain was found with a heavy tooled cut stone covered top F1012 – Photograph 5 and Film VIII 11a, 13a which led to the Museum Gardens. Adjacent to this was a 19<sup>th</sup> century stone cobbled yard area F1009 – Photograph 6. A curved cobbled drainage channel led into the drain culvert. This was obviously a yard area and the size of the culvert would accommodate a large amount of surface water. F1012. Film VIII 13a.

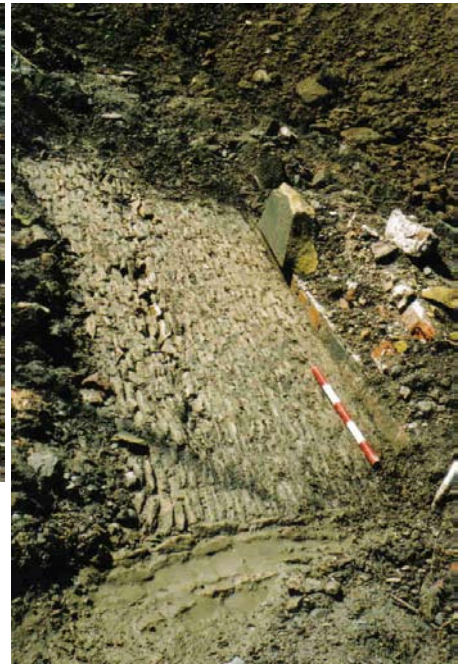
RIGHT  
PHOTOGRAPH 6 19<sup>TH</sup> CENTURY COBBLED YARD SURFACE  
F1009 SCALE 500mm

A sondage was dug into the cobbled area and revealed a sandy gravel loosely compacted, a bed for the cut stone cobbles to rest into 1017. The next layer down was sandy, crushed stone 1018, and 1019 a pink dense sticky clay, acting as a water repellent base. This pink clay continued across the whole of the yard area to the south and east of the main gateway entrance – see Film IX 16, 17, 18 & 29. Film VII, 19 shows the footprint of the main entrance stones, with an iron gate post base still in

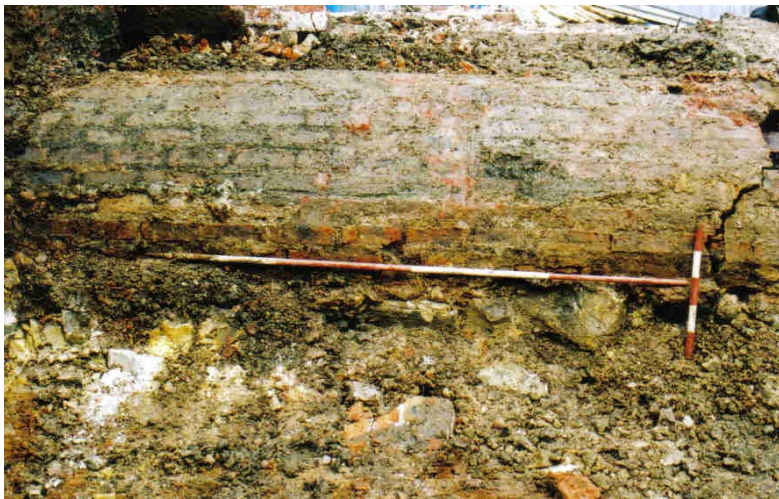
PHOTOGRAPH 7  
EXPOSED SIDE OF BRICK TUNNEL F1023  
BETWEEN THE HOUSE (TO THE LEFT)  
AND THE SITE OF THE ICE HOUSE  
SCALES 2m & 500mm

The demolition of the Plantation Hill side outer brick wall and stone wall F1003, F1004, revealed in the southern corner the top of a brick tunnel. This was built out from the cellar wall, F1023 - Photograph 7 and Film XIII 9.This was cleaned to reveal a complete tunnel 4.5 metres in length. The southern end corresponded to the inside cellar brick wall - Photograph 8 also Film XII 27a. and showed the bricked up doorway opening, leading into the tunnel.

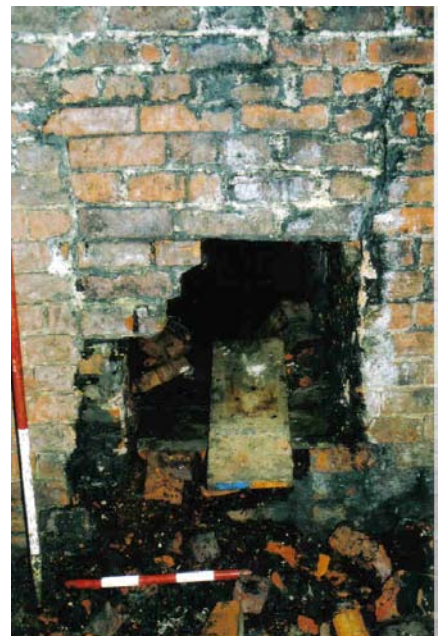
RIGHT  
PHOTOGRAPH 8  
THE HOUSE END OF THE TUNNEL  
HORIZONTAL SCALE 500mm

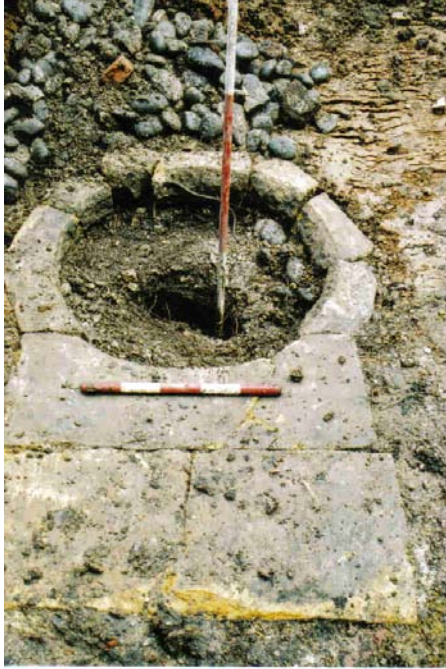
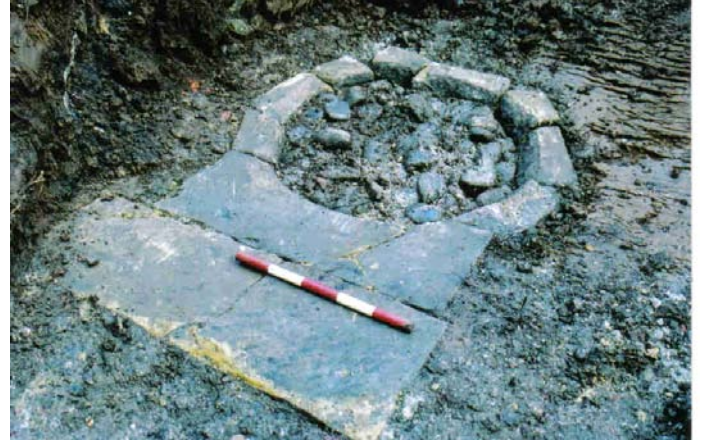
PHOTOGRAPHS 9 AND 10  
SHOWING DETAILS OF THE BASE  
OF THE ICE HOUSE  
ABOVE COBBLE FILL 1024  
LEFT STONE THRESHOLD F1026  
HORIZONTAL SCALES 500mm

A circular footprint of shingle and pebble 1024 proved to be the upper part of the fill above F1025. F1026 was the stone threshold which led from the tunnel to the circular feature which proved to be the base of the ice house. F1028 revealed the circular sump of the ice house, the only remaining in situ feature left intact. – Photographs 9, 10 and 11 - Films XIX 6 & 37, XV 2, 11 & 25; F1027,1032,1035. The main features were a circular brick collar above a cut stone collar. These were in filled with oval natural cobbles set in a gravel, pebble mix over large heavy natural rocks which sat on a level layer of bricks bedded into a clay base.

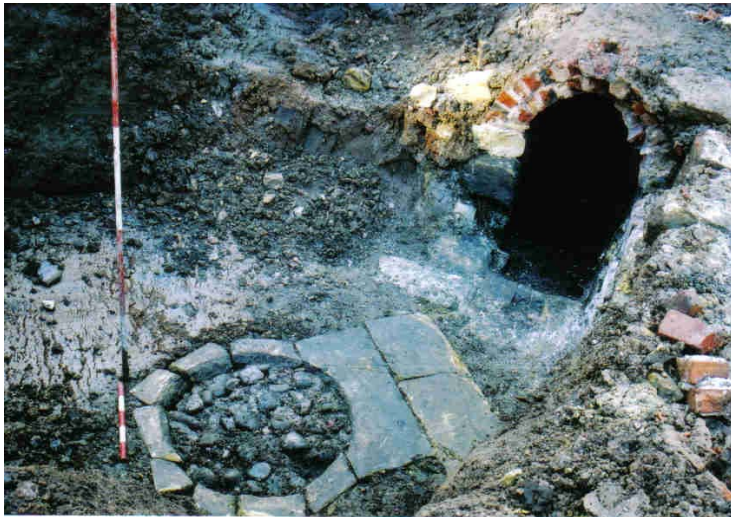
PHOTOGRAPH 11  
SHOWING RELATIONSHIP BETWEEN ICE HOUSE SUMP  
AND TUNNEL END.  
SCALES 2M & 500mm

The remains of this ice house were representative of the importance of the Wood End building in the 19thC., as only the rich could afford this luxury. The whole of this structure had been buried under a deep layer of clay - Film XIX 24, swathes of black clay - Film XV 23 and 34 interspersed with a large gritty pink, maroon layer of brick particles Film XX23a, 1039. Film XXI 19 shows the fill of the site at the eastern section against the underneath of F1004 Film XVIII 35. showing the red brick particles which a section of the wall F1004 was built off and the clay beneath. Film XVIII shows an in depth footprint of the wall F1004.

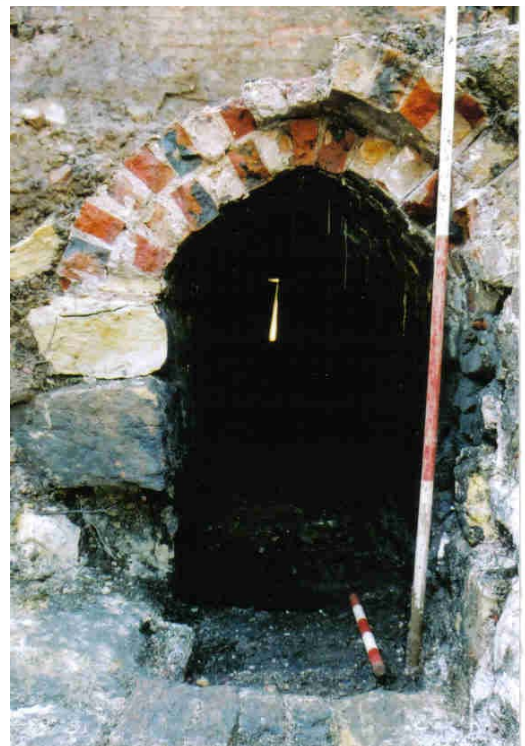
RIGHT  
PHOTOGRAPH 12  
DETAIL OF THE END OF THE TUNNEL  
F1023  
SCALES 2m & 500mm

The inside of the tunnel was empty with a black soil fill on the floor, under which was a rough random stone, cobble and brick floor . the walls were stone at the base and the arch was brick F1023 – Photograph 12 and Film XV 21.
