AN ARCHAEOLOGICAL EVALUATION
AT THE 'LOUNGE SITE' (SUNKEN GARDEN)
HARCOURT PLACE
SCARBOROUGH

Scarborough Archaeological and Historical Society
Interim Report 37 2004

NATIONAL GRID REF TA 0436 8846
SITE CODE LS04

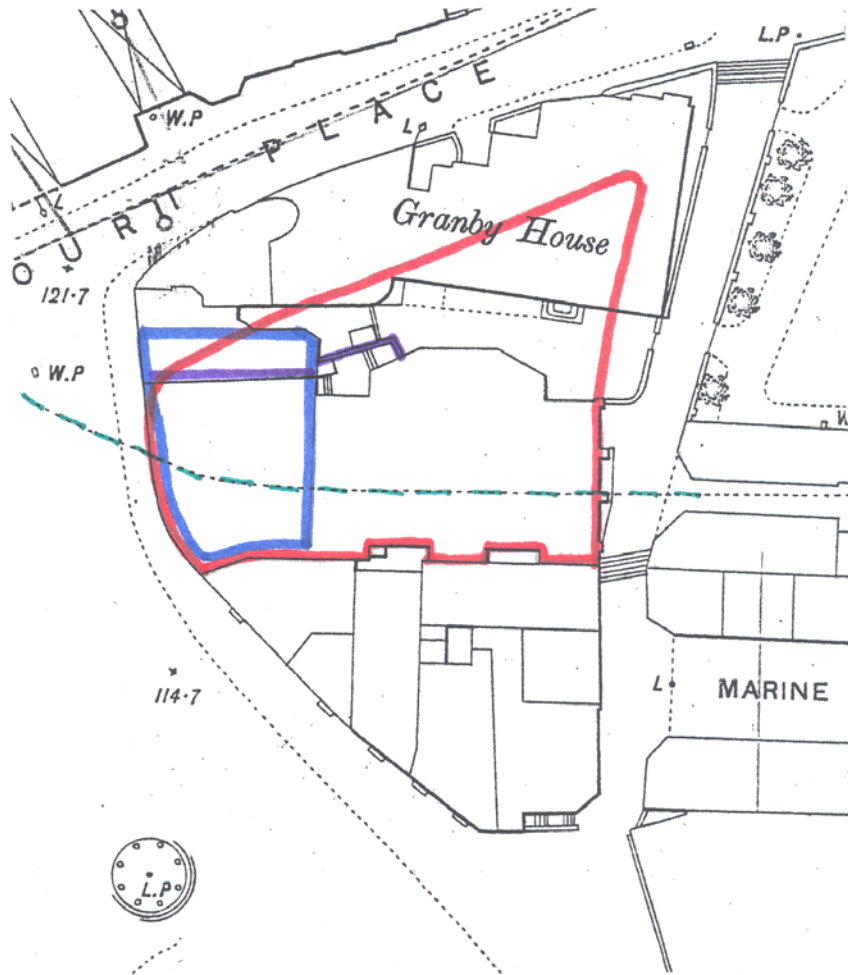
FIGURE 1
 EXTRACT FROM THE 1:500 SCALE ORDNANCE SURVEY MAP OF 1892
 SHOWING THE SITE BOUNDARY AND OTHER FEATURES

- Site boundary
- Area thought to be affected by cellars
- Extant fragments of 19th C masonry
- Line of 'moat' shown on 19th C maps

- 3.1 The site lies in an area of particular archaeological sensitivity, on or close to the defences of the New Borough of the medieval town. Information from 19th century maps indicates that the town 'moat', ie the moat or ditch which forms part of the defensive circuit, crosses the site.
- 3.2 The medieval town defences of the New Borough had their origins in the mid 13th century, and are believed to have comprised a town ditch with a rampart behind. 19th century maps indicate that the ditch ran in an east-west direction close to the southern boundary of the present

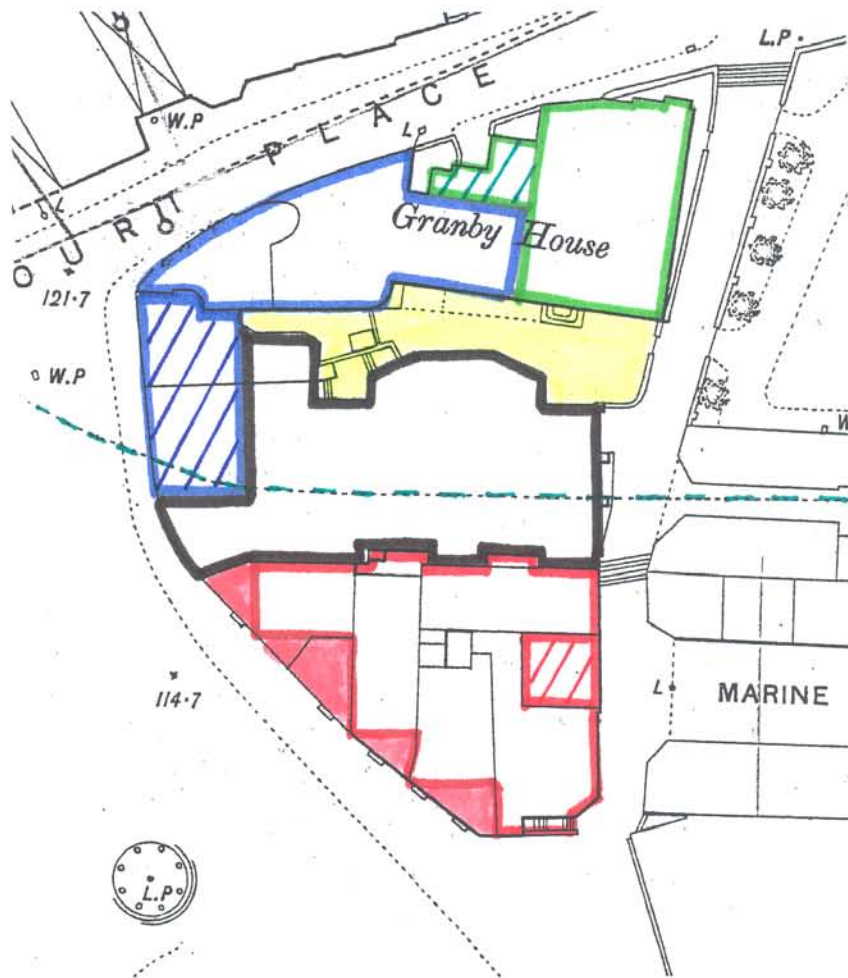
FIGURE 2
EXTRACT FROM THE 1:500 SCALE ORDNANCE SURVEY MAP OF 1892
SHOWING THE DEVELOPMENT OF THE SITE

1725-45	to	1892-1912	 
1725-45	to	present	 
1745-70	to	present	 
1745-70	to	1892-1912	 
1745-70	to	1939	 
1852-92	to	1892-1912	 
1852-92	to	1939	 
1852-92	to	present	 
Area possibly never built on			 
Line of 'moat' shown on 19 th C maps

- 3.5 The built history of the site along with that of the block of buildings to the south has been examined. This total area is included in this assessment see Figure 2

- 3.5.1 The 1725 map shows the site as undeveloped. The earliest buildings on the site date from between 1725 and 1745. One, at the north of the present site became part of a larger building known as Granby House whilst the second in the block which is still extant is on the site of or encased in the current 8 Marine Parade. The northern building ie Granby House was demolished between 1892 and 1912 and the site has been partially taken over by road widening.

- 3.5.2 Substantial development took place between 1745-1770 including the greater part of the present block of buildings to the south. During this period the street frontage to Harcourt Place was largely built up and the building which became known as Granby House enlarged. This building was demolished between 1892 and 1912 presumably simultaneously with the 1725-45 building referred to earlier. Also between 1745 and 1770 two buildings were erected on the frontage to St Nicholas Cliff – photographic details of this building exist which show that it was demolished in October 1939 (see Frontispiece). From 1798 the corner of Harcourt Place and St Nicholas Cliff was occupied by Travis' baths (Theakston p78) – the presence of a building on slightly

3.5.3 A further phase of development took place between 1852 and 1892. Numbers 32,33, 34 and 35 St Nicholas Cliff were re-fronted and possibly increased in height to take their present form. A large single storey building was erected behind the 1745-70 building fronting St Nicholas Cliff – this became known as The Lounge and was demolished in October 1939 along with the frontage building. Finally a small extension was added to Granby House which was demolished between 1892 and 1912 along with the principal building.

3.6 This analysis of the building development on the site indicates that there is a small area of land between the locations of 'The Lounge' and 'Granby House' which may never have been built upon and this area was the focus of Trench 1.

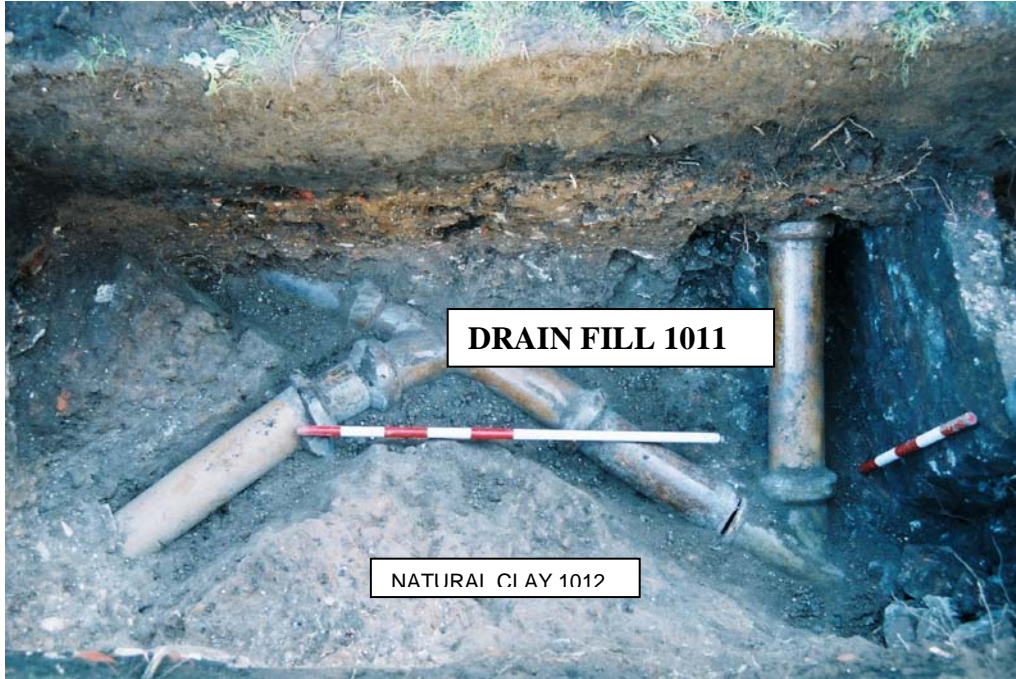
TRENCH 1 SHOWING DRAIN CUTS 1011 AND 1913 INTO NATURAL 1012
1 METRE HORIZONTAL SCALE & 500mm VERTICAL SCALE

- 5.3 Cuts F1010 and F1014 at the eastern end of the trench were an interlocking system of drains also cut into the natural and backfilled with a loose rubbly fill (1011 and 1013). These contexts produced exclusively 19th century pottery although 1011 also contained four fragments of stone roof tile which may be medieval or early post medieval and may indicate that material was imported to the site for building up levels. These drains consisted of 4" salt glazed pipes of a mid 19th century date and as one was closely associated with the wall referred to above it is safe to say that they were contemporary with the erection of the building.

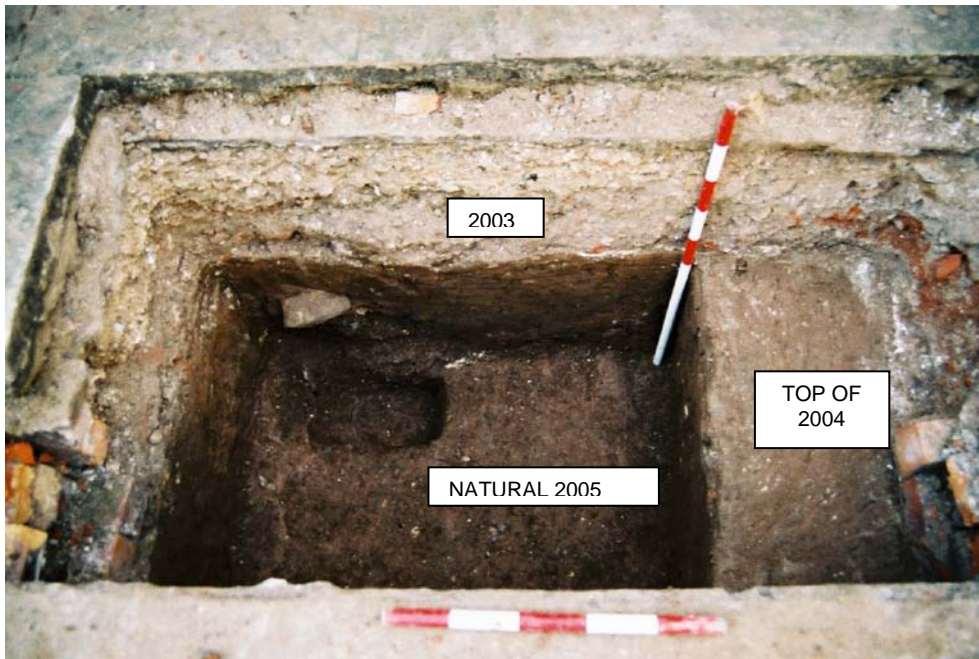
TRENCH 2 SECTION SHOWING 2000, 2003, CLAY 2004 AND NATURAL 2005
500mm HORIZONTAL SCALE & 1 METRE VERTICAL SCALE

- 6.2 This natural clay was overlain by an almost identical clay (2004) which was slightly different in colour and texture being slightly less sandy and which contained two fragments of medieval pottery. There was, however no other evidence that this clay had been disturbed or re-deposited.

- 6.3 The clay had been levelled and was overlain by a thin (10mm) bed of mortar which was overlain at one point by a brick feature consisting of two course of brick on edge walling (2001) separated by 230mm the intervening area being infilled with loose bricks (2002) which were not mortar bonded. Over the remainder of the trench the clay was overlain by a loose concretious mixture (2003) in two layers, and the whole was topped by a concrete slab interpreted as the 19th century floor of 'The Lounge'. The final phase was a sand blinding (2000) and concrete slabs presumably dating from the period after The Lounge was demolished.

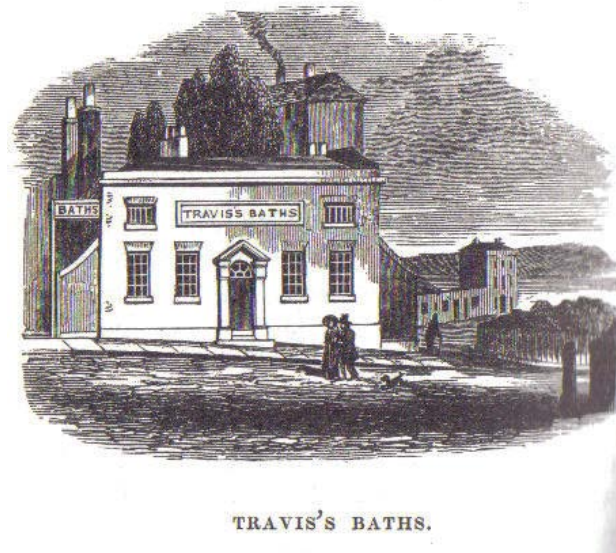
Travis's Baths from Theakstons Guide
2nd edition 1841

This establishment situate at the entrance to the Cliff, was originally opened in 1798. It has since been re-built, and the interior fitted up with every attention to comfort and elegance. The baths are of wood and marble, and are adapted either for plunging, sitting or the recumbent position. Every tide, these baths are supplied with pure sea water, and admit of ever variety of temperature. Rooms are also fitted up for steam, the Douche and Shower Baths.

earlier maps suggests that the baths were an adaptation of an existing building.
