AN ARCHAEOLOGICAL EVALUATION
EXCAVATION AT THE SITE OF THE
FORMER 23 QUAY STREET,
SCARBOROUGH

Christopher Hall

NATIONAL GRID REF	TA 04935 88835
SITE CODE	PL05
MUSEUM ACCESSION No.	SCAR.2006.51

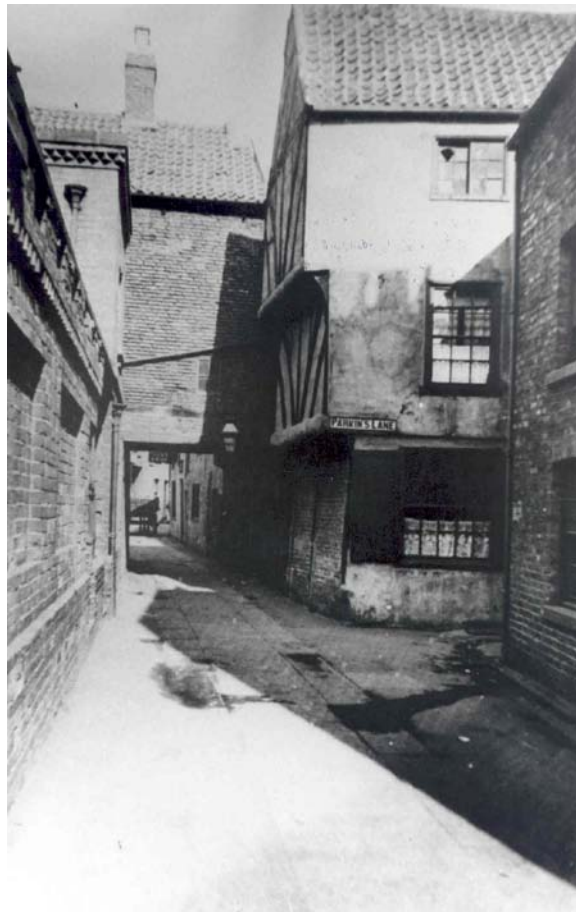
Frontispiece – a 19th century photograph of the timber framed house which occupied the site

- 3.10 Quite a lot of information is available about the house which stood on the site before the building of the garage in the 1920s. For example it is illustrated in 'Old and New Scarborough'⁷ and also in 19th century photographs. This building is almost certainly the one referred to in an article of 1888,⁸ which claims it may be 13th or 14th century and which contains the illustration of the gable end reproduced in Figure 2. The building was of three storeys with a two-bay gable end-on to Quay Street. The gable was of jettied construction, down braced, and cross braced at gable level. Stevenson's sketch implies that the infilling was plastered brick and that the building was set on a two-course stone plinth - these features are not apparent in the photograph. Clearly to be seen in both sketch and photograph however is that the ground floor

- 3.11 The gable end of this building when photographed had no windows and indeed the disposition of the framing was such that windows could never have existed here. Recent recording work has shown that there are similarities in timber-frame construction between buildings in Scarborough and York, particularly in Goodramgate, York.⁹ The former 23 Quay Street has affinities with 41-45 Goodramgate, although the latter do not have windowless gable ends. It is suggested that the same carpenters were operating in both York and Scarborough, and that they may have been Flemish. Given the trade links between Scarborough and northern Europe and the Low Countries, this would not be surprising.

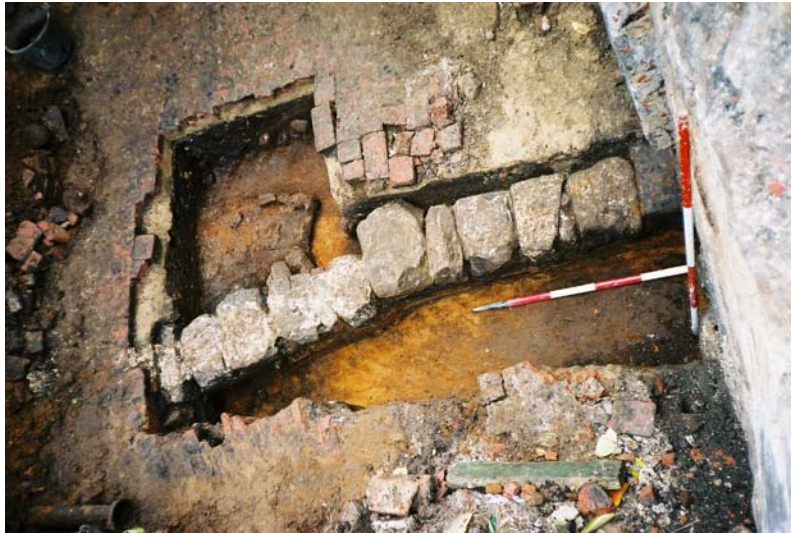
Figure 6 Looking South showing F1007.8 – scales 2metre & 500mm

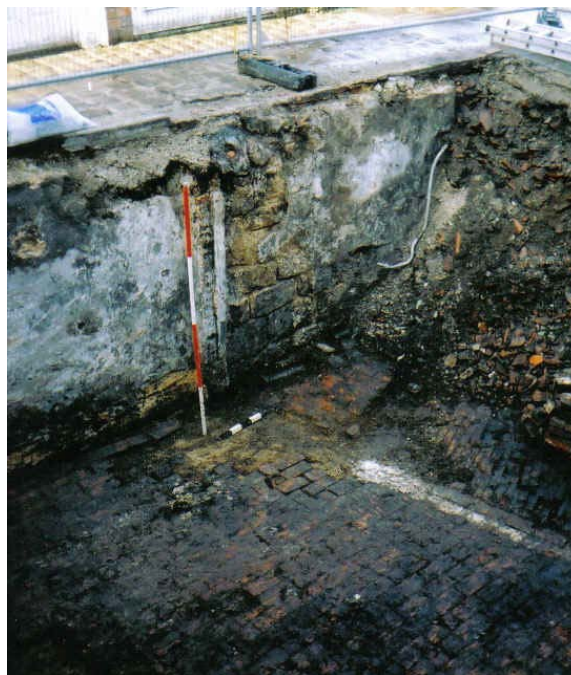
**Figure 7 Looking West showing wall F1002 and Cellar Floor F1005
Scales 2metre & 500mm**

F1002 (Figure 7) is a substantial stone wall of large squared courses forming the western boundary of the cellar and retaining Parkins Lane and is thought to be the cellar wall to the house. Its relationship with

1007.2 would be consistent with the 14th or 15th date for the building given on stylistic grounds. No evidence of the timber frame was found. The northern cellar wall lies under the present road and in any event some cellar fill had to be kept in place to support the road so it was not possible to examine this and thus to ascertain whether it is an old quay alignment as was postulated at The Three Mariners. At the south only three courses of the stone wall remained (F1006.10) underneath a later brick wall and later alterations had taken place at the east also.

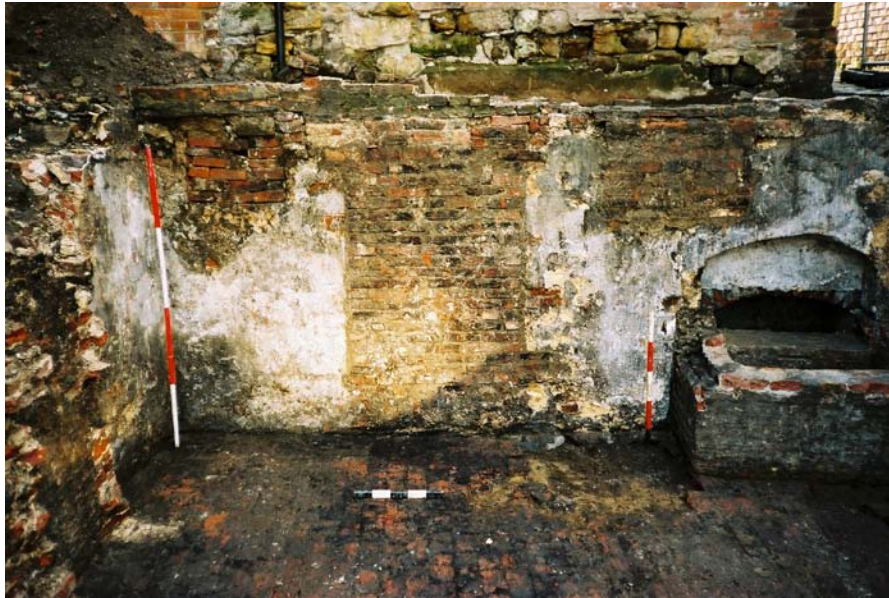
Figure 8 Looking South showing feature F1004 (to the right) brick cellar floor F1005, the brick wall with blocked openings - Scales 2m, 1m & 500mm

The cellar was re-floored using bricks (F1005, Figure 8) and judging by their size and form this was done in the 18th century. At this period the

south wall above F1006.10 was also substantially altered and re-built in brick.

There were three openings in the wall (subsequently blocked in possibly when the cellar was filled) consisting of a door opening above where trench 1006 was positioned, a small opening to its east probably for a coal chute and a larger opening to the west probably a window. At this time therefore the passage to the south must have been much lower than at present with steps up to Parkins Lane. Trench 2 – had it been proceeded with - may have revealed these steps or a void. Contemporaneously, a cross wall running on the approximate alignment of F1007.8 was built representing the phase at which the house was subdivided into two (as shown on the maps) This represents a change in status of the building from a single house to two much smaller lower class houses.

F1004 is a rectangular brick feature built against the south wall – Figure 8 and with a low arch penetrating the wall. It is of 18th or 19th date. Various theories have been put forward as to its use the most plausible being a small furnace for a blacksmith's shop (which would accord with the name Smithy Lane on Cossin's map of 1725) or a boiler containing a vessels for boiling crabs. More research is needed into this.
