THE INVESTIGATION OF A
STONE STRUCTURE
AT 100 CASTLE ROAD
SCARBOROUGH

Report 57 2022

INVESTIGATION OF A STONE STRUCTURE AT 100 CASTLE ROAD SCARBOROUGH

National Grid Ref TA 04295 89000
National Grid Co-ordinates 504295 489000
Site Code CR22

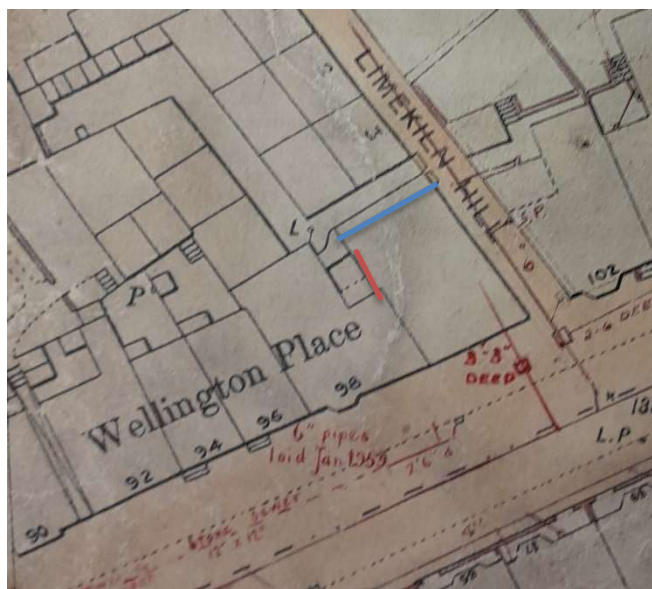
Extract from the Ordnance Survey map at the original scale of 1:500 surveyed in 1891 and published in 1892
The blue line is the north wall which contains the draw arch to the lime kiln
The red line is where the side stone wall is also visible in 98 Castle Road
Map reproduced courtesy Scarborough Museum and Galleries

This wall is marked by the blue line on the 1;500 scale map reproduced above. It is largely built in squared coursed sandstone with course heights varying between 13cm and 25cm. The tooling varies both between courses and within courses including a rather coarse herringbone pattern, a finer herringbone pattern and hammer dressed (though these are generally at the west end of the wall) and no tooling at all.

On the other side, within the back yard of 98 Castle Road, a short length of the other elevation of this wall can be seen (red line on the introductory 1:500 scale plan). This wall is white washed covering some of the constructional detail, but it appears to be of much better quality than the elevation facing in to 100 Castle Road.

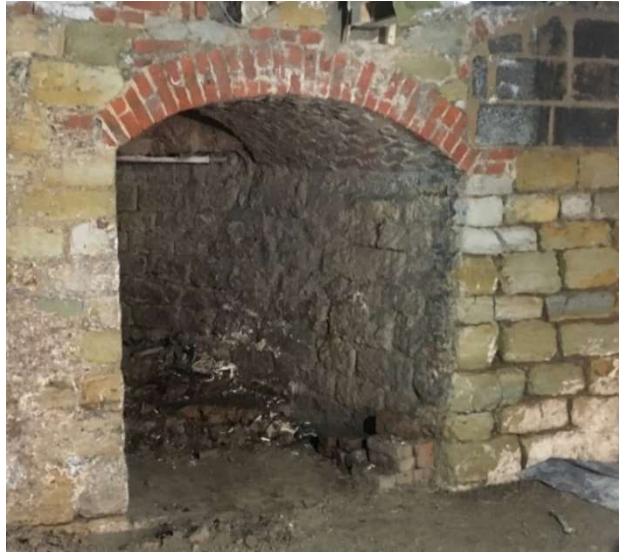
At the east end there is a large arched opening about 1.2 metres from the corner with the east wall. The voussoirs of the arch are executed in large bricks. The imposts from which the arch springs are two horizontal bricks at each end. The opening is 1.74m wide at the base increasing to 1.79m at the course where the arch springs, that is the side walls have a batter, more pronounced on the east (right) side than the west. The rise of the arch from springing line to apex is about 98cm.

**The arched feature at the east end of the north wall.
Note the batter on the side walls to the opening more pronounced on the eastern side**

It was not possible to examine within the arched feature in detail due to debris and a collapsed roof, however as noted above one flank wall does not run off perpendicular to the main wall and the east wall in at about 1.73 metres in begins to turn in to fill the end of the feature (note this area has now been infilled with blockwork and is inaccessible). At this point the top three courses of the wall are brick rather than stone. In the arched roof of the structure, 1.12 metres in from the main wall there is an oval opening 1.22 metres across on its longer axis, this must be the 'eye' to the kiln chamber or bowl above. Beyond this the roof continues as a brick arch. One the main elevation, there must have been several more courses of stonework above the arch than now visible since the chamber or bowl would have had to be deep enough to ideally reach a temperature in excess of 800°C.^{ix}. The wall may have been in the region of two metres higher. This masonry must have been taken down to accommodate the first floor

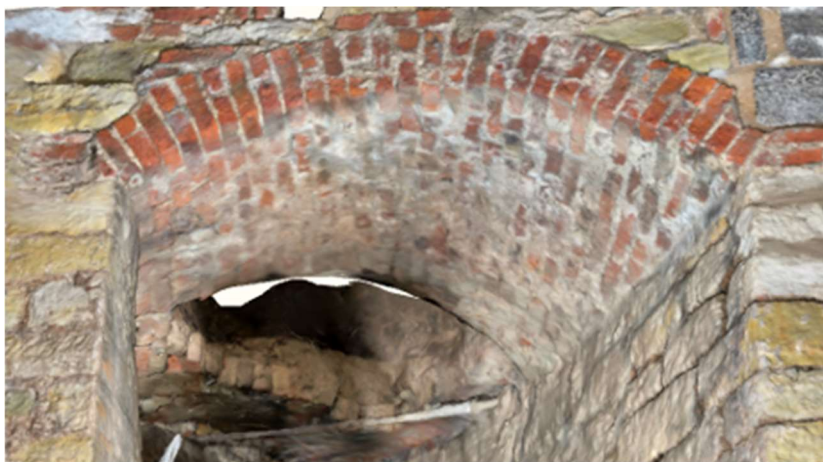
The east flank wall of the arch does not run off perpendicular to the main wall but is angled westwards. The west flank wall by contrast is initially almost, but not quite perpendicular to the main wall but both flank walls curve within the structure as seen in the Building bye-law plan above. These constructional details create the curious effect whereby the arch is on a skew at its eastern end only, and conventionally built at the western end

Arch detail showing the skew at the east (right) end

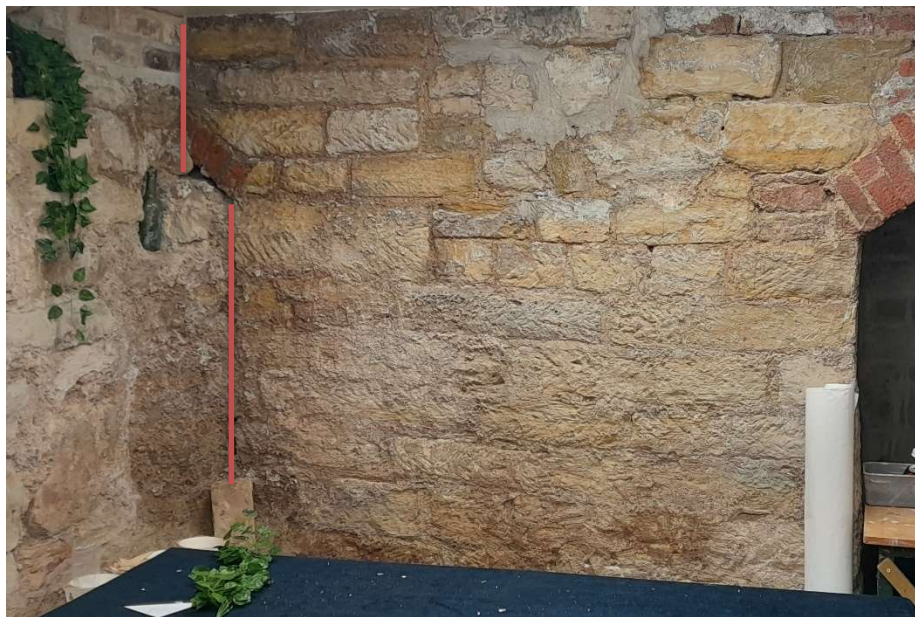
At its west end, where the wall is abutted by the west wall described below with a straight joint, a short fragment of an arch is visible. This comprises four bricks springing from a 13cm stone course. The opening below had been roughly filled with stone in part angled across the corner with another straight joint at the side wall of the arch. As it abuts this infilled arch with a straight joint, the west wall is clearly later. It is not clear how this arch relates to the arch described above, to the east but it seems likely that it is another draw arch for the lime kiln. The rest of this arch could not be seen at 98 Castle road when that was examined.

The west end of the north wall at its junction with the side wall showing the small section of visible brick arch abutted by the later side wall. Straight joints are indicated by the red lines

The west wall abuts the north wall with a straight joint and abuts an arch fragment in the north wall – the west wall therefore post-dates the north wall.

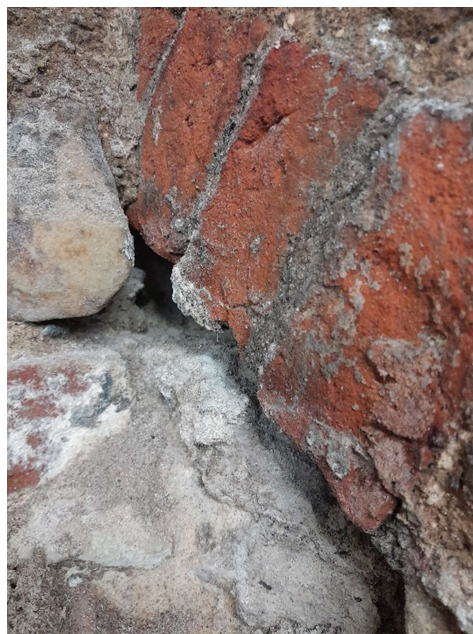
Detail of the fragment of arch at the junction between the north and west walls

The north wall is relatively straightforward consisting of the stone structure, almost certainly one build, punctuated by the draw arch of the kiln, though the relationship with the fragment of arch at the west end is problematic.

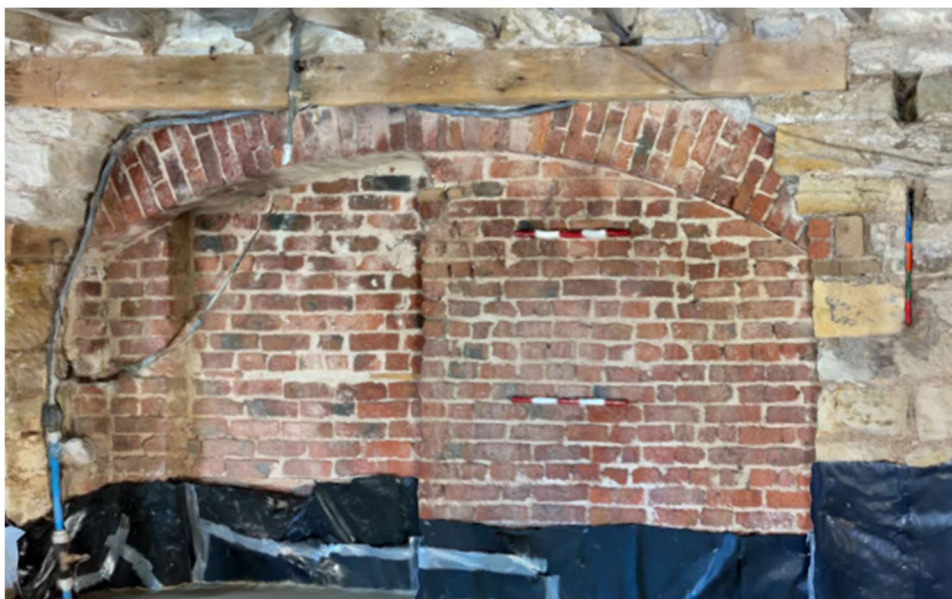
The brick element consists of a wide, fairly shallow brick arch $1\frac{1}{2}$ bricks in depth recessed about 22cm, or 1 brick length behind the stone outer leaf (A1 on the photograph above). Below this, and further recessed by about 12cm (about $\frac{1}{2}$ a brick), the arch is infilled also in brick – A2. This is carried out in English garden wall bond, well-constructed and appears to be contemporaneous with the arch above. Towards the south of the arched feature, there is a section further recessed within the arch fill, this is set back about 16cm (also about $\frac{1}{2}$ a brick) A3. This is slightly more crudely built – some thicker joints – and appears to be the later infilling of an opening. It is considered that this arched feature was designed as an architectural feature and was meant to be seen.

Detail of the arched feature A

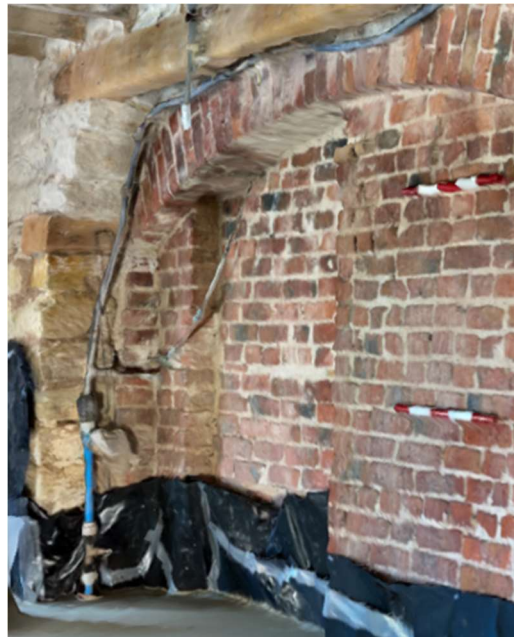
Oblique view of the corbelling 'C'

18cm by 15cm in section, which appears to have been sawn off at a later date – possibly a structure was built into the wall. To the right of the opening, the stonework rises in a similar fashion, though there is a less clear distinction between the courses in sandstone and those in limestone. Spanning between the upper corbel stones is a timber beam or bressummer (feature E) about 18cm (facing the room) by 12 cm in section. This all indicates that in building the stone wall, which must have been later, there was a deliberate intent to retain the brick arch and infill as a visible architectural feature -hence it follows from this that the stone wall is later.

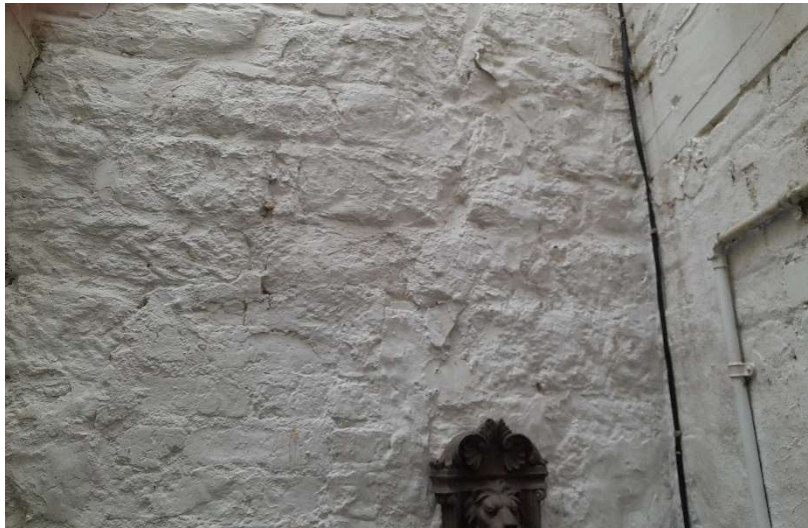
Fragment of stone wall in the yard of 98 Castle Road

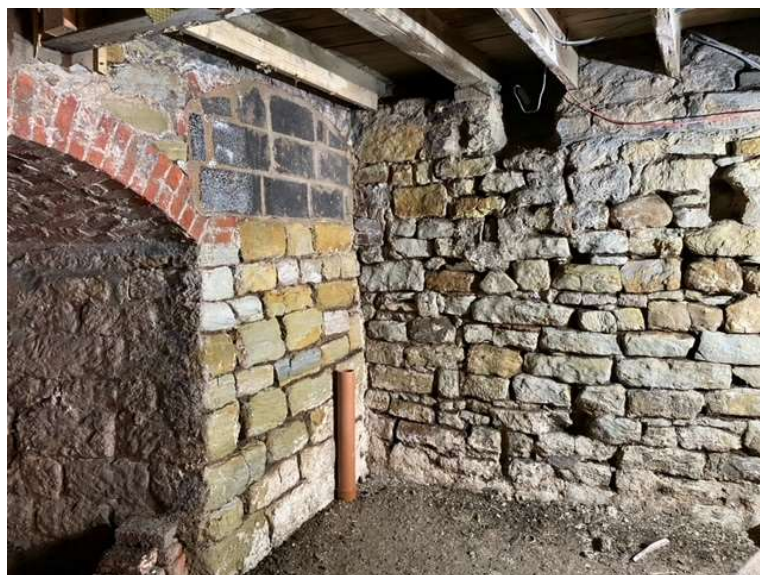
The east wall makes a straight jointed abutment with the north wall indicating that it is a later feature. The wall is constructed in roughly squared relatively thin coursed rubble and therefore has a different characteristic from the north and south walls, being more akin to the construction of rural buildings in the Scarborough hinterland.

It contains no particularly noteworthy features being of a fairly consistent build

The east wall showing the junction with the north wall and the difference in the masonry between the two walls

The east wall is relatively straightforward and again is likely to date from the building of the National School.
