ARCHAEOLOGICAL EXCAVATIONS  
AT 60-62 QUAY STREET  
SCARBOROUGH

Scarborough Archaeological and Historical Society  
Report 43

SITE: 60-62 Quay Street Scarborough 2011/12

Site Code 60QS11 and 60QS12

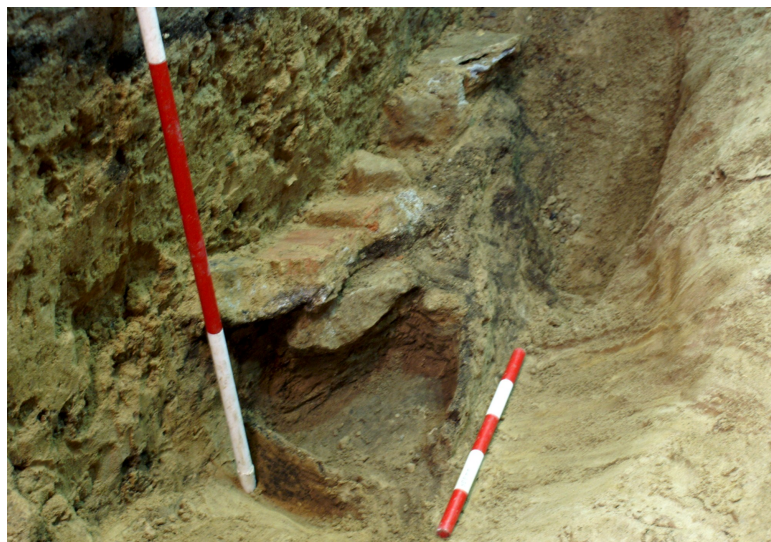
Plate 1  
Trench 1  
Looking north along the  
East facing section  
showing F40

- 4.3 At a depth of 1.65 metres (3.21 metres AOD) at the north end of the remainder of the trench on its west side under the slumped clay was an area of organic material (42) containing one post. This is thought to be associated with an adjacent feature F40 which appeared to be a buried barrel (now filled by sand) presumably for

the collection of water – see Plate 1. These two features could not be fully resolved due to the difficulties of continued excavation and no diagnostic artefacts were recovered. The next feature which was thought to be either contemporary or only a little later was a stone and brick lined saucer shaped feature F39 containing a thin layer of organic material overlain by sand and sealed by a layer of coal dust (33) – see Figures 6 and 8 and Plate 2. F39 contained entirely medieval pottery. These features taken together were interpreted as being associated with a spring or well in the cliff face and the brick layer may be a ‘hard-standing’ to aid the filling of barrels to supply ships with water.

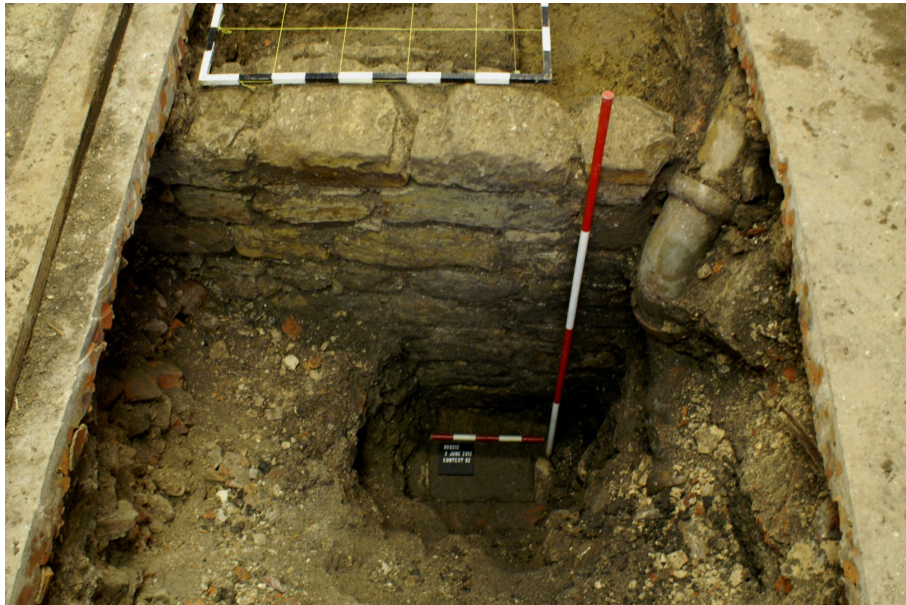
**Plate 4. Trench 2 looking north showing wall F55, drain F68, sondage into cellar fill and the cellar floor**

- 4.8 South of wall F55 was a deep deposit of rubble fill. It was not possible to safely or easily excavate this, so a sondage was put down close to wall F55. This revealed a stone and brick cellar floor at 2.0 metres AOD sitting on clay and sand, the cellar having a depth of 2.2 metres. It was topped by a brick floor surface (52) underneath the present concrete surface. This brick floor is likely to date from the early 20<sup>th</sup> century rebuilding referred to in paragraph 1.2 and it appears that a pre-existing cellar to the cottage had been in-filled by pushing the previous cottage into it. The bricks recovered from this fill suggest an early 18th century date for the cottages.
