ARCHAEOLOGICAL EVALUATIONS
& EXCAVATIONS AT THE FORMER
PENTECOSTAL CHURCH
EASTBOROUGH, SCARBOROUGH

Report 36 2022

ARCHAEOLOGICAL
EVALUATIONS AND EXCAVATIONS
AT THE FORMER PENTECOSTAL CHURCH
EASTBOROUGH, SCARBOROUGH

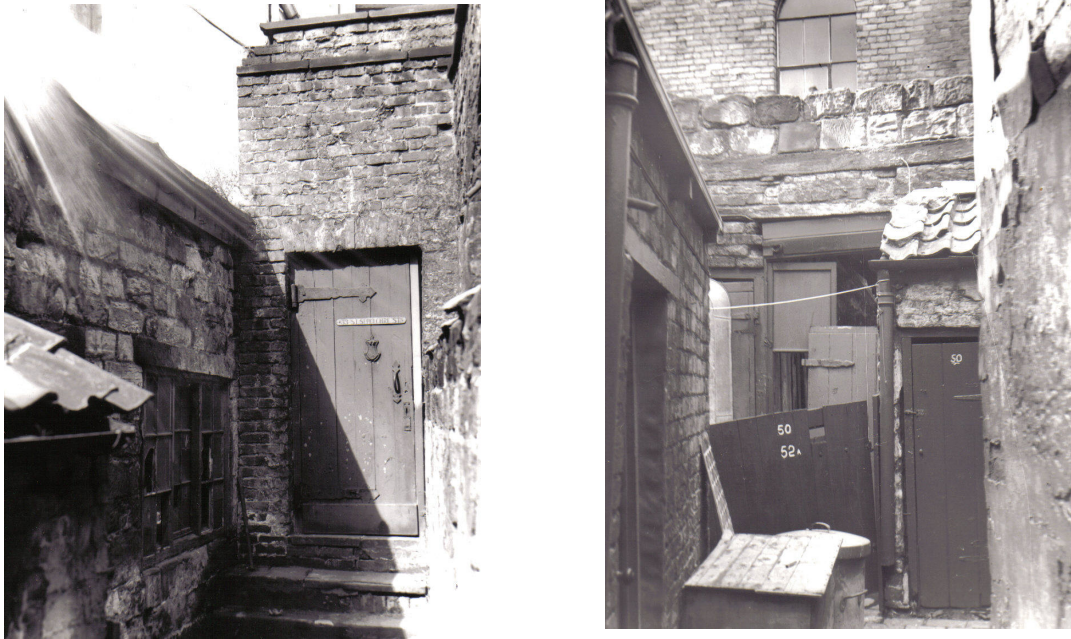
Fig 1A & 1B The outbuildings abutting the east wall 1961

council flats, the site was occupied by a range of outbuildings, which were partly stone built. (Figures 1A and 1B). The age and original use of these buildings are unknown, but they are present on the 1852 Ordnance Survey map.

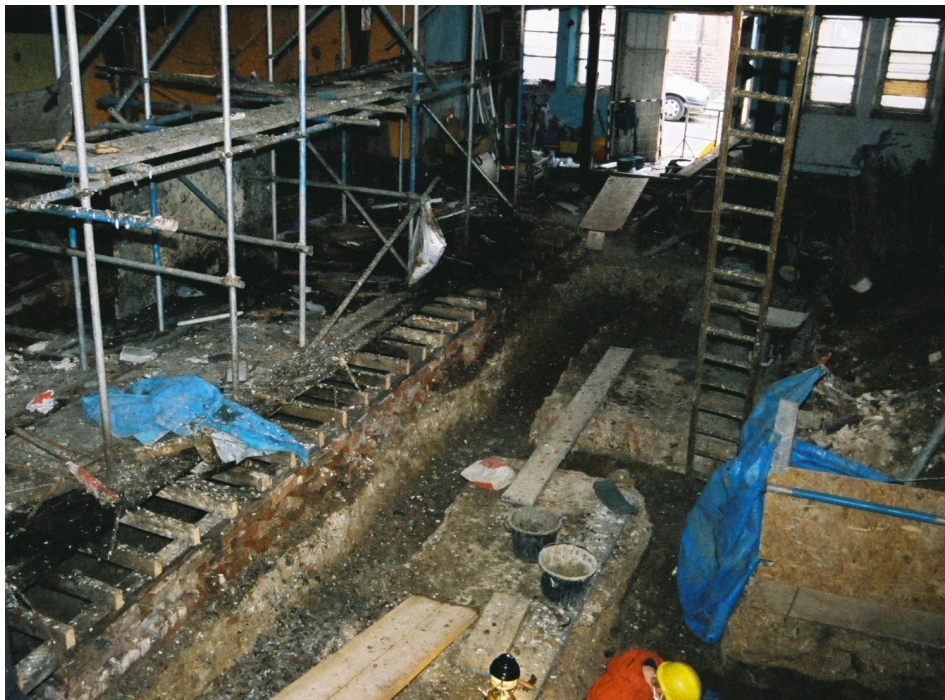
Fig 4 – the hand excavated trenches within the church in progress showing the difficult working conditions within the nave of the former church

5.2 In 2005 new proposals came forward for the redundant church involving its conversion to residential use with the associated erection of loadbearing internal walls and other groundworks. Before this work commenced, hand excavated evaluation trenches numbered 1 to 6 near to the east wall of the nave were excavated in March 2005 (Figures 3 and 4)

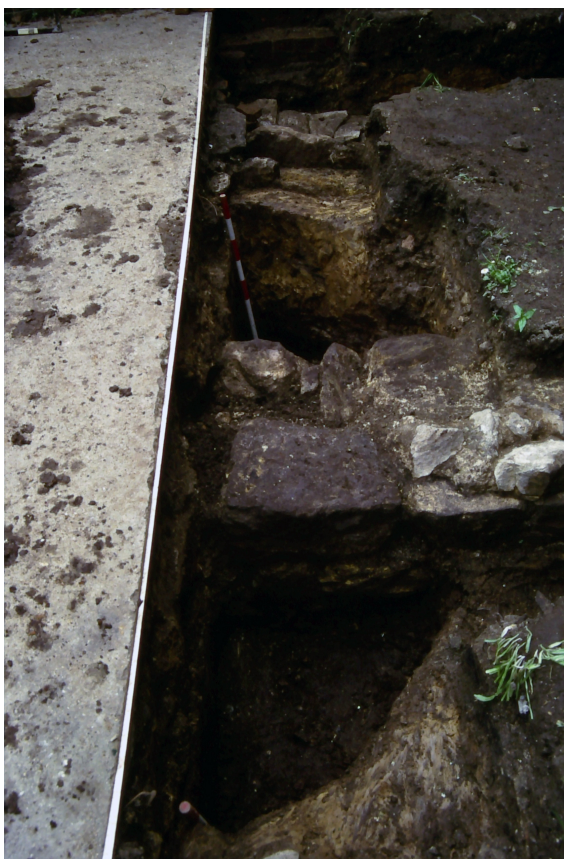
Fig 7 – looking along the south-east edge of 2003 trench showing pit 5017 bisected by wall 2004

- 6.2.4 03/F5017/F5023 formed the west side of a circular steep sided pit, the east side of which is outside the excavation trench. The feature is bisected by wall 03/F2004 (Figure 7) and hence the cut edge of the pit on either side of the wall was given a separate number, though there is no doubt that they are one and the same feature. The south-west quarter of the pit (03/F5017) was slightly undercut 0.5m from the top of the feature. The lowest excavated fill in the south-west quarter of the pit consisted of a dark brown organic deposit (layer 03/5016) which became increasingly organic with depth. A 20 litre sample of this deposit was taken for analysis for environmental remains. The results of this analysis are set out in Annex 1. Below this the fill was clayey. Due to safety considerations this deposit was not excavated but may be close to the base of the pit due to its clayey composition. The pit was overlain by layer 03/5014 - a mixed brown clay with extensive charcoal inclusions. In the north-west quarter of the pit (03/F5023) the deposit went from a clayey organic deposit, the equivalent to layer 03/5014, to a more organic deposit equivalent to layer 03/5016. Both these fills were given a single number of 03/2006. Excavation of the north-west quadrant ceased at a higher level than the south-west quadrant.

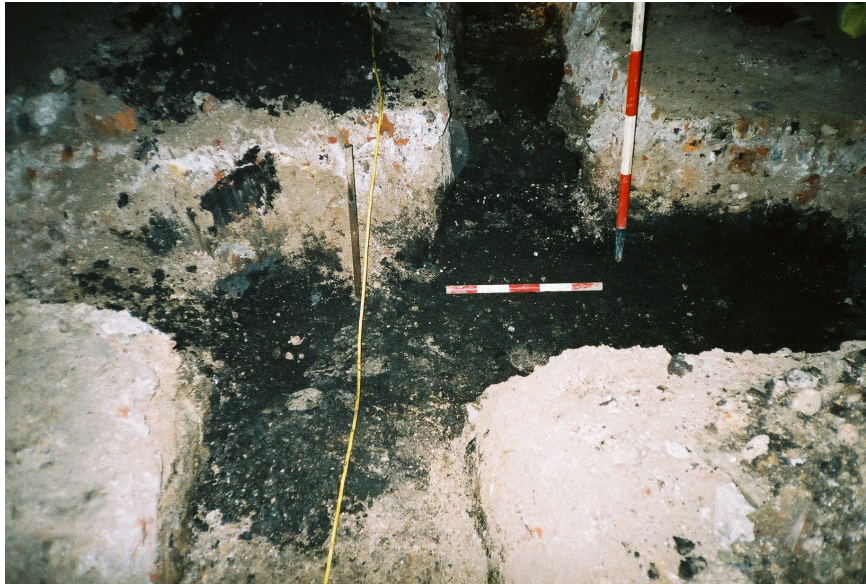
Fig 8 – the black organic material revealed following the machine excavation of the foundation trenches 7023 and 7025

- 6.2.6 In 2005 within the south-west corner of the building further evidence of pit digging was found in the form of three large areas of dark black organic material (Figures 3 and 8).

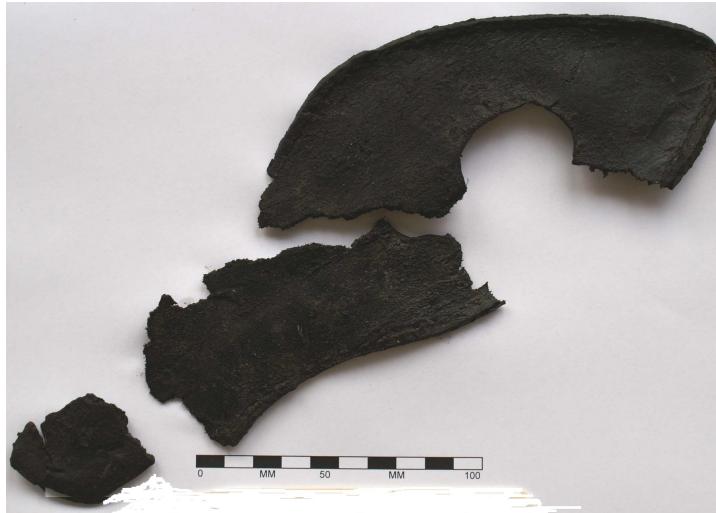
Fig 9 – example of the leather found in 05/7023

These organic deposits contained pottery, bone, fragments of leather (Figure 9), timber and textile. Feature 05/7023 was sample excavated and it was found that the organic material at this point was 2 metres deep, sitting directly upon and within natural clay. 05/7024 and 05/7025 were not excavated to their full depths. One significant piece of worked wood (Figure 10) was possibly a peg, a tool handle or a small finial.

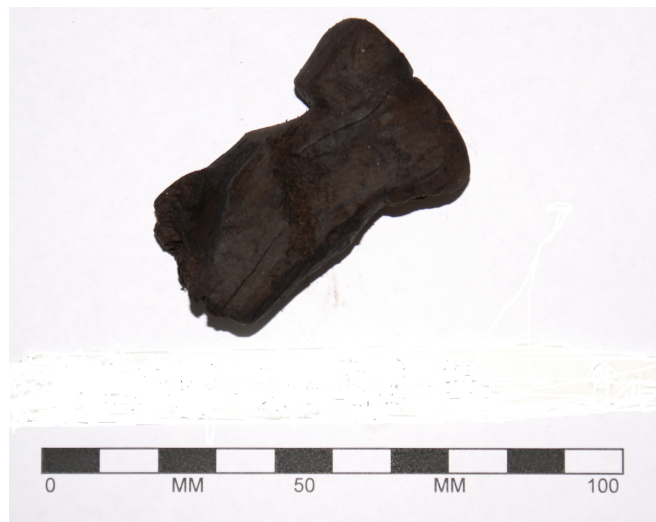
Fig 10 – the wooden object found in context 05/7023

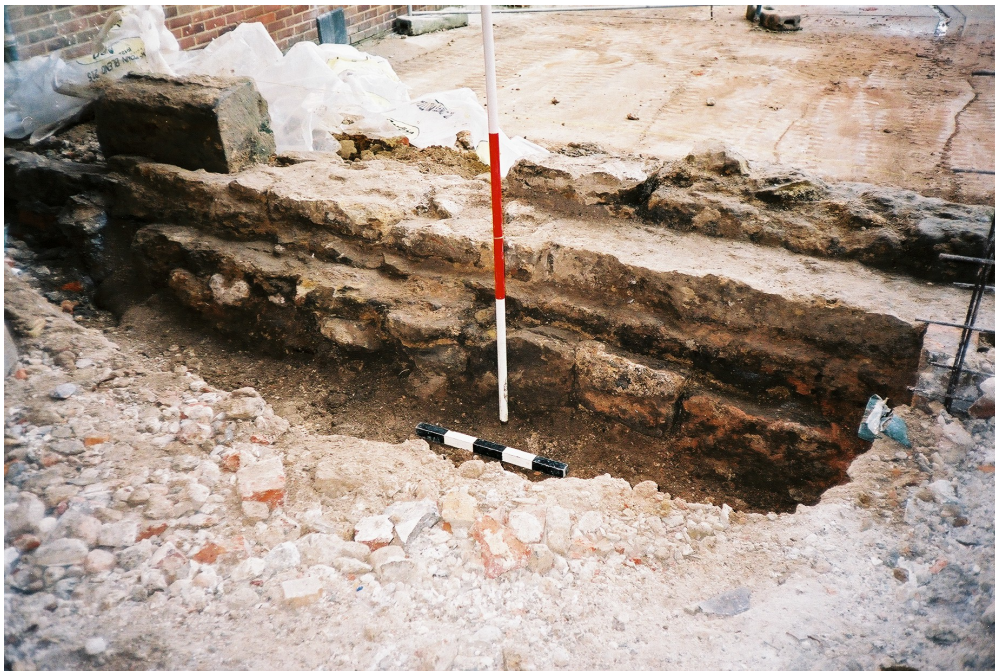
Illustration – the stone masonry revealed following the removal of the brick east wall

6.5.3 In 2005 following removal of the upper courses of brickwork in the east wall of the former church, the stone wall was recorded, revealing that it had completely separate inner and outer leaves, the outer possibly being older. Monitoring of the adjacent foundation trenches showed that the stone wall was built off clay, though exclusively medieval pottery was found in the vicinity of the wall and this confirms the findings set out in paragraph 6.5.2.
