**A SURVEY OF THE FORGE, FORGE VALLEY
SCARBOROUGH**

Scarborough Archaeological and Historical Society
Site Report 51
2019

A SURVEY OF THE FORGE, FORGE VALLEY, SCARBOROUGH
NORTH YORKSHIRE

NGR SE 98449 87104

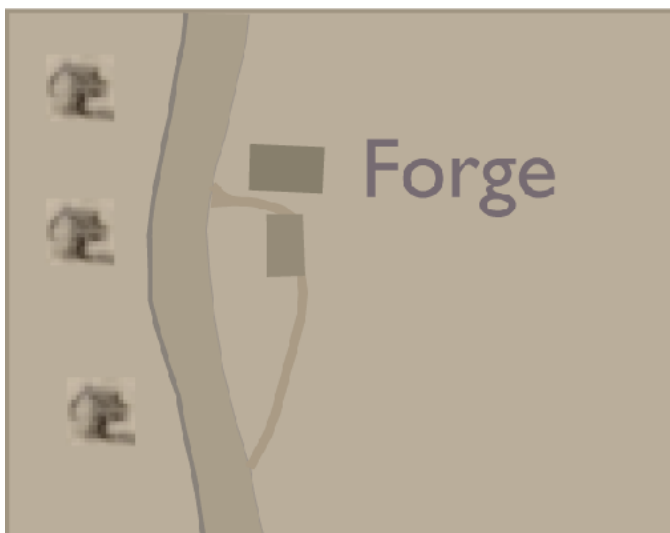
Figure 3. Redrawn extract from R. King's 1796 manuscript map showing the area of the forge.

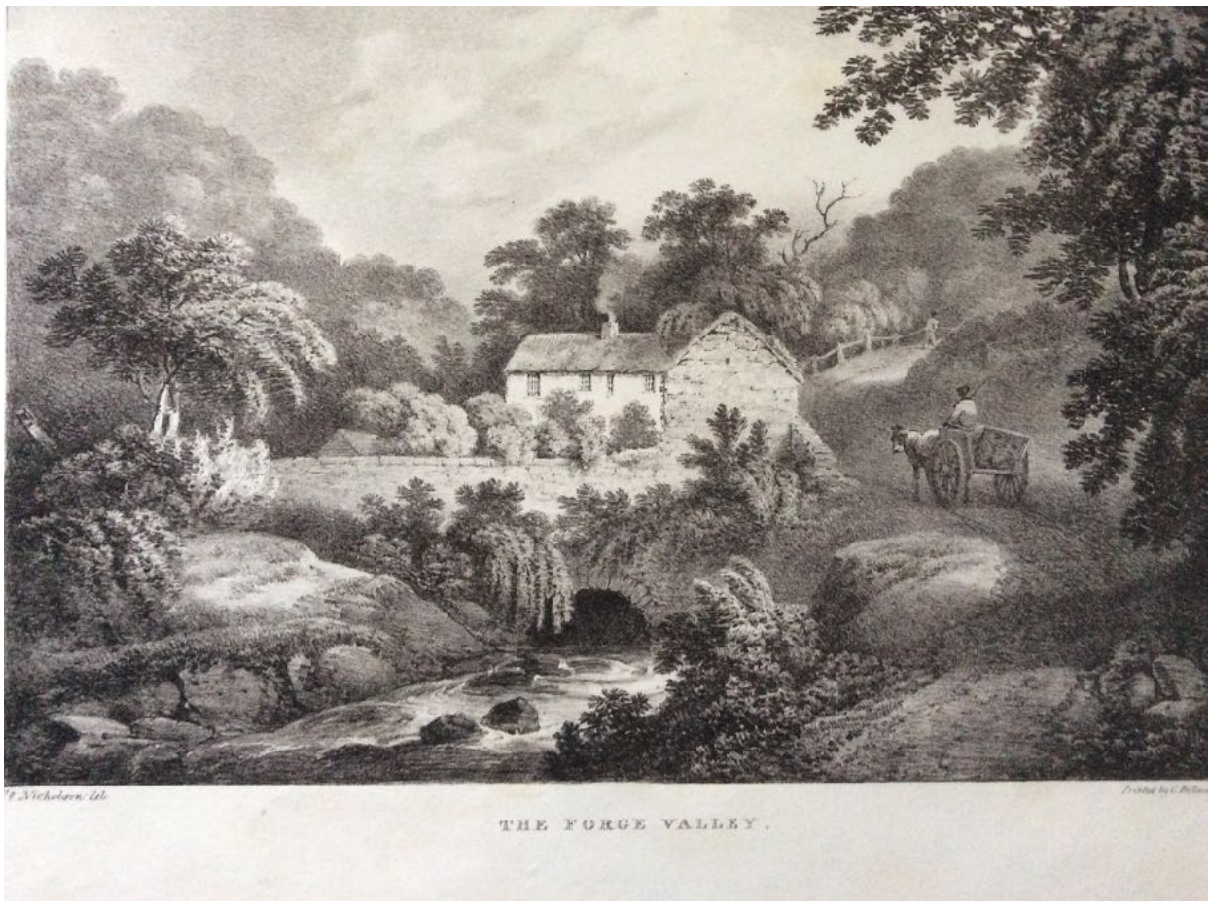
Figure 5. Lithograph of the forge from the south by Francis Nicholson published in 1822.

Two early views from the 1820s show the site from different directions but are valuable as evidence for the appearance of the site soon after the forge had ceased working. The artist Francis Nicholson published a portfolio of six lithograph views of Scarborough in 1822 including one titled 'The Forge Valley' showing the site viewed from the south next to a cart track on the line of the modern road (Nicholson, 1822). Three buildings are shown in the middle distance (Figure 5). A two-storeyed building with a single chimney facing the viewer; a second building closer to the viewer on the right shown gable-end on and a third low building to the left of which only part of the roof is visible. A stream issuing from an arched culvert adjoins the cart track and passes in front of the viewer. The second is a pencil sketch from a book of drawings in a private collection made by Mary Frances Crompton of Esholt Hall near Bradford in the early 1820s (Figure 6). Labelled 'Forge Valley', the drawing shows a low building with a tree and stream in the foreground suggesting it was drawn from across the Derwent to the north of the site.

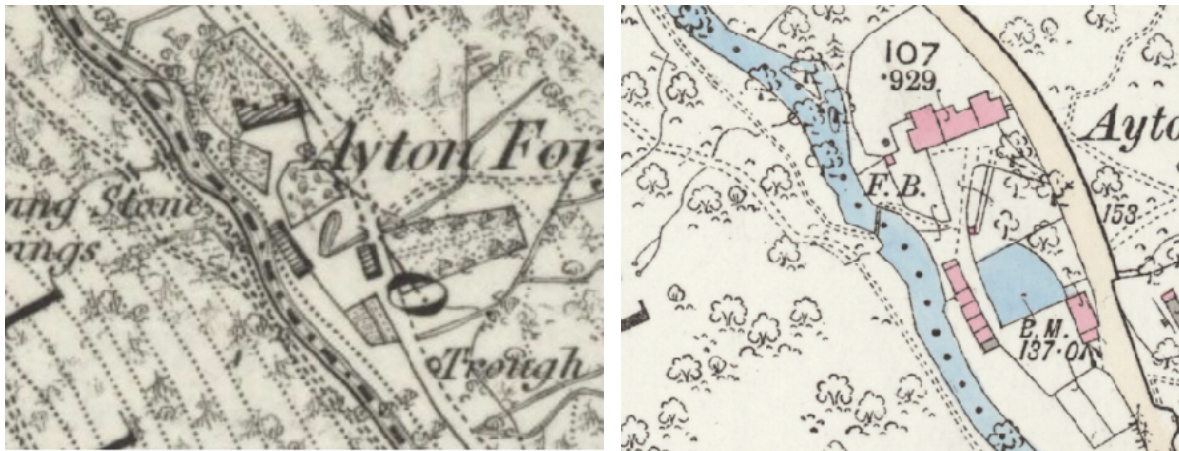
Figure 7. (left) The site depicted on the Ordnance Survey 1:10560 scale survey published in 1854 and Figure 8 (right) The site depicted on the Ordnance Survey 1:2500 scale survey published in 1892. Maps reproduced with permission of the National Library of Scotland.

The first edition Ordnance Survey map at a scale of six inch to the mile (1:10560) published in 1854 (Ordnance Survey 1854) and the more detailed 25 inch to the mile map (1:2500) published in 1892 (Ordnance Survey 1892) (Figures 7 & 8) give an accurate picture of the layout of the site in the second half of the century and shows three buildings in the same location as indicated on the 1822 Nicholson engraving.

- Building 1. (Forge Cottages). On the north of the site a terrace of buildings which became known as Forge Cottages, stood on the ridge of high ground. The 1892 map shows the terrace to comprise three properties which by that date were known as Forge Cottages. This is the two-storeyed building facing the viewer on the 1822 engraving.

- Building 2. On the west, there was a long narrow building aligned along the river. this is the building with only the roof showing on the 1822 engraving. This is also probably the long, low building viewed from across the river in the Crompton pencil sketch from the 1820s (Figure 6) and it appears on several late 19th and early 20th century photographs when it appears to have been used as stables (Figure 10).
- Building 3. On the south-east, next to the road there was a single building which was afterwards added to as both the 1912 and 1928 editions of the same map show further compartments to the west. This is the building shown gable end on on the 1822 lithograph.

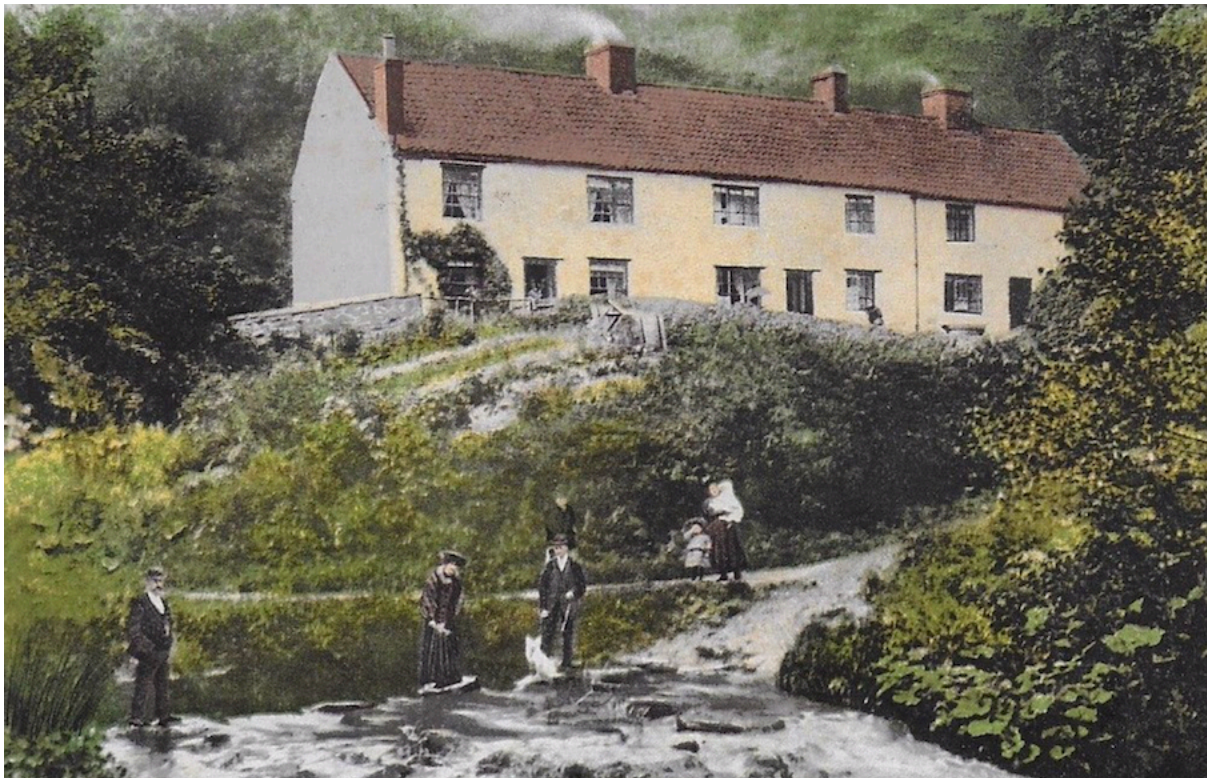
Figure 9. Forge Cottages (Building 1) viewed from across the Derwent in the early 20th century showing the stepping stones in the foreground.

There are numerous photographs surviving of the cottages (Figure 9) from which it is possible to discern that at some time the principal elevation of the building was either heavily lime-washed or lime rendered. At least one (possibly two) building ties are visible on some photographs at the gable end and other interruptions in the stonework suggest the building suffered some structural failure, possibly due to the proximity of the slope. In addition a section of the roof appears to have been repaired while one of the chimneys appears to interrupt the building in a way that it may be a later addition (S. Gandolfi pers. comm.).

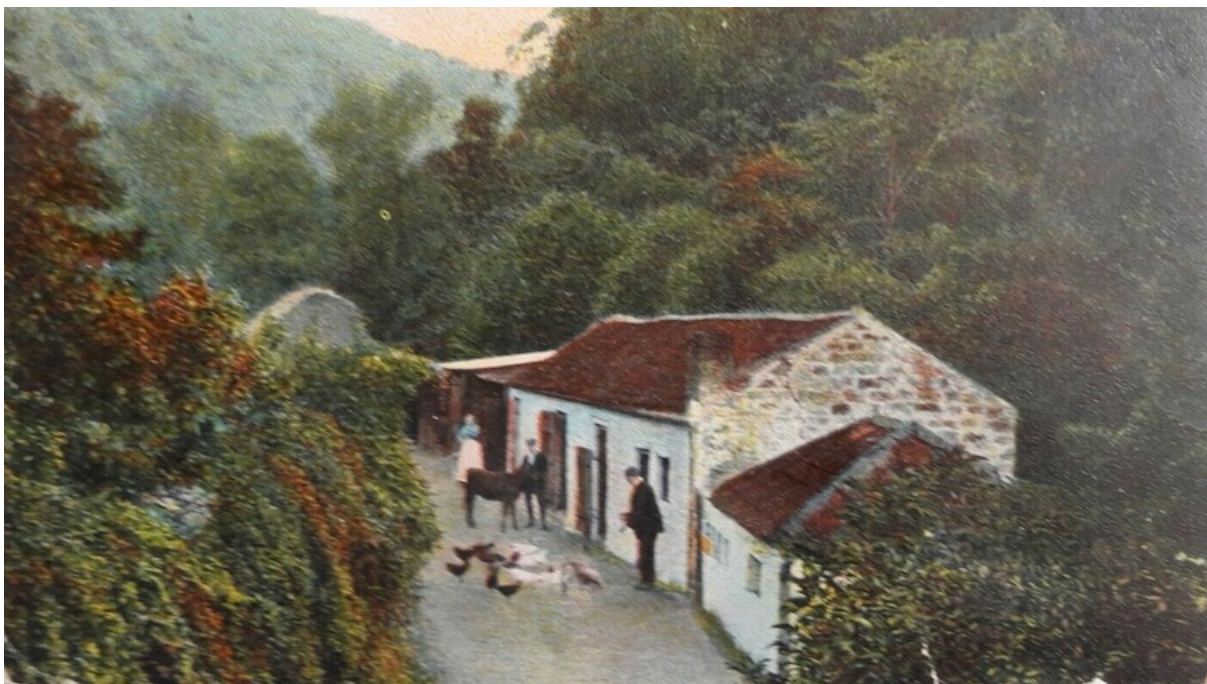
Figure 10. Building 2 viewed from the north-east in the early 20th century.

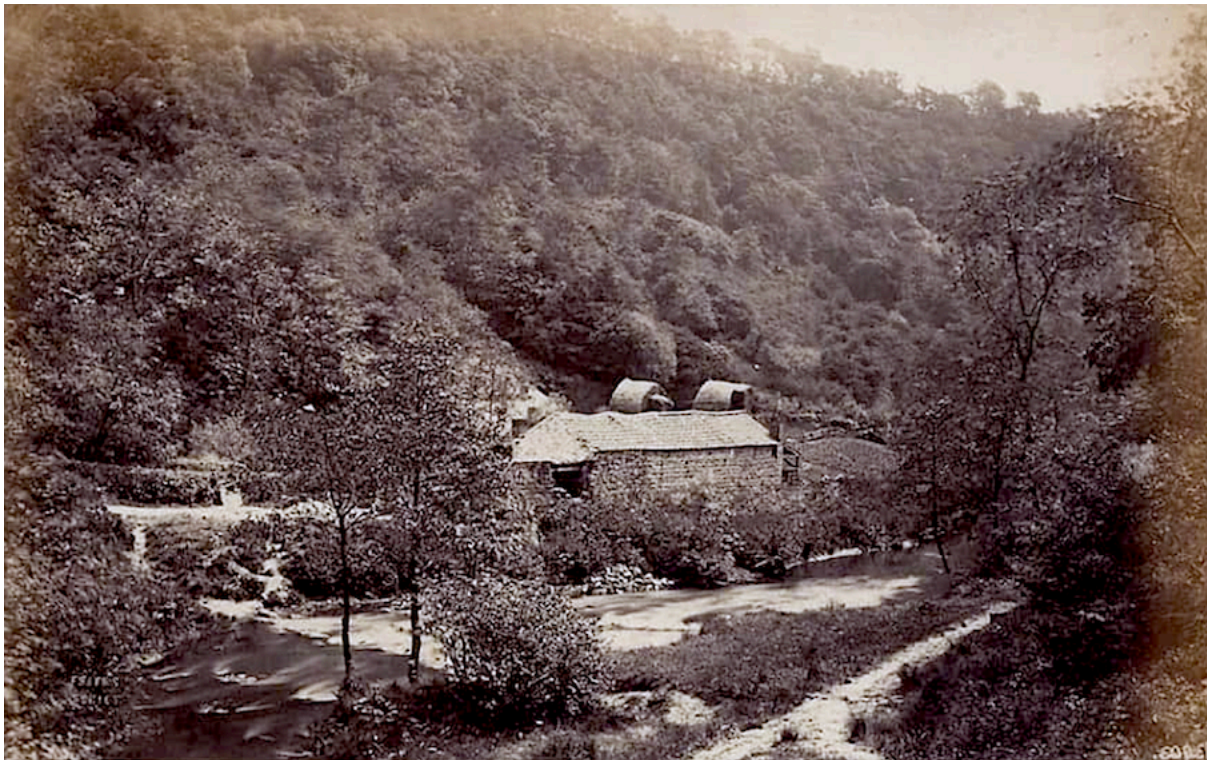
Figure 12. View of Building 2 from the north-west across the Derwent in the late 19th century.

increased in length to the south after 1854 so the building remains probably extend for another 15m beyond the south end of the visible wall foundations and for about 2m further to the north. The interior of the building and the east exterior wall could well survive below the car park. A change in the masonry visible on a photograph of the building from around the end of the 19th century supports the idea that it was constructed in two phases and interestingly, the exterior wall of the older north end had partially collapsed by that date (Figure 12).

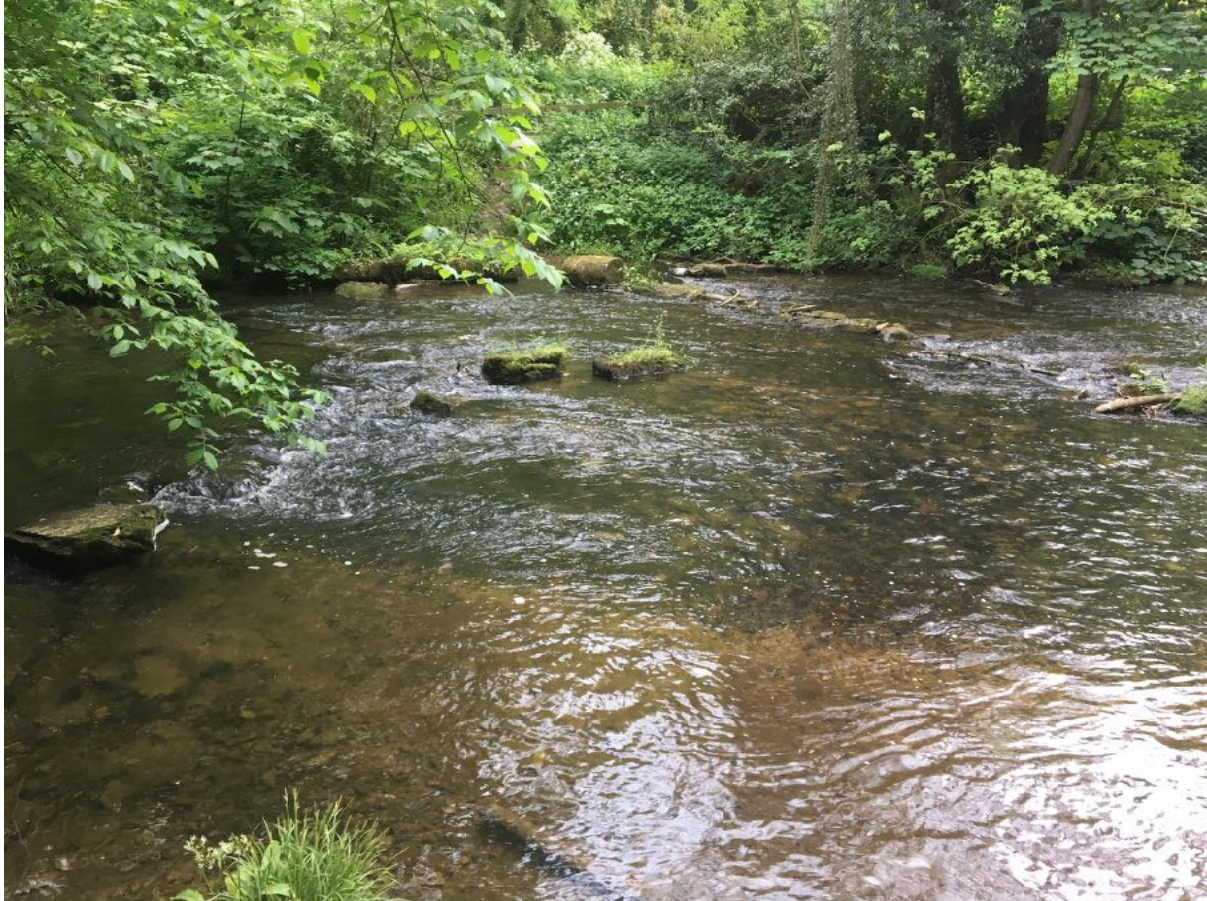
Figure 13. View across the Derwent towards the forge site showing the line of boulders in the river bed.

As part of the survey the river was examined for possible traces of the dam mentioned in the 1791 correspondence which would have been needed to manage the flow of water to power the water wheel at the forge. Though no definite traces of a dam survive, a distinct line of boulders across the stream bed 10m downstream of the footbridge could be a clue to its position (Figure 13). These served as stepping stones in the 19th century until the construction of the forerunner of the present footbridge. Alternatively, the dam could have been further upstream, perhaps at the foot of the ridge where the valley bottom is naturally narrower and so would make constructing a dam slightly easier.
