St Brandon's Church

BRANCEPETH

**AFTER THE FIRE**

Archaeological Recording  
1998-2002

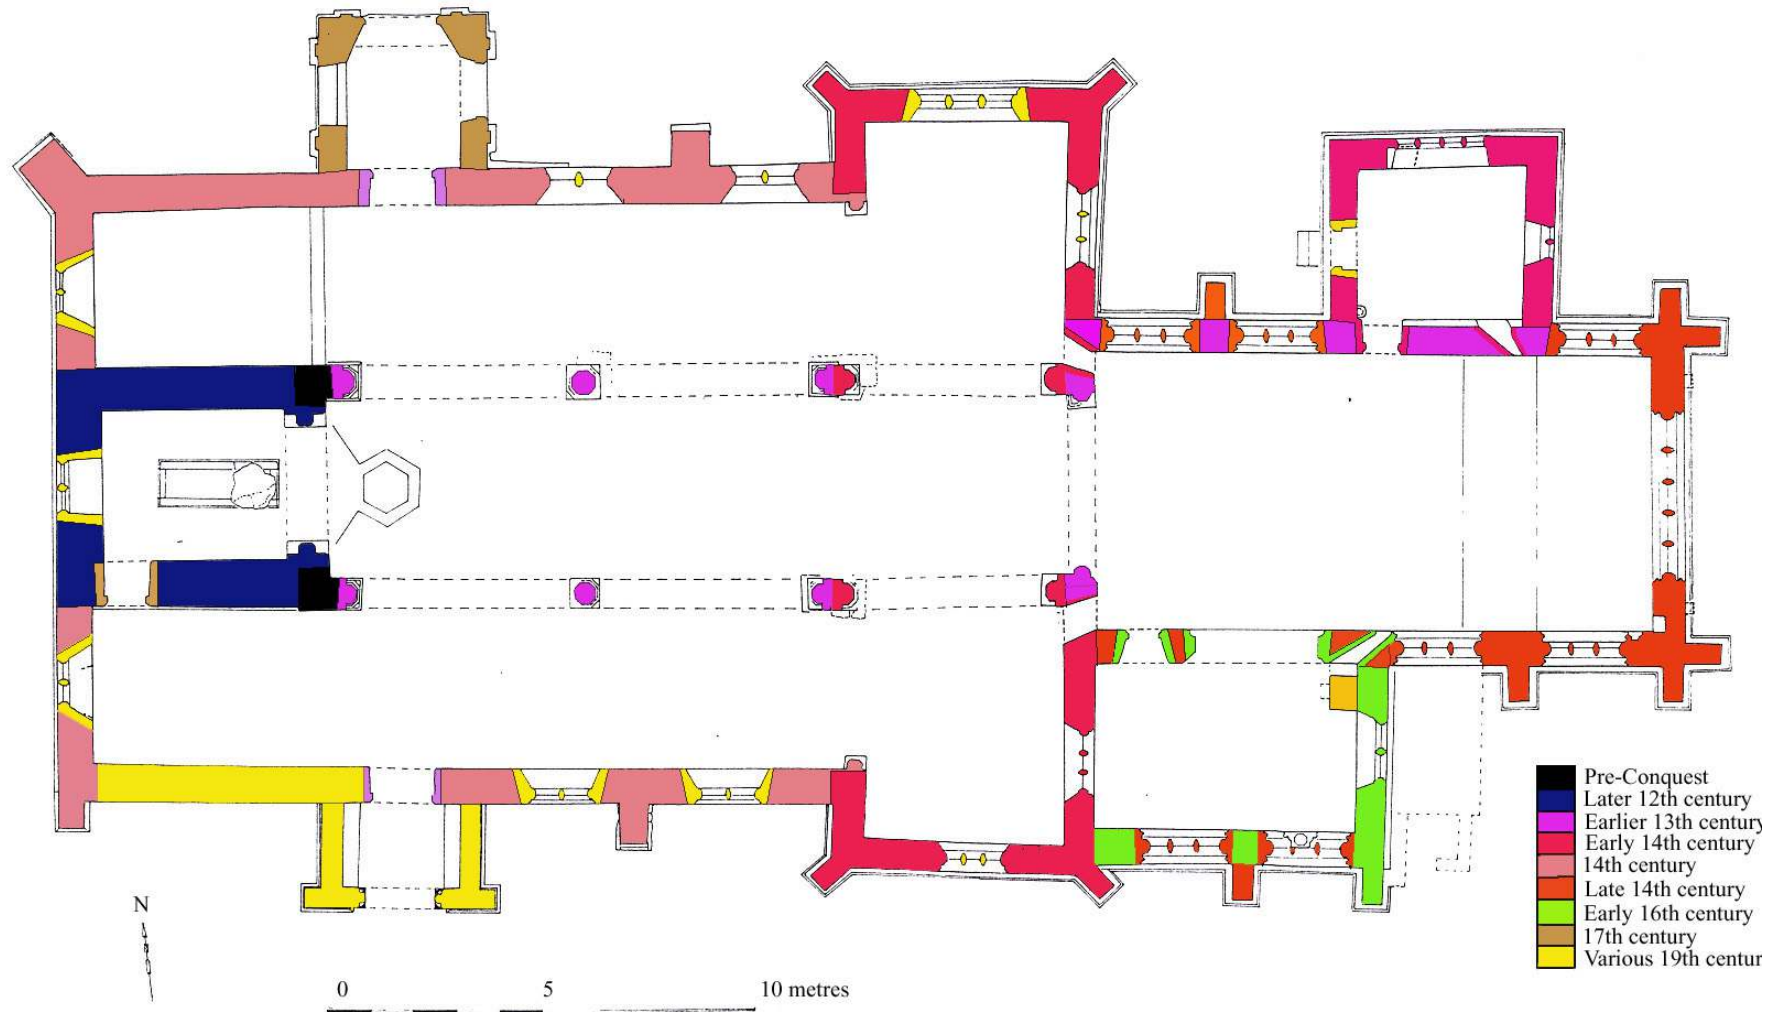
## Provisional Phased Plan

Plan based on EDM survey by R. Bayliss & L. Barker  
of the Archaeological Practise, University of Newcastle
