EPICAUM ROMAN FORT, CASTLE NOOK, ALSTON, NORTHUMBERLAND

ARCHAEOLOGICAL EVALAUTION

Interim Statement

An archaeological evaluation in advance of planning was undertaken on the proposed site of a new tea room and associated car park at Castle Nook Farm near Alston, Northumberland. The site of the proposed development was subject to an evaluation because it lay in close proximity to complex and extensive archaeological remains associated with Epiacum Roman Fort and the later development of the area. Therefore it is in an area of potential archaeological significance.

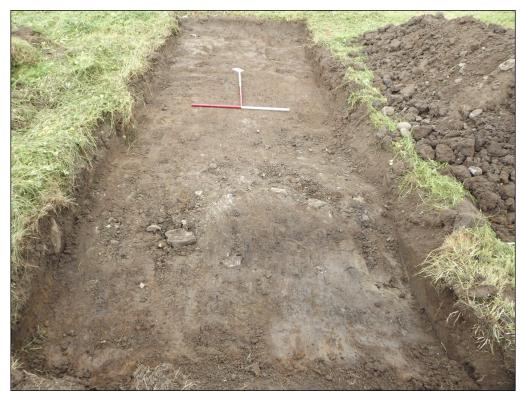
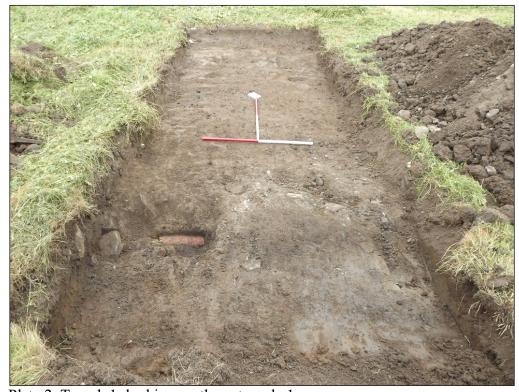
5.2 Trench 1 was at the north-western end of the site and located to investigate part of a geophysical anomaly and its possible relationship to the earth-work in the adjacent field. The excavation of the trench revealed a linear feature towards the western end of the trench that was filled with large, angular stones. A section excavated through these feature revealed the remains of a ceramic land-drain. It

appears that the original land-drain had become blocked and it was then dug out and replaced in parts with the angular stone. A small assemblage of late 19^{th} /early 20^{th} century ceramics was noted in the backfill.

Plate 1. Trench 1, looking north-east, scales 1m

Plate 2. Trench 1, looking north-east, scale 1m

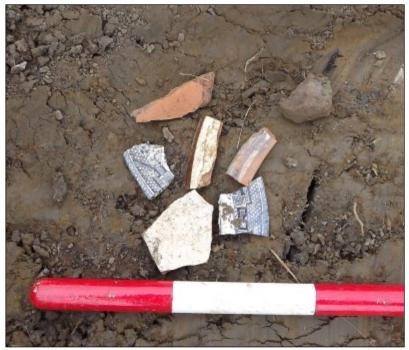
Plate 3. Trench 1, ceramic assemblage, scale interval 0.1m

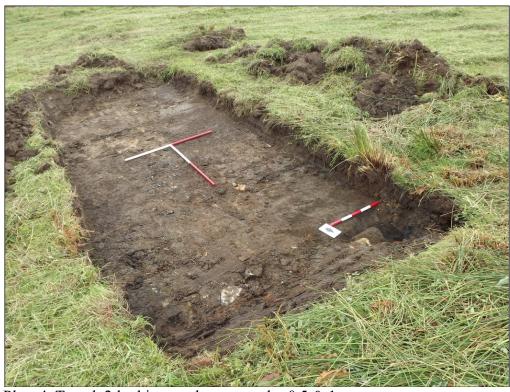
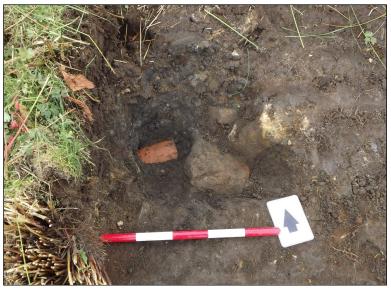
5.3 Trench 2 was located to investigate a further section of the geophysical anomaly within the footprint of the proposed building. This trench recorded the same stratigraphic sequence as described above, along with the continuation of the same stone and ceramic land-drain. From the alignment of the drain in the two trenches, it could be seen to be heading to a roadside drain in the adjacent roadway.

Plate 4. Trench 2 looking north-west, scales 0.5 & 1m

Plate 5. Trench 2, land-drain, scale 0.5m

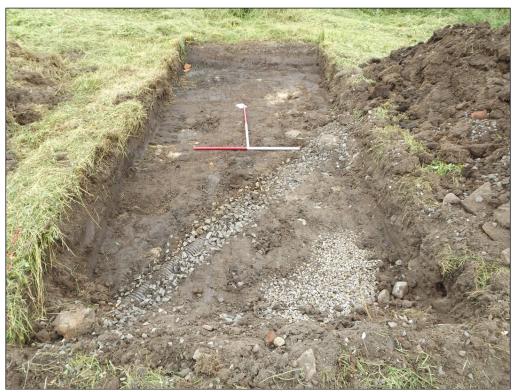
5.4 Trench 3 was located to investigate the geophysical anomaly within the area of the proposed car park. The excavation of this trench revealed a modern plastic land-drain in a trench that had been backfilled with stone chippings. There was a secondary gravel feature which also appears to represent an attempt at drainage. At the north-eastern end of the trench there was an area of very humic clayey soil which represents the discharge from the down-slope end of the land-drain noted in Trenches 1&2. Immediately adjacent to the north-eastern end of this trench, there is a gully under the roadside wall which leads to the drain in the roadway.

Plate 6. Trench 3, land-drains, looking north-east, scales 1m

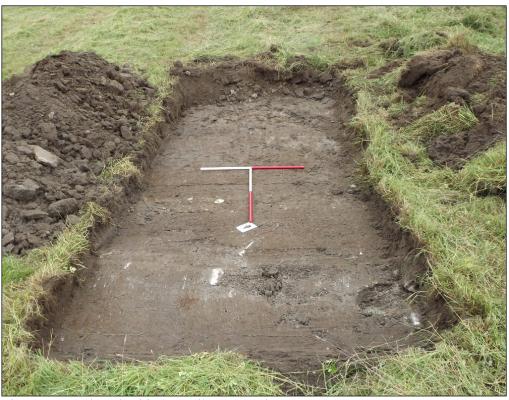
5.5 Trench 4 was located to investigate the geophysical anomaly running to the south-west. No archaeological features were recorded in this trench. It was noted however that the underlying mineral soil and stony deposits are higher in the stratigraphic sequence here, which may have caused the anomaly seen in the geophysical survey. It should also be noted that this geophysical anomaly was located very close to a gateway into the area of the proposed development and it is possible that farm traffic through this gateway has created the anomaly.

Plate 7. Trench 4, looking south-east, scales 1m

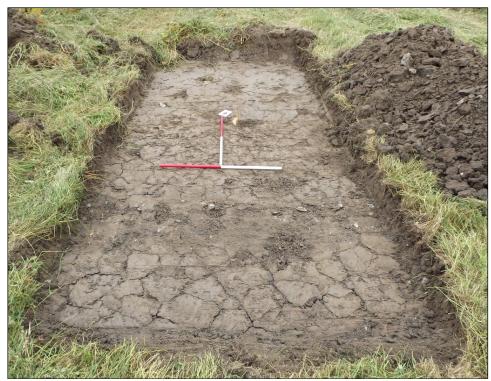
- 5.6 Trench 5 was located to investigate the geophysical anomaly running to the south-west. As with Trench 4 no archaeological features were recorded in this trench, although it was noted that the underlying mineral soil and stony deposits are higher in the stratigraphic sequence here which may have caused the anomaly seen in the geophysical survey. Interestingly in both Trenches 4&5 the anomalies run down slope to the east and would appear to probably be part of the natural draining of the site.
- 5.7 No other archaeological finds or features were encountered during the evaluation.

Plate 8. Trench 5, looking north-west, scales 1m

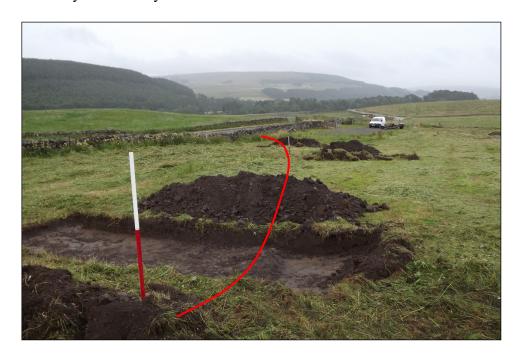
6.1 From the results described above, it can be seen that the site of the proposed development does not contain any archaeological remains. The various anomalies identified on the geophysical survey could all be seen to be either man-made or natural drainage features. The most obvious feature was the repair ceramic land-drain that had been backfilled with angular stone blocks. The back-fill of this drain produced the only finds from the evaluation – late 19th/early 20th century ceramics

- Plate 9. Trenches 1-3 showing line of the land-drain, looking SE, scales 1m No further archaeological work is recommended in the site of the proposed
- 6.2 development.
