# No. 3 Four Riggs, Darlington

Historic building report: Analysis and interpretation

Report

J. Deadman: Historic Buildings, Survey and Research

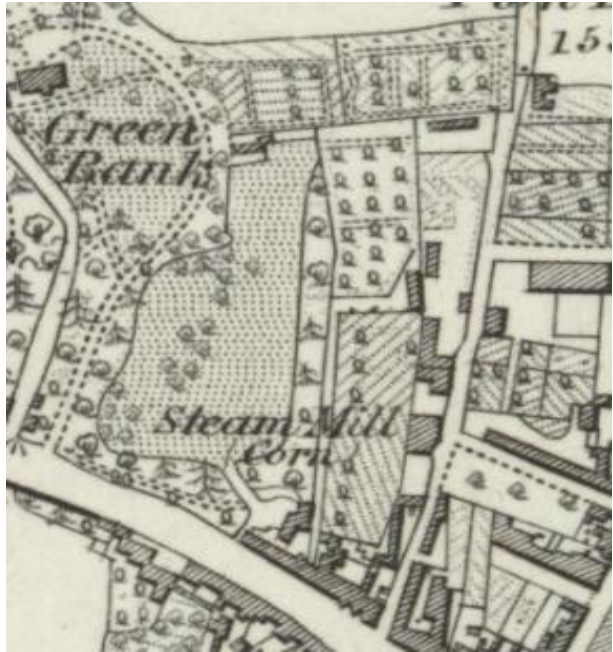
1855 OS map

The OS map of 1855 depicts the yard area to the side of no. 3 with a structure seemingly on the footprint of the present building. However, its angle to the road and that of the structures adjoining do not follow the building line of the house and terrace which is clearly in evidence by the end of the century. (ref 1896 below)

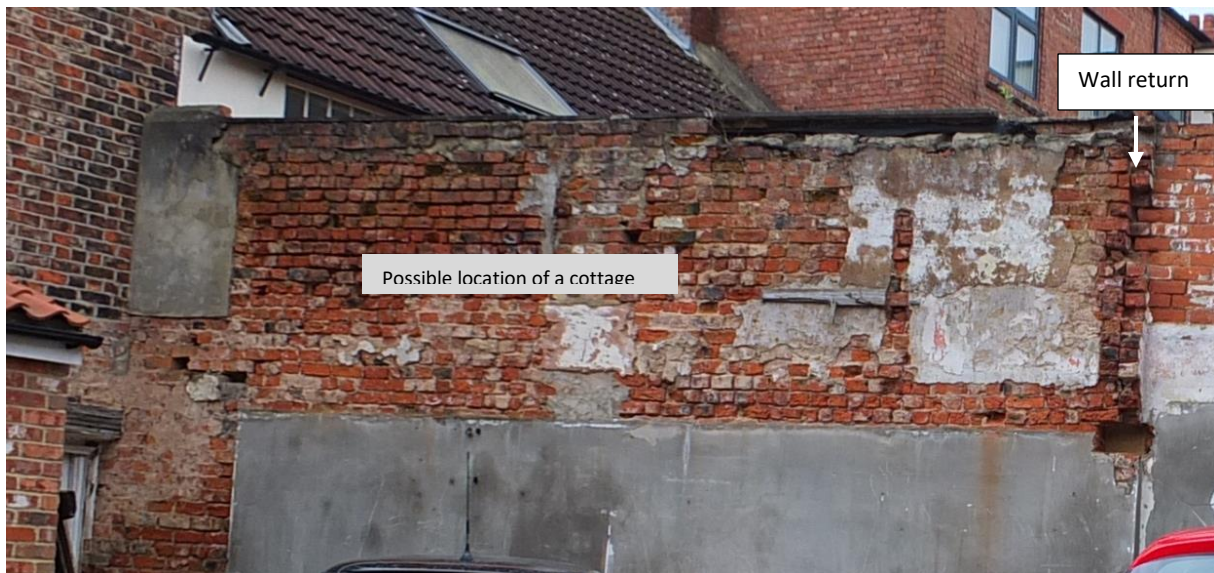
Phase 1 adjoins no. 70 Bondgate and evidences the remains of a wall return into the yard. This phase appears to have no rear access, whereas phase 2 has two access points.

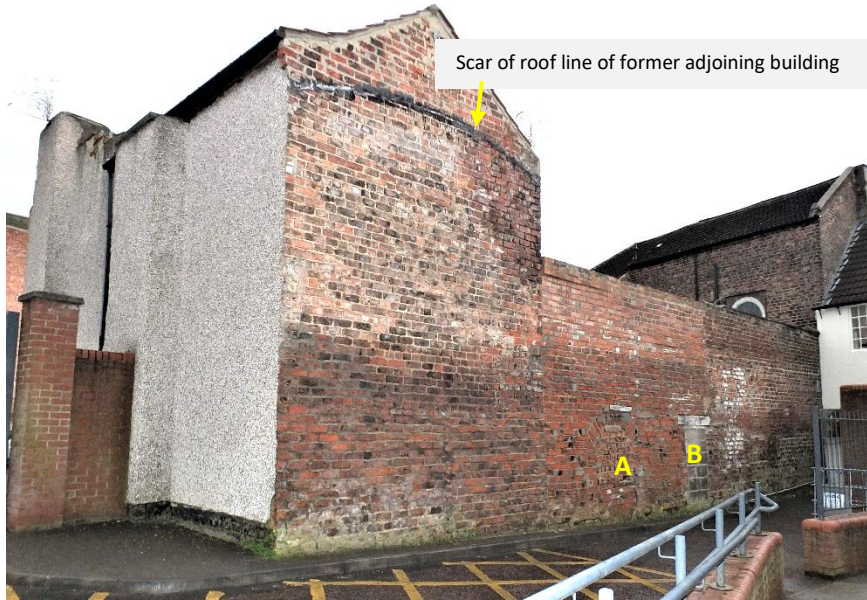
The rear of the wall evidences two doorways, referred to below as **A** and **B**, of which **A** is an original feature. It would have provided access to the neighbouring yard depicted on the 1896 OS map, and was possibly blocked when the two small structures in the adjoining yard were built.

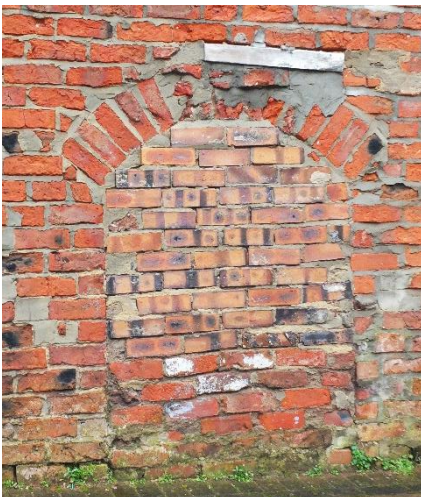
**A** comprises a low entry with arched brick lintel and brick blocking of two phases. **B** appears to be secondary, has a modern wood lintel and breeze block infill. Note the three phases of wall evident above and to the side of door **B**.

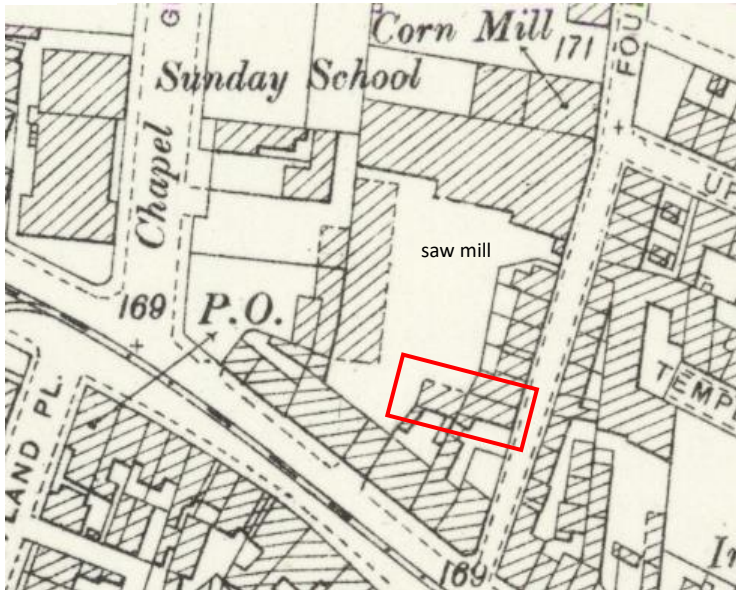
1896

At some point within the next forty years, this structure was replaced by a much larger building as depicted on the 1913 OS map

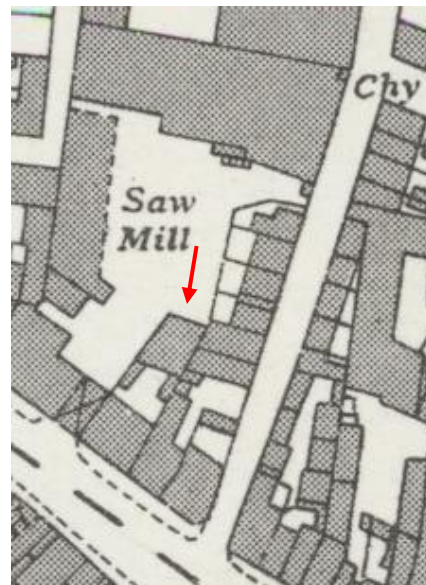
1913

By 1896 the open fields to the north were replaced by rows of terraced housing. Four Riggs comprised a modest amount of housing, but by this date was dominated on the west side by a large saw mill and steam powered corn mill. Either on the left or right-hand side of the road was stabling for tram horses and to the right was an almshouse.

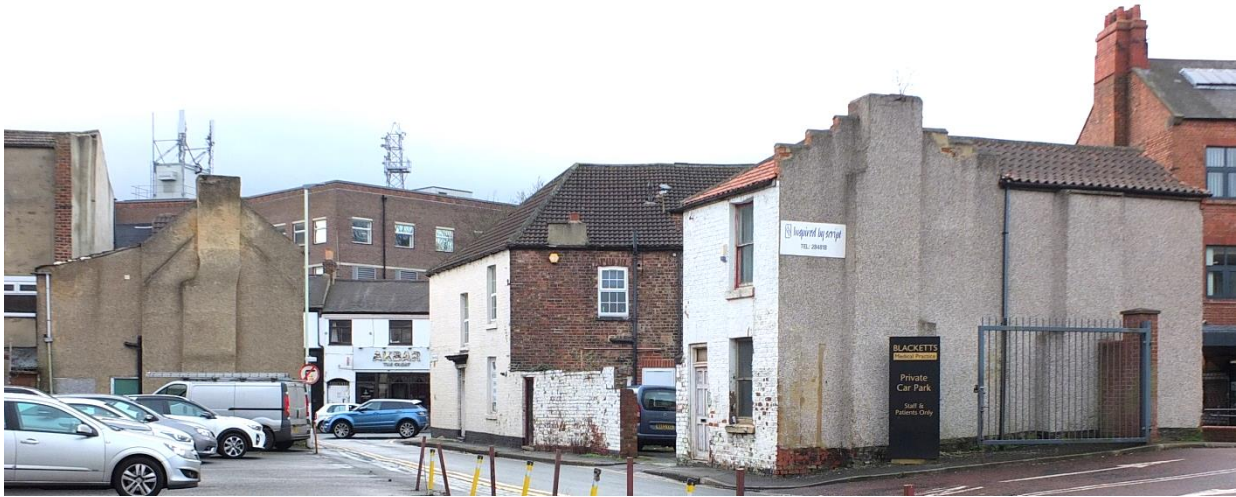
**Below:** Evidence for truncated terraces at the Bondgate end of Four Riggs. In the foreground is no. 3 with the roofline, chimney breast and stack representing the cut off point on the east side of the street.

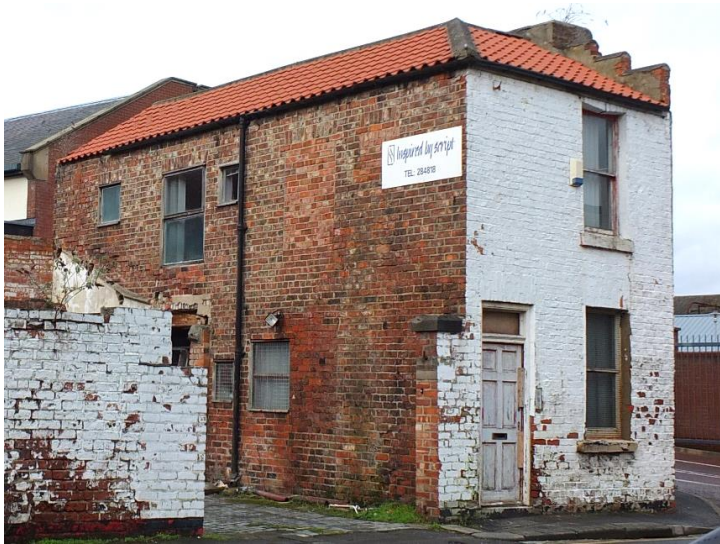
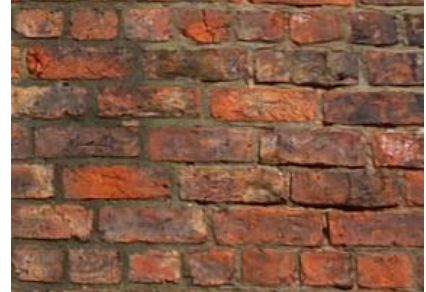
The building is two storeys high, brick built and presently set under a pantiled roof. It was located at the south end of a short run of houses and formed the return at the end of the row as evidenced by the L shaped configuration of the roof. The north elevation is rendered at the point where the terrace was truncated leaving the chimney stacks which served no. 3 and the former adjoining building. The frontage faces onto the street. There is no rear entry to the property.

Bricks are laid to 'English Garden Wall' bond, in this case five rows of stretchers to one of headers. This bond was used in solid walls, i.e. no cavity, and historically was primarily found in the north of England.

The window openings on the front elevation are original which suggests the present fenestration replaced vertical sliding sashes. There are no side dressings to the window reveals, but the lintels comprise a row of vertical headers one and a half bricks in length. The cills are of sandstone and project beyond the face of the wall. The lower cill terminates in rounded corners, the upper cill in squared.

The present door is a 20<sup>th</sup> century replacement. but the small light set above is an original feature.

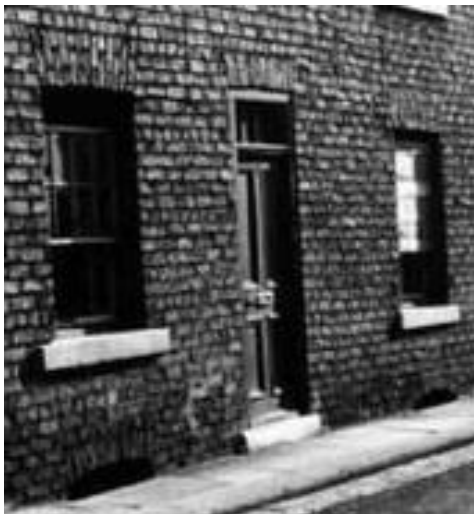
The photograph<sup>3</sup> shown below of the almshouses formerly located on the east side of the street and of a similar date (erected 1868), evidences architectural details in common with no. 3. The windows are sliding sashes although multi paned in contrast with those at no. 3 would have originally comprised four panes. The cills stand proud of the walls. The almshouse window lintels are comprised of headers set vertically to the same design as observed at no.3. The four paneled front door has a central letter box and the light above divided into three/quarter vertical sections

*Almshouses*

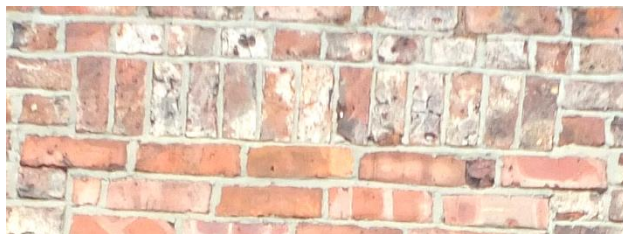
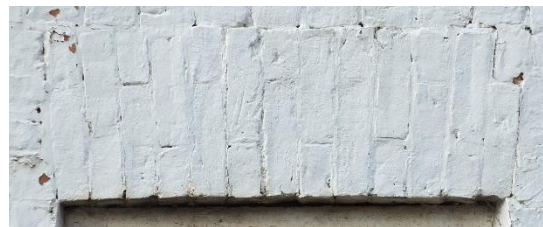
**A, B, G, H:** Window openings with lintels of headers set vertically, but not laid to the same design as those on the front elevation. Here the bricks are laid singly, whereas those to the front are one and a half bricks laid in a staggered pattern. This would suggest a later, possibly 20<sup>th</sup> century date for these inserts. There is evidence in disturbance below window B which would suggest this was originally of the same dimensions as those on the front elevation, with both the window and the later lintel, secondary features.

**C, D, E:** Later insertions, with neither lintels nor cills. **E** may have replaced a small scullery window.

**F:** Blocked doorway.

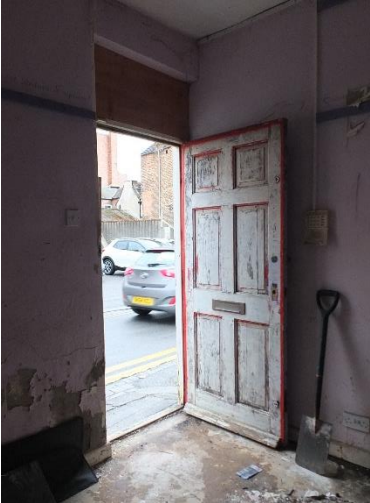
Entry from the road led directly into one room which would have served as kitchen and living area. It was lit by a window on the front elevation. To the rear of the room is the possible location of a small scullery. A window, **F**, presently located on the yard side, is a modern insertion which may have replaced an earlier window lighting the scullery area. A doorway, now blocked, possibly provided access to the yard, although it would seem unlikely two entries existed in close proximity serving one room.

*Scullery area*

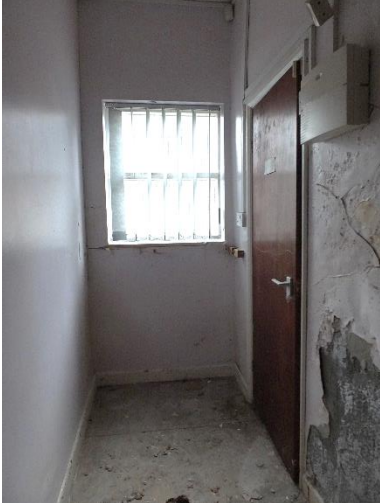
*Room looking towards stairs*

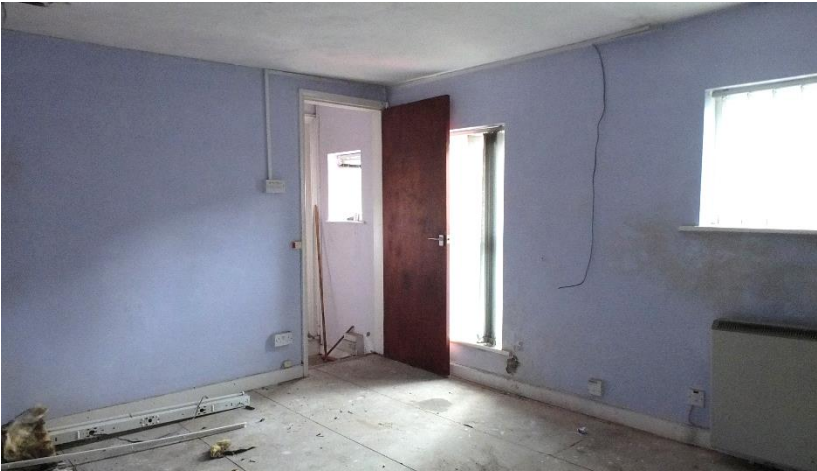
*Room above rear unit with modern fittings.*

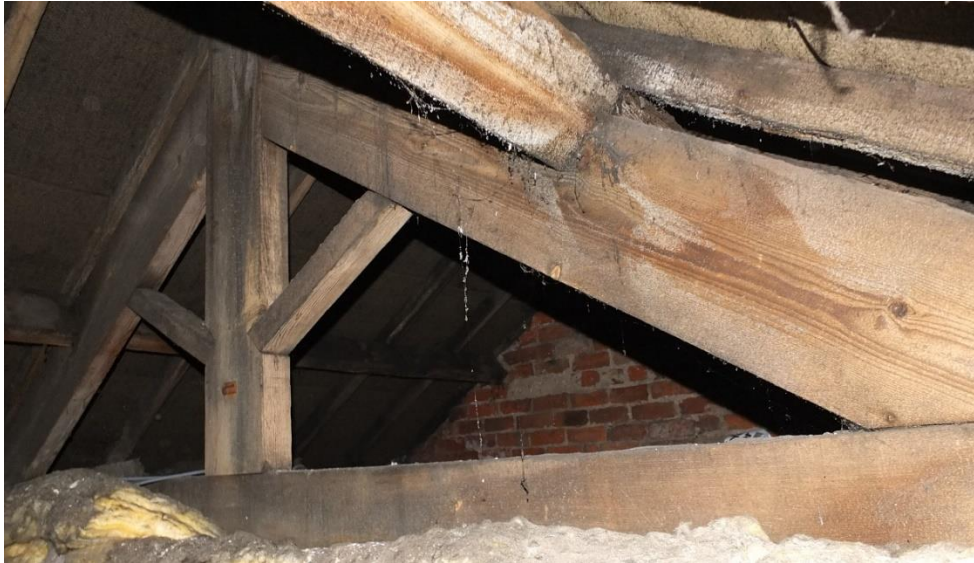
Roof truss over rear unit: Simple king post truss with struts to the principal rafter.
