EXCAVATIONS AT TILBURY FORT, ESSEX
SITE CODE: TF1 - 95.

TQ 6505 7527

M. BEASLEY.
21.06.1995.

ABSTRACT.

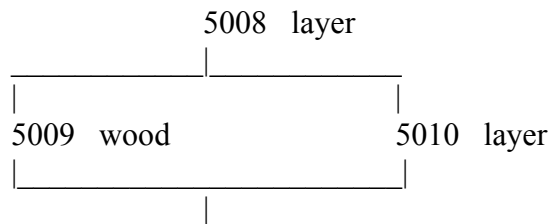
Group 1d.

5008 layer; mid grey sandy silt with coal	2.00m - 1.98m
5009 wood; decayed wood	1.99m - 1.98m
5010 layer; mid grey sandy silt with mortar	1.98m - 1.91m

Two dumped floor layers with a small piece of decayed lath-work. 18th. century date.

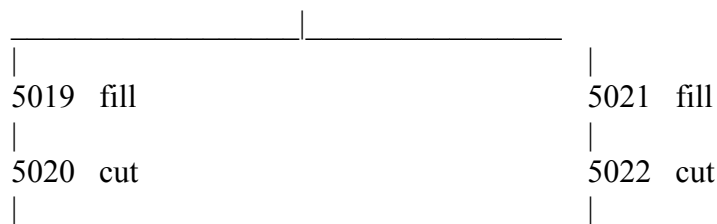
Group 1e.

5019 fill; dark grey sandy silt	1.89m - 1.63m
5020 cut; circular, abrupt change top to sides, sharp to concave bottom	1.89m - 1.63m
5021 fill; dark grey sandy clay silt	1.89m - 1.79m
5022 cut; ovoid, moderate change top to sides, gradual to concave base	1.89m - 1.79m

Two cuts with associated fills. Comprises one post hole and an amorphous cut. 18th. century date.

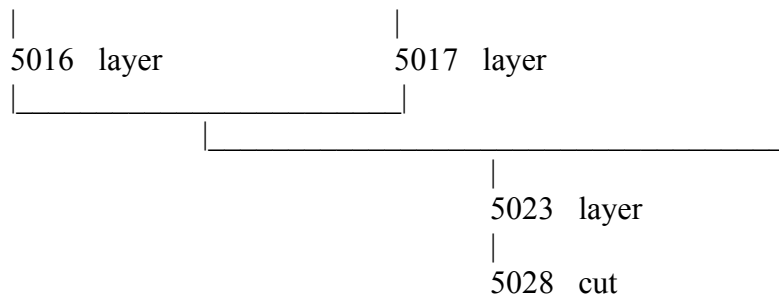
Group 1f.

5016	layer; white chalk	1.94m - 1.89m
5017	layer; black, sand, ash and coal dust	1.89m - 1.88m
5023	layer; mid red brown sand and gravel	1.91m - 1.84m
5028	cut; linear, sharp change top to straight sides, sharp to flat bottom	1.83m - 1.73m

Three layers and a cut. Comprises floor layers and gravel make-up filling the robber cut for a wall. 18th. century date.
